ADA Access Barrier Assessment Report For

**Pro Building
507 F Street
Eureka, CA 95501
Last Updated 8/14/2023**

ACCESSIBILITY COMPLIANCE ASSESSMENT REPORT

507 F Street, Eureka, CA – CASp Assessment II

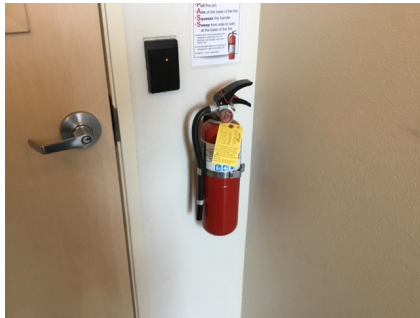
2F

Accessibility Element: Protruding Objects

Specific Item: Protruding Object

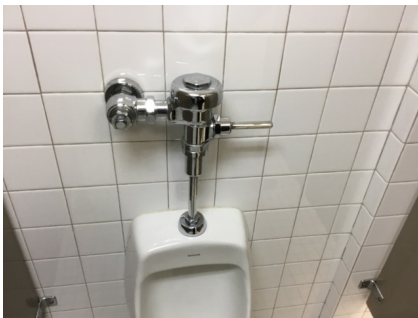
9M

Accessibility Element: Operable Parts

Specific Item: Operation

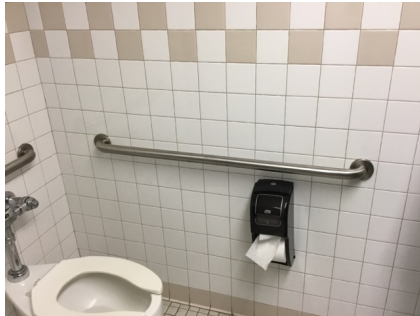
9Q

Accessibility Element: Water Closets & Toilet Compartments

Specific Item: Side Grab Bar

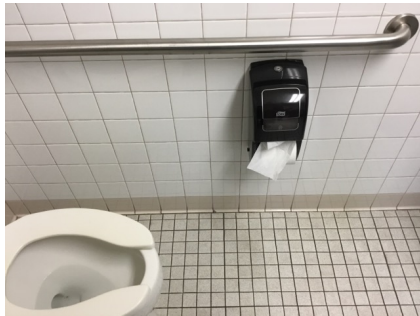
9R

Accessibility Element: Water Closets & Toilet Compartments

Specific Item: Toilet Paper Dispenser

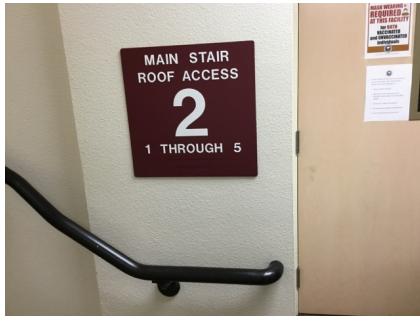
16A

Accessibility Element: Stairways

Specific Item: Stairway Identification Sign

Two signs are required for enclosed stairways: Stairway Identification Sign (provided but does not require tactile characters and braille. characters should be removed or corrected) at each floor landing in an interior exit stairway connecting more than three stories designating the floor level, the terminus of the top and bottom of the interior exit stairway and ramp and the identification of the stairway. The signage shall state the story of, and the direction to, the exit discharge and the availability of roof access from the interior exit stairway for the fire department. The sign shall be located 5 feet above the floor landing in a position that is readily visible when the doors are in the open and closed positions. Additionally: Floor identification signs required by Chapter 10, Section 1023.9 complying with Sections 11B-703.1, 11B-703.2, 11B-703.3 and 11B-703.5 shall be located at the landing of each floor level, placed adjacent to the door on the latch side, in all enclosed stairways in buildings two or more stories in height to identify the floor level. At the exit discharge level, the sign shall include a raised five pointed star located to the left of the identifying floor level. The outside diameter of the star shall be the same as the

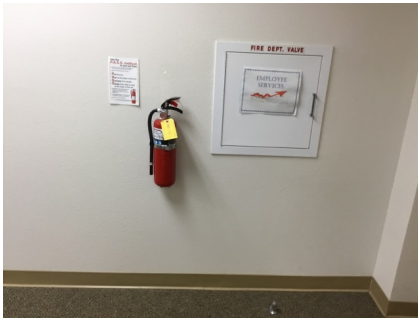
18A

Accessibility Element: **Protruding Objects**

Specific Item: **Protruding Object**

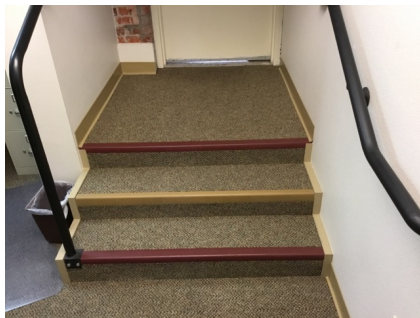
21C

Accessibility Element: Stairways

Specific Item: Contrasting Stripe

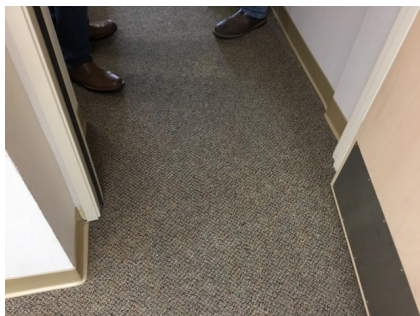
23J

Accessibility Element: Doors

Specific Item: Door Threshold

12/14/21: Carpet replaced.

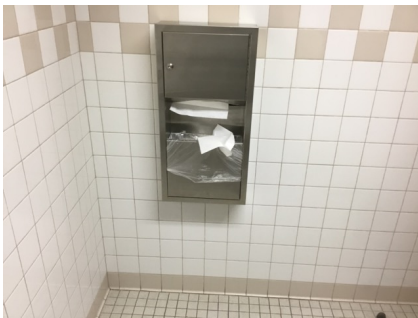
24F

Accessibility Element: Toilet and Bathing Rooms

Specific Item: Accessories

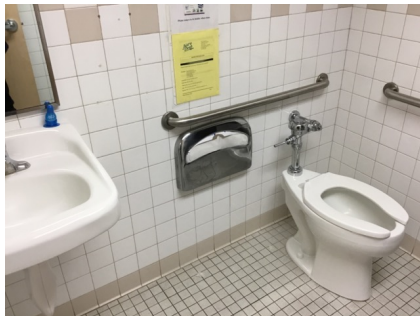
24H

Accessibility Element: Water Closets & Toilet Compartments

Specific Item: Overlap

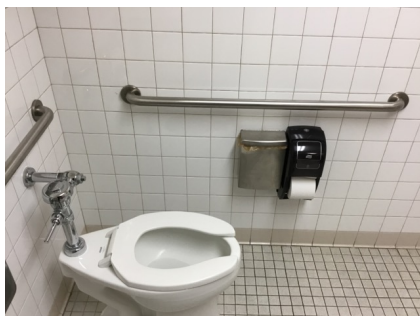
24K

Accessibility Element: Water Closets & Toilet Compartments

Specific Item: Side Grab Bar

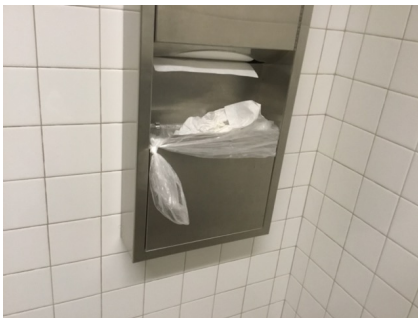
25E

Accessibility Element: Toilet and Bathing Rooms

Specific Item: Accessories

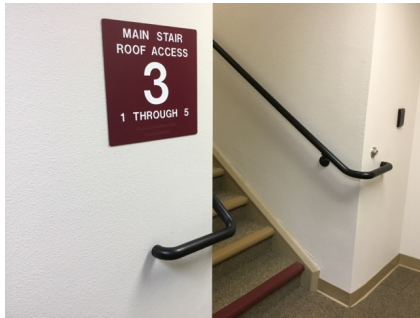
31B

Accessibility Element: Stairways

Specific Item: Stairway Identification Sign

Either remove braille or replace with compliant braille on stairway signs. Also provide compliant floor identification signs on the latch side of doors within the enclosed stairway and exit signs at stairway entries where illuminated signs are also provided. (Also see item 16A).

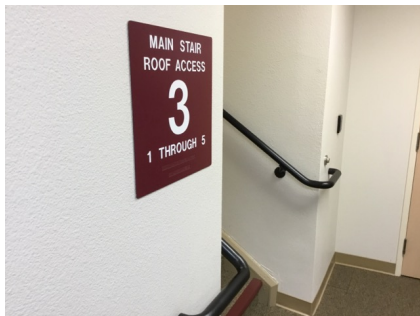
31C

Accessibility Element: Stairways

Specific Item: Stairway Identification Sign

Either remove braille or replace with compliant braille on stairway signs. Also provide compliant floor identification signs on the latch side of doors within the enclosed stairway and exit signs at stairway entries where illuminated signs are also provided. (Also see item 16A).

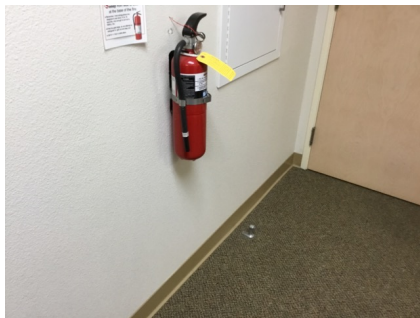
32D

Accessibility Element: **Protruding Objects**

Specific Item: **Protruding Object**

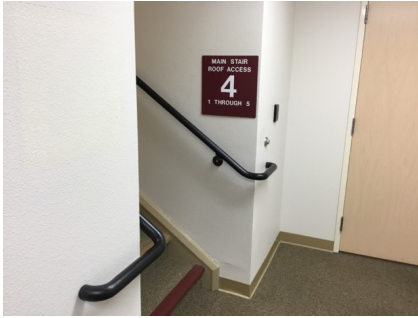
34B

Accessibility Element: Stairways

Specific Item: Stairway Identification Sign

Either remove braille or replace with compliant braille on stairway signs. Also provide compliant floor identification signs on the latch side of doors within the enclosed stairway and exit signs at stairway entries where illuminated signs are also provided. (Also see item 16A).

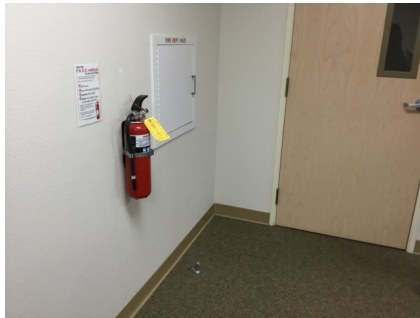
35D

Accessibility Element: **Protruding Objects**

Specific Item: **Protruding Object**

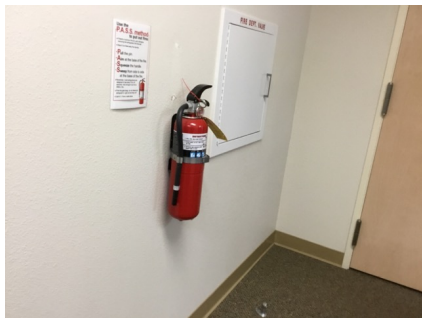
38D

Accessibility Element: **Protruding Objects**

Specific Item: **Protruding Object**

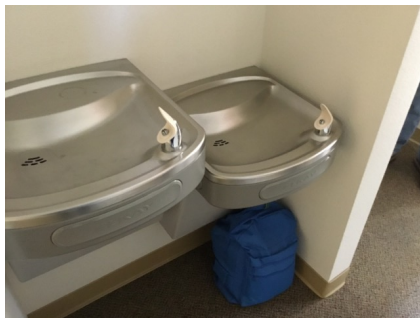
40B

Accessibility Element: Drinking Fountain

Specific Item: Clear Floor Space

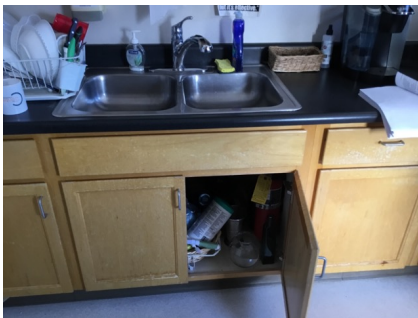
41H

Accessibility Element: Lavatories and Sinks

Specific Item: Height & Knee Clearance

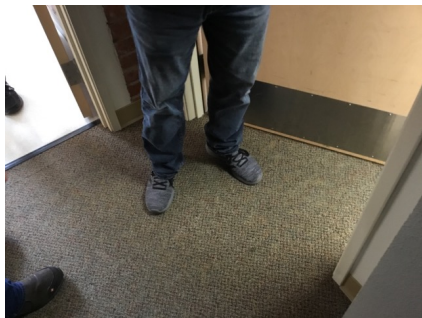
44E

Accessibility Element: Doors

Specific Item: Door Threshold

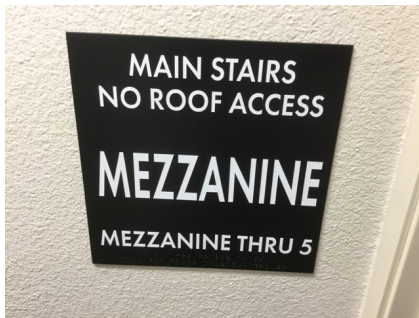
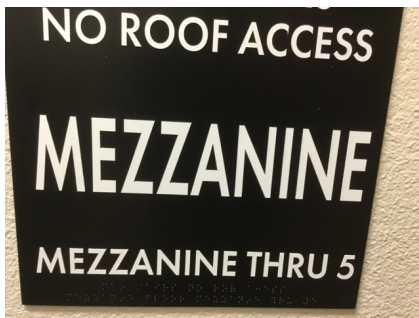
6A

Accessibility Element: Stairways

Specific Item: Stairway Identification Sign

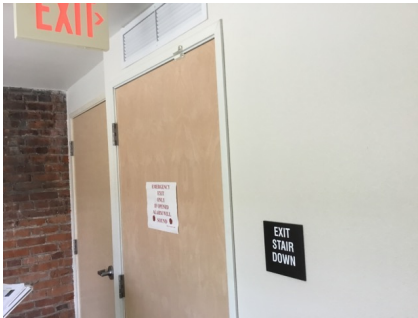
13A

Accessibility Element: Signs

Specific Item: Exit Signage

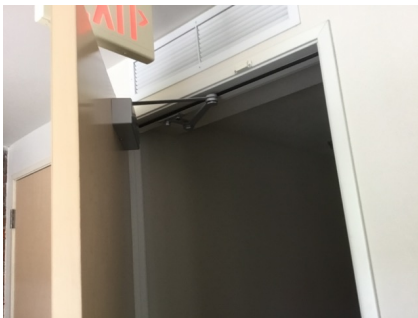
13C

Accessibility Element: Doors

Specific Item: Door Pressure

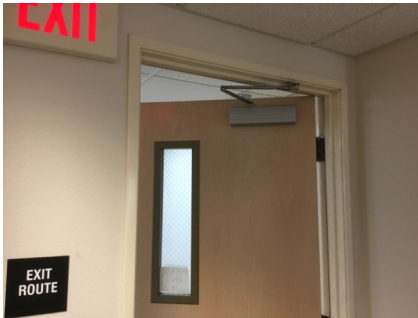
19D

Accessibility Element: Doors

Specific Item: Door Pressure

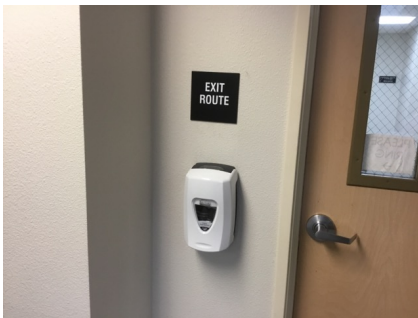
19F

Accessibility Element: Signs

Specific Item: Installation

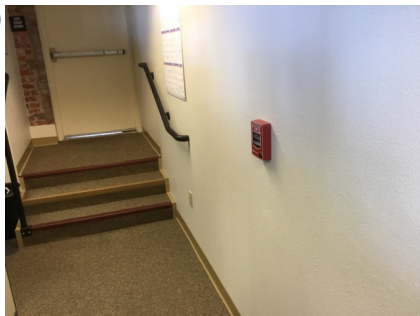
21D

Accessibility Element: Fire Alarms

Specific Item: Fire Alarm Boxes

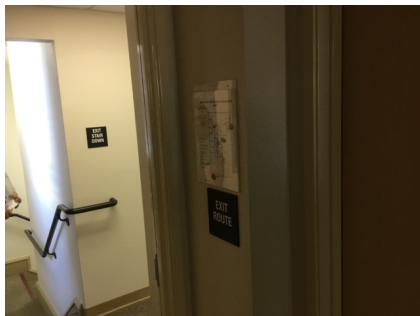
23E

Accessibility Element: Signs

Specific Item: Installation

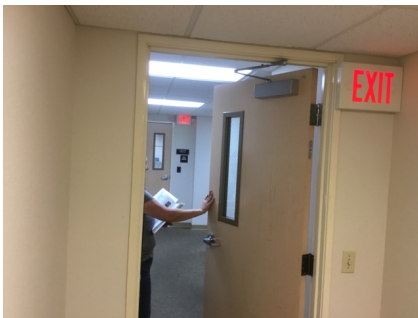
26E

Accessibility Element: Signs

Specific Item: Exit Signage

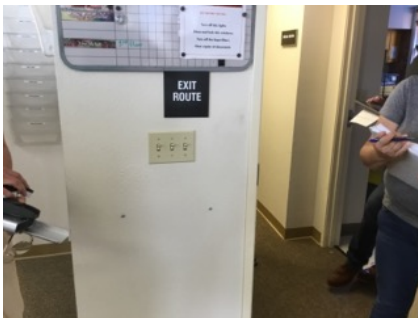
27E

Accessibility Element: Signs

Specific Item: Installation

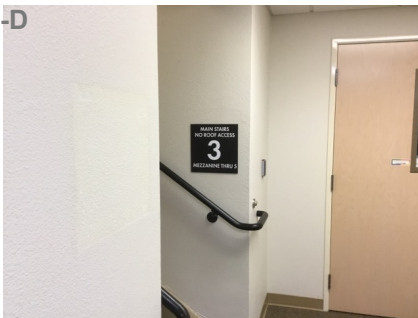
31B-D

Accessibility Element: Stairways

Specific Item: Stairway Identification Sign

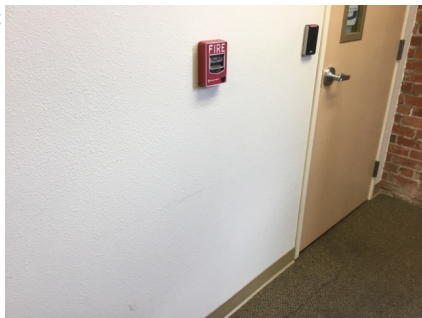
32C

Accessibility Element: Fire Alarms

Specific Item: Fire Alarm Boxes

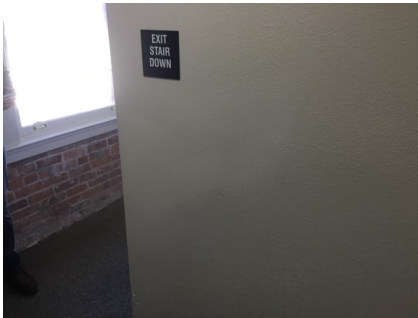
34A

Accessibility Element: Signs

Specific Item: Exit Signage

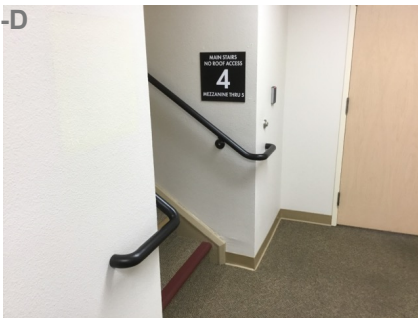
34B-D

Accessibility Element: Stairways

Specific Item: Stairway Identification Sign

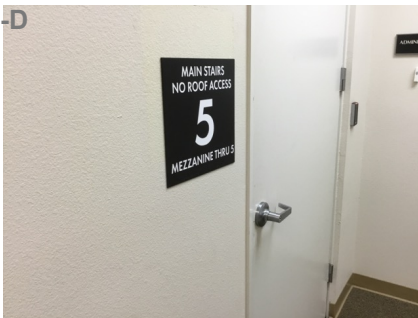
37B-D

Accessibility Element: Stairways

Specific Item: Stairway Identification Sign

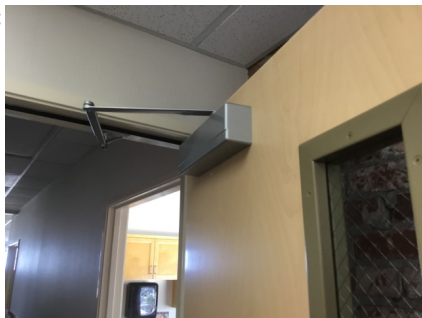
39C

Accessibility Element: Doors

Specific Item: Door Pressure

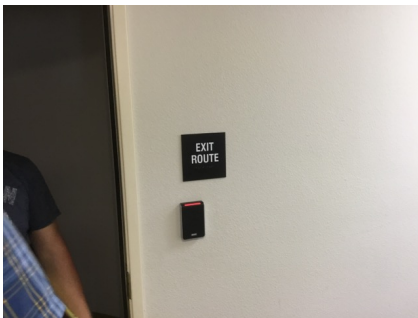
44G

Accessibility Element: Signs

Specific Item: Exit Signage
