**ASBESTOS SURVEY
LEAD PAINT SAMPLING &
LEAD WASTE CHARACTERIZATION
FOR DEMOLITION OR RENOVATION OF THE
GARBERVILLE VETERANS BUILDING
483 CONGER STREET
GARBERVILLE, CA**

January 8, 2021

Project # 2000311

Prepared for:
Humboldt County Public Works
Attn: Mr. Jake Johnson
1106 2nd Street
Eureka, CA 95501
(707) 445-7652

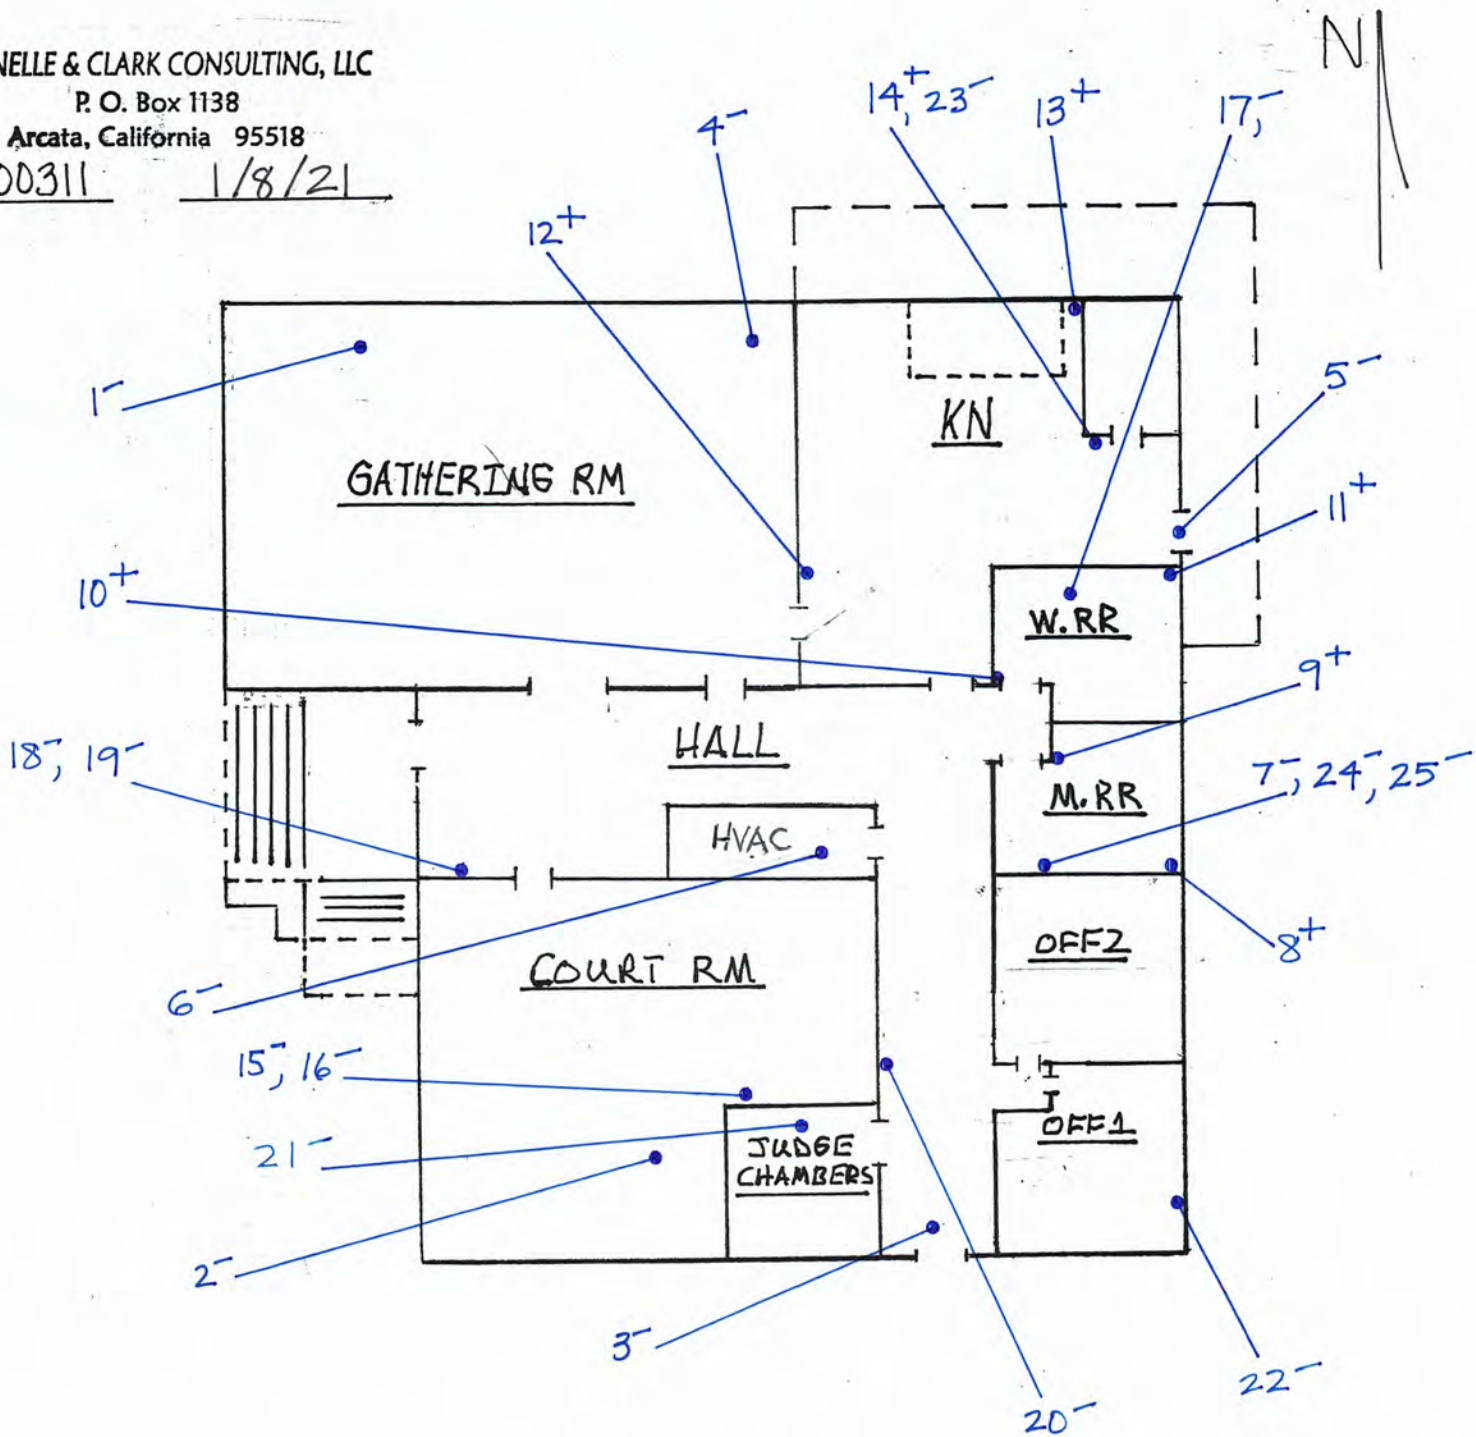
FIG. 1

SAMPLE LOCATIONS

(Asbestos Samples: 1-25)

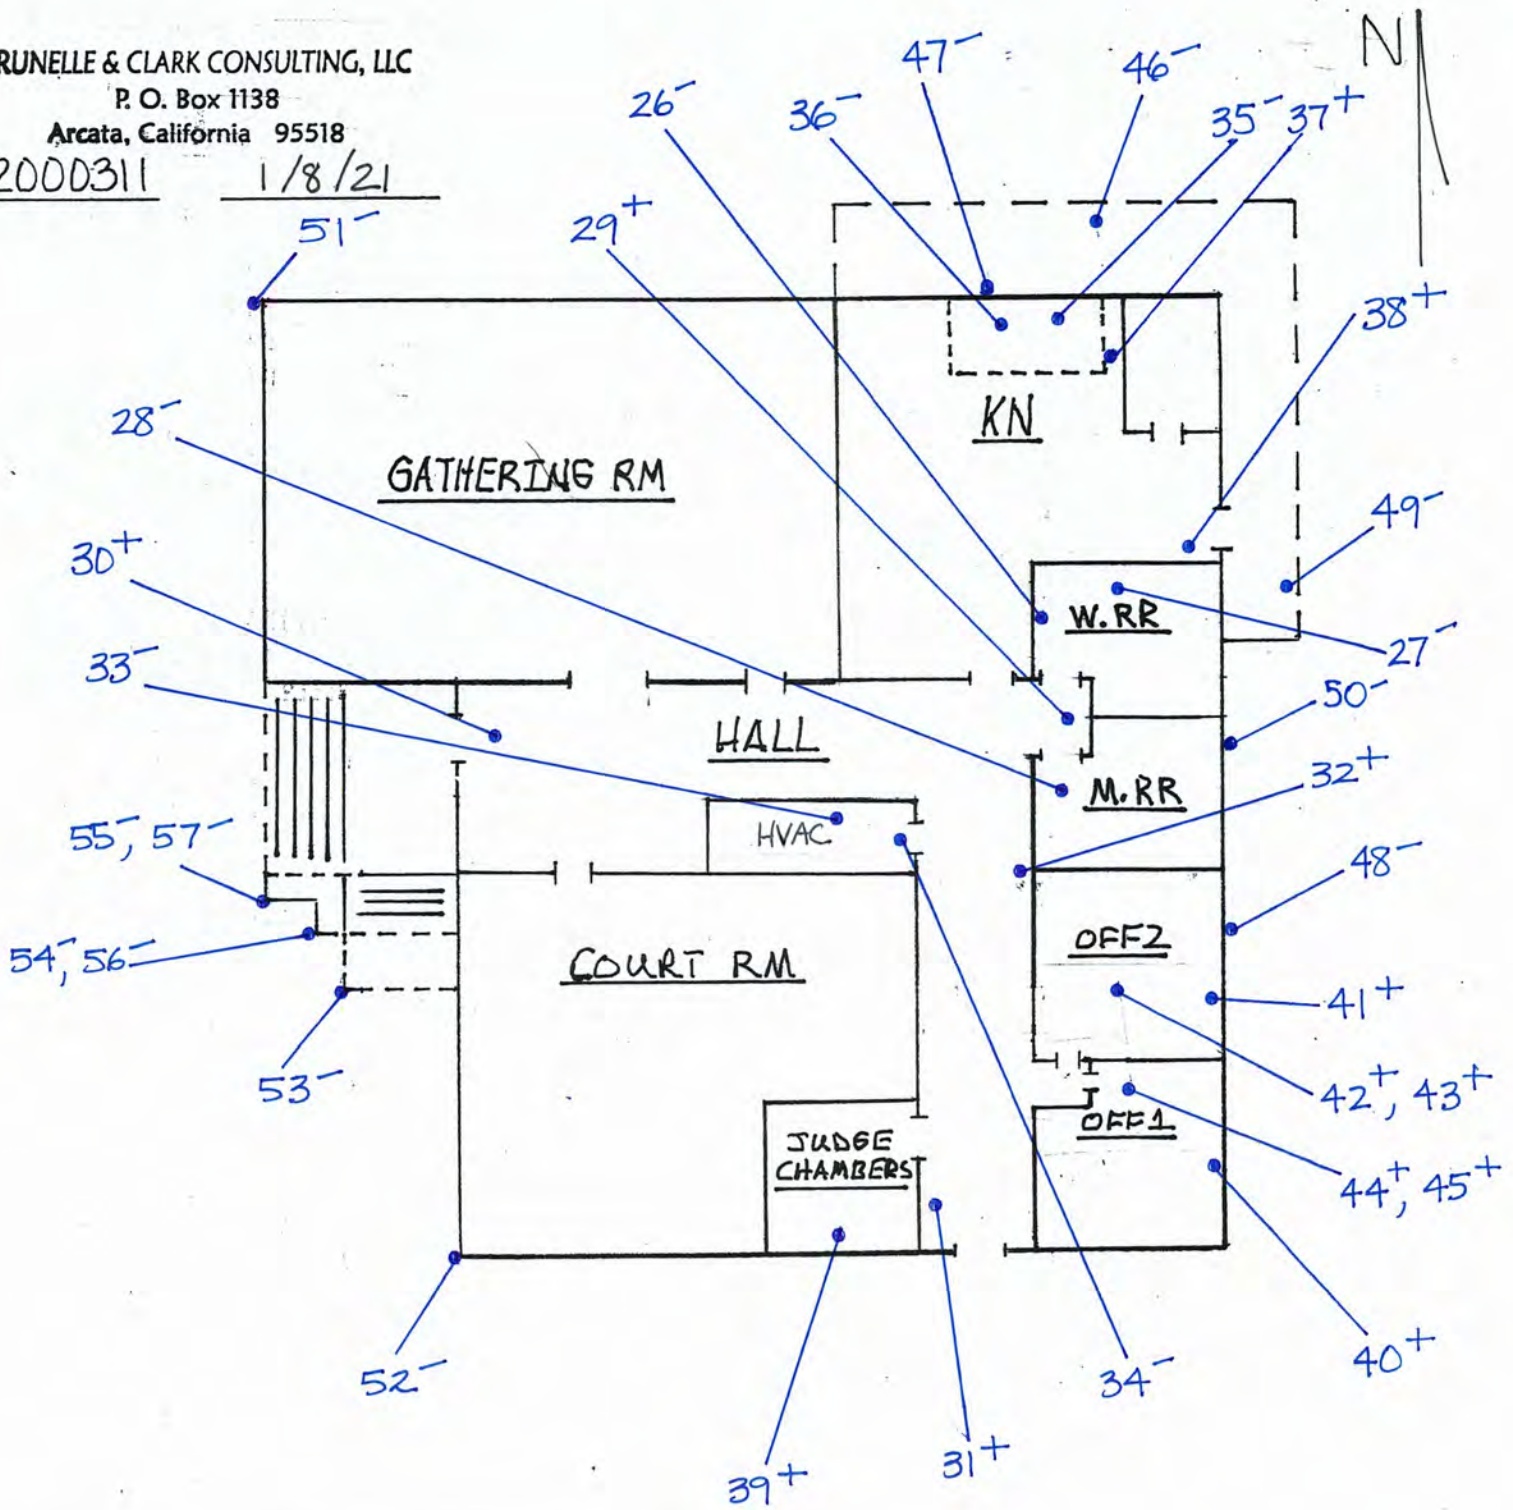
FIG. 2

SAMPLE LOCATIONS

(Asbestos Samples: 26-57)

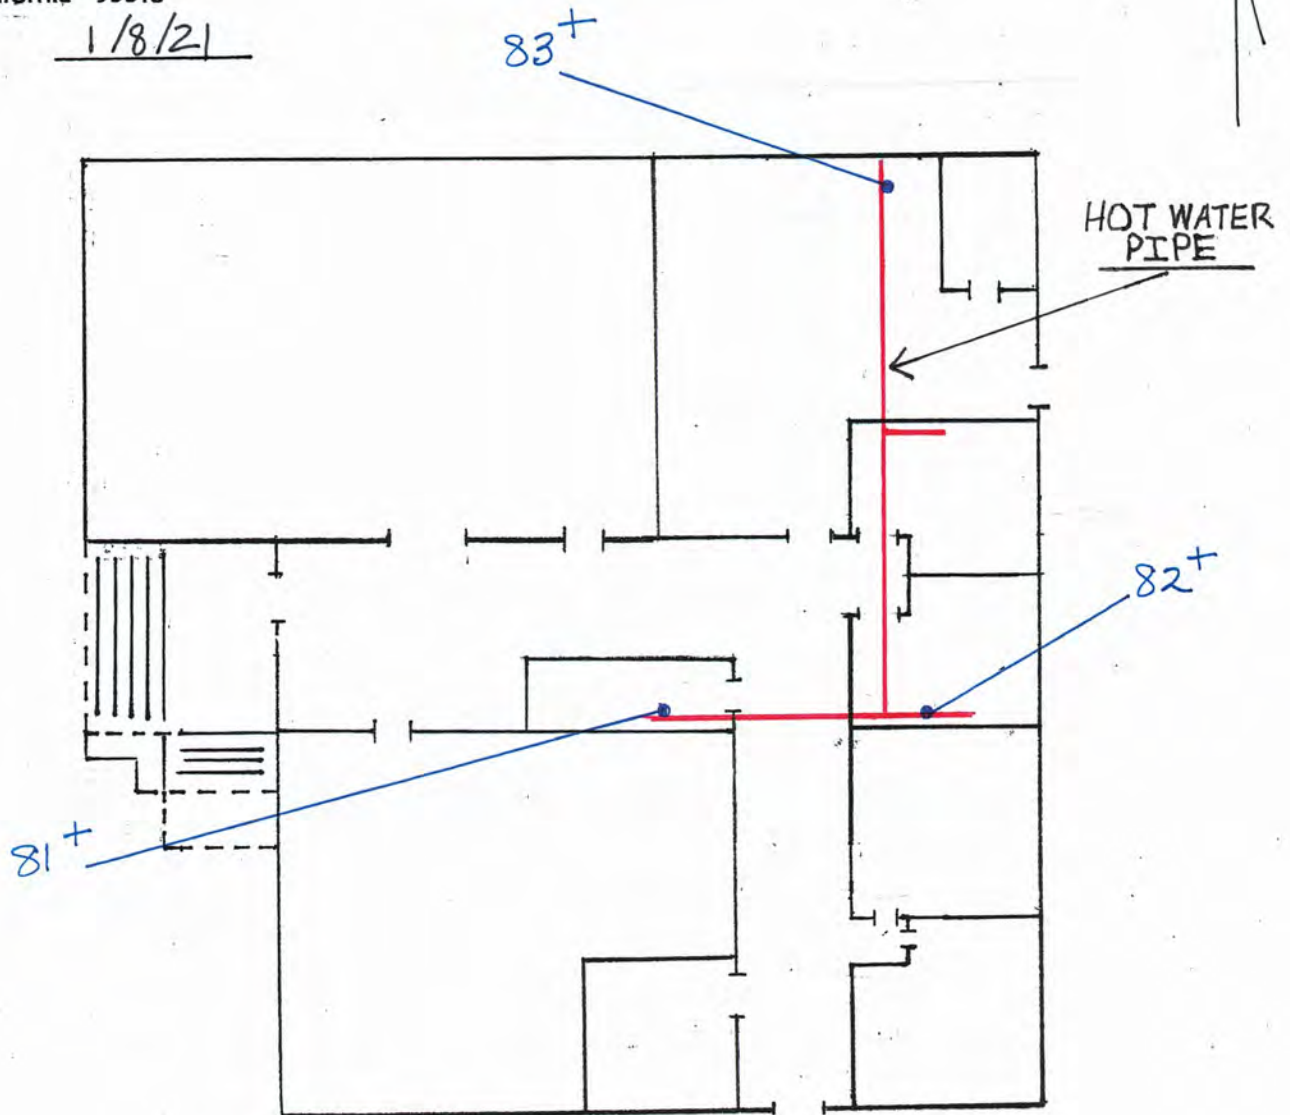
FIG. 3

SAMPLE LOCATIONS

(Asbestos Samples: 81-83)

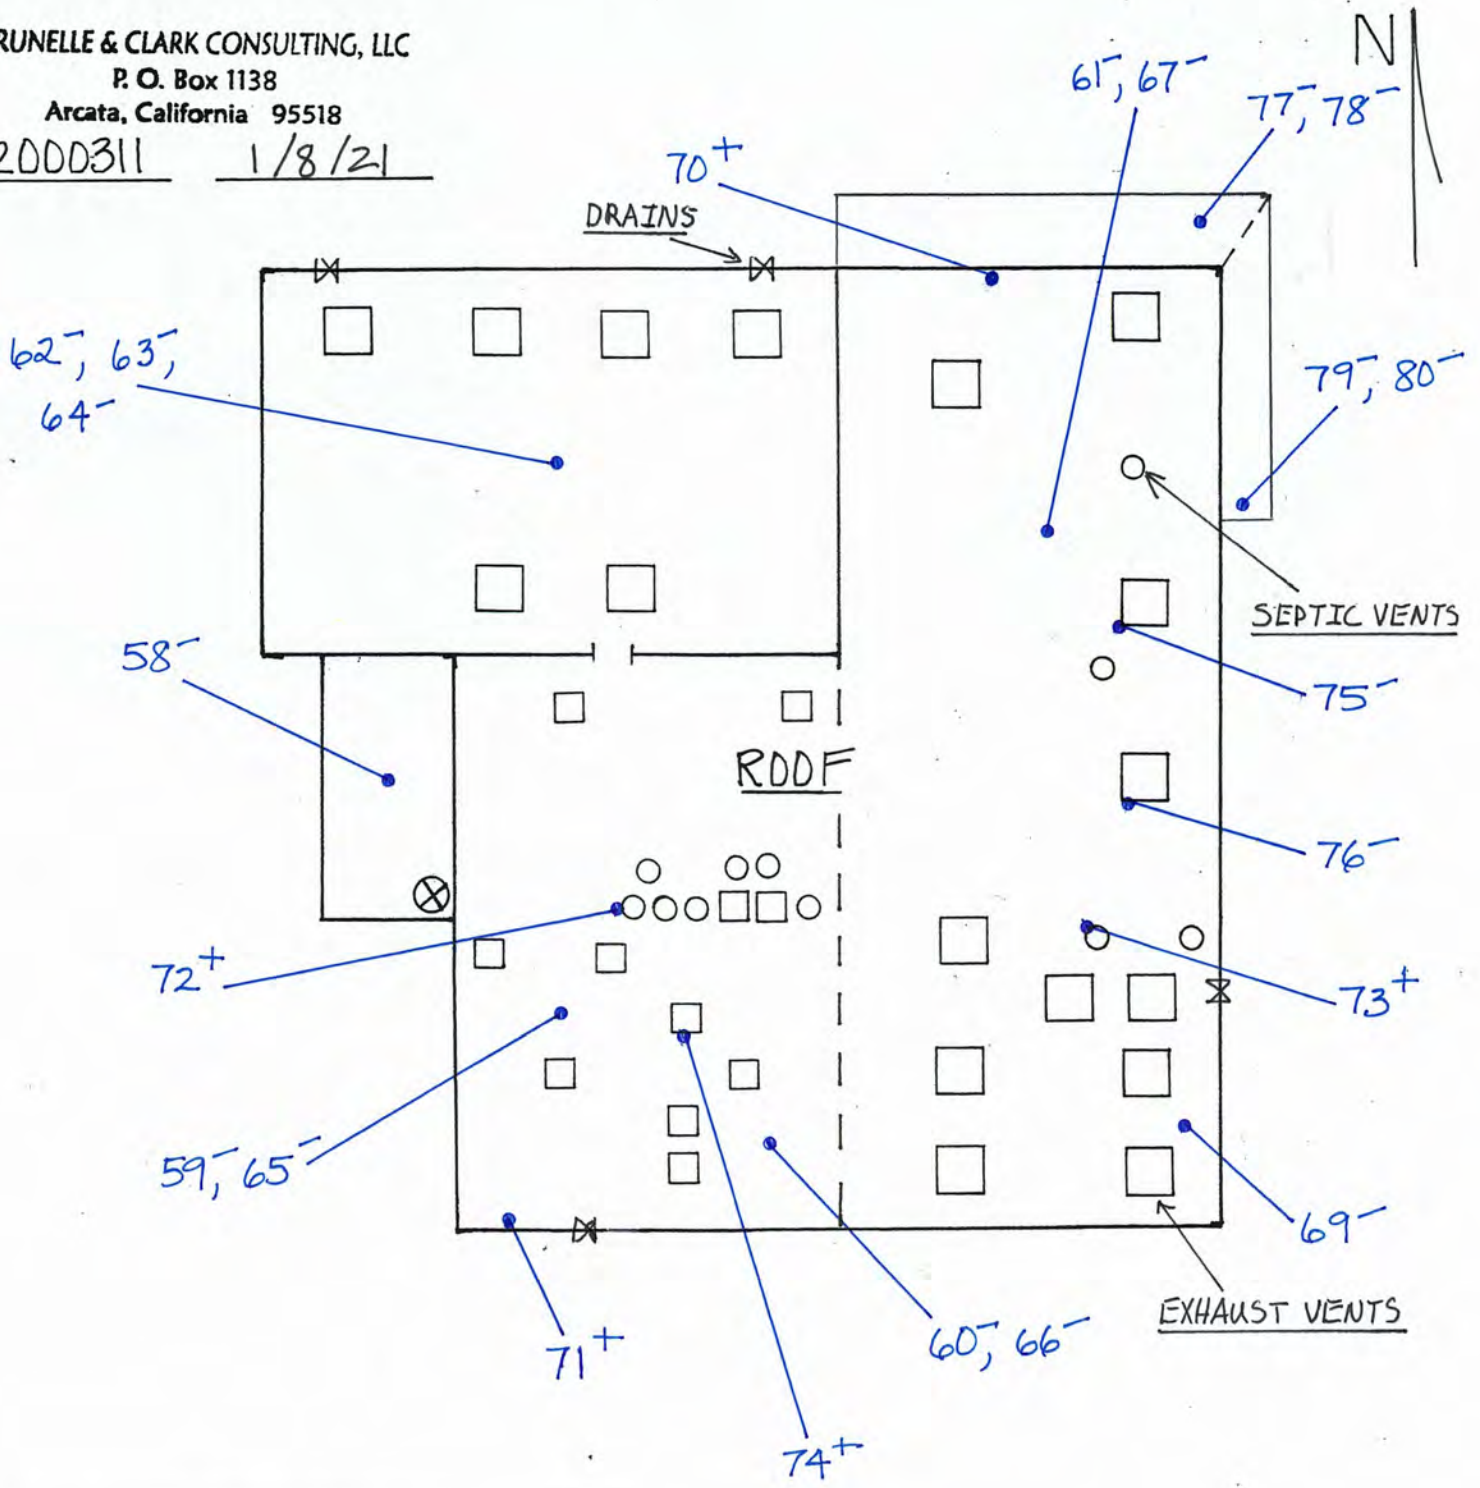
FIG. 4

SAMPLE LOCATIONS

(Asbestos Samples: 58-67, 69-80)

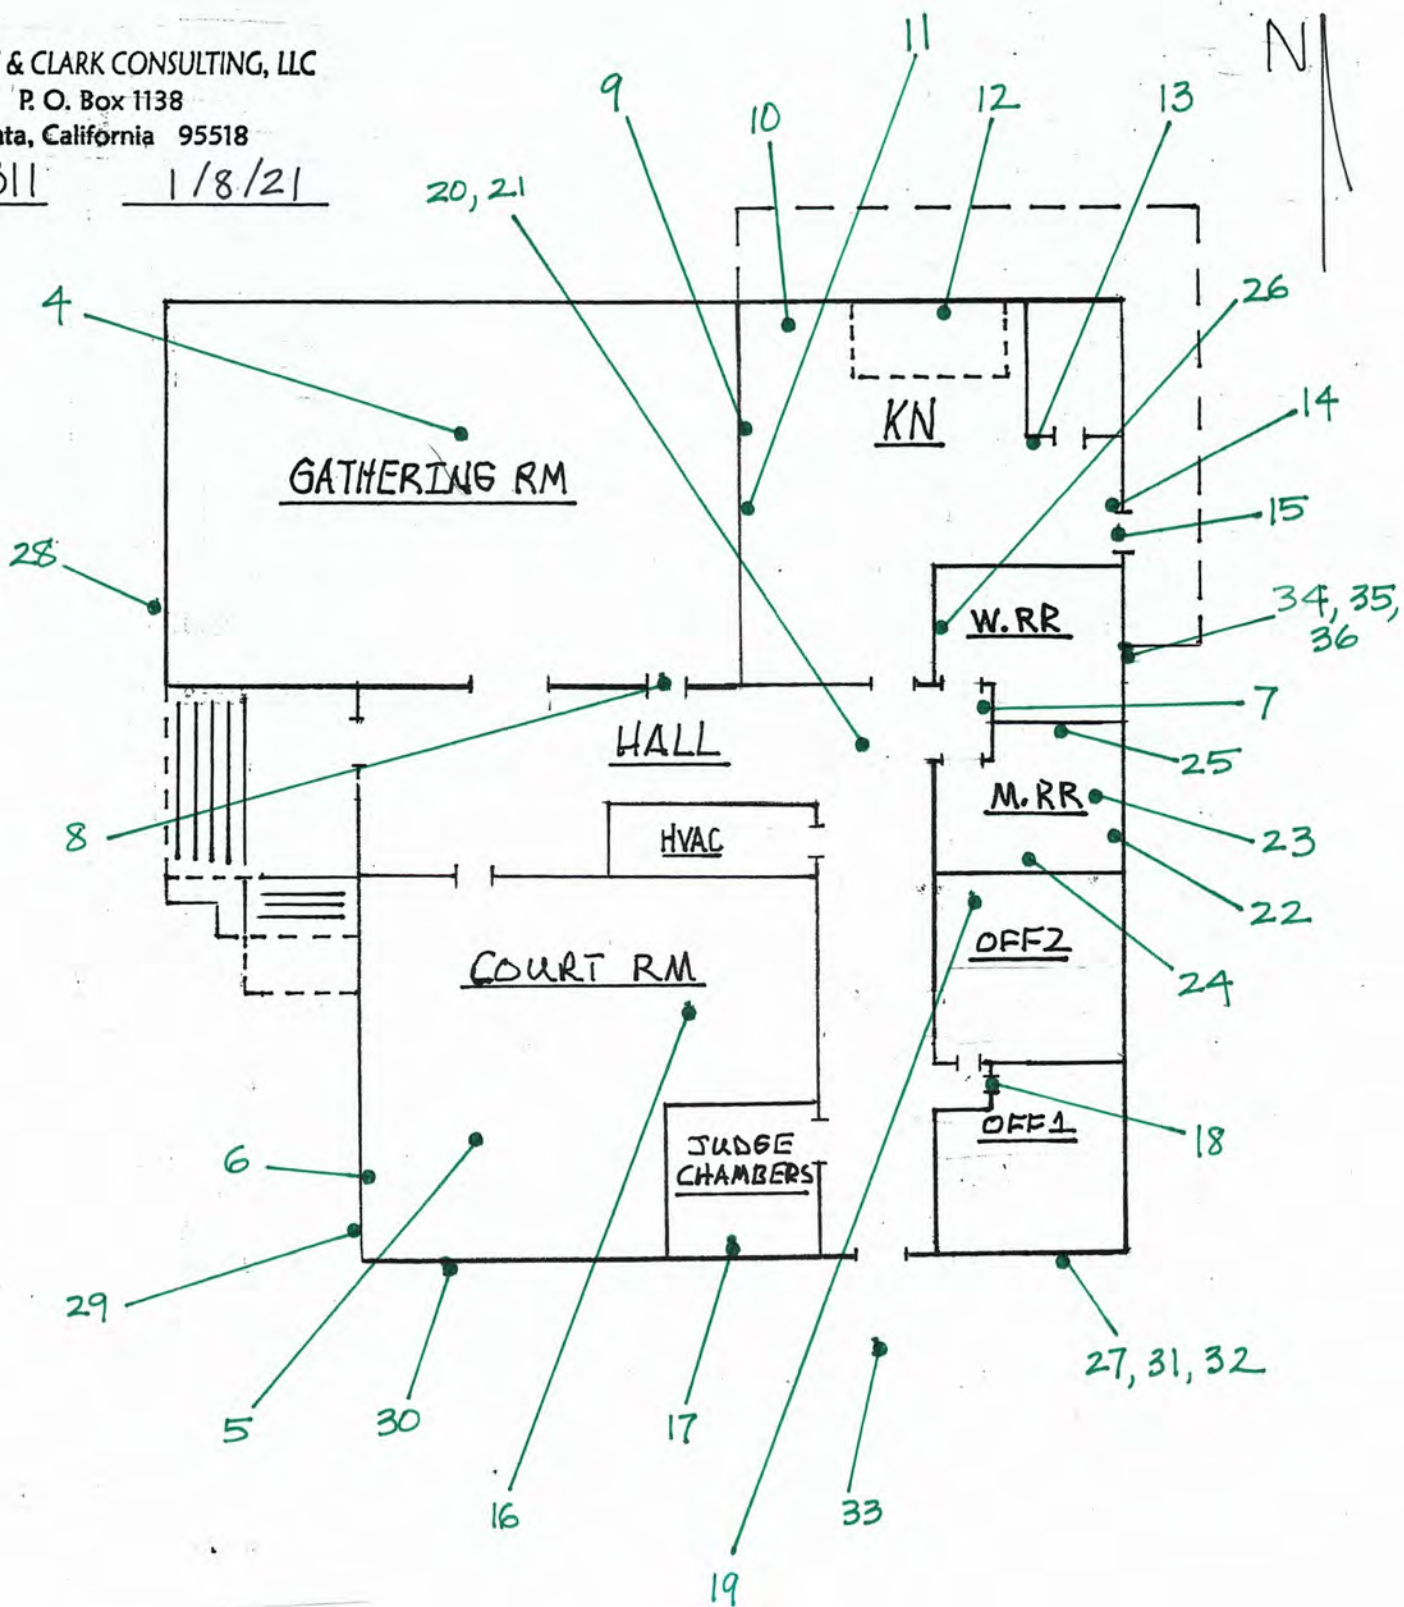
FIG. 5

XRF SAMPLE LOCATIONS

(Samples: 4-36)

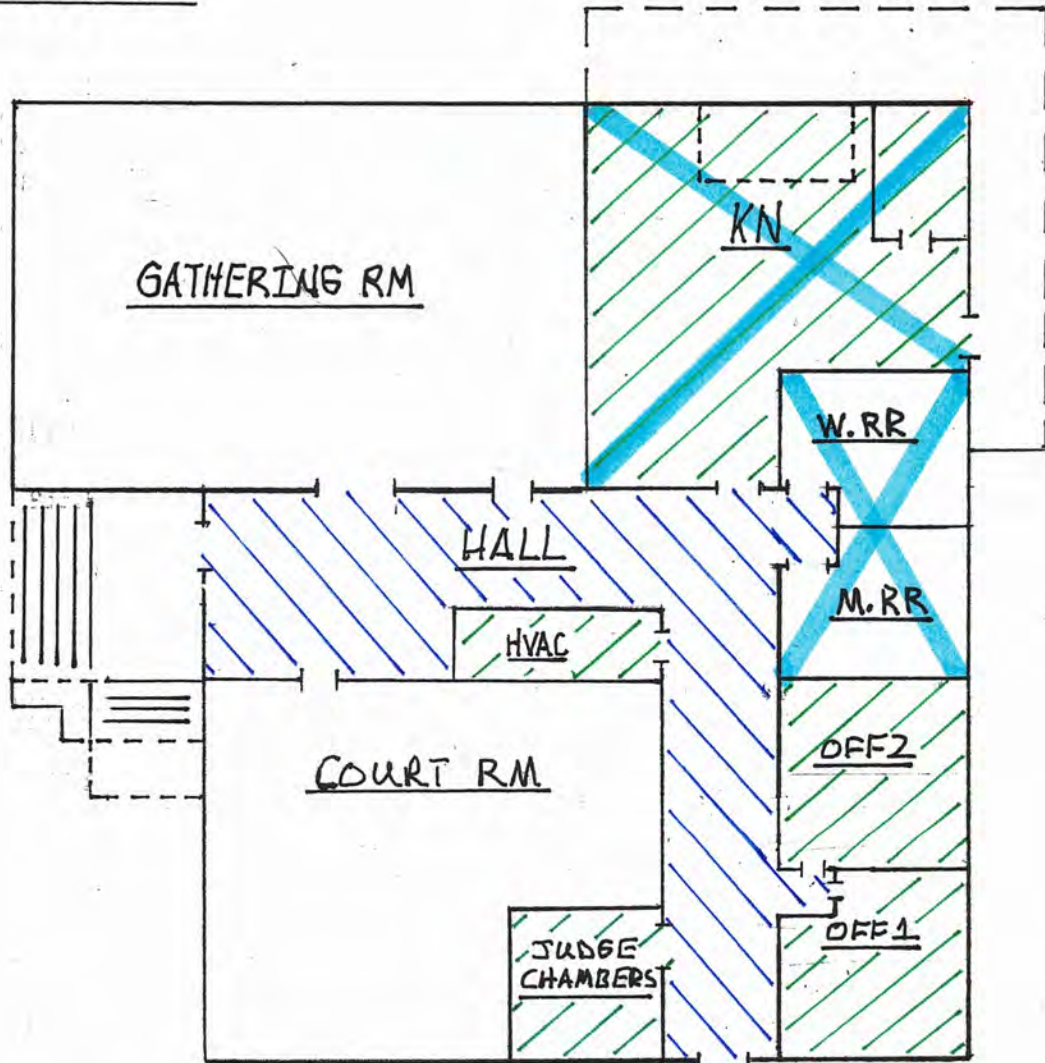
ASBESTOS LOCATIONS

HOT WATER PIPE
WITH ACM PIPE
INSULATION

RACM Pipe Insulation: Any abatement of the ACM pipe insulation (TSI) identified in this report must be done by a licensed asbestos abatement contractor as Class I work, using Class I methods. The abated waste must be disposed of as “friable” asbestos waste. This will require the use of a licensed “hazardous” waste hauler. In addition, a temporary hazardous waste generator number from the EPA will need to be obtained for the site. An abatement contractor will typically handle these issues.

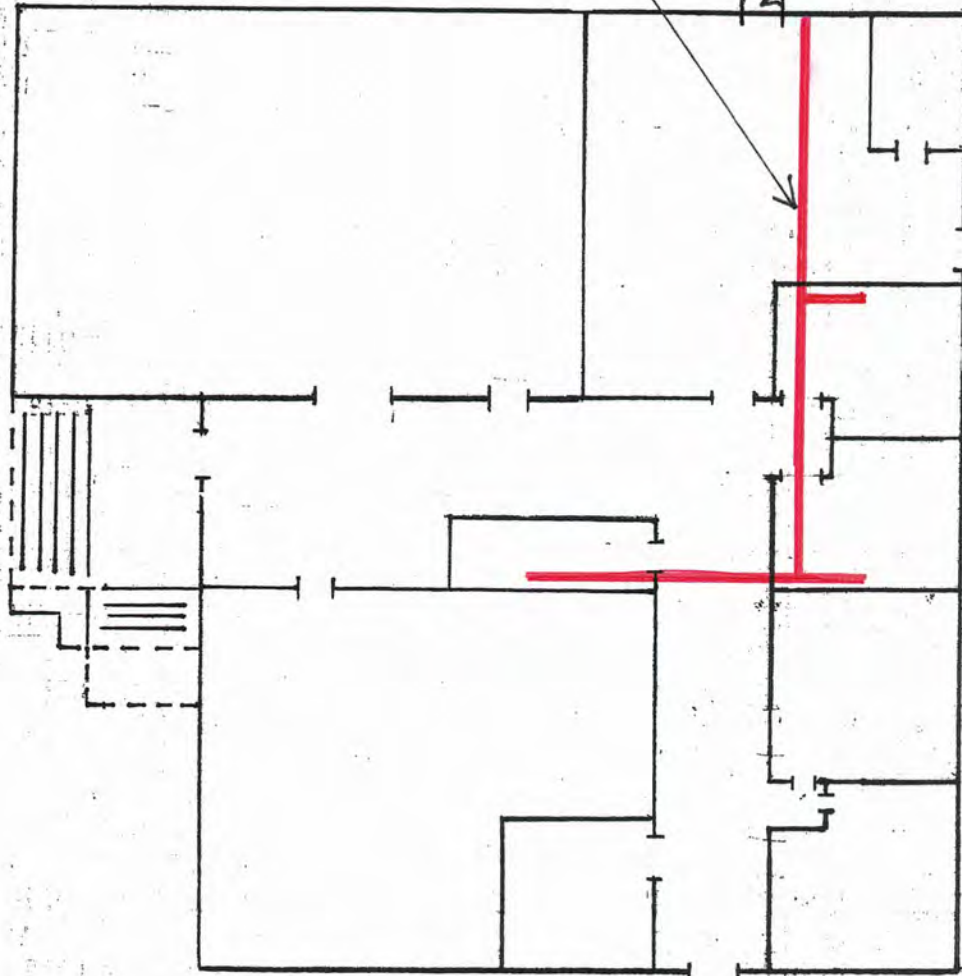
FIG. 7

ASBESTOS LOCATIONS

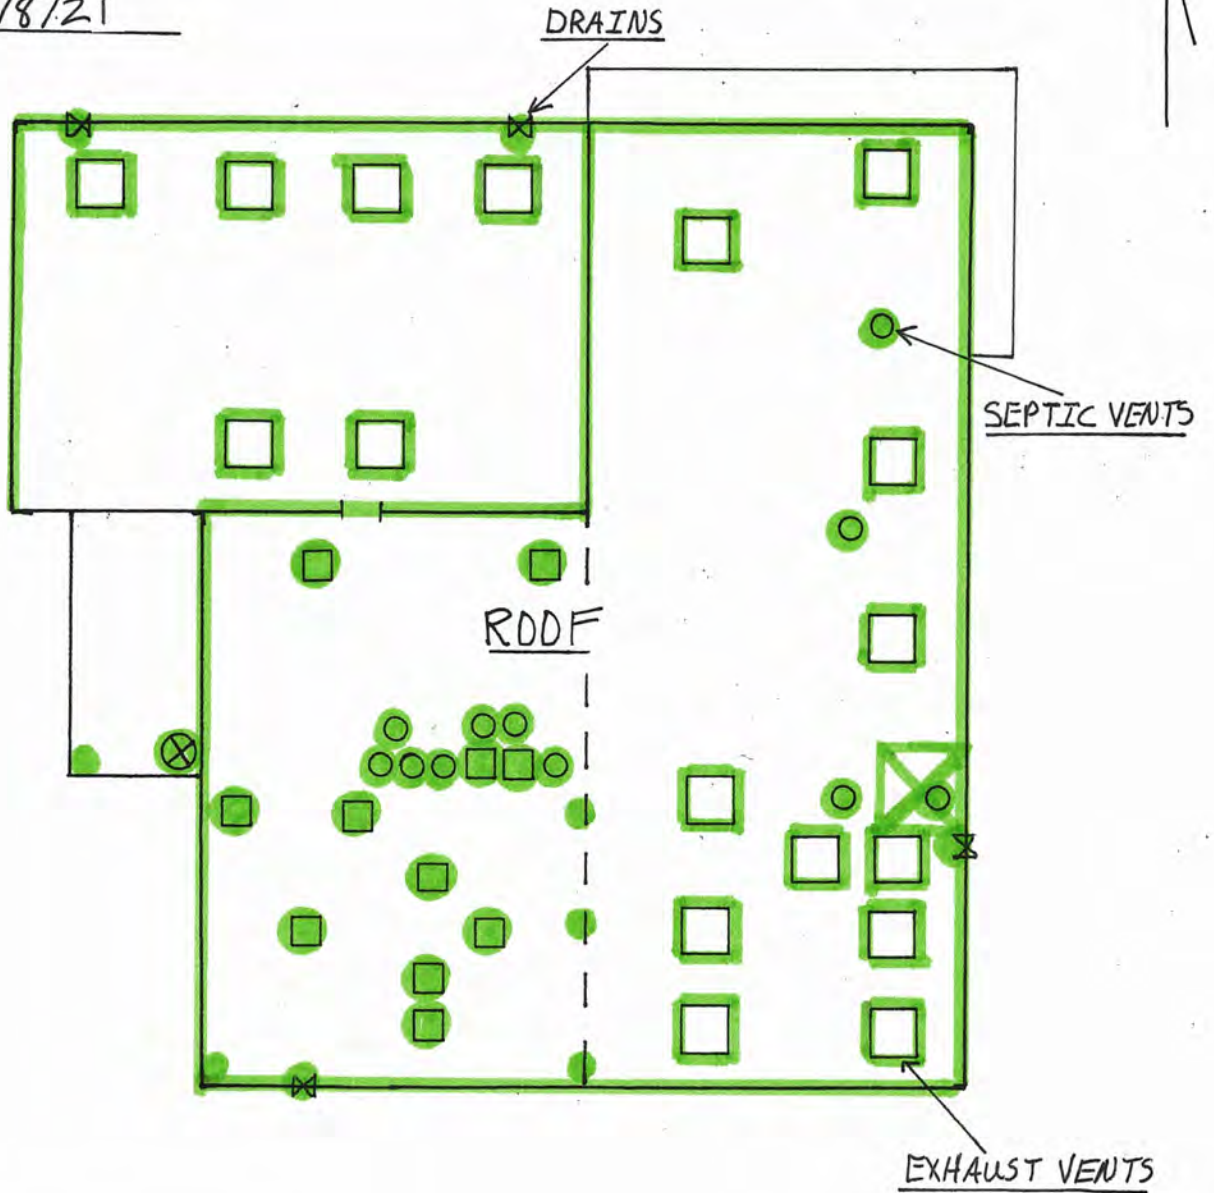
ASBESTOS LOCATIONS

- ACM Tar Roof Patch, gray
Note: all roof patch is ACM
