HUMBOLDT COUNTY DEPARTMENT OF PUBLIC WORKS
ROAD EVALUATION REPORT

Road Name: DINSMORE / BEAR CREEK ROAD (complete a separate form for each road)

ROAD ASSESSMENT

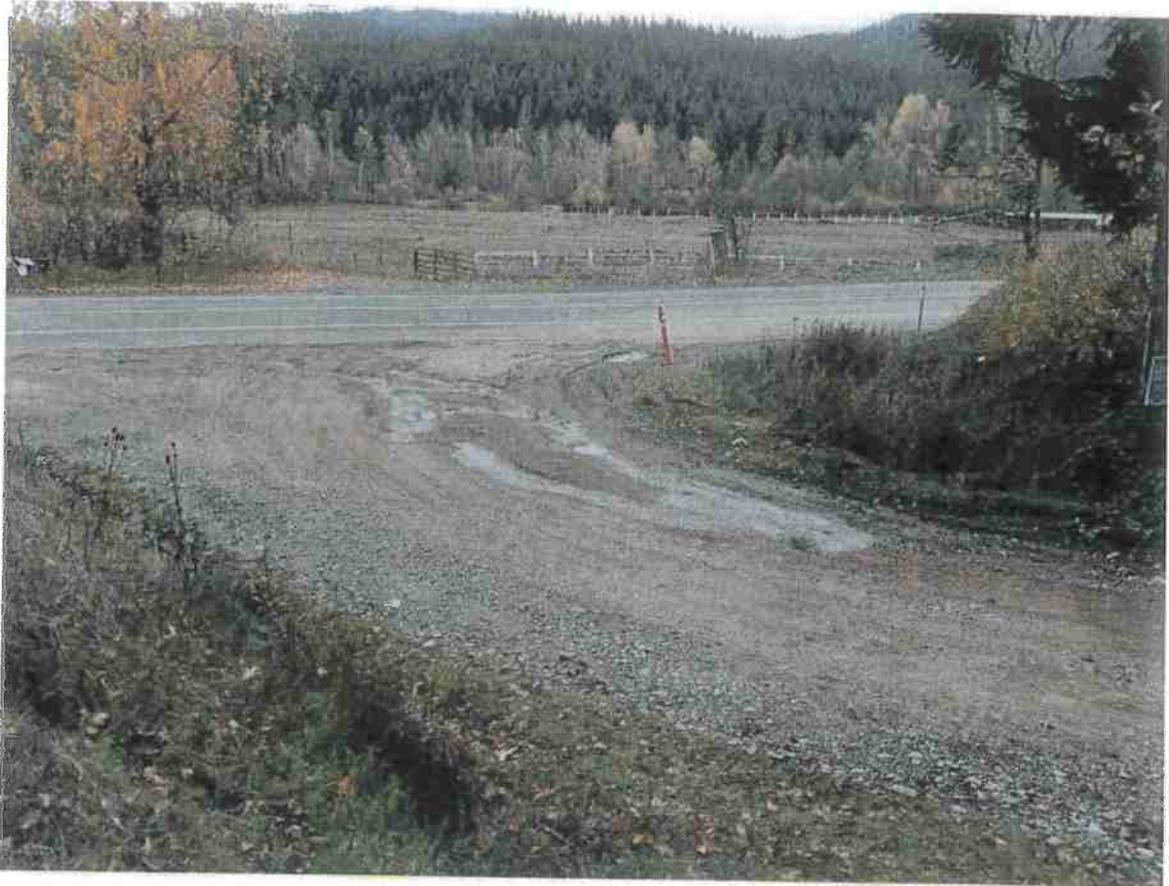
Road Point 1: At the intersection of Bear Creek Road with Highway 36, and up the road, the surface should be graded to remove the minor puddles and channels on the surface and to re-establish the crowned drainage pattern per the attached Crowned Road BMPs. Photo date 11-18-2021.

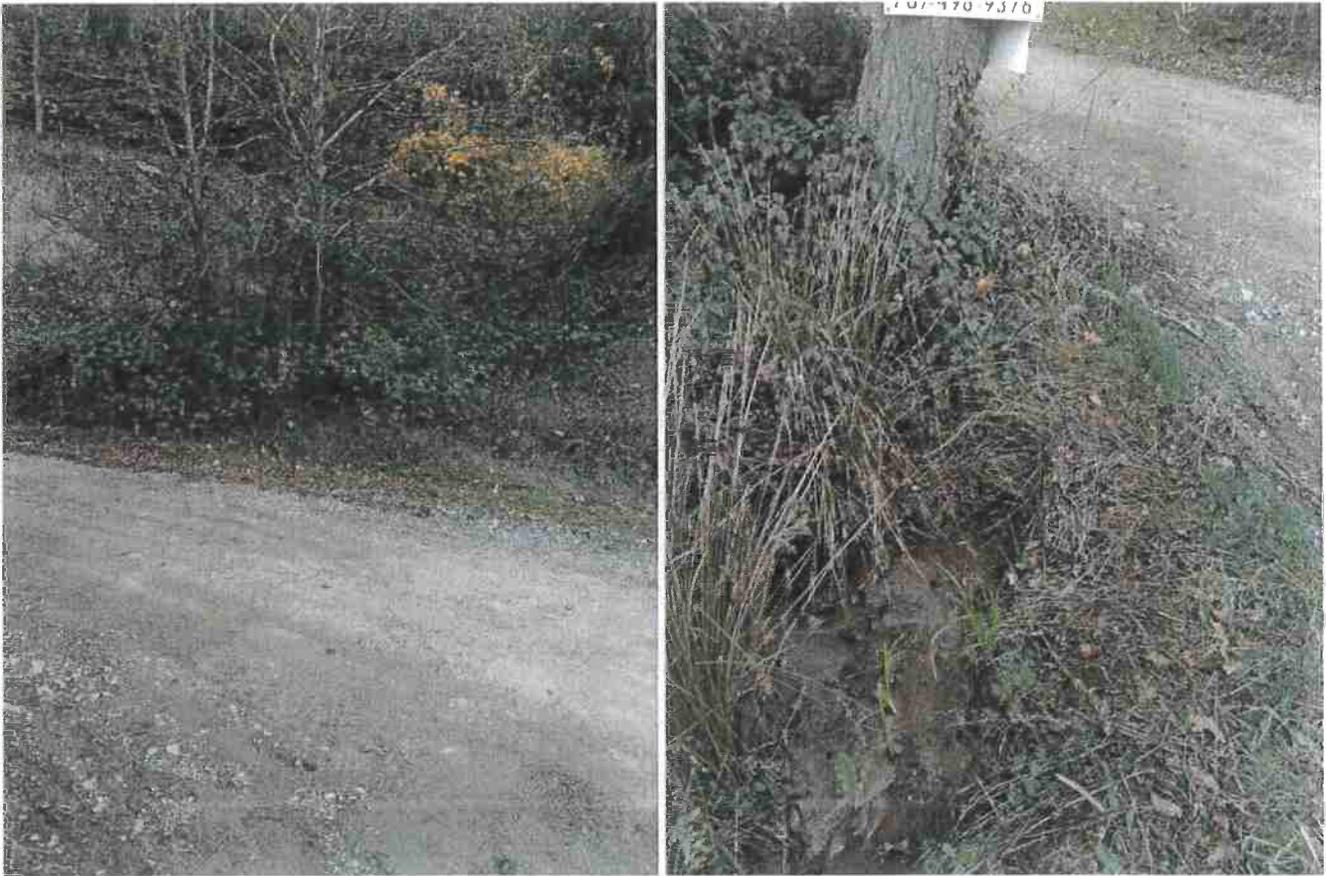
Road Point 2: Existing 18-inch diameter metal culvert crossing of a Class III watercourse. The picture on the left shows the inlet area and the picture on the right shows the outlet that is plugged with road related sediment. The culvert is undersized and should be replaced with a properly sized culvert per the attached BMPs. Photo date 11-18-2021.

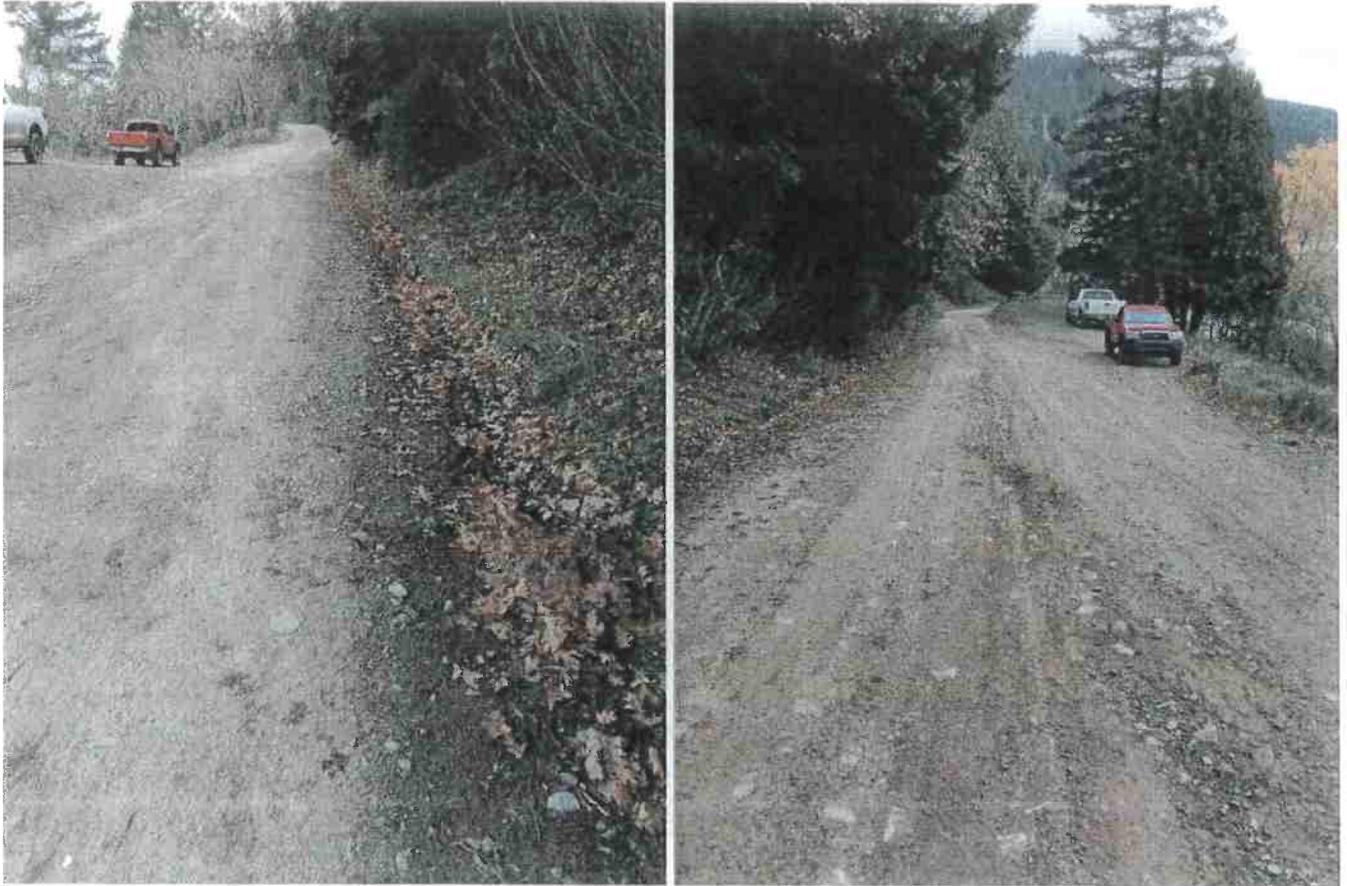
Road Segment 2 to 6: Road Segment is rocked with a mostly crowned drainage pattern. The picture on the right is taken near Road Point 4 on the map. The road surface should be graded to remove the minor channels that have developed on the surface and to re-establish or maintain the crowned drainage pattern per the attached Crowned Road BMPs. Photo date 11-18-2021.

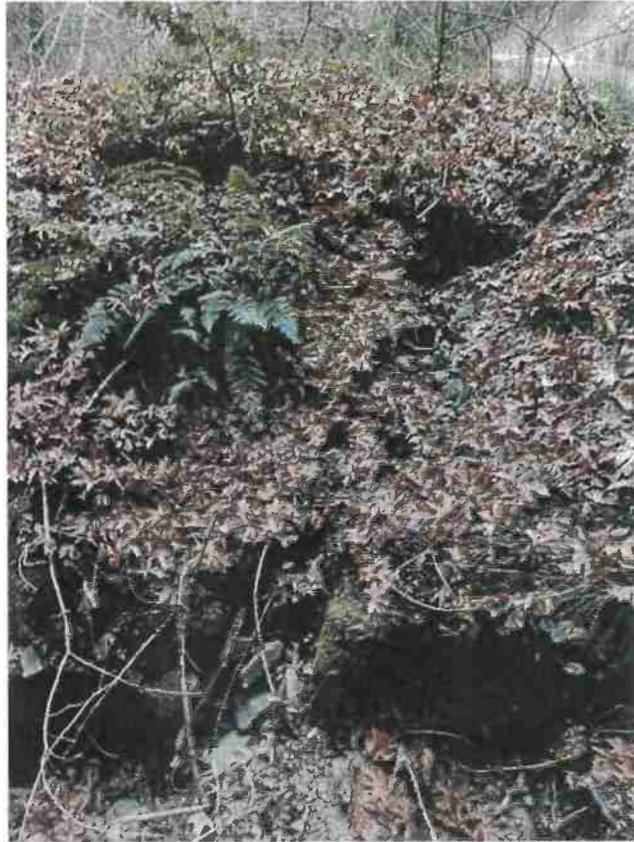
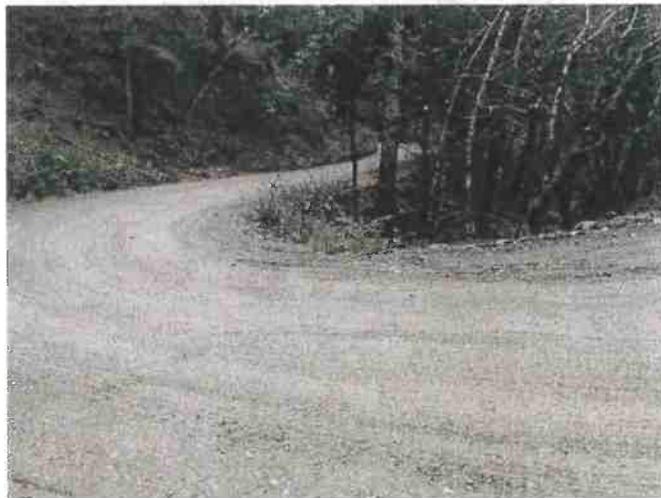
Road Point 6: Existing 36-inch diameter metal culvert crossing of a Class II watercourse. The photo on the top shows the inlet and the photo on the bottom shows the crossing approach. The culvert appeared to be in fair condition and functioning, but is undersized. A properly sized culvert should be installed per the attached BMPs. Photo date 11-18-2021.

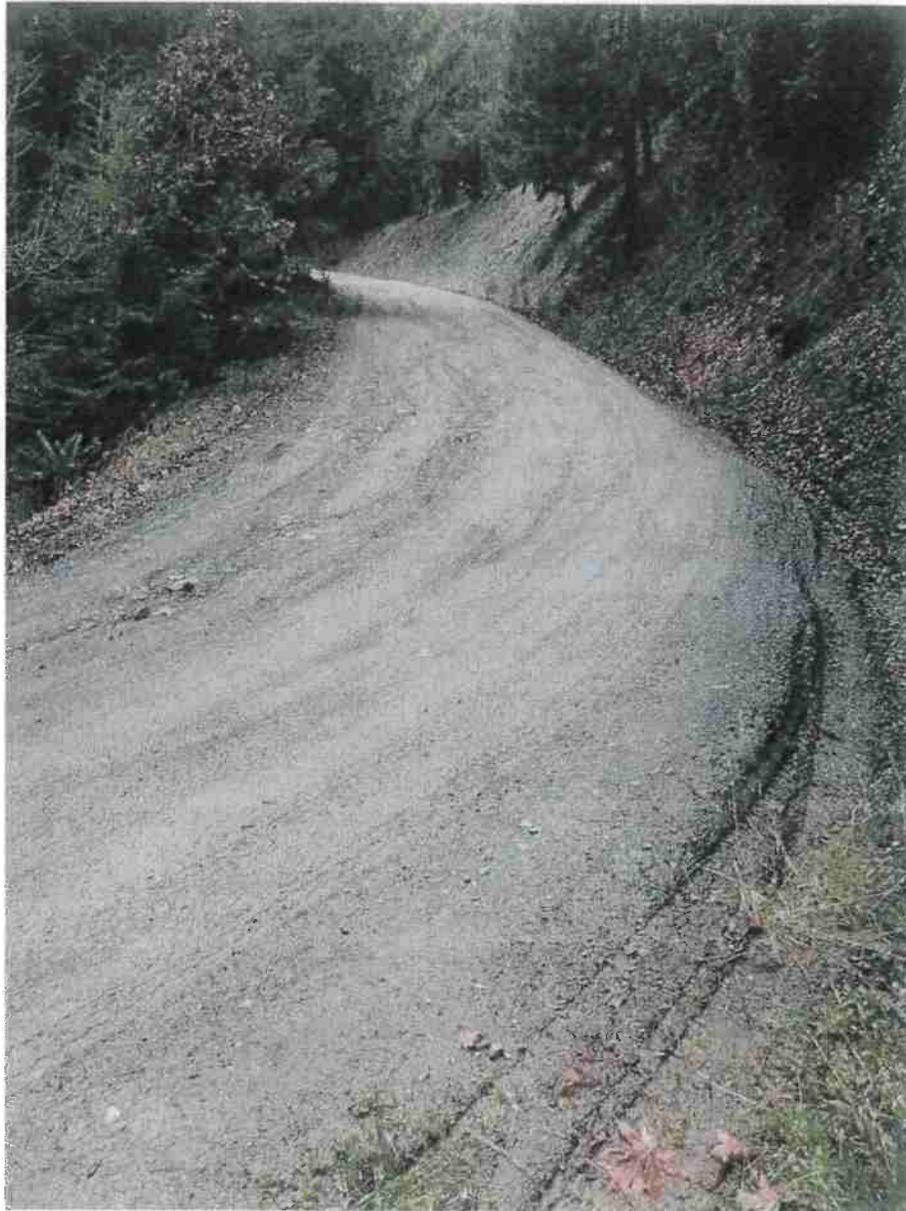
Road Segment 6 to 9: Photo shows the western approach to the watercourse crossing at Point 6. Road Segment is rocked with a mostly crowned drainage pattern, but an inside ditch connects to the watercourse crossing at Road Point 6, and runoff along the outer half of the road flows over the outboard edge at the culvert outlet. Along this segment, relieve the inside ditch by installing a ditch relief culvert per the attached BMPs at Point 7 and opening the surface lead-out at Point 8. Grade the road surface to remove minor channels that have developed on the surface and re-establish the crowned drainage pattern per the attached Crowned Road BMPs. Photo date 11-18-2021.

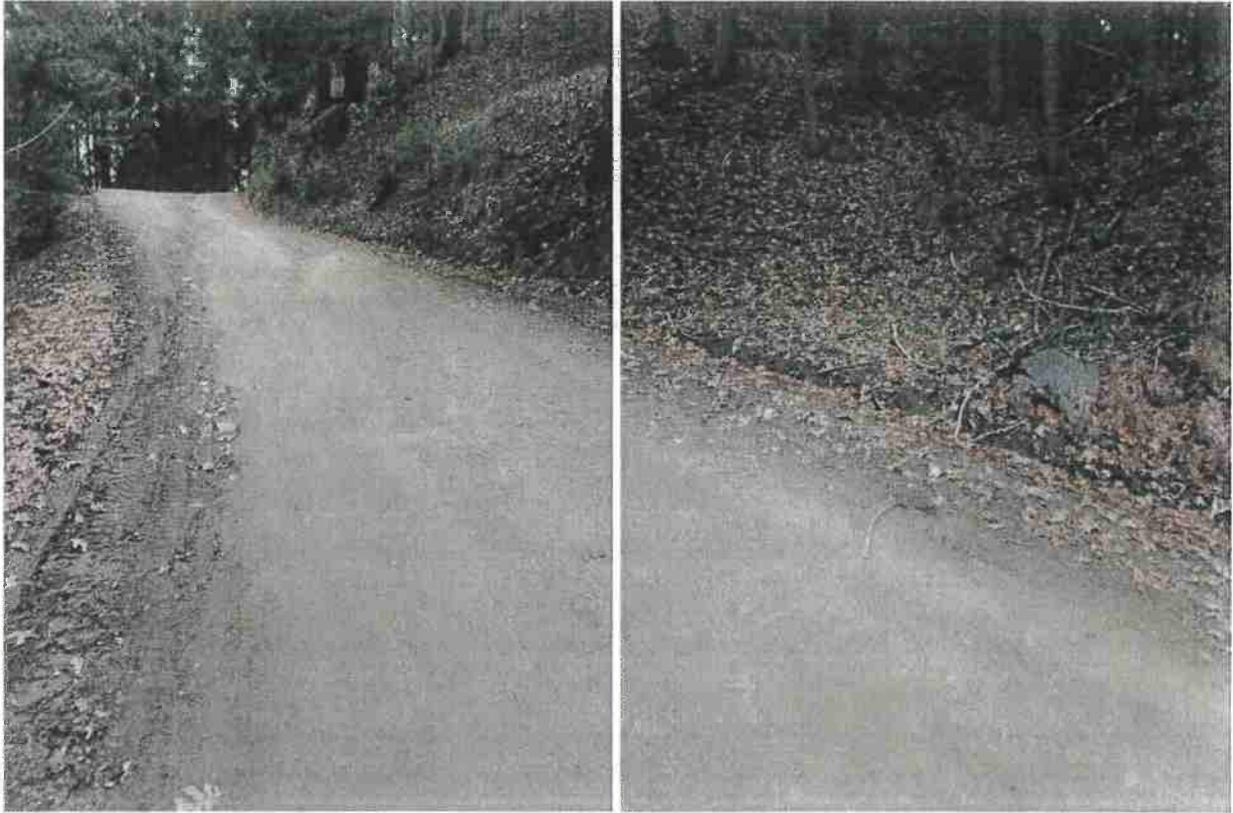
Road Segment 12 to 18: Photos taken at Road Point 13. Road Segment is rocked with a mostly crowned drainage pattern, and is maintained by occasional road grading. Short segments have minor channeling along the surface. The inside ditch in the photo is connected to the watercourse crossing at Point 12. At Road Point 13, install a new ditch relief culvert at the natural swale location to drain the ditch before it enters the inlet of the crossing at Point 12. Grade the road surface to remove minor channels that have developed on the surface and re-establish the crowned or outsloped drainage pattern per the attached BMPs. Photo date 11-18-2021.

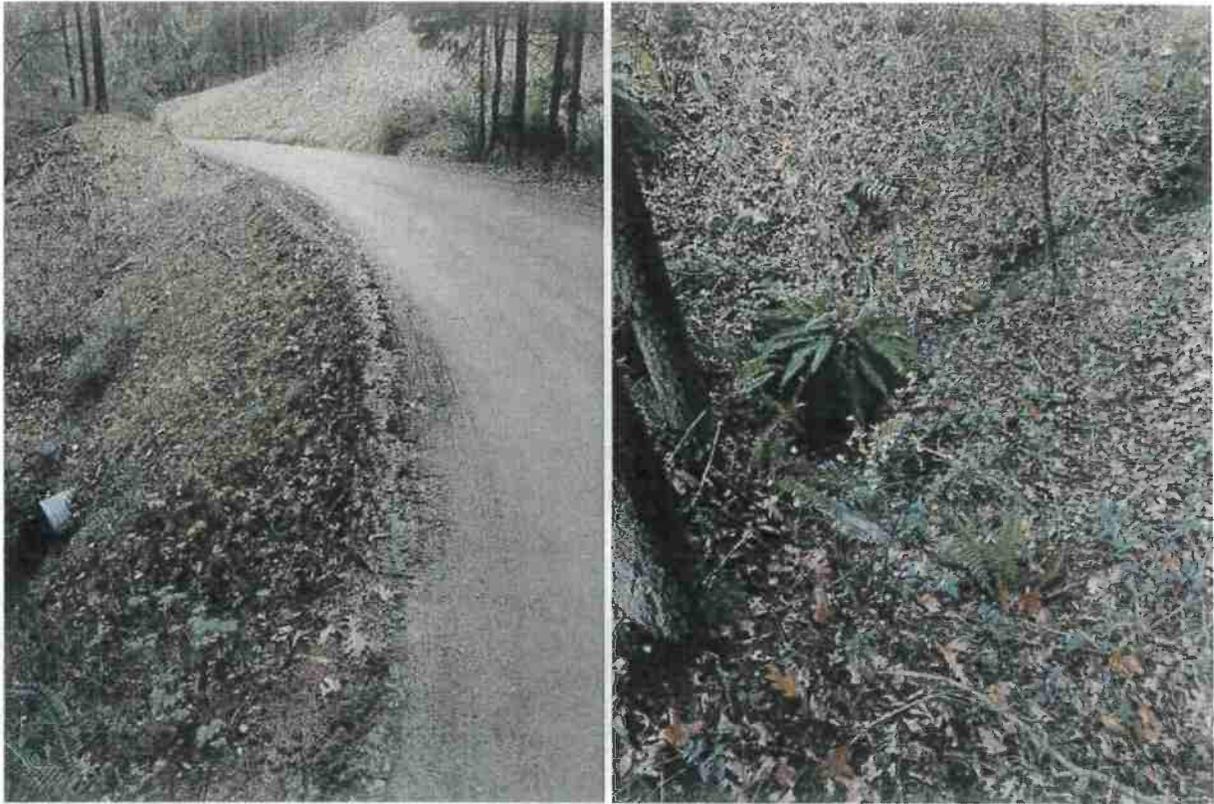
Road Point 18: Existing 24-inch diameter metal culvert crossing of a Class II watercourse. Photo on the left shows the outlet and the photo on the right shows the incoming watercourse. The culvert appeared to be in fair condition and functioning. Its bottom is beginning to rust, it is slightly "shotgunned" at the outlet, and it is calculated as undersized. It should be replaced with a properly sized culvert installed per the attached BMPs. Photo date 11-18-2021.

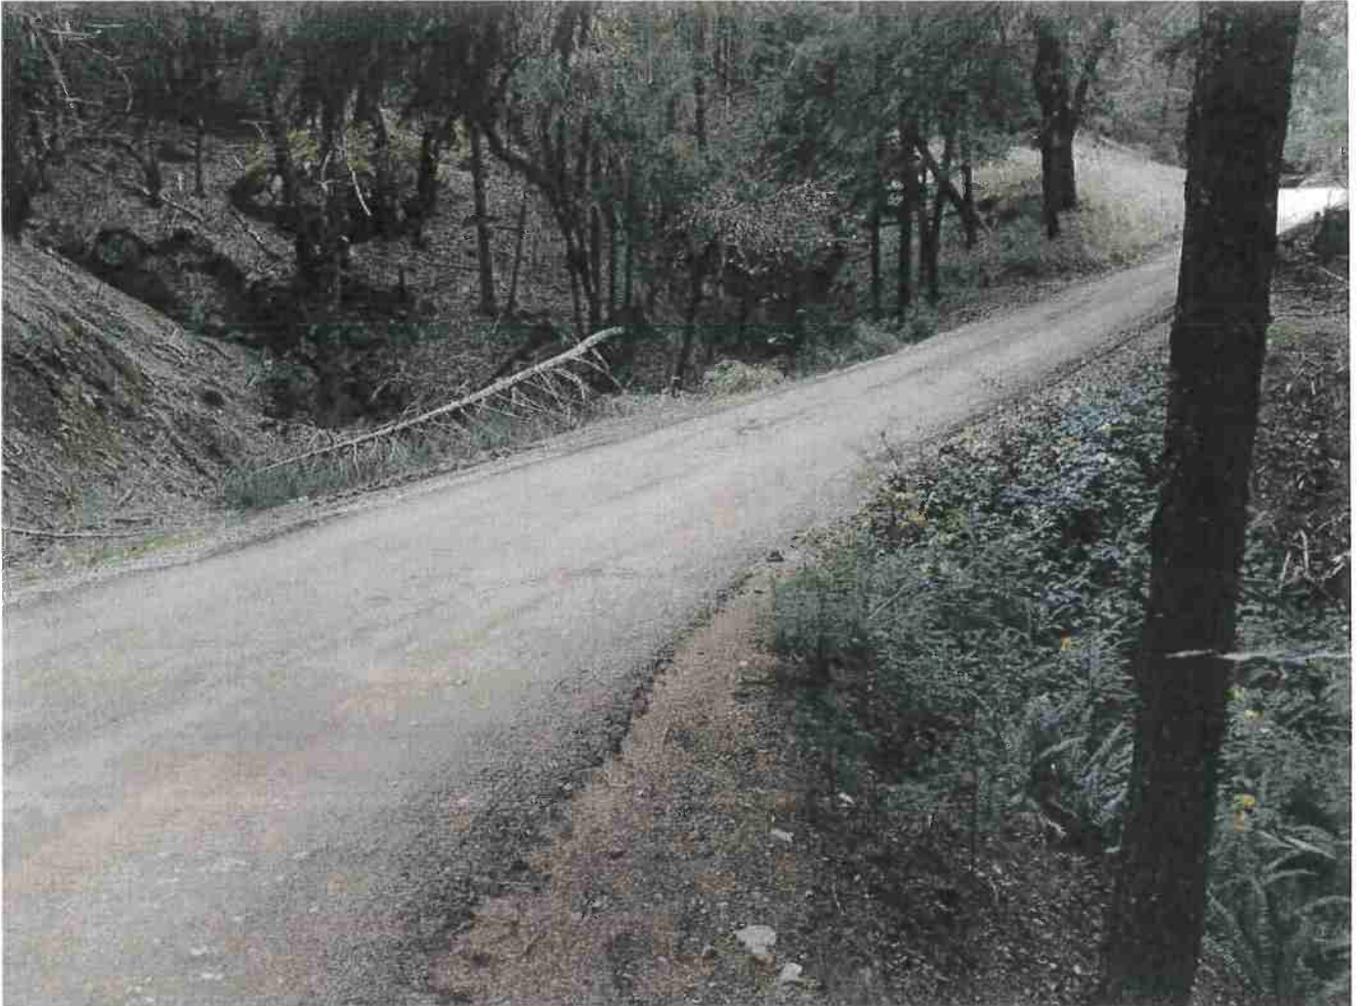
Road Point 19: Photo shows the road approaches through the existing 60-inch diameter metal culvert watercourse crossing. The inlet is set at the confluence of two Class II watercourses. The culvert appeared to be in good condition, functioning properly, but is showing beginning signs of wear. The culvert is sized adequately for the 100 year peak streamflow. At Road Point 19, monitor to make sure that the culvert remains open and functioning. Photo date 11-18-2021.

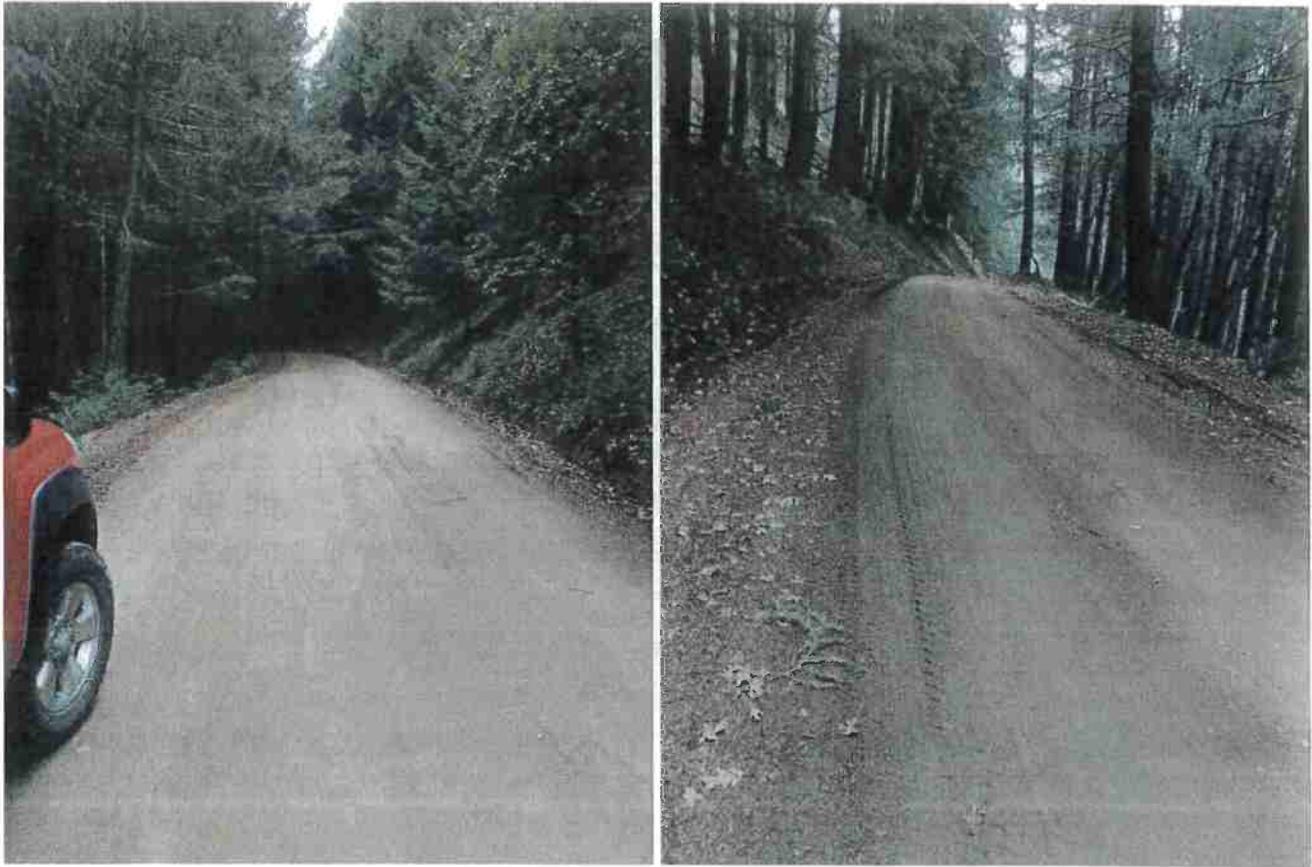
Road Segment 19 to 23: Photo on the left is taken near Road Point 20 and the photo on the right is taken near Road Point 21. Road Segment is rocked with a mostly outsloped surface that becomes more of a crowned drainage pattern along the approaches to the existing ditch relief culvert at Point 22. At Road Point 20 and 21 proper rocked rolling dips that can hold up to the road's traffic should be installed. Photo date 11-18-2021.

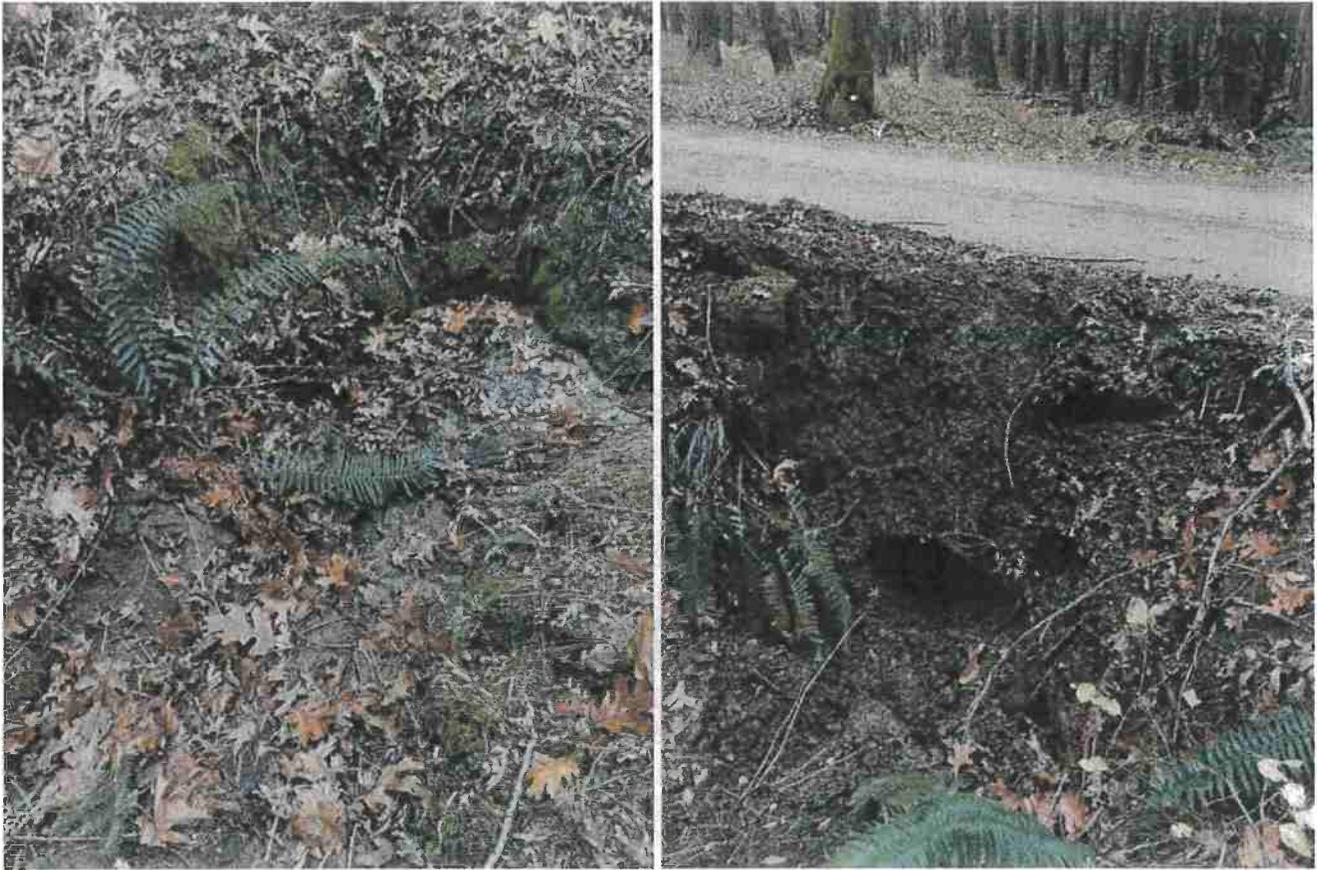
Road Point 23: Existing 24-inch diameter culvert crossing of a Class III watercourse. The photo on the left shows the inlet plugged with fine, road related sediment. The photo on the right shows the outlet partially blocked by a small amount of fill material that recently fell loose from the outboard edge of the road. The culvert length is too short to extend beyond road fills but its diameter is adequate for the 100-year peak streamflow. At Road Point 23, the ends of the culvert are in need of maintenance to remove the blockages and to assess the physical condition of the culvert. Road Points 24, 26, and 27 up the road will help to address road related sediment entering the Class III watercourse from above. If the culvert is found to be rusted and worn out, it should be replaced with a properly sized culvert installed per the attached BMPs. Photo date 11-18-2021.

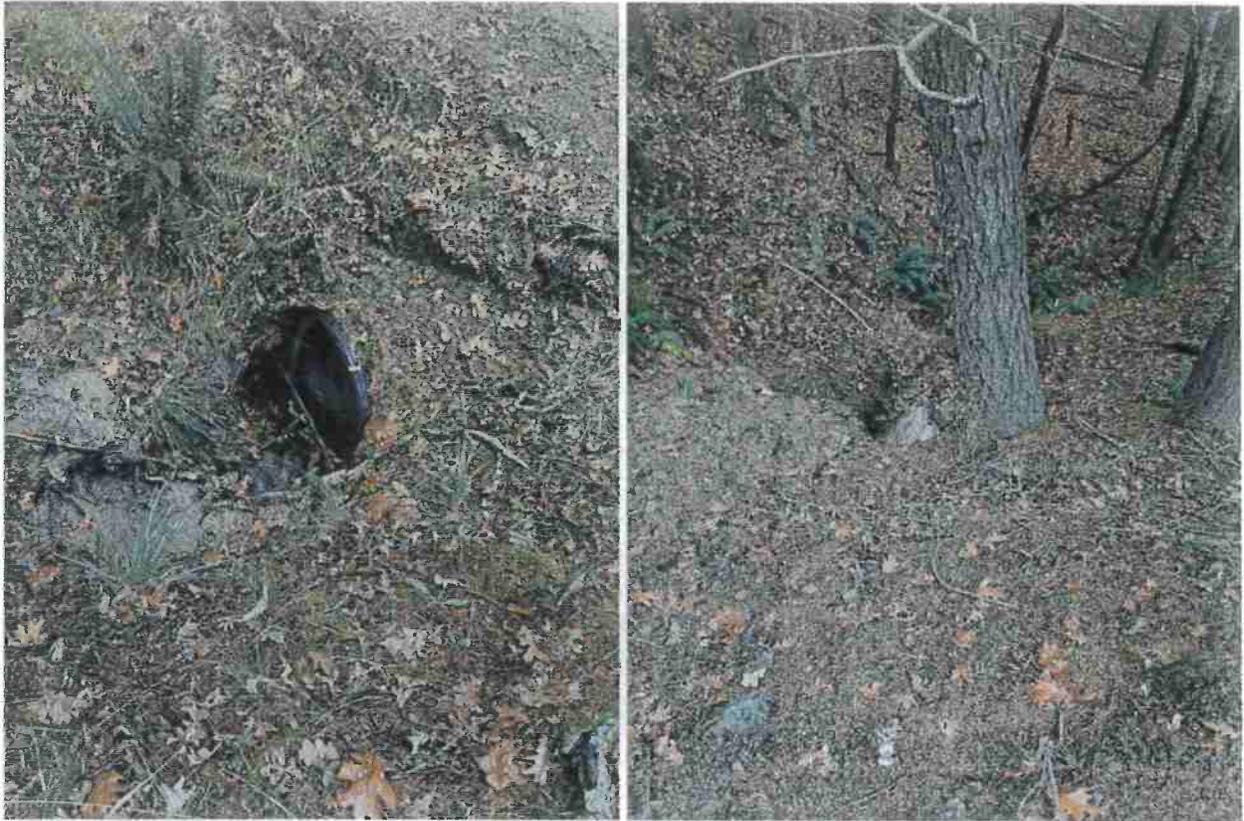
Road Point 25: Existing 30-inch diameter plastic culvert watercourse crossing of a Class III watercourse. The photo on the left shows the inlet and the photo on the right is looking down at the outlet. The culvert appeared to be in good condition, functioning properly, and is adequately sized. It has a slightly "shotgunned" outlet that can be mitigated by the placement of a small amount of rock for energy dissipation. The Class III watercourse had received road related sediment from upstream and from a connected inside ditch during the first rainy period of mid-October and early November 2021. Road Points 26 through 31 up the road will help to address road related sediment entering the Class III watercourse from above by breaking up concentrated road surface runoff. Photo date 11-18-2021.

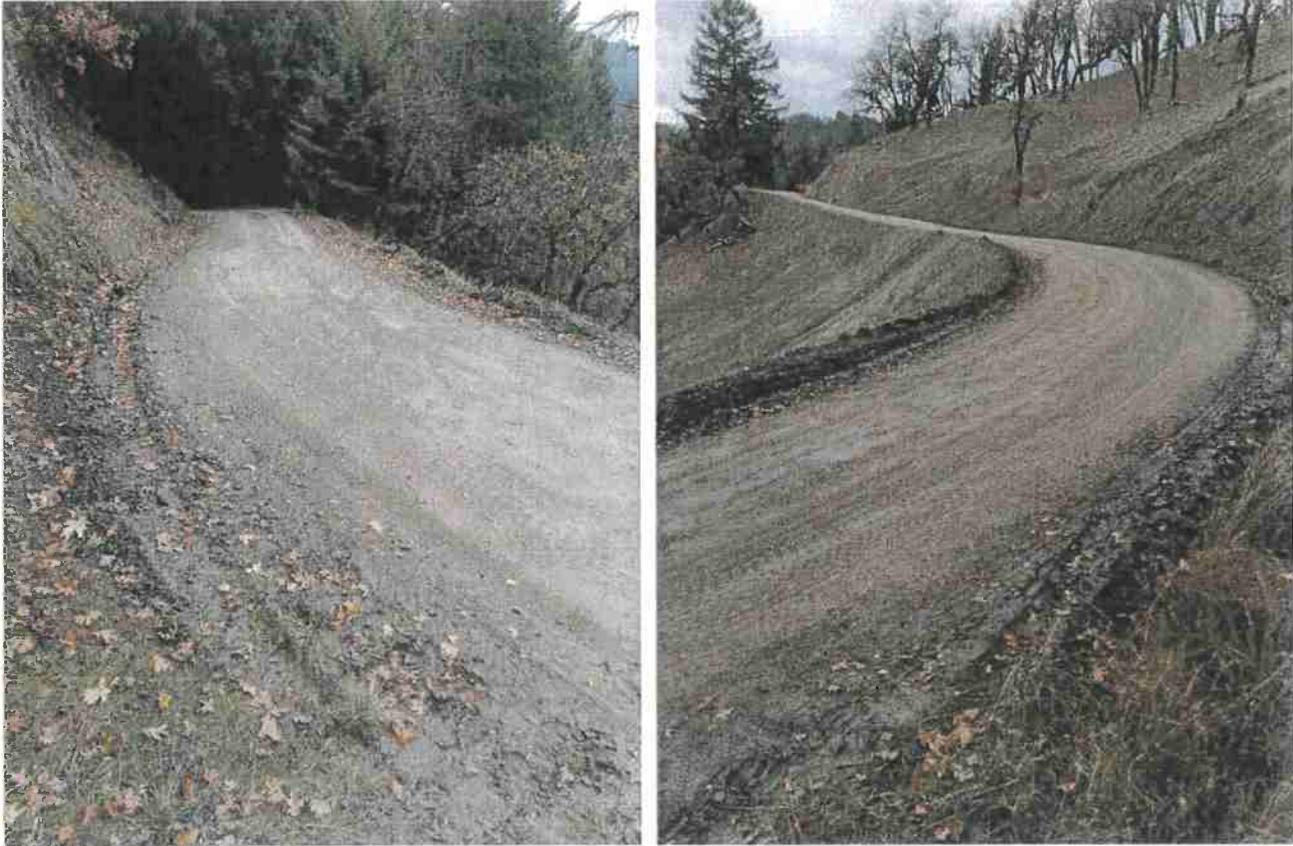
Road Point 32: Photos are taken looking each direction at the properly functioning ditch relief culvert at Road Point 32. It is situated above the head of a Class III watercourse, but didn't appear to be the source of sediment in the Class III watercourse downstream at Point 23 and 25. Between Road Point 32 and Point 25, there are several surface drainage features described above that are in need of maintenance or improvement to disperse concentrated road runoff. Photo date 11-18-2021.

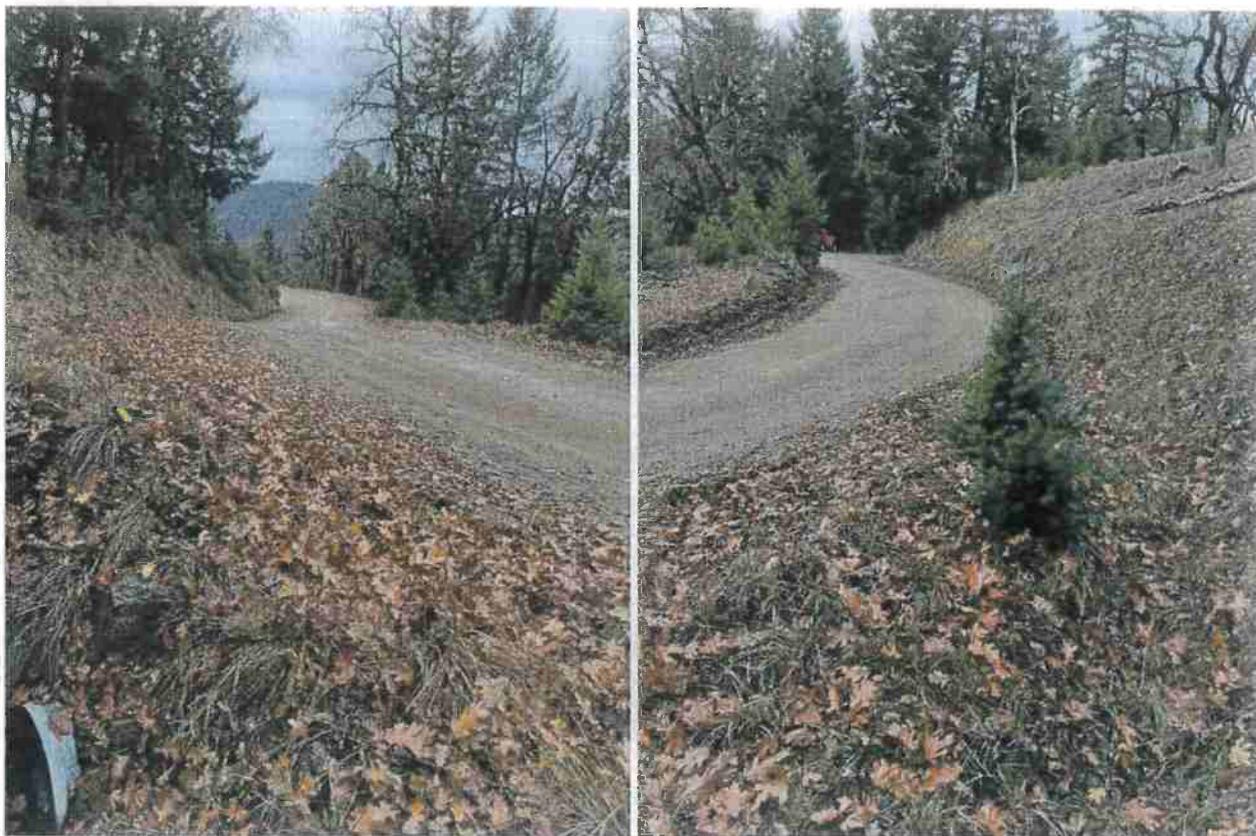
Road Point 33: Photo shows the road looking each direction at the existing 18-inch diameter metal culvert, Class III watercourse crossing. The culvert appeared to be in fair condition, functioning properly, and adequately sized for the 100 year peak streamflow. The culvert is set at a natural low spot in the road and surface runoff flows over the outboard edge of the road towards the outlet. At Road Point 33 keep the culvert open and maintained, and if feasible, breach the outboard berm and establish a surface lead-out to disperse road runoff approximately 40 feet to the north. Photo date 11-18-2021.

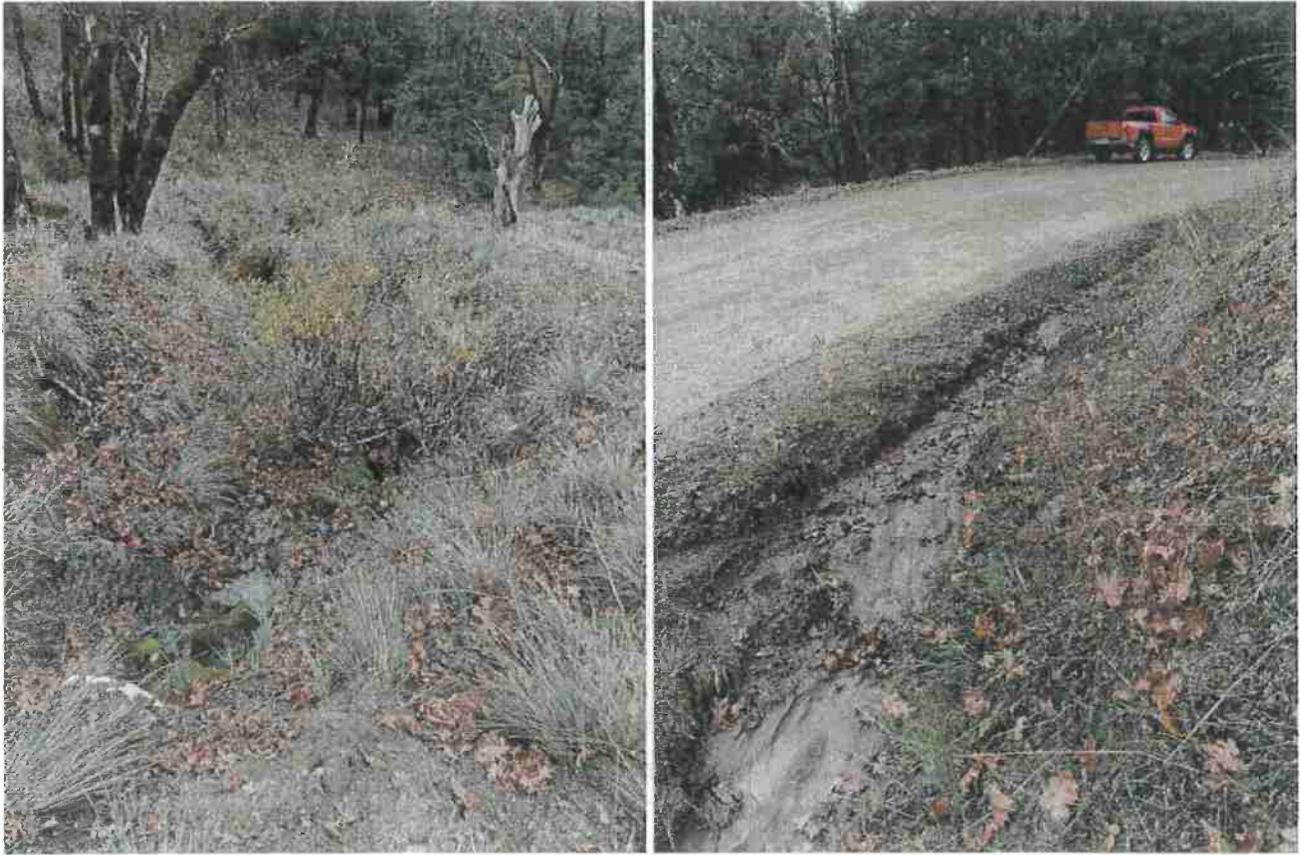
Road Point 34: Existing 18-inch diameter metal culvert crossing of a small Class III watercourse. The photo on the left shows the view looking down at the outlet and the photo on the right shows the incoming hydrologically connected inside ditch. The culvert appeared to be in fair condition, functioning properly, and calculated as slightly undersized. At Road Point 34 hydrologically disconnect the incoming road surface to the northwest per the maintenance described for Road Point 35 of this report. Upon its replacement, a properly sized culvert should be installed per the attached BMPs. Photo date 11-18-2021.

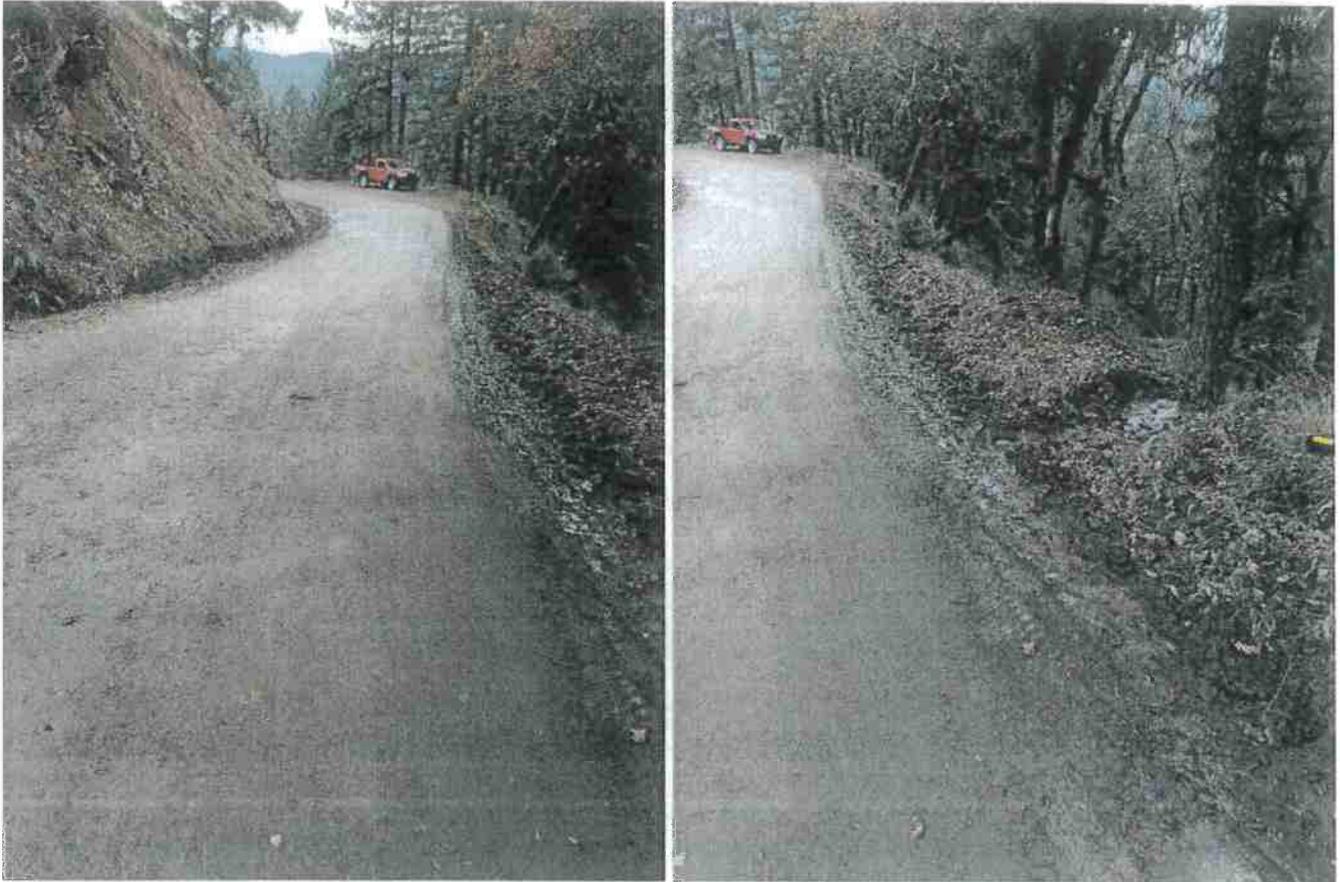
Road Point 35: Existing surface lead-out that is not functioning properly. Photos show that currently runoff is able to bypass the surface lead-out / berm breach, and crosses to the inside ditch in front of the pickup in the distance, and continues to the inlet at Point 34. At Point 35 deepen and lengthen the existing lead-out so that it drains the road surface and the inside ditch. As an alternative, a new ditch relief culvert could be installed at this location along with re-establishing a crowned road surface and inside ditch up the road towards Point 36. Photo date 11-18-2021.

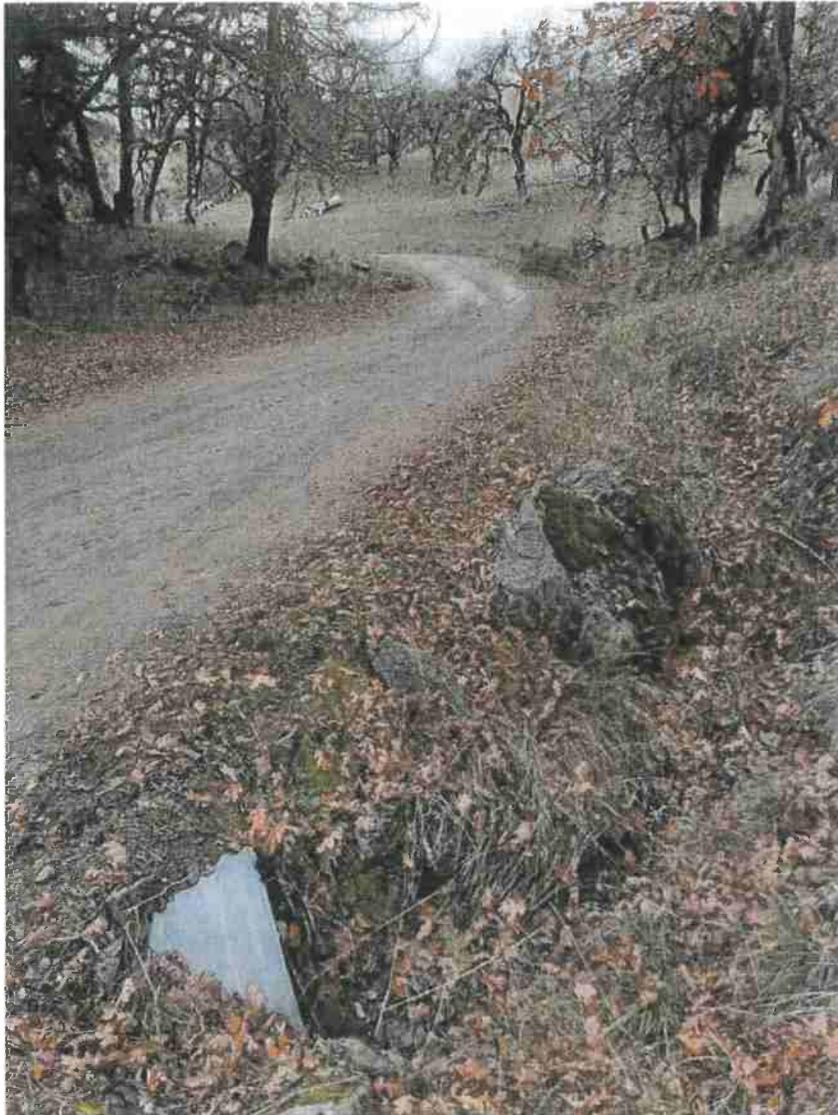
Road Point 36: Existing 24-inch diameter metal culvert watercourse crossing of a small Class III watercourse. A very short, vegetated inside ditch with no sign of erosion connects to the inlet. The culvert appeared to be in good condition, functioning properly, and it is sized adequately for the 100 year peak streamflow. At Road Point 36 keep the culvert open and free of obstructions. Photo date 11-18-2021.

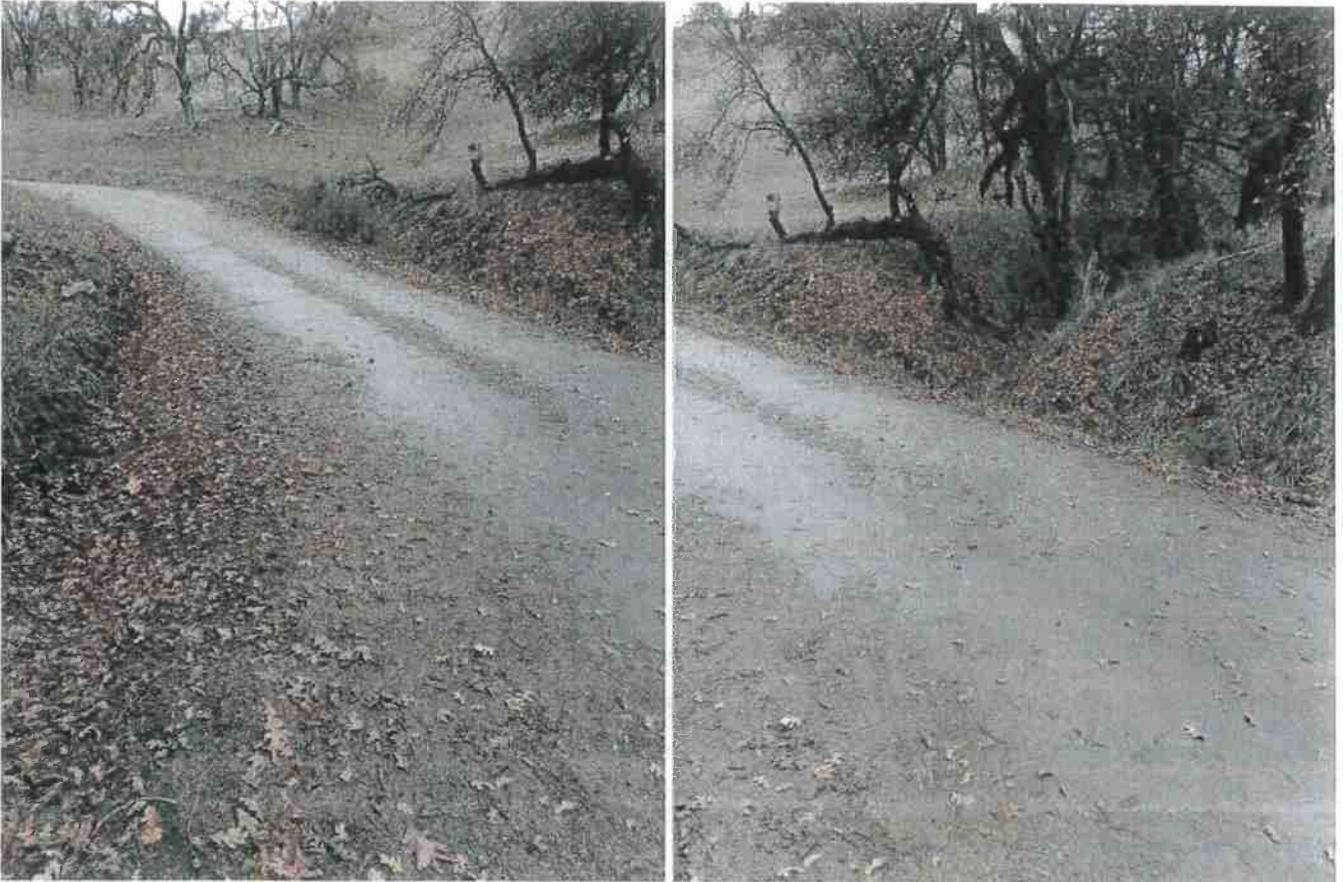
Road Point 37: Existing 18-inch diameter metal culvert watercourse crossing of a small Class III watercourse. The photo on the left shows the view up the road northwesterly and the photo on the right shows the view looking up the watercourse. The culvert also receives inside ditch runoff from the northwest from a low gradient vegetated inside ditch with no erosion. The culvert appeared to be in fair condition, functioning, and it is calculated as slightly undersized. Upon its replacement, a properly sized culvert should be installed per the attached BMPs. Photo date 11-18-2021.

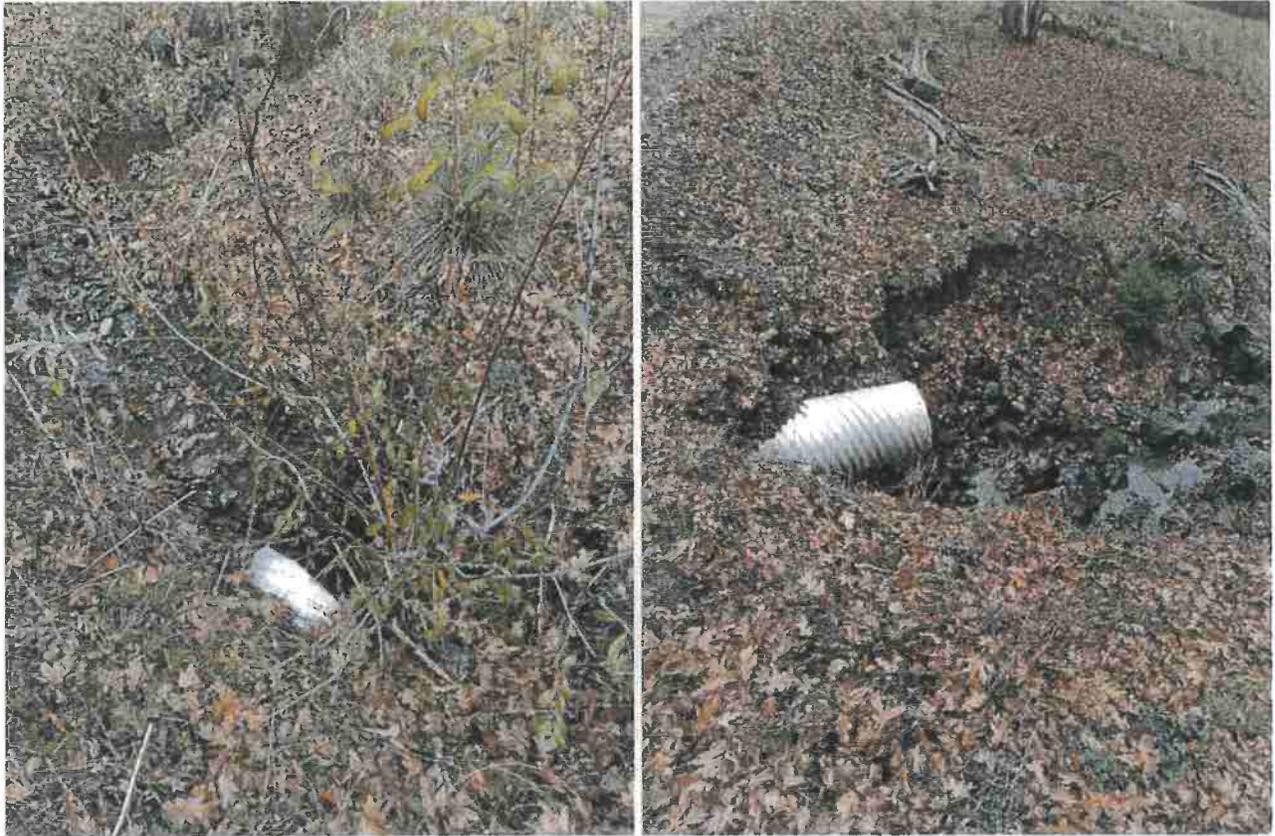
Road Point 39: Existing 18-inch diameter metal culvert watercourse crossing of a small Class III watercourse. The photo on the left shows the inlet and the photo on the right shows the outlet. The culvert is slightly misaligned at the inlet, and was set above the natural grade at the outlet that resulted in past erosion. It is calculated as slightly undersized. The road approaches are mostly outsloped through the crossing and surface runoff flows over the outboard edge of the road towards the outlet. At Road Point 39 a properly sized culvert should be installed per the attached BMPs. Continue to maintain the current outsloped drainage pattern by grading berm material that builds up over time with traffic use. This will allow runoff to sheet off the road without becoming concentrated directly over the culvert outlet. Photo date 11-18-2021.
