HUMBOLDT COUNTY DEPARTMENT OF PUBLIC WORKS
ROAD EVALUATION REPORT

Road Name: DINSMORE / BEAR CREEK ROAD (complete a separate form for each road)

ROAD ASSESSMENT

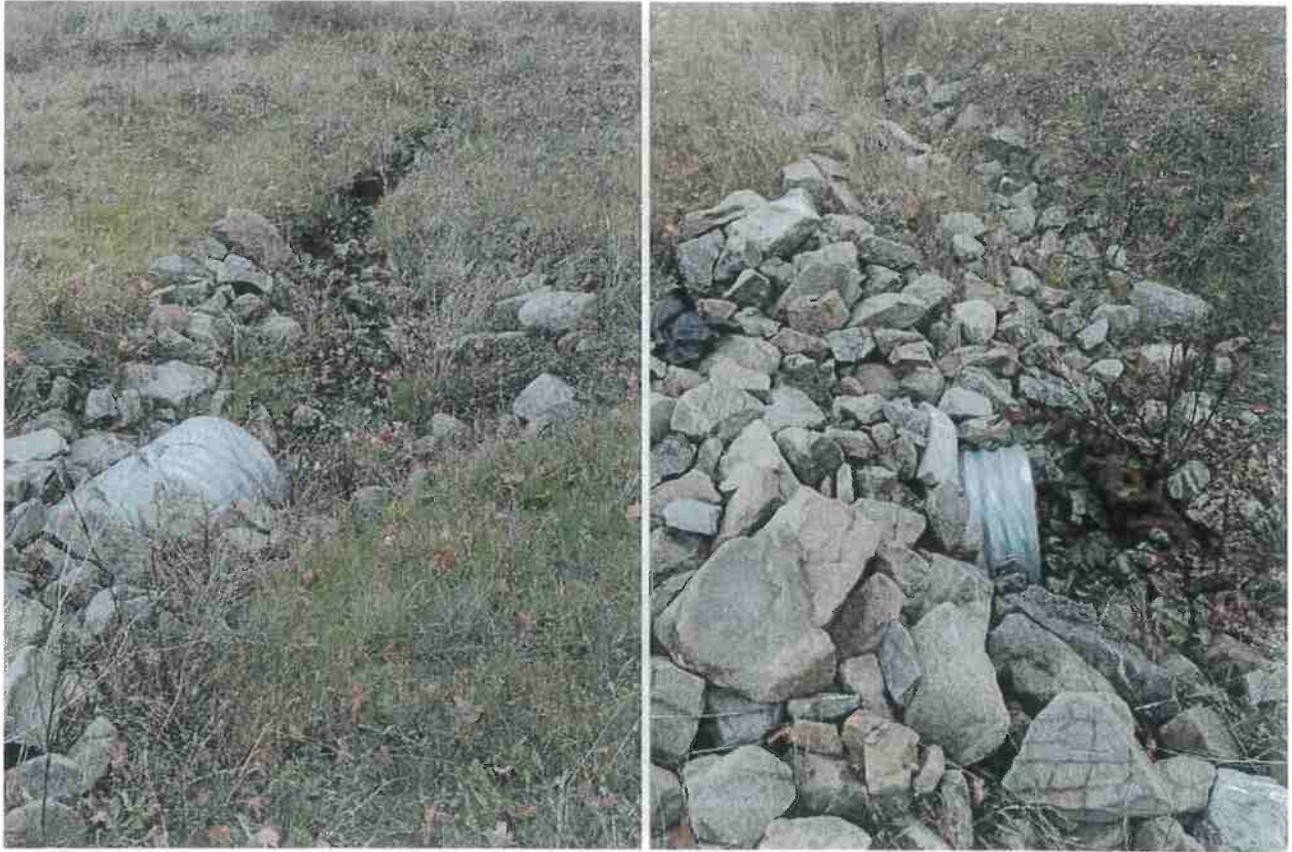
Road Point 42: Existing 24-inch diameter metal culvert watercourse crossing. The photo on the left shows the outlet and the photo on the right shows the inlet. The crossing was upgraded within the last 5 years. The inlet and outlet are heavily rock armored and the culvert appeared to be in very good condition, functioning properly, and it is sized adequately for the 100 year peak streamflow. At Road Point 42, monitor to make sure that the culvert remains open and functioning. Photo date 11-18-2021.

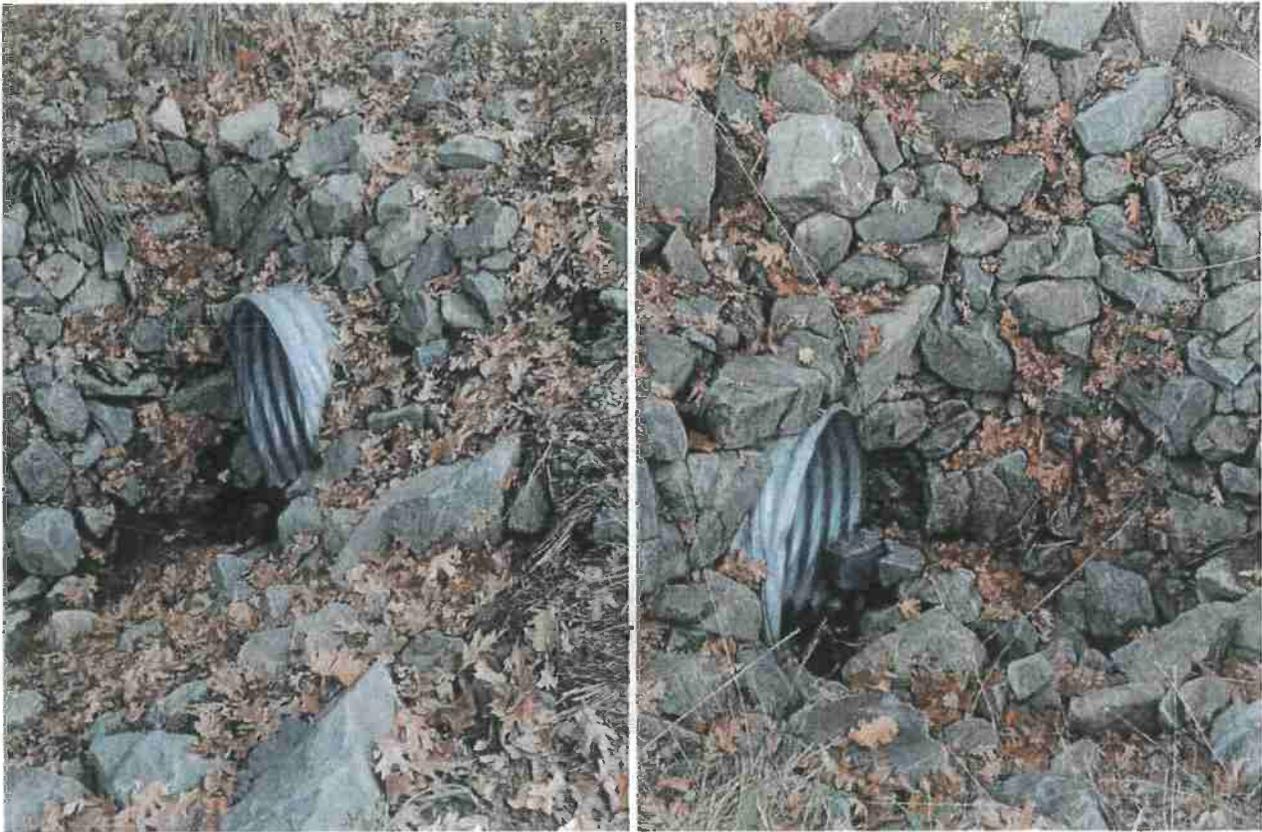
Road Point 43: Existing 36-inch diameter metal culvert watercourse crossing. The photo on the left shows the outlet and the photo on the right shows the inlet. The crossing was upgraded within the last 5 years. The inlet and outlet are heavily rock armored and the culvert appeared to be in very good condition, functioning properly, and it is sized adequately for the 100 year peak streamflow. At Road Point 43, monitor to make sure that the culvert remains open and functioning. Photo date 11-18-2021.

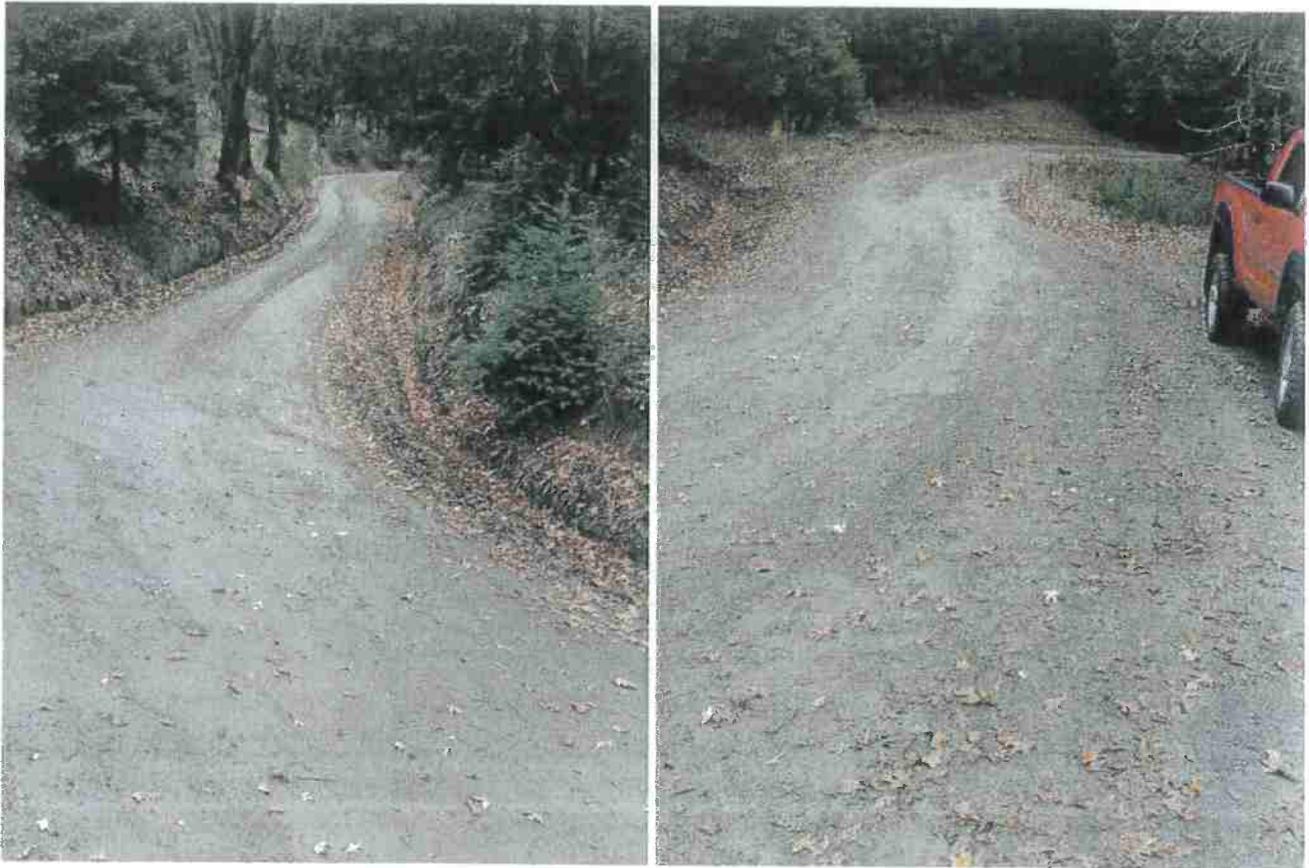
Road Point 44, 45, and 46: The photo on the left is taken at Road Point 45 and is looking up the through-cut section towards Point 46. The photo on the right is taken at Road Point 45 and is looking towards the crossing at Road Point 44 at the turn behind the pickup. The crossing is a 36-inch diameter culvert that was upgraded in the last 5 years. It is heavily rock armored at the inlet and the outlet, in very good condition, and is sized adequately for the 100 year peak streamflow. Runoff from a portion of a through-cut section of road between Point 45 and Point 46 drains via a hydrologically connected inside ditch to the inlet of this culvert. Approximately 40 feet south of the crossing at Point 44, a rocked rolling dip should be installed to cross drain the ditch and road surface. Alternatively, there may be a location approximately 80 south of Point 44 to install a ditch relief culvert. Photo date 11-18-2021.

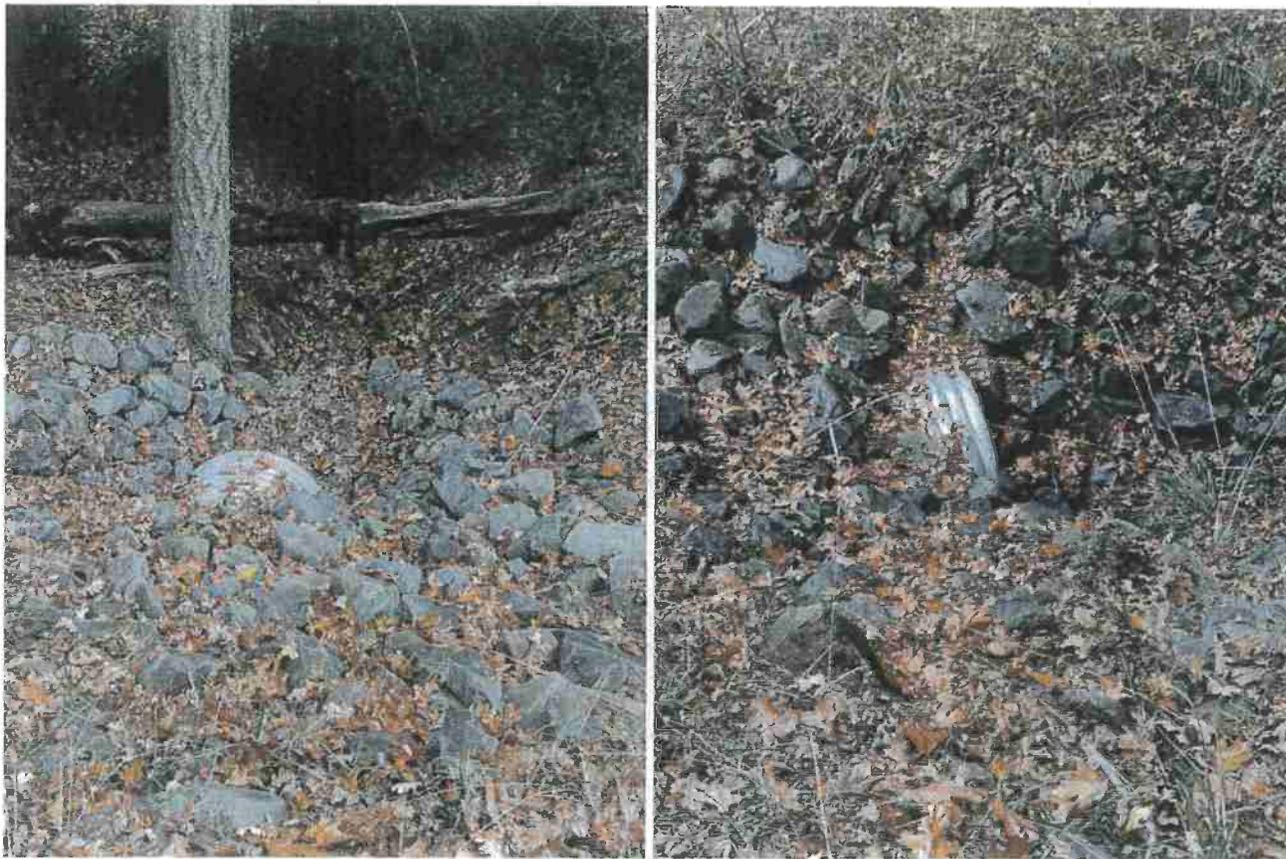
Road Point 47: Existing 36-inch diameter metal culvert watercourse crossing. The photo on the left shows the outlet and the photo on the right shows the inlet. The crossing was upgraded within the last 5 years. The inlet and outlet are heavily rock armored and the culvert appeared to be in very good condition, functioning properly, and it is sized adequately for the 100 year peak streamflow. At Road Point 47, monitor to make sure that the culvert remains open and functioning. The Class III watercourse had received road related sediment from upstream and from a connected inside ditch during the first rainy period of mid-October and early November 2021. Maintenance and installation of road drainage features up the road at Road Point 48 through 54 will help to address road related sediment entering the Class III watercourse from above by dispersing road surface runoff. Photo date 11-18-2021.

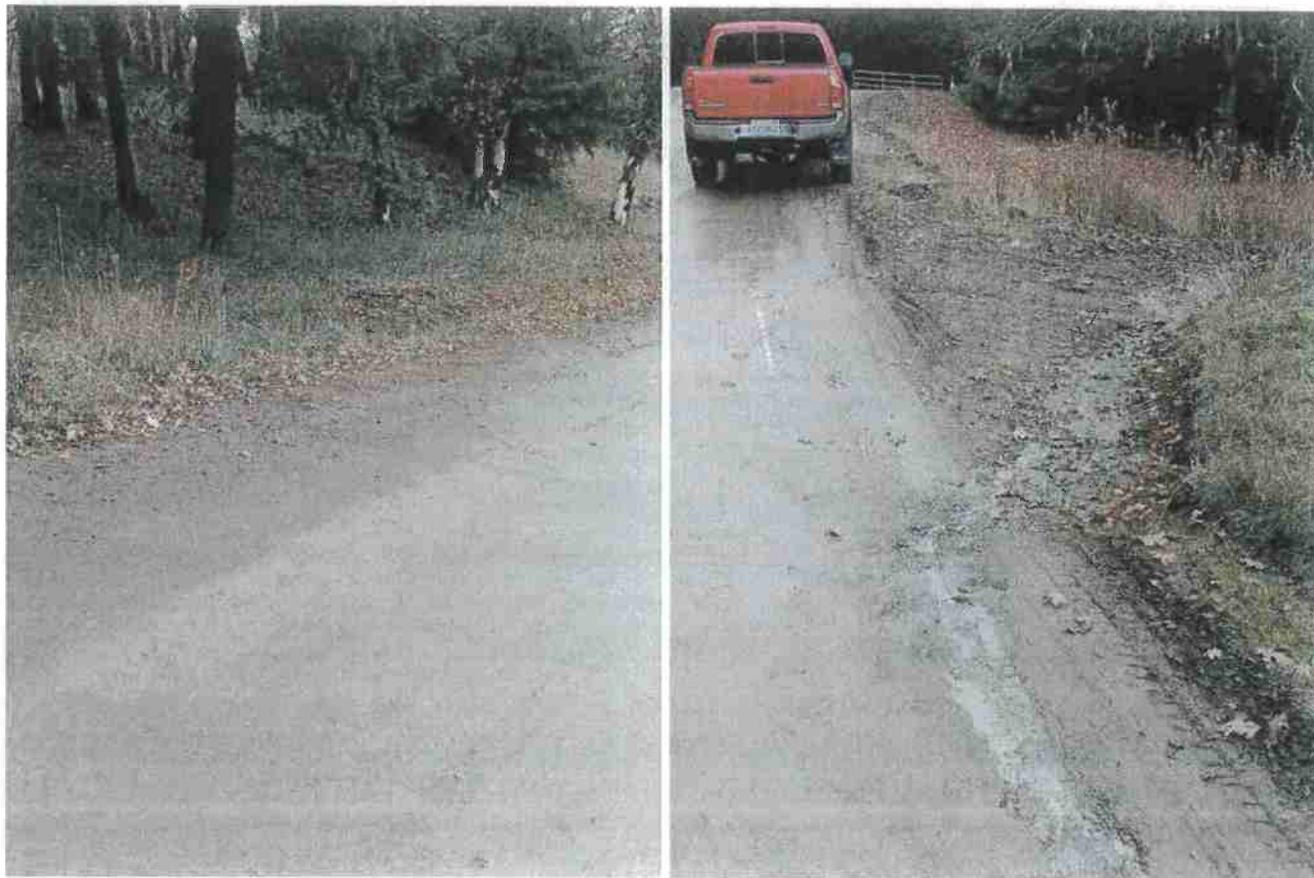
Road Point 57: Road Point 57 is an existing 18-inch diameter ditch relief culvert. The inlet area is pictured on the left and the outlet area is pictured on the right. The inlet was open and the outlet was buried by recent road grading that looked to have been conducted to push open a surface lead-out. At Point 57, clean out the buried outlet and maintain the road surface lead-out. If the ditch relief culvert is damaged, it should be replaced. Photo date 11-18-2021.

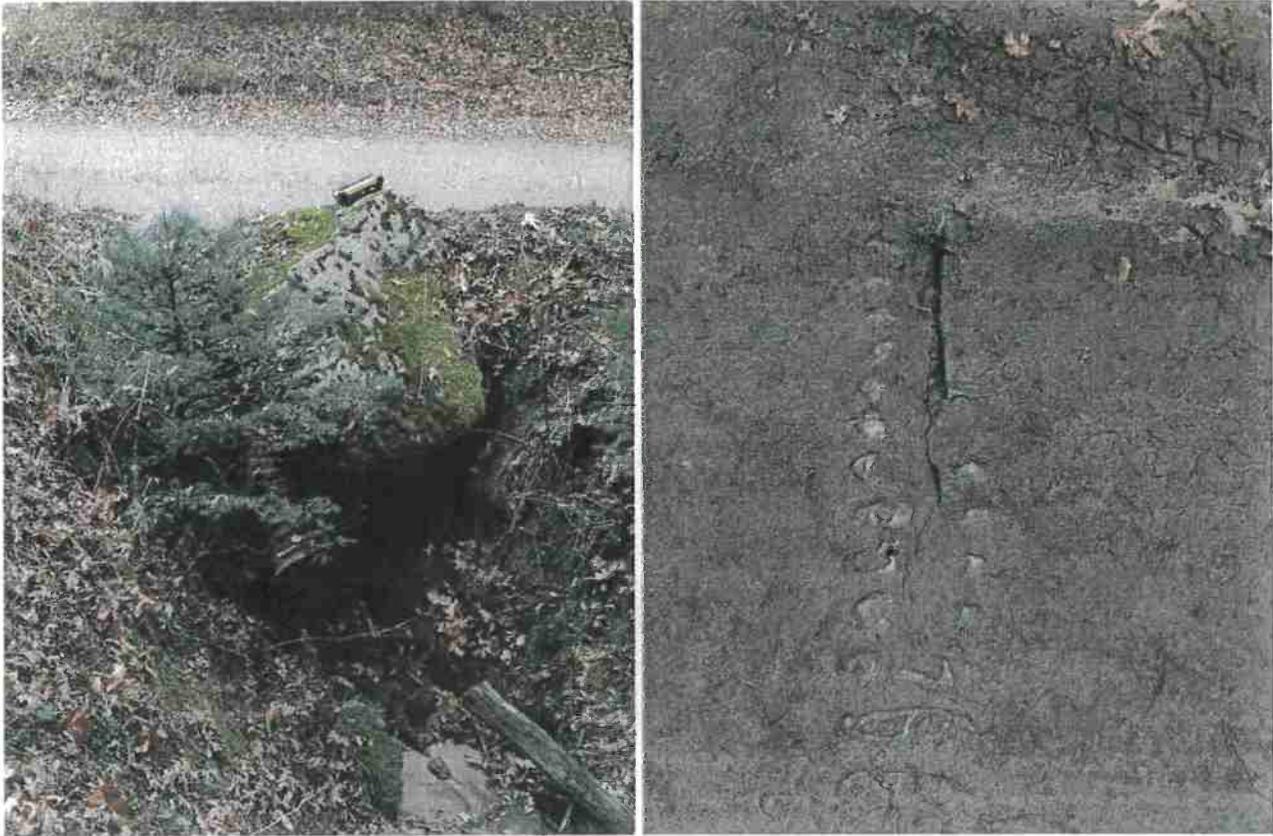
Road Point 59 and 60: Points 59 and 60 are two small Class III watercourse crossings in close proximity, both in need of crossing upgrades. At Point 59 a very small Class III watercourse hits the road at an angle with no crossing structure in place and is diverted down the road towards Point 60. Point 60 is a badly damaged, worn out 15-inch diameter culvert crossing of a small Class III watercourse (pictured). At both Road Point 59 and 60, properly sized culverts should be installed per the attached BMPs. Photo date 11-18-2021.

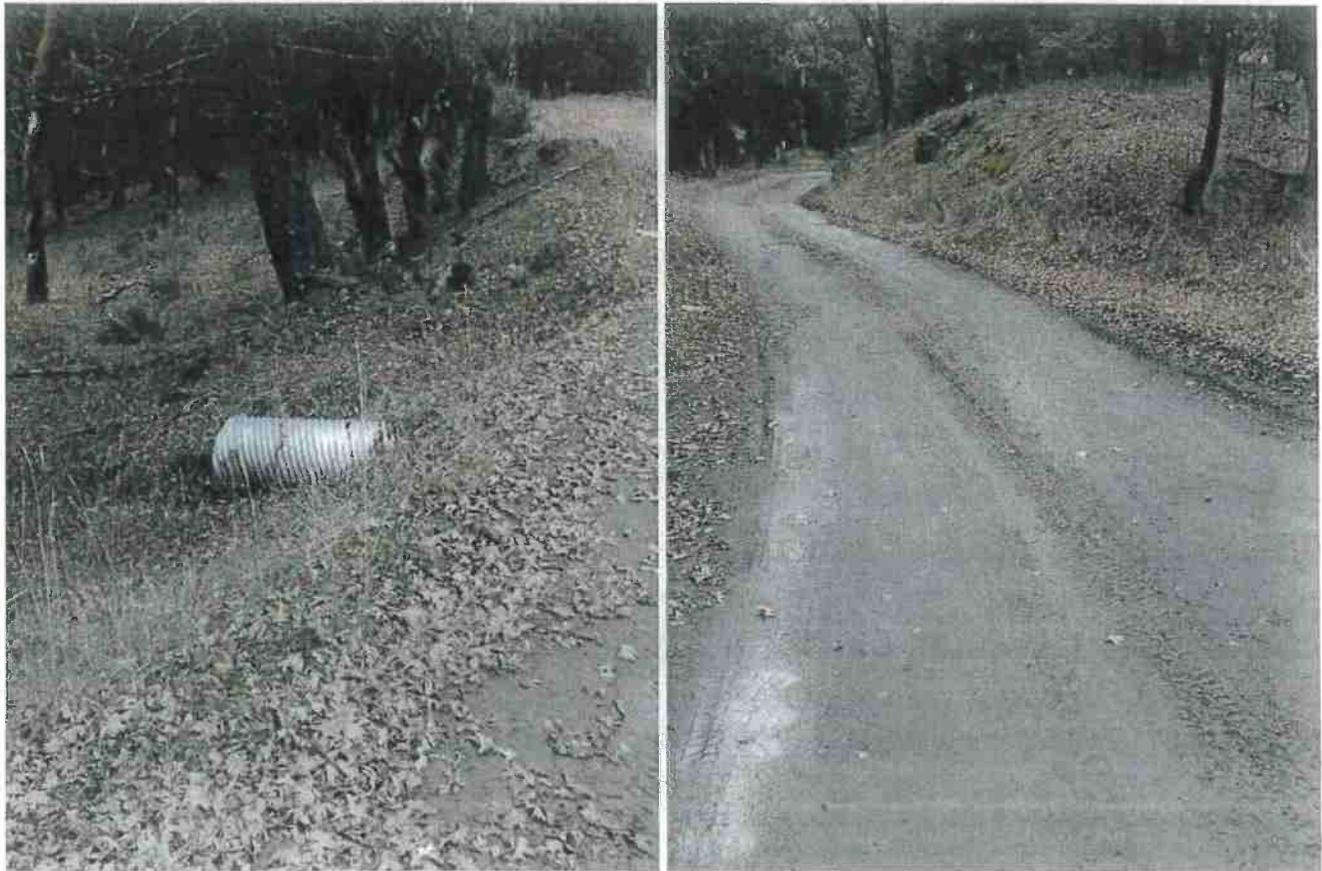
Road Point 61: Road Point 61 is an existing 18-inch diameter ditch relief culvert. Photos show the outboard edge and the road surface at the properly functioning ditch relief culvert. It is situated above the head of a Class III watercourse, but didn't appear to be a source of sediment to the Class III watercourse. Photo date 11-18-2021.

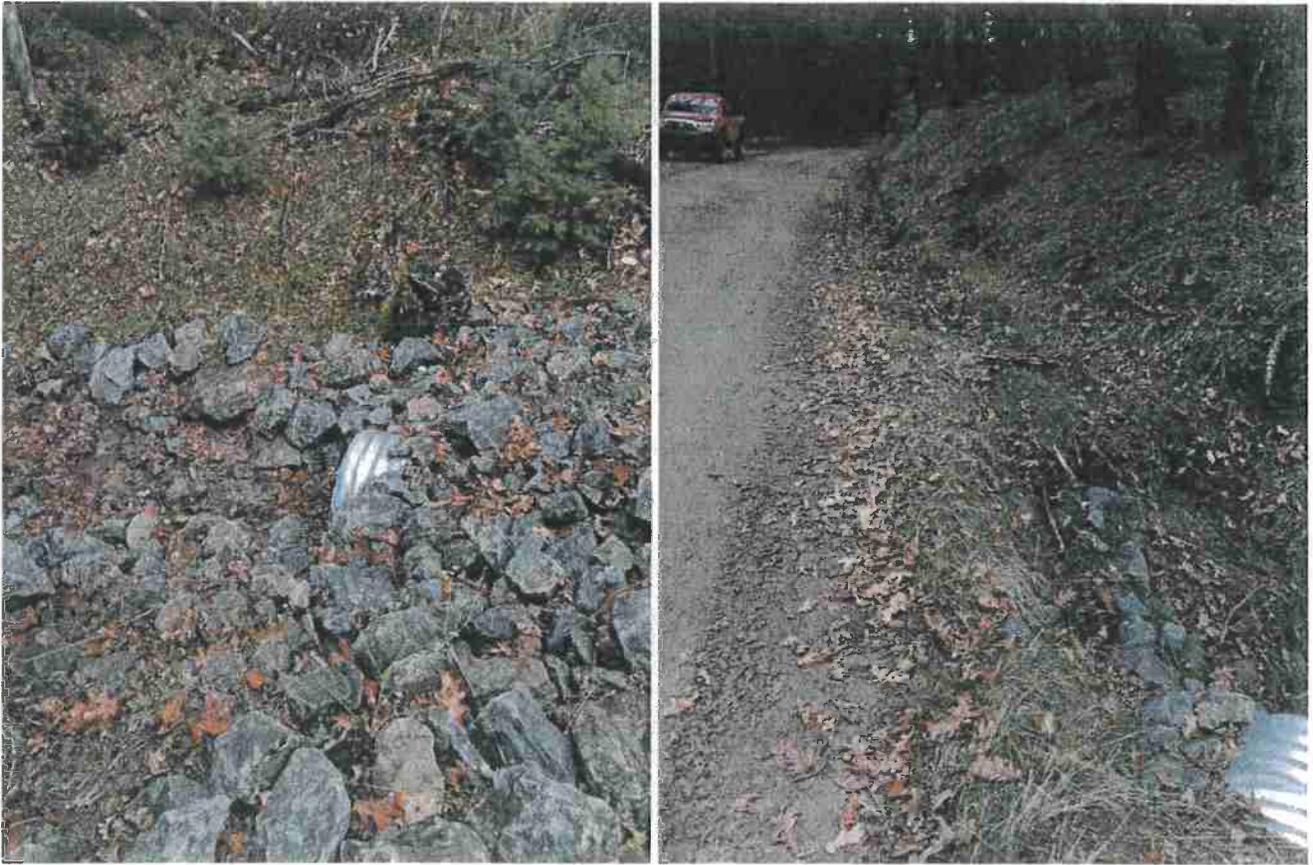
Road Point 63: Road Point 63 is an existing 24-inch diameter ditch relief culvert. The photo on the left shows the outlet and the photo on the right shows the incoming inside ditch and inlet. Approximately 250 feet to the southeast at Road Point 62, a new ditch relief culvert should be installed to reduce the amount of concentrated flows entering this culvert. Photo date 11-18-2021.

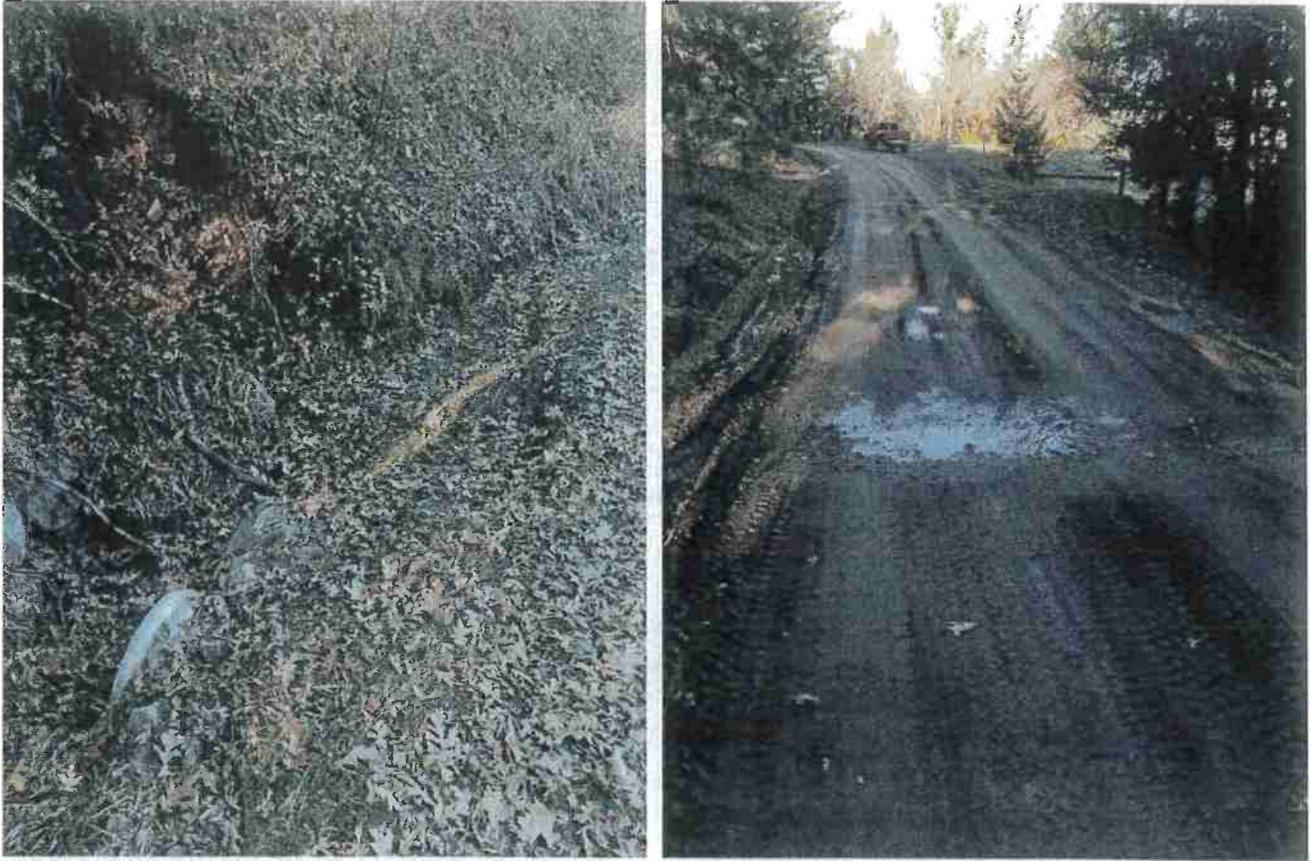
Road Point 64: Road Point 64 is an existing 18-inch ditch relief culvert that is in good condition. It needs minor maintenance to clean out the inside ditch for approximately 60 feet to the northwest. Also, approximately 30 feet to the northwest is a worn, partially filled in rolling dip that could be cleaned out during road grading as an added surface drainage feature. Continue to grade the road surface to maintain the current crowned drainage pattern per the attached BMPs. Photo date 11-22-2021.

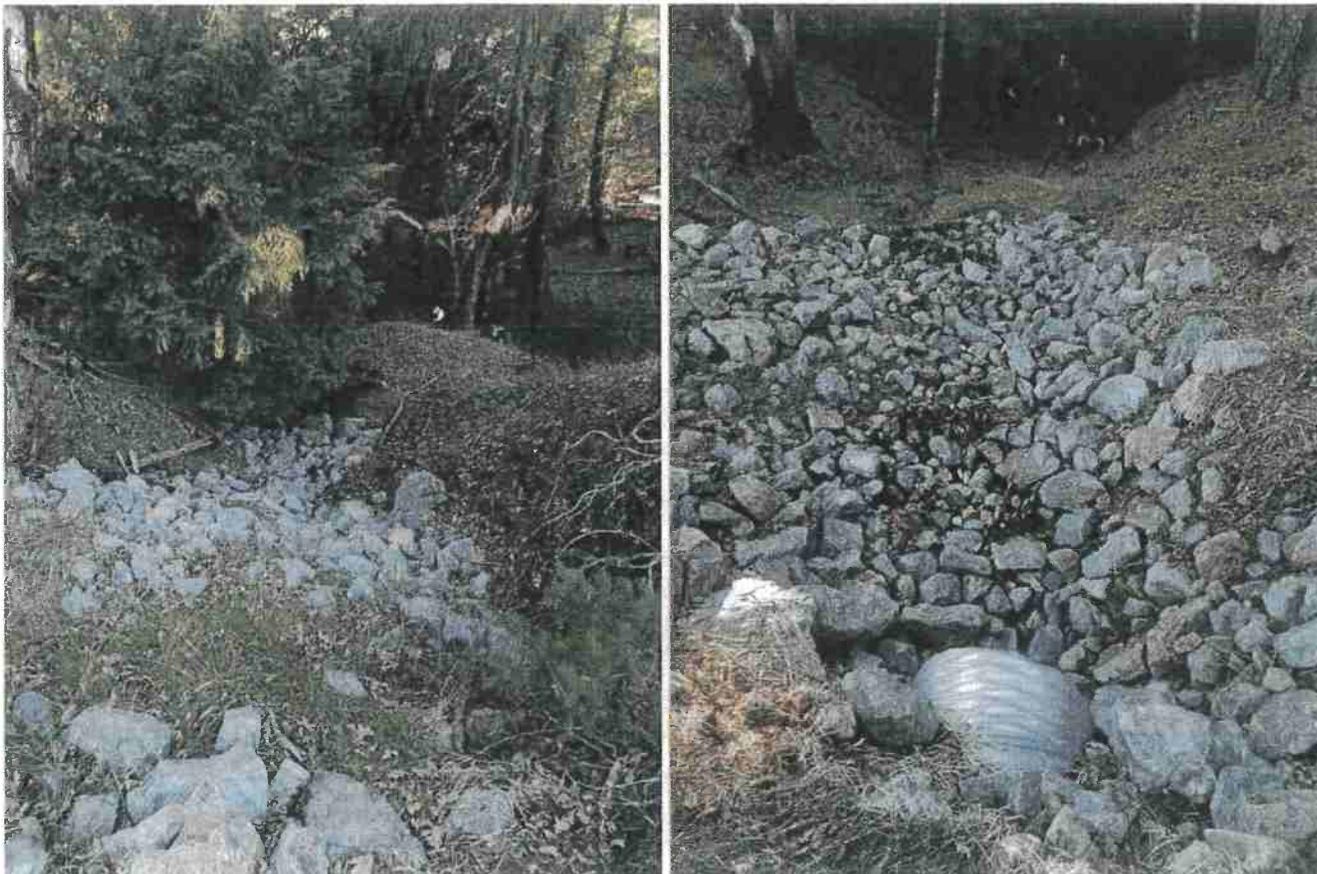
Road Point 65: Existing 30-inch diameter metal culvert watercourse crossing. The photo on the left shows the outlet and the photo on the right shows the inlet. The crossing was upgraded within the last 5 years. The inlet and outlet are heavily rock armored and the culvert appeared to be in very good condition, functioning properly, and it is sized adequately for the 100 year peak streamflow. At Road Point 65, monitor to make sure that the culvert remains open and functioning. Photo date 11-22-2021.

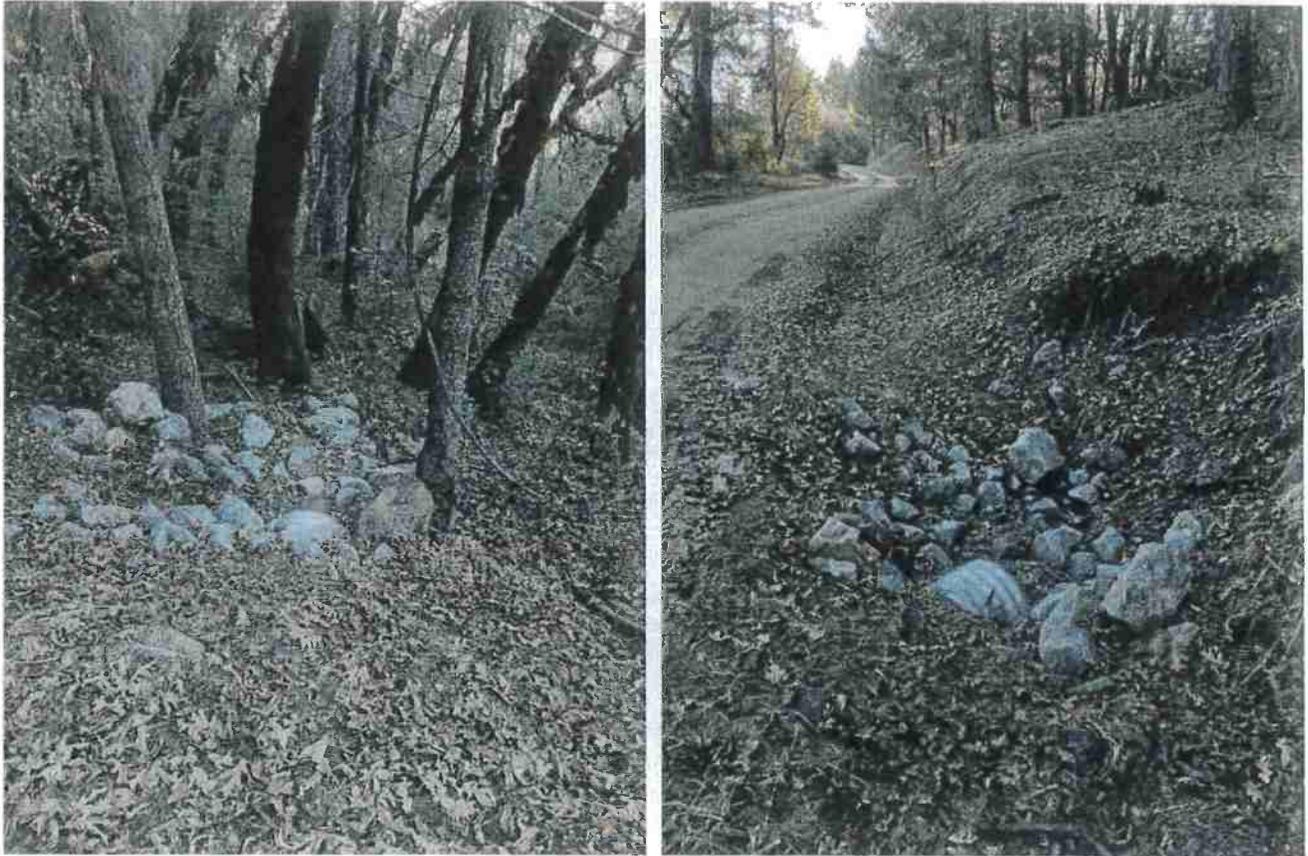
Road Point 66: Road Point 66 is an existing 18-inch diameter ditch relief culvert. The photo on the left shows the outlet and the photo on the right shows the incoming inside ditch and inlet. Photo date 11-22-2021.

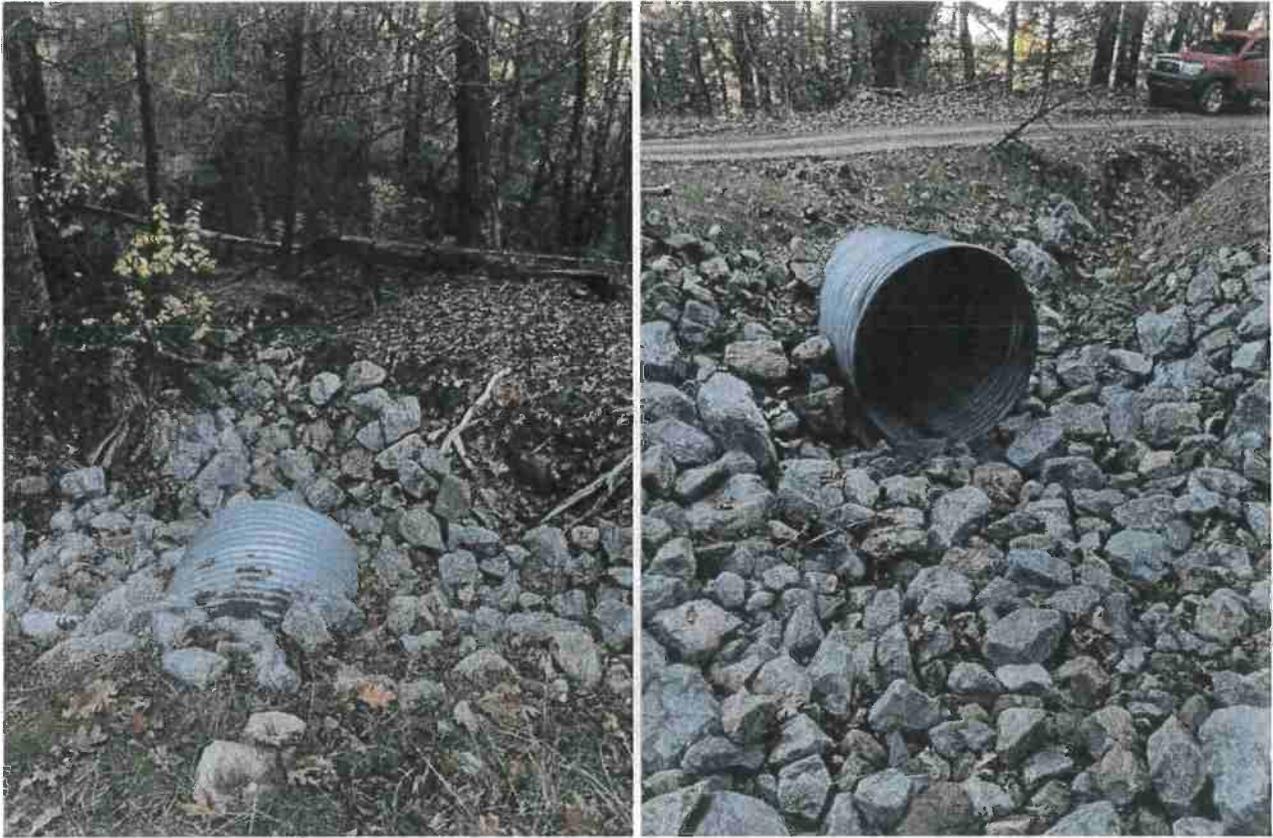
Road Point 67: Existing 48-inch diameter metal culvert watercourse crossing. The photo on the left shows the outlet and the photo on the right shows the inlet. The crossing was upgraded within the last 5 years. The inlet and outlet are heavily rock armored and the culvert appeared to be in very good condition, functioning properly, and it is sized adequately for the 100 year peak streamflow. At Road Point 67, monitor to make sure that the culvert remains open and functioning. Photo date 11-22-2021.

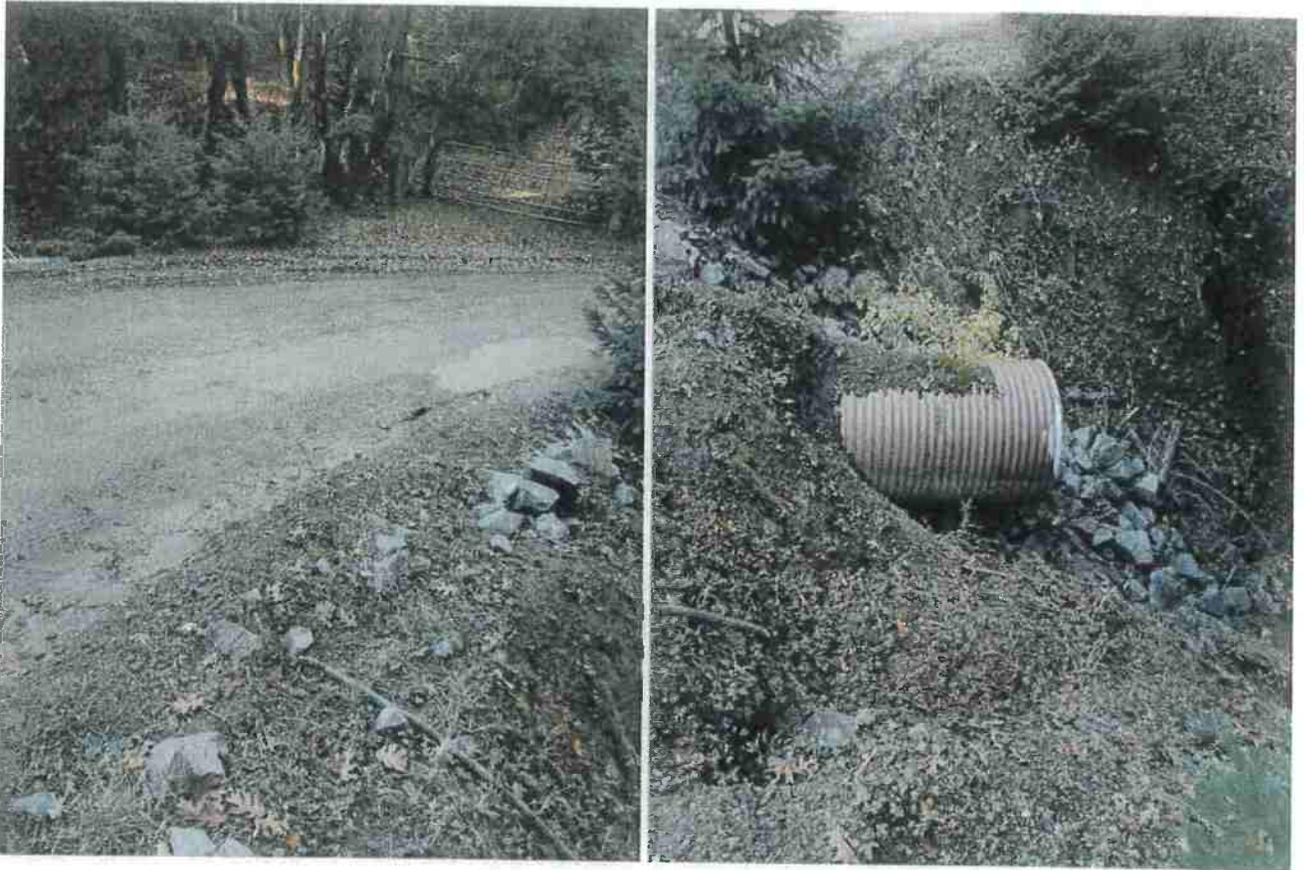
Road Point 72: Existing old, rusted 48-inch diameter metal culvert crossing of a Class II watercourse. The culvert when installed many years ago was too short and not set to grade at the outlet resulting in erosion of the fills in the past. The culvert is worn and has a partially rusted bottom, but its sizing is adequate. At Road Point 72, a properly sized culvert should be installed per the attached BMPs. Photo date 11-22-21.

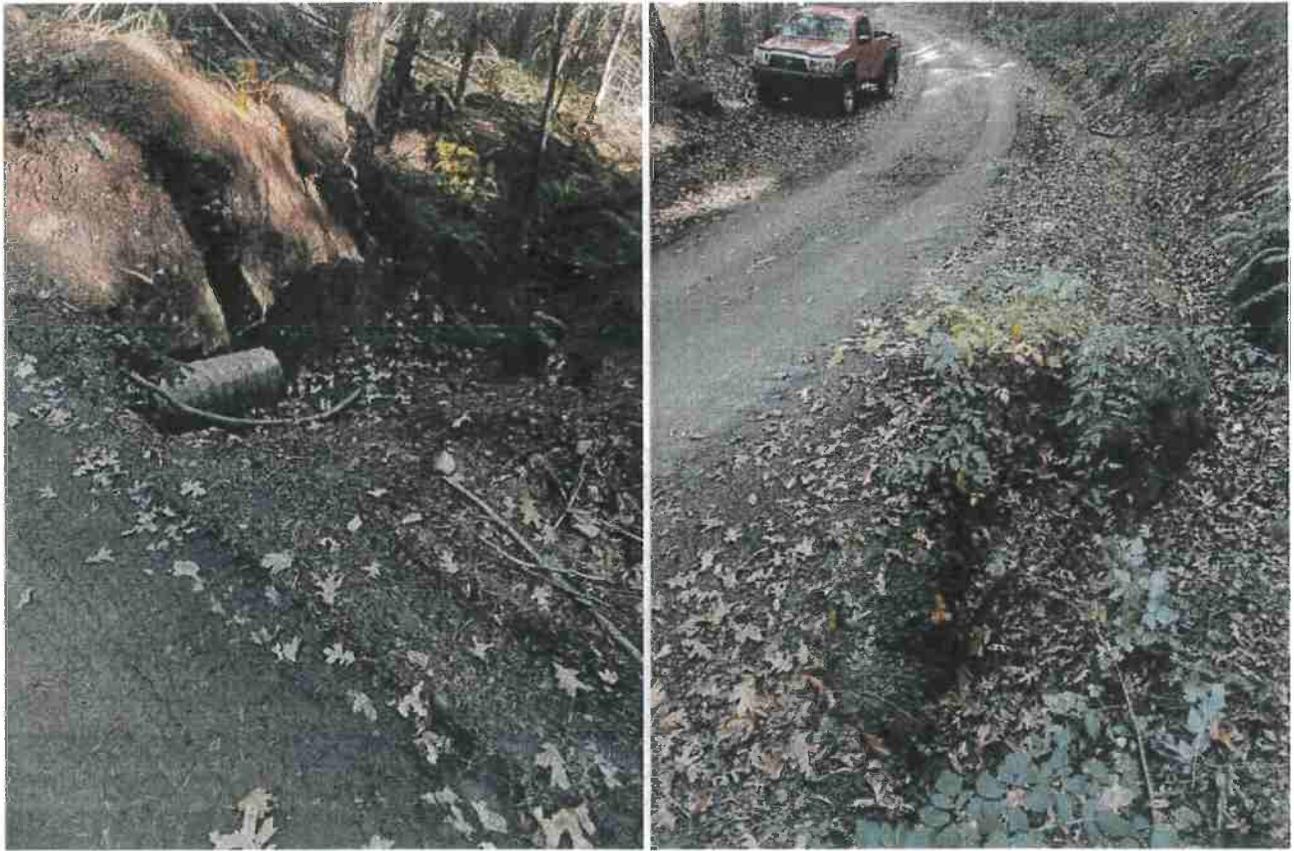
Road Point 73 and 74: Points 73 and 74 are two small Class III watercourse crossings in close proximity, both in need of crossing upgrades. At Point 73 a very small Class III watercourse hits the road at an angle with no crossing structure in place and is diverted down the ditch and road surface towards Point 74. Point 74 is a worn out 12-inch diameter culvert crossing of a small Class III watercourse. The picture on the right shows the inlet at Point 74 and the incoming inside ditch looking southwest. The picture on the left shows the outlet at Point 74. At both Road Point 73 and 74, properly sized culverts should be installed per the attached BMPs. Photo date 11-22-2021.

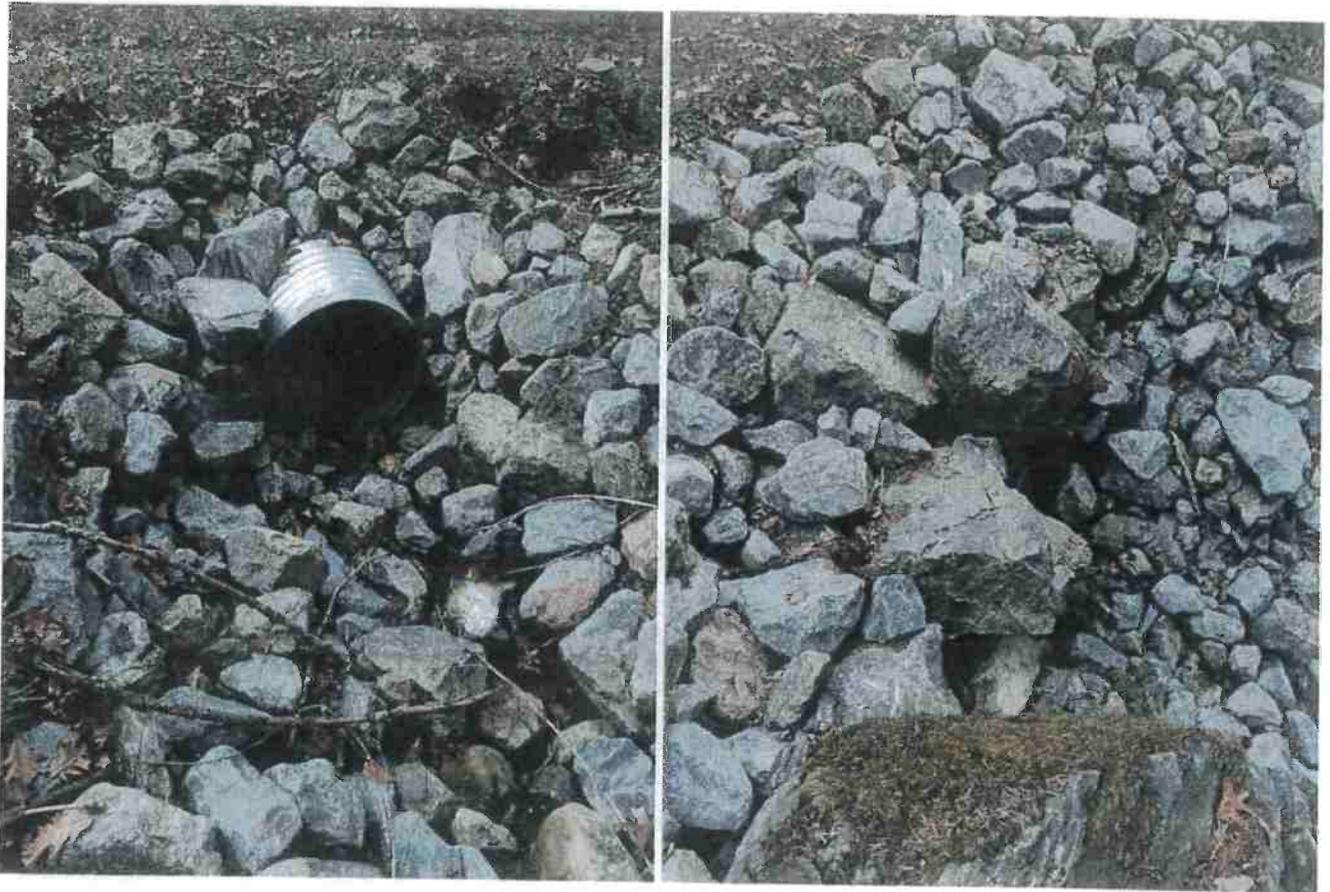
Map Point 78: Existing 24-inch diameter metal culvert watercourse crossing. The photo on the left shows the inlet and the photo on the right shows the outlet. The crossing was upgraded within the last 5 years. The inlet and outlet are heavily rock armored and the culvert appeared to be in very good condition and functioning properly. At Road Point 78, monitor to make sure that the culvert remains open and functioning. Photo date 11-22-2021.

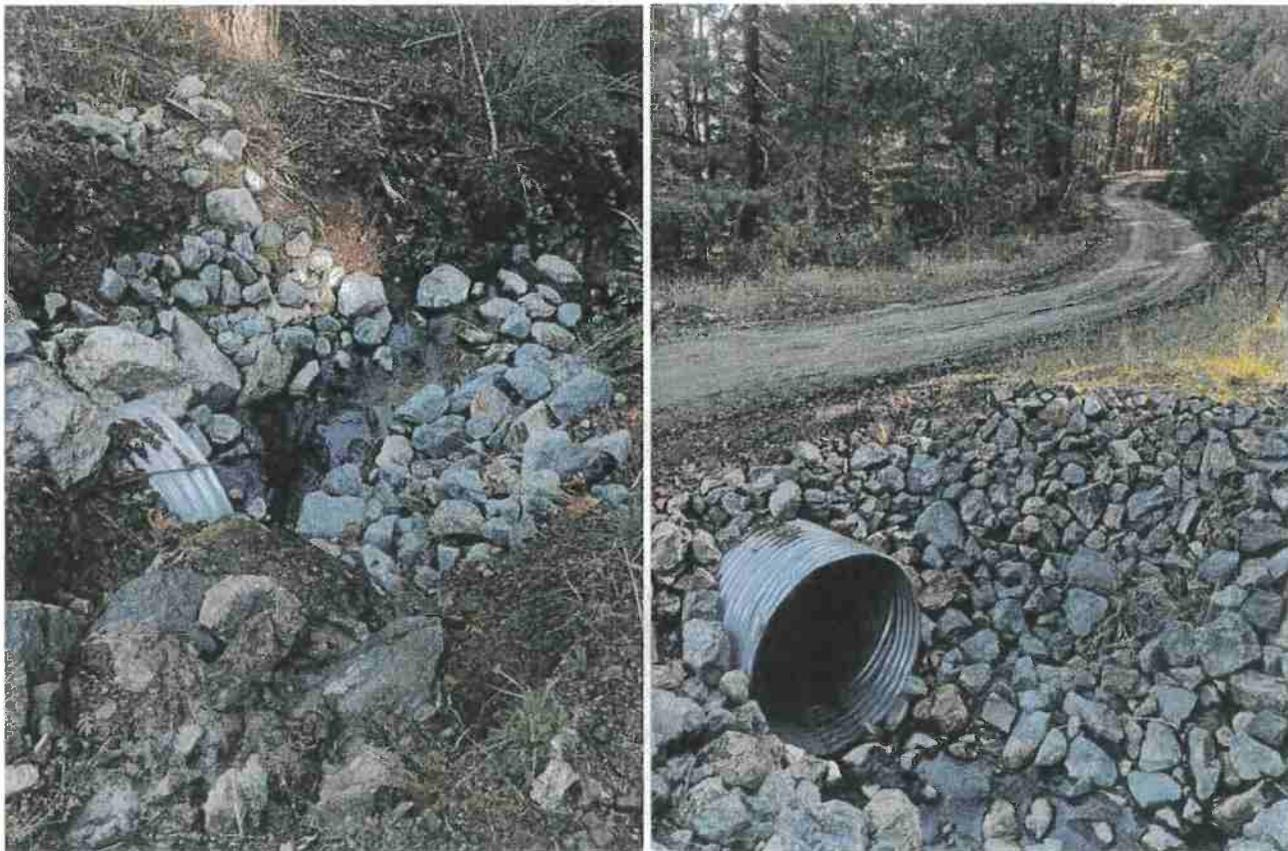
Map Point 80: Existing 48-inch diameter metal culvert watercourse crossing. The photo on the left shows the outlet and the photo on the right shows the inlet and the view looking southwesterly. The crossing was upgraded within the last 5 years. The inlet and outlet are heavily rock armored and the culvert appeared to be in very good condition and functioning properly. At Road Point 80, monitor to make sure that the culvert remains open and functioning. Photo date 11-22-2021.

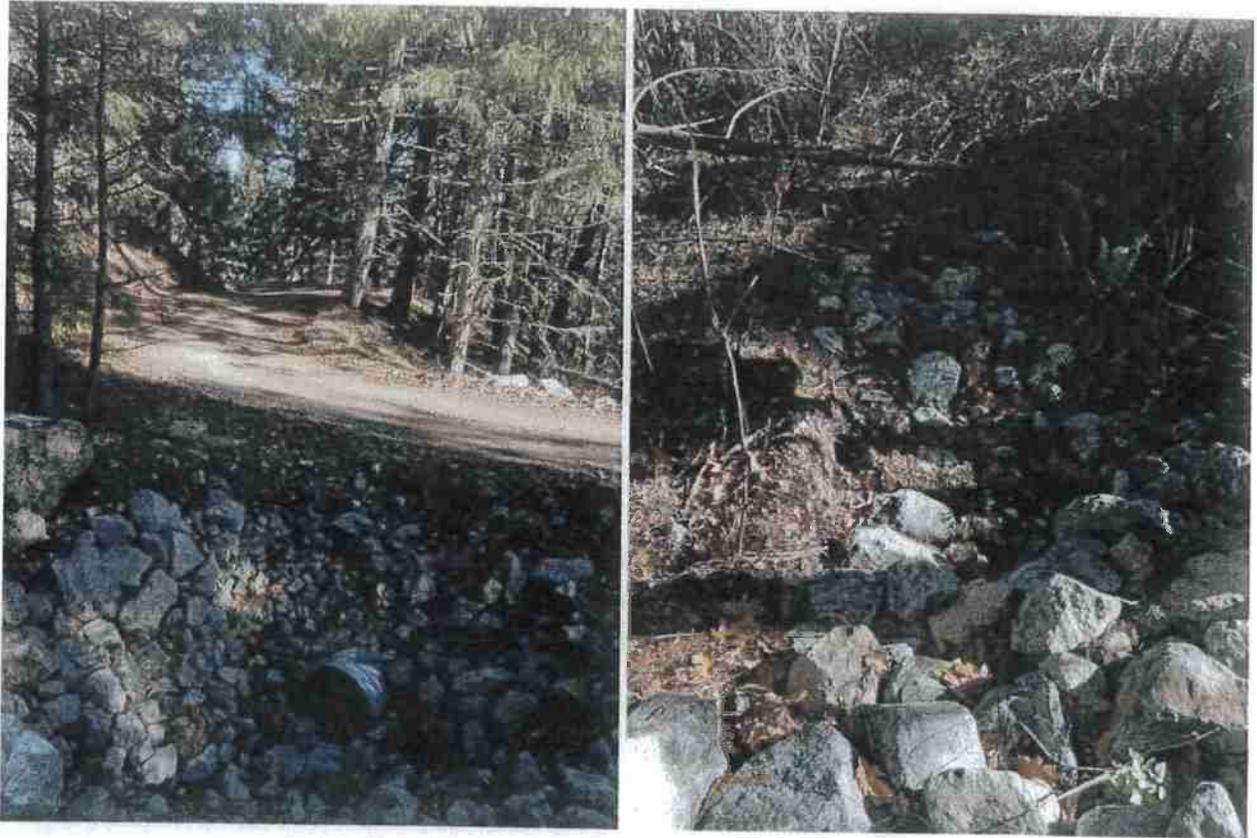
Map Point 82: Existing 18-inch diameter metal culvert watercourse crossing. The photo on the left shows the inlet and the photo on the right shows the outlet. The crossing was upgraded within the last 5 years. The inlet and outlet are heavily rock armored and the culvert appeared to be in very good condition, functioning properly, and it is sized adequately for the 100 year peak streamflow. At Road Point 82, monitor to make sure that the culvert remains open and functioning. Photo date 11-22-2021.

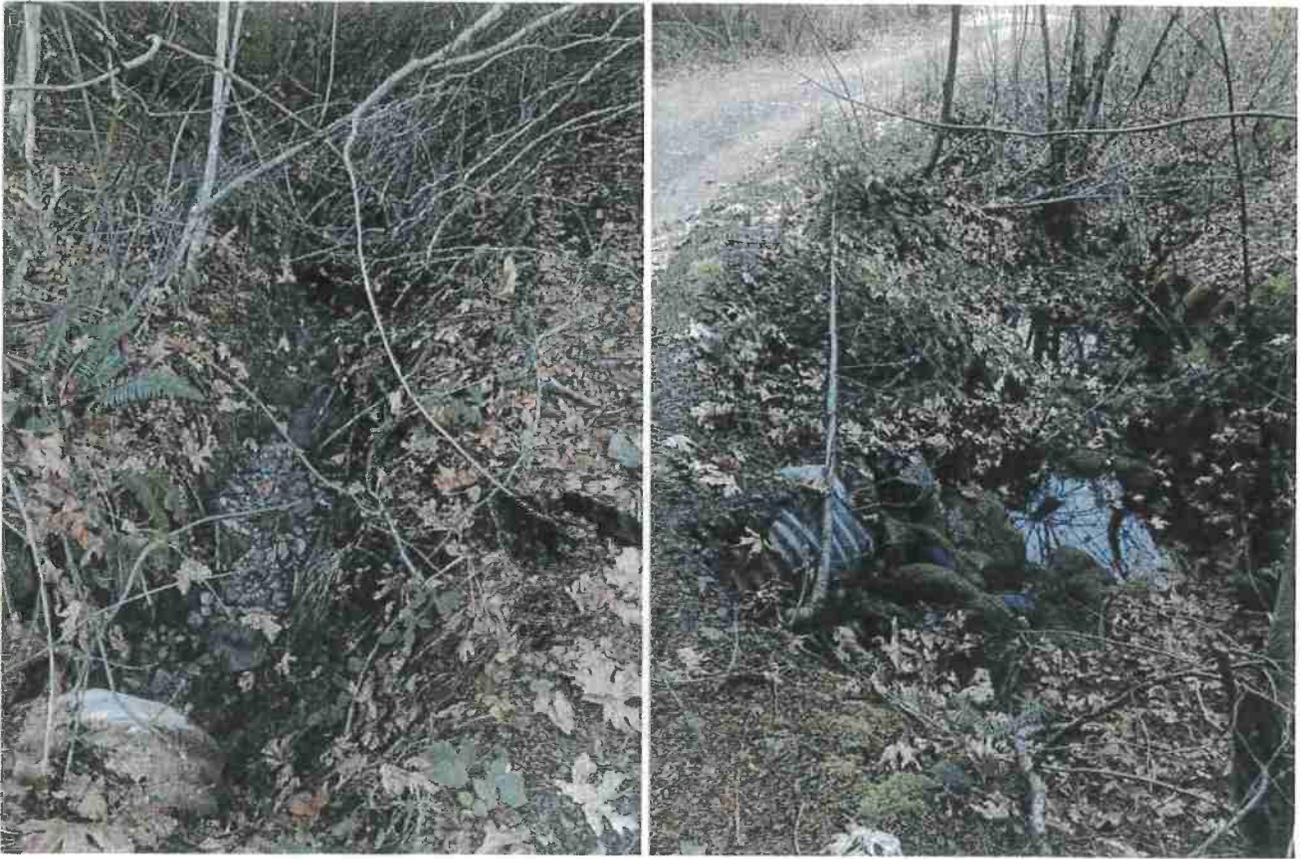
Road Point 89: Existing old, rusted 24-inch diameter metal culvert crossing of a Class II watercourse. The culvert when installed many years ago was too short and not set to grade at the outlet resulting in erosion of the fills in the past. The culvert is worn and has a partially rusted bottom, and is undersized. At Road Point 89, a properly sized culvert should be installed per the attached BMPs. Photo date 11-22-21.
