HUMBOLDT COUNTY DEPARTMENT OF PUBLIC WORKS
ROAD EVALUATION REPORT

Road Name: DINSMORE / BEAR CREEK ROAD (complete a separate form for each road)

ROAD ASSESSMENT

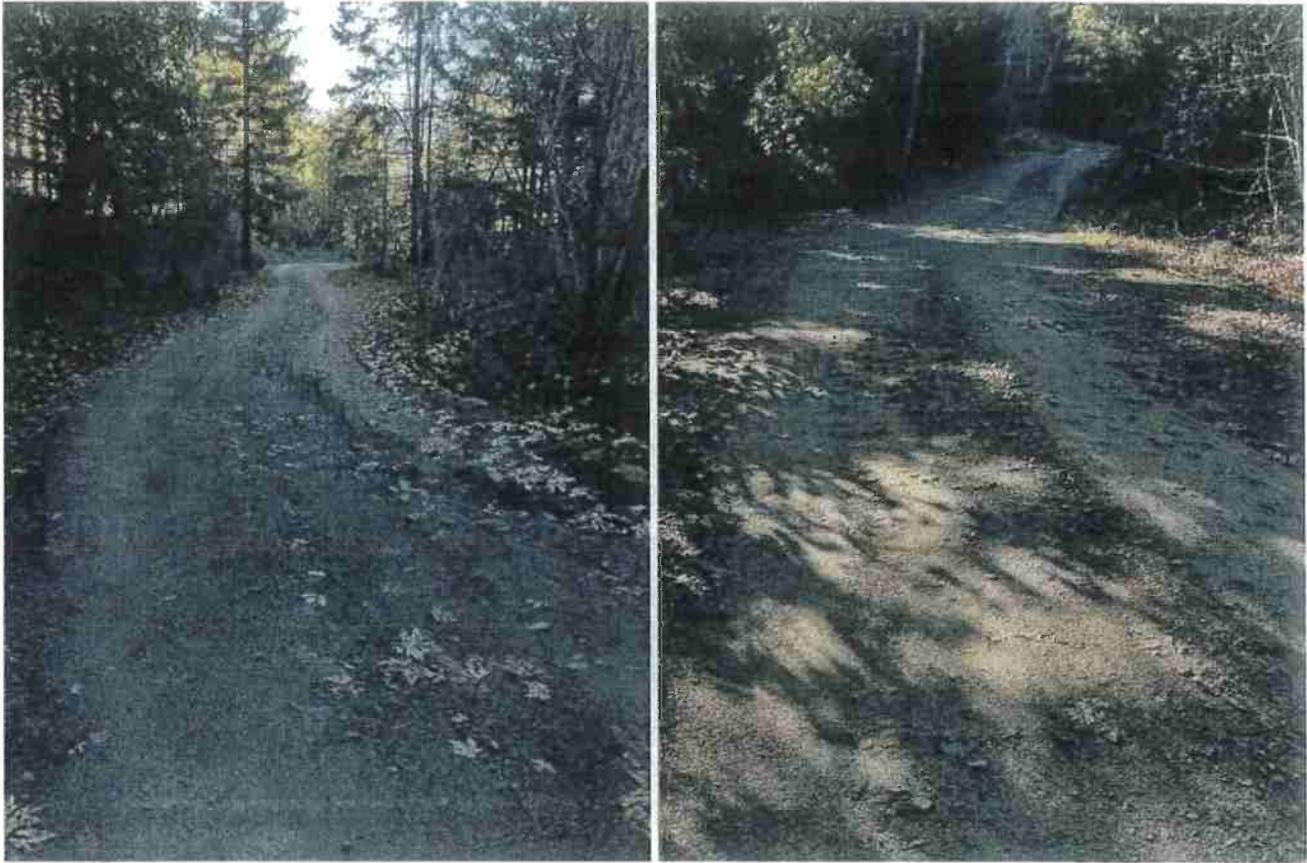
Road Segment 89 to 91: Photo on the left shows the view facing northeasterly from Point 89 and the photo on the right shows the southwesterly view from Point 90. The road surface is very rocky but not well drained, and has an interrupted inside ditch line. Runoff currently conveys down the road surface and drains to the nearby Class II watercourse at natural breaches in the outboard berm. Along this segment, a properly crowned road surface should be established per the attached BMPs, and the inside ditch should be opened up and reconstructed. The new inside ditch should be connected to a new ditch relief culvert at Point 90. Approximately 60 feet south of Point 90, a rocked rolling dip should be installed. The surface should be rocked with clean, compacted rock with numerous surface lead-outs. Photo date 11-22-21.

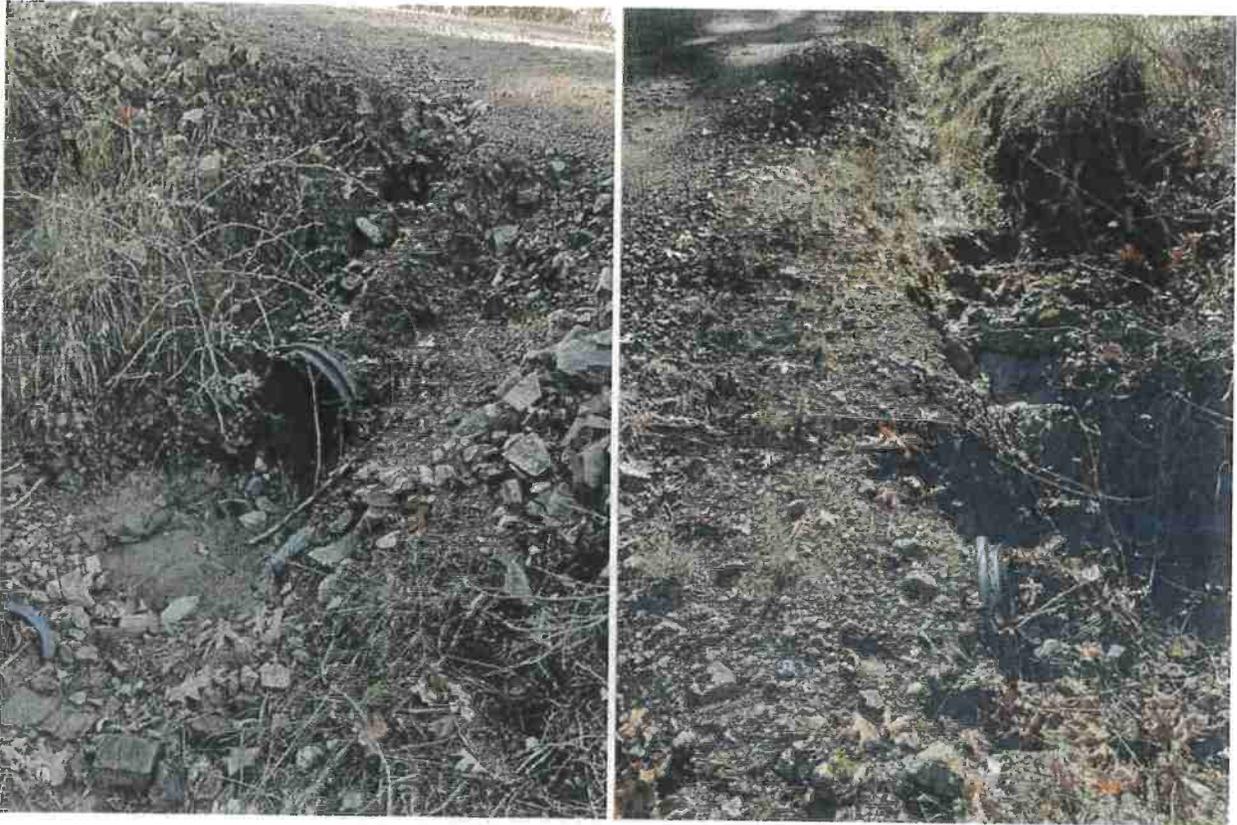
Road Point 91: Existing 18-inch diameter plastic culvert crossing of a Class III watercourse. The culvert also receives runoff from the hydrologically connected road and inside ditch to the south. The photo on the left shows the outlet and a small gully above the outlet, and the photo on the right shows the inlet and the incoming inside ditch. The culvert appeared to be in fair condition and functioning properly. The culvert is calculated as adequately sized, but should be increased in size upon its replacement. Installation of a new ditch relief culvert and rocked rolling dip at Road Point 90, along with the grading described above for Road Segment 89 to 91 will hydrologically disconnect the road surface to the south. Photo date 11-22-21.

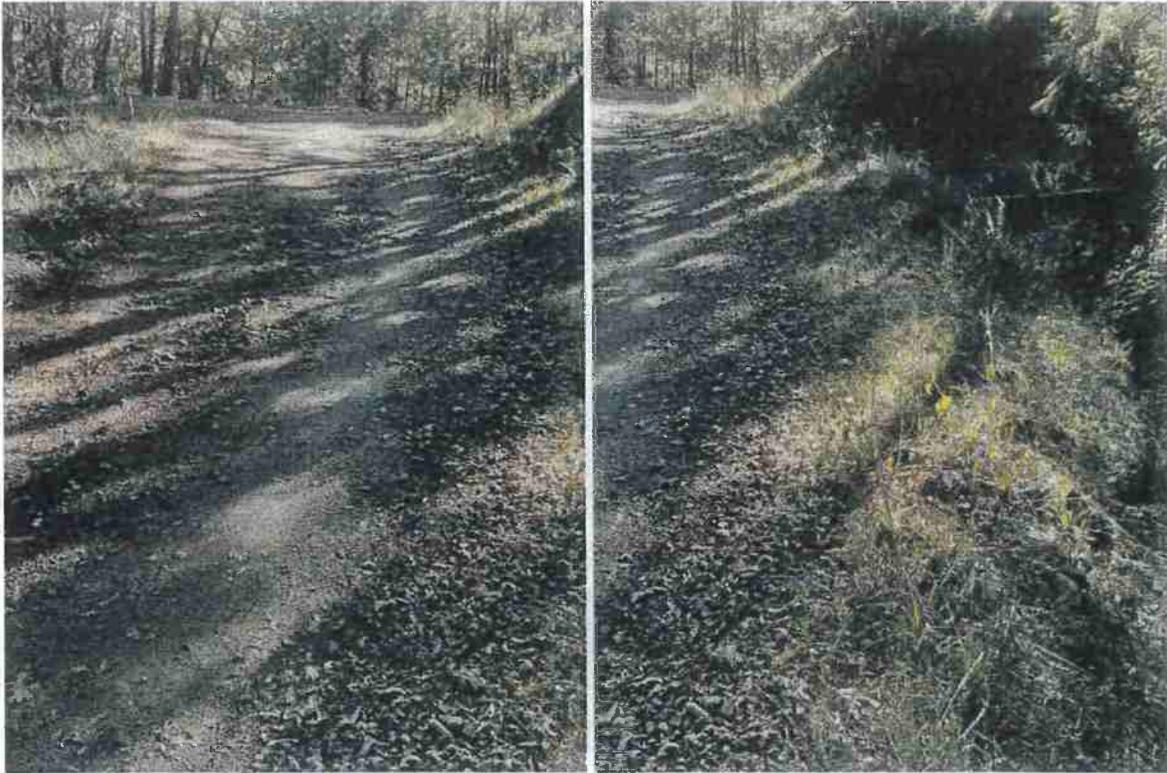
Road Point 93: Existing 18-inch diameter ditch relief culvert located near the top of a Class III watercourse. The ditch relief culvert has thick grass and vegetation blocking the inlet and the outlet. It should be maintained by cleaning out vegetation and debris at the inlet and the outlet, and upon better inspection, it should be replaced if found to be damaged. The incoming road surface is not drained well and conveys runoff towards the culvert outlet. There is a built-up berm that is vegetated with grass that prevents road surface runoff from draining towards the ditch. The road from Point 92 to 93 should be graded to a crowned surface and berms that impede proper road surface drainage should be removed. Photo date 11-22-21.

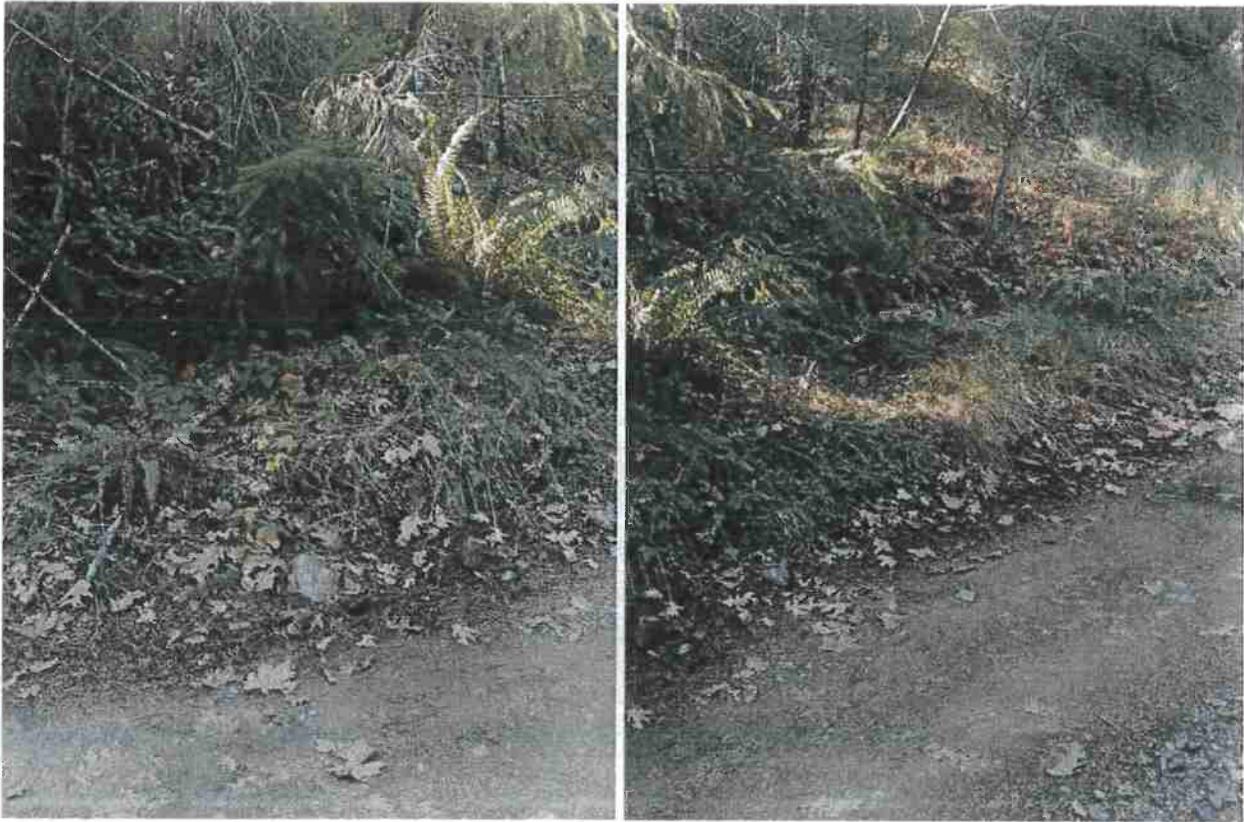
Road Point 97: Existing worn, rusted 18-inch diameter metal culvert crossing of a Class III watercourse. The culvert was not installed in line with the natural watercourse channel. The photos on the left shows the inlet area of the culvert and the photo on the right shows a portion of the inside ditch that diverts the Class III watercourse. The watercourse is diverted down the inside ditch for approximately 25 feet to the inlet of the culvert. The culvert is calculated as adequately sized. At Road Point 97 a properly sized culvert should be installed at the natural watercourse channel location, per the attached BMPs. This location is approximately 25 feet northwest of the existing culvert. Photo date 11-22-21.

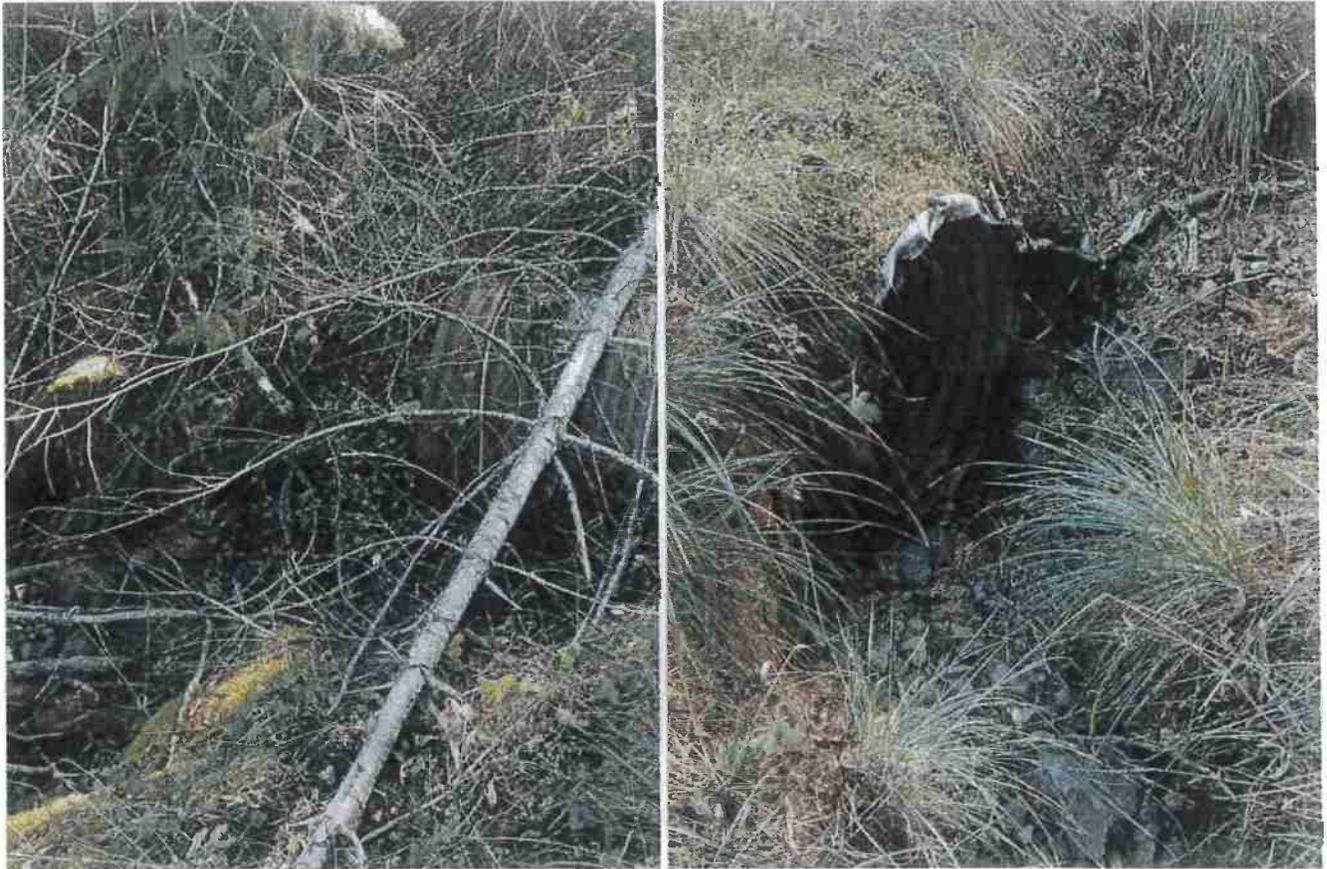
Road Point 99: Existing 30-inch diameter metal culvert crossing of a Class II watercourse that is showing signs of wear. The culvert installed was too short and not set to the grade of the natural watercourse. The photo on the left shows the outlet and the photo on the right shows the inlet. At Road Point 99, a properly sized culvert should be installed per the attached BMPs. Also, maintain the existing rolling dips at each approach. Photo date 11-22-21.

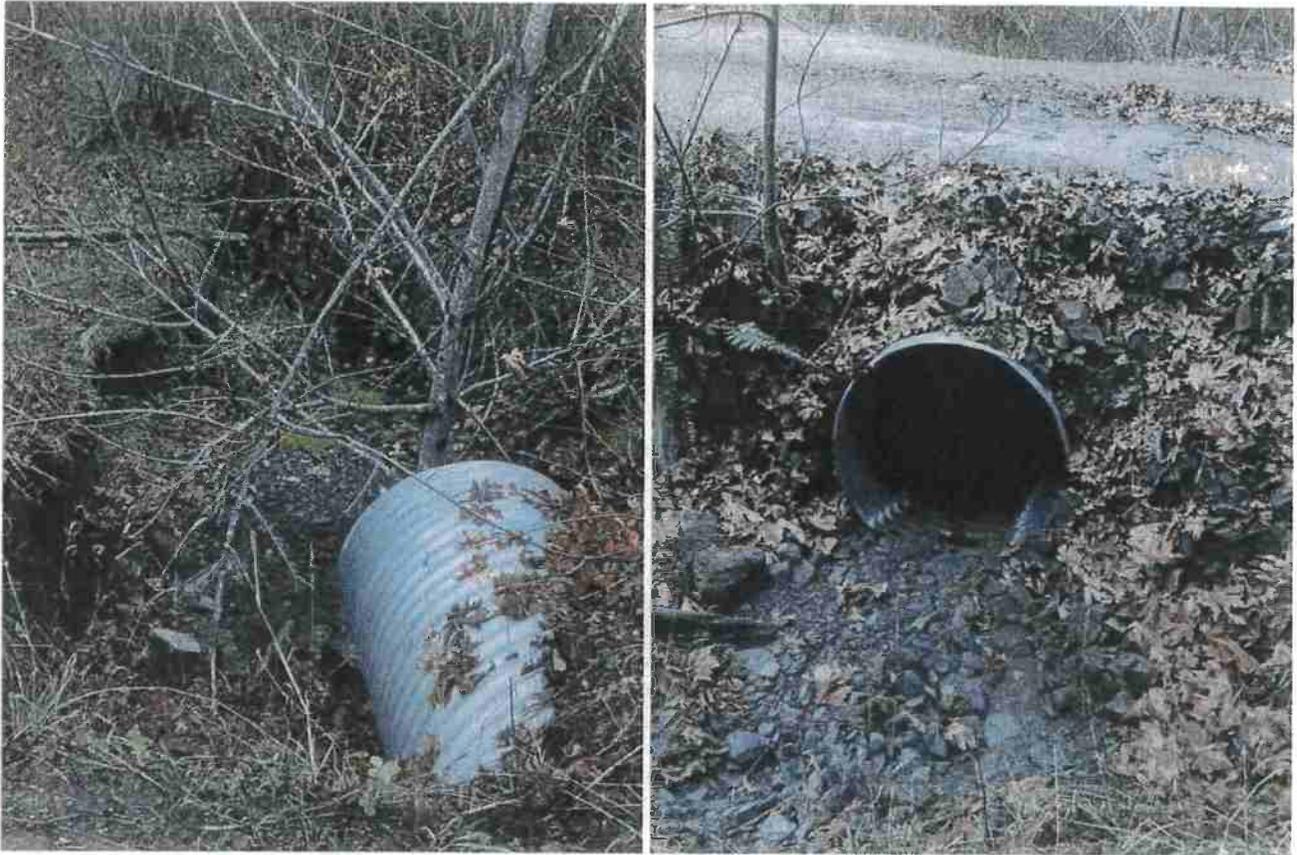
Road Point 101: Existing 36-inch diameter metal culvert crossing of a Class II watercourse. The photo on the left shows the outlet and the photo on the right shows the inlet. The culvert when installed many years ago was too short and not set to grade at the outlet and has a "shotgun" outlet. The culvert is solid and in good condition, but is undersized. At Road Point 101, a properly sized culvert should be installed per the attached BMPs. Photo date 11-22-21.

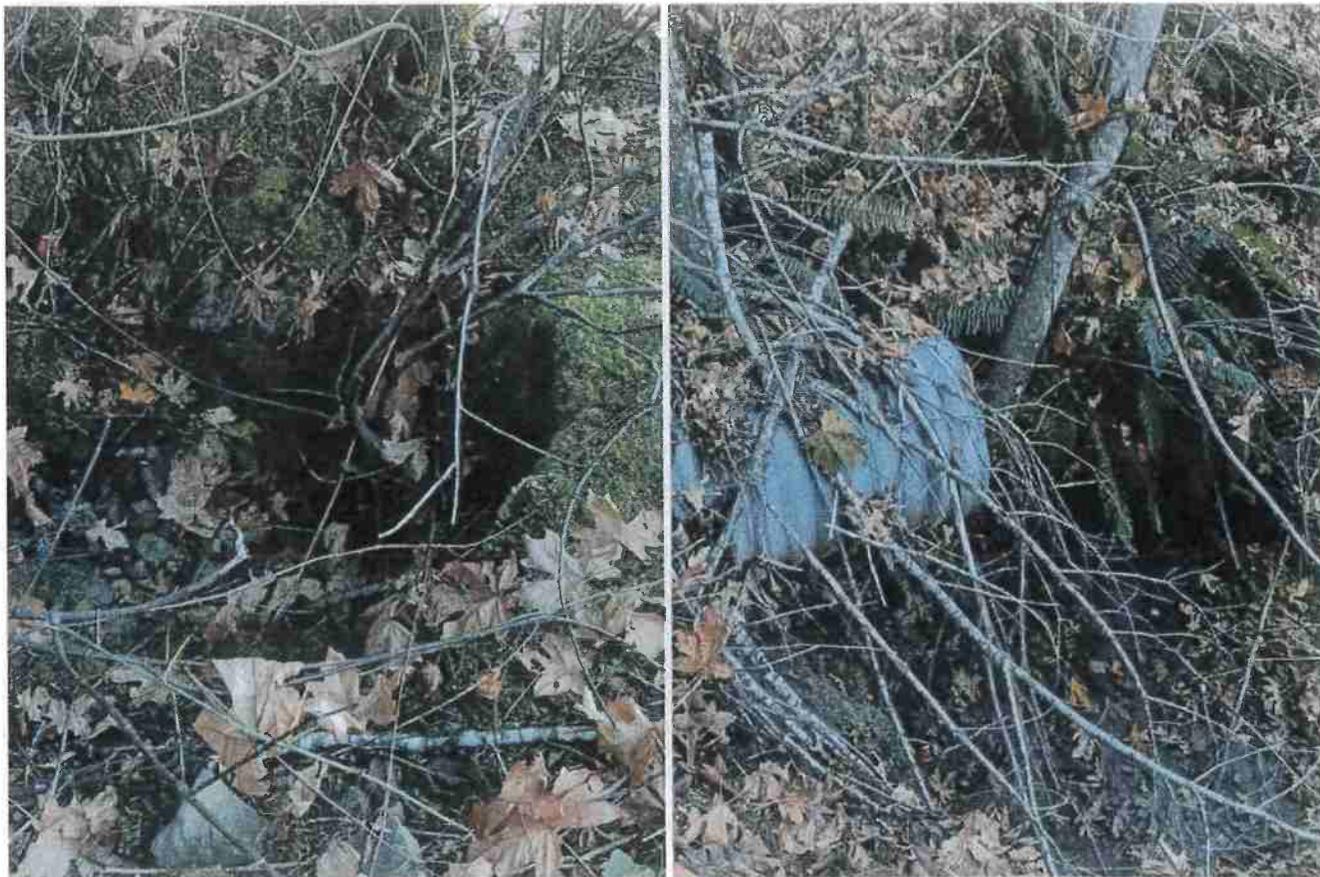
Road Point 104: Existing 18-inch diameter metal culvert crossing of a Class III watercourse. The culvert installed is too short, not set to the grade of the watercourse, and is badly "shotgunned". It is rusted, in poor condition, and is undersized. The photo on the left shows the inlet and the photo on the right shows the outlet. At Road Point 104, a properly sized culvert should be installed per the attached BMPs. Photo date 11-22-21.

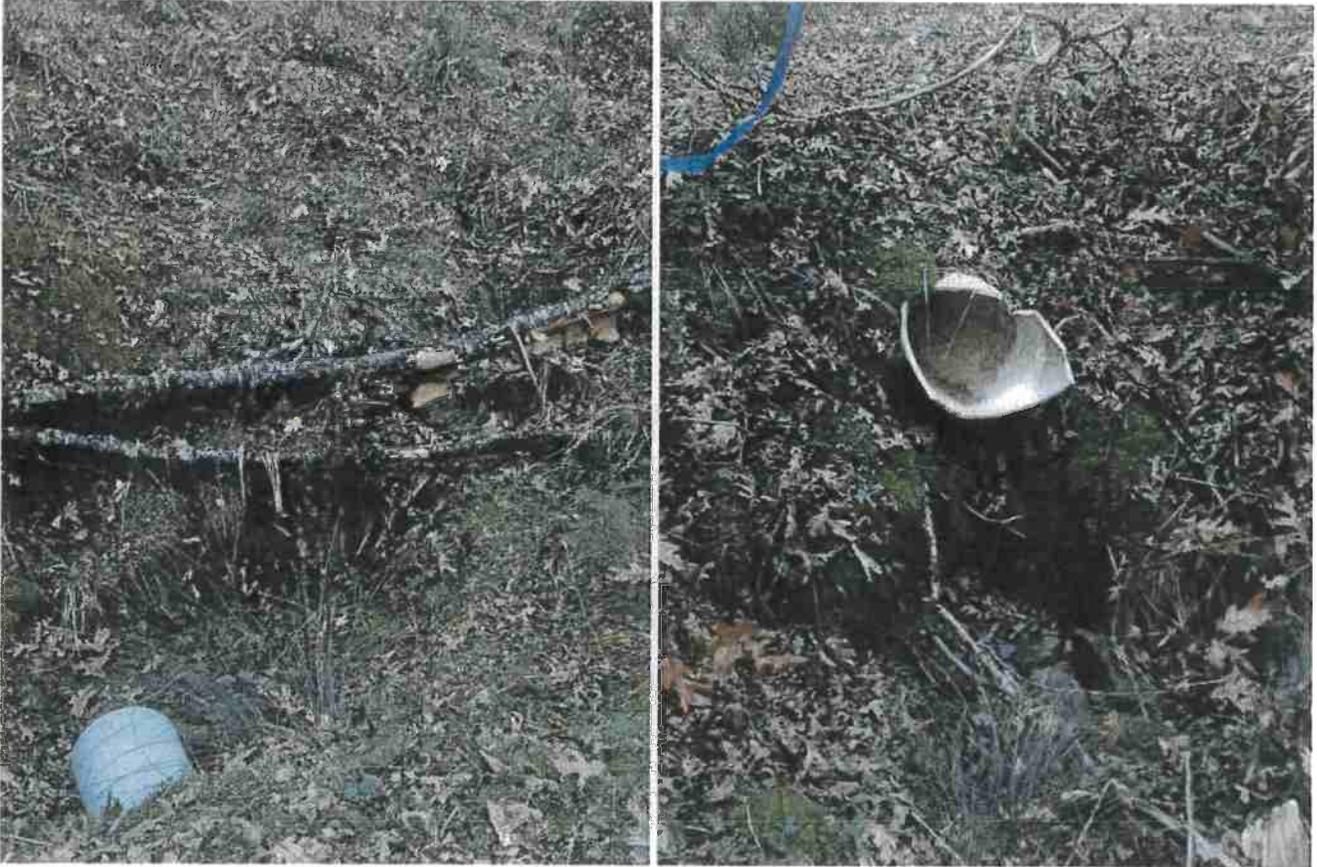
Road Point 109: Existing 12-inch diameter plastic culvert crossing of a very small Class III watercourse. The culvert is in fair condition, but is broken off at the outlet and it is slightly undersized. The photo on the left shows the inlet and the photo on the right shows the outlet. At Road Point 109, a properly sized culvert should be installed per the attached BMPs. Photo date 11-22-21.
