January 25, 2021

Building Envelope Evaluation Report

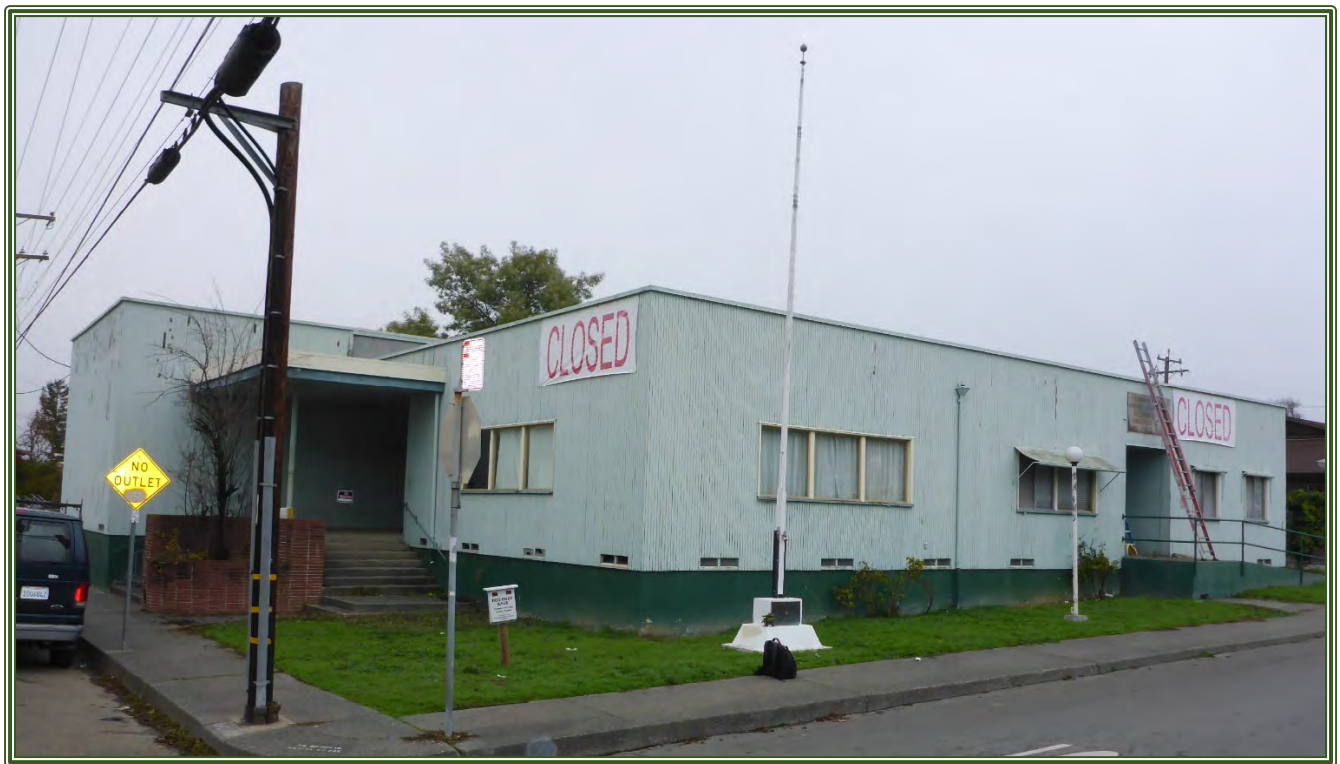
Photo #1: Veterans Office and Superior Court

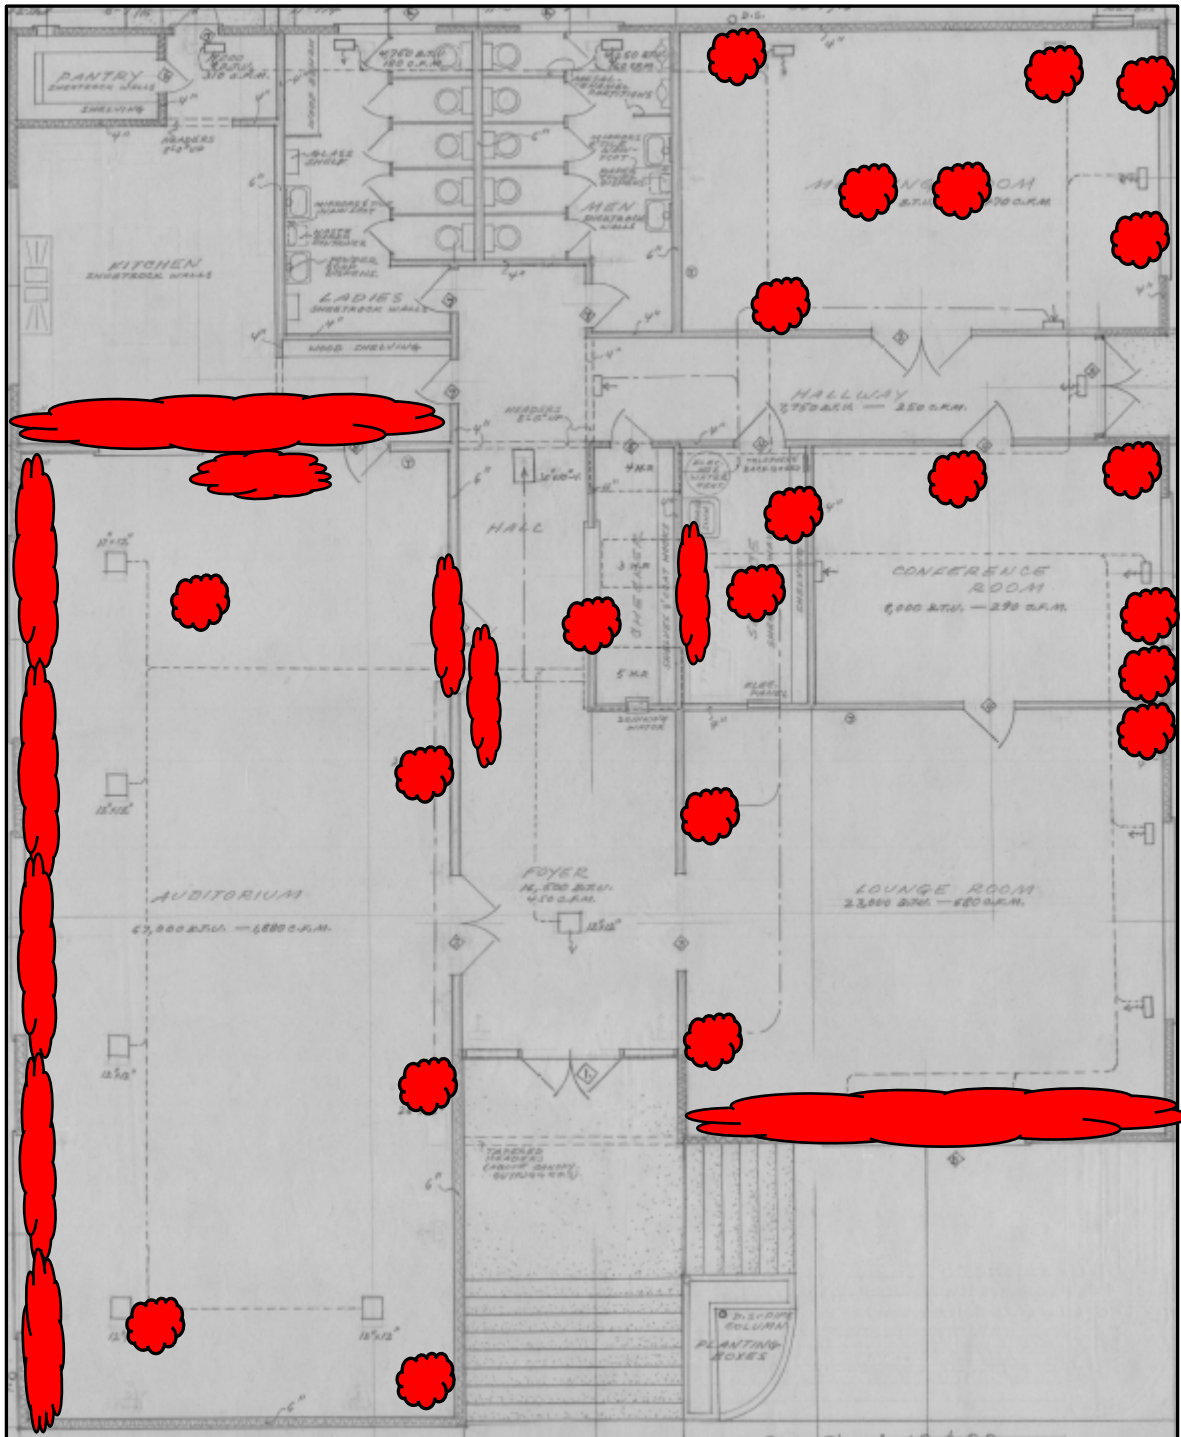
ABB documented many roof leak stains throughout the building. Please see leak stain map below:

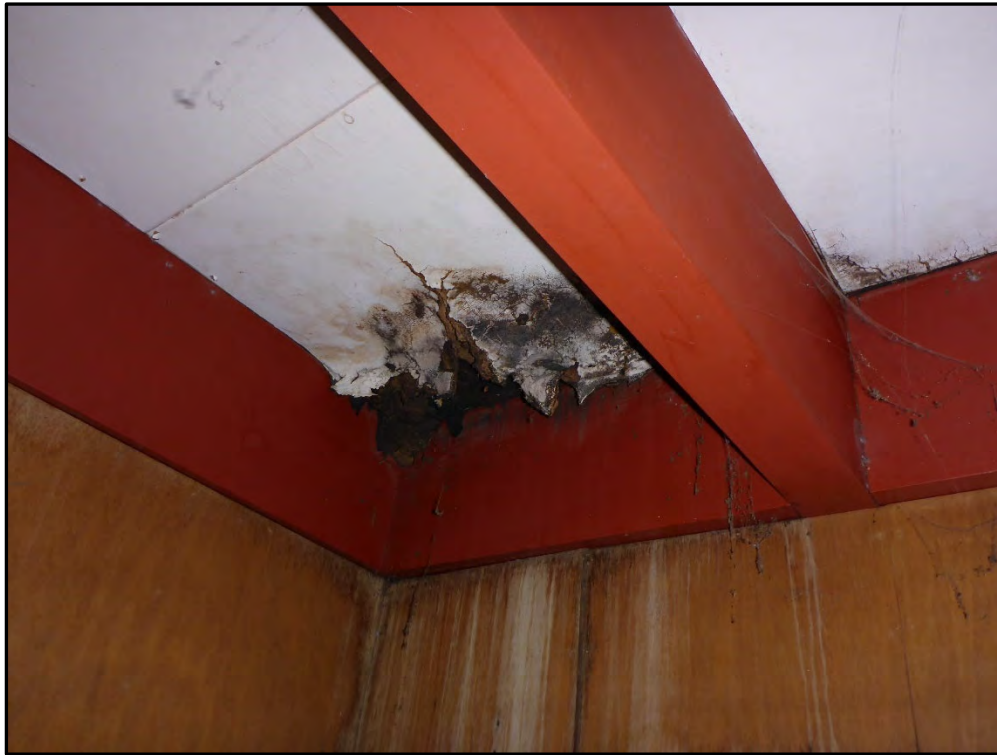
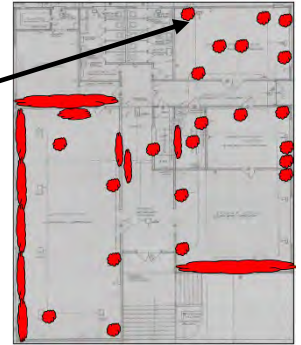
Photo #2: Damage from roof leaks.

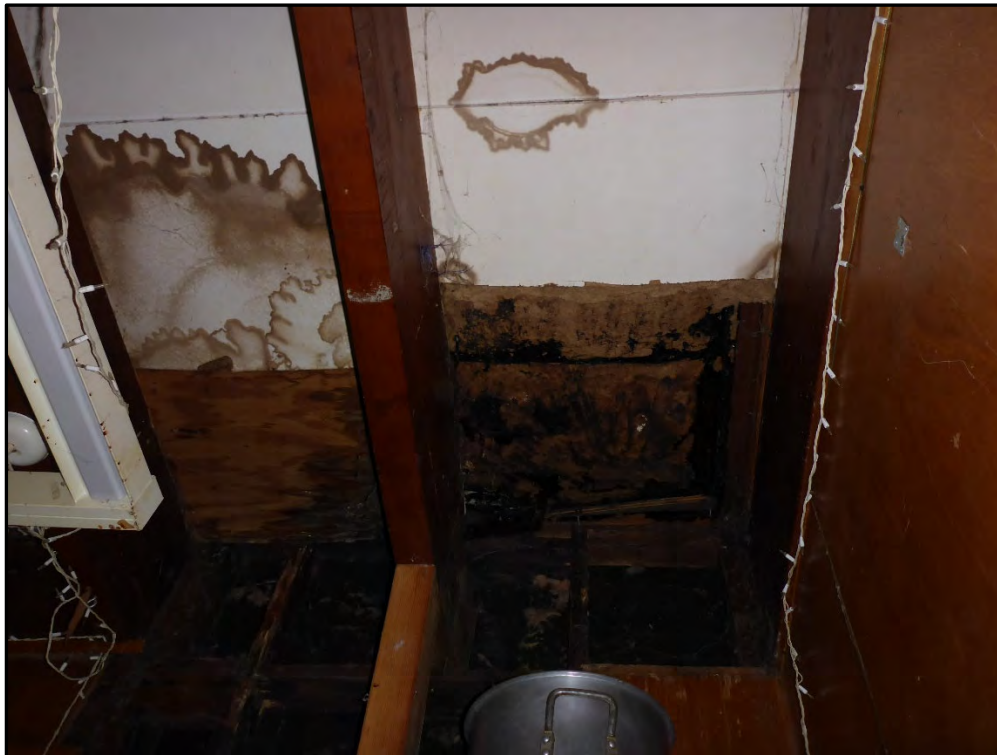
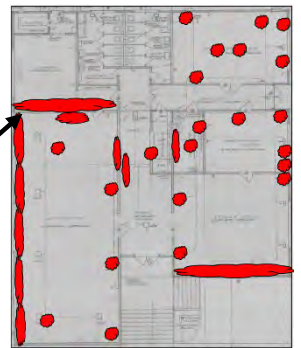
Photo #3: Damage from roof leaks.

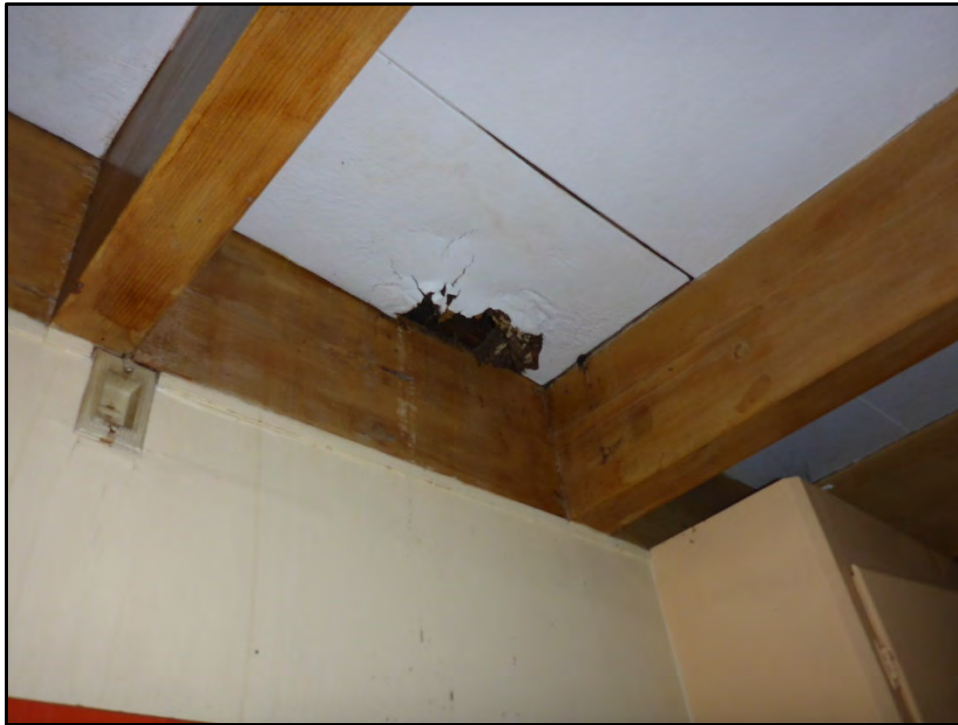
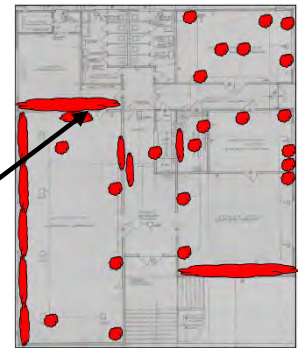
Photo #4: Damage from roof leaks.

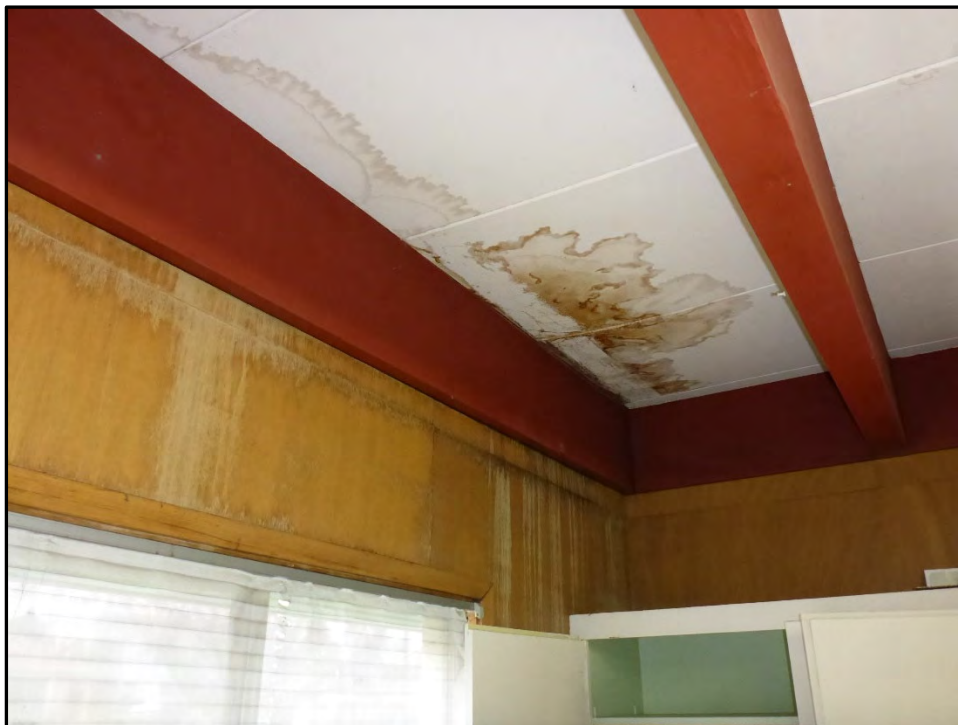
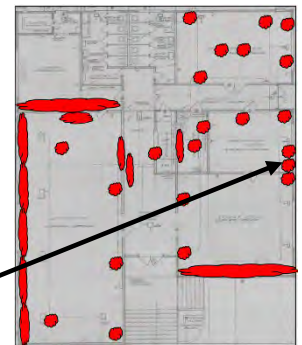
Photo #5: Damage from roof leaks.

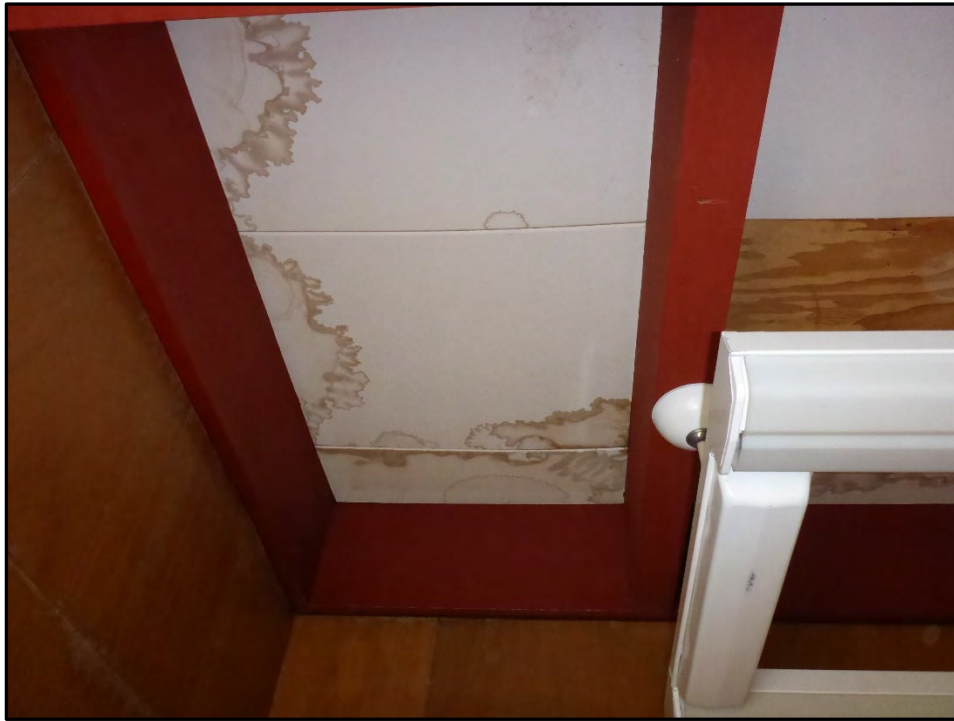
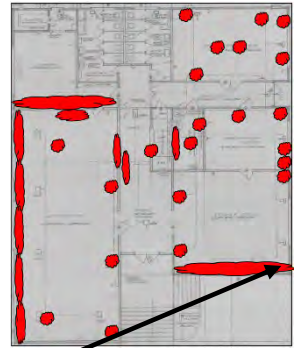
Photo #6: Damage from roof leaks.

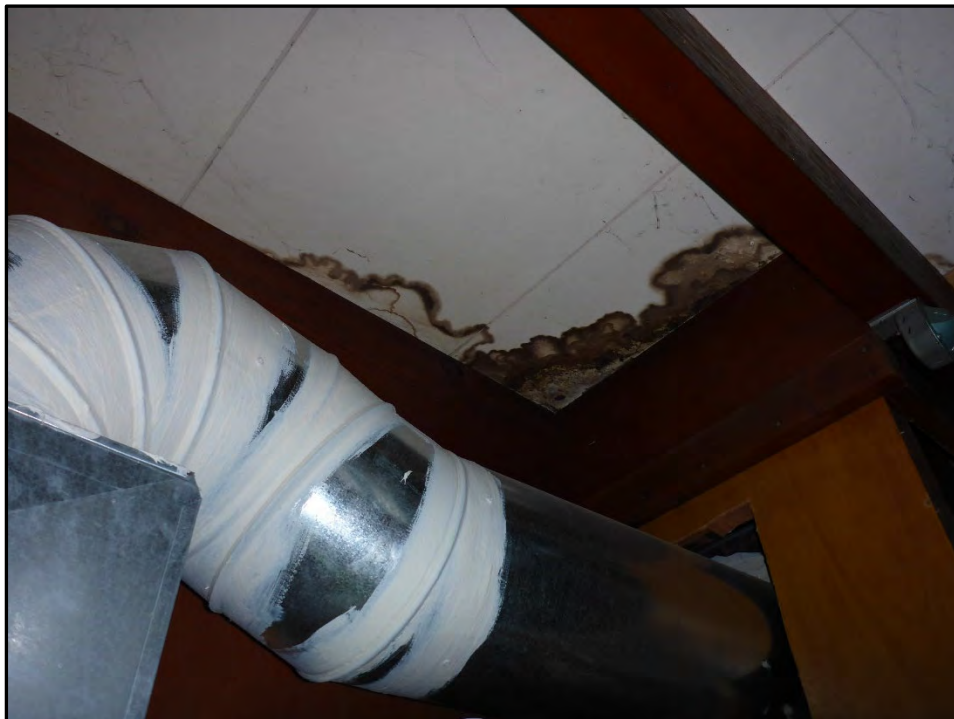
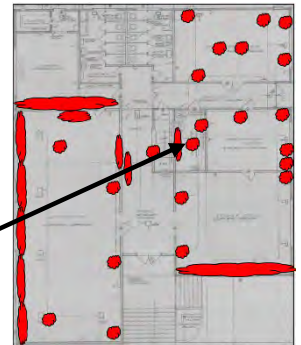
Photo #7: Damage from roof leaks.

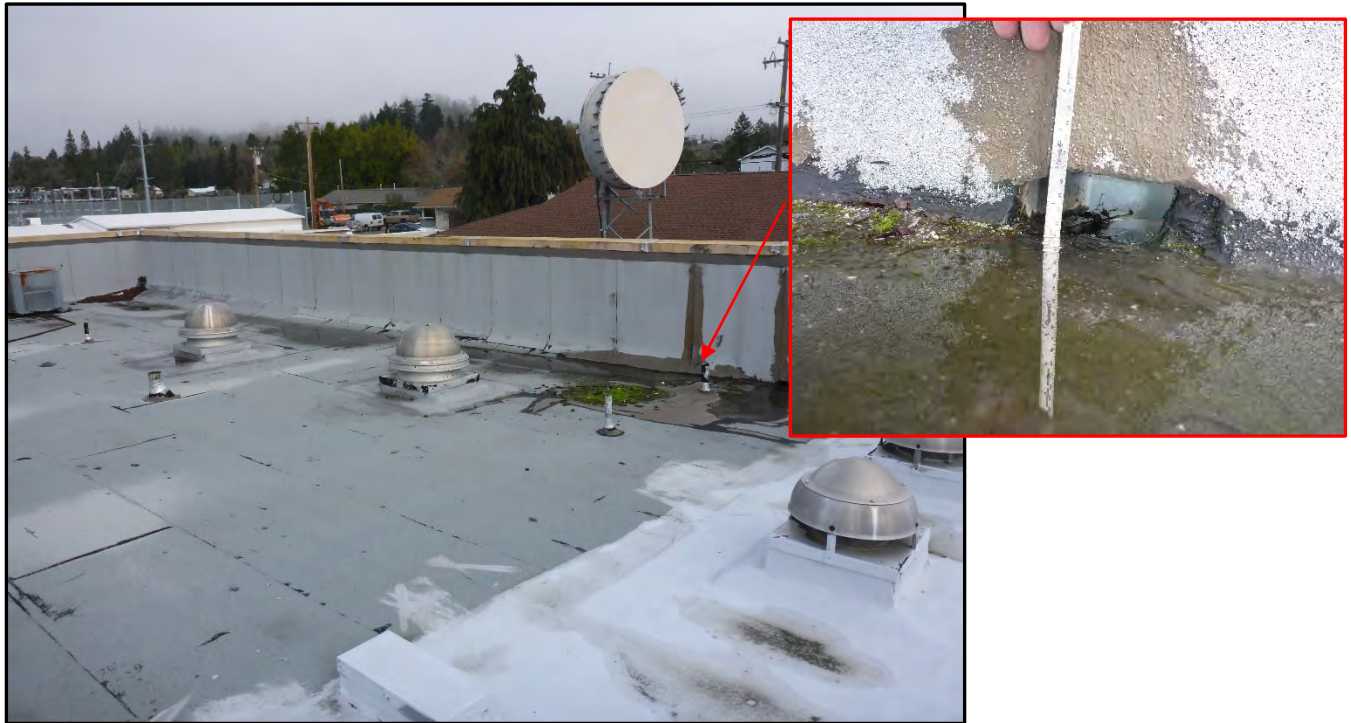
Photo #8: Roofs lack proper drain assemblies. Too small of an opening and no overflow drains.

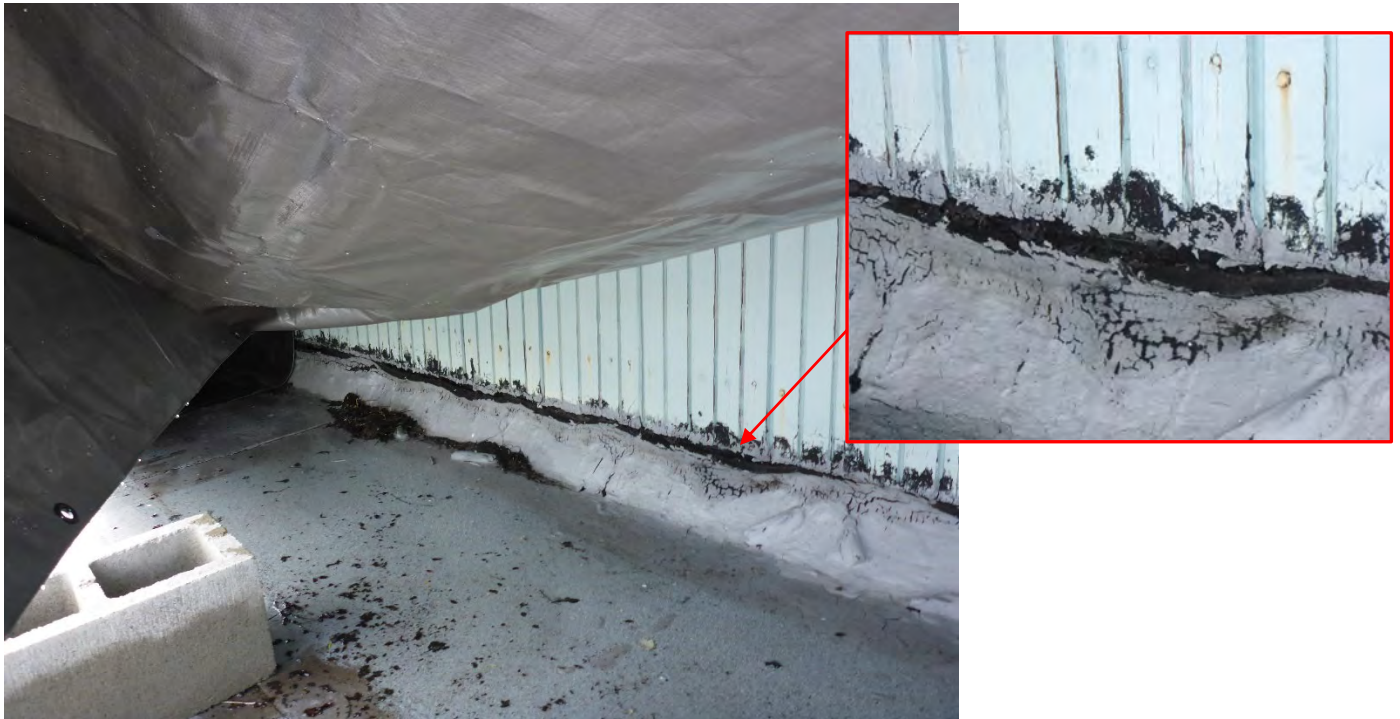
Photo #10: Roof base flashings are improper and or are missing. Roof is not flashed up under wall siding.

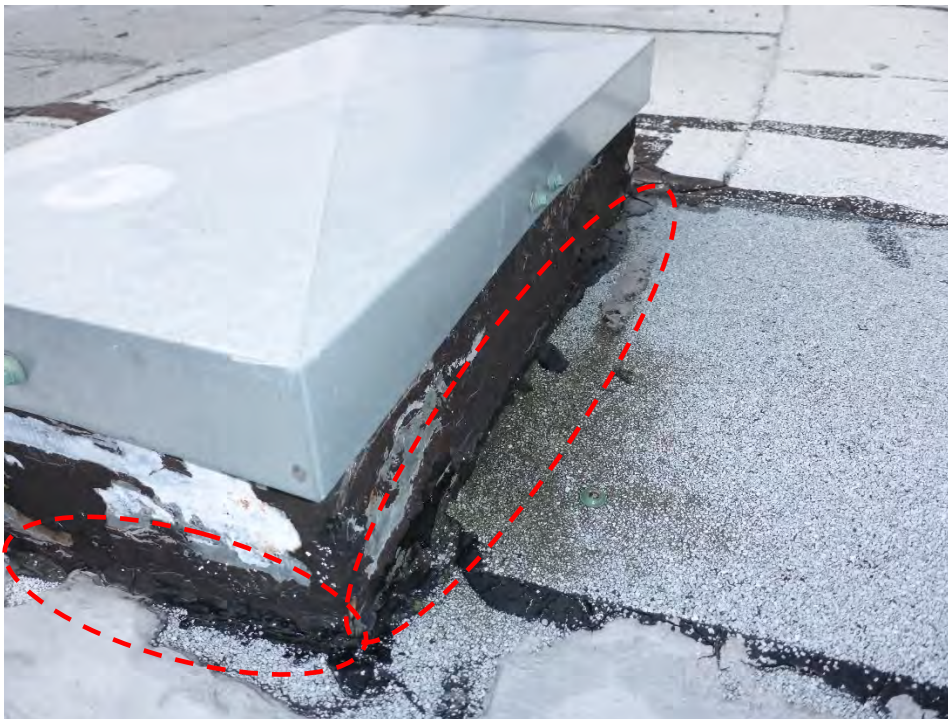
Photo #11: Roof base flashings are improper and or are missing. Roofing should also run down the curb and lap over membrane on the deck. Open voids are present.

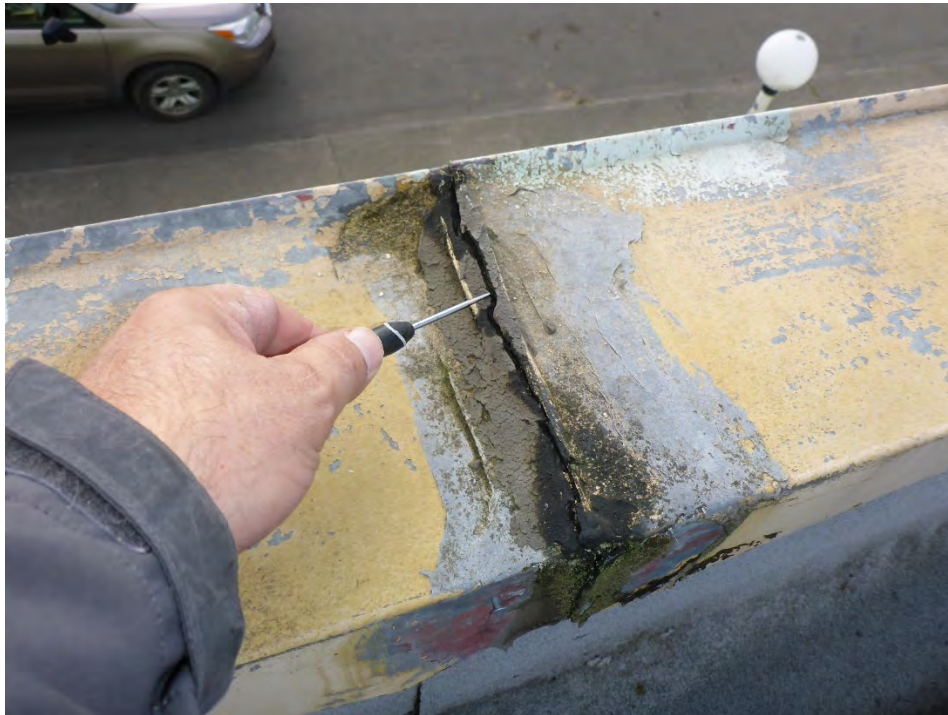
Photo #12: Roof coping caps have unsealed joints.

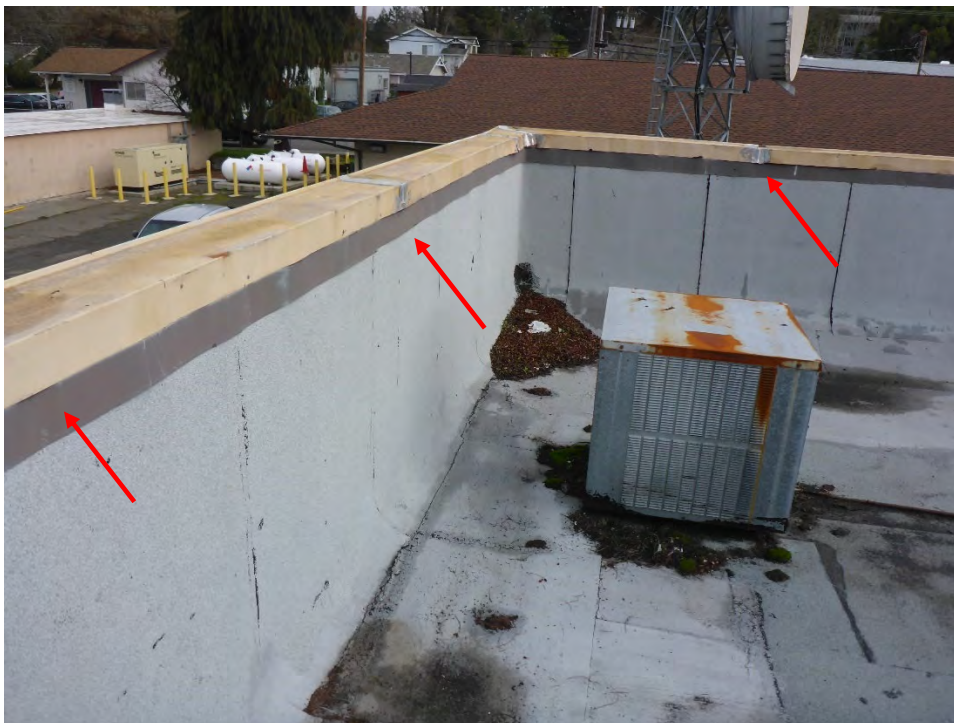
Photo #13: Roof coping caps have unsealed joints. Sheetmetal extension tucked up under coping cap in efforts to terminate re-roof. The termination is improper. It doesn't seal water infiltration through coping cap joints.

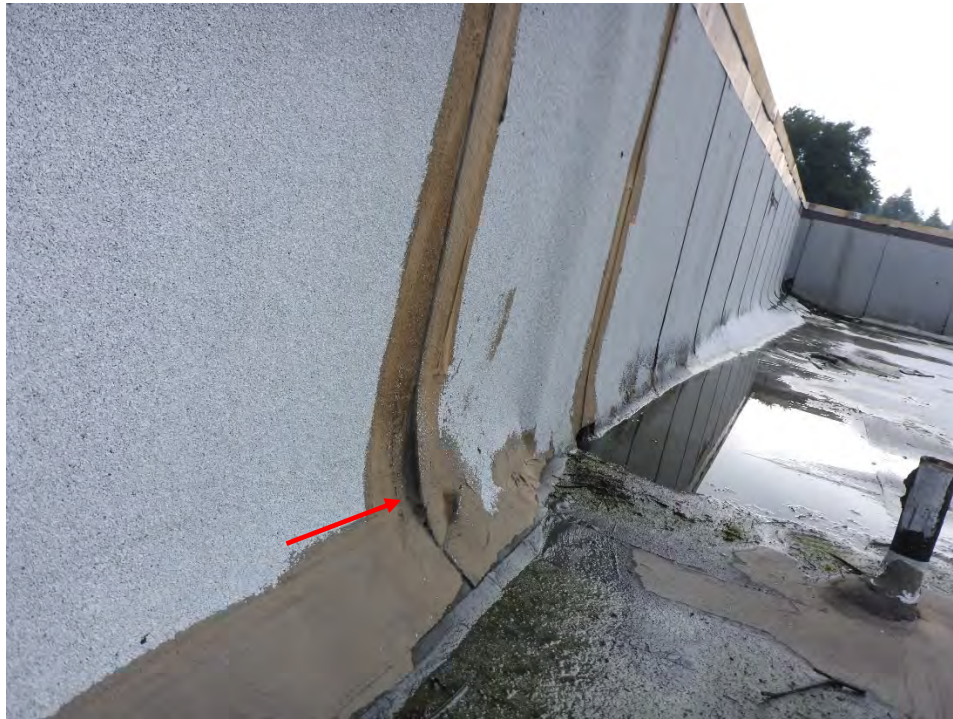
Photo #14: Roofing laps are not sealed. Open voids.

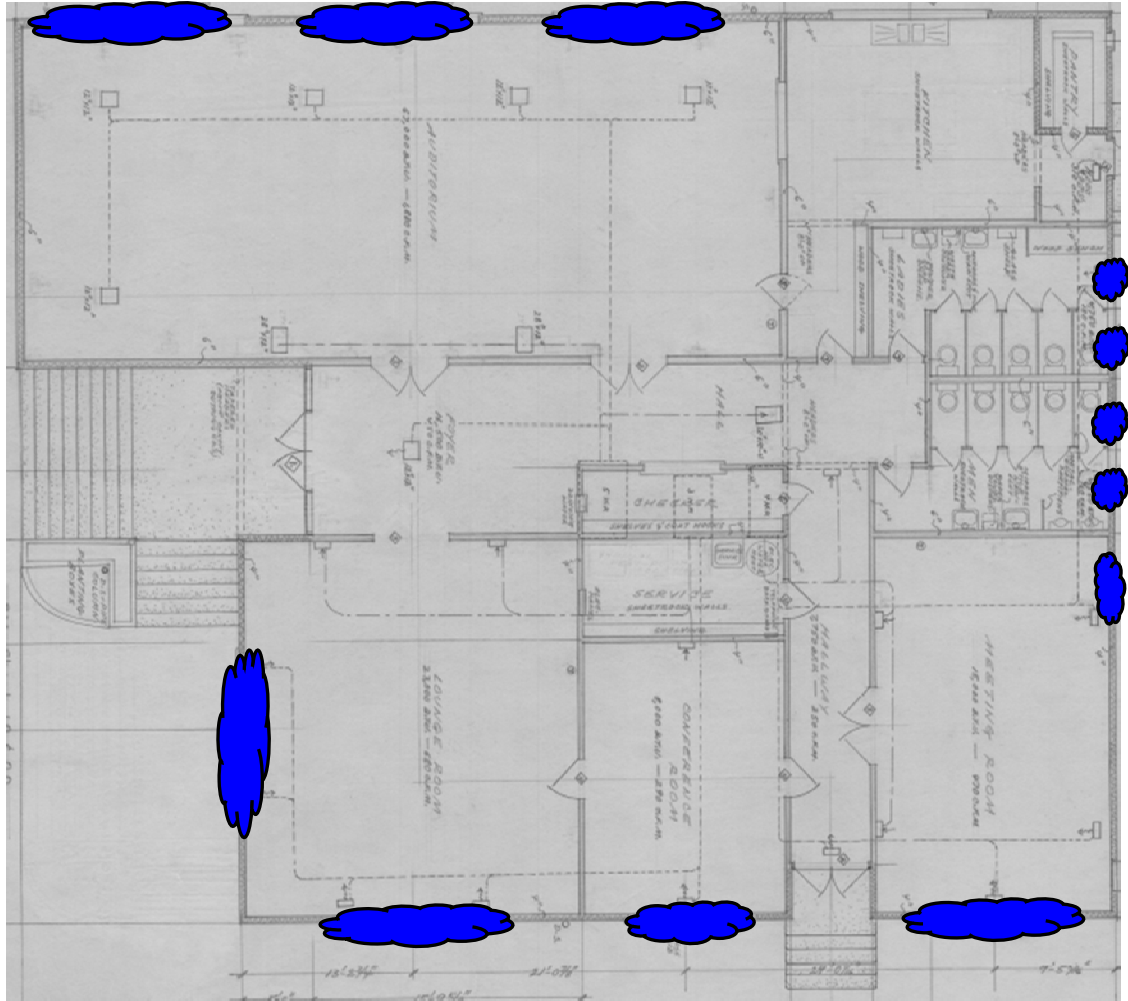
ABB documented many window leak stains throughout the building. Please see leak stain map below:

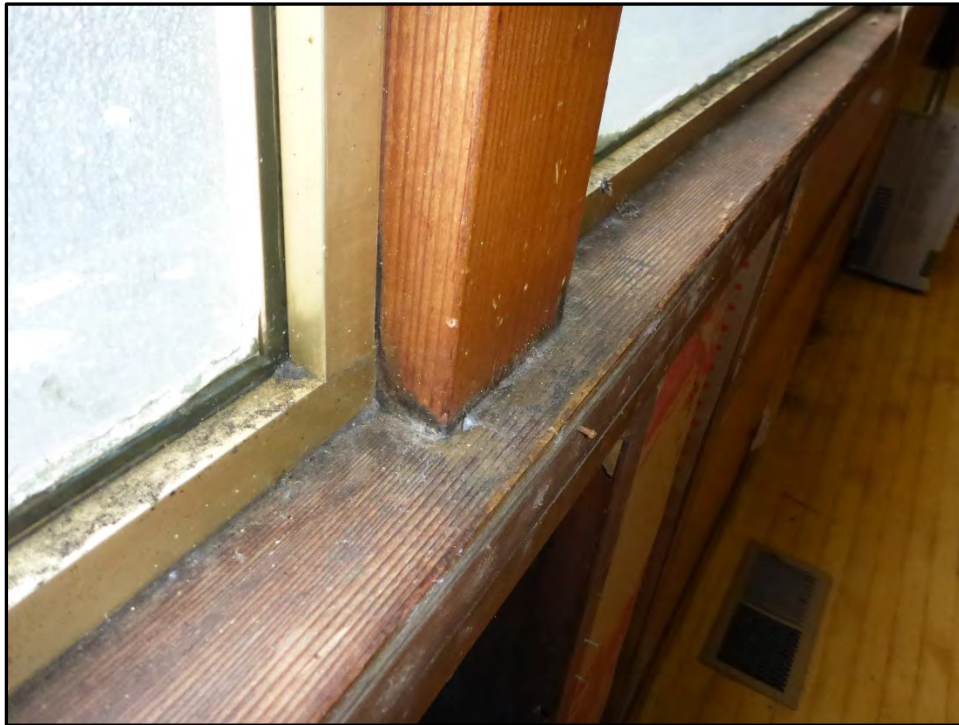
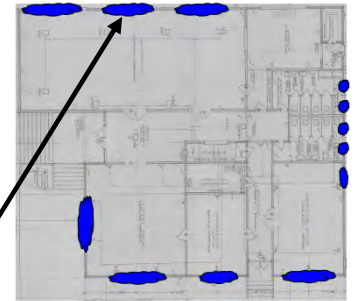
Photo #19: Damage from window leaks.

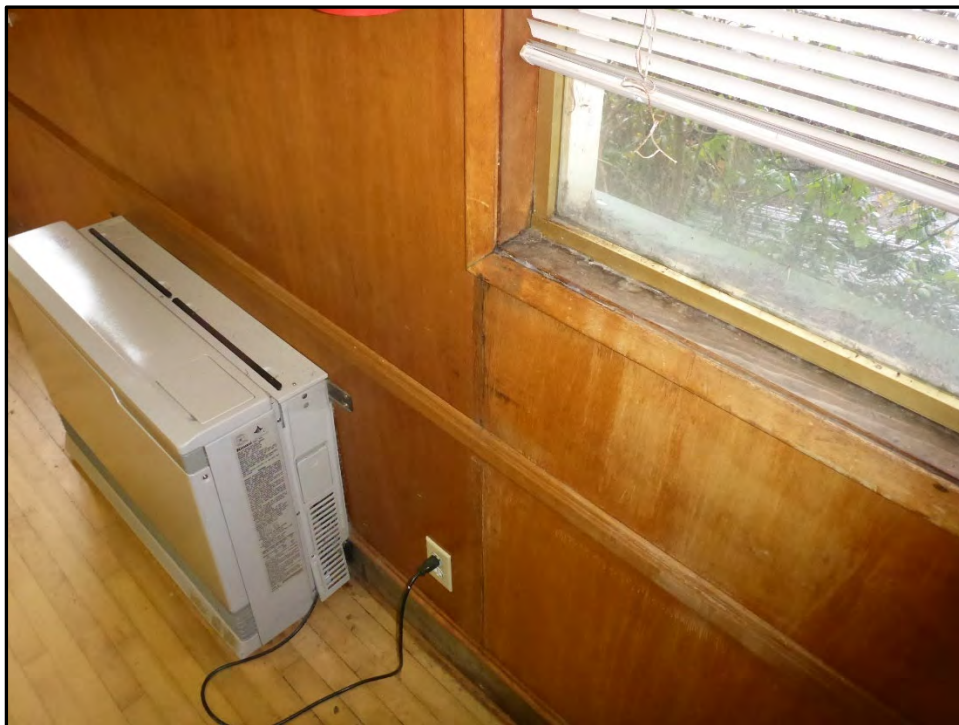
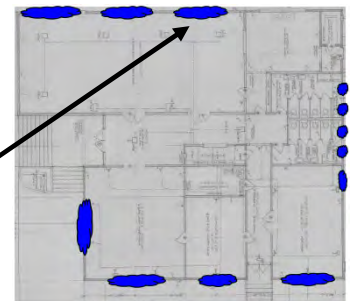
Photo #20: Damage from window leaks.

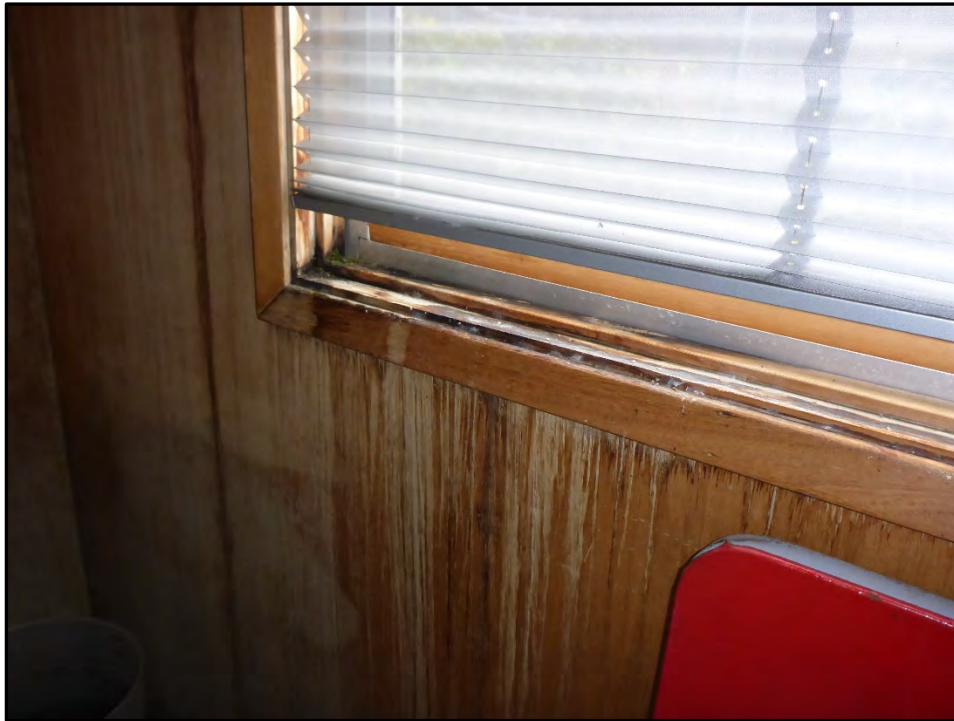
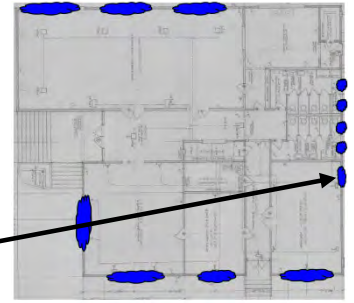
Photo #21: Damage from window leaks.

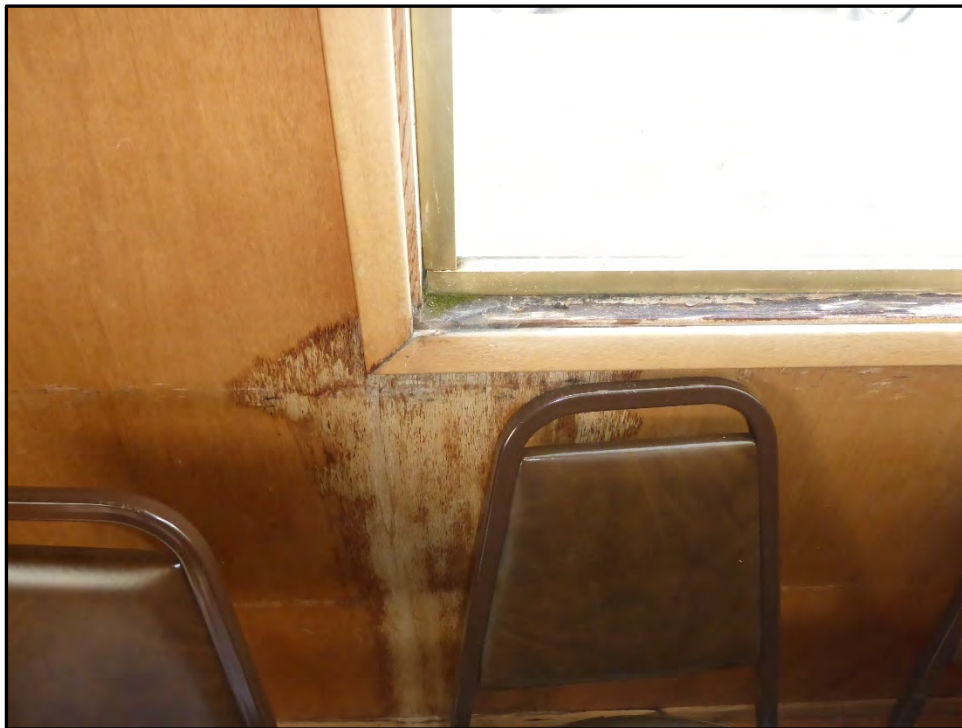
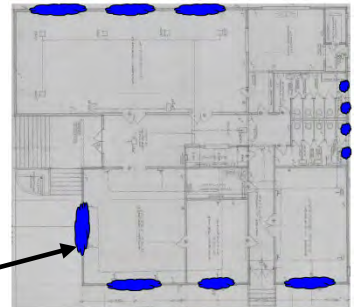
Photo #22: Damage from window leaks.

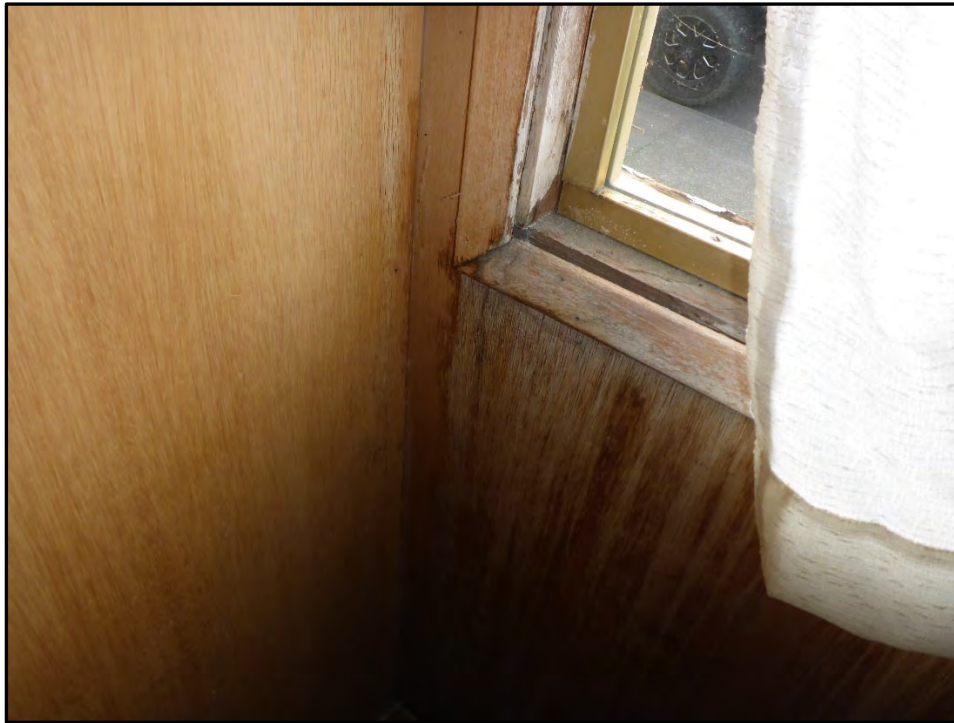
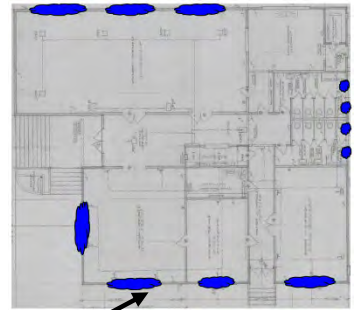
Photo #23: Damage from window leaks.

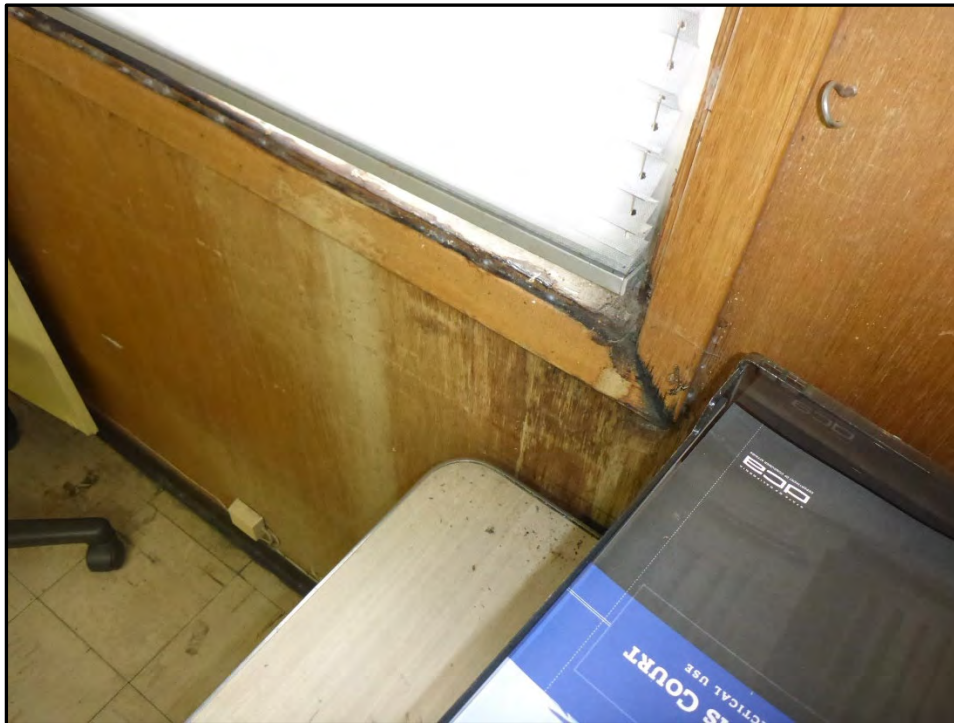
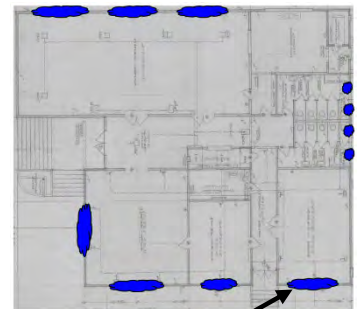
Photo #24: Damage from window leaks.

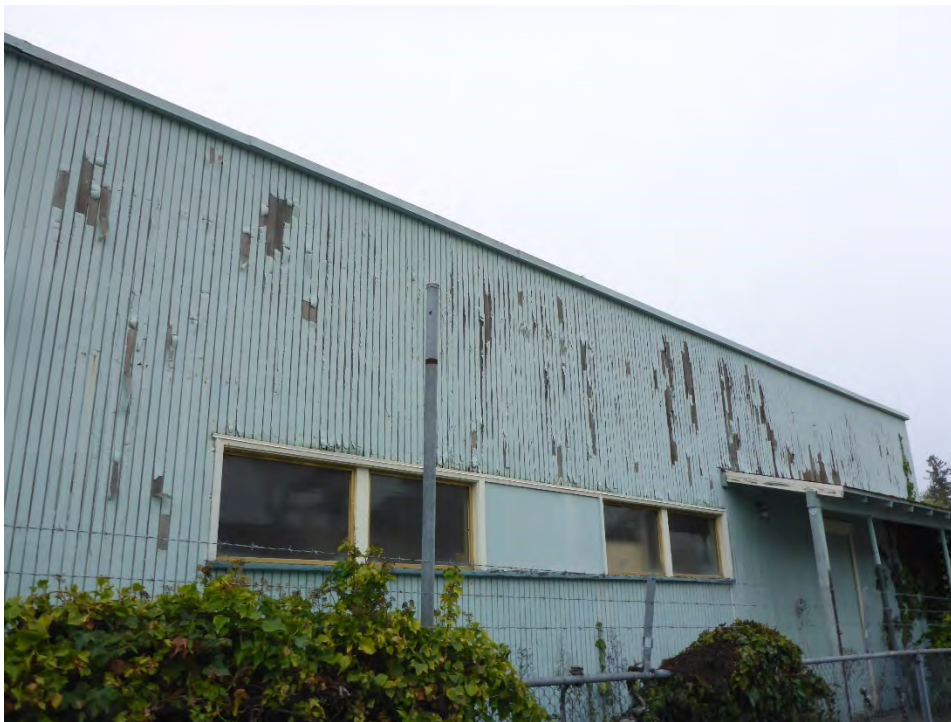
Photo #25: Exterior paint has reached the end of its useful life.

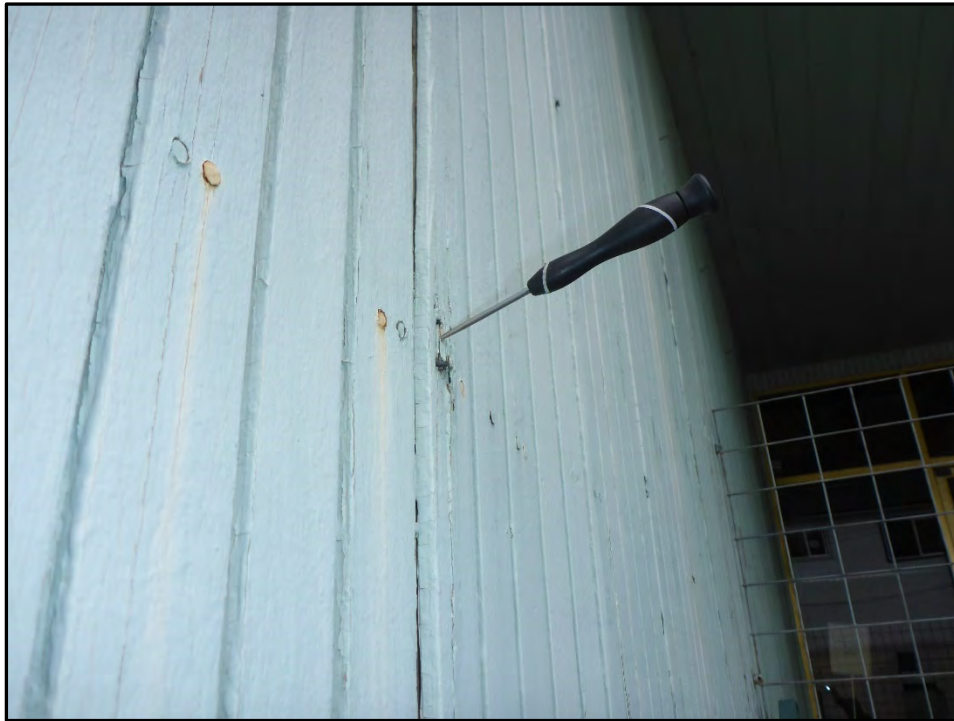
Photo #28: Exterior wall panels are decayed

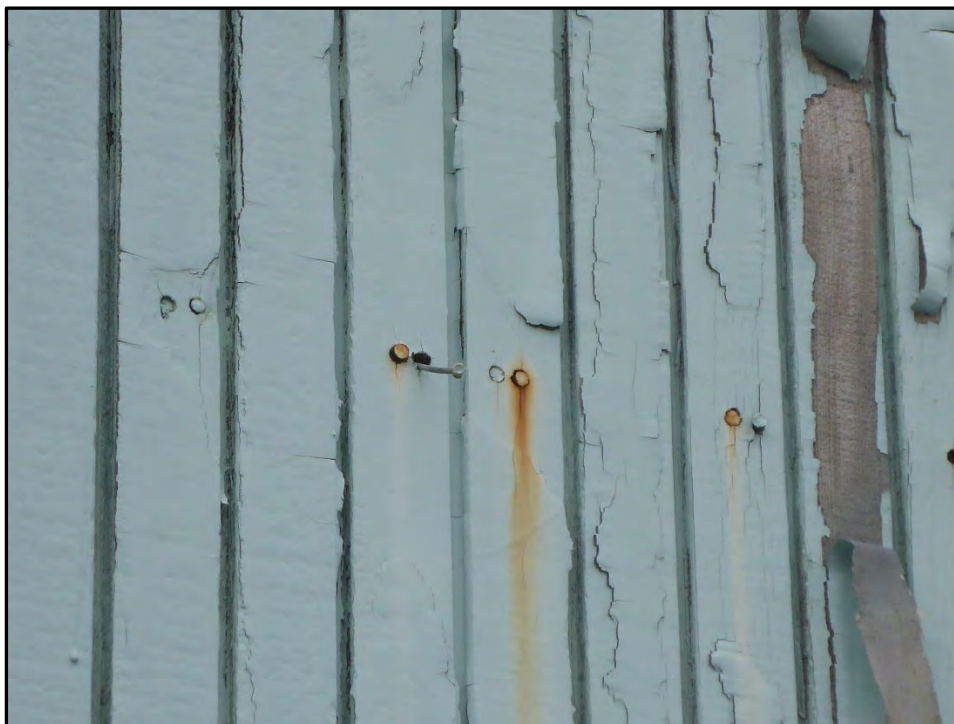
Photo #29: Exterior wall siding fasteners are rusting and are backing out

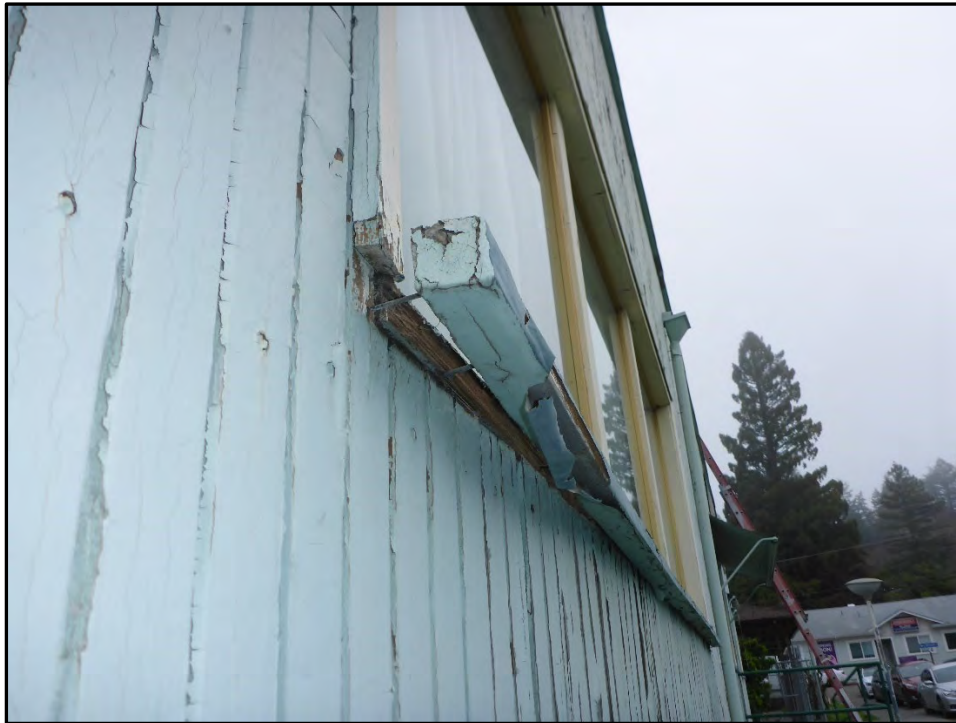
Photo #30: Exterior trim is decayed and is failing

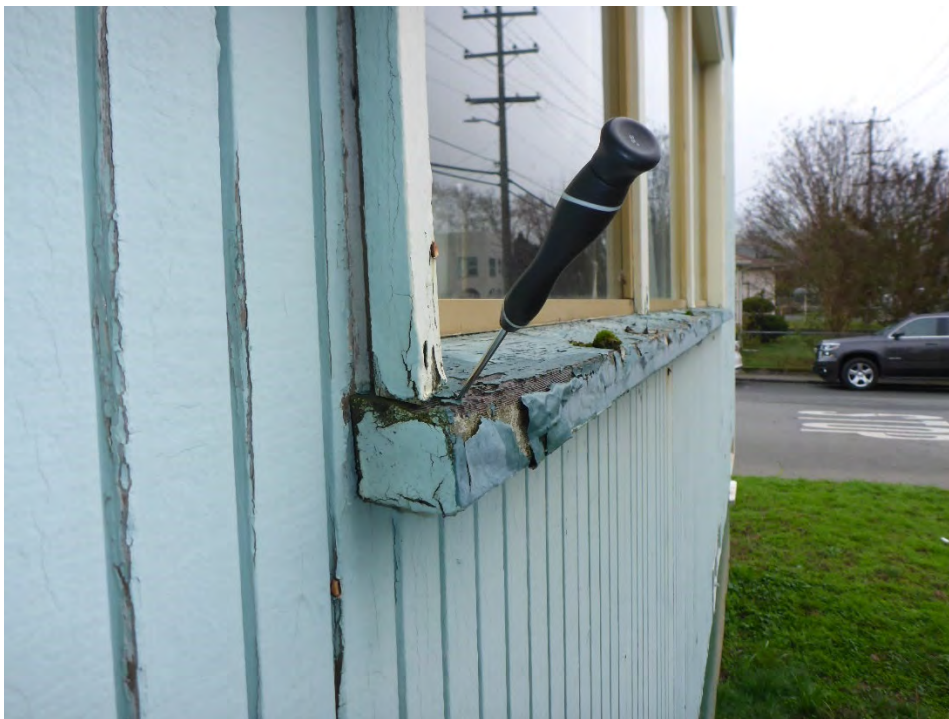
Photo #31: Exterior trim is decayed and is failing

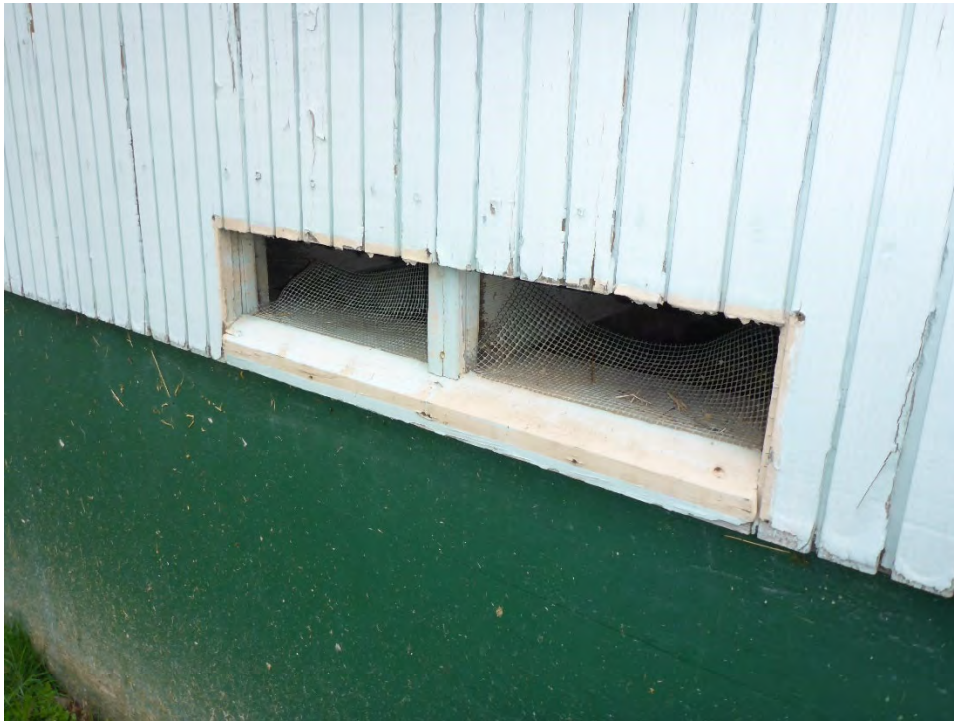
Photo #32: Foundation vents are damaged and are open
