January 25, 2021

Building Envelope Evaluation Report

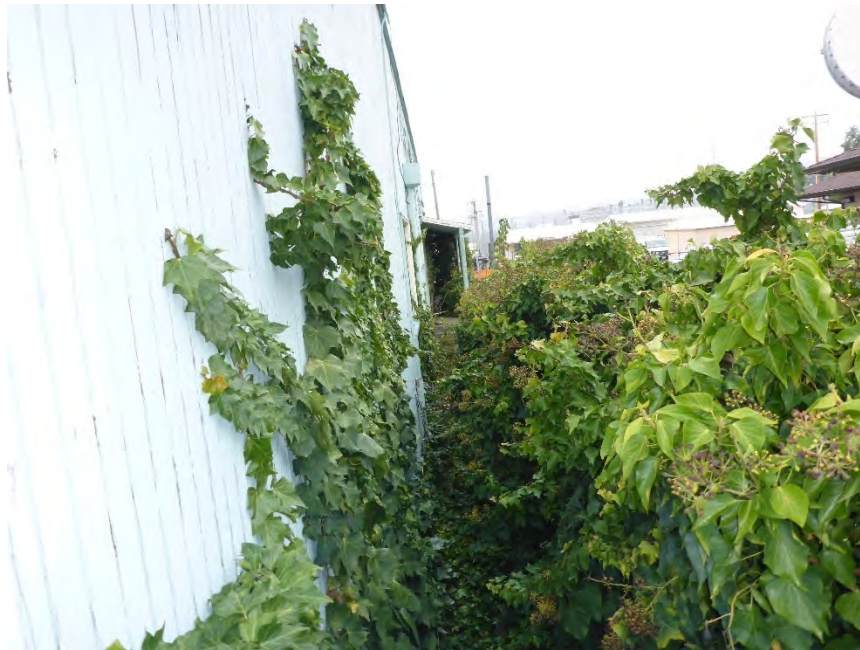
Photo #34: Ivey has grown onto exterior walls.

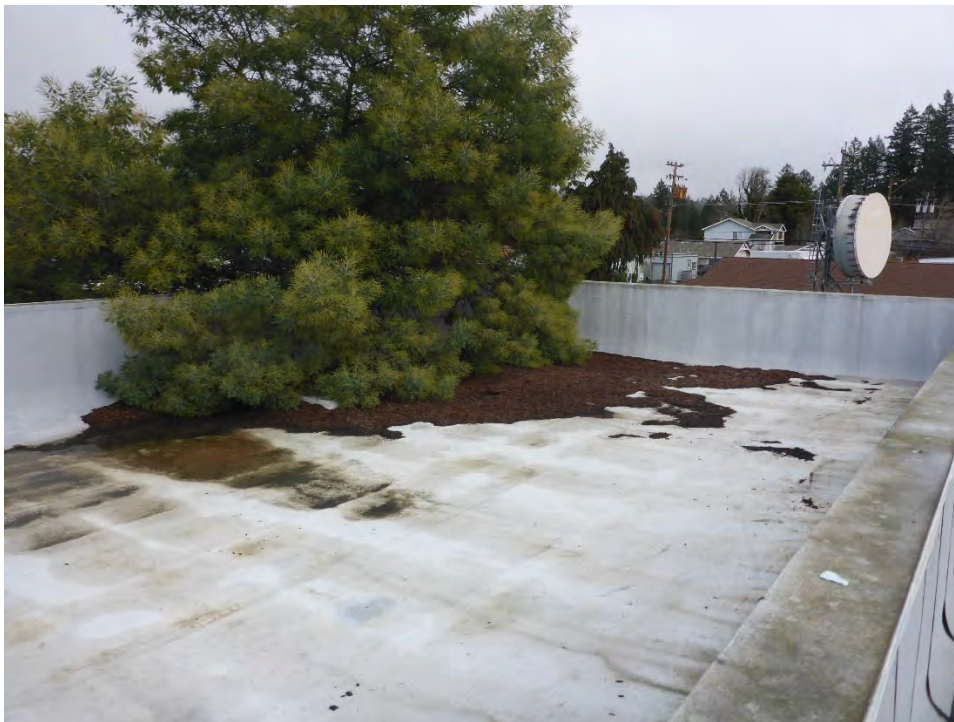
Photo #36: Adjacent tree is growing under foundation and is dispersing debris on to roof. This condition allows the drains to become clogged.

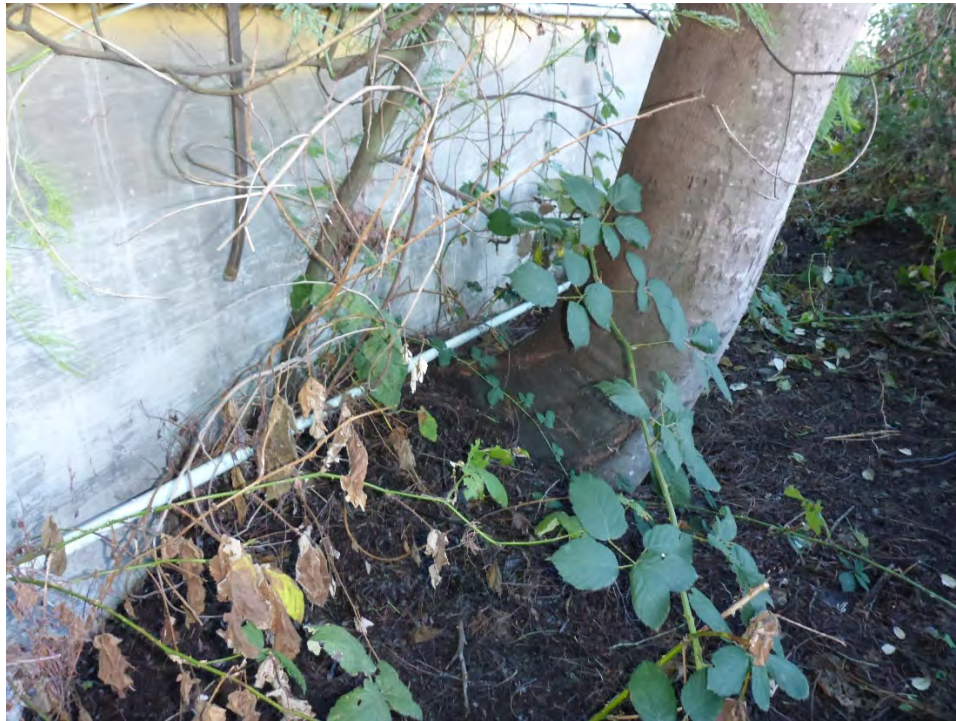
Photo #37: Adjacent tree is growing under foundation and is dispersing debris on to roof.

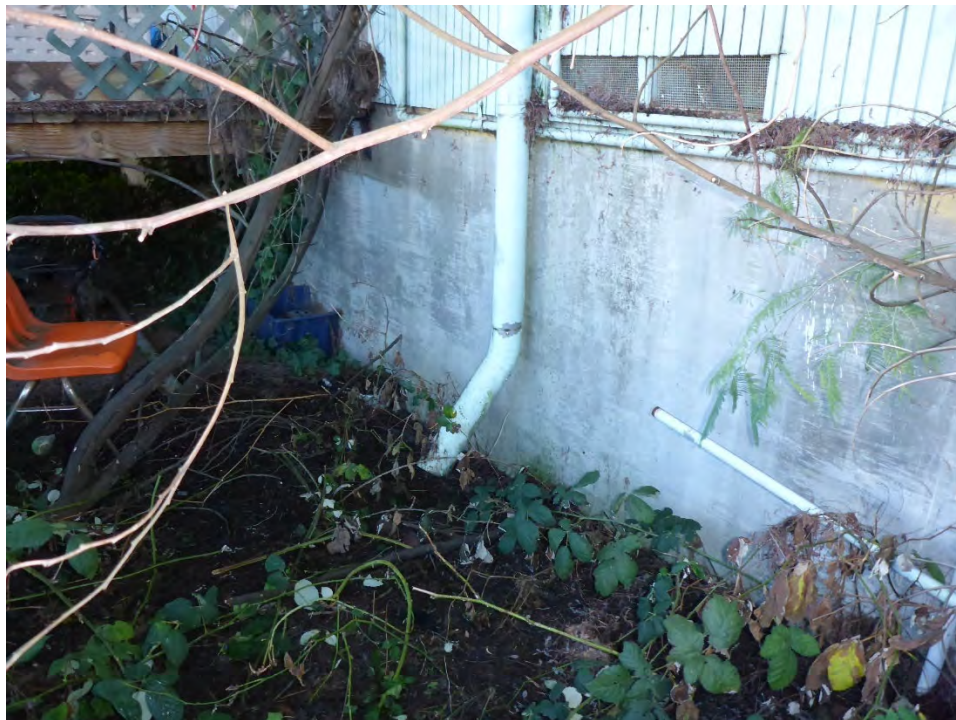
Photo #38: Roof downspout does not drain to street.

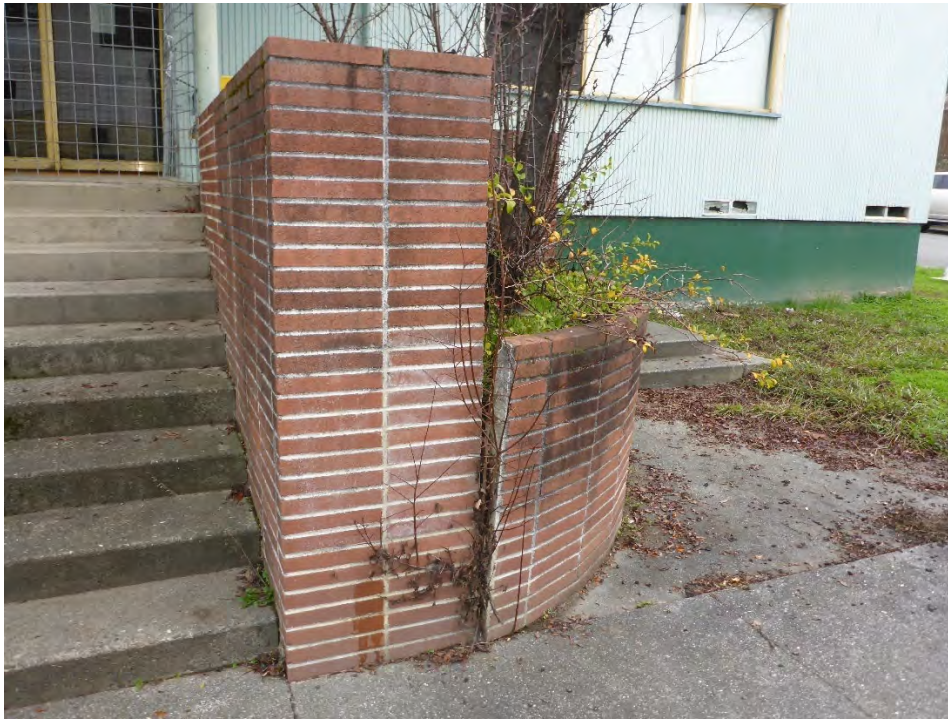
Photo #39: Planter Is Cracked and Is Failing.
