Structural Assessment
Garberville Veterans Building
Garberville, CA

KPFF Consulting Engineers
San Francisco, CA
February 26, 2021

This report presents the findings of the structural assessment of the Garberville Veterans Building located at 483 Conger St, Garberville, CA. The objective of this study was to assess the current condition of the building and to develop recommendations for structural strengthening and repair needed to bring the building up to the California Existing Building Code, 2019 edition.

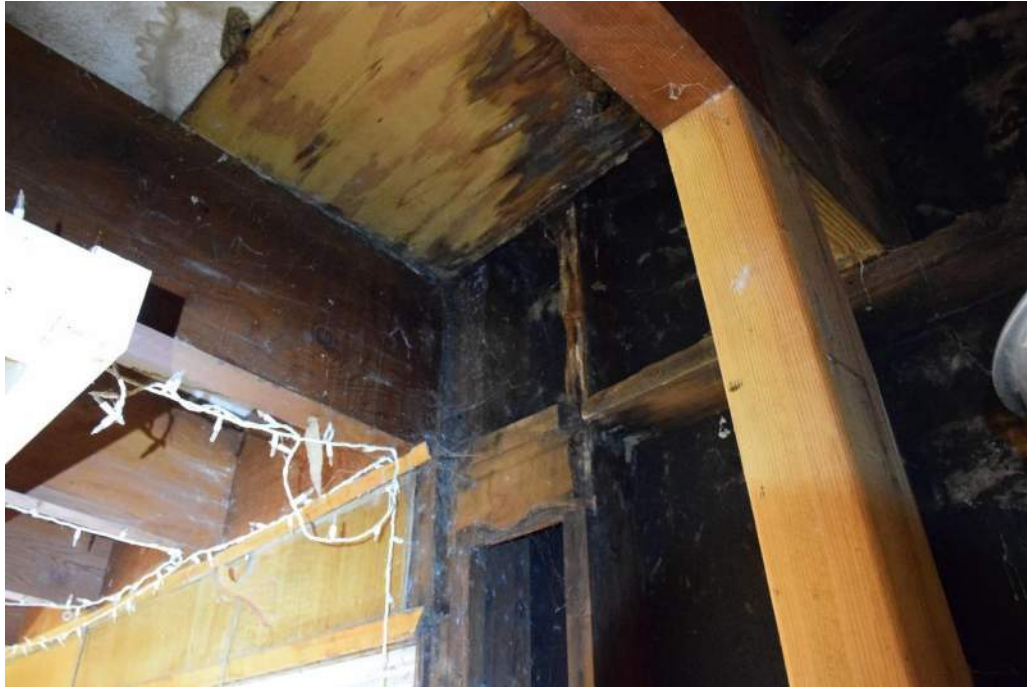
Figure 3 – Damaged beam, wall studs, and support ledger in the Auditorium

The primary immediate concern was with the leaks in the auditorium roof, which caused deterioration of the support of the roof beams. The end of a beam at the east end of the auditorium had rotted and was shored up with a wood post, pictured in figure 3 below. The photo is taken from below looking up towards the ceiling. The support detail of these roof beams consists of a 1x6 ledger notched into the wall studs, a detail that is susceptible to water damage. A remaining portion of the ledger can be seen to the left of the wood post in the figure.

Overall, the roof was leaking in several locations around the building leading to other water damage, which was visible on the ceiling, wall, and floor finishes. The roof insulating panels were deteriorating and softening due to water. Where they were visible, the redwood roof members appeared to be in good condition, aside from the auditorium beam in figure 3 above.

- 7.3 Replace the damaged beam and parapet studs in the auditorium. Remove the finishes at other water damaged locations and inspect the structural members for rot, replacing members as needed. The typical connections between roof beams and walls are unconventional compared to today's construction standards but are acceptable provided that the members are found to be in good condition. In the case of the damaged beam in the auditorium, the entire connection was deteriorated, and we have provided a conceptual detail for replacement.

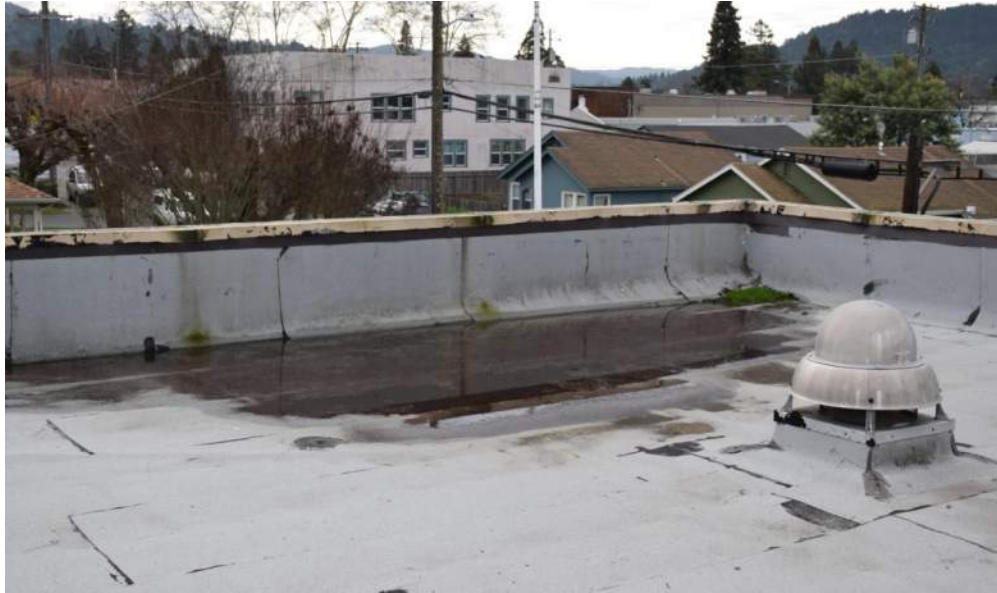
Figure 4 – Ponding at roof above spectator lounge

In the spectator lounge, a sag in the long span 4x20 beams was visible with some minor splitting occurring at the bottom of one beam. Ponding on the roof 1-2" deep was observed above these beams, shown in figure 4 below.

- 7.4 Replace the sagging wood beams in the spectator lounge. Due to size and span of original members, the replaced members will be engineered lumber of a similar size. The existing bearing connections may be reused if they are found to be in good condition.

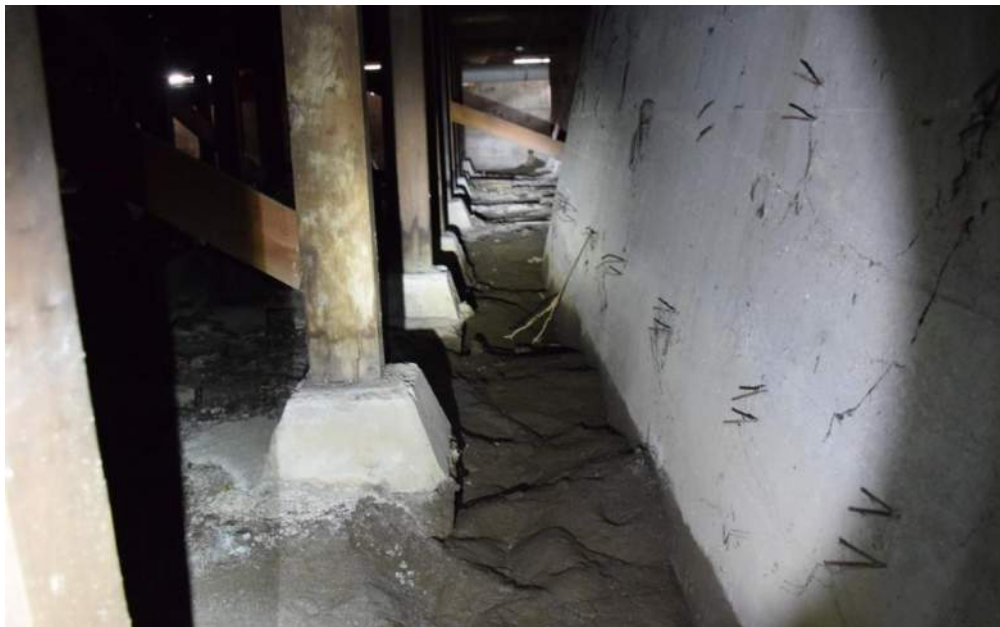
Figure 5A – Erosion of soil at isolated footings near west perimeter wall

Another area experiencing water damage was in the foundations. It was observed that water flowing along the edges of the perimeter grade beams had begun to erode the soil at the grade beams and adjacent footings, pictured in figure 5A and 5B below. The erosion does not appear to have yet undermined the foundations and therefore is likely not an immediate risk to the building foundation; however, our observations did not include potholing to observe whether there are voids beneath the foundations.

- 7.6 Add drainage as needed in the foundations. Replace the eroded soil in the foundation per recommendations from the geotechnical engineer.
- 7.7 If the entire structure above the foundation were to be removed and rebuilt with similar construction, we anticipate that the exterior foundations could be reused with similar doweling as shown in the conceptual sketches. The possibility of reusing the interior piers would depend on the programming and the recommendations of a geotechnical engineer.
