## FOCUSED ENGINEERING GEOLOGIC EVALUATION OF ROAD MAP POINTS FOR SUPPLY CREEK 2013 PROJECT, HUMBOLDT CO.,

### Oswald Geologic

**Supply Creek 2013 Project**

**Figure 2a: Site 004 and 009 Map**

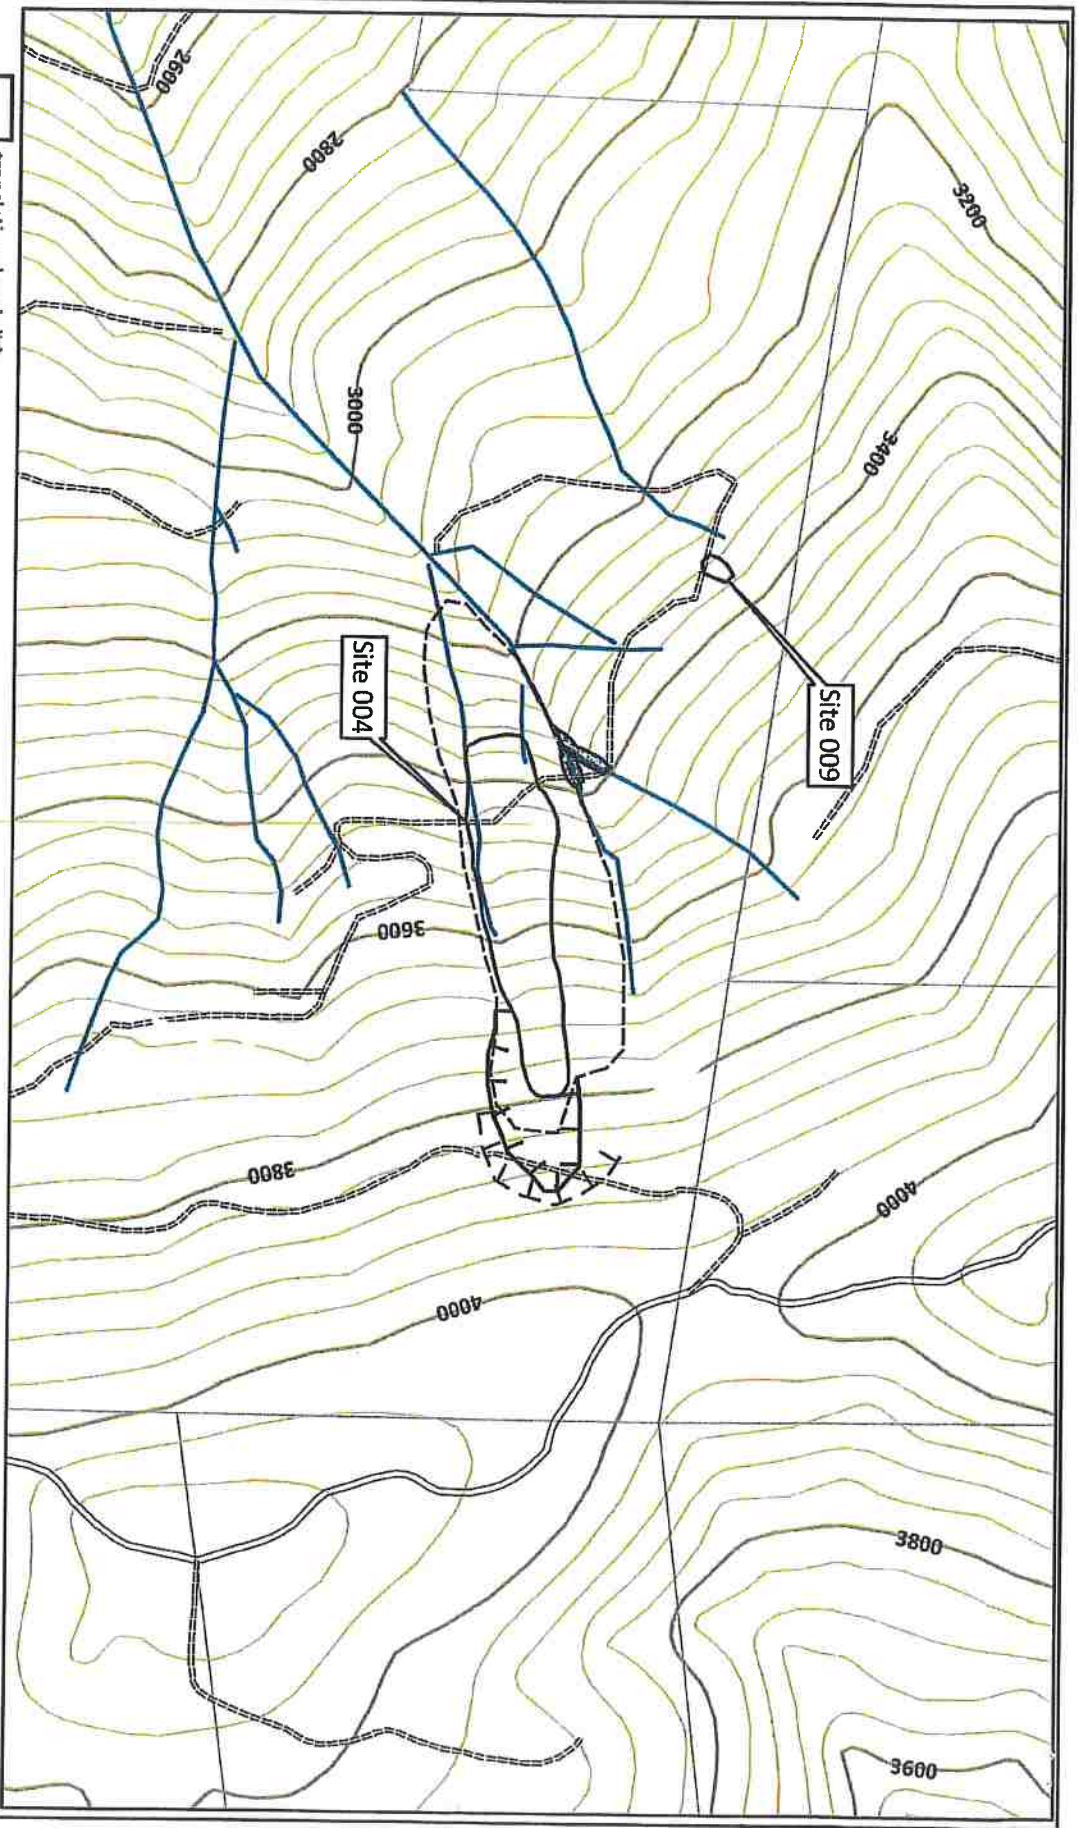
Site 004 is a section of road reconstruction through an unstable area first observed in the 1972 aerial photography. The failure is a dormant-historic, advancing, translational rockslide (Figure 2a). Road alignments and skid trails are truncated at the lateral margins and the body is hummocky with undrained depressions and sharp, well defined lateral scarps. Old Growth stumps in the body of the unstable area are deformed and the second growth timber is predominantly undeformed with pockets of deformed conifer near scarps and on steep slopes. The upper extent of the failure appears less active than other portions of the unstable area and the crown scarp has morphology indicative of a dormant-young activity status. A rock road crosses the crown scarp and is undeformed. There is an undeformed skid road downslope of Site 004 that runs immediately downslope of the toe of the unstable area. The morphology of the slopes adjacent the toe of the recent failure is consistent with a larger, pre-existing dormant-young rockslide at this location. The existing road alignment is located on the lower body of the displaced mass. The road prism is offset and deformed by movement on the landslide but the alignment can be traced across most of the unstable area. A Class III watercourse extends up the left lateral margin of the unstable area and has eroded through the road prism in a gully that is about 2- to 5-feet deep. Adjacent to the Class III watercourse a lobe of slide mass covers the road prism and is about 8-10 feet deep. An internal scarp crosses the road alignment and the road is offset about 6-8 feet on the far side of the lobe from the watercourse. The Class III watercourse crossing should be "built to fail". Ford crossings are preferred. Culverts, if used, should have armored inlets and have a well established and armored critical dips and outfall. The amount of fills used to reconstruct the crossing should be minimized. Smooth grade transition across sharp topography within the unstable area should be attained by both cutting into the top of the sharp grade transition and placing fill at the base of the sharp grade transition. Based on review of the site cuts into the unstable area and fills placed on the unstable area should **not** be greater than 5 feet in height or depth, respectively. The final road alignment should be outsloped and be a minimum width needed for equipment access. Cutslopes should be graded to 1:1 (h:v) or less or graded to match adjacent natural slopes. Fillslopes should be final graded to 1.5:1 (h:v) or less. Fills should be track compacted in 6- to 8-inch lifts to form a firm unyielding surface.

Site 009 is a dormant-historic cutbank failure. The failure is about 75 feet wide and 125 feet long. The majority of the failed cut rests on and covers the existing road prism. The outboard edge of the road is eroded and steeply inclined. The upper extent of the failed mass is inclined at about  $57^\circ$  ( $\sim 0.5:1$ , h:v). The toe of the failed mass is steeper and extends to the edge of the steeply inclined outboard edge of the road. The failure did not delivery to a watercourse. The road prism across the failure should be reconstructed using a combination of cutting into the slide mass on the road and ramping onto the lower portions of the slide mass. A smooth grade transition across the unstable area should be attained by both cutting into the top of the failed mass and placing fill at the base of the failed mass to reduce the grade transition. Fills should be placed in 6- to 8-inch lifts and compacted to a firm unyielding surface. The final cutslope should be graded to  $0.5:1$  (h:v) or less to match adjacent cuts. The road prism should be full bench and insloped across the unstable area. A cross road drainage structure (bar or berm) should be placed up road grade of insloped road section. The insloped road section should be drained outside of unstable area by means of cross road drainage structure (bar, berm, culvert).
