SZS ENGINEERING ACCESS

FAMILY VISITATION CENTER

ADA ACCESS COMPLIANCE ASSESSMENT

231 D STREET, EUREKA CA
(COUNTY LEASED FACILITY)

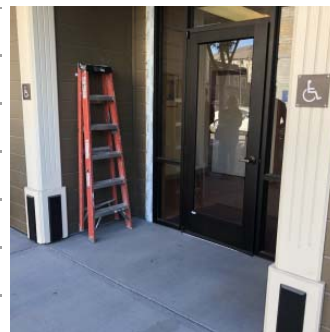
Field Date: 10/29/2019 Report Date: 10/29/2019 Barrier #: 3H
 Facility: Family Visitation Center - 231 2nd St, Eureka
 Location: First Floor - North Entrance for 3rd Floor Program
 Official Responsible: Karen Clower, ADA Coordinator
 Consent Decree: No Paragraph: M.51 Dwg: 1 of 2
 Barrier Area: Doors or Gates Remediation: N/A
 Barrier Type: Smooth Surface at Bottom - Kickplate

Barrier Description: Door/Gate lacks min. 10" smooth uninterrupted bottom surface

Code References: CBC 11B-404.2.10 and 2010 ADAS 404.2.10

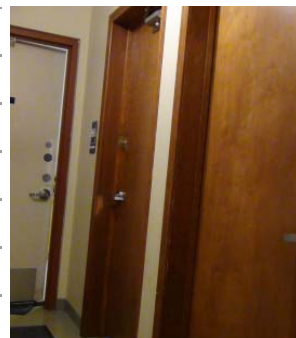
Field Date: 10/29/2019 Report Date: 10/29/2019 Barrier #: 10A
 Facility: Family Visitation Center - 231 2nd St, Eureka
 Location: First Floor - Unisex Toilet Room #2
 Official Responsible: Karen Clower, ADA Coordinator
 Consent Decree: No Paragraph: M.51 Dwg: 1 of 2
 Barrier Area: Restrooms Remediation: N/A
 Barrier Type: Sign - Braille/tactile Information

Barrier Description: No sign with Braille/Tactile information provided to identify restroom

Code References: CBC 11B-216.2 and ADAS 216.2

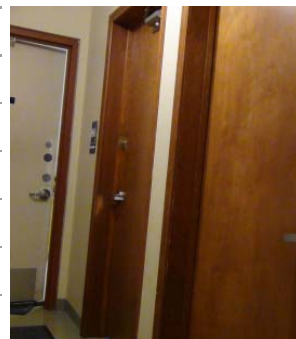
Field Date: 10/29/2019 Report Date: 10/29/2019 Barrier #: 10B
 Facility: Family Visitation Center - 231 2nd St, Eureka
 Location: First Floor - Unisex Toilet Room #2
 Official Responsible: Karen Clower, ADA Coordinator
 Consent Decree: No Paragraph: M.51 Dwg: 1 of 2
 Barrier Area: Restrooms Remediation: Required
 Barrier Type: Sign - Raised characters

Barrier Description: Raised characters not between 5/8" and 2" high

Code References: CBC 11B-703.2.5 and 2010 ADAS 703.2.5

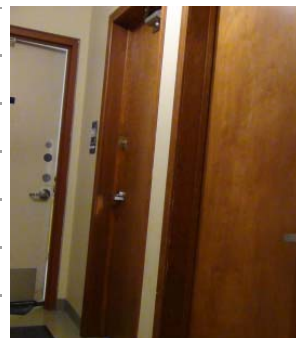
Field Date: 10/29/2019 Report Date: 10/29/2019 Barrier #: 10C
 Facility: Family Visitation Center - 231 2nd St, Eureka
 Location: First Floor - Unisex Toilet Room #2
 Official Responsible: Karen Clower, ADA Coordinator
 Consent Decree: No Paragraph: M.51 Dwg: 1 of 2
 Barrier Area: Restrooms Remediation: Required
 Barrier Type: Accessible Route - ISA Directional Sign

Barrier Description: Sanitary facility entry not visible from existing accessible route

Code References: CBC 11B-216.8 and ADAS 216.8

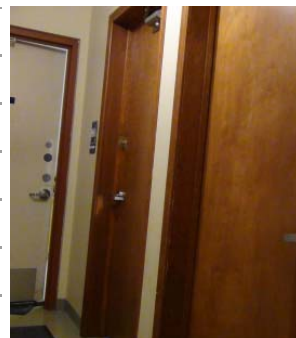
Field Date: 10/29/2019 Report Date: 10/29/2019 Barrier #: 10E
 Facility: Family Visitation Center - 231 2nd St, Eureka
 Location: First Floor - Unisex Toilet Room #2
 Official Responsible: Karen Clower, ADA Coordinator
 Consent Decree: No Paragraph: M.51 Dwg: 1 of 2
 Barrier Area: Restrooms Remediation: Required
 Barrier Type: Sign - 12" Circle/Triangle at Unisex Restroom

Barrier Description: No 12" triangle superimposed on 12" circle provided on door or doorway to unisex toilet room

Code References: CBC 11B-703.7.2.6.3

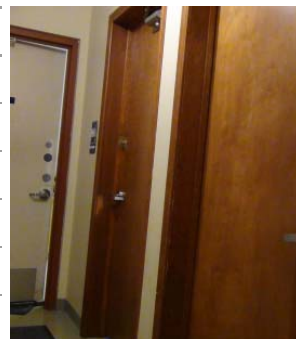
Field Date: 10/29/2019 Report Date: 10/29/2019 Barrier #: 10F
 Facility: Family Visitation Center - 231 2nd St, Eureka
 Location: First Floor - Unisex Toilet Room #2
 Official Responsible: Karen Clower, ADA Coordinator
 Consent Decree: No Paragraph: M.51 Dwg: 1 of 2
 Barrier Area: Doors or Gates Remediation: Required
 Barrier Type: Door Closer - Interior Automatic Device

Barrier Description: Door opening force exceeds 5 lbf

Code References: CBC 11B-404.2.9 and 2010 ADAS 404.2.9

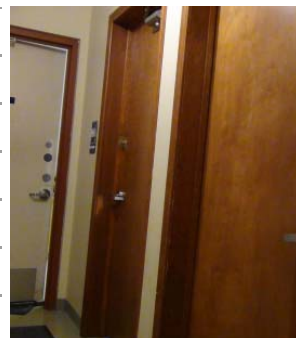
Barrier Type: Door Closer - Interior Sweep

Barrier Description: Door closer lacks min. 5 second sweep period/back check

Code References: CBC 11B-404.2.8.1 and ADA/ABA 404.2.8.1

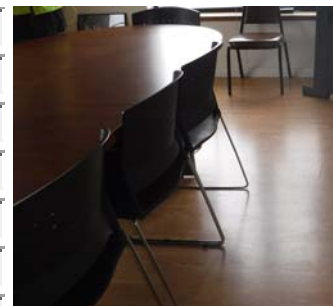
Barrier Type: Table - Knee Clearance

Barrier Description: Knee clearance of at least 27" high, 30" wide and 19" deep not provided

Code References: CBC 11B-306.3 and 2010 ADAS 306.3
