Reference: 018181

June 11, 2019

Subject: Engineering Geologic Evaluation and Soils Reporting for Existing and Proposed Improvements, APN's 216-081-013, 216-135-015, 216-136-004, and 216-135-008; Harris, Humboldt County, California

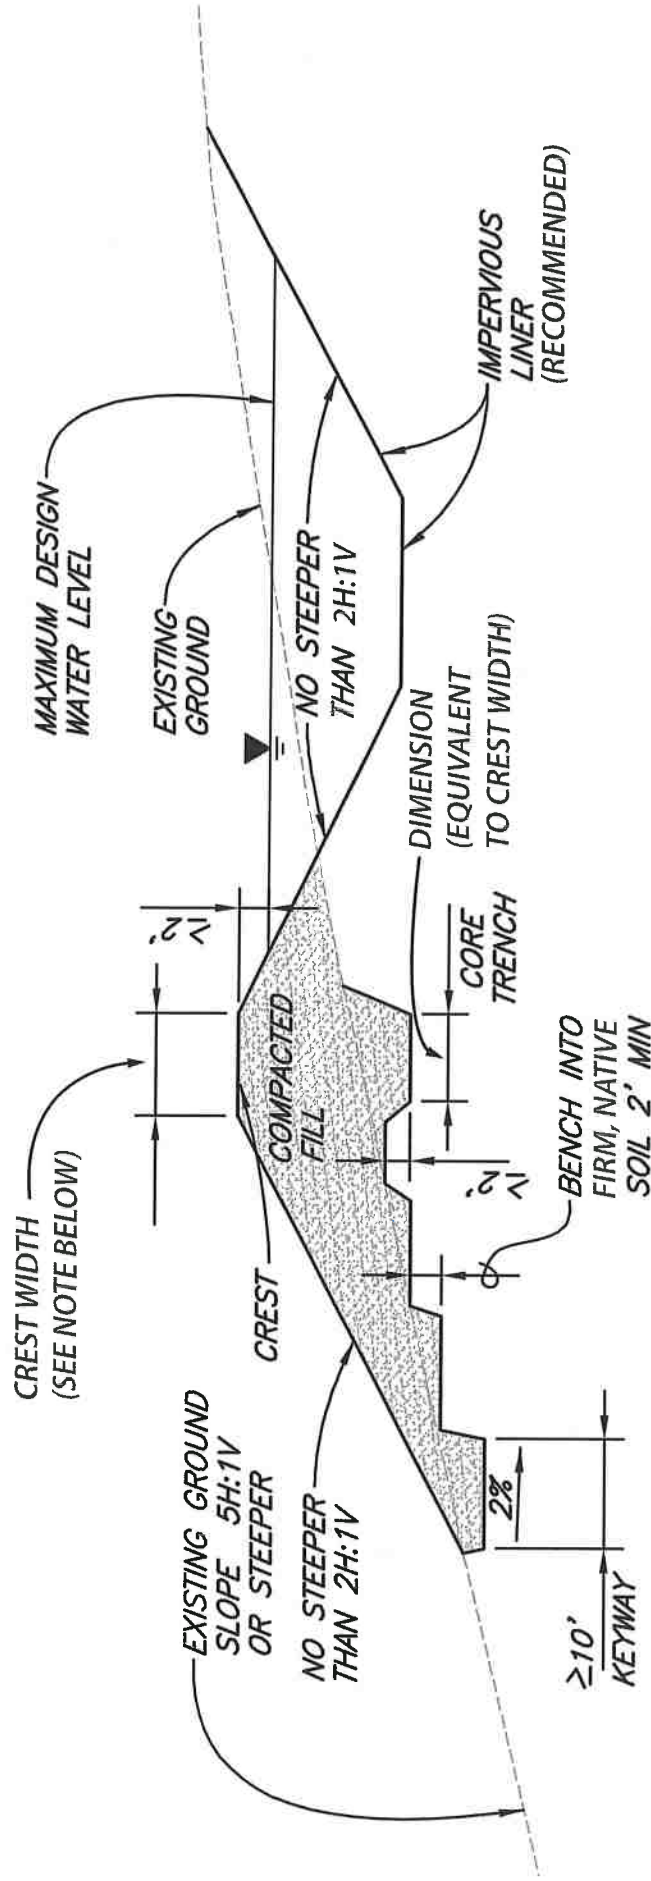
Figure 3

Pond Embankment Illustrative Cross Section

- Design the pond such that the volume of material from cuts is, at a minimum, equal to the volume of material needed for fills. If possible, design the pond such that the volume of material from cuts is approximately 10 percent greater than the volume of material needed for fills.
- The exterior and interior slopes of the pond embankments should be inclined no steeper than 2H:1V (see conceptual embankment section in Figure 3).

- The crest of pond embankments should be at least 2 feet (freeboard) above the maximum pond water level to minimize the potential for breaching during a seismic event.

- The crest of pond embankments should be at least 6 feet wide for embankments less than 10 feet high; taller embankments should have crest widths of at least 10 feet.

- A core trench at least 10 feet wide should be excavated beneath the axis of dam embankments. The trench should extend at least 2 feet vertically into firm, native soils.
