Mr. Aaron Baker  
Mr. Rick Cooper - Humboldt Sanctuary Farm  
10 November 2020

APN 221-071-020, APPS 12990

**RE: Humboldt Sanctuary February Site Visit Assessment and Findings**

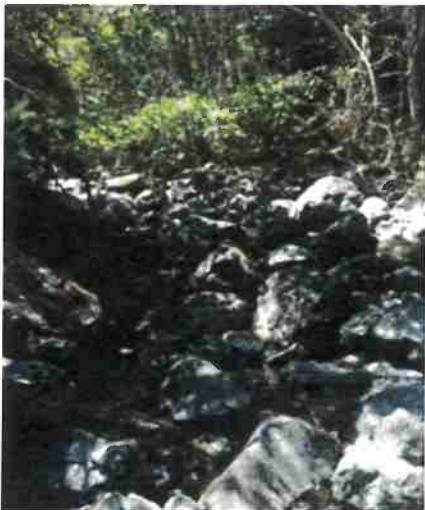
The Right Bank Tributary #10 survey began at the confluence with Salmon Creek (Photo 1). Young-of-the-year and 1+ juvenile steelhead were observed in shallow pools and one pool ~1.5 feet in depth in the first 0.19 mile (1,003 feet) (Photo 2). No fish or aquatic vertebrate species were observed for the remainder of the survey. The habitat is mostly large boulders with very shallow riffles, which consistently gain in elevation for the remainder of the survey (Photo 3). An over six feet tall set of boulders blocks the channel at 0.32 mile (1,690 feet) (Photos 4 and 5) which marks the transition from a Class I to a Class II stream, and the end of salmonid anadromy. We piled up rocks and pulled ourselves through the right bank root wad to continue the survey another 0.47 mile (2500 feet) looking for fish until a large, impassable debris jam caused by a landslide was encountered and intermittent, subsurface flow (Photo 6). I returned to the stream channel when the stream was on Humboldt Sanctuary Farm's

Photo 1: Confluence with Salmon Creek (Class I)

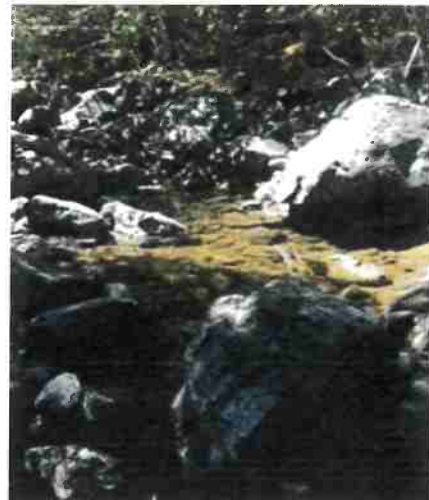
Photo 2: Juvenile steelhead present (Class I)

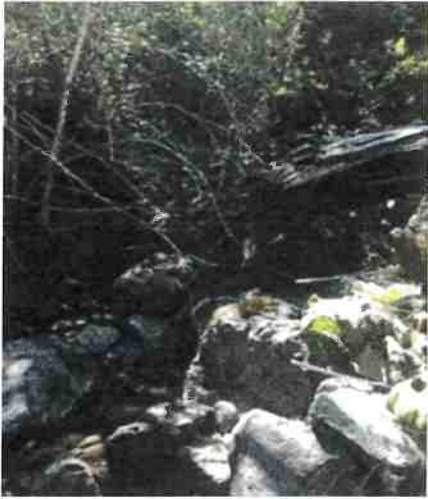
Photo 3: No aquatic vertebrates observed

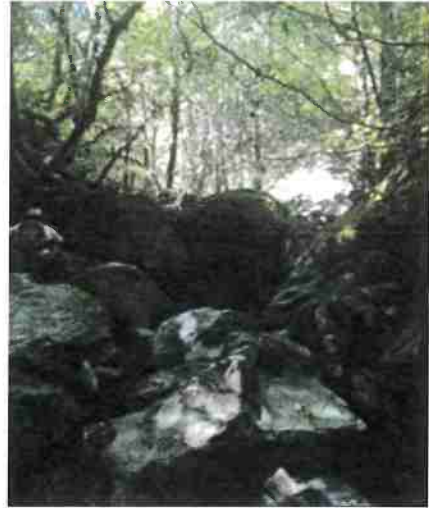
Photo 4: End of salmonid anadromy (Class I to Class II)

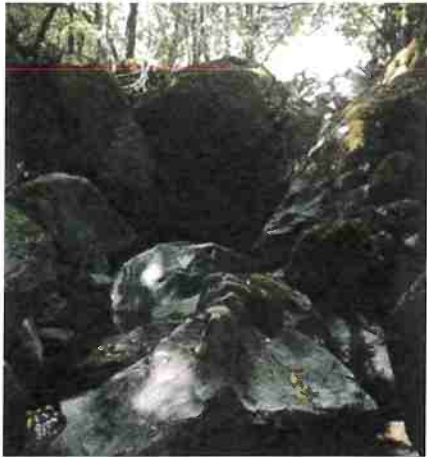
Photo 5: End of salmonid anadromy (Class I to Class II)

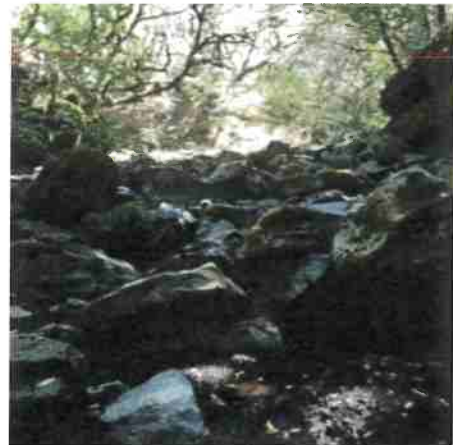
Photo 6: Subsurface flow (Class II)

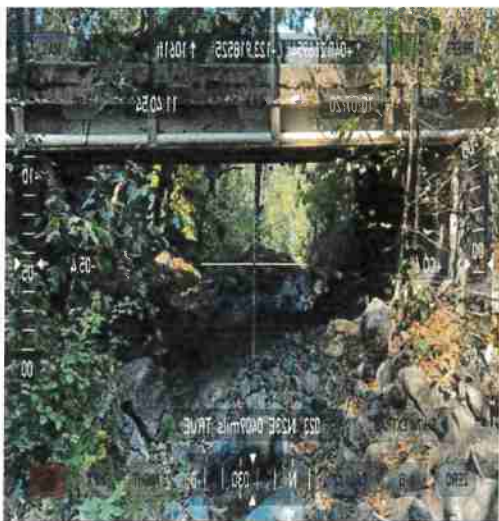
property and continue to survey for fish and/or aquatic vertebrates. None were observed. No insects were observed. Nearing the headwater of this tributary, the flow became intermittently subsurface several times, and 100% subsurface 25 feet below the bridge (Photo 7). Approximately, 20 feet above the bridge, the channel divides into left and right channels. The left channel is near Cultivation Area 2. The left channel was completely dry and devoid of biological life. Right Bank Tributary #10 transitions from a Class II stream to a Class III stream about 50 feet above the bridge (Photo 8).

Photo 7. Bridge near Class II to Class III transition

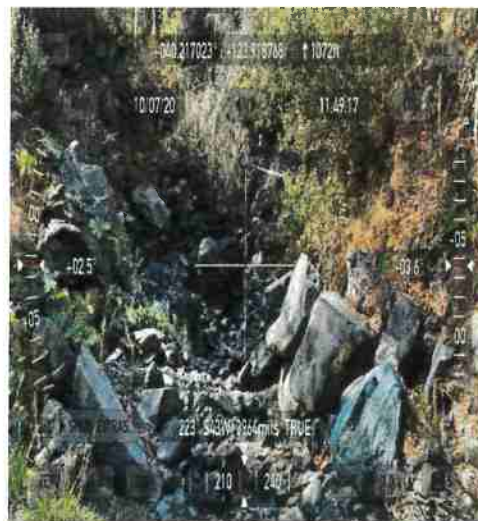
Photo 8. Class III transition left channel.
