Garberville Veterans Hall

Access Compliance Survey Report

January 2021

SSA Project #: 20033.01.00

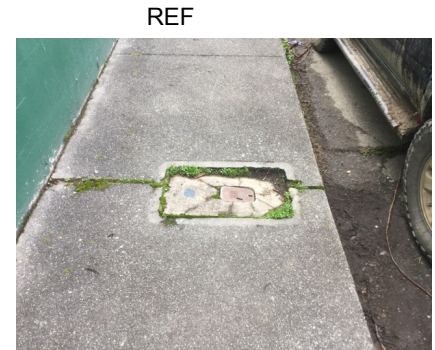
1 Path of Travel within Public Right of Way

Changes in Level

19 • *As-Built Description:*
 Walk: Pavement dislocation creates abrupt change in level exceeding 1/2" in accessible route.

• *Notes:*
Due to water meter cover and incorporate work with sidewalk improvements.

PCODE EF03REF
 ADAAG 91 4.3.8
 ADA 2010 403.4
 CBC 2007 1133B.7.4
 CBC 2019 11B-403.4

• *Proposed Solution:*
 Remove, replace or repair area of pavement sufficient to correct abrupt change in level.

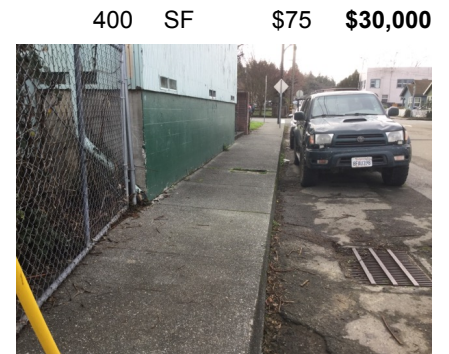
Cross Slope

16 • *As-Built Description:*
 Sidewalk Cross slope more than 1":48" (2.083%).

• *As-Built:* **1.6%-4.8%**

PCODE EF07
 ADAAG 91 4.3.7
 ADA 2010 403.3
 CBC 2007 1133B.7.1.3
 CBC 2019 11B-403.3

• *Proposed Solution:*
 Modify sidewalk cross slope.

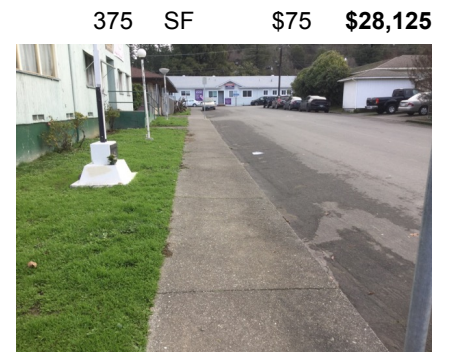
21 • *As-Built Description:*
 Sidewalk Cross slope more than 1":48" (2.083%).

• *As-Built:* **1.3%-3.4%**

• *Notes:*
Random cross slope issues at sidewalk.

PCODE EF07
 ADAAG 91 4.3.7
 ADA 2010 403.3
 CBC 2007 1133B.7.1.3
 CBC 2019 11B-403.3

• *Proposed Solution:*
 Modify sidewalk cross slope.

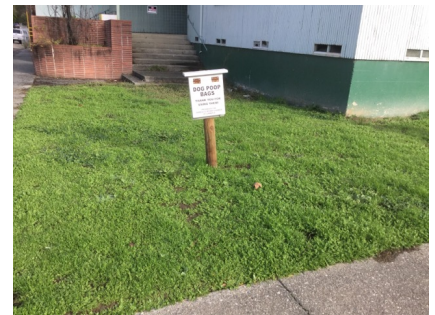
Reach Range

- 39
- *As-Built Description:*
Reach height to control or access point, where side approach is available, exceeds 48" or is less than 15" in height, or exceeds 10" in depth.
 - *As-Built:* **5' from sidewalk**
 - *Proposed Solution:*
Relocate existing dog poop bags stand.

PCODE IE02
 ADAAG 91 4.2.6
 ADA 2010 308.3.1
 CBC 2007 1118B.6
 CBC 2019 11B-308.3

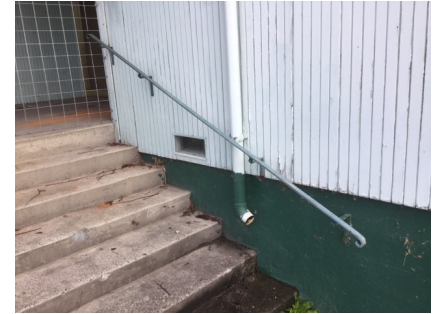
Height

23	<ul style="list-style-type: none"> <i>As-Built Description:</i> Handrail gripping surface top not mounted between 34" and 38" above ramp surface or stair nosings. <i>As-Built:</i> 31" high <i>Proposed Solution:</i> Remove existing and provide new handrail. 	PCODE ED02 ADAAG 91 4.9.4(5) ADA 2010 505.4 CBC 2007 1133B.4.2.1 & B.5.5.1 CBC 2019 11B-505.4 Mitigated: <input type="radio"/> YES <input checked="" type="radio"/> NO	10	LF	\$225	\$2,250
----	------------------------------------------------------------------------------------------------------------------------------------------------------------------------------------------------------------------------------------------------------------------------------------------------------------------	-------------------------------------------------------------------------------------------------------------------------------------------------------------------------------------------------	----	----	-------	---------

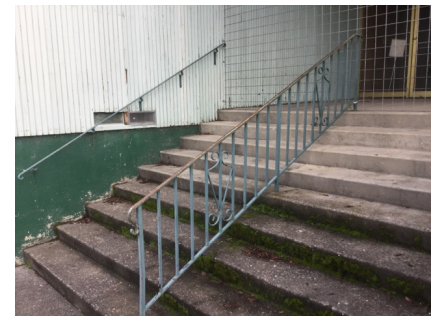
28	<ul style="list-style-type: none"> <i>As-Built Description:</i> Handrail gripping surface top not mounted between 34" and 38" above ramp surface or stair nosings. <i>As-Built:</i> 31" high <i>Proposed Solution:</i> Remove existing and provide new handrails. <i>Notes:</i> Replaces both sets including middle handrail. 	PCODE ED02 ADAAG 91 4.9.4(5) ADA 2010 505.4 CBC 2007 1133B.4.2.1 & B.5.5.1 CBC 2019 11B-505.4 Mitigated: <input type="radio"/> YES <input checked="" type="radio"/> NO	20	LF	\$225	\$4,500
----	---------------------------------------------------------------------------------------------------------------------------------------------------------------------------------------------------------------------------------------------------------------------------------------------------------------------------------------------------------------------------------------------------	-------------------------------------------------------------------------------------------------------------------------------------------------------------------------------------------------	----	----	-------	---------

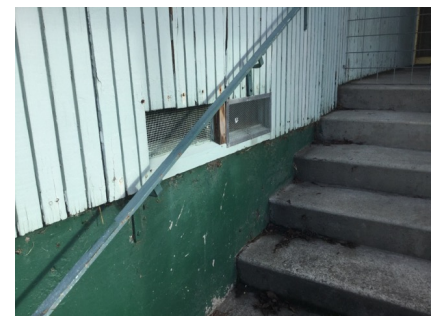
40	<ul style="list-style-type: none"> <i>As-Built Description:</i> Handrail adjacent surface have abrasive or sharp elements. <i>Proposed Solution:</i> Install vent cover to provide smooth surface adjacent to handrail. 	PCODE ED02NT ADAAG 91 4.9.4(5) ADA 2010 505.4 CBC 2007 1133B.4.2.1 & B.5.5.1 CBC 2019 11B-505.4 Mitigated: <input type="radio"/> YES <input checked="" type="radio"/> NO	1	JOB	\$225	\$225
----	---------------------------------------------------------------------------------------------------------------------------------------------------------------------------------------------------------------------------------------------------------	---------------------------------------------------------------------------------------------------------------------------------------------------------------------------------------------------	---	-----	-------	-------

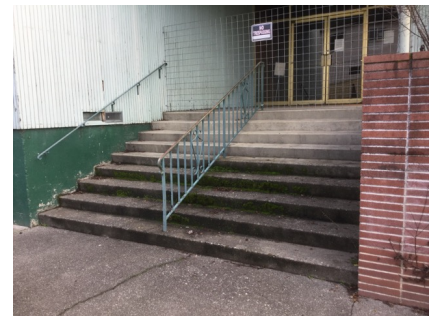
26	<ul style="list-style-type: none"> <i>As-Built Description:</i> The leading 2" of the tread does not have visual contrast of dark-on-light or light-on-dark from the remainder of the tread. <i>Proposed Solution:</i> Provide contrasting color strips at all exterior stair treads. 	<p>PCODE EC02 ADA 2010 504.4 CBC 2007 1133B.4.4 CBC 2019 11B-504.4.1</p> <p>Mitigated: <input type="radio"/> YES <input checked="" type="radio"/> NO</p>	90	LF	\$27	\$2,430
----	-----------------------------------------------------------------------------------------------------------------------------------------------------------------------------------------------------------------------------------------------------------------------------------------------------------------------	---------------------------------------------------------------------------------------------------------------------------------------------------------------------------------------	----	----	------	---------

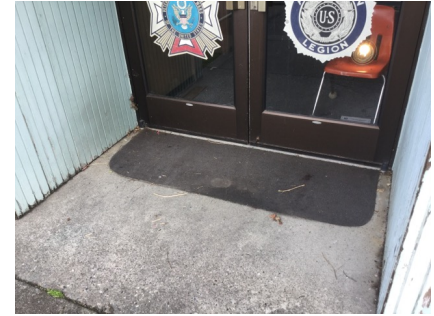
Carpet/Doormat

- 34 • *As-Built Description:*
Doormat not securely attached to ground or floor structure.
- *Proposed Solution:*
Attach doormat to floor surface or remove doormat.

PCODE **ID05A**
 ADAAG 91 **4.5.3**
 ADA 2010 **302.2**
 CBC 2007 **1124B.3**
 CBC 2019 **11B-302.2**

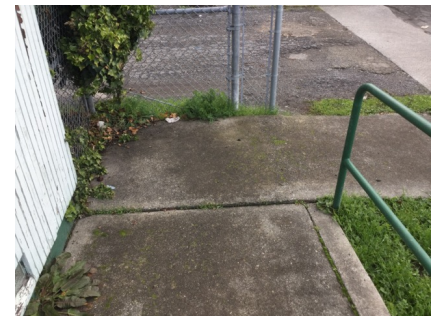
Change in Direction

- 31 • *As-Built Description:*
Landing at change of direction not 60" minimum by 72" minimum in the direction of downward travel from the upper ramp run.
- *As-Built:* **52.5" long**
- *Proposed Solution:*
Modify landing at change of direction to 60" x 72".
- *Notes:*
Incorporate required landing when installing proposed ramp.

PCODE **EB08REF**
 ADAAG 91 **4.8.4(3)**
 ADA 2010 **405.7.4**
 CBC 2007 **1133B.5.4**
 CBC 2019 **11B-405.7.4**

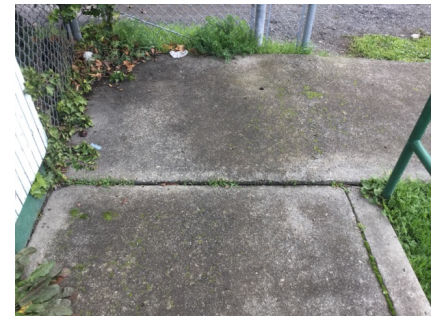
Changes in Level

- 32 • *As-Built Description:*
Ramp dislocation creates abrupt change in level exceeding 1/2" in accessible route.
- *As-Built:* **0.5"-1" high**
- *Proposed Solution:*
Remove, replace or repair area of ramp sufficient to correct abrupt change in level.
- *Notes:*
Incorporate correction when installing proposed ramp.

PCODE **EF03REF**
 ADAAG 91 **4.3.8**
 ADA 2010 **403.4**
 CBC 2007 **1133B.7.4**
 CBC 2019 **11B-403.4**

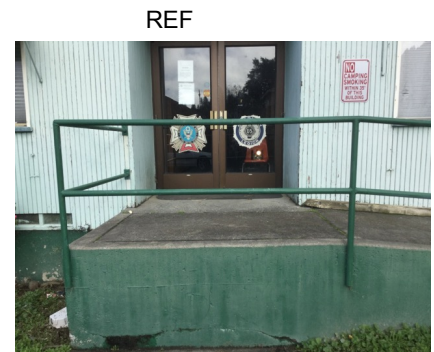
36 • *As-Built Description:*
 Open guards does not have balusters or ornamental patterns such that a 4-inch-diameter (102 mm) sphere cannot pass through any opening.

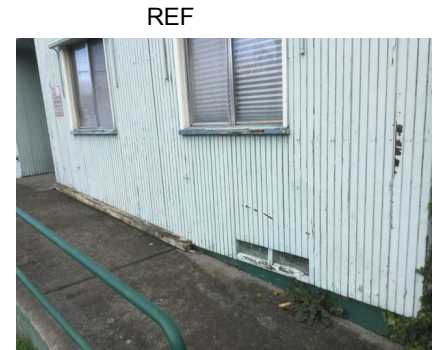
33	<ul style="list-style-type: none"> <i>As-Built Description:</i> Handrail not provided at stairs or ramp, required on both sides (not required at curb ramps or adjacent to seating areas). <i>Proposed Solution:</i> Provide new handrail for each side including extensions. <i>Notes:</i> Incorporate required handrails when installing proposed ramp. 	PCODE ED01REF ADAAG 91 4.8.5 & 4.9.4 ADA 2010 505.2 CBC 2007 1133B.4.1.1 & .5.5 CBC 2019 11B-505.2				
----	---------------------------------------------------------------------------------------------------------------------------------------------------------------------------------------------------------------------------------------------------------------------------------------------------------------------------------------------------------------------------------------------------------------	----------------------------------------------------------------------------------------------------------------	--	--	--	--

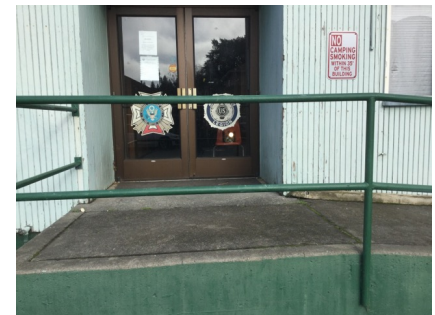
Signage

136	<ul style="list-style-type: none"> <i>As-Built Description:</i> Accessible building entrance when not all are accessible not identified with a sign showing the International Symbol of Accessibility. <i>Proposed Solution:</i> Provide building entrance sign that shows international symbol at accessible entrance. 	PCODE SA12 ADAAG 91 4.1.2(7)(c) ADA 2010 216.6 CBC 2007 1127B.3 CBC 2019 11B-216.6				
-----	---------------------------------------------------------------------------------------------------------------------------------------------------------------------------------------------------------------------------------------------------------------------------------------------------------------------------------------------------------	------------------------------------------------------------------------------------------------	--	--	--	--

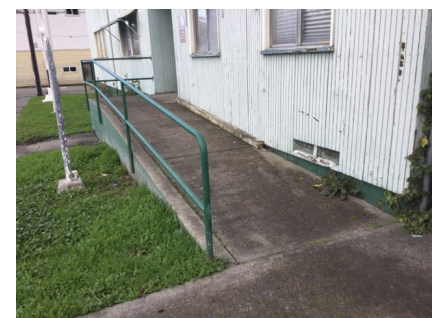
Slope

30	<ul style="list-style-type: none"> <i>As-Built Description:</i> Slope greater than 1:12 (8.3%). <i>As-Built:</i> 6.9%-9.3% <i>Proposed Solution:</i> Demolish existing and provide new ramp with handrails. 	PCODE EB02 ADAAG 91 4.8.2 ADA 2010 405.2 CBC 2007 1133B.5.3 CBC 2019 11B-405.2				
----	-------------------------------------------------------------------------------------------------------------------------------------------------------------------------------------------------------------------------------------------------------------	--------------------------------------------------------------------------------------------	--	--	--	--

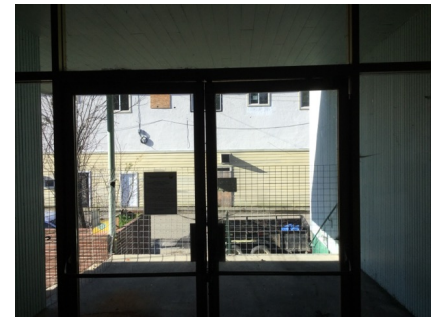
- 53
- *As-Built Description:*
Excessive force required to open door.
 - *Proposed Solution:*
Adjust regular door closer to accessible standards (5 lbs. max).

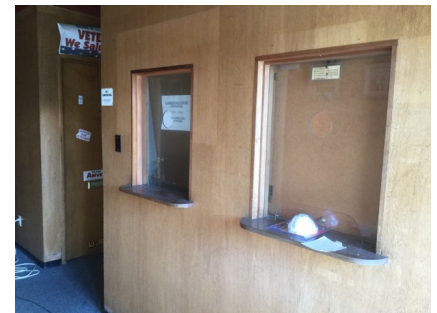
45	<ul style="list-style-type: none"> As-Built Description: Service counter (stand-up): Accessible section min. 36" length and 36" max. height (in CA: 28" to 34" high) not provided. As-Built: 42" high Proposed Solution: Retrofit existing counter to provide accessible section. Interim solution: Provide auxiliary counter, table, or clipboard. 	PCODE IN03 ADAAG 91 7.2(2) ADA 2010 904.4 CBC 2007 1122B.4 CBC 2019 11B-904.4 Mitigated: <input type="radio"/> YES <input checked="" type="radio"/> NO	1	JOB	\$6,000	\$6,000
----	---------------------------------------------------------------------------------------------------------------------------------------------------------------------------------------------------------------------------------------------------------------------------------------------------------------------------------------------------------------------------------------------	---------------------------------------------------------------------------------------------------------------------------------------------------------------------------------	---	-----	---------	---------

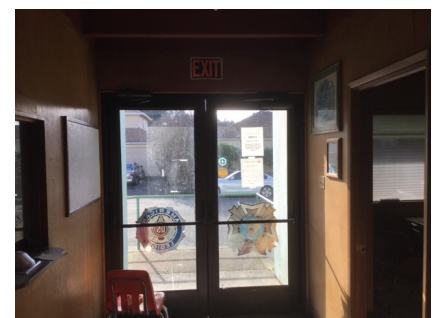
Signage

43	<ul style="list-style-type: none"> As-Built Description: At door leading into exit ramp: Where required exit signs are installed, signs to provide exiting information for people with vision impairment are not provided. Proposed Solution: Provide raised letter/Braille "EXIT RAMP UP/DOWN" sign at door. 	PCODE SA10C ADAAG 91 4.1.3(16) ADA 2010 216.4.1 CBC 2007 1011.3 CBC 2019 11B-216.4.1 Mitigated: <input type="radio"/> YES <input checked="" type="radio"/> NO	1	JOB	\$270	\$270
----	---------------------------------------------------------------------------------------------------------------------------------------------------------------------------------------------------------------------------------------------------------------------------------------------------------------------------------------	----------------------------------------------------------------------------------------------------------------------------------------------------------------------------------------	---	-----	-------	-------

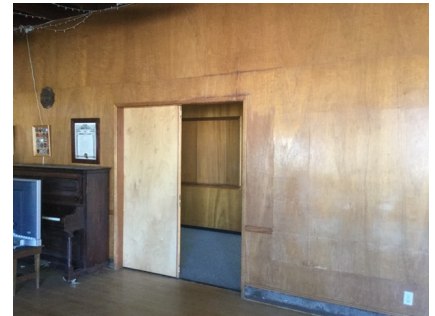
55 • *As-Built Description:*
 No signs at the building or assembly area entrance to notify patrons that an assistive listening system is available.
 • *Proposed Solution:*
 Provide assistive listening signage.

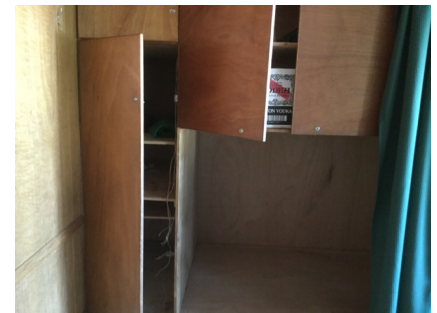
57	<ul style="list-style-type: none"> <i>As-Built Description:</i> Cabinet or storage door / drawer does not have accessible hardware. <i>Proposed Solution:</i> Provide accessible pull / latch (touch latches or U-pulls). 	PCODE ID07A ADAAG 91 4.25.4 ADA 2010 309.4 CBC 2007 1125B.4 CBC 2019 11B-309.4 Mitigated: <input type="radio"/> YES <input checked="" type="radio"/> NO	1	JOB	\$300	\$300
----	-----------------------------------------------------------------------------------------------------------------------------------------------------------------------------------------------------------------------------------------------------------	----------------------------------------------------------------------------------------------------------------------------------------------------------------------------------	---	-----	-------	-------

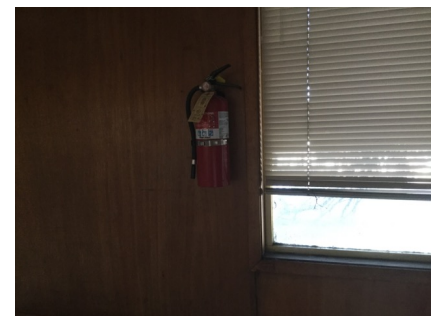
Protrusion Limits

56	<ul style="list-style-type: none"> <i>As-Built Description:</i> Protruding objects more than 4" from wall, when bottom of object more than 27" or less than 80" above finished floor. <i>As-Built:</i> Protruding 4.75" at 54.5" high <i>Proposed Solution:</i> Remove/relocate protruding object. Patch existing surface. <i>Notes:</i> Relocate FE lowest edge at 27" maximum. 	PCODE EG04 ADAAG 91 4.4.1 ADA 2010 307.2 CBC 2007 1133B.8.6.1 CBC 2019 11B-307.2 Mitigated: <input type="radio"/> YES <input checked="" type="radio"/> NO	1	JOB	\$300	\$300
----	------------------------------------------------------------------------------------------------------------------------------------------------------------------------------------------------------------------------------------------------------------------------------------------------------------------------------------------------------------------------------------------------------------------------------------------------------	------------------------------------------------------------------------------------------------------------------------------------------------------------------------------------	---	-----	-------	-------

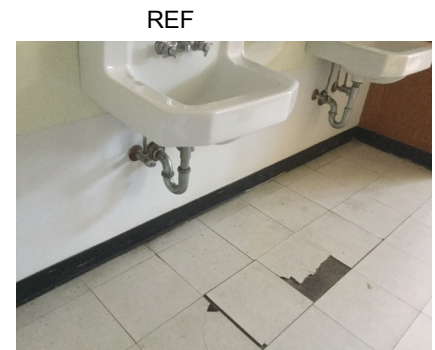
81 • *As-Built Description:*
 Hot or sharp-surfaced water/drain pipe not insulated or covered.
 • *Proposed Solution:*
 Insulate or cover water/drain pipe.

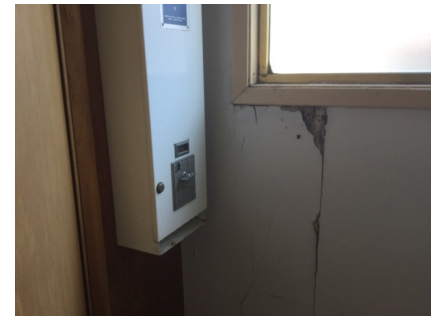
86	<ul style="list-style-type: none"> <i>As-Built Description:</i> Protruding objects more than 4" from wall, when bottom of object more than 27" or less than 80" above finished floor. <i>As-Built:</i> Protrudes 5" at 42" high <i>Proposed Solution:</i> Remove/relocate protruding object. Patch existing surface. 	PCODE EG04REF ADAAG 91 4.4.1 ADA 2010 307.2 CBC 2007 1133B.8.6.1 CBC 2019 11B-307.2 Mitigated: <input type="radio"/> YES <input checked="" type="radio"/> NO				REF
<input type="radio"/> Staff Only

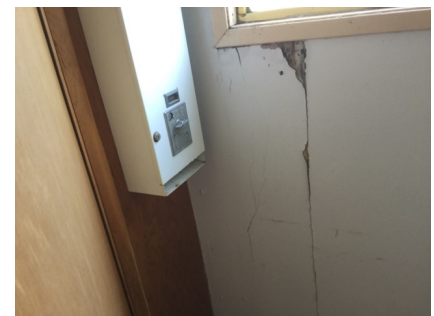
Reach Range

85	<ul style="list-style-type: none"> <i>As-Built Description:</i> Reach height to control or access point, where only forward approach is available, exceeds 48" or is less than 15". <i>As-Built:</i> 50" to highest operable part <i>Proposed Solution:</i> Modify equipment or mounting. 	PCODE IE01REF ADAAG 91 4.2.5 ADA 2010 308.2.1 CBC 2007 1118B.5 CBC 2019 11B-308.2.1 Mitigated: <input type="radio"/> YES <input checked="" type="radio"/> NO				REF
<input type="radio"/> Staff Only

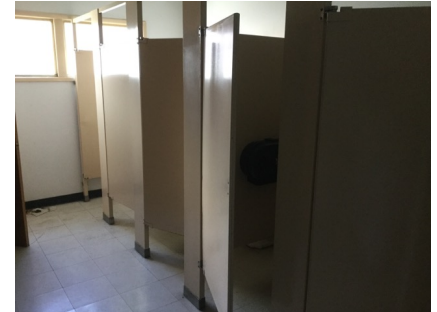
84	<ul style="list-style-type: none"> <i>As-Built Description:</i> Multiple accommodation restroom not accessible; multiple compliance violations. <i>Proposed Solution:</i> Remodel area to provide accessible restroom with one accessible stall, lavatory (and one urinal at Mens). 	PCODE WA01A ADAAG 91 4.22 ADA 2010 603.1 CBC 2007 1115B.3.1 CBC 2019 11B-603.1 Mitigated: <input type="radio"/> YES <input checked="" type="radio"/> NO	1	JOB	\$105,000	\$105,000
----	---------------------------------------------------------------------------------------------------------------------------------------------------------------------------------------------------------------------------------------------------------------------------------------------------------------------	-----------------------------------------------------------------------------------------------------------------------------------------------------------------------------------------	---	-----	-----------	-----------

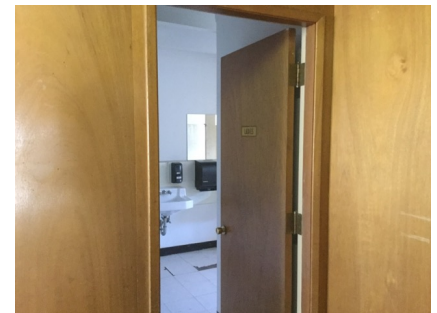
Signage

76	<ul style="list-style-type: none"> <i>As-Built Description:</i> Entrance to toilet or bathing facility identified with California signage on door leaf not identified with ADAAG compliant signage. <i>Proposed Solution:</i> Provide ADAAG compliant sign with raised letters and pictogram, mounted 5' high on center on nearest adjacent wall, on latch side of a single door. 	PCODE SA11AREF ADAAG 91 4.1.3(16)(a) ADA 2010 216.8 CBC 2019 11B-216.8 Mitigated: <input type="radio"/> YES <input checked="" type="radio"/> NO	REF			
----	-------------------------------------------------------------------------------------------------------------------------------------------------------------------------------------------------------------------------------------------------------------------------------------------------------------------------------------------------------------------------------------------------------------------	------------------------------------------------------------------------------------------------------------------------------------------------------------------------------	-----	--	--	--

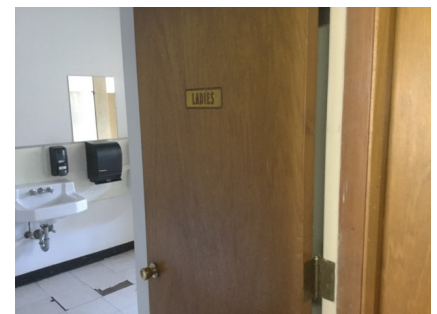
77	<ul style="list-style-type: none"> <i>As-Built Description:</i> Required in CA only: identification symbol centered 58" to 60" high on sanitary facility door that contrasts with the door not provided (women: 12" ø circle, men: 12" triangle, unisex: combined symbol). <i>Proposed Solution:</i> Provide properly mounted sanitary facility symbol when altering area. If wheelchair accessible, include International Symbol of Accessibility on sign. 	PCODE SA15REF CBC 2007 1115B.6 CBC 2019 11B-703.7.2.6 Mitigated: <input type="radio"/> YES <input checked="" type="radio"/> NO	REF			
----	---------------------------------------------------------------------------------------------------------------------------------------------------------------------------------------------------------------------------------------------------------------------------------------------------------------------------------------------------------------------------------------------------------------------------------------------------------------------------------------------	----------------------------------------------------------------------------------------------------------------------------------------------------------	-----	--	--	--

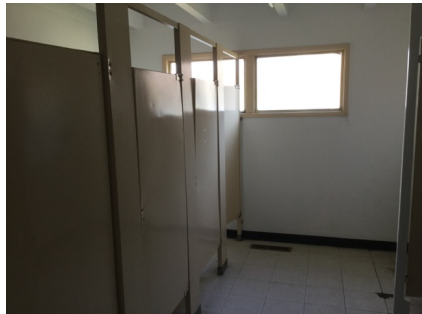
99	<ul style="list-style-type: none"> As-Built Description: Multiple accommodation restroom not accessible; multiple compliance violations. Proposed Solution: Remodel area to provide accessible restroom with one accessible stall, lavatory (and one urinal at Mens). 	PCODE WA01A ADAAG 91 4.22 ADA 2010 603.1 CBC 2007 1115B.3.1 CBC 2019 11B-603.1 Mitigated: <input type="radio"/> YES <input checked="" type="radio"/> NO			1 JOB \$105,000	\$105,000

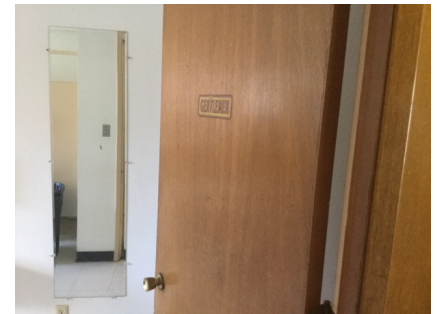
89 • *As-Built Description:*
 Required in CA only: identification symbol centered 58" to 60" high on sanitary facility door that contrasts with the door not provided (women: 12" ø circle, men: 12" triangle, unisex: combined symbol).
 • *Proposed Solution:*
 Provide properly mounted sanitary facility symbol when altering area. If wheelchair accessible, include International Symbol of Accessibility on sign.

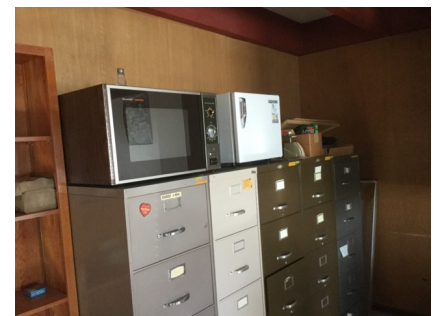
110	<ul style="list-style-type: none"> As-Built Description: Reach height to control or access point, where only forward approach is available, exceeds 48" or is less than 15". As-Built: 72" to highest operable parts Proposed Solution: Relocate existing microwave and refrigerator. 	PCODE IE01REF ADAAG 91 4.2.5 ADA 2010 308.2.1 CBC 2007 1118B.5 CBC 2019 11B-308.2.1 Mitigated: <input type="radio"/> YES <input checked="" type="radio"/> NO		REF		
-----	-------------------------------------------------------------------------------------------------------------------------------------------------------------------------------------------------------------------------------------------------------------------------------------------------------------------------------	---------------------------------------------------------------------------------------------------------------------------------------------------------------------------------------	--	-----	--	--

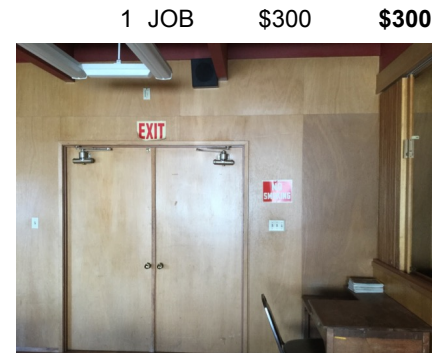
118 • *As-Built Description:*
 No signs at the building or assembly area entrance to notify patrons that an assistive listening system is available.
 • *Proposed Solution:*
 Provide assistive listening signage.

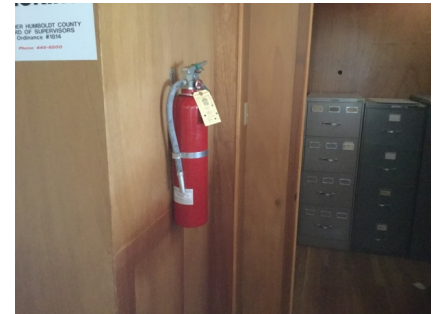
124	<ul style="list-style-type: none"> <i>As-Built Description:</i> Protruding objects more than 4" from wall, when bottom of object more than 27" or less than 80" above finished floor. <i>As-Built:</i> Protruding 5" at 39.5" high <i>Proposed Solution:</i> Remove/relocate protruding object. Patch existing surface. <i>Notes:</i> Relocate FE lowest edge at 27" maximum. 	PCODE EG04 ADAAG 91 4.4.1 ADA 2010 307.2 CBC 2007 1133B.8.6.1 CBC 2019 11B-307.2 Mitigated: <input type="radio"/> YES <input checked="" type="radio"/> NO	1	JOB	\$300	\$300
-----	---------------------------------------------------------------------------------------------------------------------------------------------------------------------------------------------------------------------------------------------------------------------------------------------------------------------------------------------------------------------------------------------------------------------------------------------------	------------------------------------------------------------------------------------------------------------------------------------------------------------------------------------	---	-----	-------	-------

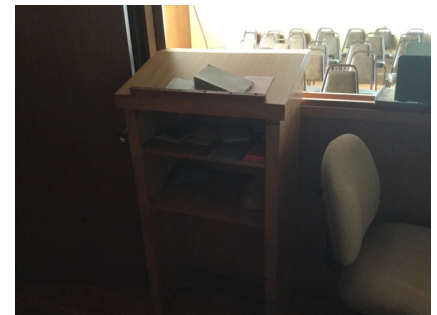
Public Participation Counter

126	<ul style="list-style-type: none"> <i>As-Built Description:</i> Speaker podium is not accessible. Upper edge of podium is more than 34" above the finished floor, and knee space is less than 27" high, 30" wide, and 19" deep. <i>As-Built:</i> 44" high <i>Proposed Solution:</i> Provide additional, integrated, and accessible speaker podium. 	PCODE GB02A ADAAG 91 4.32.3 ADA 2010 902.3 CBC 2007 1122B.3 CBC 2019 11B-902.3 Mitigated: <input type="radio"/> YES <input checked="" type="radio"/> NO	1	JOB	\$6,000	\$6,000
-----	----------------------------------------------------------------------------------------------------------------------------------------------------------------------------------------------------------------------------------------------------------------------------------------------------------------------------------------------------------------------------------------------------	----------------------------------------------------------------------------------------------------------------------------------------------------------------------------------	---	-----	---------	---------

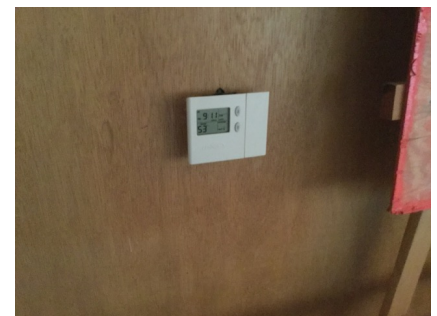
Reach Range

132	<ul style="list-style-type: none"> <i>As-Built Description:</i> Reach height to control or access point, exceeds 48" or is less than 15". <i>As-Built:</i> 53" to highest operable button <i>Proposed Solution:</i> Modify equipment or mounting. 	PCODE IE01 ADAAG 91 4.2.5 ADA 2010 308.2.1 CBC 2007 1118B.5 CBC 2019 11B-308.2.1 Mitigated: <input type="radio"/> YES <input checked="" type="radio"/> NO	1	JOB	\$300	\$300
-----	---------------------------------------------------------------------------------------------------------------------------------------------------------------------------------------------------------------------------------------------------------------------------------------------------	------------------------------------------------------------------------------------------------------------------------------------------------------------------------------------	---	-----	-------	-------
