Water Resource Protection Plan

APN 522-031-007

TRC# 180101020102TRC245

1/3/2017

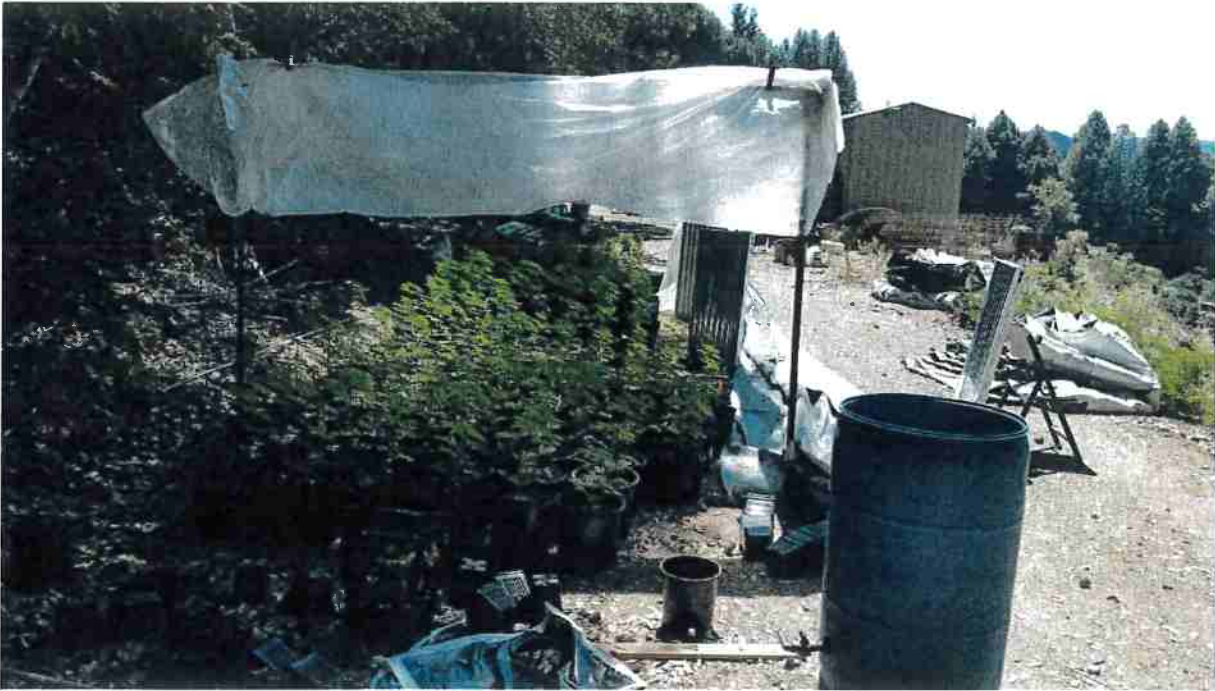
←
No
Dark
sky
standards

Picture 3: Nursery area located above the cultivation area.

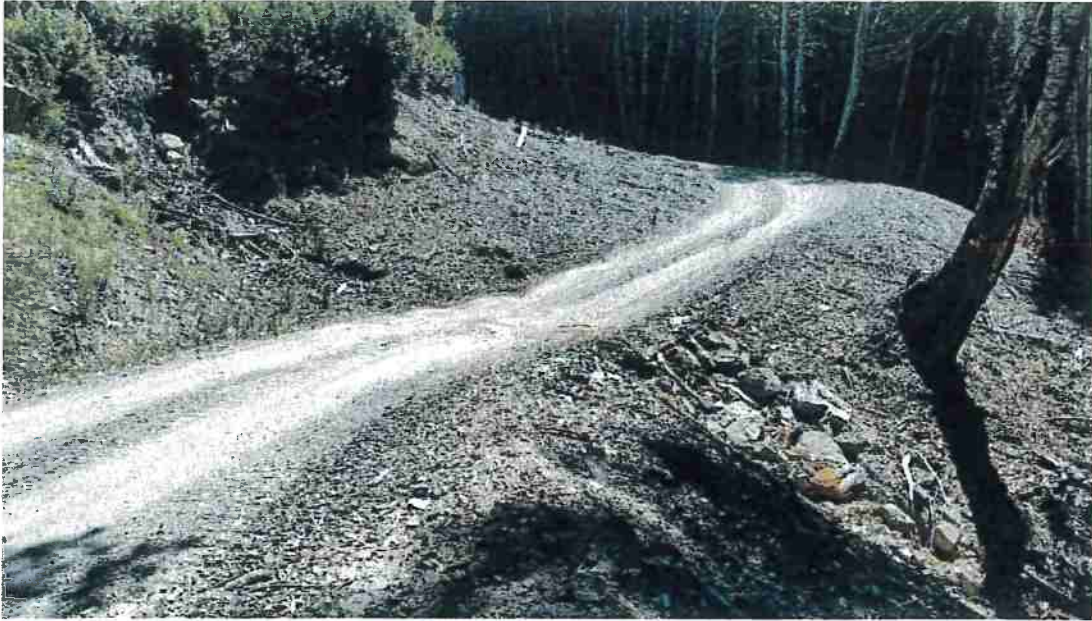
Picture 5: Road Point 3, an armored fill/rocked ford will be placed here to upgrade the degraded existing one.

Unique Point	UTM 10 NAD 83	Road Type	Mitigation Planned	Monitor	1600	Standard Conditions	Treatment Priority	Date Completed
RP 3	435945 4535306	Permanent Rock Road	X	X		A.1.	Prior to 11/15/17 pending approval of applicable permits	
Current Condition: A road crossing over a head of a Class III watercourse is located here. Concentrated hillslope runoff originating from the cultivation area flat is saturating the road resulting in rutting of the road and large amounts of sediment discharge.						Prescribed BMP: The discharger will install an armored fill/rocked ford crossing at this location to secure the road surface and to prevent sediment delivery to the Class III watercourse below.		
Unique Point	UTM 10 NAD 83	Road Type	Mitigation Planned	Monitor	1600	Standard Conditions	Treatment Priority	Date Completed
RP 4	435866 4535343	Permanent Rock Road	X	X		A.1.	Prior to 10/15/18 pending approval of applicable permits

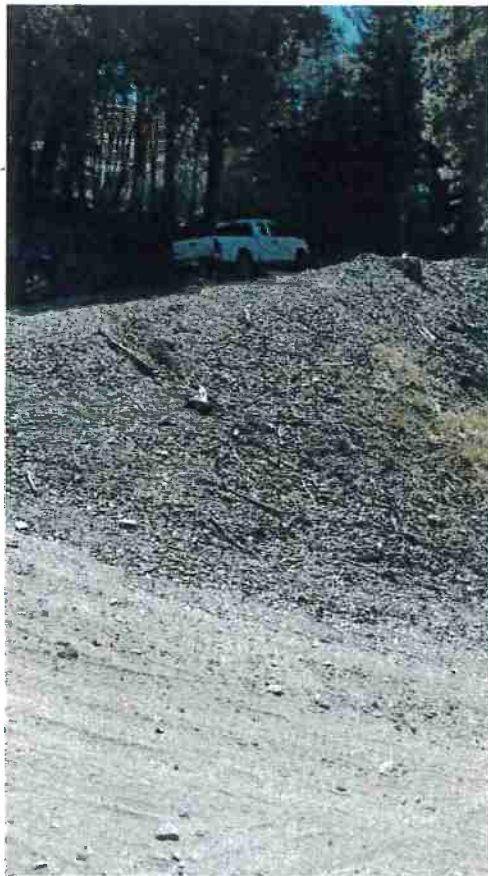
Picture 6: Road Point 4, the fill slope will be stabilized by placing rock on the inside corner and spreading seed to vegetate the rest of the fill slope.

Current Condition: Concentrated road surface runoff is causing erosion of the fill slope.						Prescribed BMP: The discharger will maintain the fill slope by placing stabilizing rock on the inside corner and spreading seed to vegetate the rest of the fill slope.		
Unique Point	UTM 10 NAD 83	Road Type	Mitigation Planned	Monitor	1600	Standard Conditions	Treatment Priority	Date Completed
RP 5	435851 4535339	Permanent Rock Road	X	X		A.1.	Prior to 10/15/18 pending approval of applicable permits	
Current Condition: Concentrated road surface runoff is eroding the road surface.						Prescribed BMP: The discharger will apply road rock to the three-way intersection, 20 feet of road surface leading up the intersection and 20 feet past the erosion site in the direction of the neighbor's property line to secure the roads surface and slope.

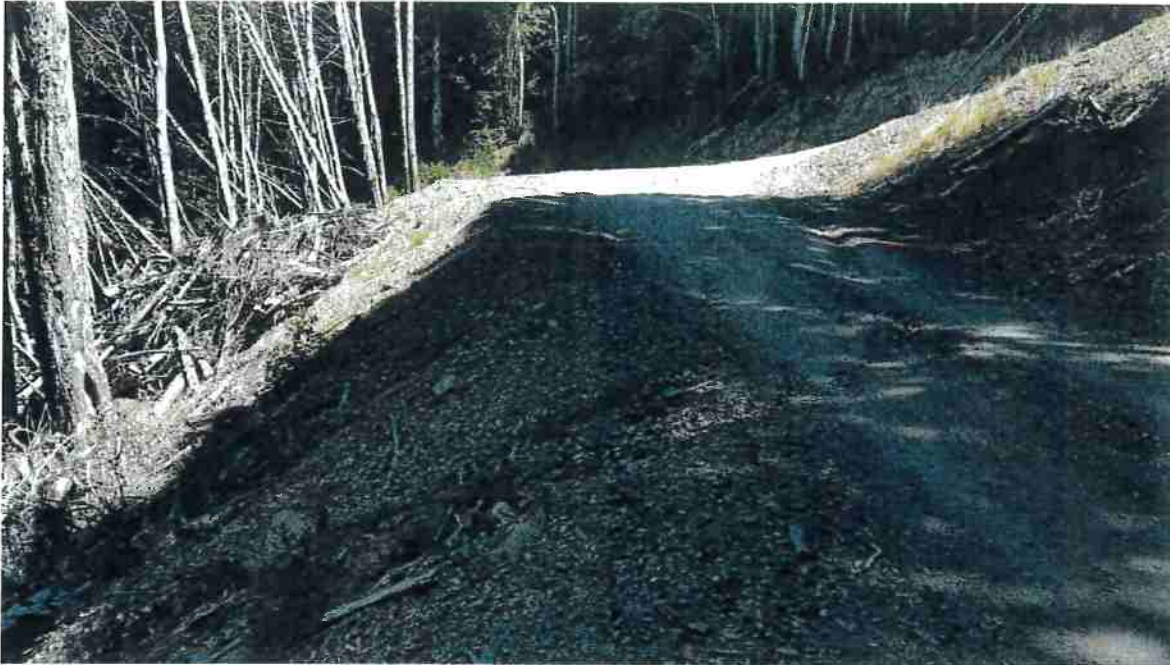
Picture 7: Road Point 5, the Discharger will apply road rock to the three-way intersection to secure the roads surface and slope.

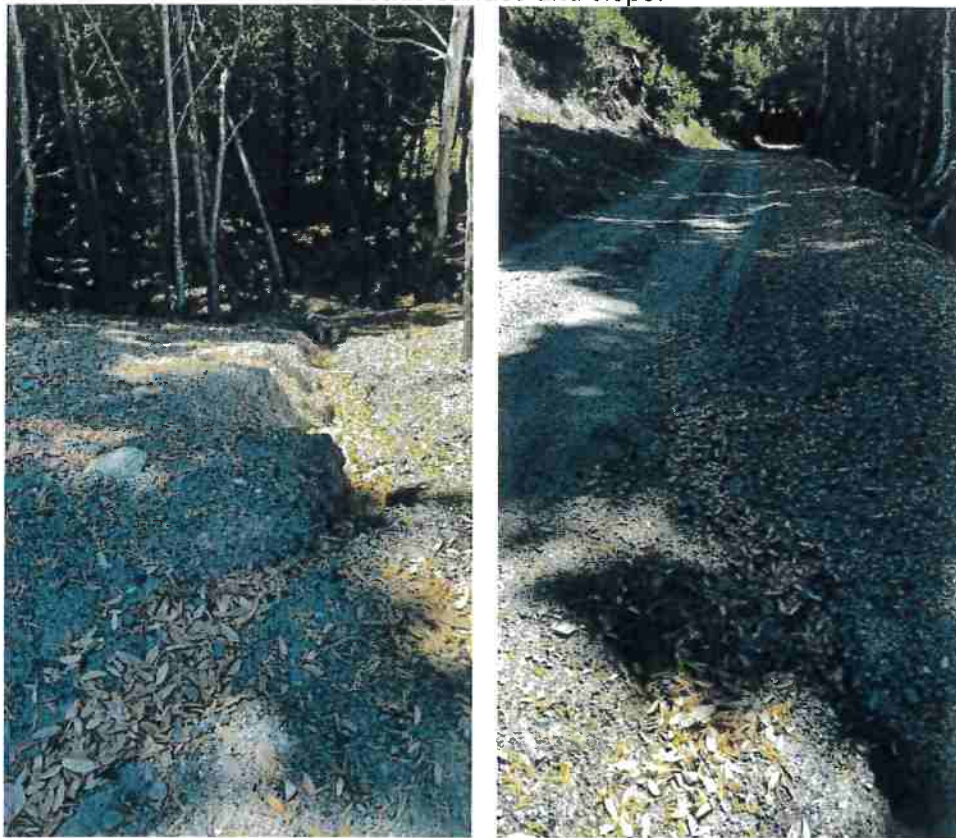
Picture 8: Road Point 14, the Discharger will out-slope the road around the base of the cultivation site fill slope to the armored fill/rocked ford at Road Point 3 and resurface the road with road rock.

Unique Point	UTM 10 NAD 87	Road Type	Mitigation Planned	Monitor	1600	Standard Conditions	Treatment Priority	Date Completed
RP 14	435963 4535282	Permanent Rock Road	X	X		A.1.	Prior to 10/15/18 pending approval of applicable permits	
<p>Current Condition: Concentrated road surface and hillslope runoff, originating from the cultivation site flat and the fill slope, is eroding the road surface and road fill slope.</p>						<p>Prescribed BMP: The discharger will out-slope the road around the base of the cultivation site fill slope to the armored fill/rocked ford at Road Point 3 and resurface the road with road rock.</p>

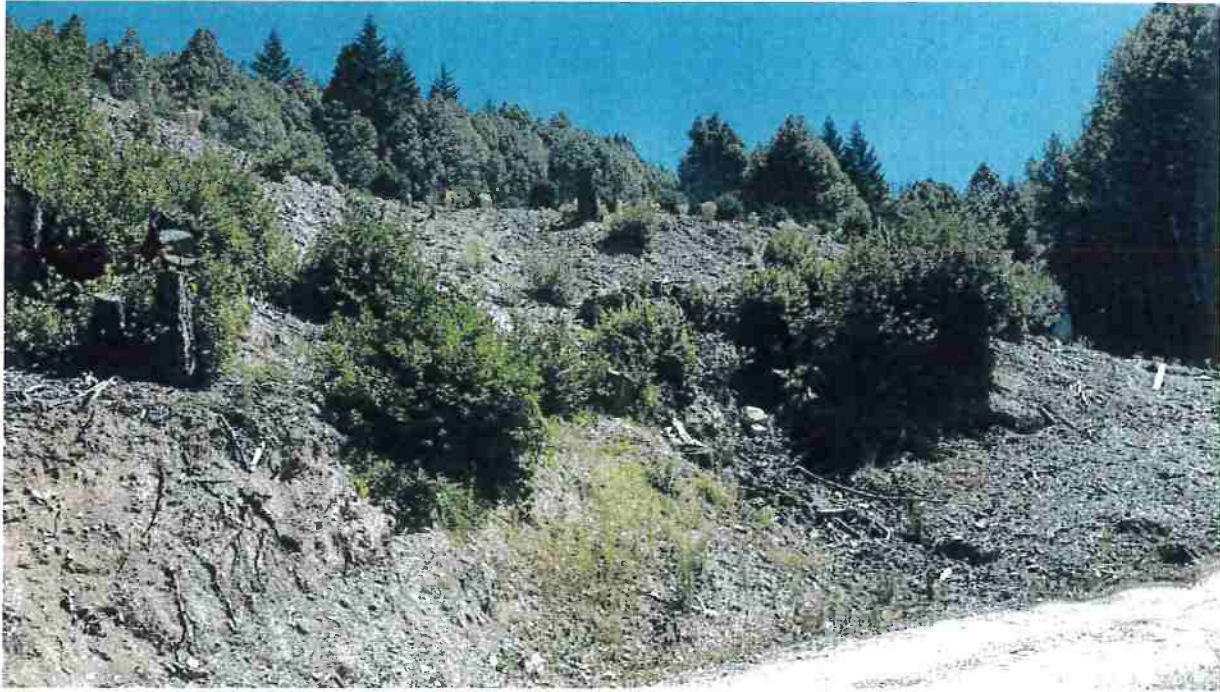
Picture 9: Looking up at Map Point 1 from Road Point 3.

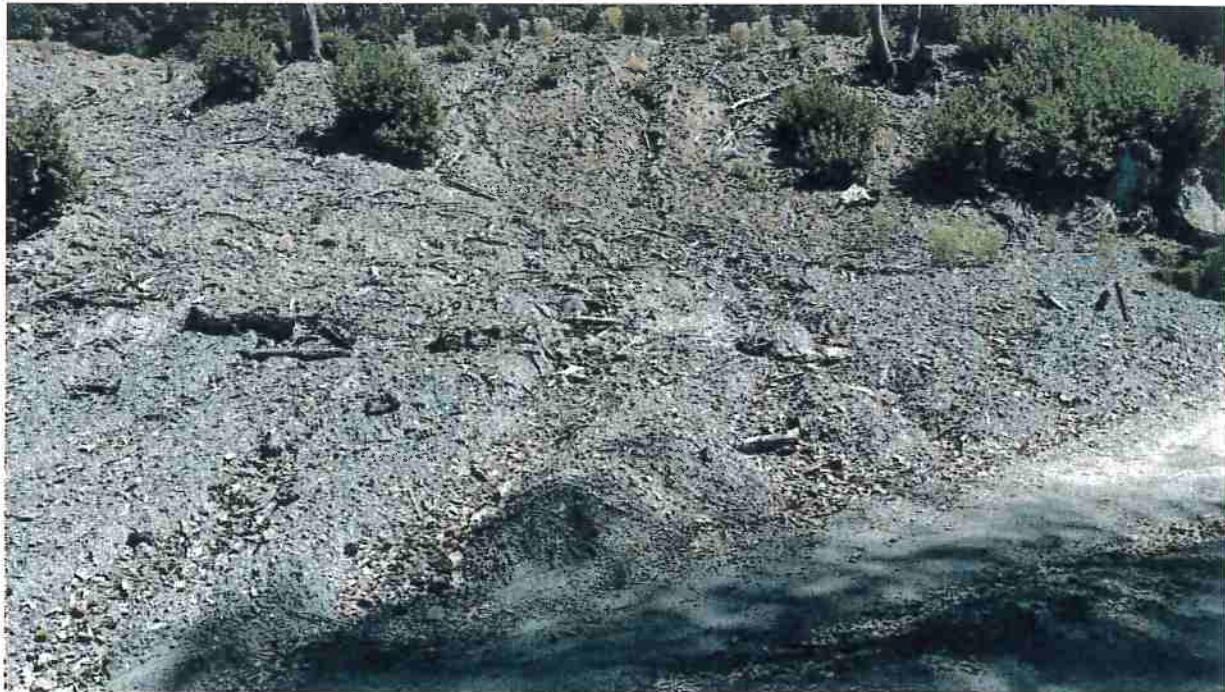
Picture 10: Looking up at Map Point 1 from the road below.

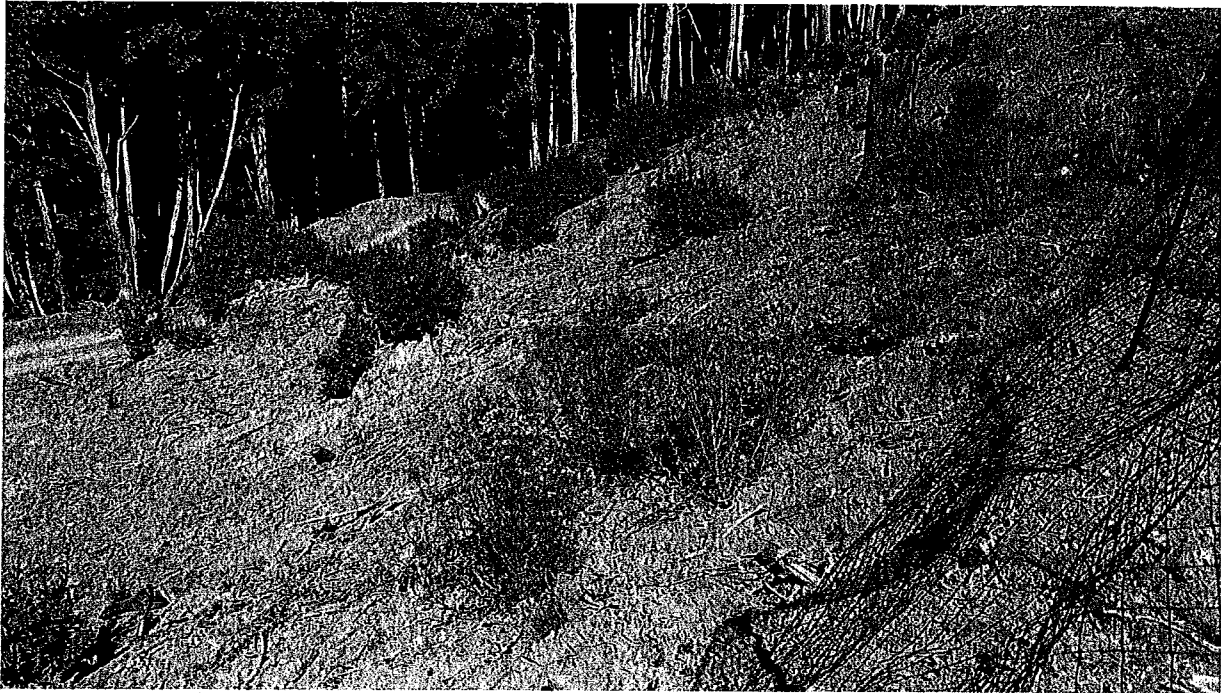
All cultivation activities on the Dischargers property are located beyond 50 feet from any Class III watercourse and 100 feet of any Class I or II watercourse. The fill slope of the cultivation area is showing signs of sediment delivery to the head of the Class III watercourse below. Mitigation measures for this are stated under Standard Condition 1.A. This standard condition is not being met at this time.

Picture 10: Looking down at the eroding fill slope below Map Point 1.

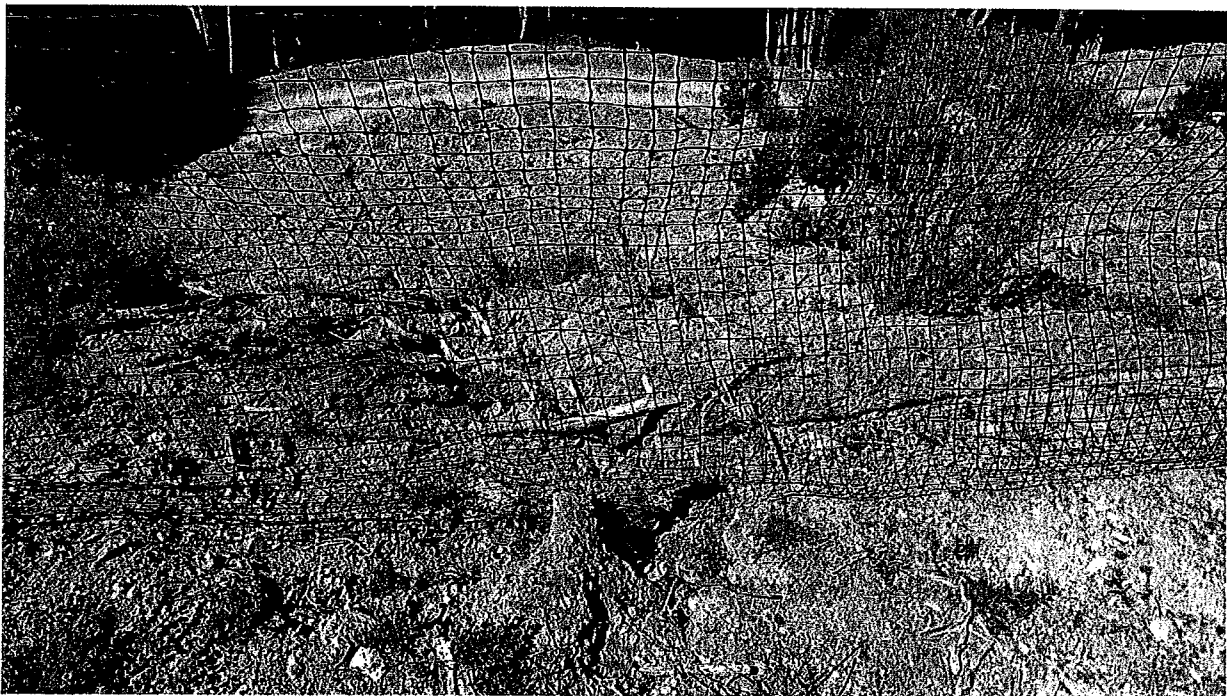
Picture 11: Looking down the fill slope from Map Point 1 showing the beginning of erosion rilling and gullyng.

Unique Point	UTM 10 NAD 83	Road Type	Mitigation Planned	Monitor	1600	Standard Conditions	Treatment Priority	Date Completed
MP 1	435981 4535313		X	X		A.1.	Prior to 10/15/17 pending approval of applicable permits	
Current Condition: Concentrated runoff coming from the cultivation site area is causing erosion of the fill slope down to Road Point 3 and Road Point 14.						Prescribed BMP: The discharger will also in-slope the entire cultivation flat to prevent surface flows from traveling over the fill slopes edge and traveling down the fill slope to Road Points 3 and 14. The discharger will seed and mulch the fill slope of the cultivation site.		
Unique Point	UTM 10 NAD 83	Road Type	Mitigation Planned	Monitor	1600	Standard Conditions	Treatment Priority	Date Completed
MP 2	436016 4535337		X	X		A.9.a.	Prior to 10/15/17 pending approval of applicable permits	
Current Condition: Oil bottles and small gas canisters were found without caps around the generator site.						Prescribed BMP: Any un-sealed chemical container will require secondary containment.

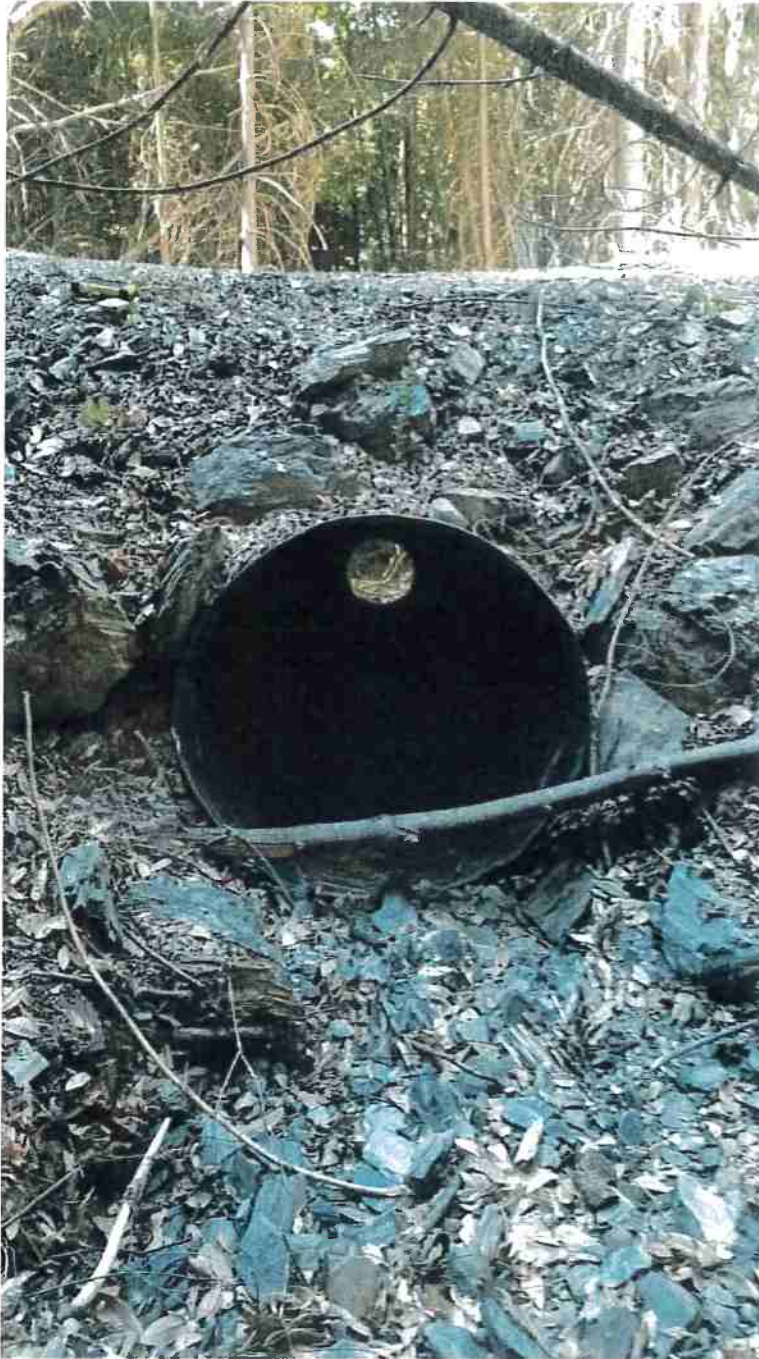
Road Point 9 – Class III watercourse crossing with a 48-inch diameter corrugated metal pipe. The culvert is appropriately sized for 100-year peak streamflow accounting for a HW/D (headwall to culvert diameter) of 1.4, but is not sized correctly for a HW/D of 1.0, which is the desired standard. Inlet and outlet are rock armored with no signs of scour, down cutting, or erosion of the fill slope. The road is in good condition and shows no sign of erosion from culvert plugging and overtopping. The culvert will be monitored for plugging of debris. Debris will be removed if either the debris is plugging the culvert or if it poses a future risk of plugging.

Picture 12: Road Point 9, Class II watercourse crossing with a 30-inch diameter corrugated metal pipe. This culvert has a large branch across the inlet. Removal of this debris is recommended before winter to prevent further accumulation of debris resulting in severe plugging of the culvert.

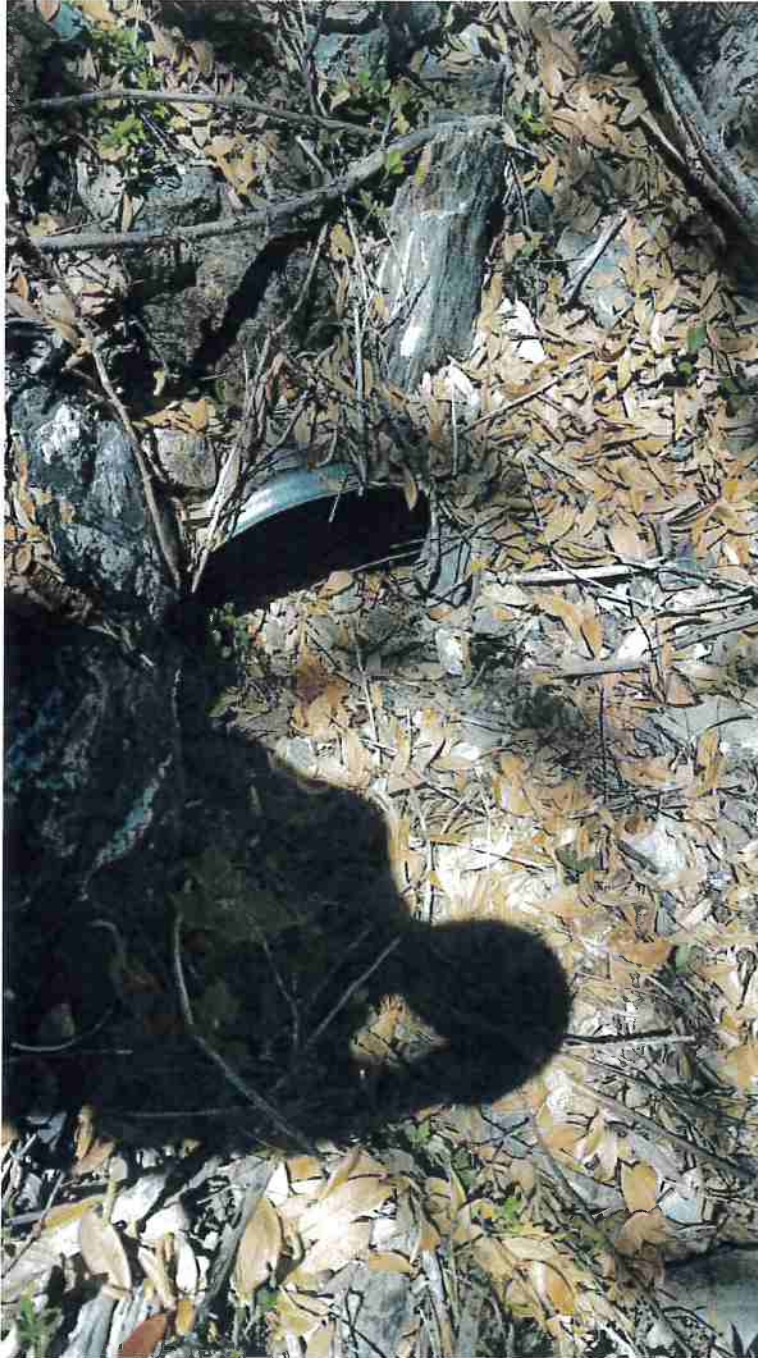
Road Point 12 – Class III watercourse crossing with a 24-inch diameter corrugated metal pipe. The culvert is appropriately sized for 100-year peak streamflow accounting for a HW/D (headwall to culvert diameter) of 1.5, but is not sized correctly for a HW/D of 1.0, which is the desired standard. Inlet and outlet are rock armored with no signs of scour, down cutting, or erosion of the fill slope. The road is in good condition and shows no sign of erosion from culvert plugging and overtopping. The culvert will be monitored for plugging of debris. Debris will be removed if either the debris is plugging the culvert or if it poses a future risk of plugging. If through monitoring it becomes apparent that the culvert is undersized, it will be replaced with an upsized culvert.

This culvert is beginning to plug with native rock material from around the inlet. Removal of this debris is recommended before winter to prevent further accumulation of debris resulting in plugging of the culvert.

Picture 13: Road Point 12, Class III watercourse crossing with a 24-inch diameter corrugated metal pipe. This culvert is beginning to plug with native rock material from around the inlet. Removal of this debris is recommended before winter to prevent further accumulation of debris resulting in severe plugging of the culvert.

Unique Point	UTM 10 NAD 86	Road Type	Mitigation Planned	Monitor	1600	Standard Conditions	Treatment Priority	Date Completed
RP 12	435615 4535608	Permanent Rock Road	X	X		A.2.	Prior to 10/15/17 pending approval of applicable permits	
<p>Current Condition: Class III watercourse crossing with an 24-inch corrugated metal pipe. Inlet and outlet are rock armored with no signs of scour, down cutting, or erosion of the fill slope. The road is in good condition and shows no sign of erosion from culvert plugging and overtopping.</p>						<p>Prescribed BMP: The culvert will be monitored for plugging of debris. Debris will be removed if either the debris is plugging the culvert or if it poses a future risk of plugging. This culvert is beginning to plug with native rock material from around the inlet. Removal of this debris is recommended before winter to prevent further accumulation of debris resulting in plugging of the culvert.</p>
