Subject; Robert Scarlett – Residential Hazard Tree

Arborist Report

Tree Risk Assessment

20 Oak Ridge Dr.
Redway, CA 95560
3/23/2026

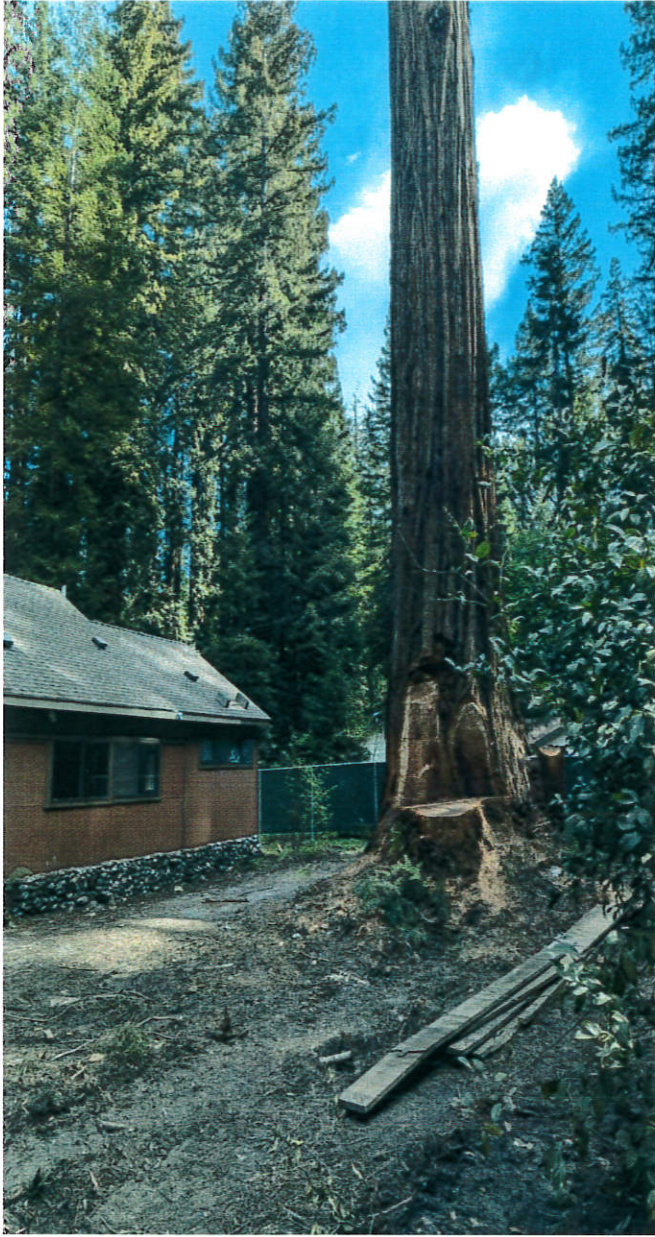
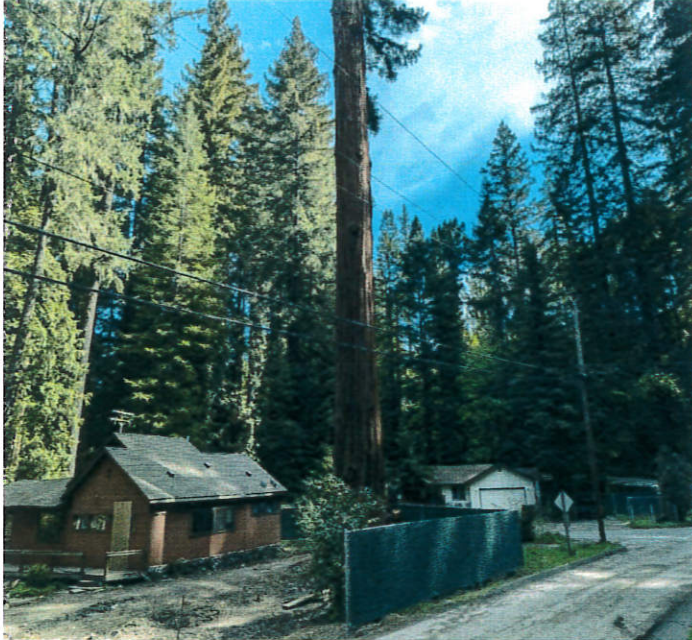
One very large Coastal Redwood (*Sequoia sempervirens*) stands in the southeast corner of a residential parcel located on the corner of Oakridge Dr and Eel River Ln in Redway. The tree measures 118" in diameter at breast height and stands at over 250'. Directly north of the tree by approximately 20 feet is the house, and to the east, there is a neighboring property with a house that sits within striking distance of the tree. To the south, there are high voltage powerlines within 30 feet of the trunk and Briceland Rd lies just beyond the power lines.

Due to the home being built in such close proximity, the tree has likely experienced damage from the home's construction in the form of soil compaction and damaged roots. At the time of the site visit, there was some severe damage inflicted to the tree trunk. There was a very large cut made along the base of the tree just above the root flare and into the trunk. This cut was likely done to remove a smaller stem protruding from the side of the tree. However, this cut leaves a very large wound on the trunk which will almost certainly facilitate the presence of rot and decay within the trunk at a faster rate. In addition, almost all of the lower canopy has been removed resulting in an unnaturally raised crown. The tree has been known to shed large limbs over the years, striking and damaging the house on numerous occasions. The tree stands quite a bit taller than any others in the immediate vicinity and appears to be in a spot where it would be directly exposed to heavy winds during any wind events.

Mitigation options such as pruning would be unfeasible without retaining a high level of risk due to the lack of remaining canopy and the severe trunk damage the tree has suffered. It would be unreasonable to expect the residents of this house to continue to live at this address without addressing the risk posed by this tree. Therefore, I would recommend the immediate removal of this tree due to the potential of severe consequences that would result in the case of this tree's failure.
