Reference: 018181

June 11, 2019

Subject: Engineering Geologic Evaluation and Soils Reporting for Existing and Proposed Improvements, APN's 216-081-013, 216-135-015, 216-136-004, and 216-135-008; Harris, Humboldt County, California

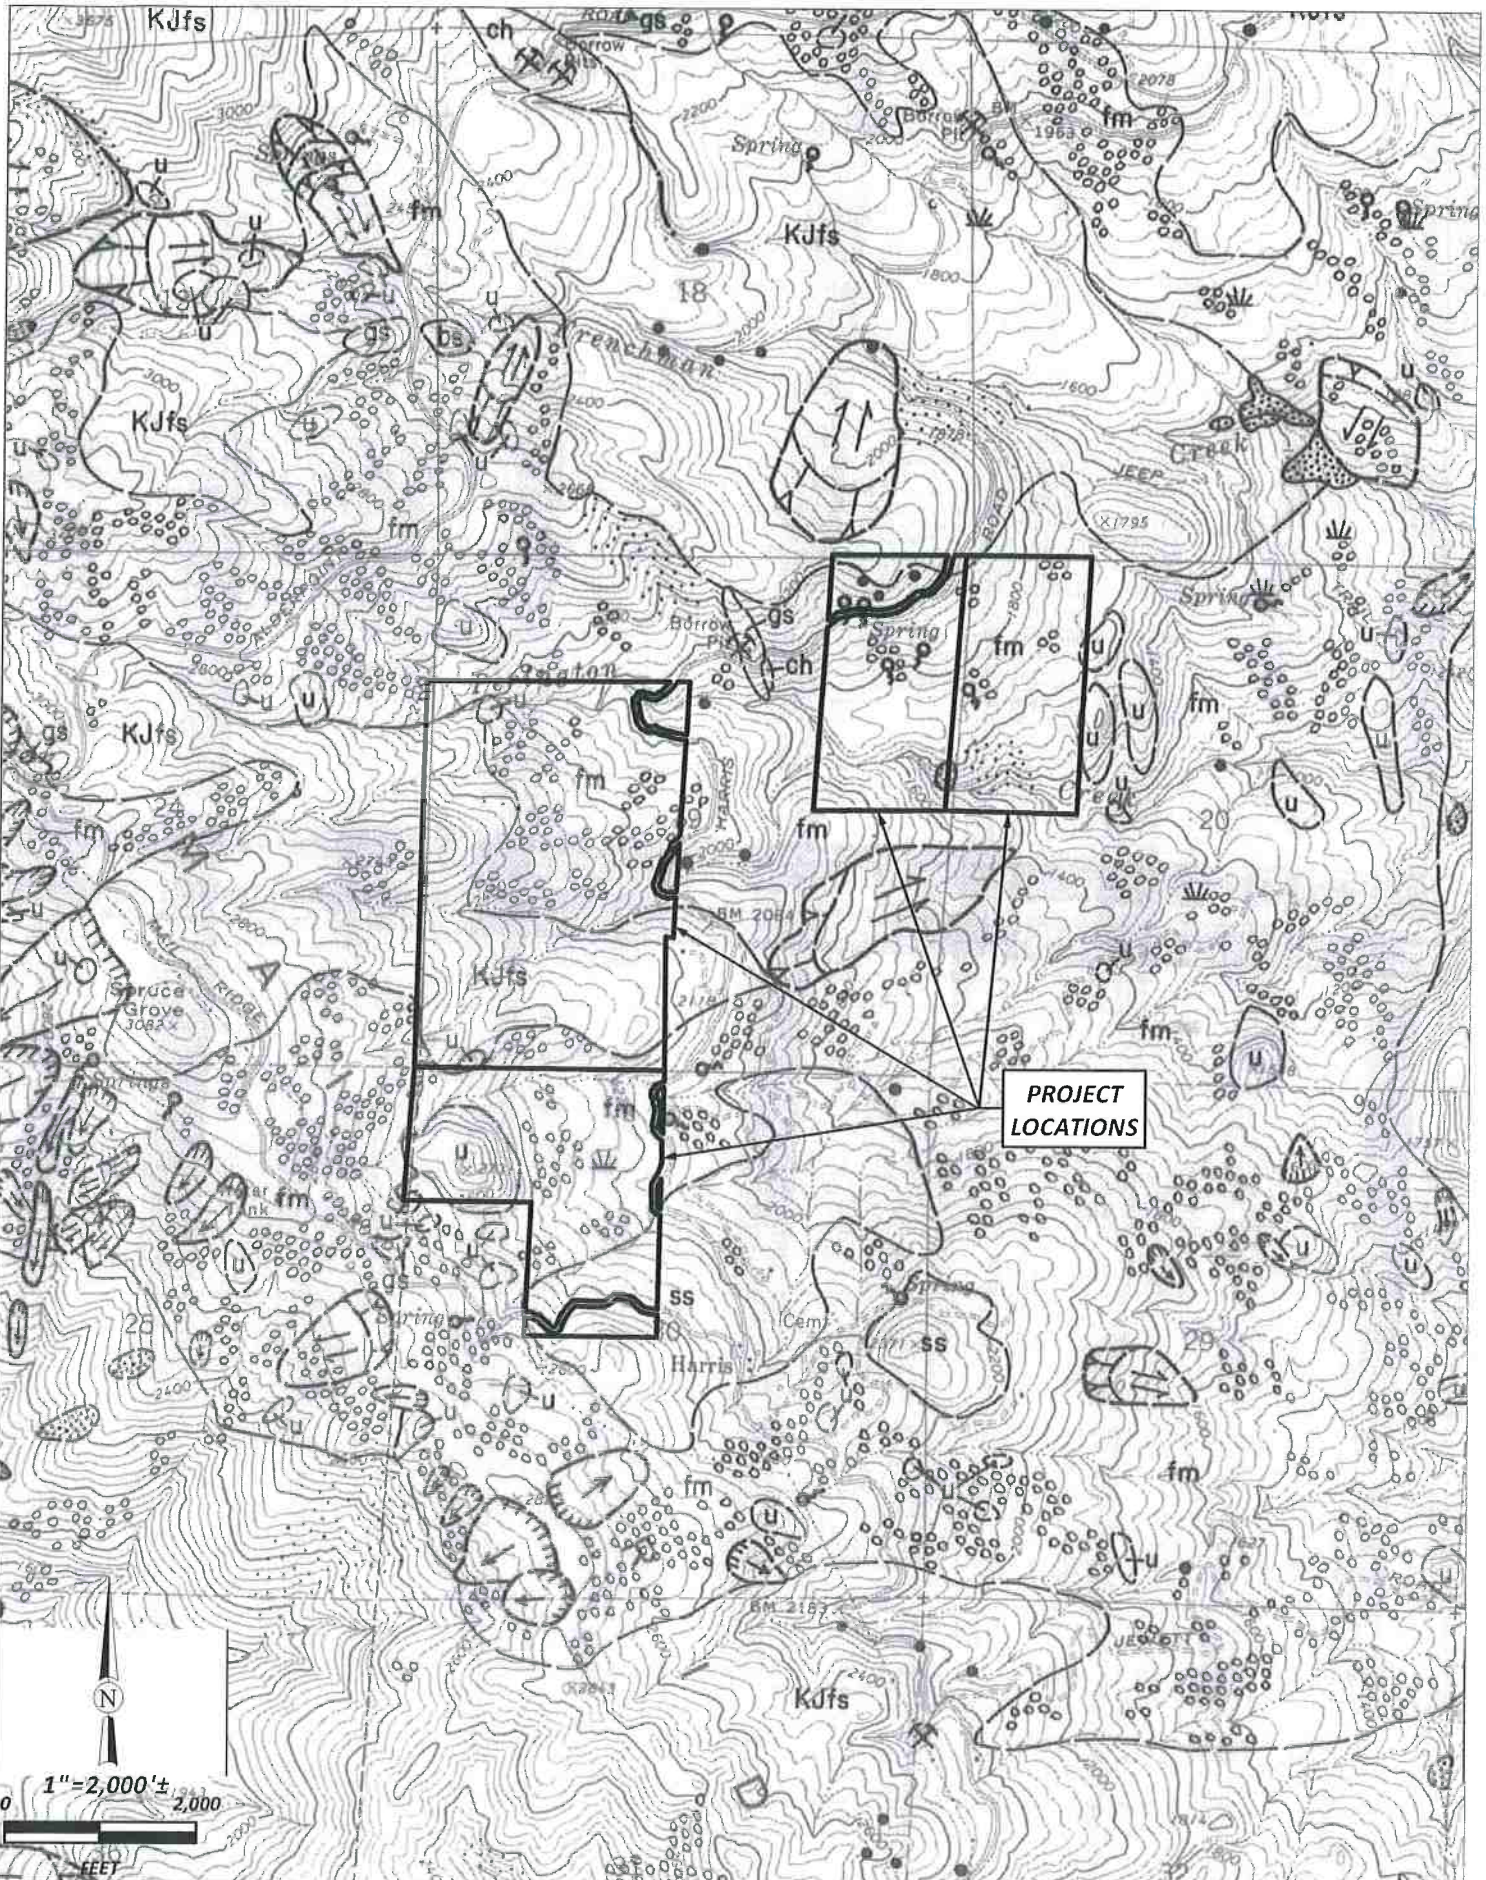
Figure 2

The area is mapped as being underlain by Cretaceous to Jurassic age bedrock of the central belt of the Franciscan Complex (Figure 2). The central belt subunit of the Franciscan Complex is a heterogeneous bedrock unit formed during crustal subduction that contains a wide variety of rock types. The unit is structurally complex with pervasive shearing and a preponderance of *mélange* materials (block-in-matrix texture where hard rock blocks are entrained in a low-strength matrix). Mapping by Spittler (1984) shows the subject parcels as being underlain by *mélange* and various large sandstone blocks.

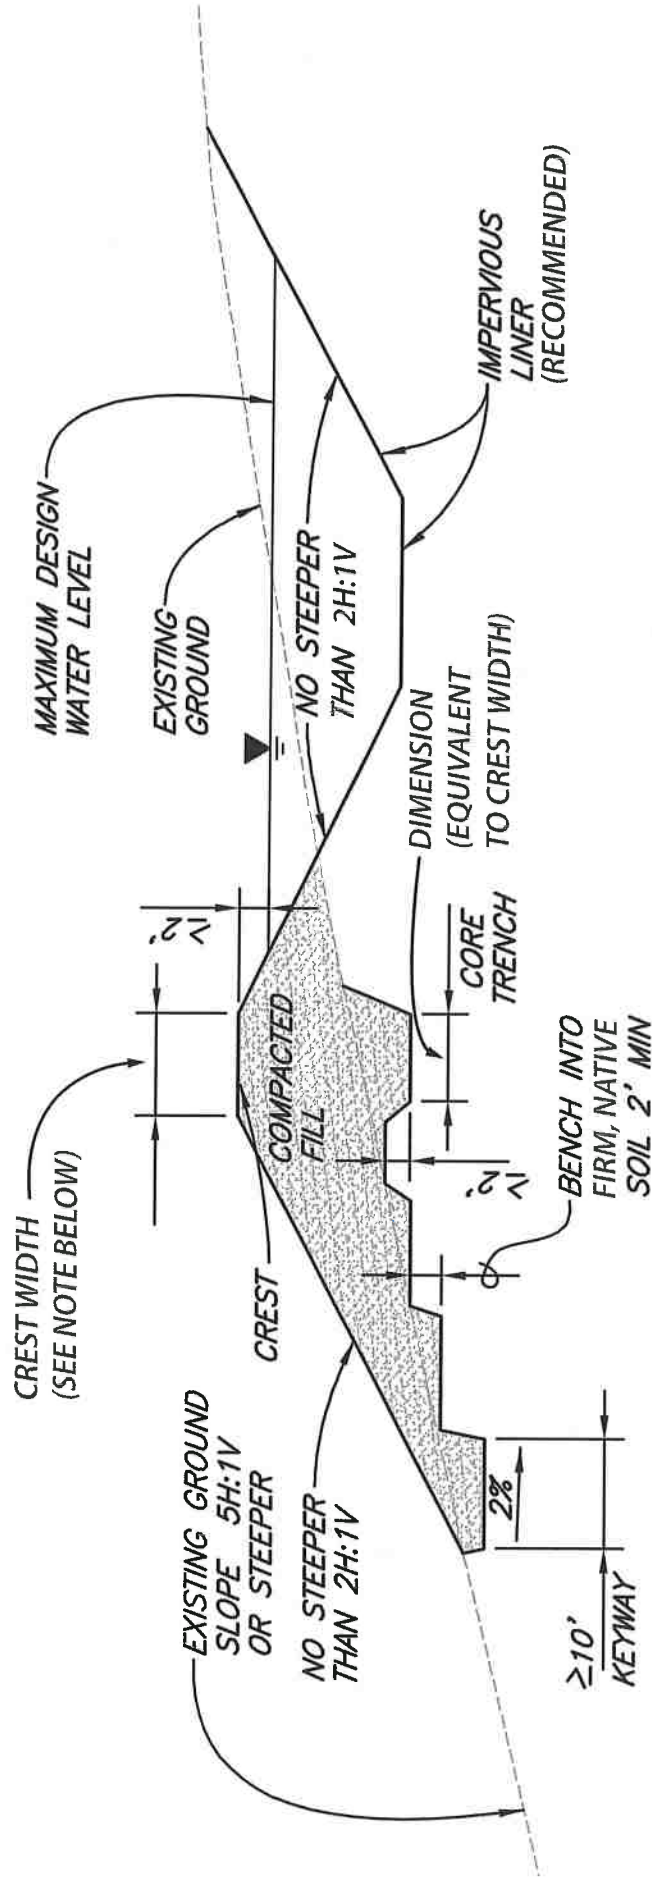
NOTE: THIS SCHEMATIC APPLIES TO EMBANKMENTS ON SLOPES OF 5H:1V OR STEEPER
CREST WIDTH: FOR EMBANKMENTS < 10 FEET HIGH, CREST WIDTH SHOULD BE A MINIMUM OF 6 FEET; FOR TALLER EMBANKMENTS, CREST WIDTH SHOULD BE 10 FEET

- Design the pond such that the volume of material from cuts is, at a minimum, equal to the volume of material needed for fills. If possible, design the pond such that the volume of material from cuts is approximately 10 percent greater than the volume of material needed for fills.
- The exterior and interior slopes of the pond embankments should be inclined no steeper than 2H:1V (see conceptual embankment section in Figure 3).

- The crest of pond embankments should be at least 2 feet (freeboard) above the maximum pond water level to minimize the potential for breaching during a seismic event.

- The crest of pond embankments should be at least 6 feet wide for embankments less than 10 feet high; taller embankments should have crest widths of at least 10 feet.
