ROADWAY ASSESSMENT REPORT

SITE ACCESS ROAD(S)

**French Road
Miranda, California
APN: 214-234-006
and
APN: 214-234-007**

**September, 2018
Josh McKnight, P.E.
Job #756.05**

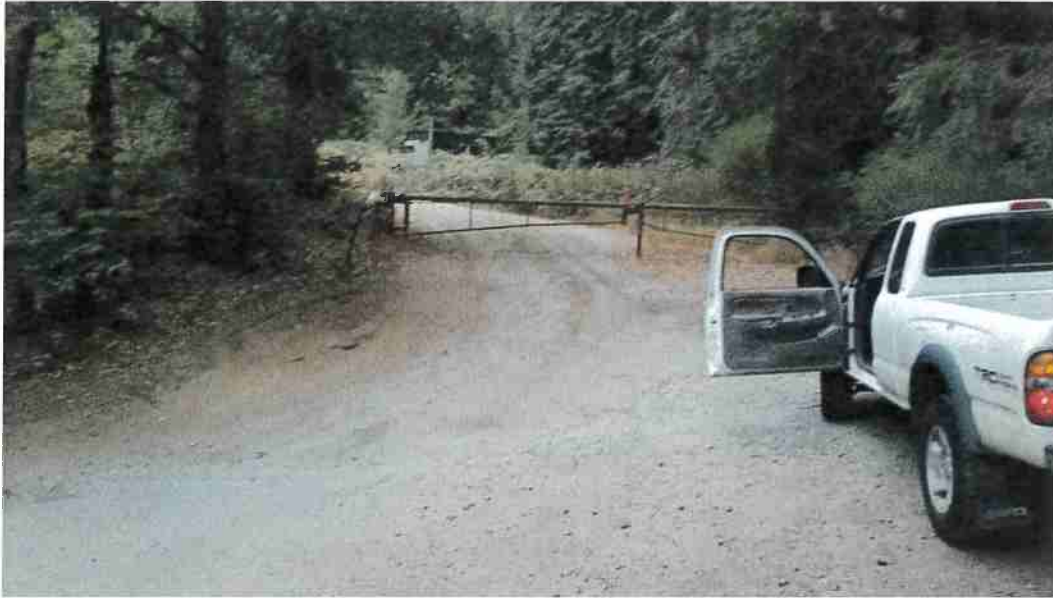
Figure 3. Photograph showing Road Point 100, the gate at the intersection of Gibney Drive and French road. French Road will need an encroachment permit to pave the first 30 feet of French Road from the intersection of Gibney Drive..

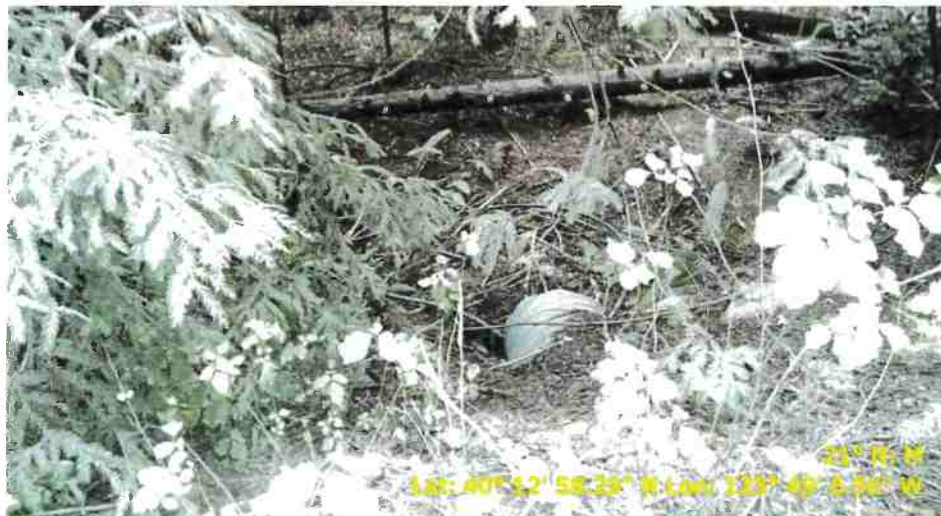
Figure 4. Road point 58 showing an 18-inch drainage relief culvert that is in good condition.

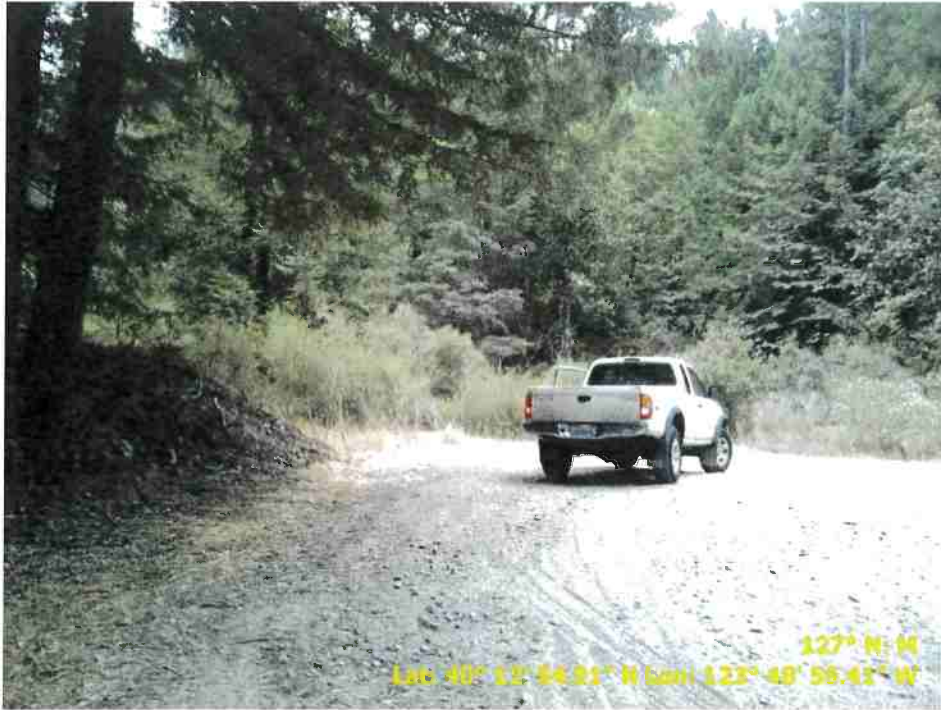
Figure 5. Photograph showing Road Point 24 which is a pullout that shall be maintained as a pullout.

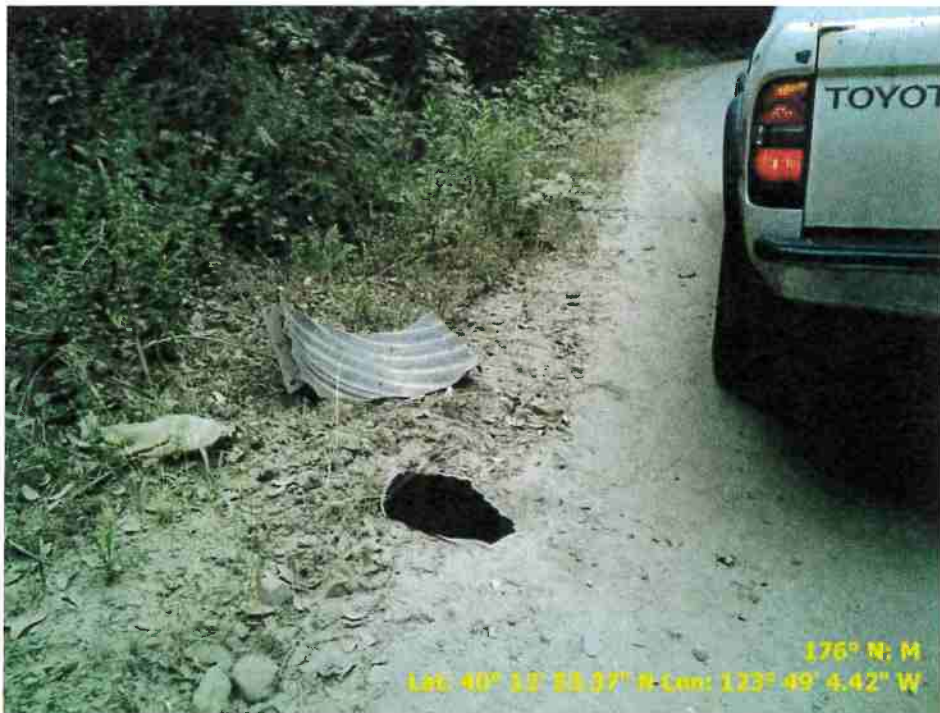
Figure 6. Road point 15 shows an 18" drainage relief culvert with an exposed opening that needs to be repaired or replaced.

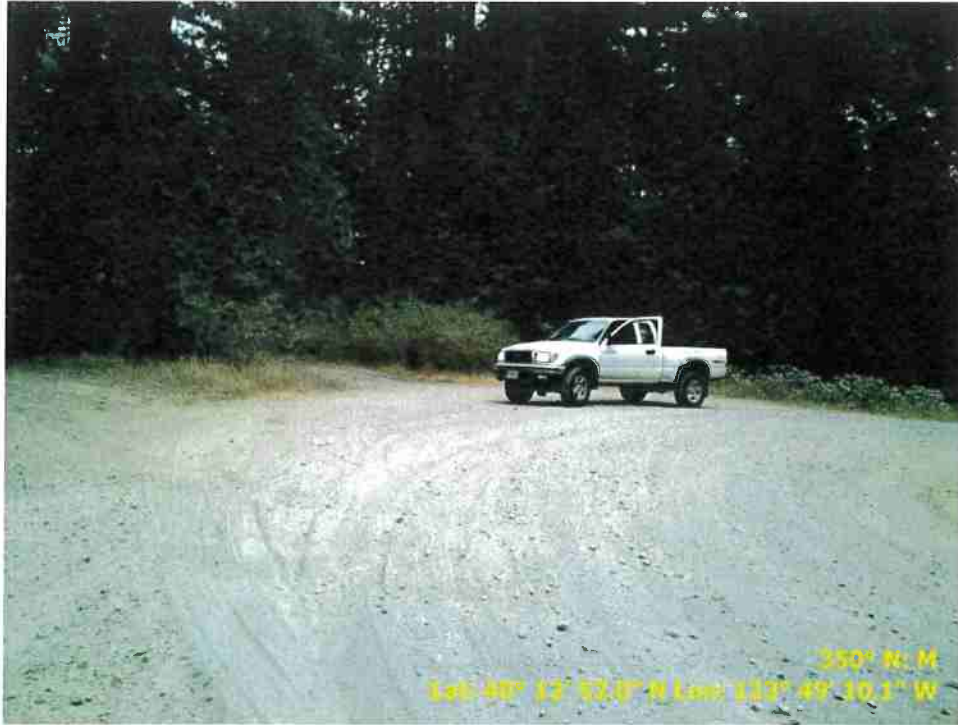
Figure 7. Photo of Road Point 14 which is a good pullout that will need to be maintained as a pullout.

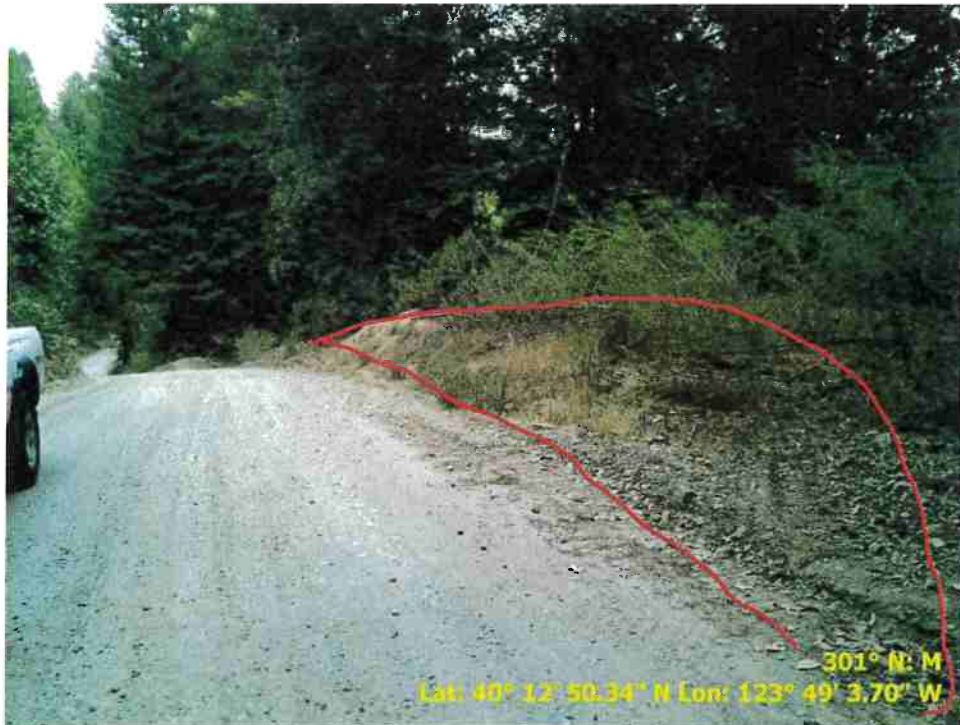
Figure 8. Photograph showing Road Point 16 which is a pullout that need to be regraded.

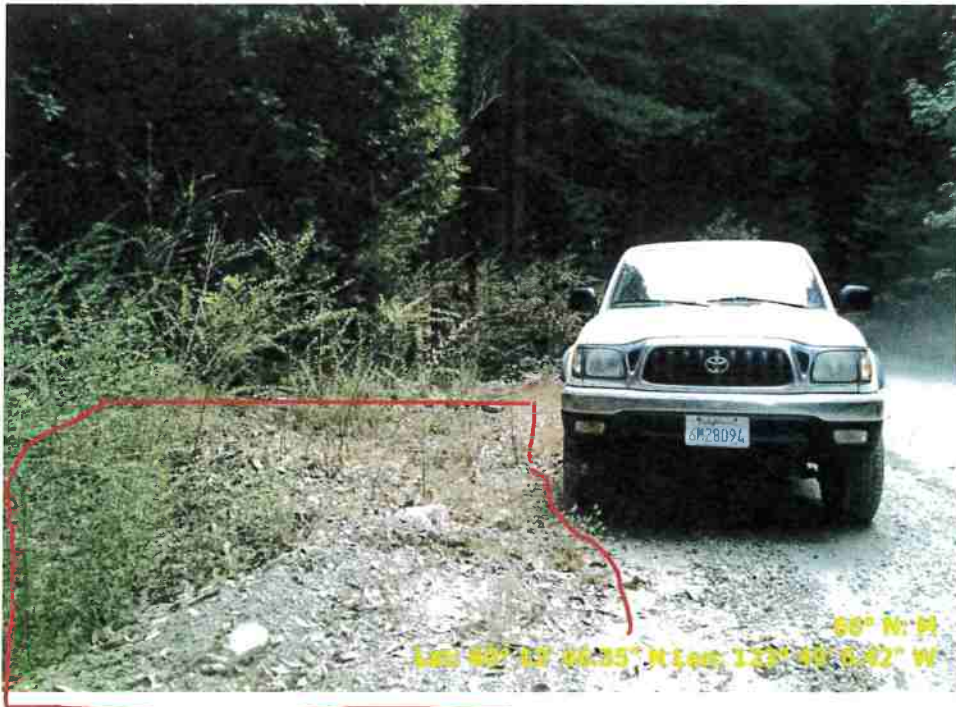
Figure 9. Photograph showing Road Point 27 which is a pullout that need to be regraded.

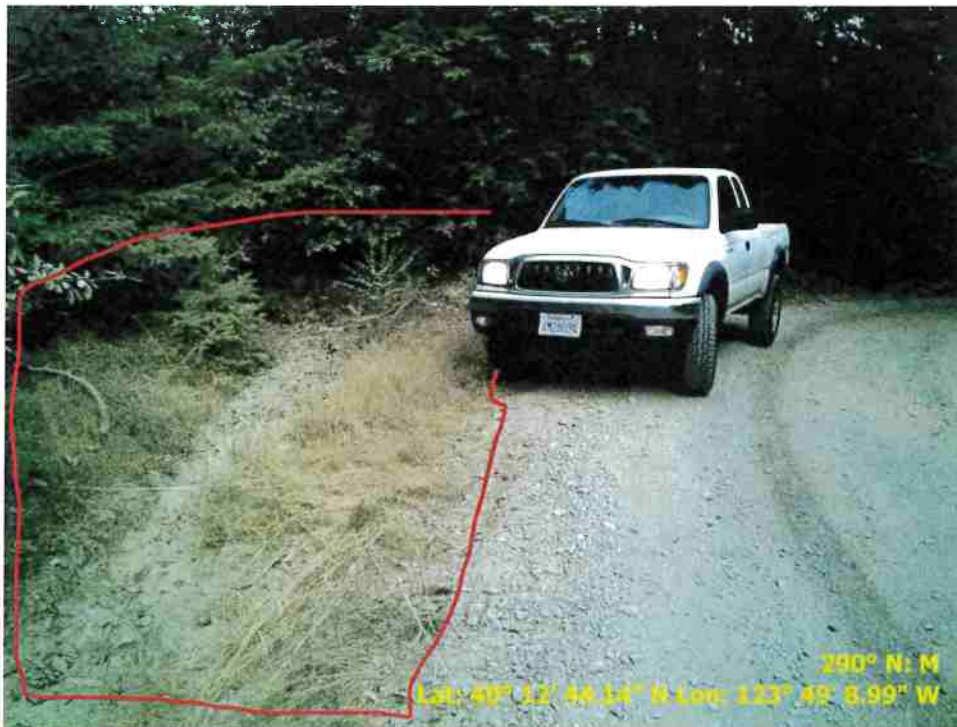
Figure 10. Photograph showing Road Point 31 which is a pullout that need to be regraded.

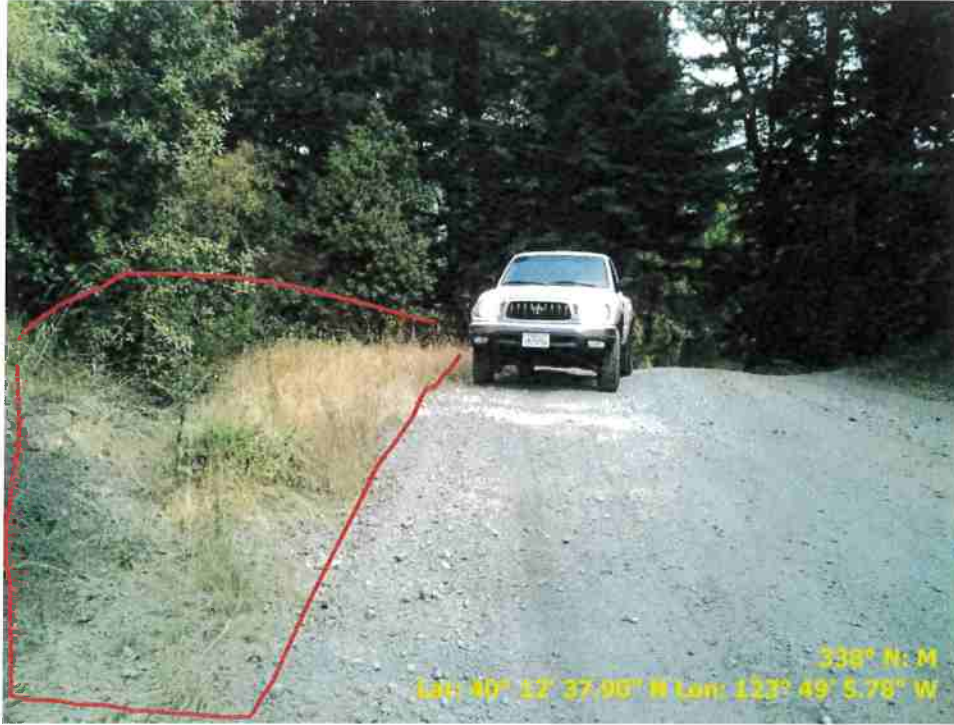
Figure 11. Photograph showing Road Point 40 which is a pullout that need to be regraded.

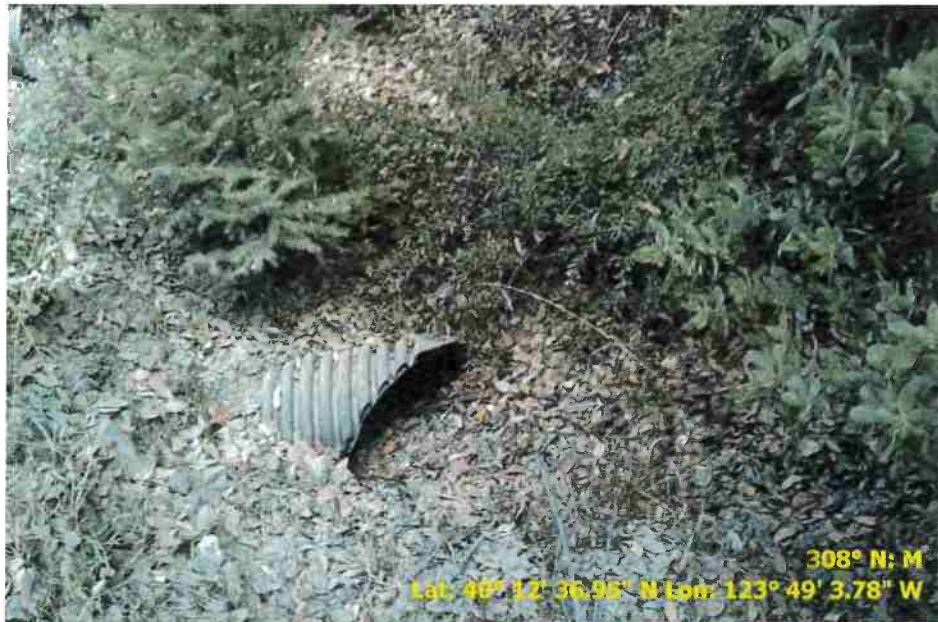
Figure 12. Photograph showing Road Point 42 which is 18" drainage relief culvert with debris in the inlet that needs to be cleared.

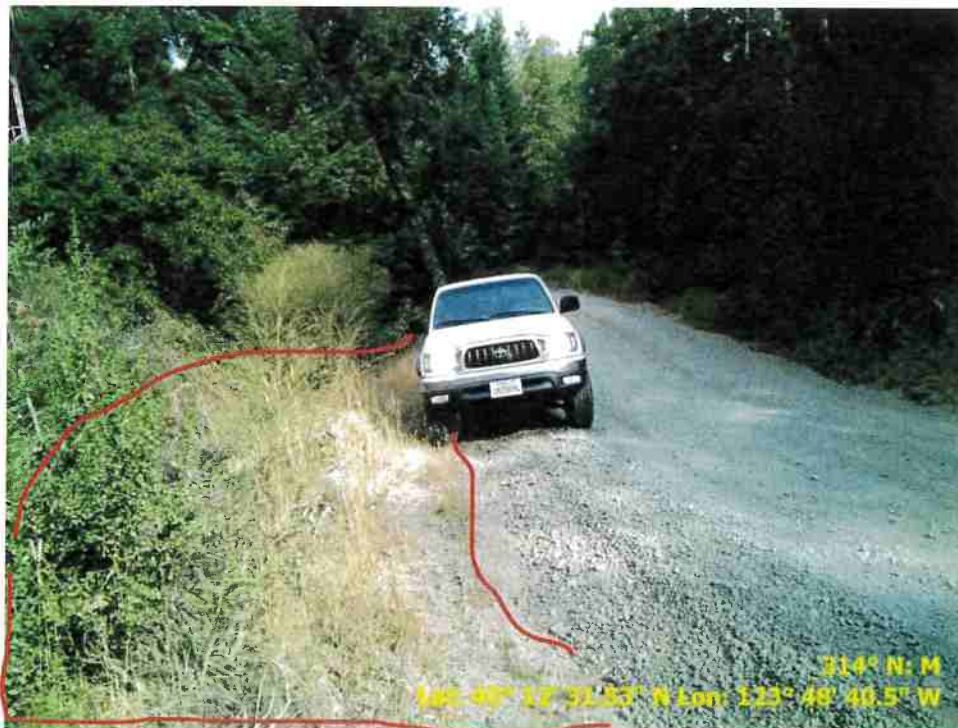
Figure 14. Photo of Road Point 67 showing a pullout that needs to be regraded and vegetation cleared.

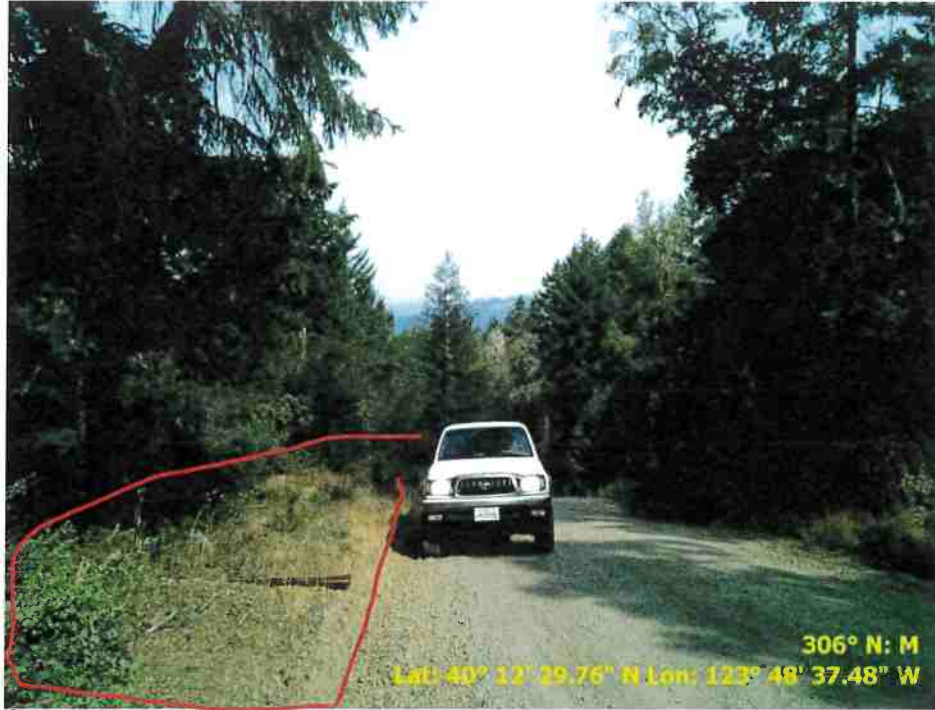
Figure 15. Photo of Road Point 71 showing a pullout that needs to be regraded.

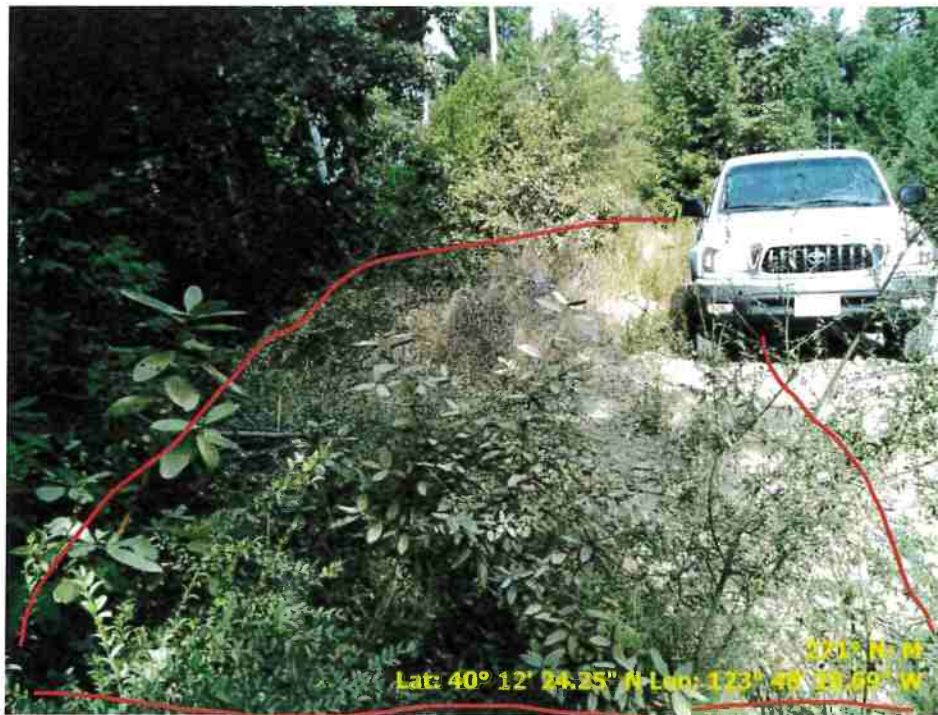
Figure 16. Photo of Road Point 74 showing a pullout that needs to be regraded and vegetation cleared.

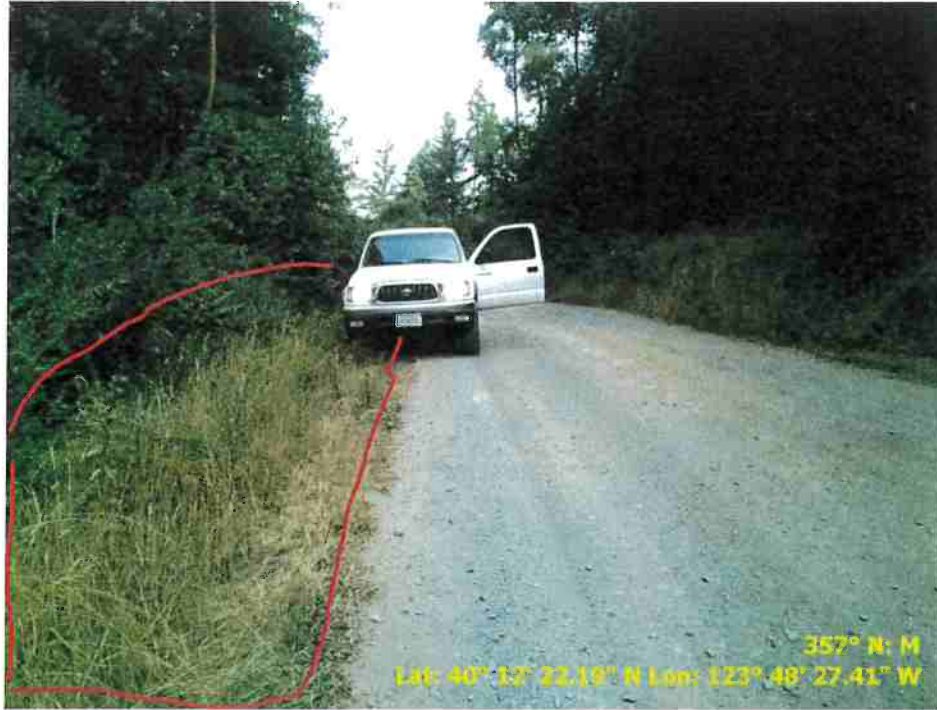
Figure 17. Photo of Road Point 76 showing a pullout that needs to be regraded...

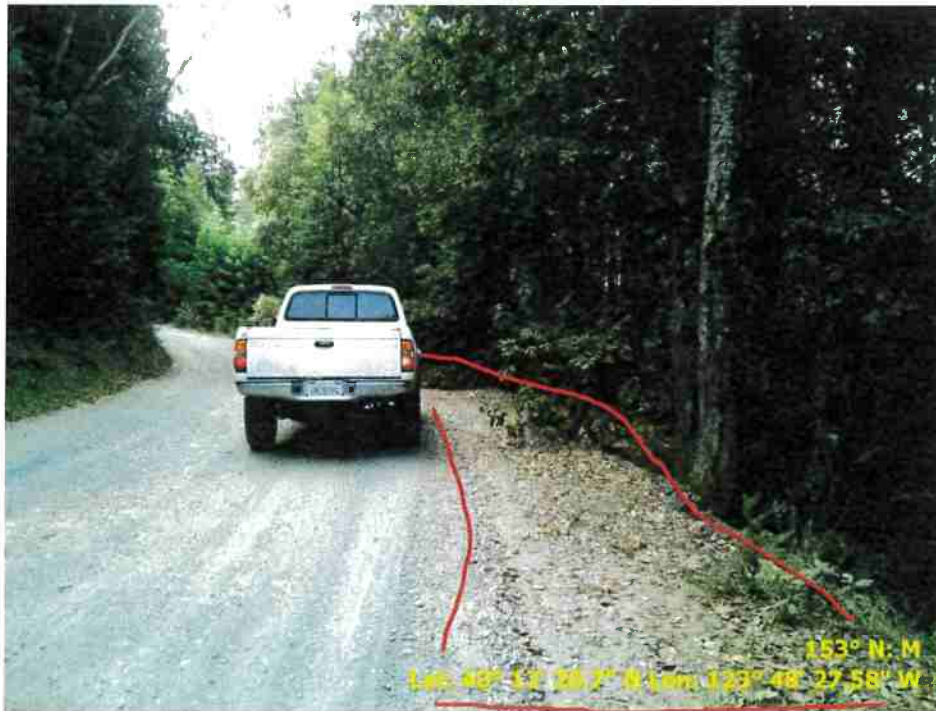
Figure 18. Photo of Road Point 77 showing a pullout that needs to have a stump cleared and regraded.

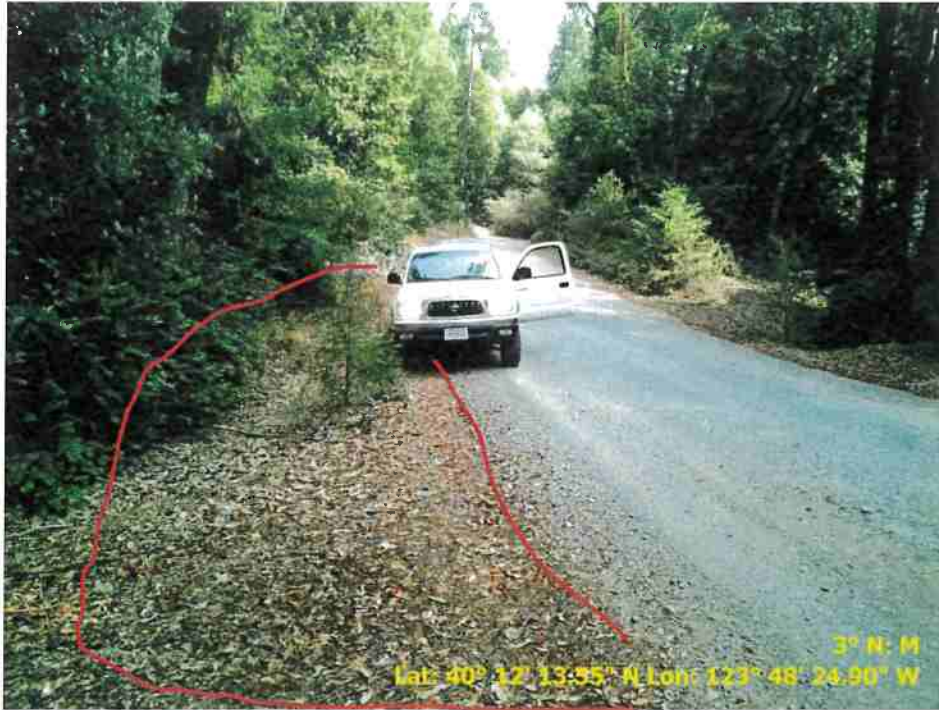
Figure 19. Photo of Road Point 79 showing a pullout that needs to be regraded and vegetation cleared.

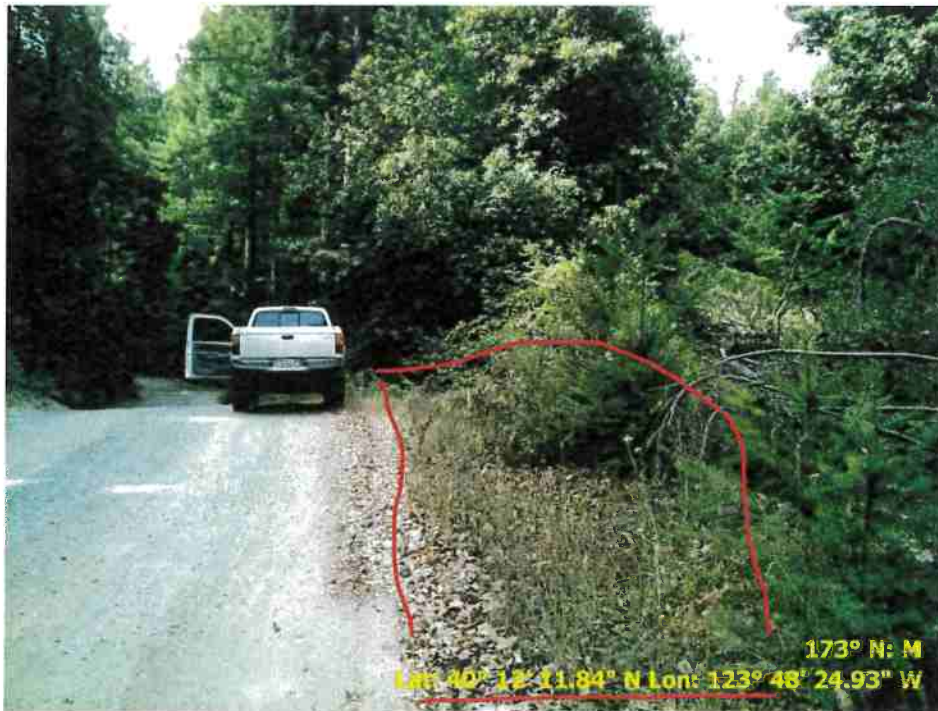
Figure 20. Photo of Road Point 80 showing a pullout that needs to be regraded and vegetation cleared.

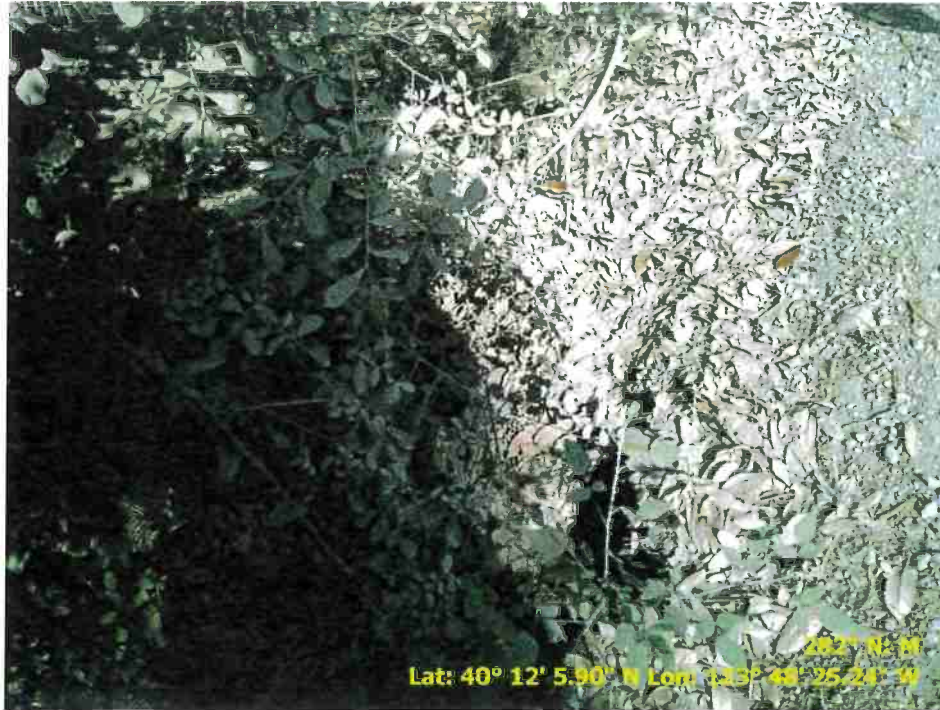
Figure 21. Photograph of Road Point 82 showing an a partially plugged inlet to an 18 inch drainage relief culvert. The fix is to clear the inlet with a shovel.

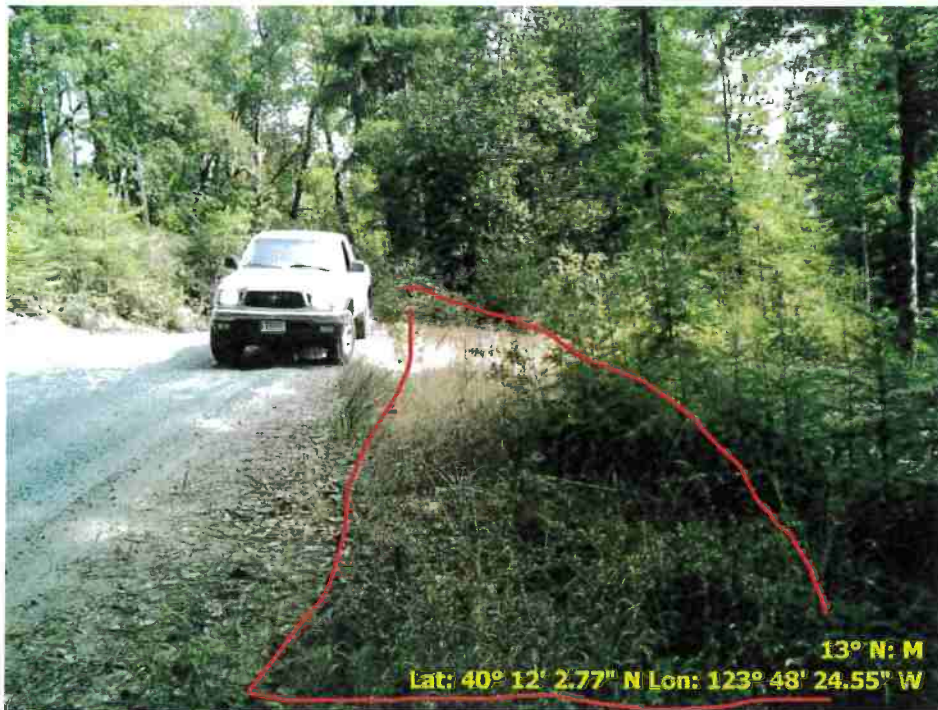
Figure 22. Photo of Road Point 84 showing a pullout that needs to be regraded and vegetation cleared.

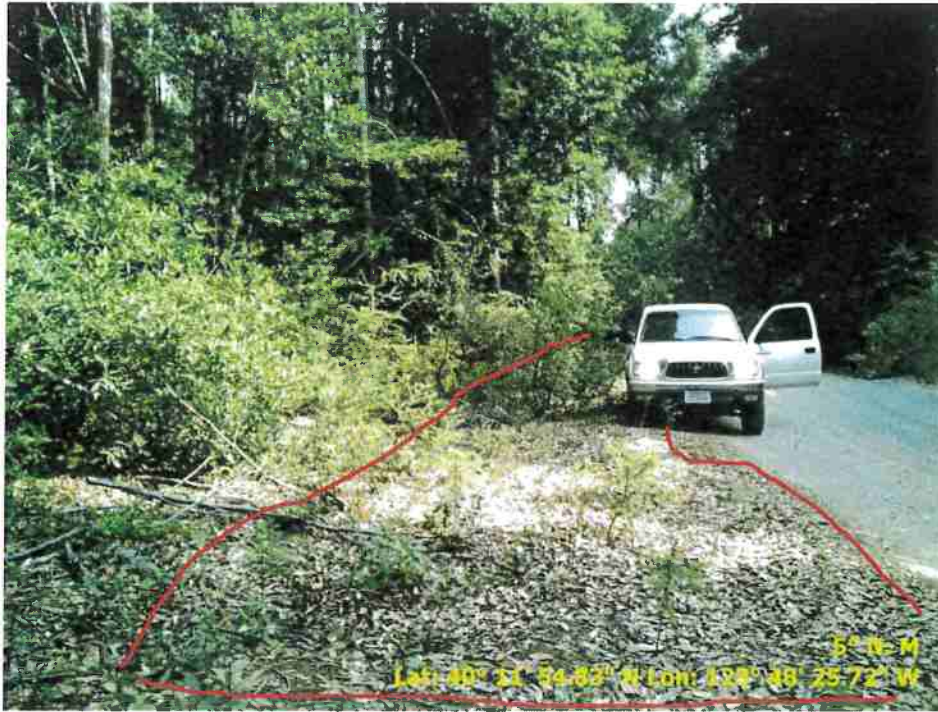
Figure 23. Photo of Road Point 80 showing a pullout that needs to be regraded and vegetation cleared.

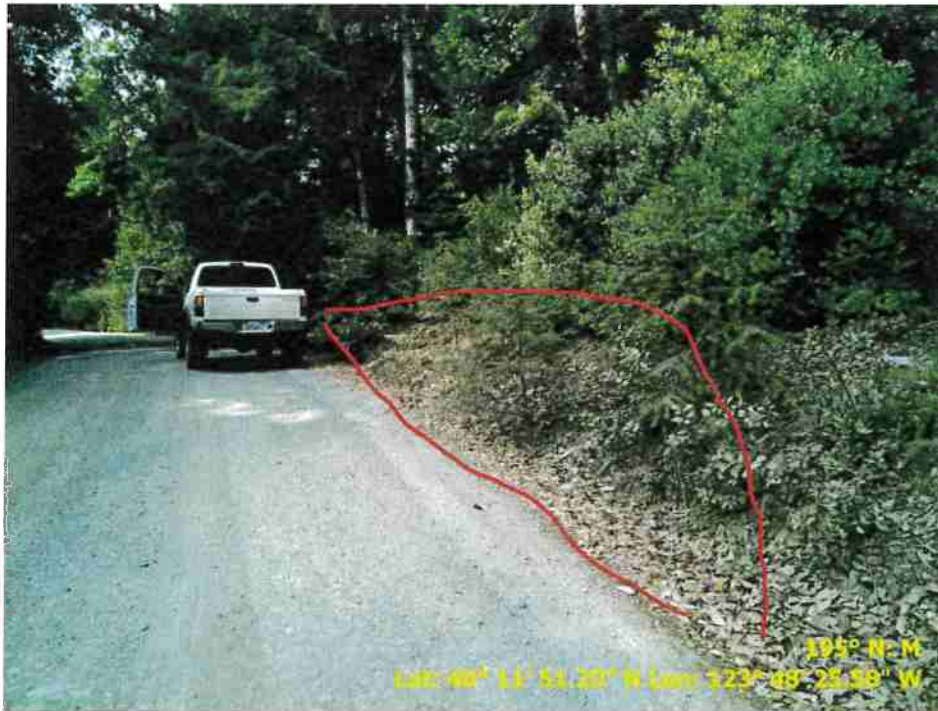
Figure 24. Photo of Road Point 89 showing a pullout that needs to be regraded and vegetation cleared.

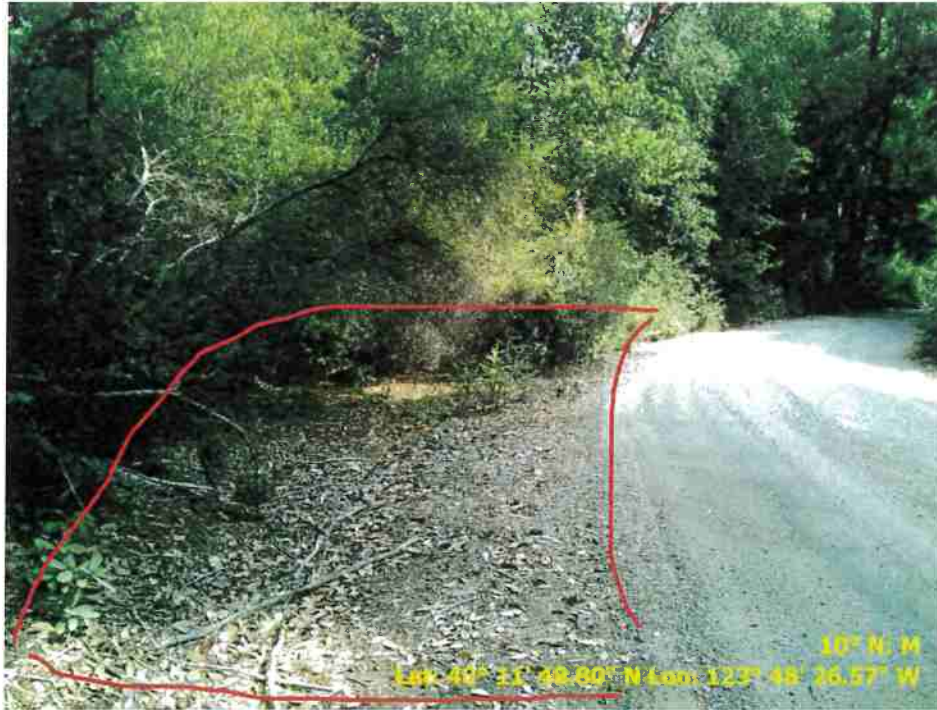
Figure 25. Photo of Road Point 91 showing a pullout that needs vegetation cleared and to be regraded.

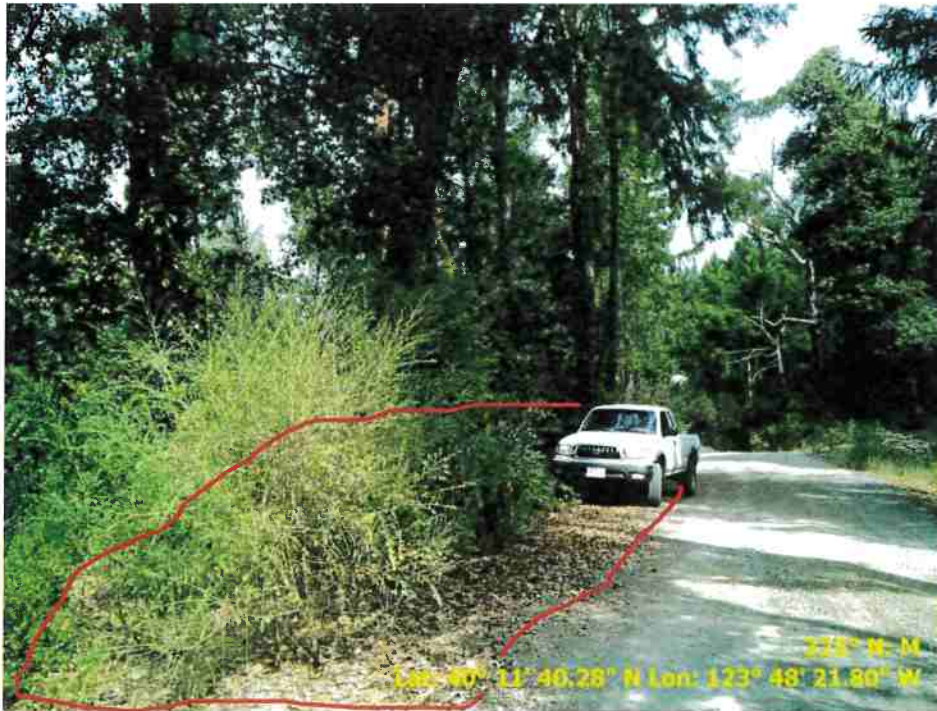
Figure 26. Photo of Road Point 94 showing a pullout that needs to be regraded and vegetation cleared.

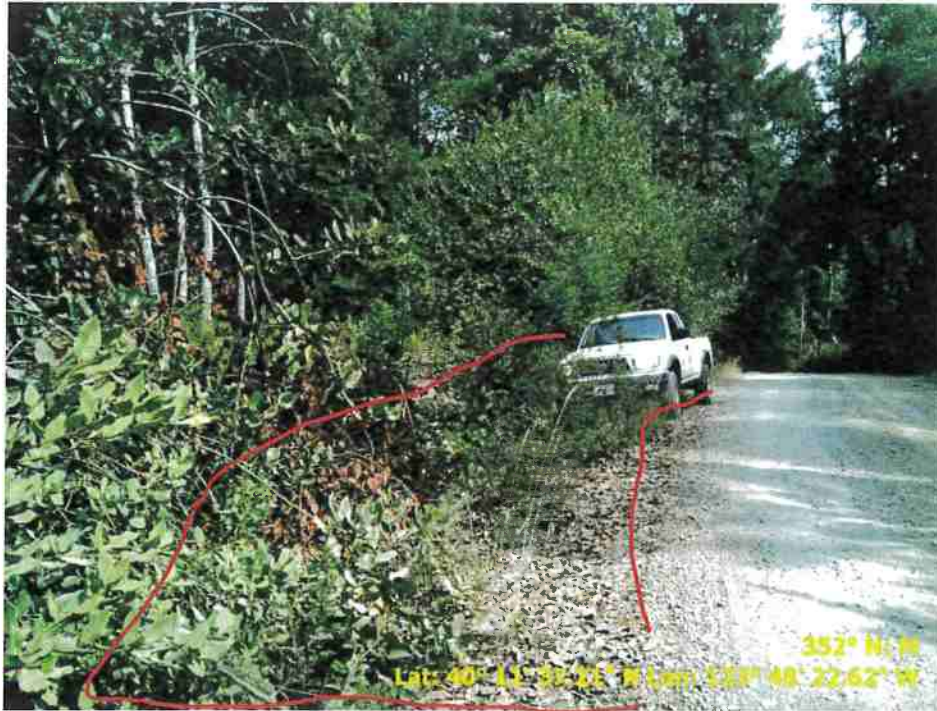
Figure 27. Photo of Road Point 91 showing a pullout that needs vegetation cleared and to be regraded.

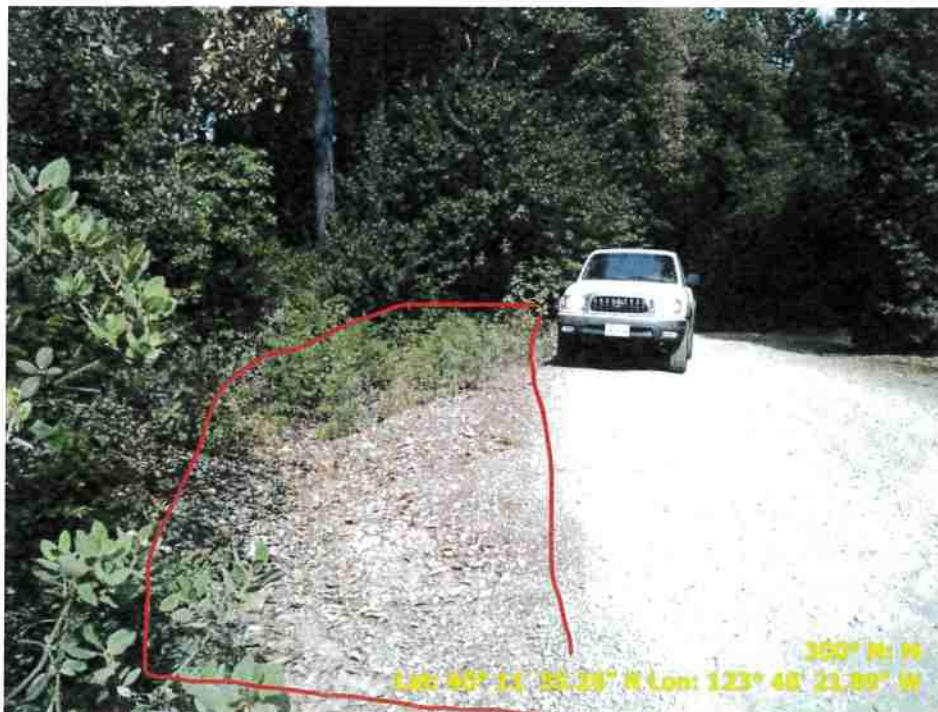
Figure 28. Photo showing a pullout that needs to be regraded and vegetation cleared.

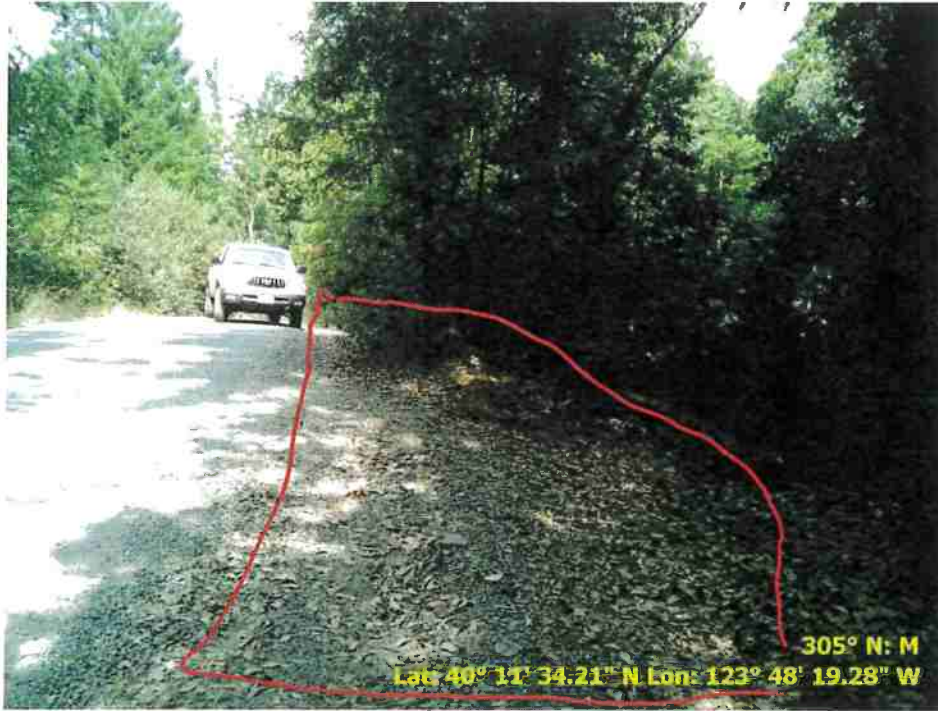
Figure 29. Photo showing a pullout that needs vegetation cleared and regrading.

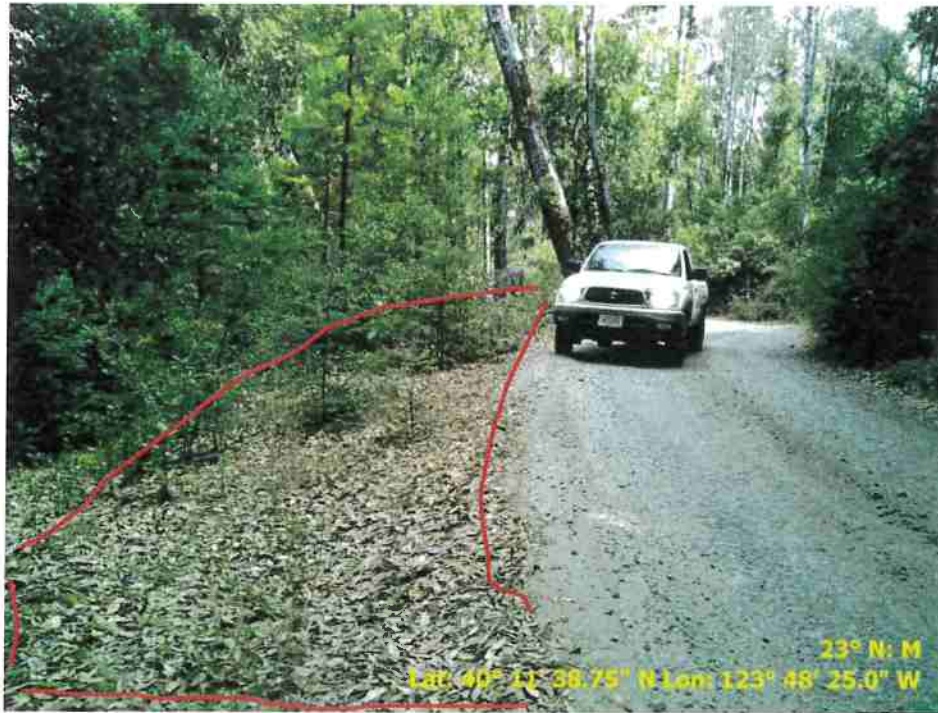
Figure 31. Photo of Road Point 104 showing a pullout that needs to be cleared of vegetation and regrading.

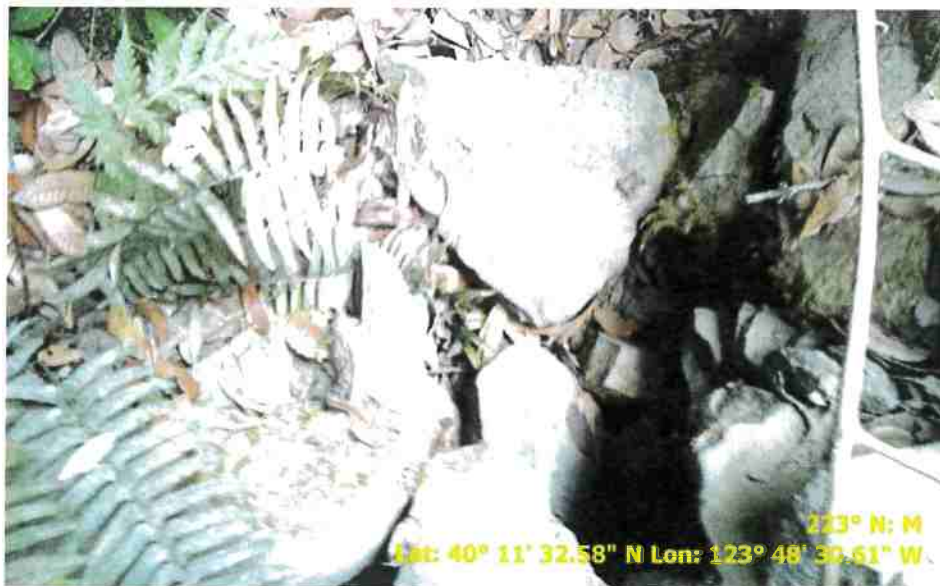
Figure 32. Photo of Road Point 190 showing the inlet of and 18" drainage relief culvert that needs to be cleared.

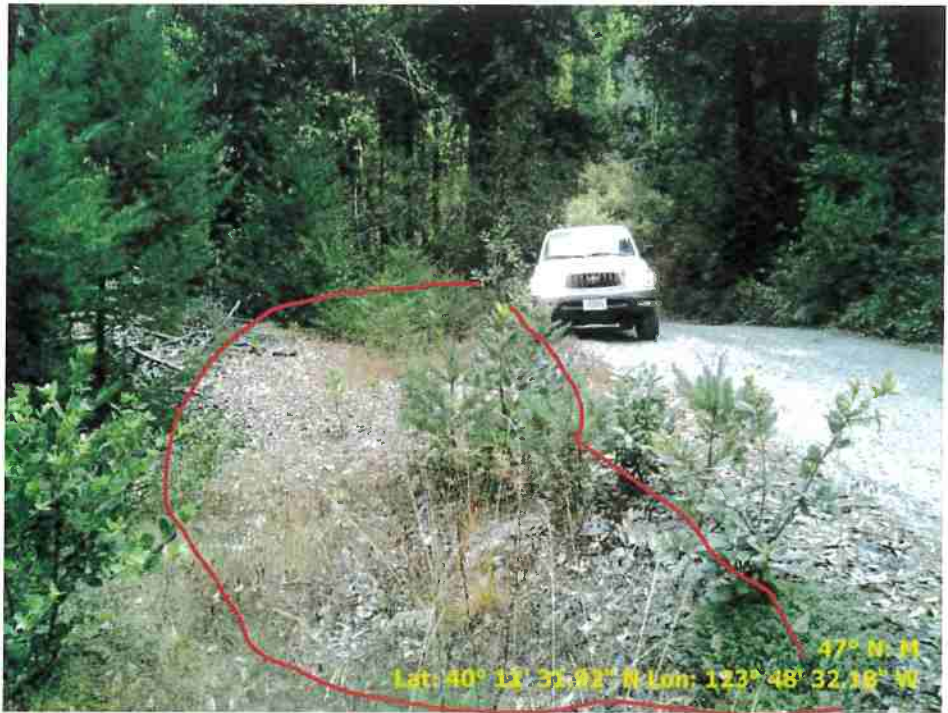
Figure 33.. Photo of Road Point 110 showing a pullout that needs to be cleared of vegetation and regrading.

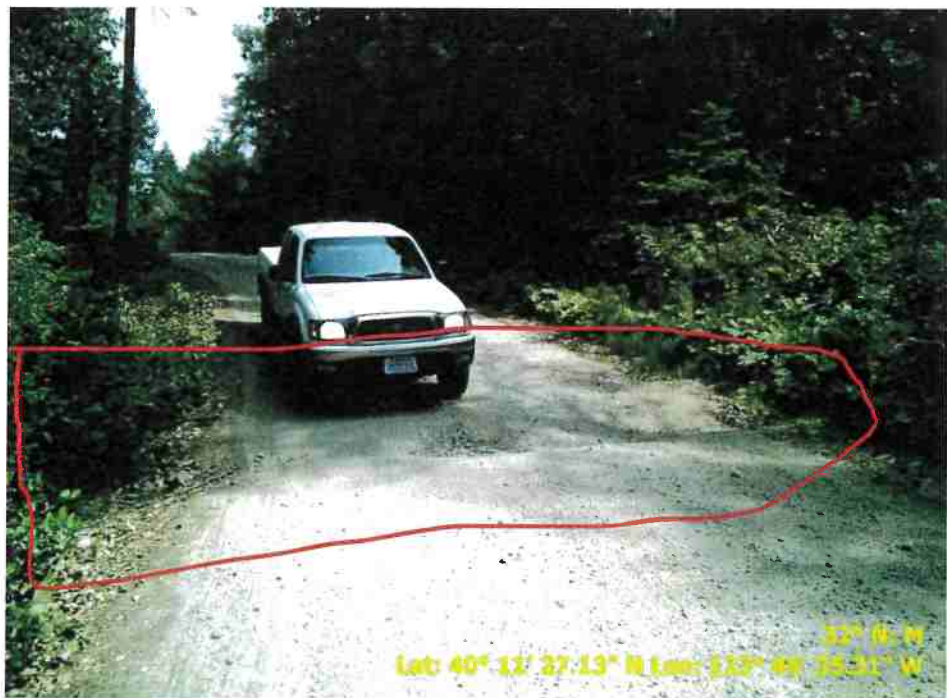
Figure 34. Photo of Road Point 112 showing where concentrated road runoff crosses the road. The fix is to install a culvert or a rocked rolling dip.

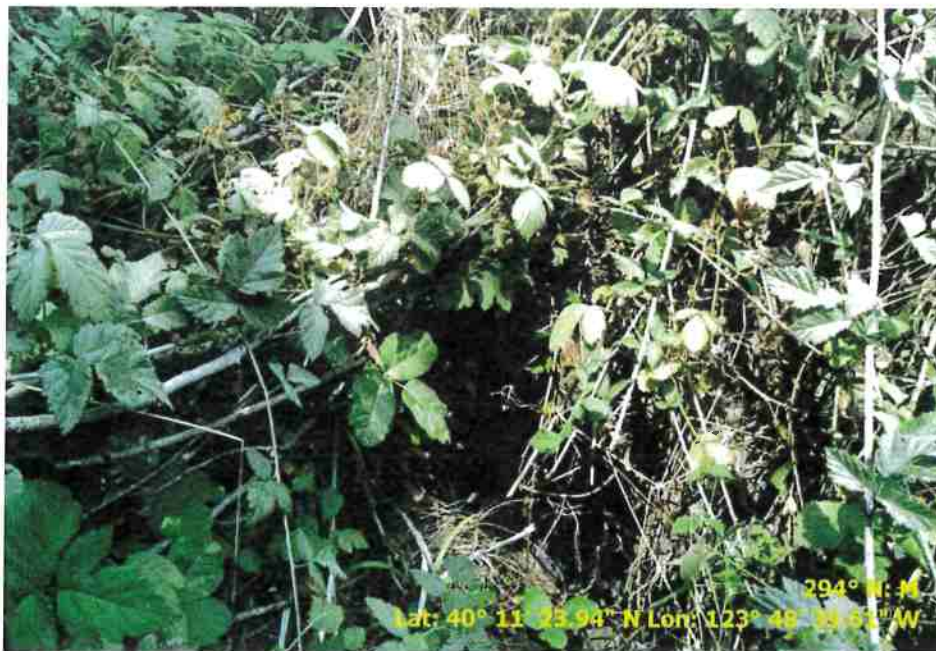
Figure 35. Photo of Road Point 115 showing the inlet of a 36" onstream culvert that needs the inlet cleared.

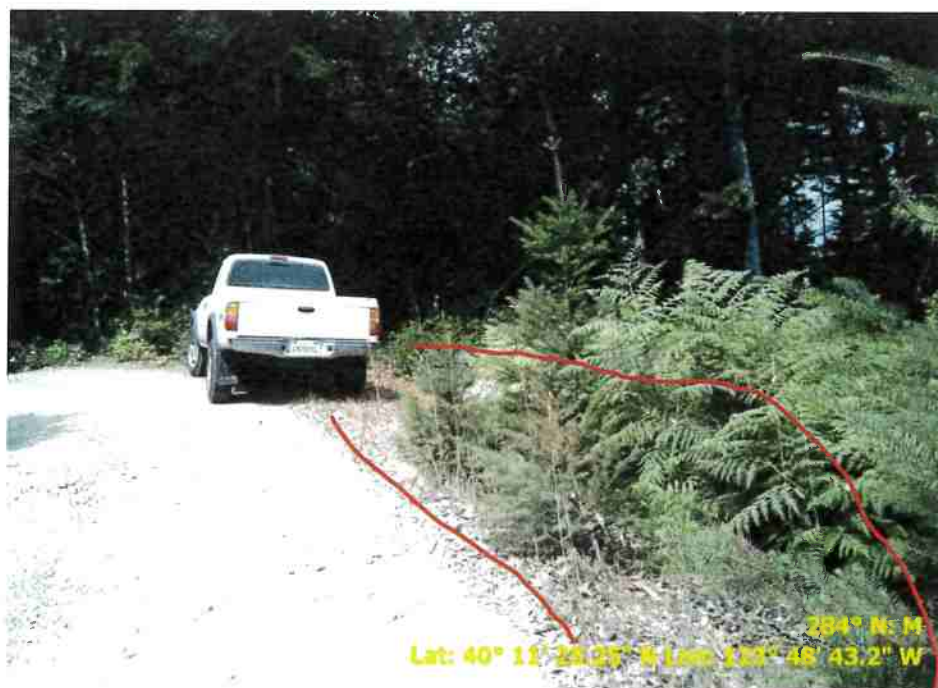
Figure 36. Photo of Road Point 118 showing a pullout that needs to be cleared of vegetation and regrading.

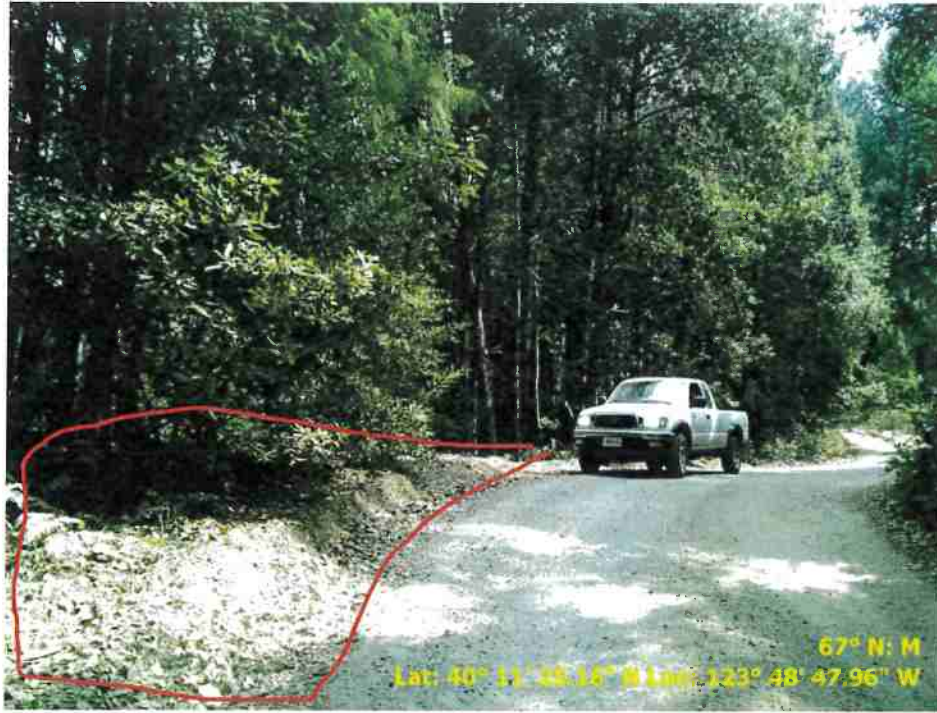
Figure 37. Photo of Road Point 119 showing a pullout that needs to be cleared of vegetation and regrading.
