ROADWAY ASSESSMENT REPORT

SITE ACCESS ROAD(S)

**French Road
Miranda, California
APN: 214-234-006
and
APN: 214-234-007**

**September, 2018
Josh McKnight, P.E.
Job #756.05**

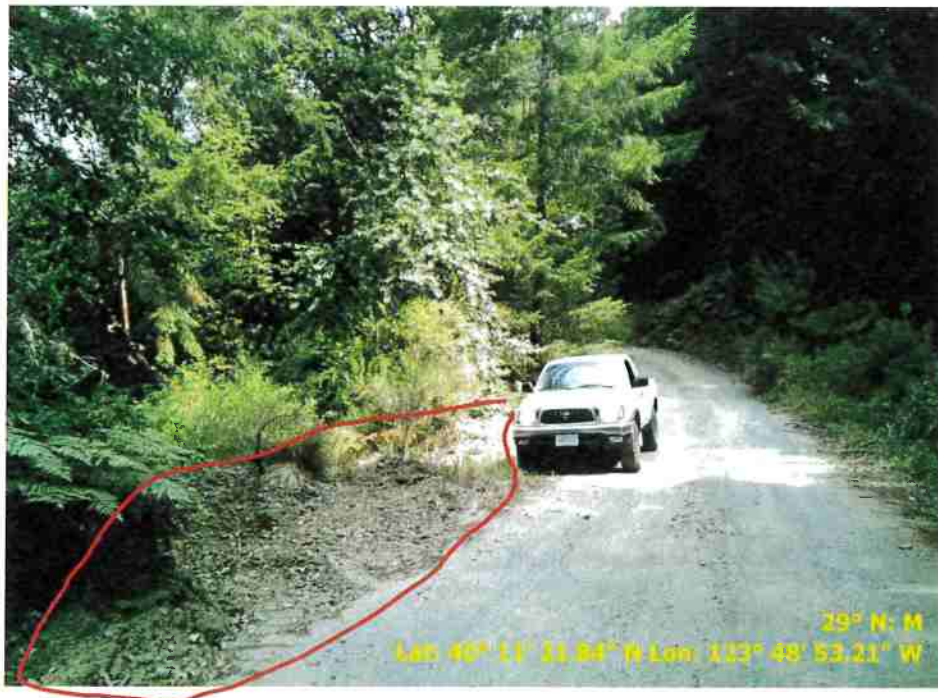
Figure 38. Photo of Road Point 123 showing a pullout that needs to be cleared of vegetation and regrading.

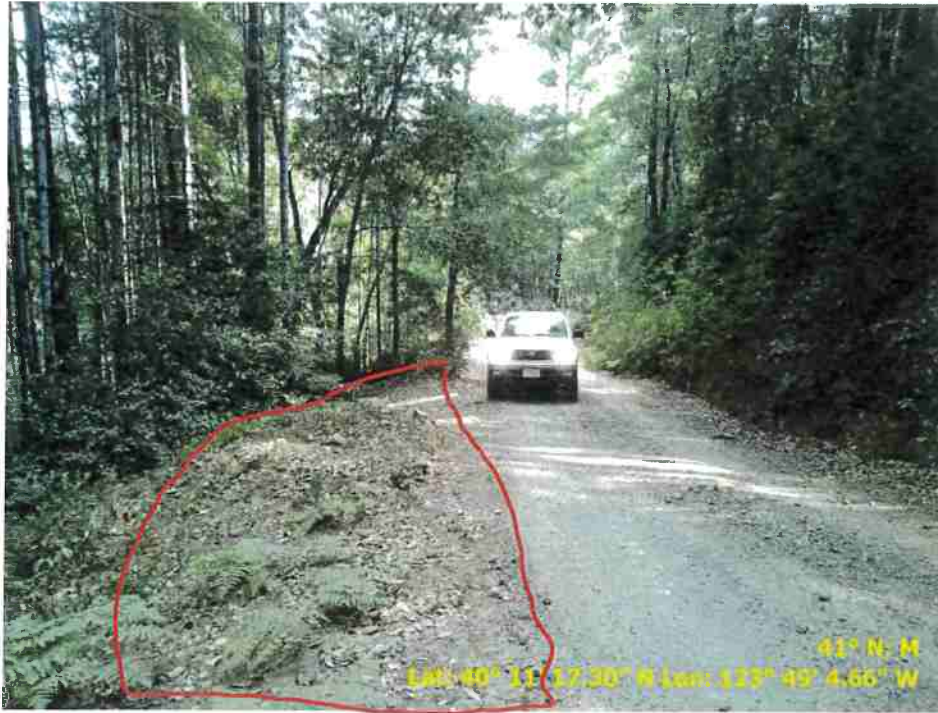
Figure 39. Photo of Road Point 127 showing a pullout that needs to be cleared of vegetation and regrading.

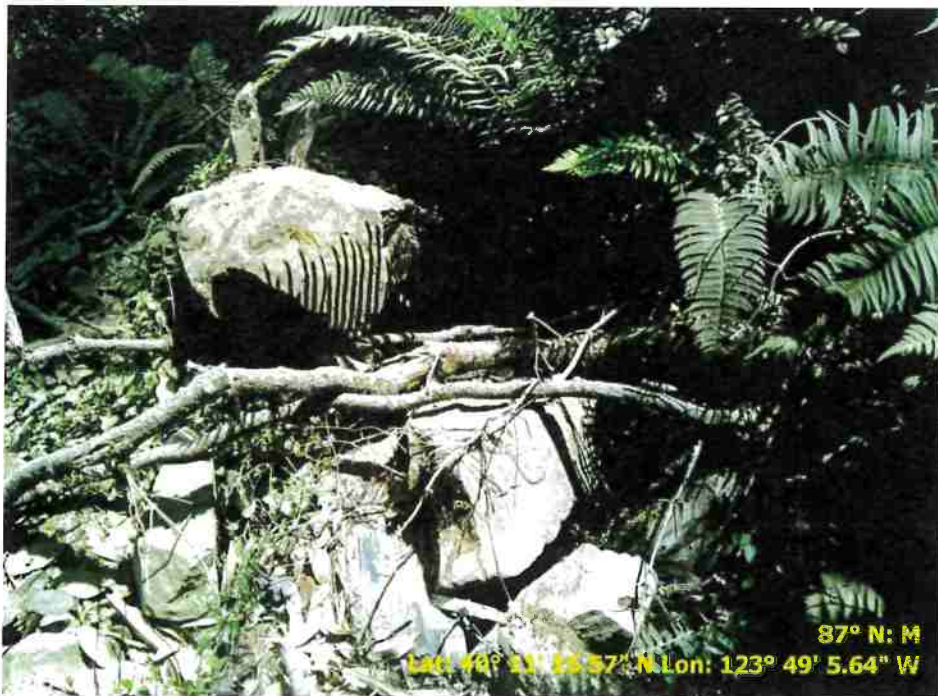
Figure 40. Photo of Road Point 132 showing the inlet of a 18" onstream culvert that needs the inlet cleared.

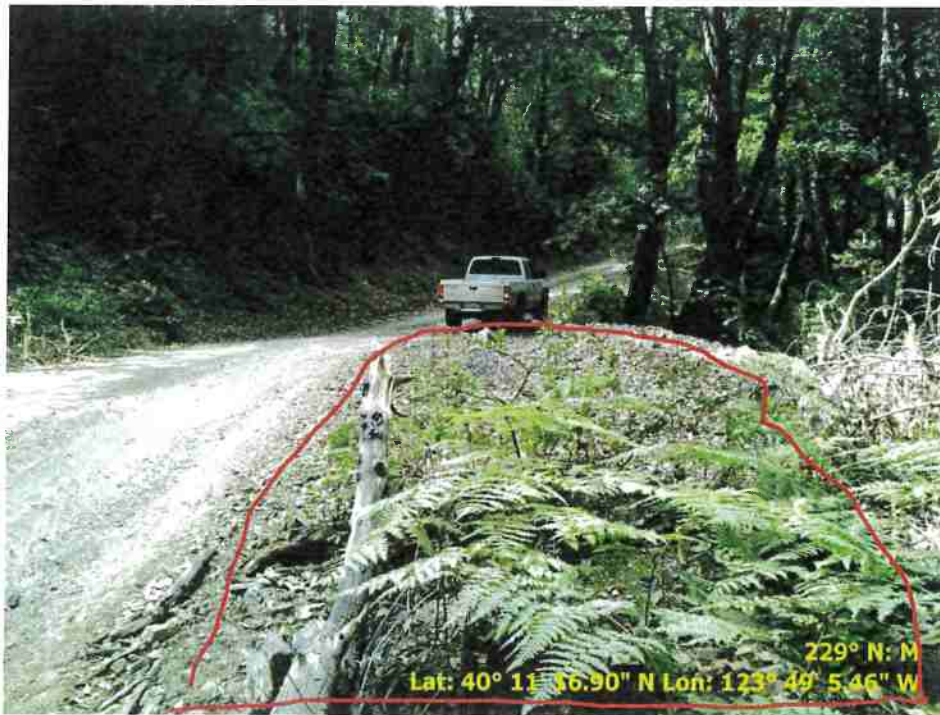
Figure 41. Photo of Road Point 133 showing a pullout that needs to be cleared of vegetation and to be regraded.

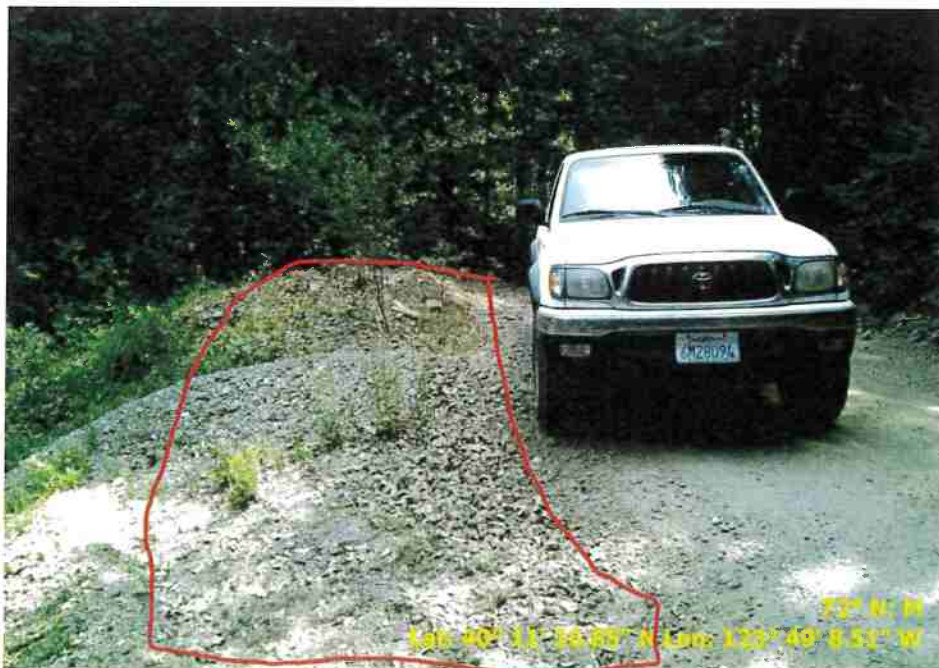
Figure 42.. Photo of Road Point 136 showing a pullout that needs to be cleared of vegetation and regraded.

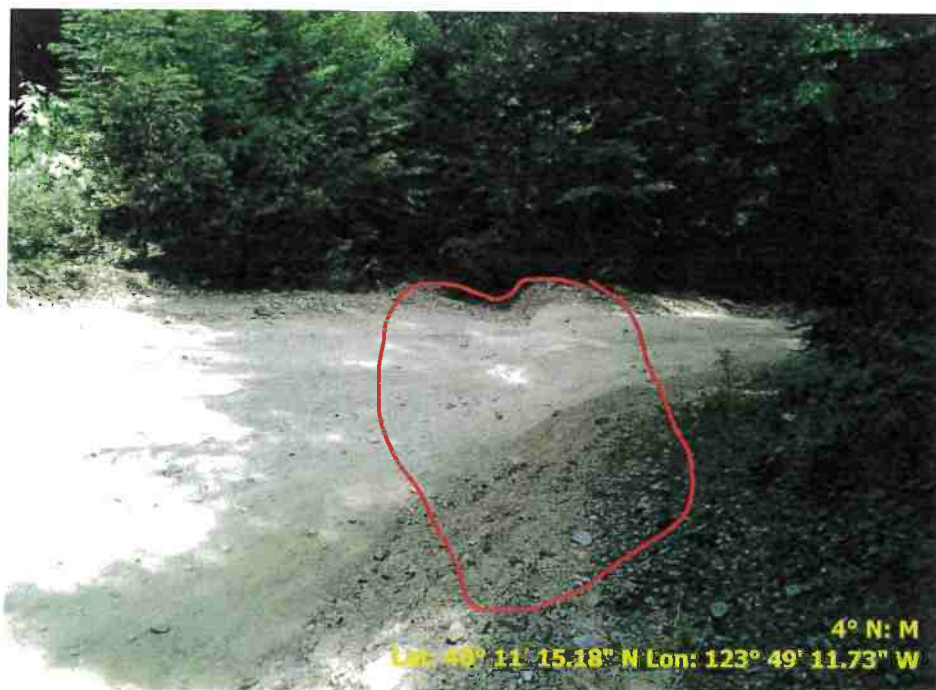
Figure 43. Photo of Road Point 301 showing water-bar/rolling dip that needs surface rock..

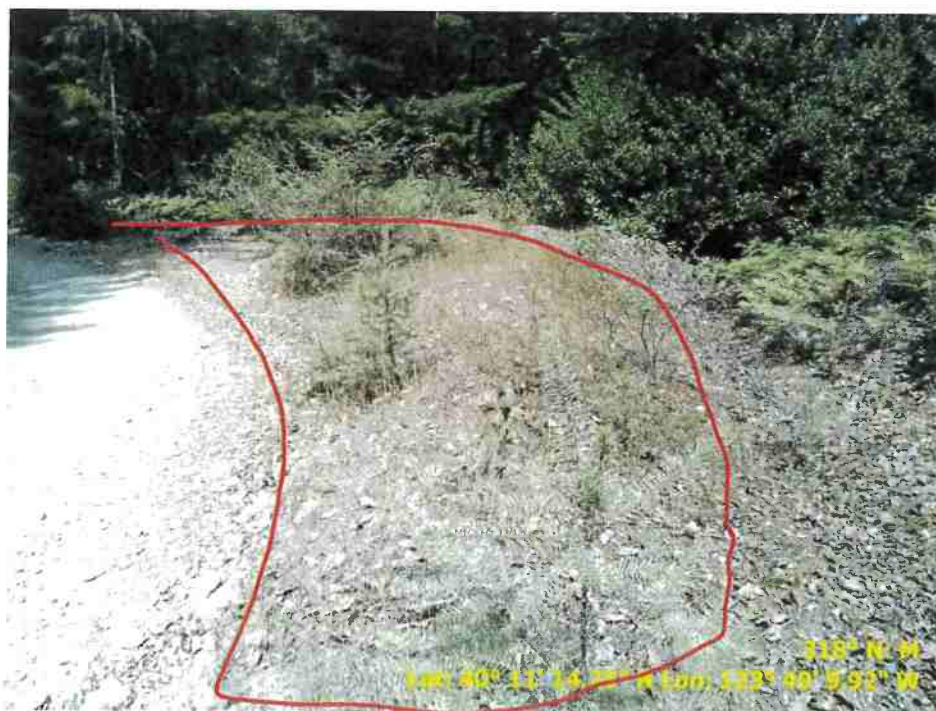
Figure 44. Photo of Road Point 141 showing a pullout that needs to be cleared of vegetation and regraded.

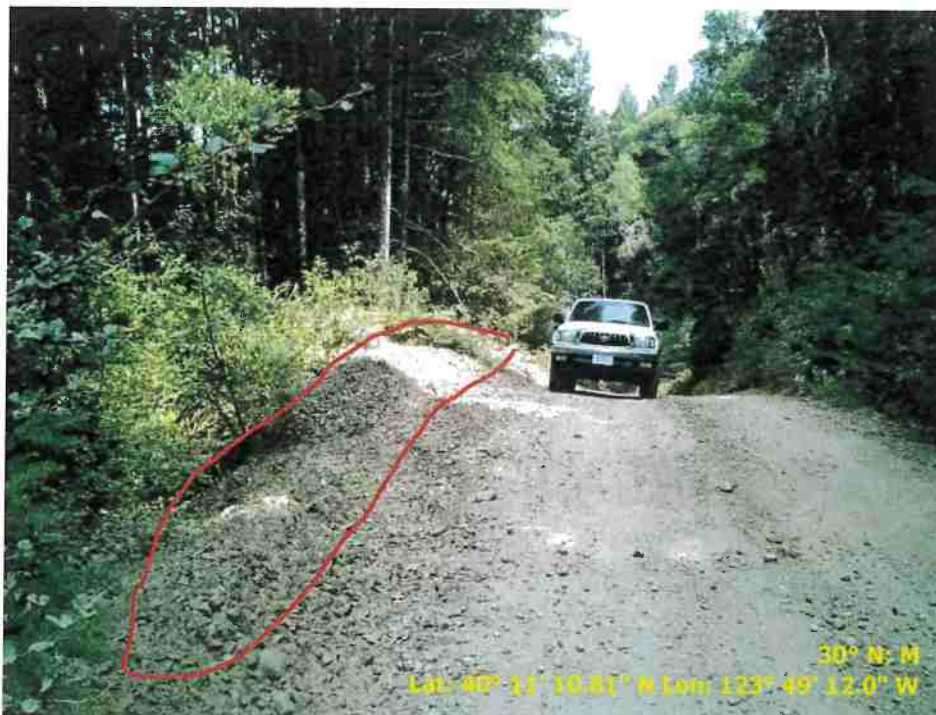
Figure 45. Photo of Road Point 145 showing a pullout that needs to be cleared of vegetation and regraded.

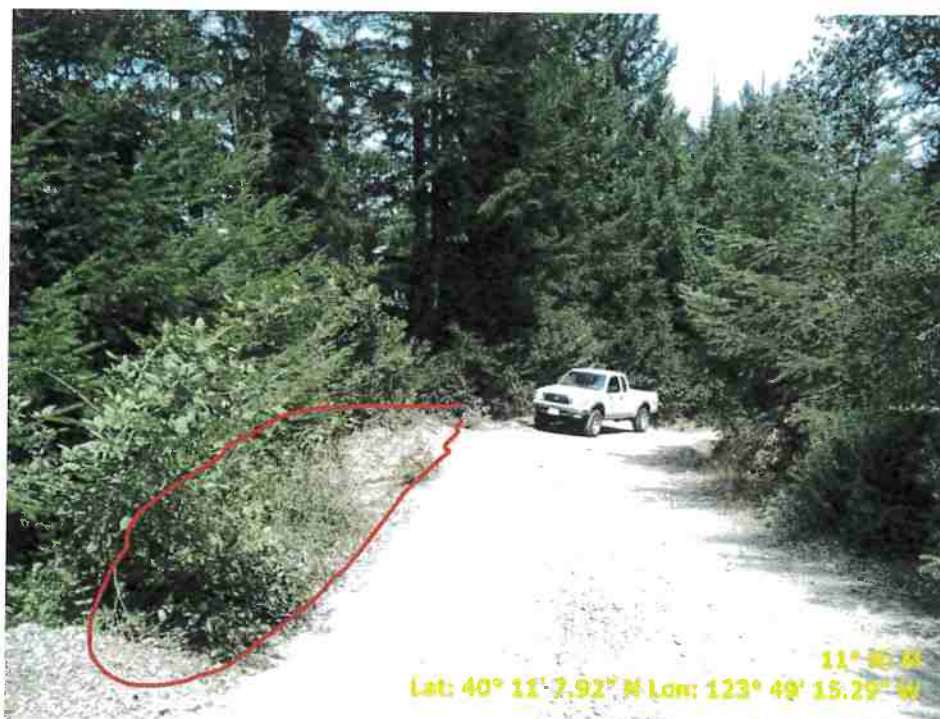
Figure 47. Photo of Road Point 150 showing a pullout that needs to be cleared of vegetation and regraded.

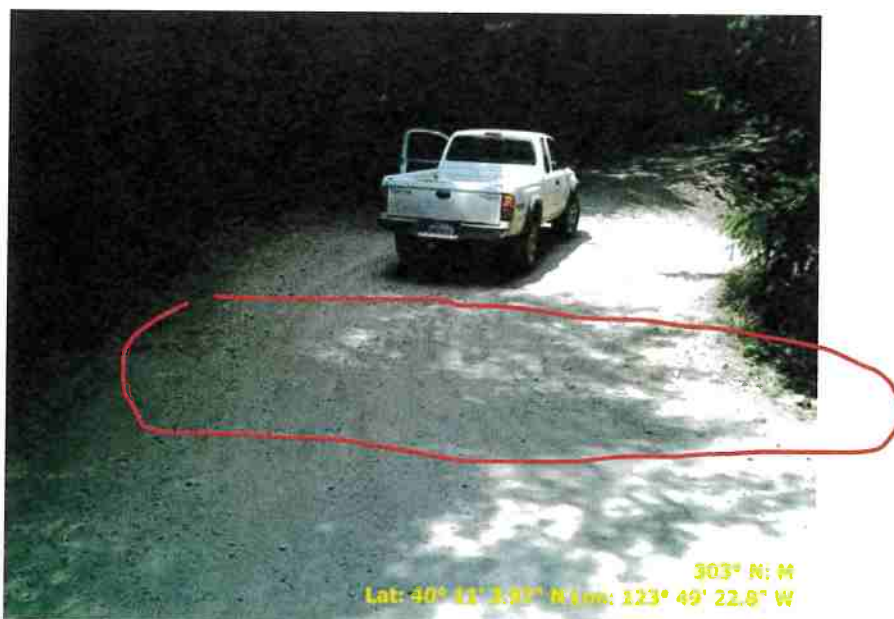
Figure 48. Photo of Road Point 159 showing a class three stream crossing that need a culvert or rock ford.

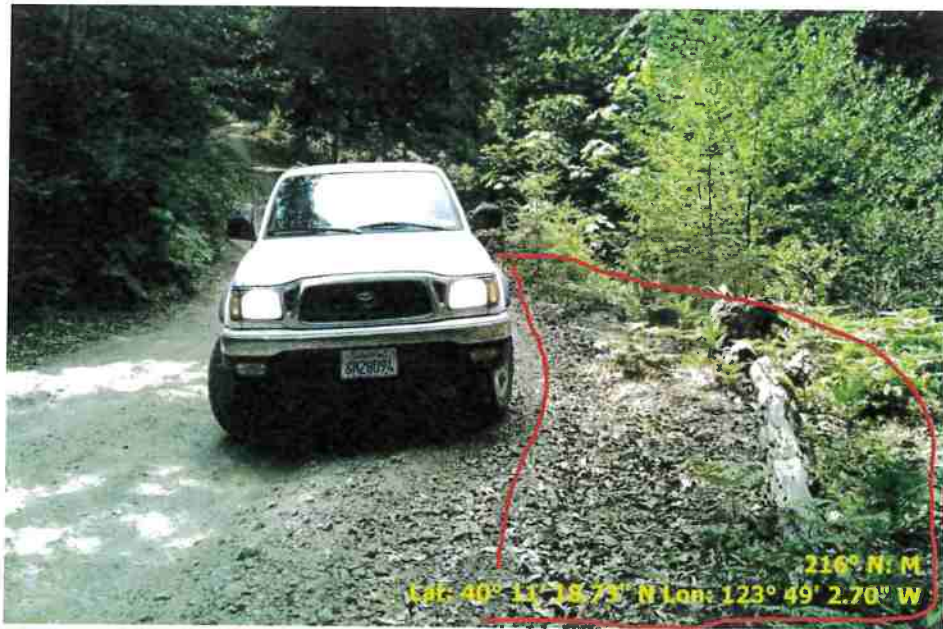
Figure 49. Photo of Road Point 162 showing a pullout that needs to be cleared of vegetation and regraded.
