**ENGINEERING-GEOLOGIC R-2
SOILS EXPLORATION REPORT**

Existing Grading and Cut Fill Construction
422 Wood Ranch Road
Redway, California

Assessor's Parcel Number: APN: 214-231-011

Prepared for:
Mr. Jade Hass

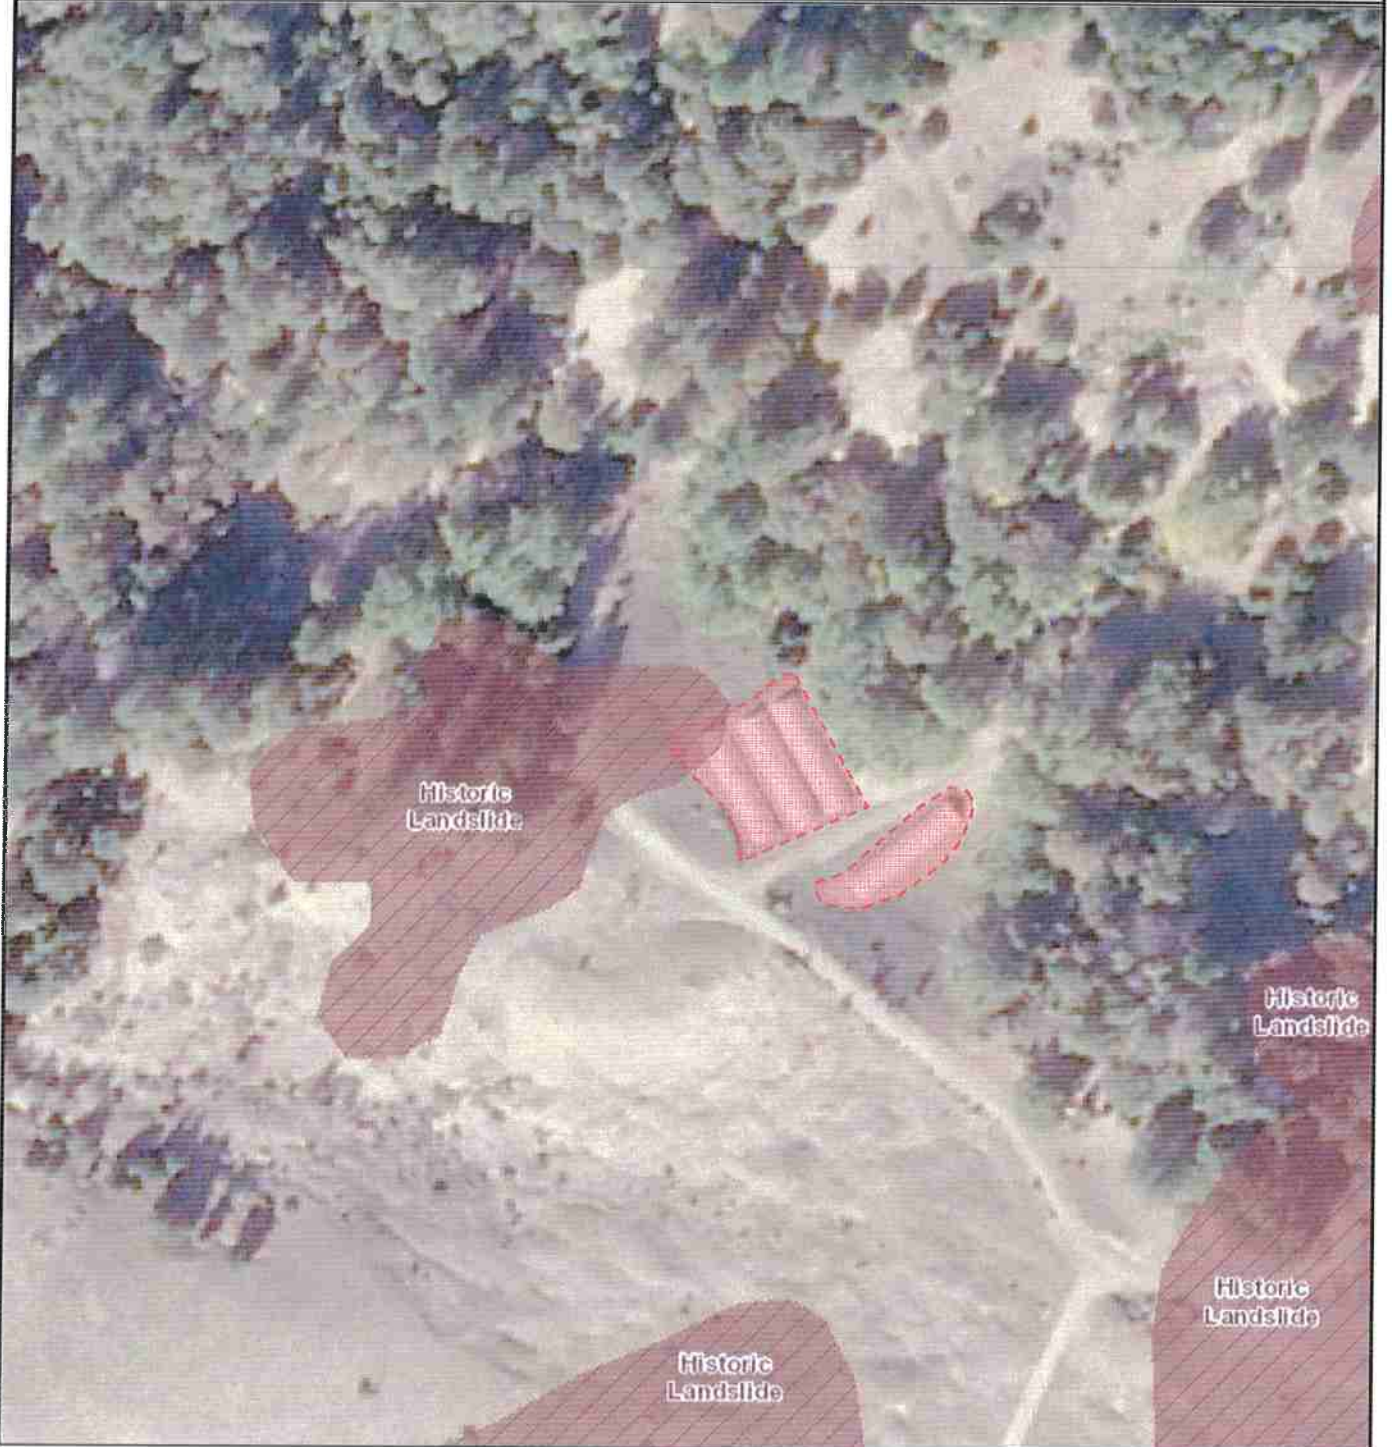
Based on available Humboldt County Web GIS satellite imagery, initial grading occurred after 2016; greenhouses are observable in the May, 2018, satellite imagery (Figure 3). Prior to grading, these areas of the parcel appear to have been small prairies bordered by undeveloped forest lands. Historically, the property was logged for timber and grazed with cattle.

To characterize soil and groundwater conditions at this location the soil profile was observed in the cut faces around this cut fill pad (Figure 3). In the field, the soil profile was described in general accordance with ASTM D 2488 standards, and as discussed previously, the soil profile consists of thin topsoil and sod over silt with fine sand and clay, with gravel, grading to bedrock composed of fractured silty fine sandstone.

Some minor erosion and some raveling of cut slopes was observed. Humboldt County Planning's Web GIS database rates the relative stability of this parcel as "Moderate Instability" due to the steepness, and the fact that there has been historic landsliding mapped on parcel 214-231-011 on the Humboldt County WebGIS site. A large landslide is shown east of the property on the county website and on the geologic map (McLaughlin *et al.*, 2000). A small historic landslide is shown on the county website overlapping the northwest corner of the north graded area. Based on our on-site observations, review of published geologic maps, it is our opinion that the Humboldt County WebGIS historic landslide mapping is less than accurate. In our opinion, based on our

field review, that the mapped historic landslide is actually located to the north of the two graded sites and that the grading occurred outside of the extents of the historic landslide. Provided our recommendations are adhered to, slope instability or landsliding are not anticipated to negatively impact these two grading sites.
