**LIMITED ASBESTOS
SURVEY & PAINT SAMPLING
FOR ADA RENOVATIONS AT THE
HUMBOLDT COUNTY MENTAL
HEALTH FACILITY
720 WOOD STREET
EUREKA, CALIFORNIA**

December 24, 2018

Project #1800321

Prepared for:
County of Humboldt
County Administrative Office
ADA Compliance Team
Attn: Mr. Travis I. Smith
825 5th Street, Room 112
Eureka, CA 95501
(707) 476-2388

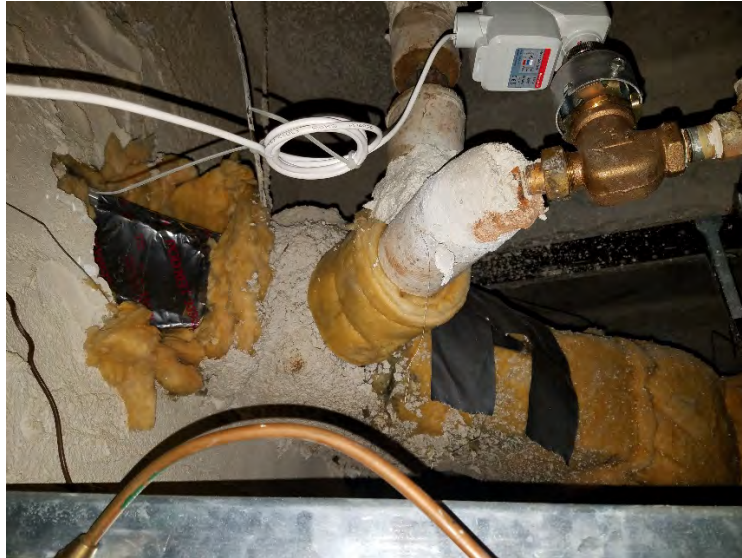
Above ceiling in Rm. 229 & RR 230, ACM pipe insulation on pipe elbows & tees, and ACM spray on fireproofing as overspray on fiberglass duct insulation

ACM Pipe Insulation Elbows & Tees (TSI): The white pipe insulation compound identified in this report contains asbestos, and is categorized as RACM. Any abatement of the ACM pipe insulation must be done by a licensed asbestos abatement contractor as Class I work using Class I methods. The abated waste must be disposed of as “friable” asbestos waste. This will require the use of a licensed “hazardous” waste hauler. In addition, a temporary hazardous waste generator number from the EPA will need to be obtained for the site. An abatement contractor will typically handle these issues.

PACM Spray-on Fireproofing (TSI): The gray spray on fireproofing identified in this report contains asbestos, and is presumed to be RACM. Any abatement of the ACM pipe insulation must be done by a licensed asbestos abatement contractor as Class I work using Class I methods. The abated waste must be disposed of as “friable” asbestos waste. This will require the use of a licensed “hazardous” waste hauler. In addition, a temporary hazardous waste generator number from the EPA will need to be obtained for the site. An abatement contractor will typically handle these issues.

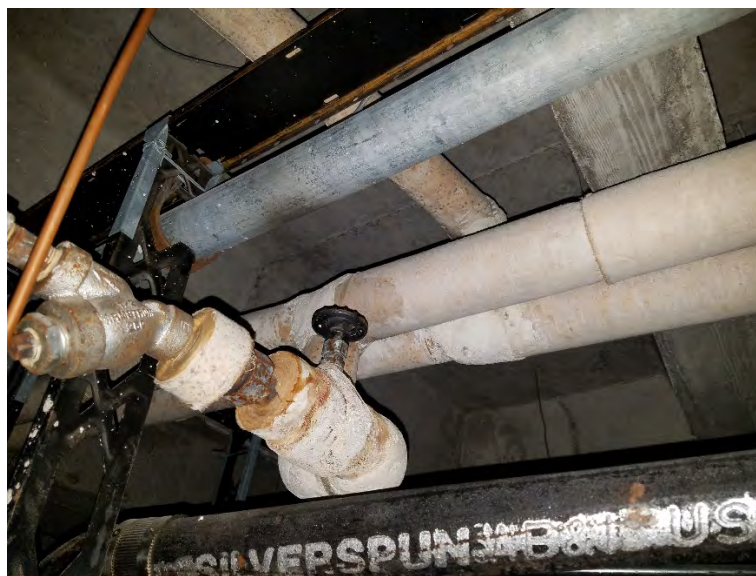
Above ceiling in Rm. 229 & RR 230, ACM pipe insulation on pipe elbows & tees

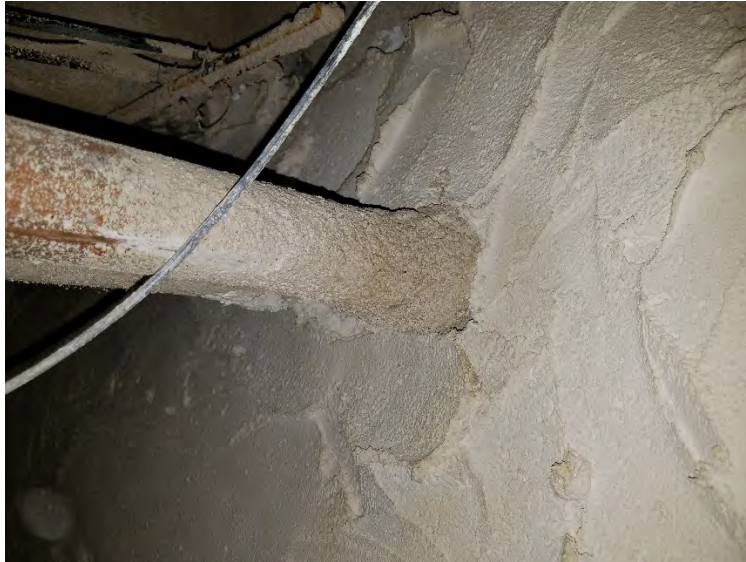
Above ceiling in Rm. 229 & RR 230, ACM spray on fireproofing on pipe at wall penetration

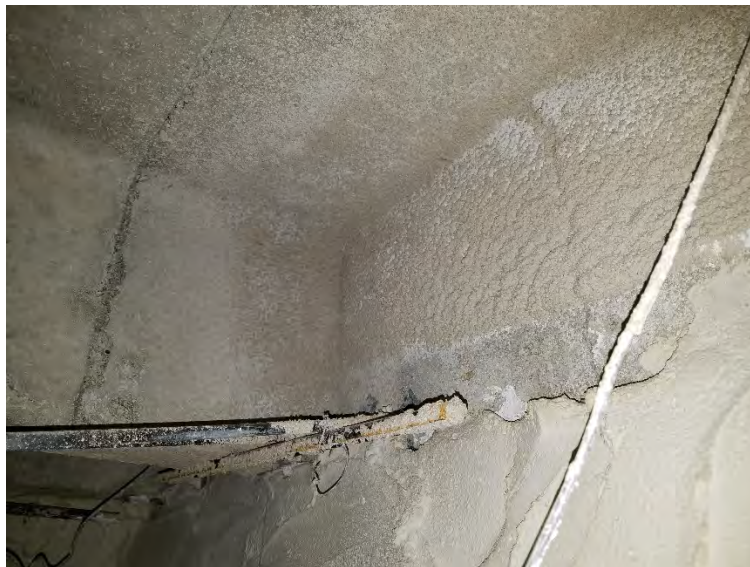
Above ceiling in Rm. 229 & RR 230, ACM spray on fireproofing on concrete ceiling & beams

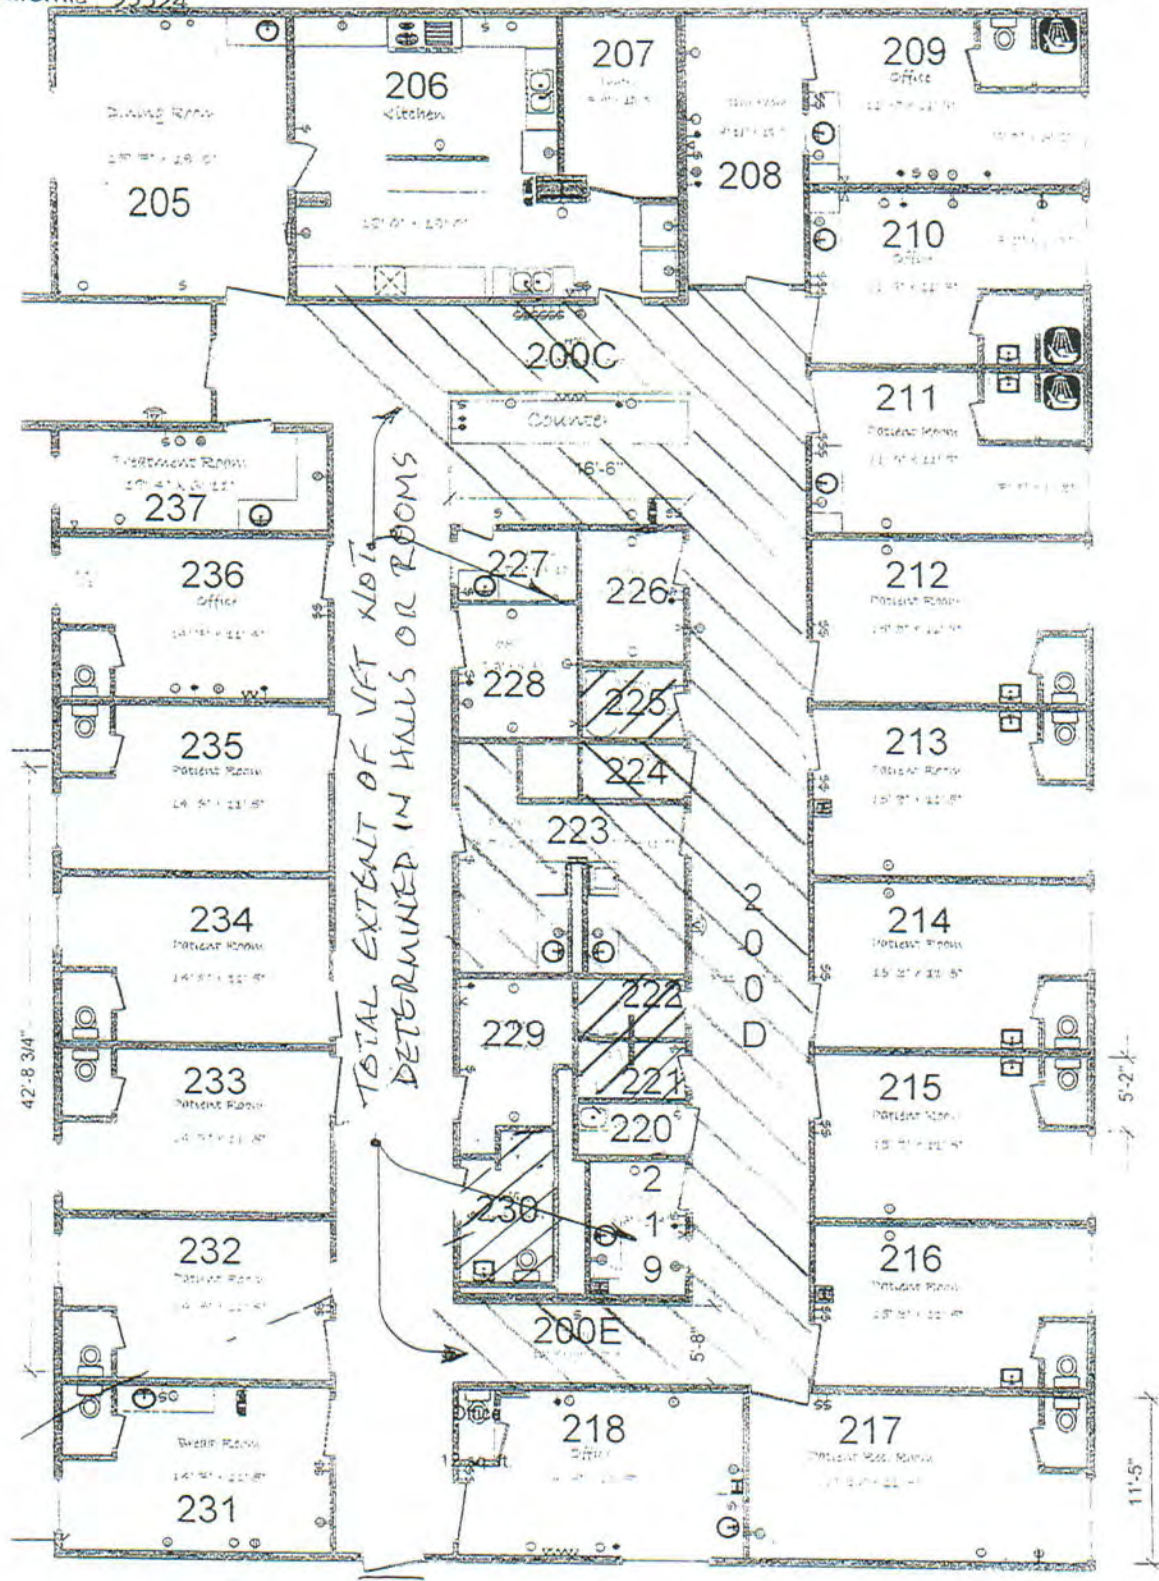
Second Floor

- ☒ ACM plaster and tile grout. Also denotes lead containing ceramic tile.
- ☒ ACM VFT, light brown 9" x 9" / mastic. Except for room 224, total extent was not determined in other rooms and the hallways.

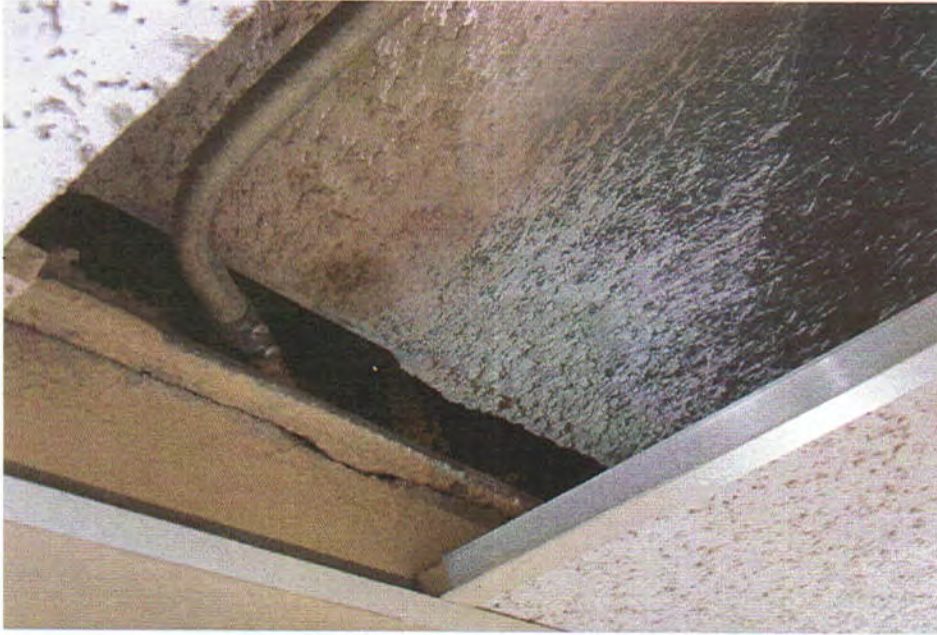
Top—Over-spray of ACM insulation above drop ceiling, 1st floor, east side of west corridor.1

Bottom—1st level roof over SE corner of Coroners offices, note silver ACM reflective paint on membrane, piping and all penetration seals/flashings.
