Jennifer Farley  
JAG Architects  
428 1st Street  
Eureka, CA 95501

At your request we have provided our professional opinion, based on one site inspection, for the historical integrity of those building structures at 281 Table Bluff Rd., Loleta CA. There are five building on site, named for the purpose of this survey as: (1) Single Family Residence, (2) Stable, (3) Garage, (4) Animal Pen and (5) Barn. (See attached annotated image, Figure 1.2)

## **Introduction**

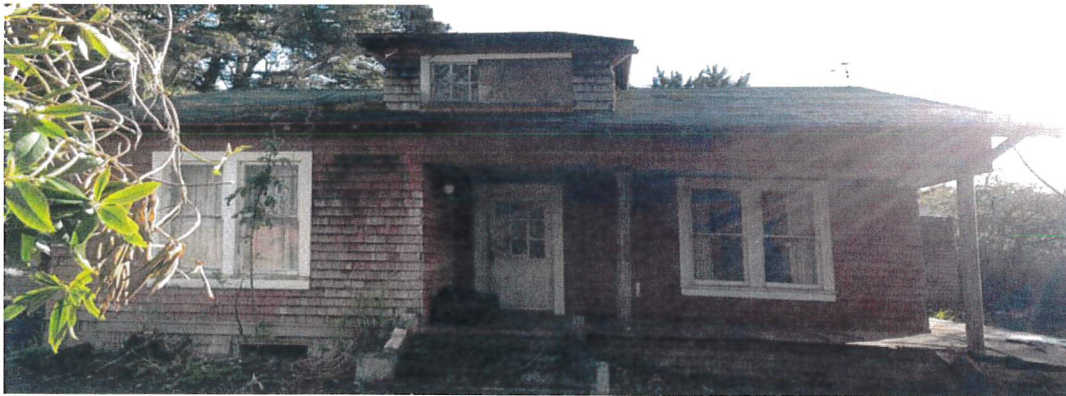
Figure 1.3 Single Family House, South Elevation

**(1) Single Family Residence** The residence is a single story structure with attic, built primarily on a wood foundation. Observation of the exterior shows that either a chimney or stove was removed from the West elevation of the house. There are twenty exterior windows: six single sash windows appear to be original. As noted, a window of similar construction is observed in the barn structure. Two aluminum windows were added with the mud room. Four triple pane contemporary windows are located in the Sun room. The eight remaining wood windows, do not appear to be significant. The mud room looks to be an addition which is indicated by the change in exterior siding, and the use of a concrete foundation, see Figure 1.6. Large sections of the exterior siding, including the porch and North elevation have been re-shingled. Remaining material is estimated to be fifty percent original. All original door hardware has been removed. Plumbing and electricity were added, surface mounted on the exterior of the house. No character defining molding or tile is found on the interior of the house. A new asphalt shingle roof was added. The deck is plywood and badly deteriorated beyond repair. The interior flooring and wall coverings are insignificant. No original hardware remains.

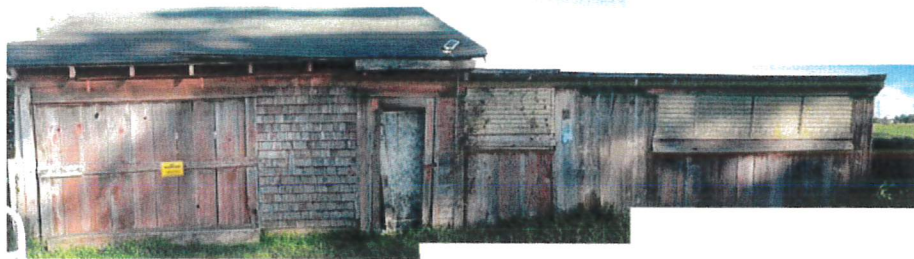
Figure 2.1 Stable, East Elevation

**(2) Stable** The stable was originally a smaller structure, with an addition. It was originally built with wood shingles over wood framing. The roof, like the rest of the structures on site has been repaired and or replaced by asphalt shingles. A majority of the stable is a later addition, built with a concrete foundation and vertical siding. The windows have been boarded up with corrugated metal. The interior has been gutted and the stall partitions replaced with metal gating.

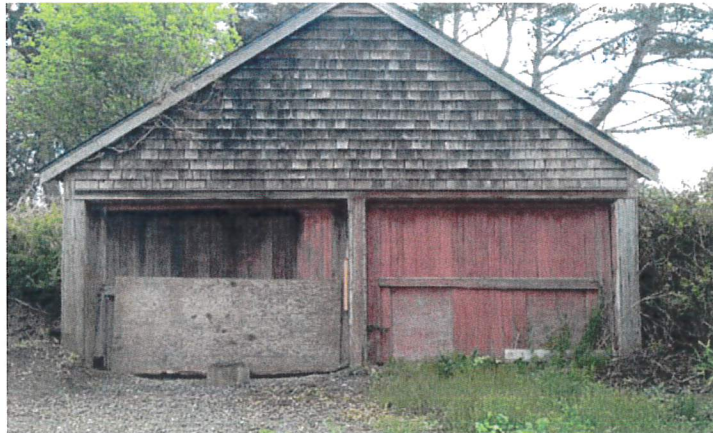
Figure 3.1 Garage, South Elevation

**(3) Garage** The garage seems to be a later addition. The size of the shingles used, is not comparative to the original fabric of the single family residence and barn, indicating that they are not historic. The gabled roof was constructed with vent-less eaves, not in context with the method of construction used on the stable. The asphalt shingle roof, matches the rest of the structures.

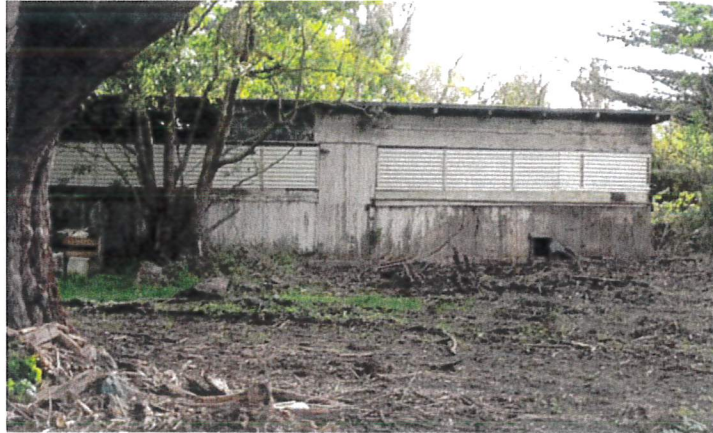
**(4) Animal Pen** The Animal pen is a newer addition. It has a concrete foundation and vertical siding. The windows have been boarded up with corrugated metal.

Figure 4.2 Corrugated Metal

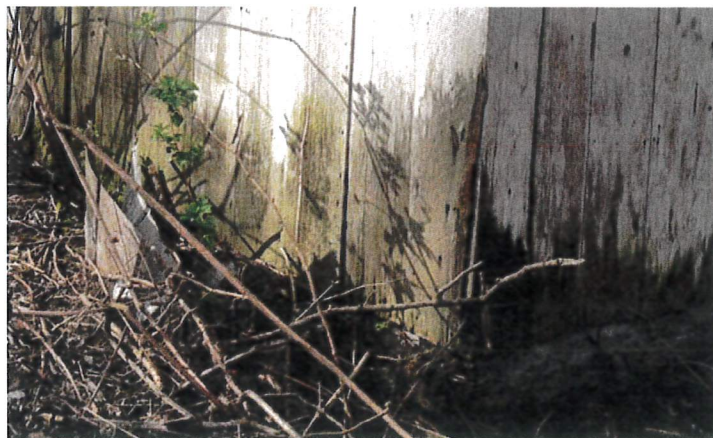
Figure 4.1 Concrete Foundation

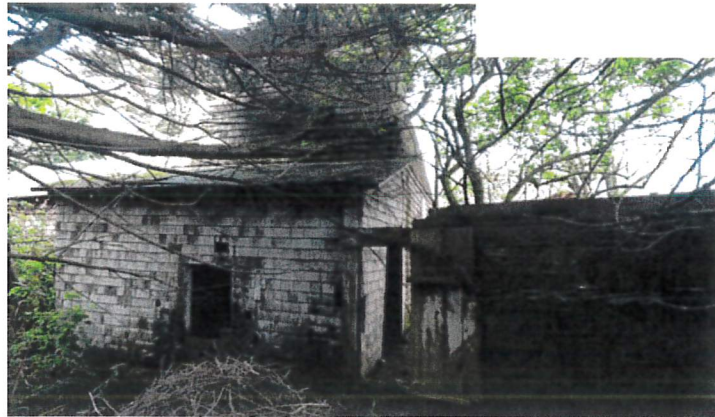
Figure 5.1 Barn, North Elevation

**(5) Barn** The barn has a unique shape. It has a vented roof, possibly original but has recently been covered with asphalt shingles. It is suspected that this new roofing material has covered any access to the original hay loft, as there is no visible entrance into the top half of the structure. The exterior retains a majority of its original shingles, but the structure is dilapidated to the point of unsafe access. Parts of the interior have been renovated with wall paper and a roughly constructed shelving system. There is one original wood window, matching the structure to the single family residence. All exterior doors are missing, and in several cases, so are the frames.
