Jennifer Farley JAG Architects 428 1st Street Eureka, CA 95501

April 17, 2012

At your request we have provided our professional opinion, based on one site inspection, for the historical integrity of those building structures at 281 Table Bluff Rd., Loleta CA. There are five building on site, named for the purpose of this survey as: (1) Single Family Residence, (2) Stable, (3) Garage, (4) Animal Pen and (5)Barn. (See attached annotated image, Figure 1.2)

The purpose of this report is to document the presence of historical resources, if any, located at 281 Table Bluff Road, Loleta CA, and to determine their significance, provide findings and recommendations.

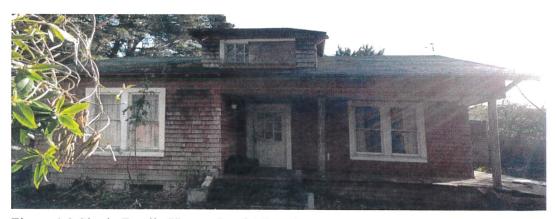
Figure 1.3 Single Family House, South Elevation

- (1) Single Family Residence The residence is a single story structure with attic, built primarily on a wood foundation. Observation of the exterior shows that either a chimney or stove was removed from the West elevation of the house. There are twenty exterior windows: six single sash windows appear to be original. As noted, a window of similar construction is observed in the barn structure. Two aluminum windows were added with the mud room. Four triple pane contemporary windows are located in the Sun room. The eight remaining wood windows, do not appear to be significant. The mud room looks to be an addition which is indicated by the change in exterior siding, and the use of a concrete foundation, see Figure 1.6. Large sections of the exterior siding, including the porch and North elevation have been re-shingled. Remaining material is estimated to be fifty percent original. All original door hardware has been removed. Plumbing and electricity were added, surface mounted on the exterior of the house. No character defining molding or tile is found on the interior of the house. A new asphalt shingle roof was added. The deck is plywood and badly deteriorated beyond repair. The interior flooring and wall coverings are insignificant. No original hardware remains.

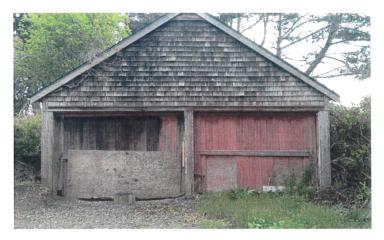
Figure 3.1 Garage, South Elevation

- (3) Garage The garage seems to be a later addition. The size of the shingles used, is not comparative to the original fabric of the single family residence and barn, indicating that they are not historic. The gabled roof was constructed with vent-less eaves, not in context with the method of construction used on the stable. The asphalt shingle roof, matches the rest of the structures.

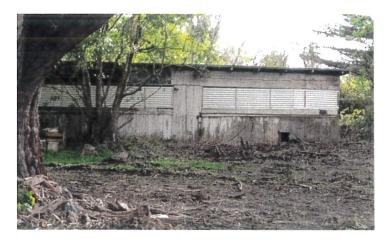
Figure 4.2 Corrugated Metal

- **(4) Animal Pen** The Animal pen is a newer addition. It has a concrete foundation and vertical siding. The windows have been boarded up with corrugated metal.

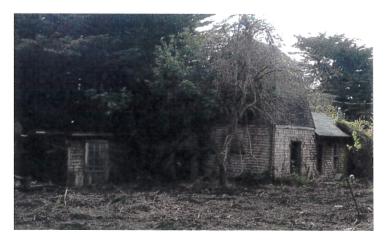
Figure 5.2 Barn, South Elevation

- (5) Barn The barn has a unique shape. It has a vented roof, possibly original but has recently been covered with asphalt shingles. It is suspected that this new roofing material has covered any access to the original hay loft, as there is no visible entrance into the top half of the structure. The exterior retains a majority of its original shingles, but the structure is dilapidated to the point of unsafe access. Parts of the interior have been renovated with wall paper and a roughly constructed shelving system. There is one original wood window, matching the structure to the single family residence. All exterior doors are missing, and in several cases, so are the frames.
