ALL POINTS
 SIGN REPAIR
 HIGHWAY 101
 BETWEEN EUREKA & ARCATA

Client: Allpoints Signs, Owner

Project: Sign Repair

Highway 101 Between Eureka and Arcata
Eureka, CA.

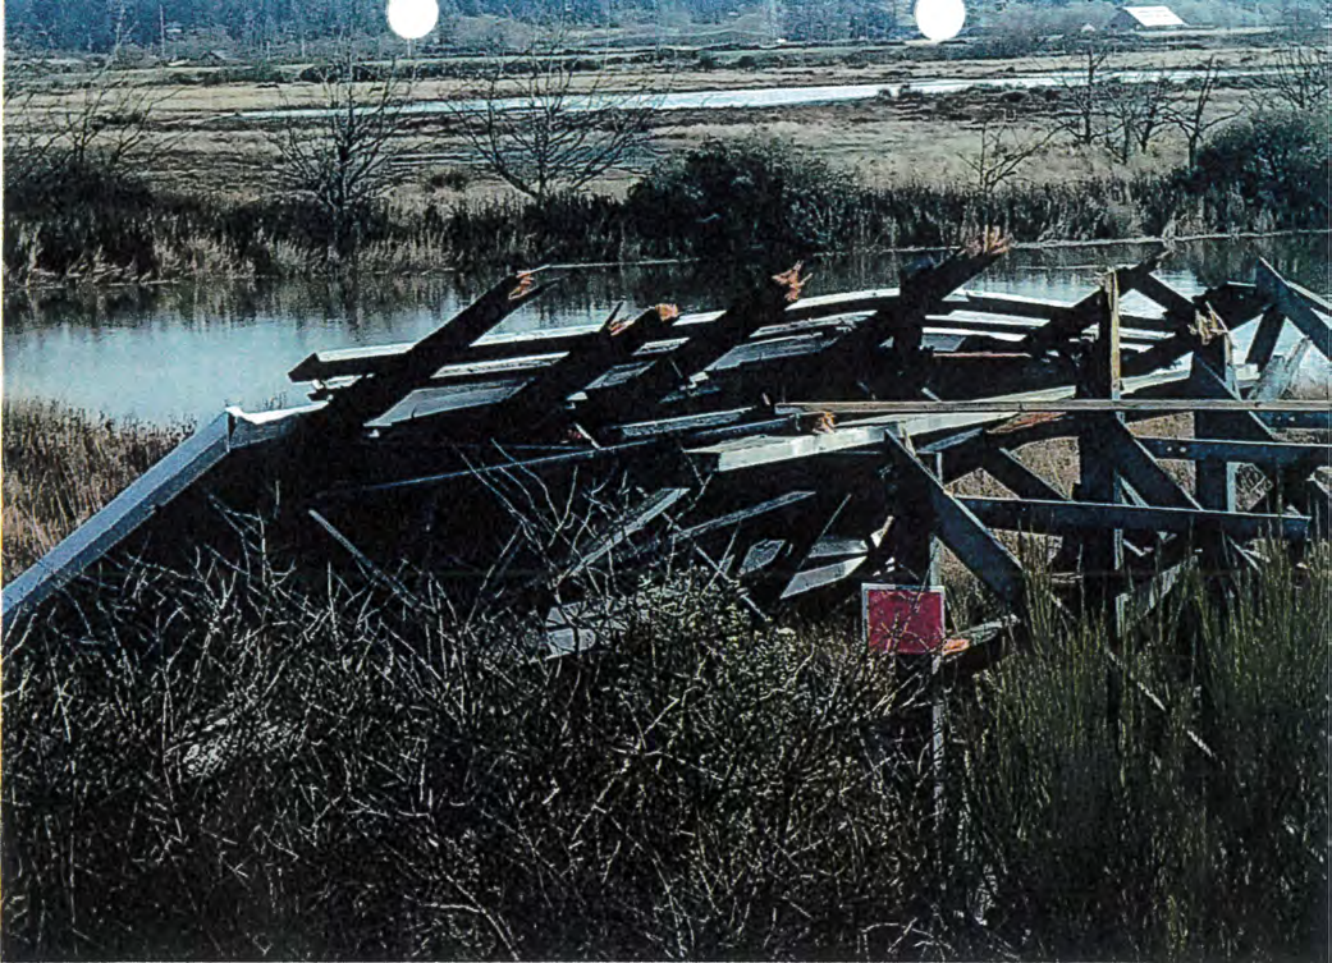
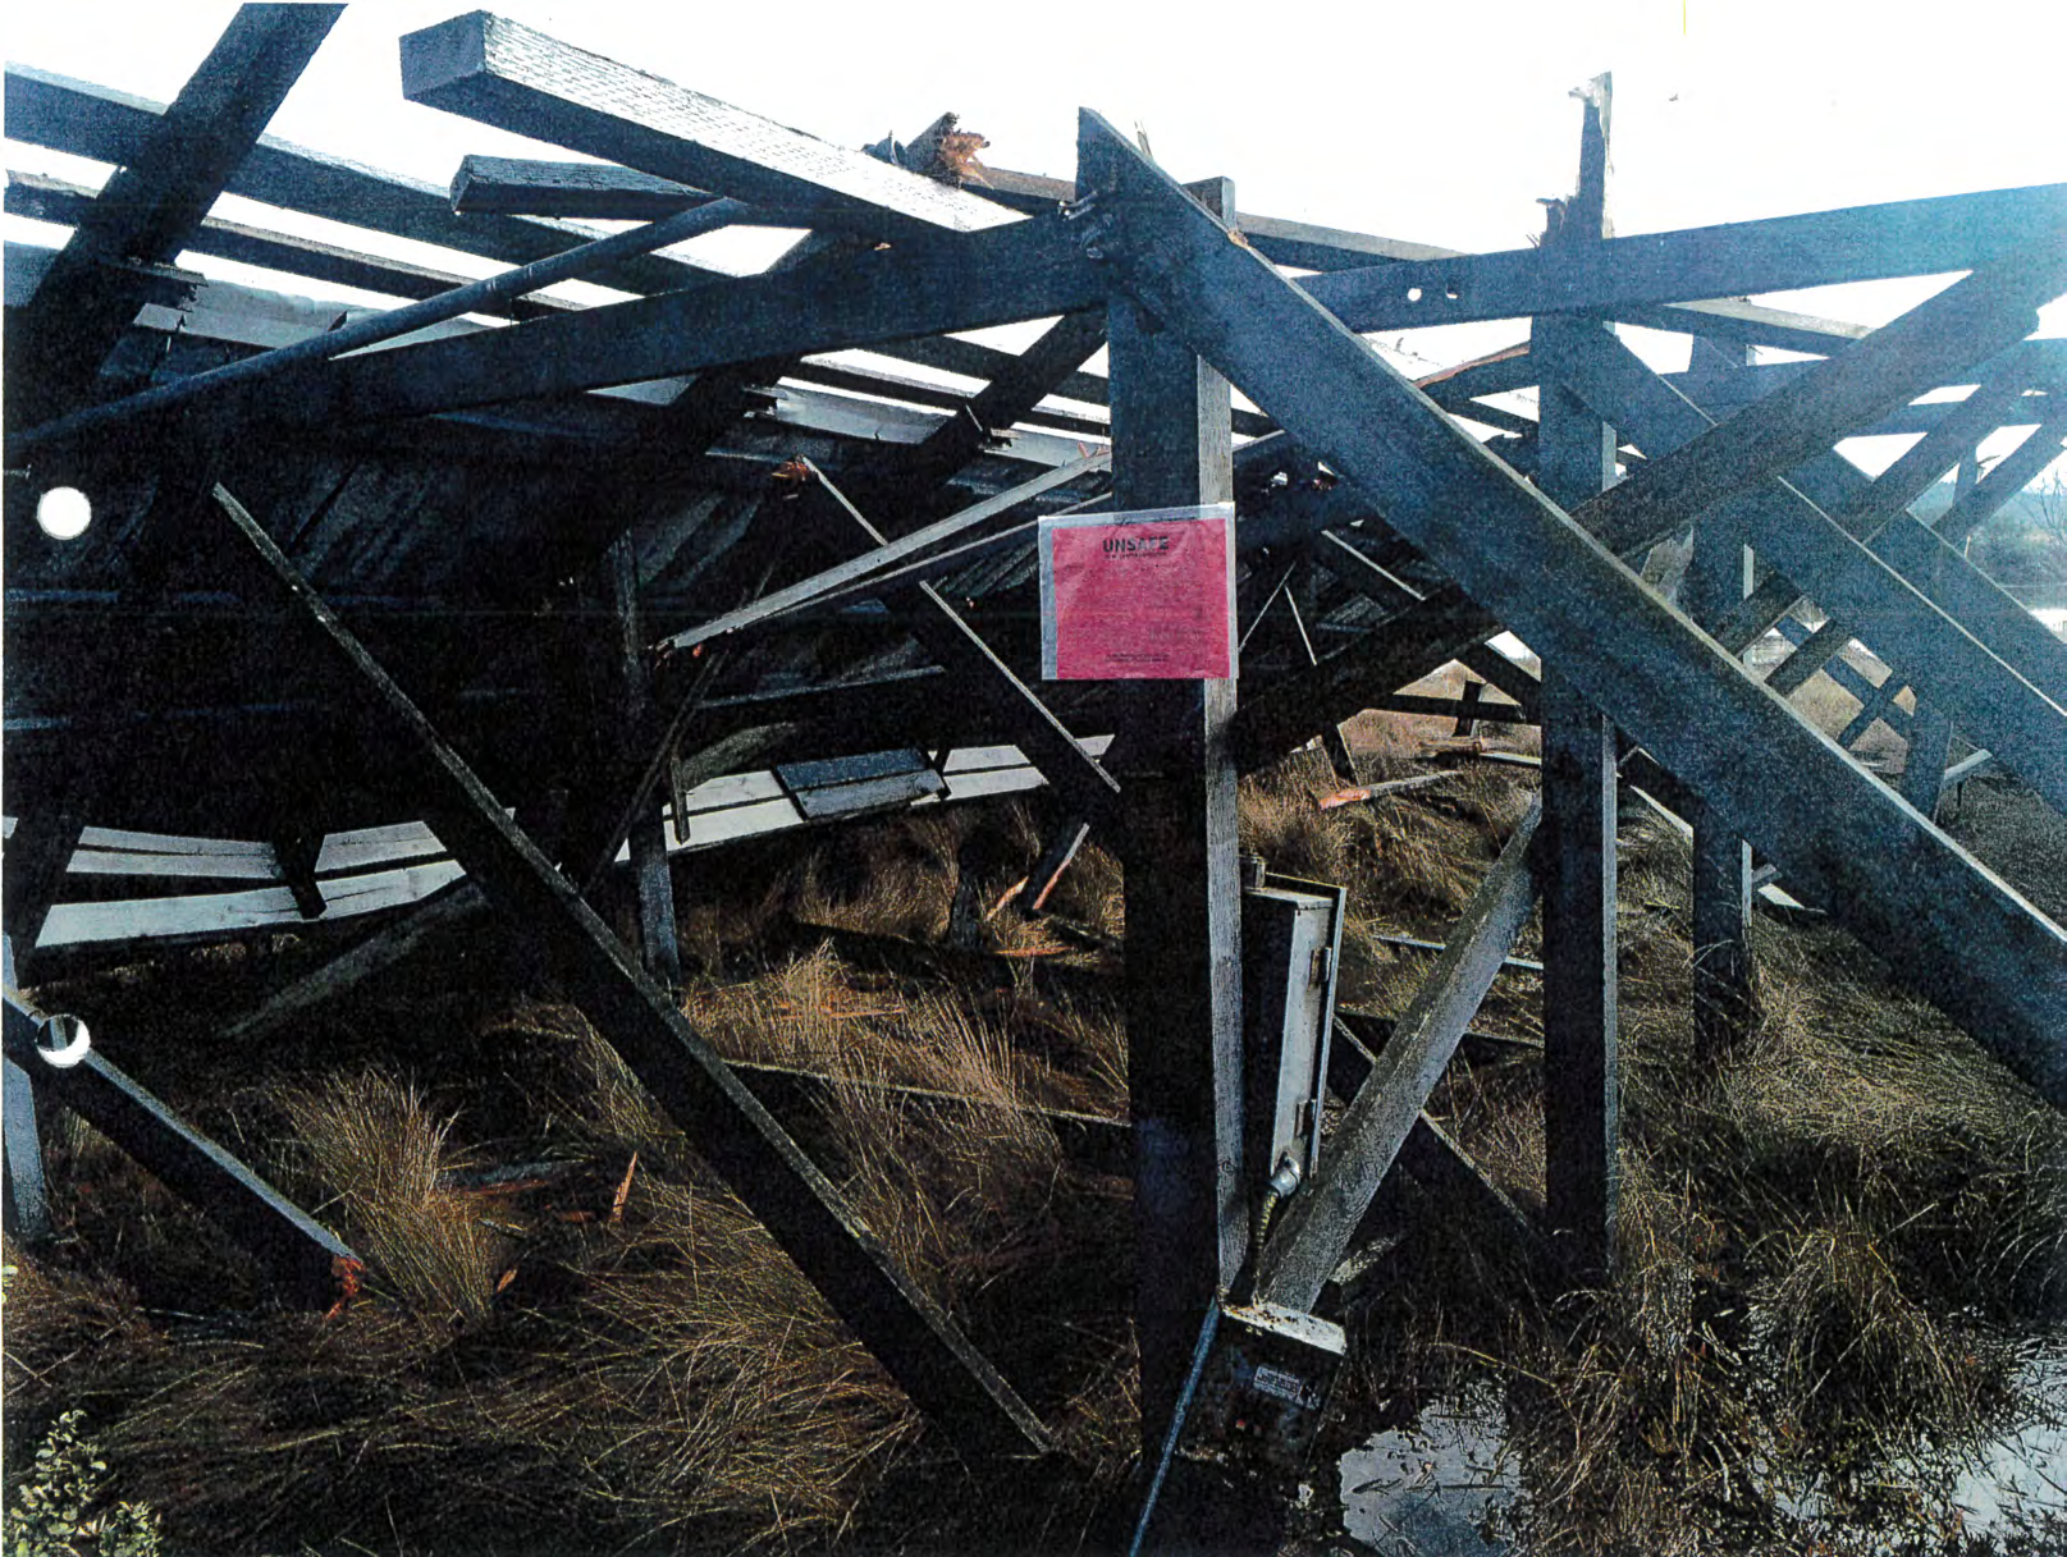
UNSAFE
DO NOT ENTER
This structure is unsafe for use.
All users are advised to avoid this structure.
If you see this sign, please report it to the appropriate authority.

2. Once all non-usable parts are removed we will begin repairing the structure. This billboard actually broke about 8' up the post so in this case it looks like 6-9 of the vertical uprights will be able to be reused. For the remaining 3-6 uprights we will remove old post & concrete and dig new holes in their location. If old post cannot be removed we will dig a new hole next to old post.

1. Crews will begin demoing all non reusable elements of the structure. This consist of using sawzalls to cut wood into sizes we are able to carry. Once small enough to carry all non-usable elements are stacked in a pile on the shoulder of the highway behind the guardrail.

3. Once all post holes are dug we set new upright in holes and hand mix bags of concrete into the hole one bag at a time.
4. Once all post are set you connect main post to back brace post.

5. Run new horizontal stringers connecting all main post.
6. Mount front and rear catwalks.
7. Sheet face with plywood
8. Install new billboard wrap.
