# HUMBOLDT COUNTY MOTOR POOL EQUIPMENT MAINTENANCE

Location: 3130 Jacobs Avenue, Eureka, CA 95501

Use: Motor Pool & Equipment Maintenance

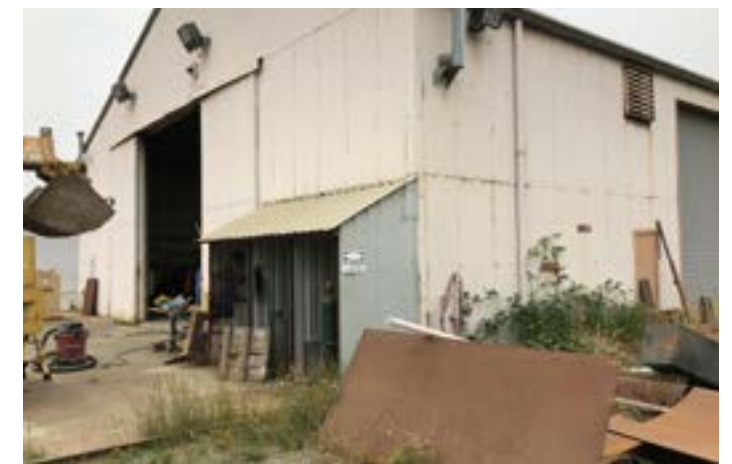
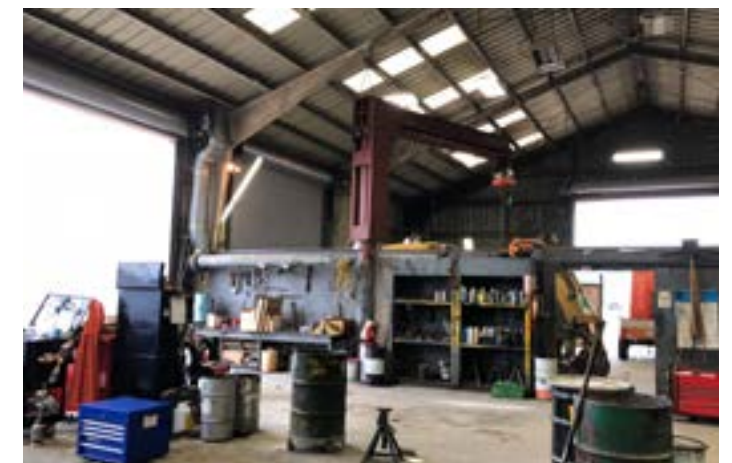
**Site:** Landscaping surrounding this facility is overgrown with mown ground cover patches and sprouting weeds in many places. Fences appear to be in acceptable condition but are covered in overgrown weeds especially at the back of the site. Some cracking and discoloration is evident on parking surfaces. Hoses and other equipment around the site has been improperly stored and/or concealed.

**Exterior Envelope:** Rusting is evident on some building cladding materials. Exterior man door hardware is corroded especially around the Tire Shop door.

**Roof:** Skylights have accumulated debris visible from below and are leaking in some places.

**Structure:** Bolted connections at steel column corners and some tension members show some surface rust and discoloration.

**Site:** Remediate weed growth as well as unhealthy and weedy ground cover. Repair cracks in asphalt if surface becomes uneven. Organize and store (or dispose of) equipment left out around the site.

**Exterior Envelope:** Replace rusted siding panels if rusting has compromised the structural integrity of the material. Replace frame and hardware at damaged man doors.

**Roof:** Clean debris from skylights to prevent further damage and repair or replace leaking skylights.

**Interior Elements:** Clean and possibly replace vinyl flooring before total separation occurs. Consider rearranging interior to maximize facility usage.

**MEP:** Upgrade fire suppression sprinkler system. Expand and/or update electrical system. Replace fluorescent lights with LED or similar fixtures.

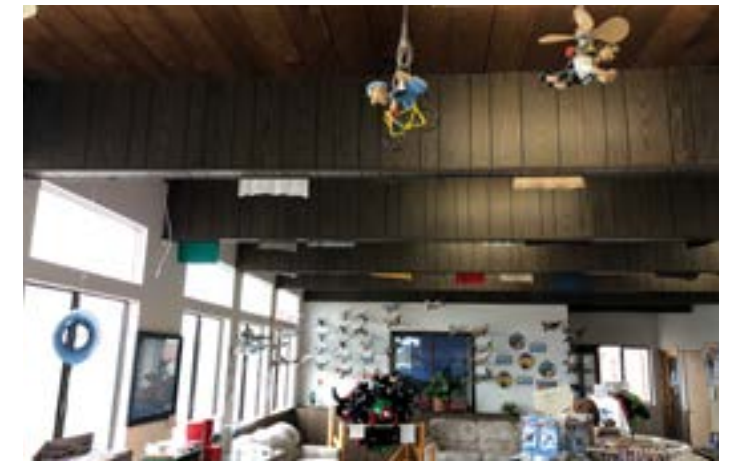
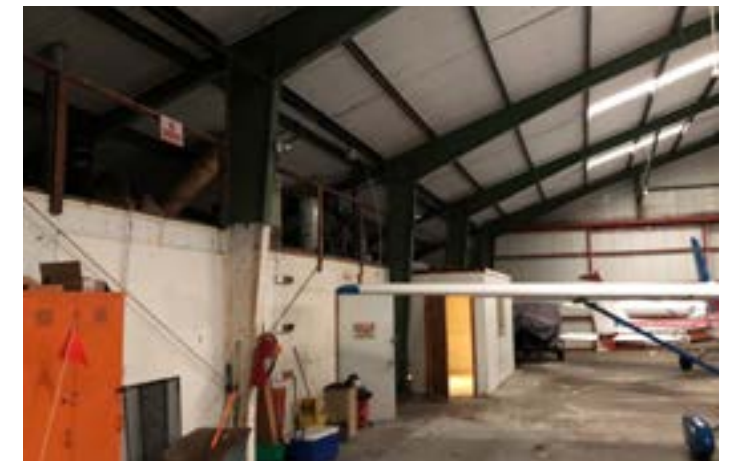
**Site:** Some cracking is visible in asphalt surrounding the building. Weeds are growing in asphalt cracks and near facility wall bases. Exterior light fixtures have accumulated mildew and are visibly aging. Panels and structure of the exterior phone booth are warped.

**Roof:** Some rusting is visible on the corrugated metal roof surface. Skylights have accumulated mildew and debris.

**Structure:** Rust is apparent on bolted corner connections of the steel structure. Paint over steel structure is peeling away due to rust in several areas. The structure is deteriorated at areas near the doors. There is some wood rot in the roof structure. Structure likely requires extensive renovation.

**Interior Elements:** Carpet in gift shop is stained in several places. Storage in hangars is a potential hazardous materials concern. Restaurant area is in fair condition with the exception of a dirty grease trap.

**Site:** Remediate unwanted plant growth around the building. Replace compromised exterior light fixtures. Replace or remove deteriorating exterior phone booth.

**Exterior Envelope:** Repaint metal siding with suitably durable exterior paint. Replace inefficient windows as possible especially in heavily trafficked areas. Investigate exterior sliding door track issues, replace track hardware if possible and replace entire door panel as well if necessary.

**Roof:** Replace rusted roof panels and consider full roof replacement. Clean skylights to prevent damage.

**Interior Elements:** Clean and replace carpeting in gift shop. Organize and create proper storage for materials in the storage hangar. Clean and maintain grease trap in restaurant area prior to tenant moving in.

**MEP:** Update lighting throughout the facility.

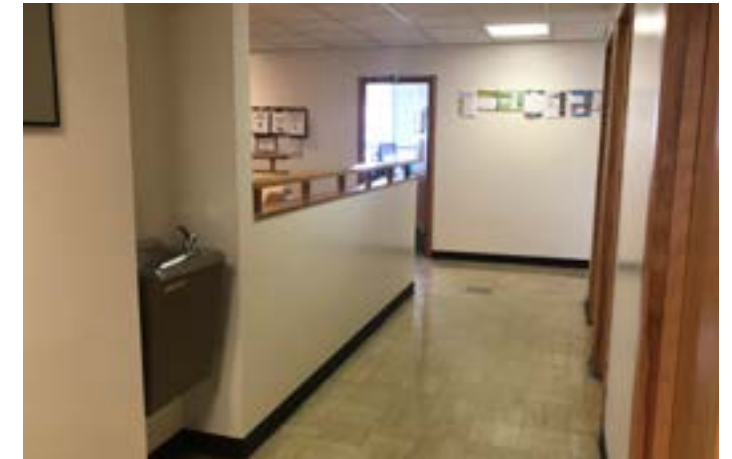
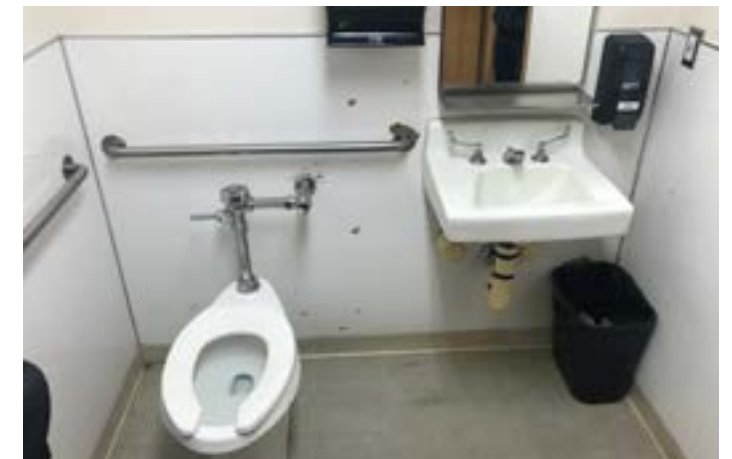
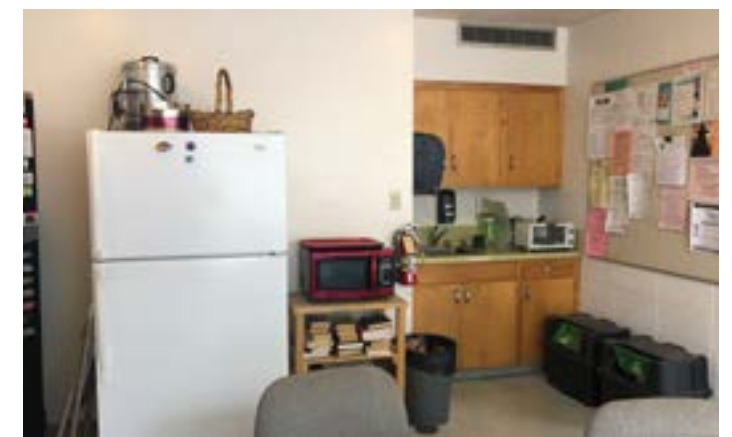
**Site:** Weeds are growing between cracks in sidewalk, curbing and pavement. Primary ground cover plants are dying and there are weeds growing throughout grass and mulch areas.

**Exterior Envelope:** Exterior envelope appears to be in acceptable condition although some discoloration and potential damage was observed at roof eaves and the edges of roof flashing. Single pane windows in the facility are inefficient and have deteriorating seam materials. Paint is peeling and faded in areas.

**Interior Elements:** Flooring materials on carpeted interior stairs are discolored and worn down. Some discoloration is also apparent in vinyl flooring at reception counter area and around vending machine/kitchen areas. Insulation in mechanical room is tearing away from the ceiling especially around the roof access hatch. Some wall partitions in stair areas have peeling paint and very visible wear and tear. Wainscot in toilet area is ripped and torn especially in corners and around wall mounted accessory points of contact. Discoloration and added insulation around plumbing fixtures implies possible leakage.

**Exterior Envelope:** Investigate and mediate discoloration at roof eaves and flashing. Replacement of windows is optional.

**Interior Elements:** Replace carpet on stairs with more durable and slip resistant material. Clean and potentially replace damaged vinyl flooring tiles. Secure detaching insulation in mechanical room to the ceiling. Repaint deteriorated wall partition caps. Replace compromised restroom wall material. Investigate leaking plumbing and replace as necessary.

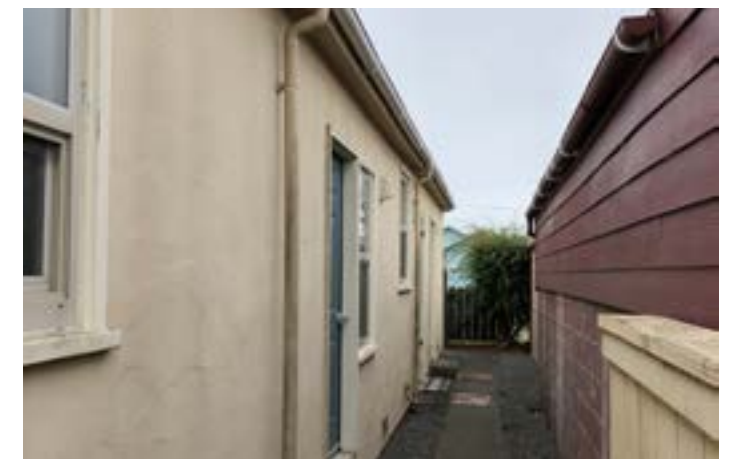
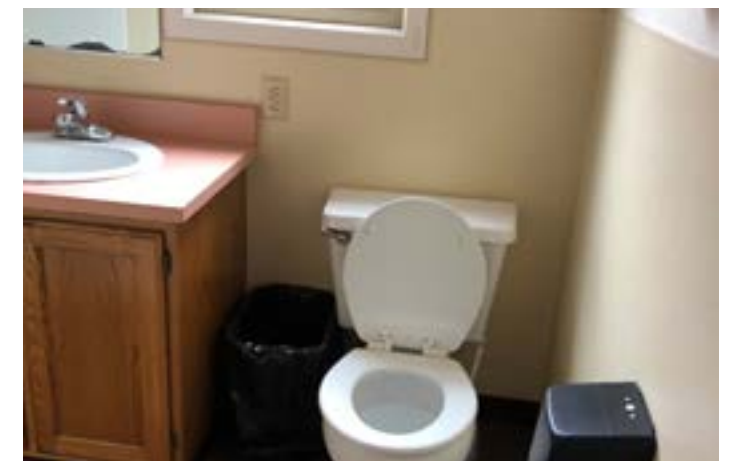
**Site:** Fence hardware is rusted especially around latch. Ground cover has weeds and some dead patches. Asphalt parking areas and walkways show cracking with weeds growing in cracks. Exterior light fixtures are dirty and could be updated.

**Exterior Envelope:** Some cracking is present in exterior wall finish with heavy weathering apparent around windows that are missing trim on backside of the facility. Deterioration and accumulated mildew is present at roof fascia around gutters. Single pane windows are inefficient and show cracking and discoloration around some seams. Ground level venting is dented and shows heavy wear and signs of incomplete repair.

**Roof:** Roof surface appears to be in functional condition. Paint is peeling from metal gutters and downspouts in some places and some downspouts are cracked at their ground level outlet.

**Interior Elements:** Replace restroom mirror and consider accessibility improvements to kitchen and other areas.

**MEP:** Investigate functionality of facility systems, update or maintain as needed.
