July 16, 2019

**NOTIFICATION NO. 1600-2015-0100-R1 – PROJECT INSPECTION REPORT**

Subject: Engineering-Geologic Review; Existing Agricultural Pond, AP #208-241-017  
Timberline Ranch Estates, Unit P-134, County Line Rd., Mad River, California

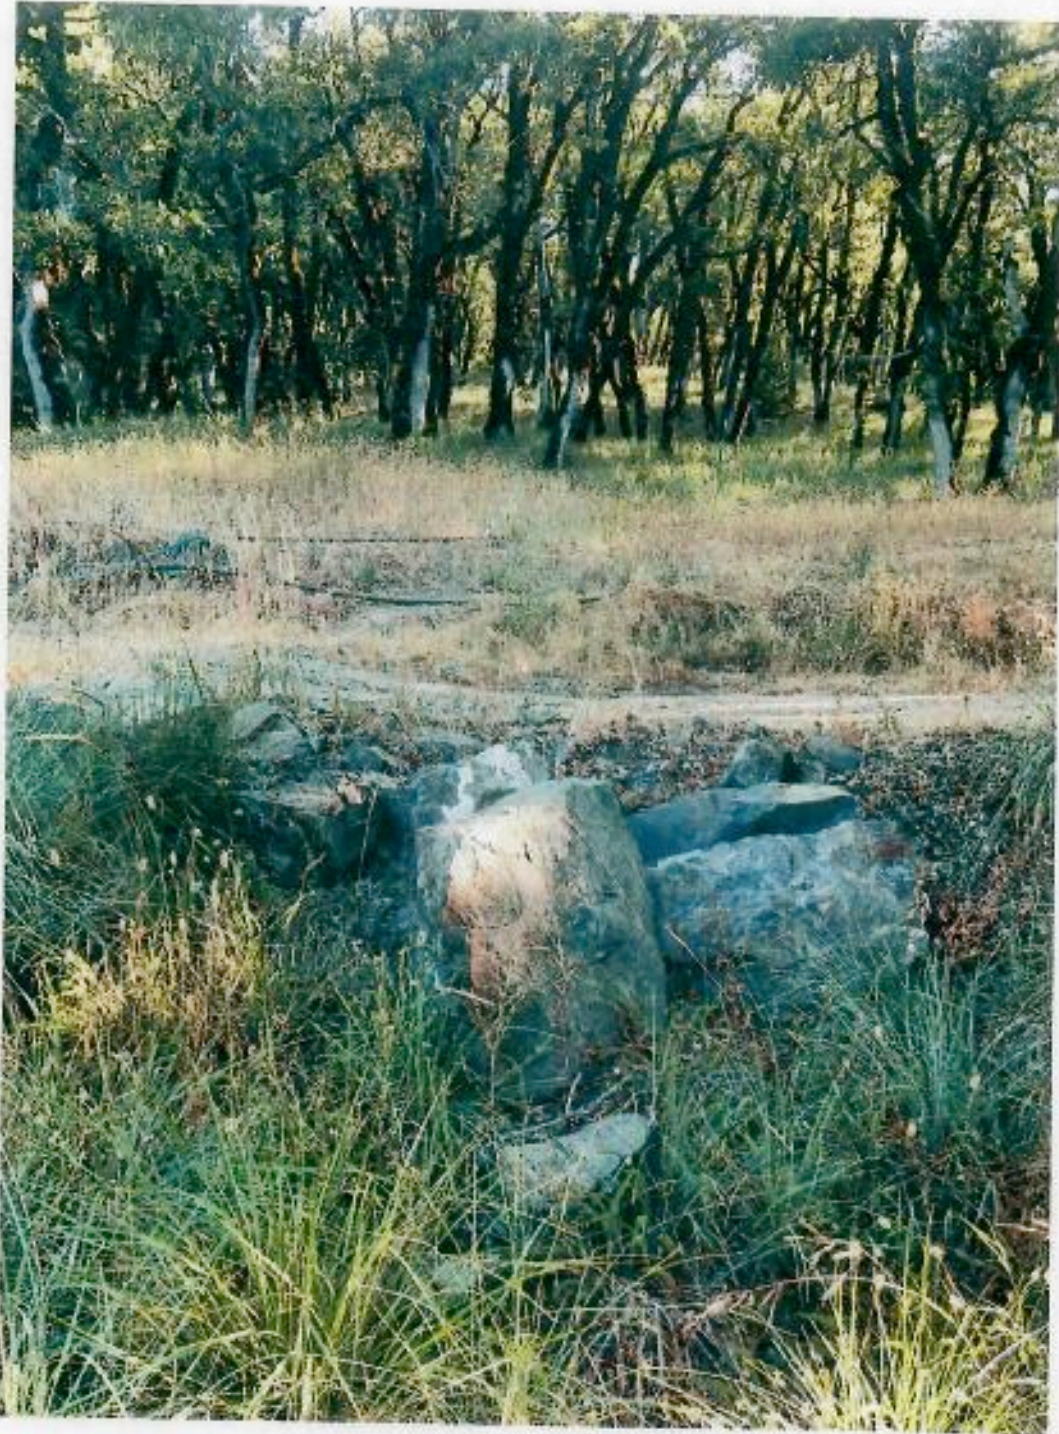
**Crossing #1:** The rocked ford was installed by the former landowner/Applicant per the specifications stated in the notification and agreement. See attached photographs. TRC recommends maintenance in the form of rocking the approaches to provide a stable operating surface. TRC will be preparing the Site Management Plan and this shall be a recommendation.

Outlet of Rock Ford – Crossing #1. Photo date: 7-16-2019

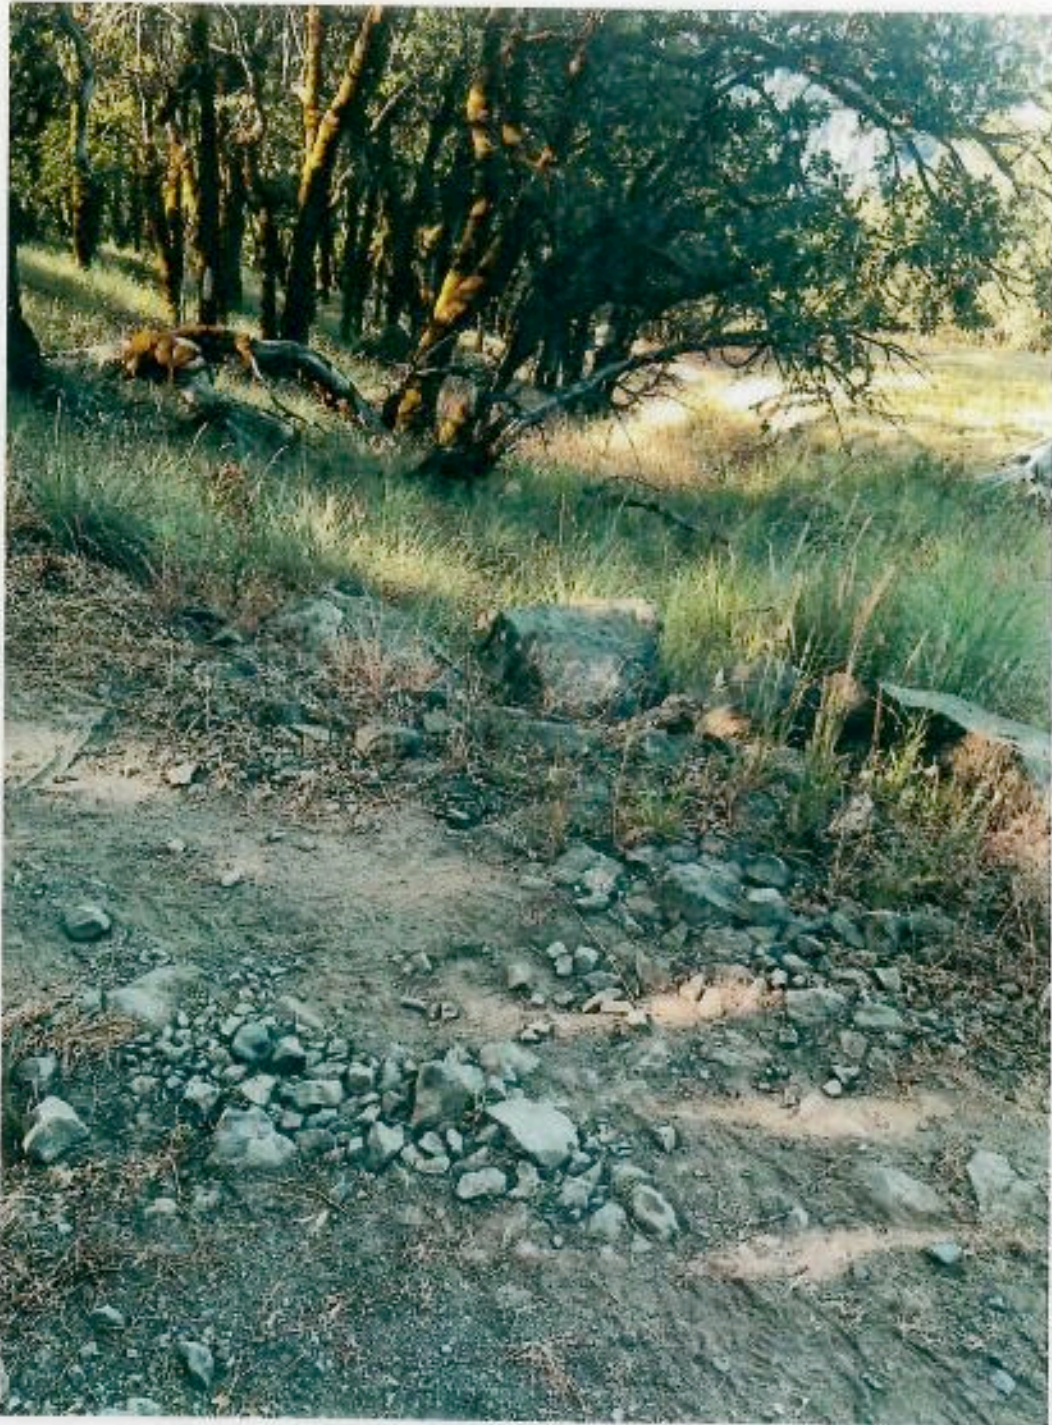
Outlet of Rock Ford – Crossing #1. Note pulverized rock and dust, which shall be addressed by adding more surface rock to the approaches. Photo date: 7-16-2019

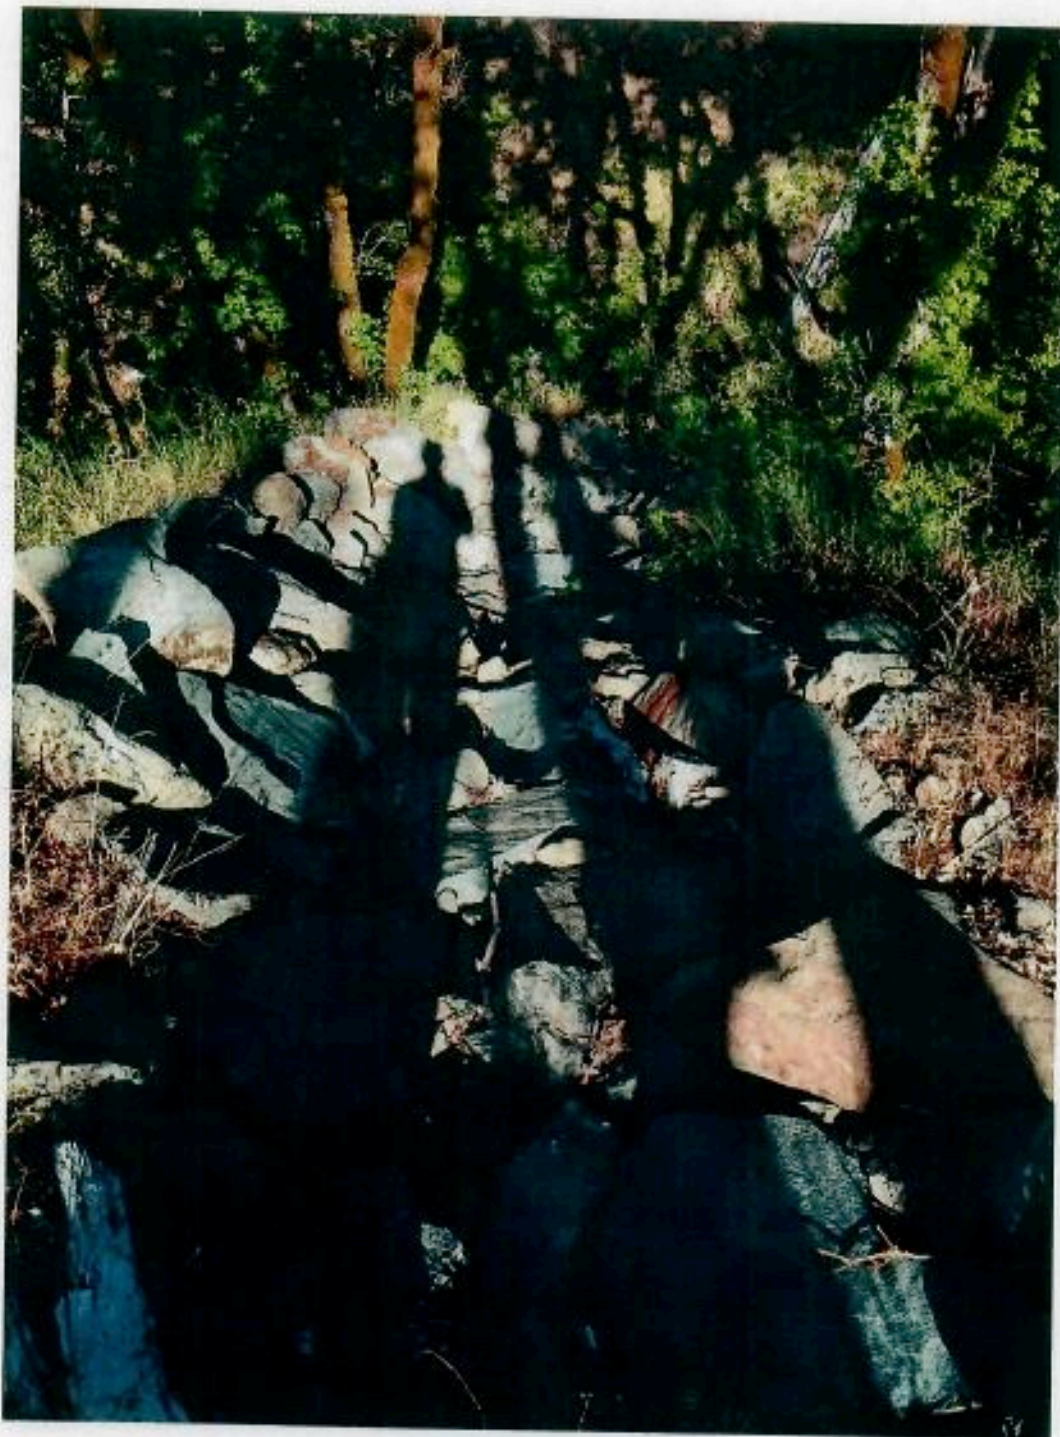
**Pond Inspection:** See attached Engineering-Geologic Review. All of the CEG's recommendations have been implemented by the former landowner/Applicant as follows: (1) Freeboard was increased to 2-feet; (2) Pond spillway was reconstructed with 1/8-1/16-ton boulders over geotextile; (3) Pond lined with Bentonite, and (4) Erosion control was applied post reconstruction. See attached photographs.

Rock-lined V-ditch-Pond Spillway. Photo date: 7-16-2019

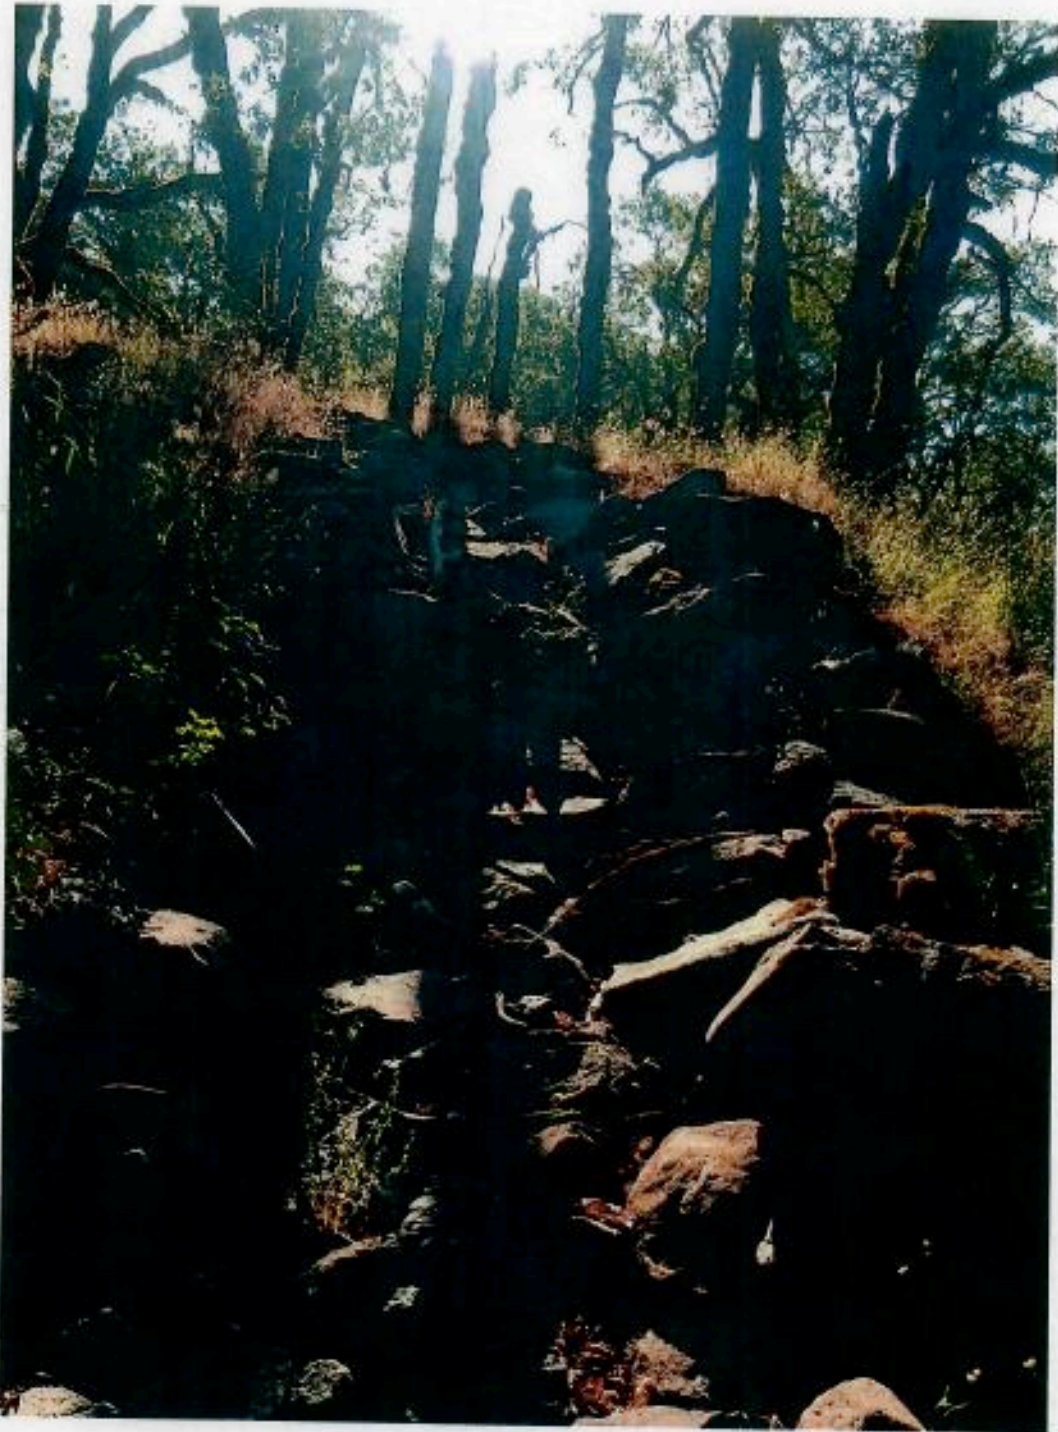
Rock-lined V-ditch-Pond Spillway. Photo date: 7-16-2019

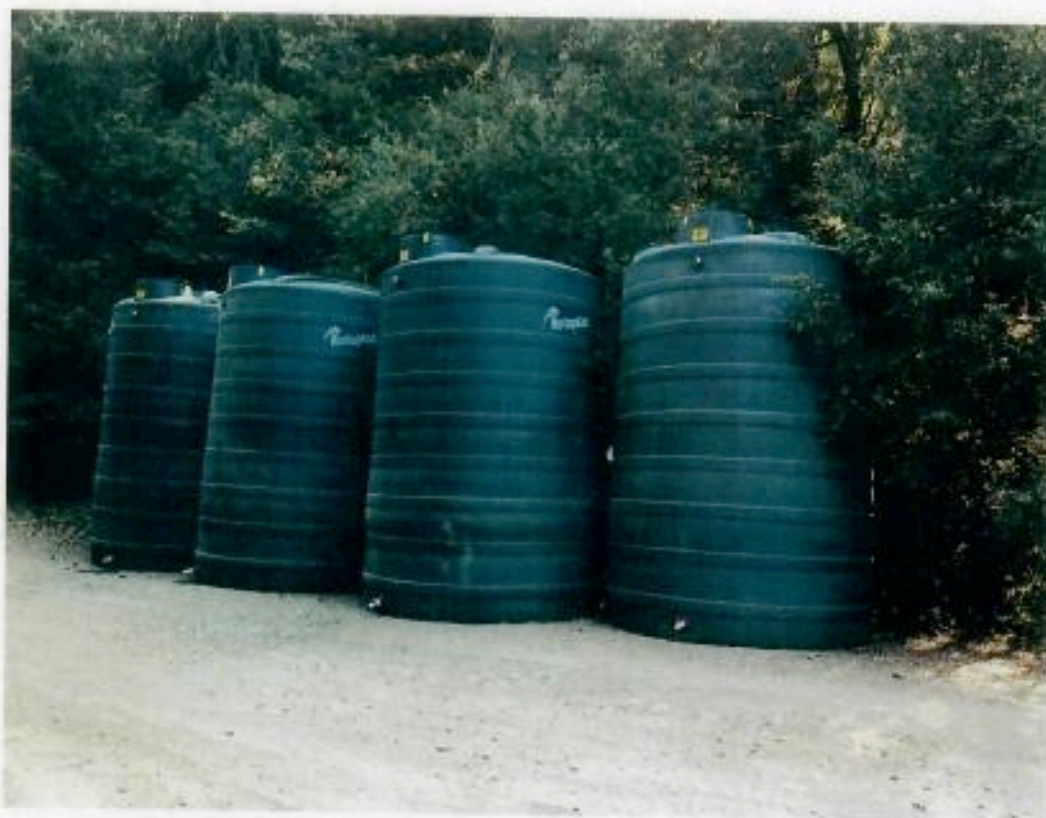
**Forbearance Period:** There is presently 93,750 gallons of hard plastic storage; 20,000 gallons of which was recently added by the new owner. In addition, there is an estimated 300,000 gallons of impounded water in the Class III on-stream pond. The new owner is permitted for 4,050 ft<sup>2</sup> of mixed-light and 7,650 ft<sup>2</sup> of outdoor. There appears to be enough stored water to serve the cultivation site.

Four 5,000-gallon plastic tanks recently added to the property, which were not part of the original notification.
