App# 12030-CUP16

Timberland Conversion Evaluation Report

Legal Description of Ownership: **PARCEL 43 TIMBERLINE RANCH EST RS BK 26 PG 135**
Address: **River Rd. off County Line Creek Rd. (USFS 1N15)**

APN(s): **208-221-006**
Section 28; T2N; R5E; HB&M; Humboldt County
Parcel Size: **Approximately 40 acres**
Acres Converted: **2.99 acres**

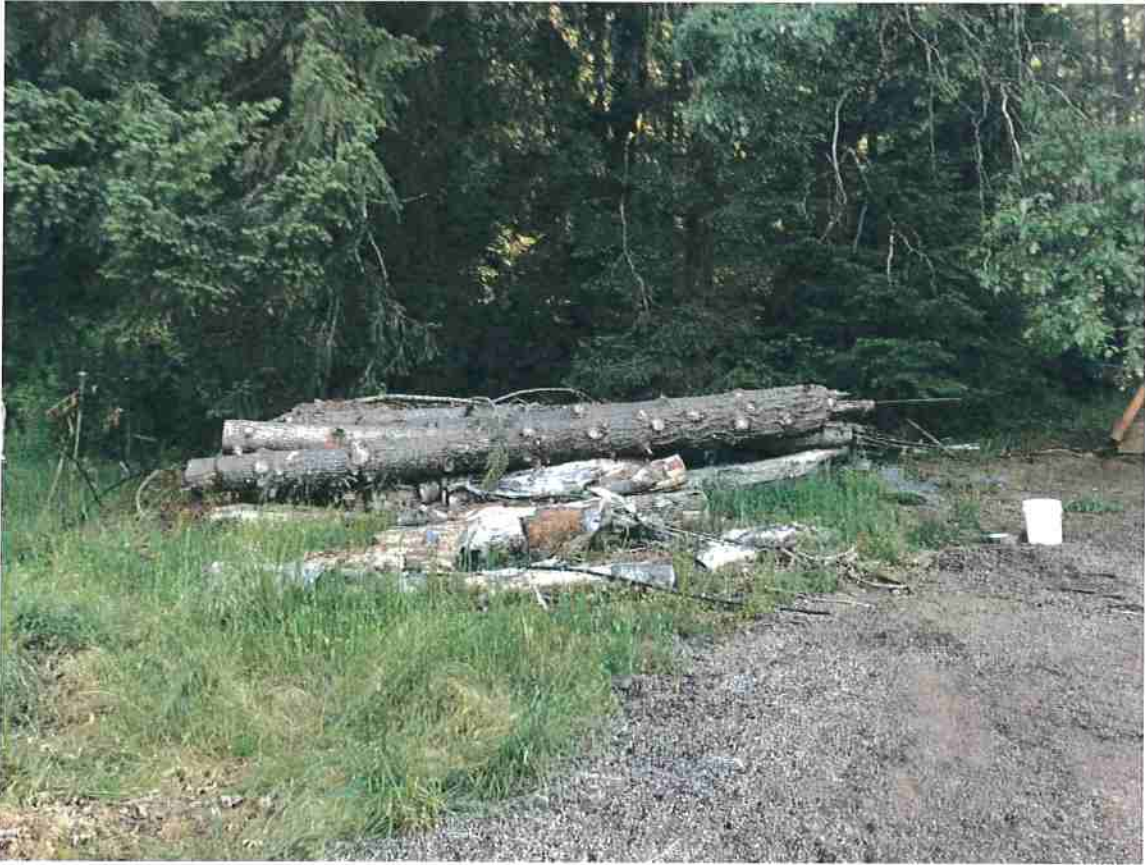
Photo 1. Observation Point 1(a) at Conversion Area #1 – Cut white oak and Douglas-fir trees stacked.

Recommendations: Cut sawlogs at Observation Sites 1(a), 2(a) and 3(b) to a minimum of 2 feet in length as per 14 CCR 1104.1(a)(2)(D)(1).

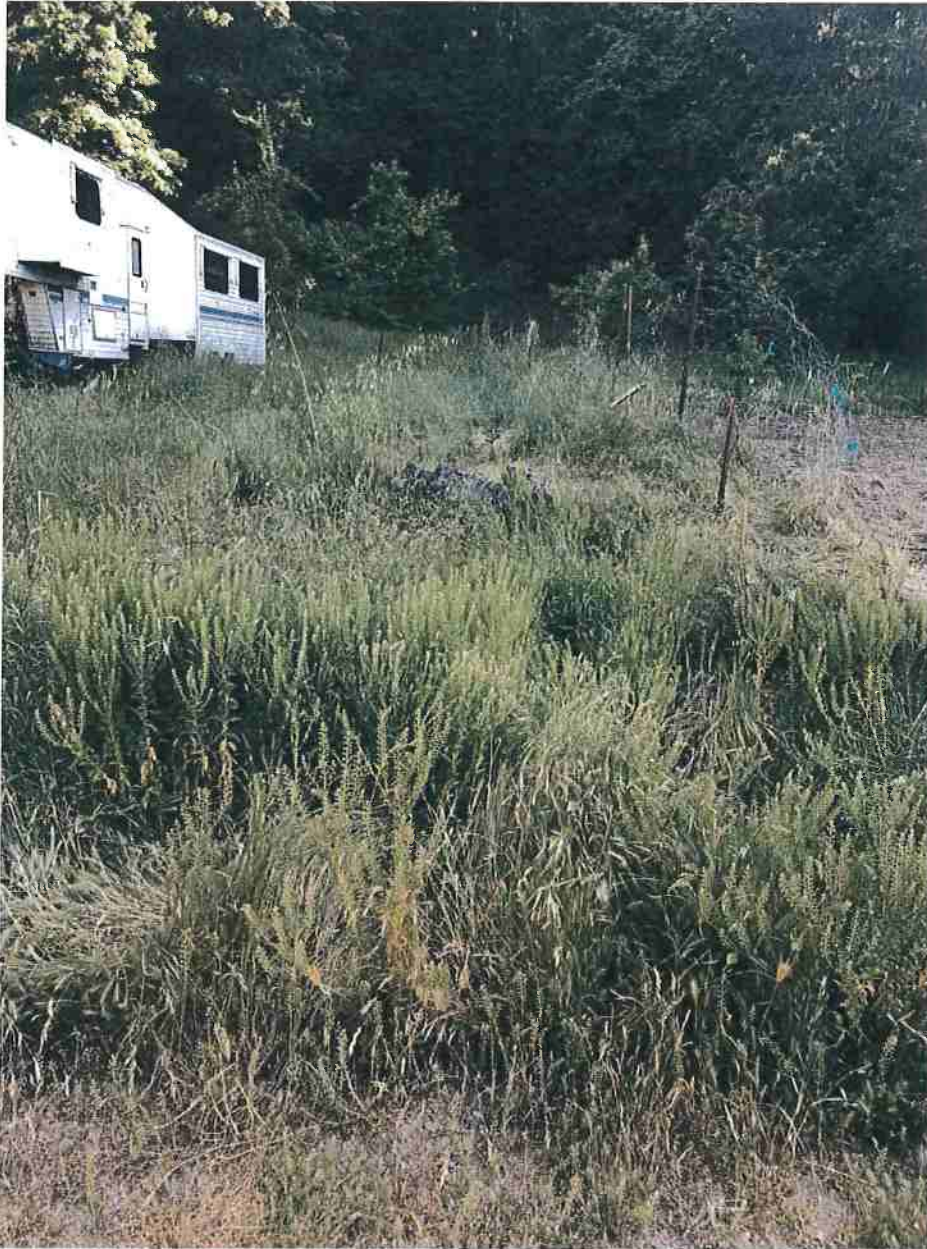
Photo 2. Looking upstream of the Class III watercourse from at watercourse crossing STX1 at Conversion Area #1.

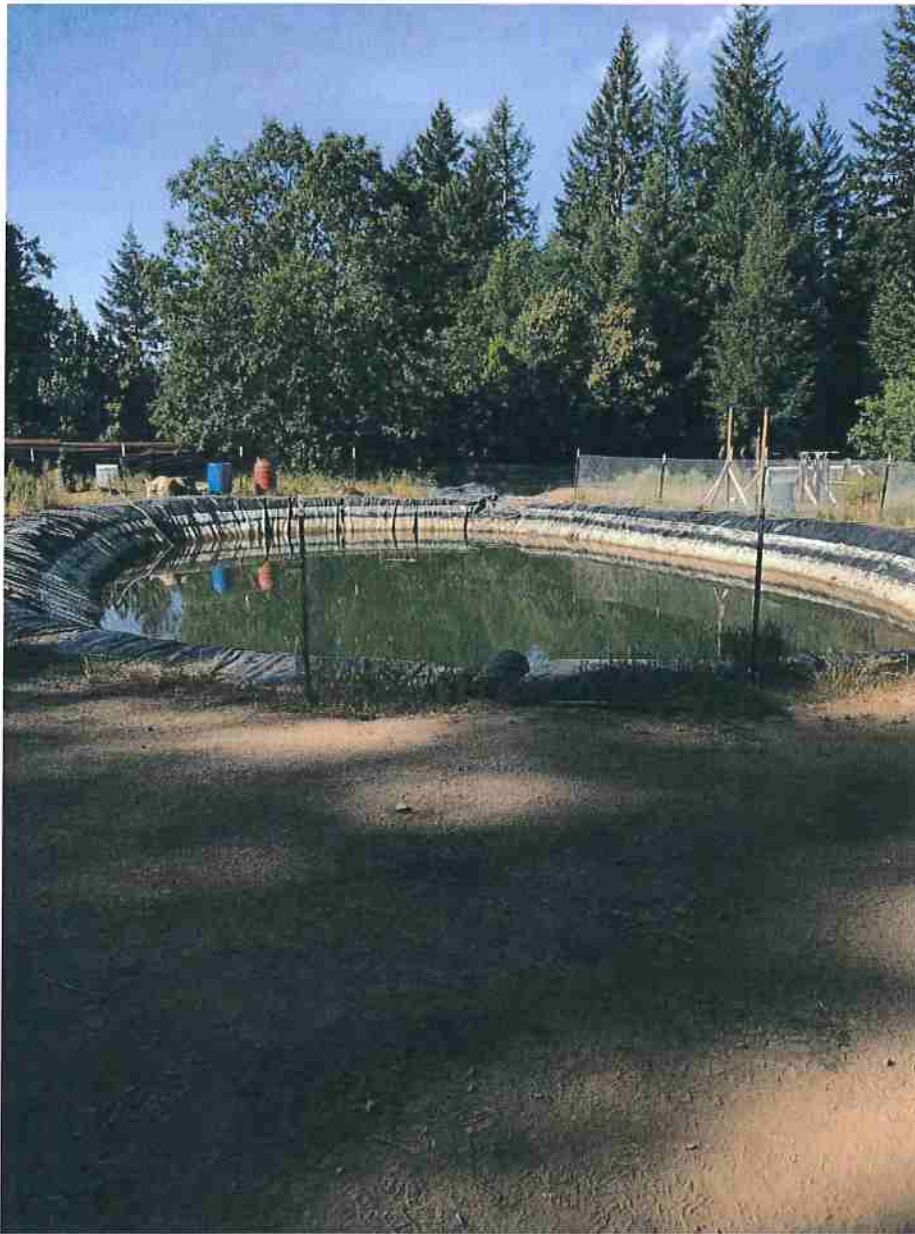
The oak tree or trees removed next to the Class III watercourse was minor in scale compared to other conversion activities that have occurred on the property. Because there were such a small number of trees (white oak) removed from the Class III watercourse WLPZ at the time of the pond construction, the RPF is not concerned about re-planting trees in an area where historically there was meadow habitat void of trees. The RPF does recommend that the pond be infilled, and the natural path of the original watercourse be re-established, and banks be seeded and mulched. When the culvert is placed to grade in the channel at STX1, the outlet should be rocked to minimize scouring where the channel is re-established.

Photo 3. Looking south at retaining pond constructed in channel of Class III watercourse (Observation Point 1(b)) from crossing STX1 at Conversion Area #1.

Site ID	Description	Recommendation
Observation Point <u>1(b)</u>	Trees removed and retaining pond constructed within the channel of a Class III watercourse.	Infill pond and restore a channel in the path of the original watercourse. Seed and mulch disturbed soil near channel banks.
Observation Point <u>3(a)</u>	Operations were conducted, and trees were removed from within 75 feet of a Class II Watercourse Protection Zone.	Restore to "timberland" as defined by PRC 4526. Immediately mulch and/or seed area to prevent further erosion. Replant area with Douglas-fir seedlings to comply with minimum stocking standards of 14CCR 912.7.

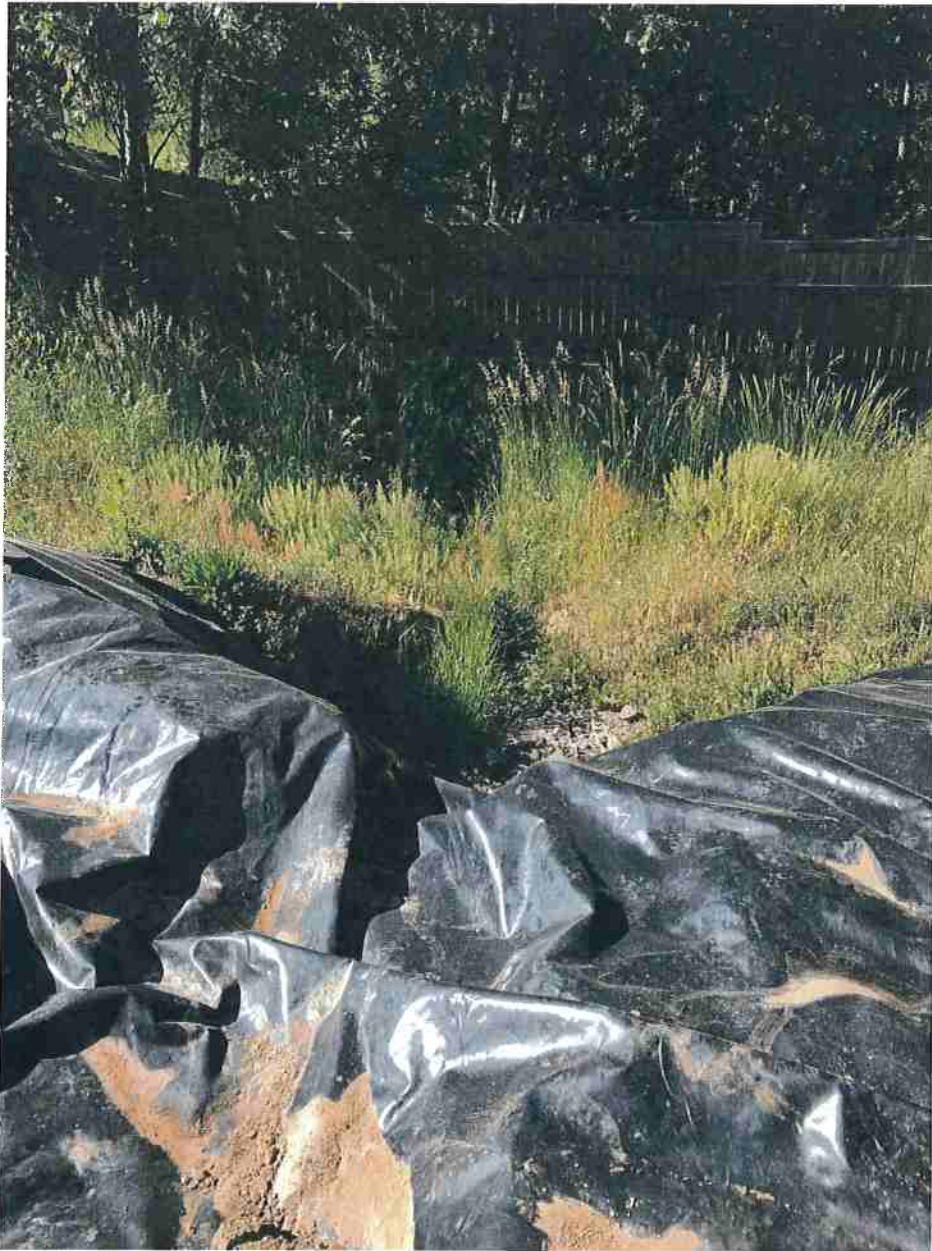
Photo 4. Looking south at spillway to Class III channel from retaining pond (Observation Point 1(b)) at Conversion Area #1.

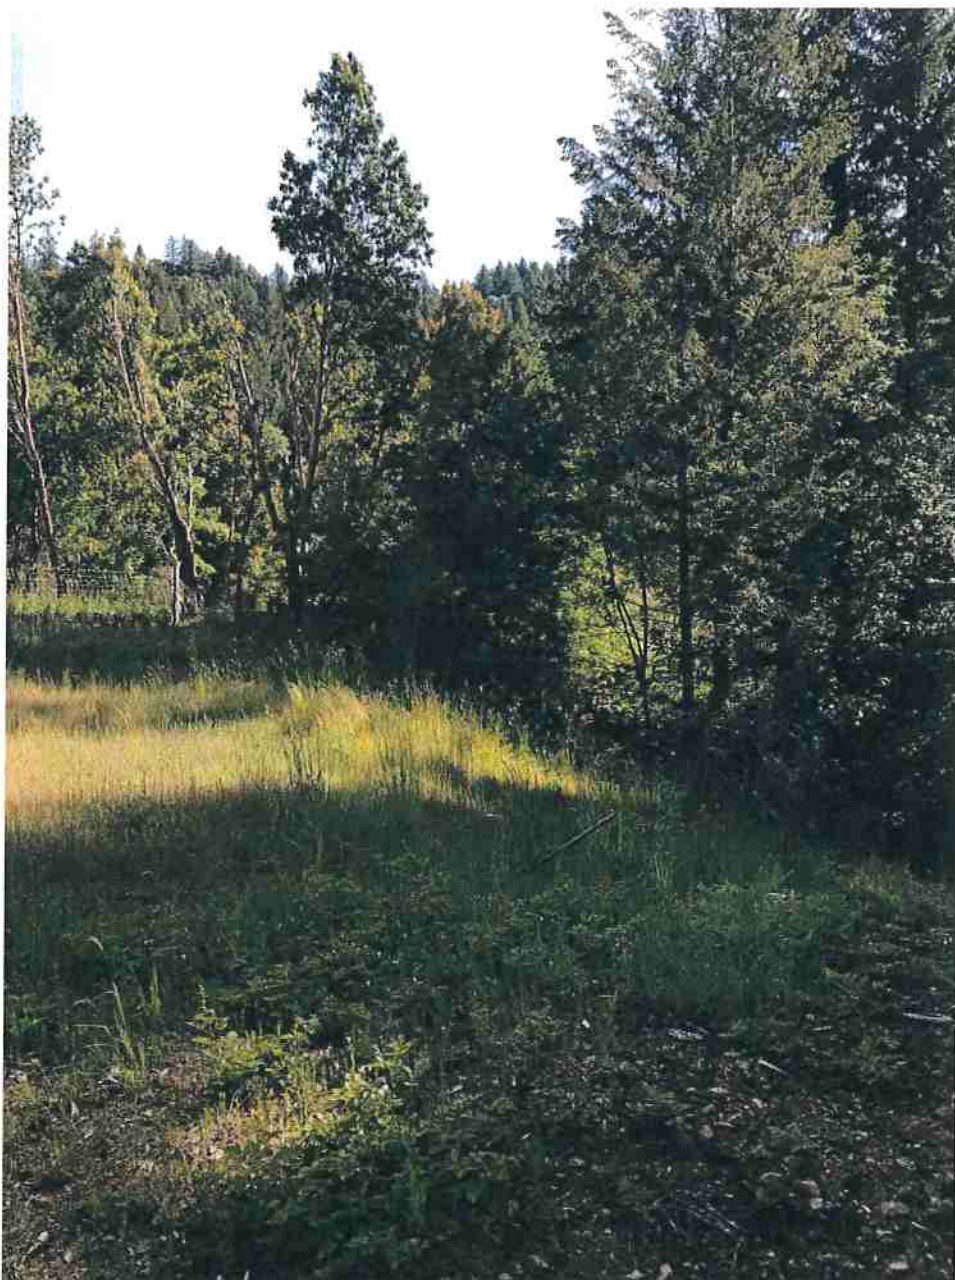
Timber harvesting occurred within the WLPZ of a Class II watercourse along the eastern side of Conversion Area #3 during the most recent conversion steps (Observation Point 3(a)). This was apparent from stumps seen within the required 75' WLPZ buffer for Class II streams as determined under 14CCR 916.5 (75' buffer was flagged on site visit). The RPF recommends that the area within 75' from the Class II watercourse transition line be restored to "timberland" as defined by PRC 4526. Immediately mulch and/or seed area to prevent further erosion. Replant area with seedlings to comply with minimum stocking standards of 14CCR 912.7.

Photo 5. Class II WLPZ area along the eastern boundary of Conversion Area #3 (Observation Point 3(a)).

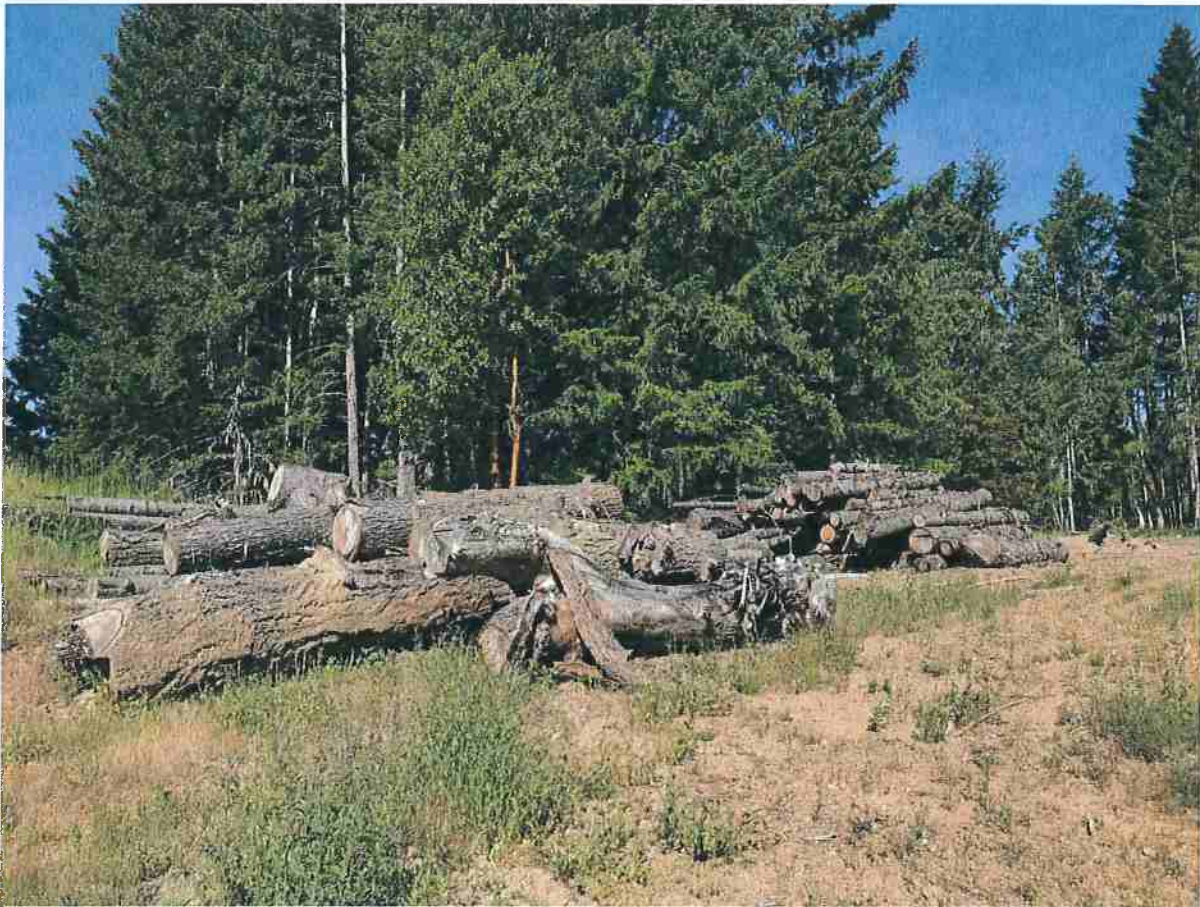
Photo 6. Observation Point 3(b) – log deck from timber operations conducted at Conversion Area #3.

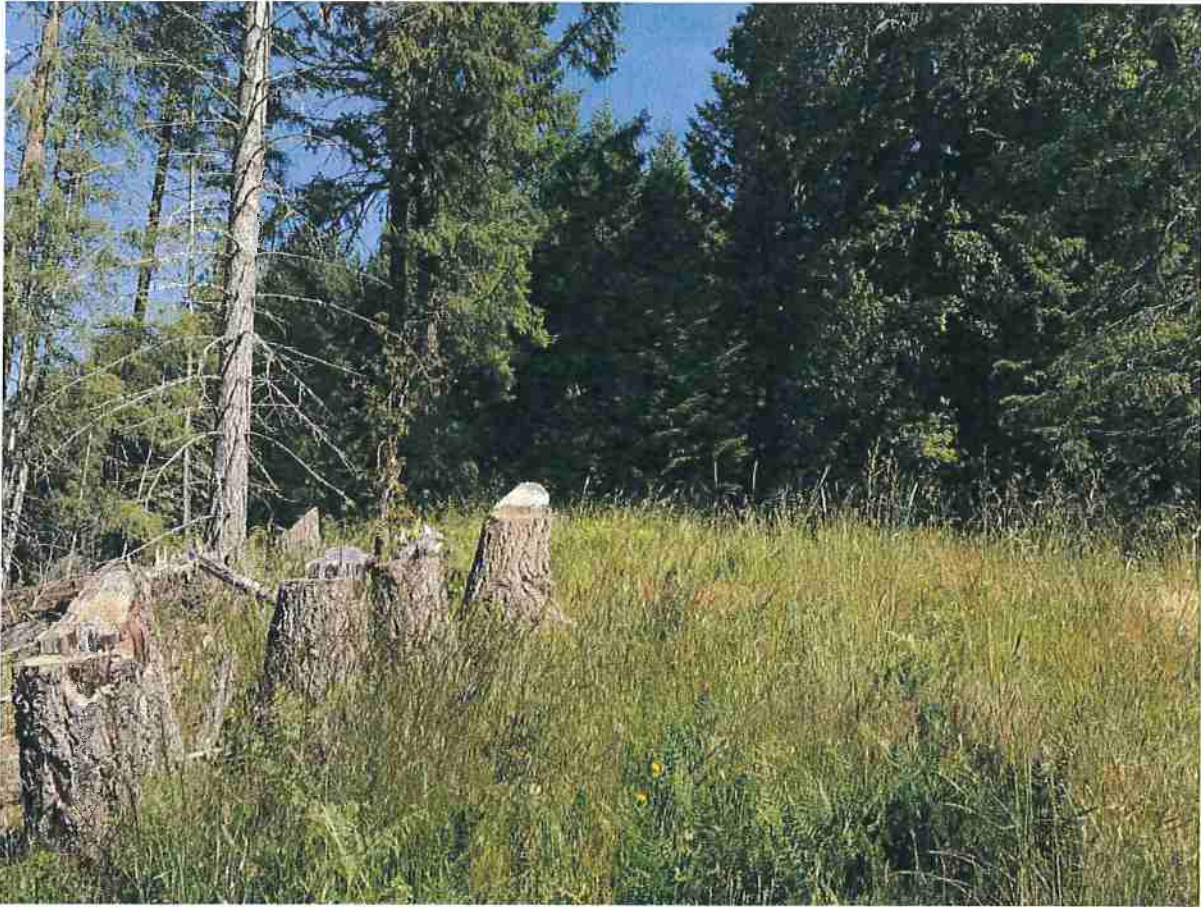
Photo 7. Stumps resulting from timberland conversion activities on the western slope of Conversion Area #3.

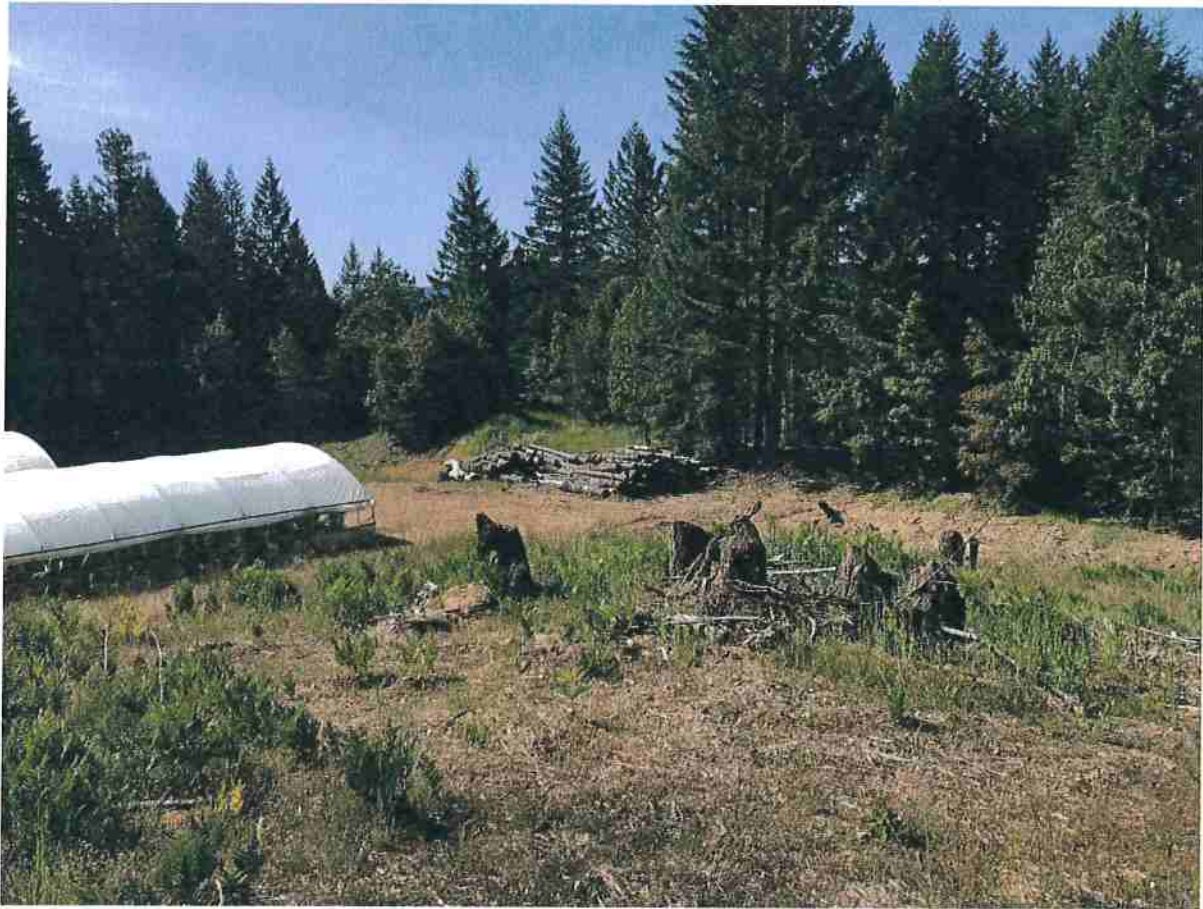
Photo 8. Looking down at Conversion Area #3 from the northwest corner. The log deck (Observation Point 3(b)) can be seen along the south side of the Conversion Area.

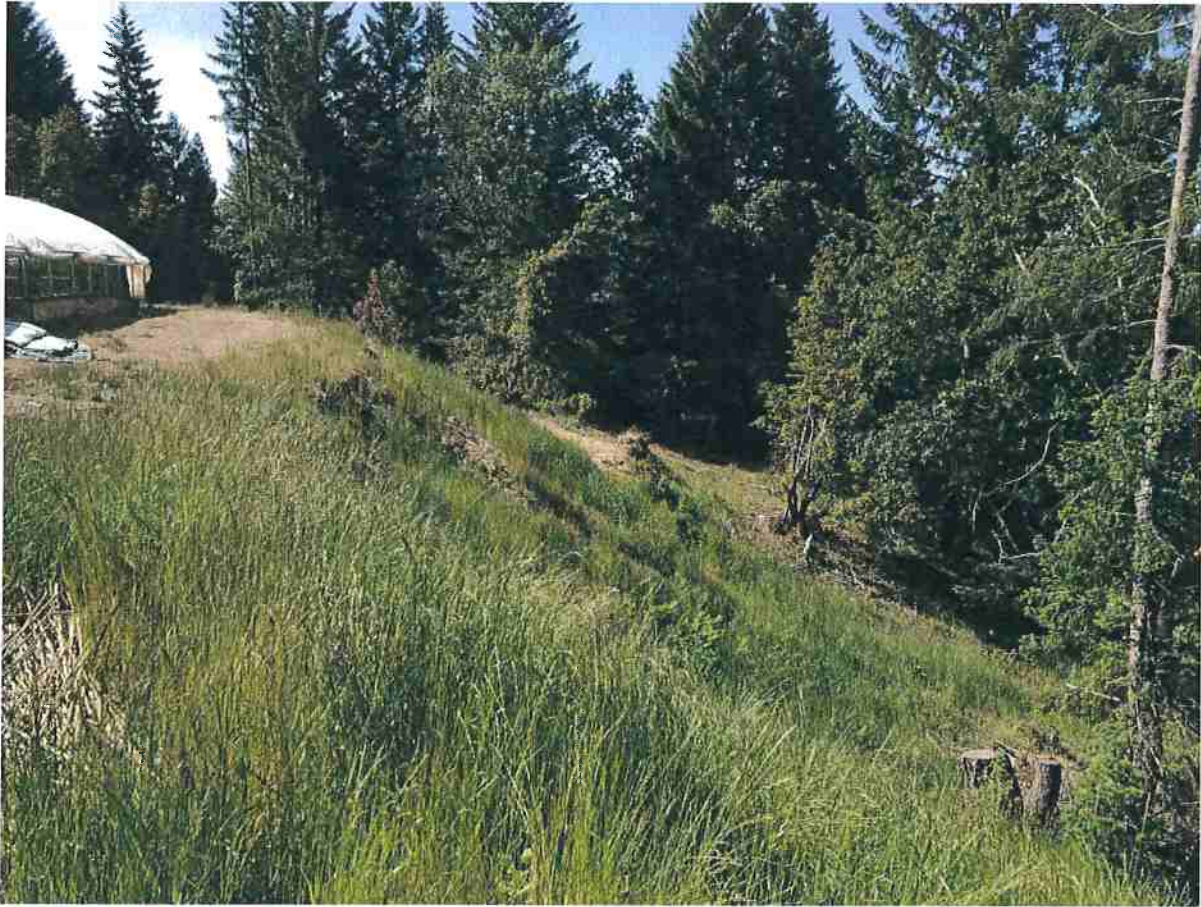
Photo 9. Conversion Area #2 where trees were removed below the fill slope of graded area.

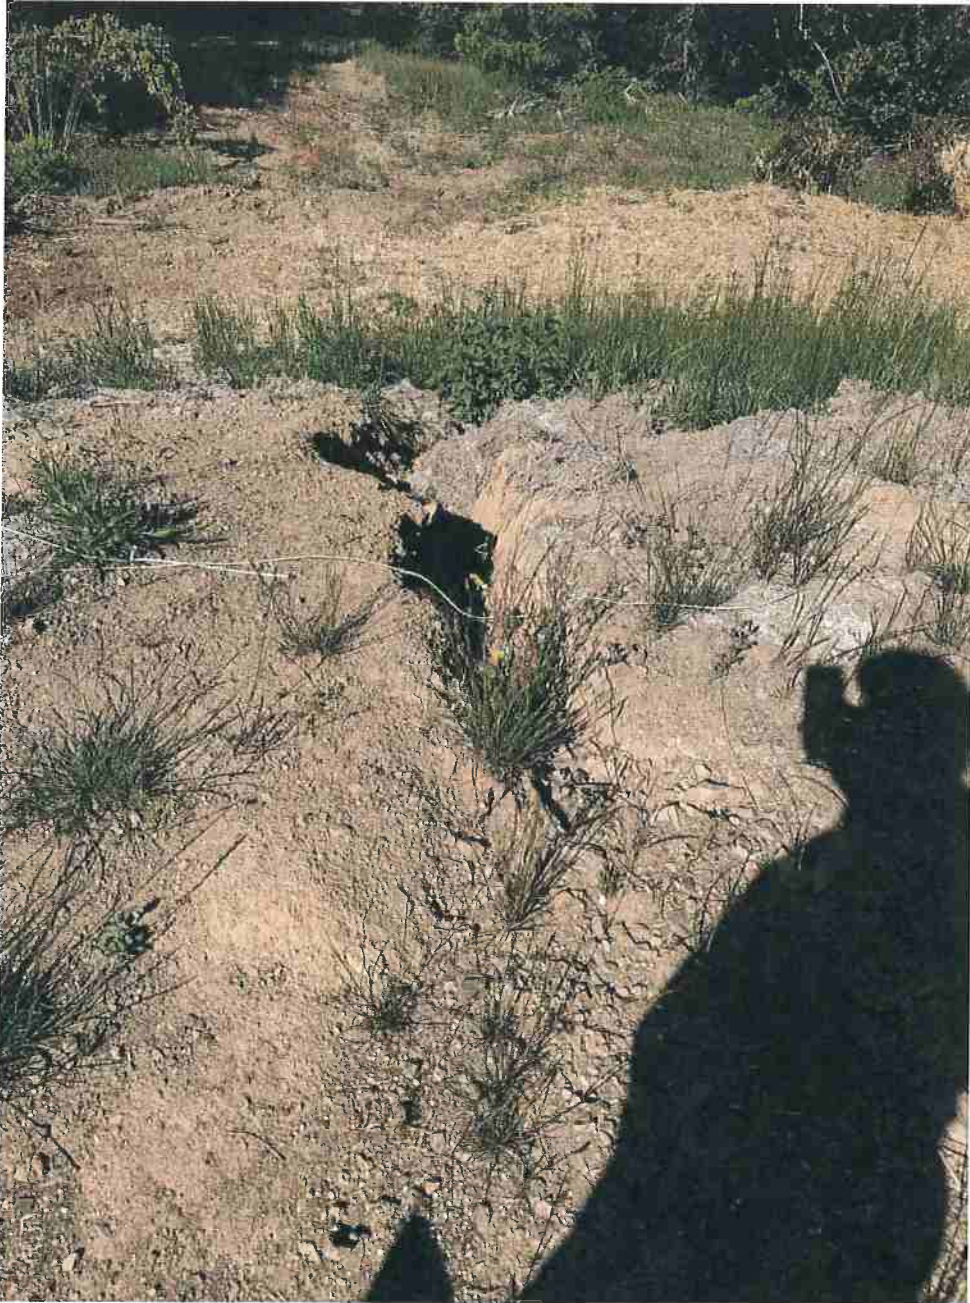
Photo 10. Gullying/rutting occurring along the fill slope of grading above Conversion Area #2 (Observation Point 2(b)) from water running off of the graded area.

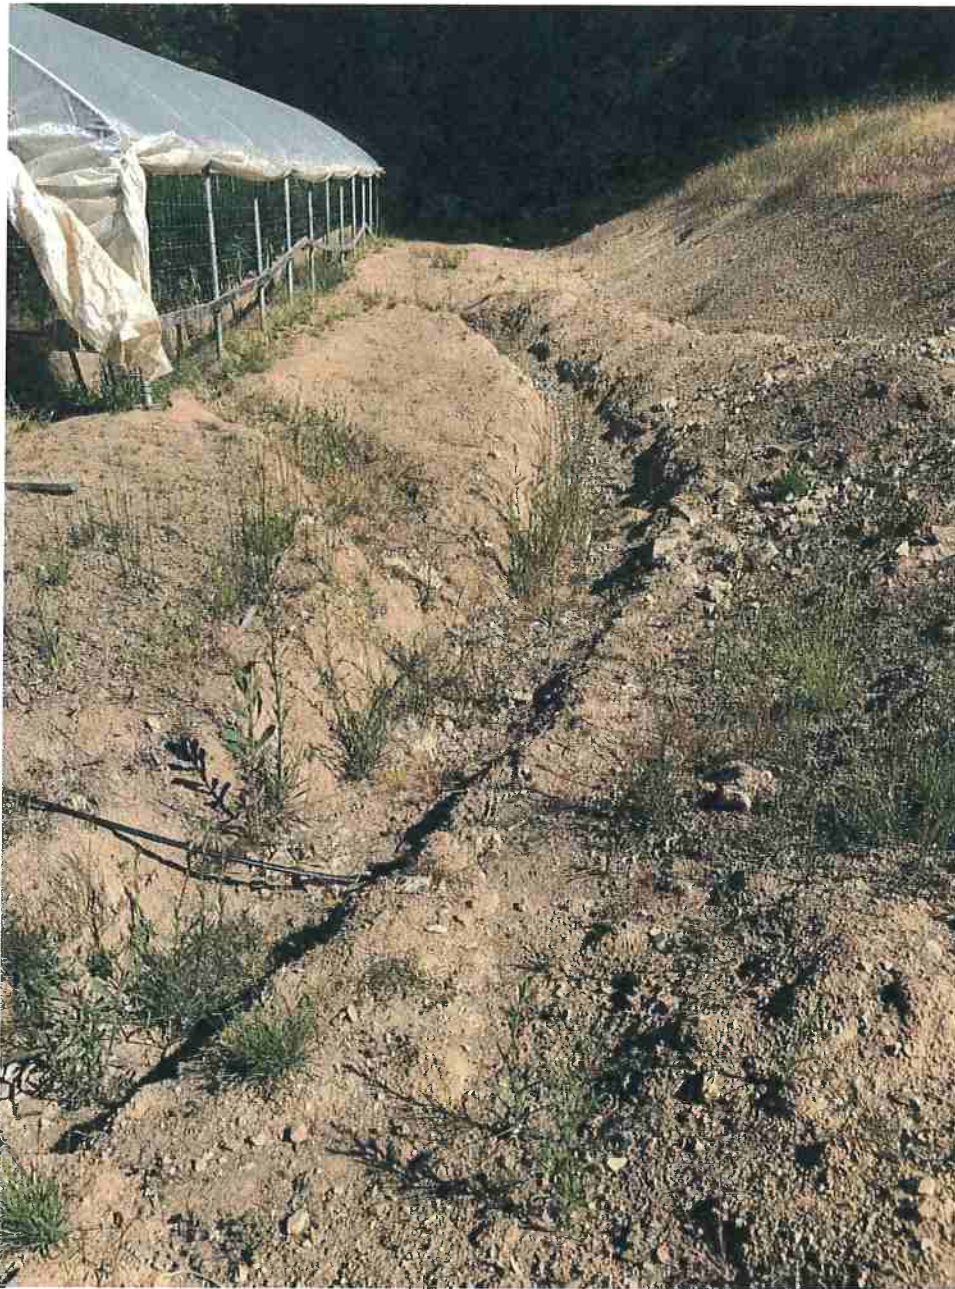
Photo 11. Observation Point 2(b) – drainage ditch constructed to drain cultivation area off of fill slope at Conversion Area #2.

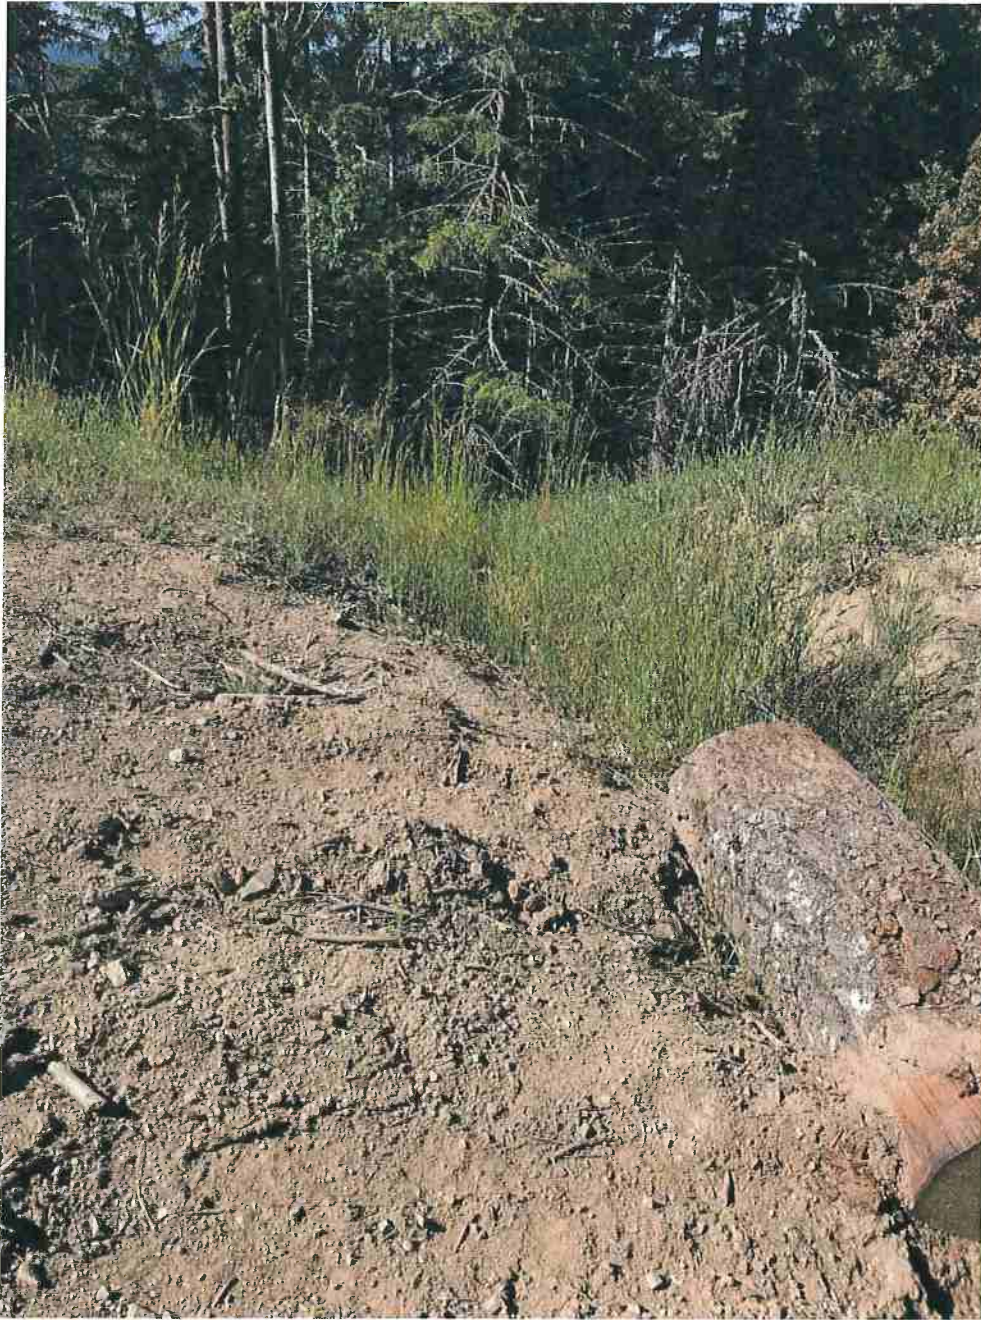
Photo 12. End of Observation Point 2(b) where water runs down fill slope of graded flat at Conversion Area #2.

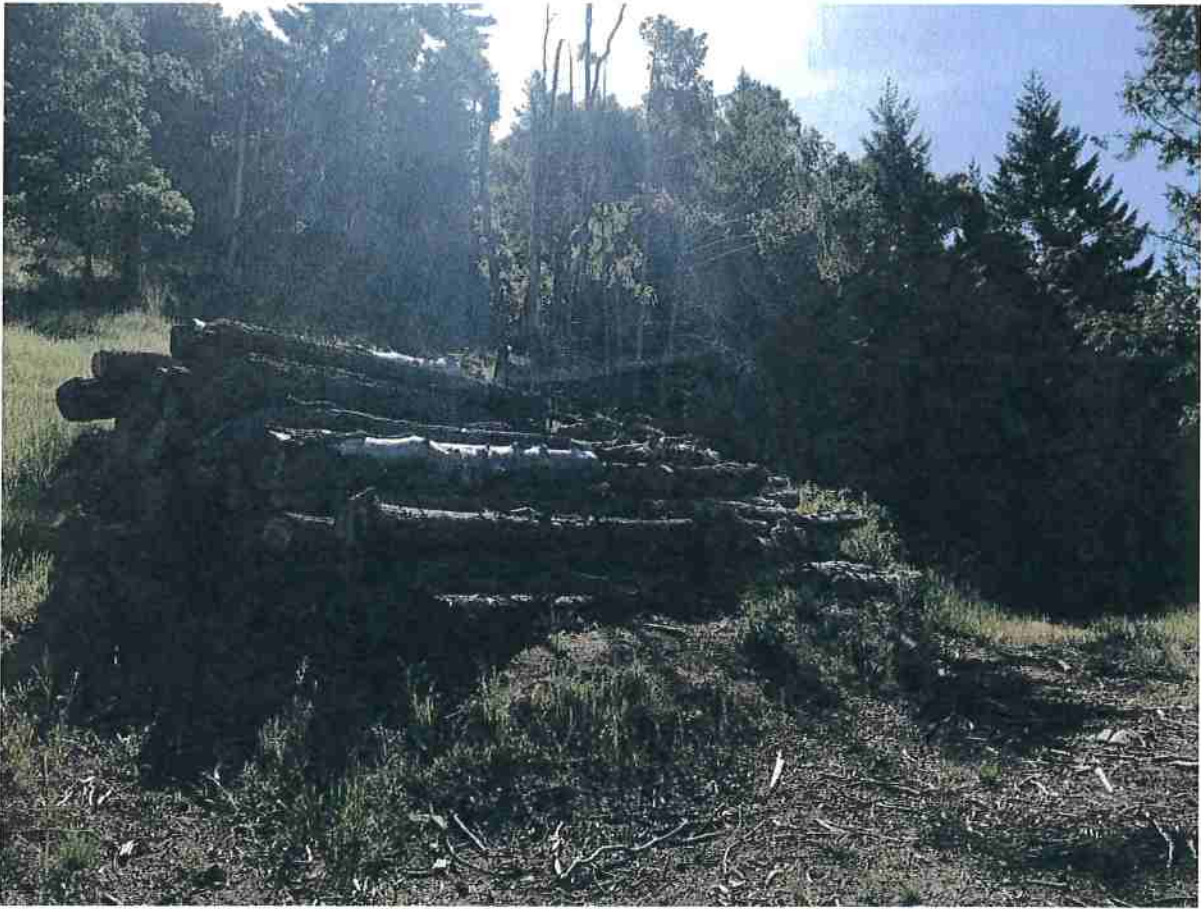
Photo 13. Observation Point 2(a) – log deck resulting from conversion activities at Conversion Area #2.

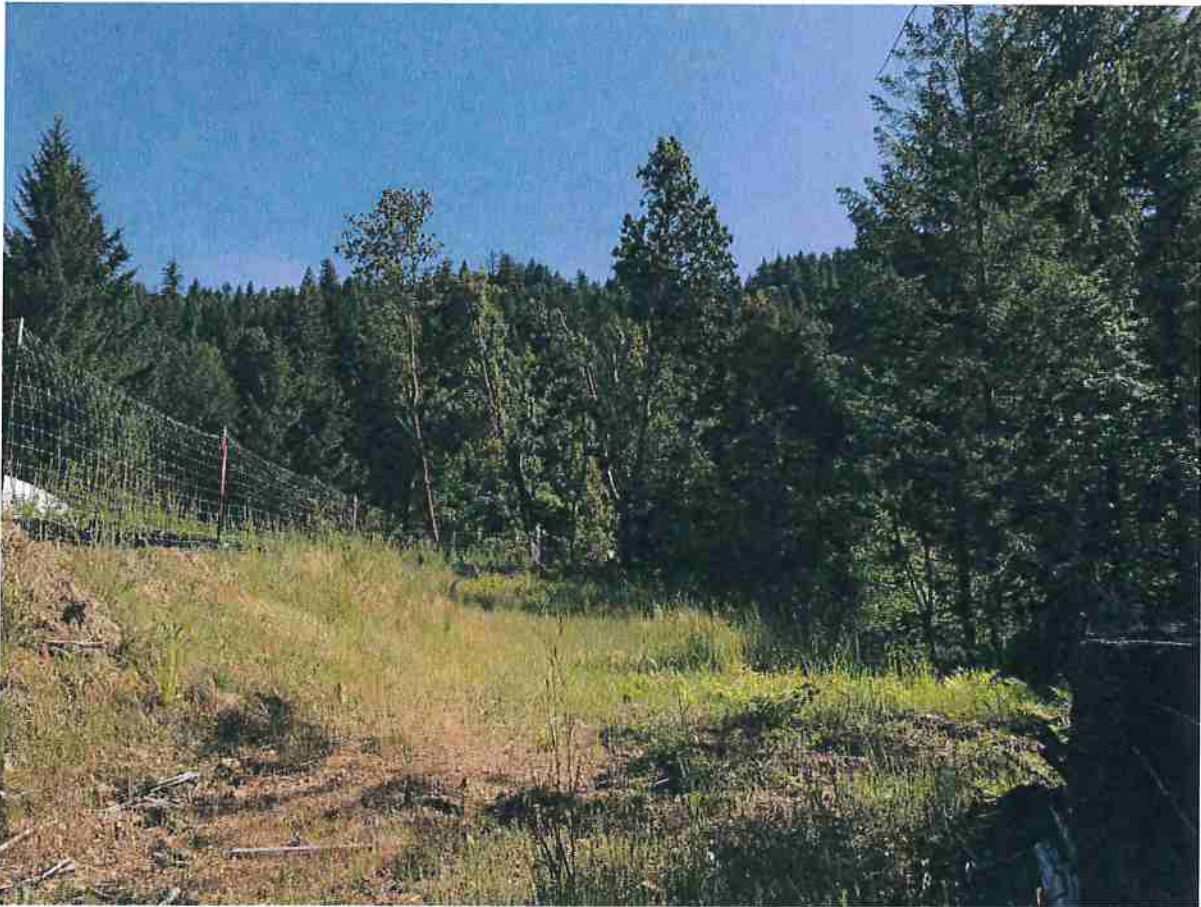
Photo 14. Observation Point 3(a) looking north where timber was cut within 75' of a Class II watercourse. (note the pink flag line on the left at 75').

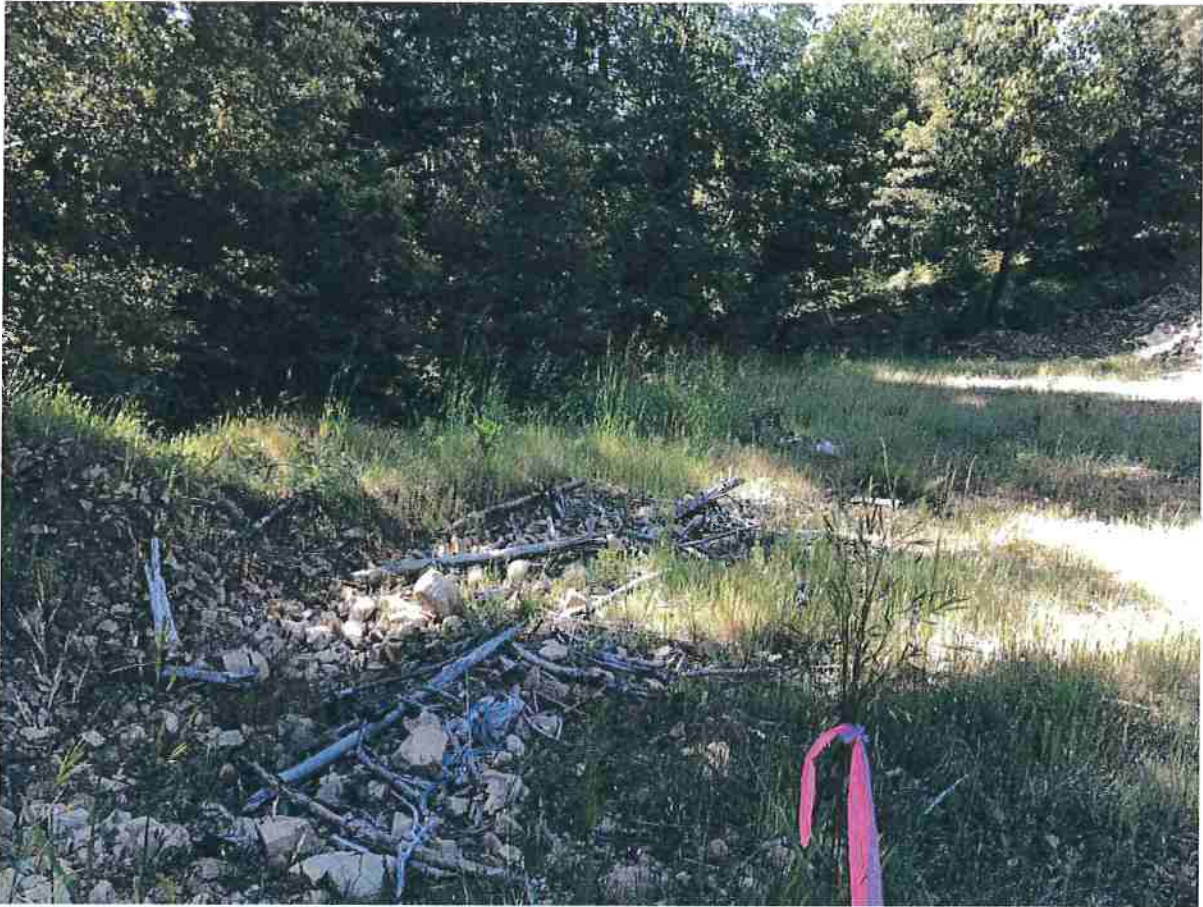
Photo 15. Observation Point 3(a) looking south where timber operations occurred within 75' of a Class III watercourse (pink flags hung at 75')
