PHYSICAL NEEDS ASSESSMENT

MURRAY DUPLEXES
1419-1457 Murray Road
McKinleyville, California 95519

January 24, 2019

PHYSICAL PROPERTY ANALYSIS, LLC

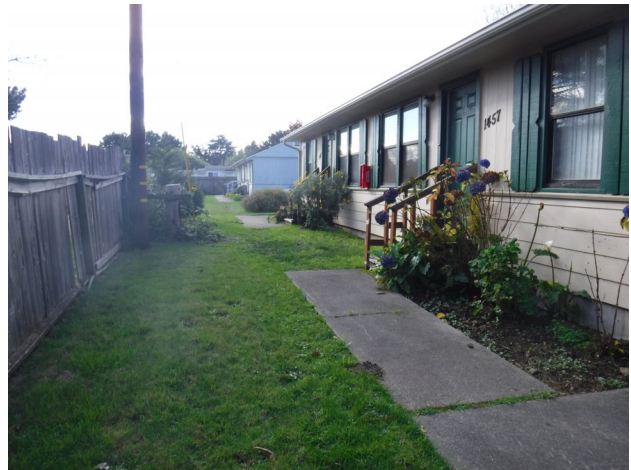
2. East perimeter of the Property, view south. Note damaged wood fencing.

- Provide improved property identification signage, site map, and unit signage throughout.
- Replace damaged wood fencing at perimeter and units.
- The paving at the attached carports, open parking areas, and drive aisles is poorly sloped, or otherwise damaged. Regrade to promote proper water flow. Following repairs, seal and restripe all parking areas.

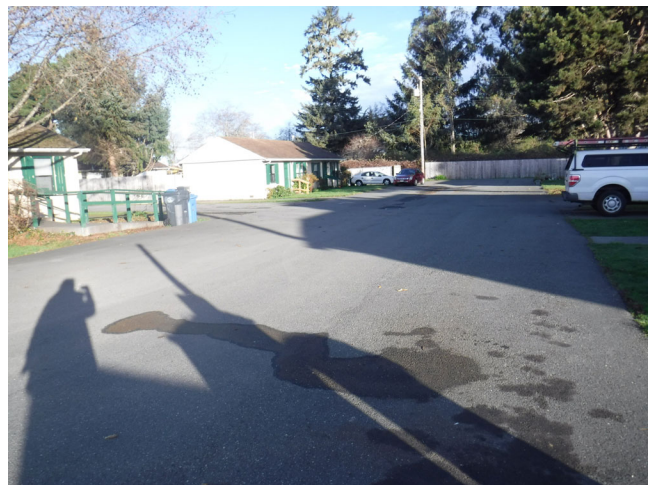
4. Typical condition of the asphalt paving and landscaping.

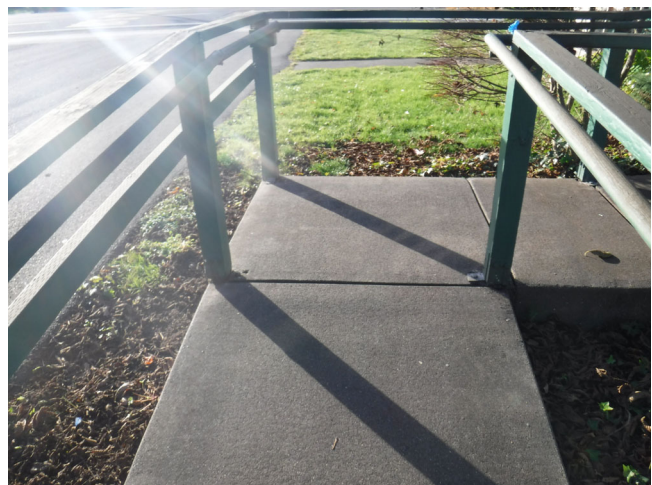
6. Non-conforming ramp at accessible unit entry.

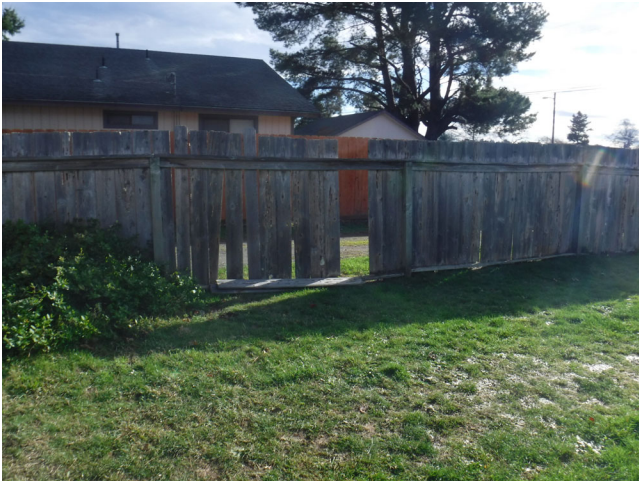
9. Damaged and missing site fencing.

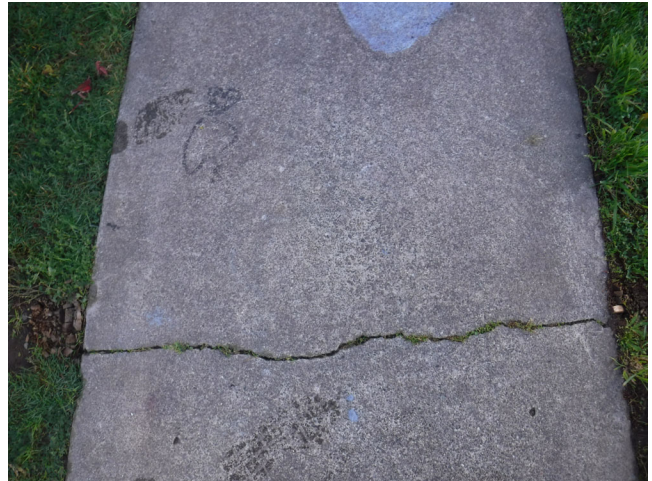
10. Damaged walkway.

- There are areas of damaged walkways throughout the Property. Locations are uneven and present trip hazards. Replace any damaged or uneven walkways, and add new concrete walkways where needed to provide a safe path of travel throughout the site.

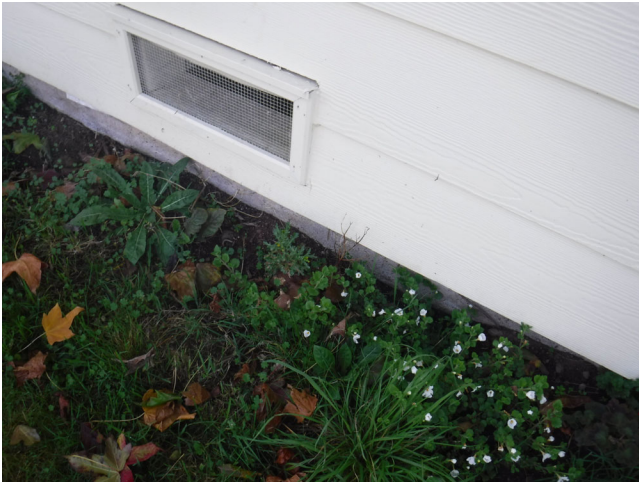
13. Crawl space ventilation and concrete stem wall.

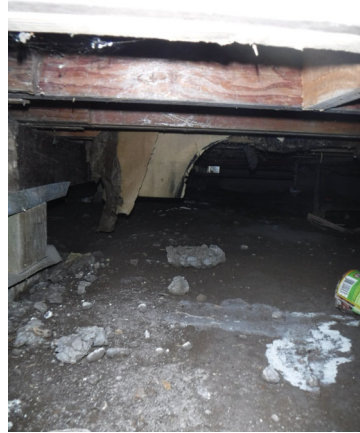
14. Typical crawl space conditions, not damaged insulation, waste, debris and moisture.

- Due to reported lack of code conforming access and clearances at the crawlspaces, lack of vapor barrier, and evidence of floor movement in a portion of the units, a detailed inspection and redesign or upgrade to the structural foundation systems is recommended. Reinforcement of the existing structures, addition of a vapor barrier, excavation to provide adequate access and clearances, improved ventilation, replace rotted wood components, add mechanical ventilation if deemed necessary. Design and feasibility analysis required. Evidence of standing water, mold growth on soil and insulation, as well a lack of insulation, were observed.

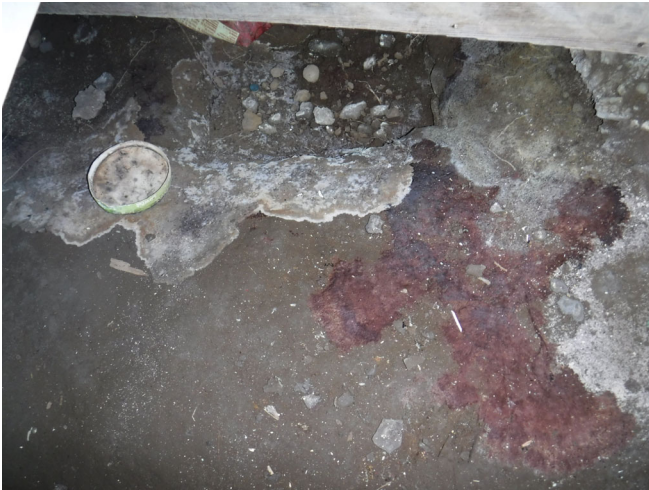
- Management reported ongoing issues with mildew, and potential mold growth was observed in some crawlspace areas that were accessed. Anticipate some level of remediation, at a minimum replacing framing and finishes and cleaning of mold in the structures, during rehab.

15. Debris in crawl space and mildew or mold on soil, lack of vapor barrier.

- Due to lack of vapor barrier in the crawl spaces, and evidence of wood damage at limited floor areas, a full wood destroying pest survey is recommended.

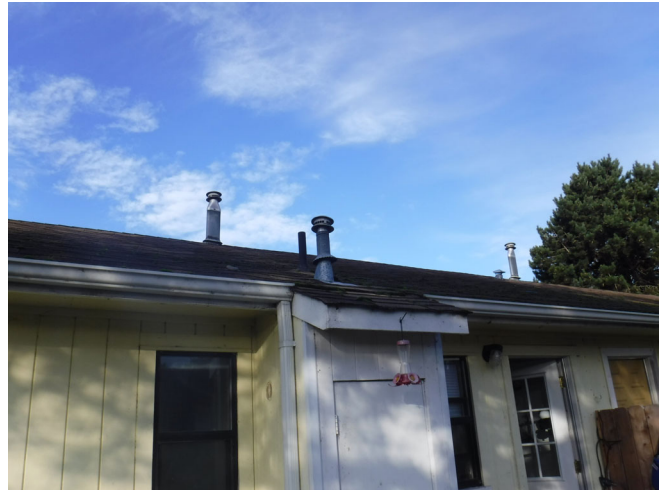
16. Typical older roofing conditions. Note exterior water heater closet.

- Prepare and paint all exteriors including carports and exterior trim elements.
- The roof coverings have reached the end of their useful life based on surface wear and age. Replace with a minimum 35-year dimensional shingle. Replace all flashings. Consider radiant barrier for improved insulation factor.

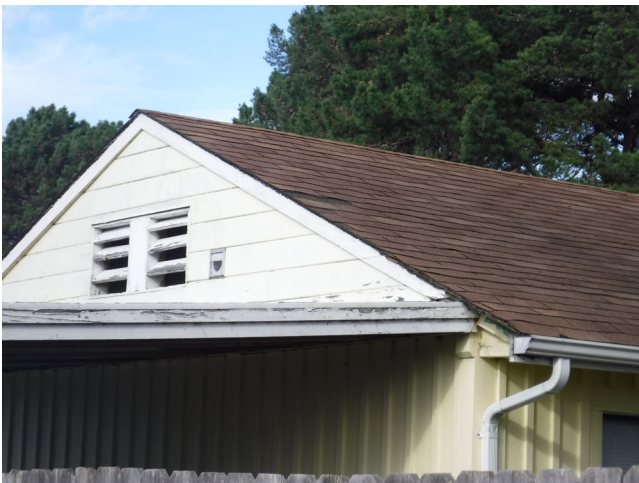
17. Worn and missing roofing, peeling paint and damaged siding.

- Based on the age, anticipate at least partial site water and waste line replacements during rehab.
- Given the age of the siding, the plan to significantly rehab the structures, and for improved long-term durability, removal and replacement of any damaged siding, waterproofing and other exterior trim elements is recommended.

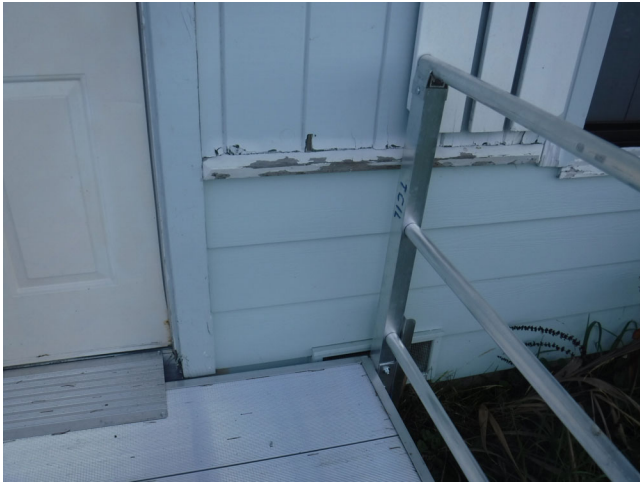
19. Peeling paint at exterior siding and trim.

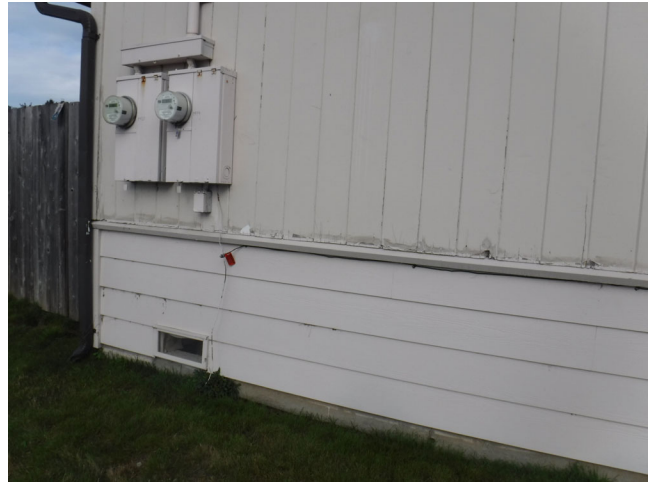
20. Damaged siding and individual electrical meters.

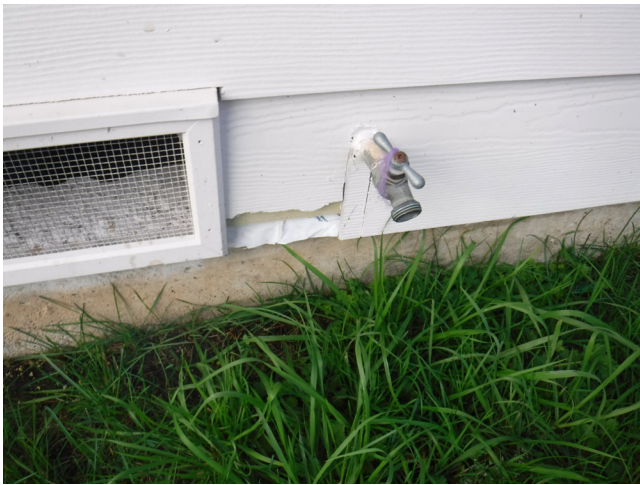
21. Damaged siding.

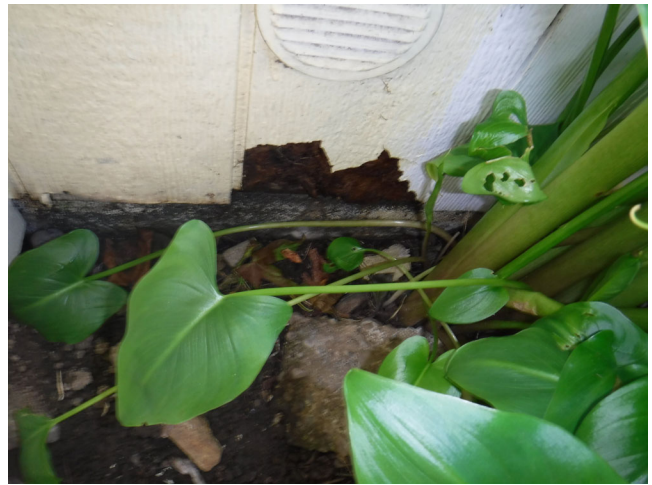
22. Damaged siding

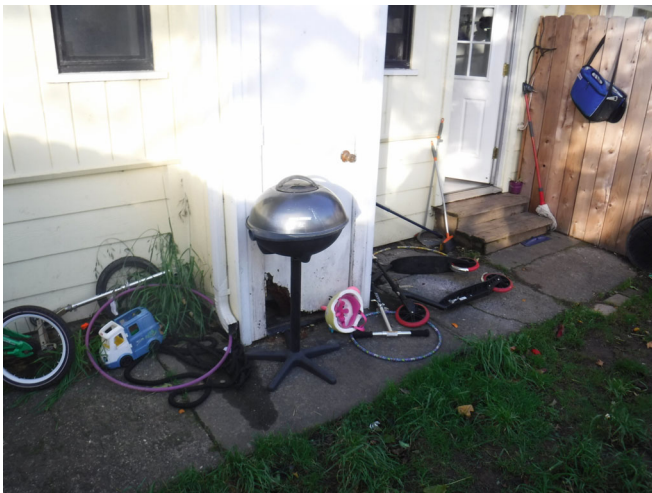
23. Damaged water heater enclosure door and typical rear entry to the units.

- Replace roof drainage components and extend leaders or add tight lines as part of the drainage upgrades.
- Remove and replace the exterior doors with insulated metal fixtures for improved insulation of the units and durability. Provide new door locks and hardware. Front and rear entry doors at each unit. Replace water heater closet doors with more durable system.

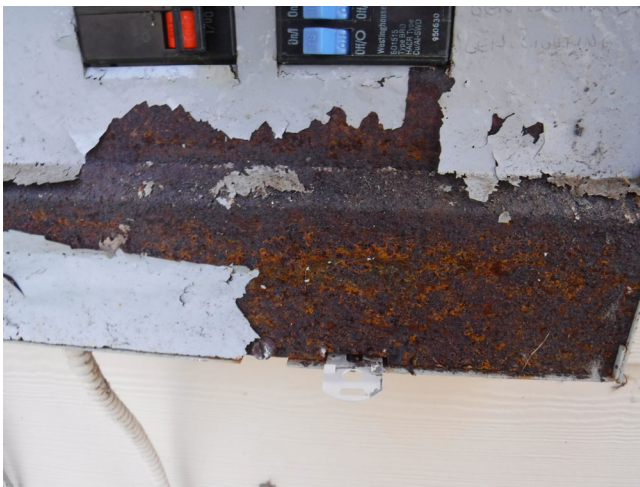
27. Rust damaged electrical subpanel at meter.

- Install new electrical panels and subpanels, GFCI, ARC Fault, outlets and switches.
- Replace all unit lighting with LED for improved energy efficiency.

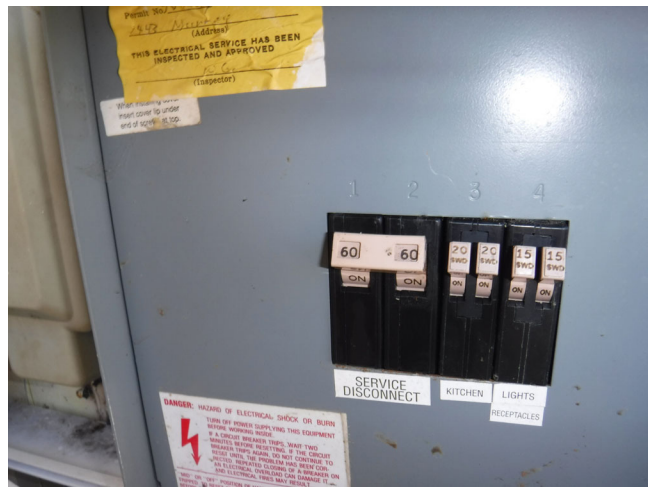
28. 60-amp electrical service to the units.

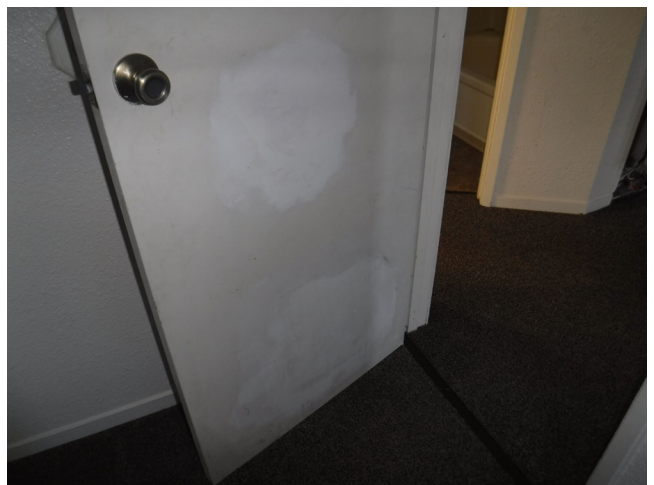
42. Repaired damaged to interior door and carpeting at living areas.

- Replace interior doors with recessed panel, laminated fixtures with new hardware and lever handles. Replace closet doors with durable bypass system.
- Remove and replace the older and original cabinets, vanities, and counters. Consider a solid wood face frame cabinet and solid surface counter for improved durability.

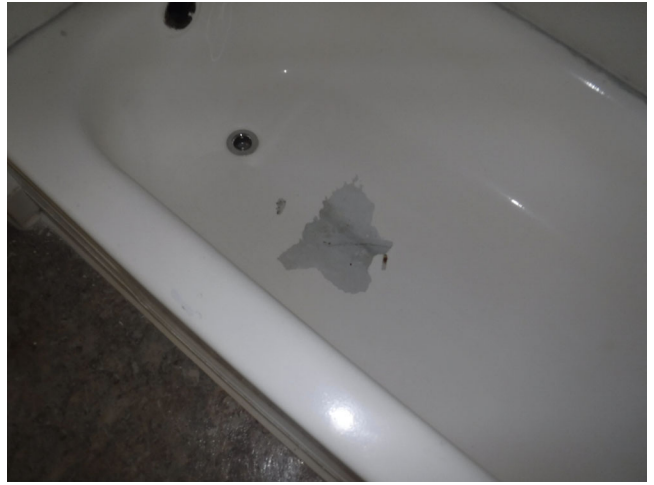
44. Peeling finish at bathroom tub.

- The tubs and enclosures are stained, worn and in need of refurbishment and in some cases complete replacement. The existing accessible unit shower can be refurbished.
