# Project Inspection Report

**APN: 316-071-004**

**Notification #1600-2017-0319-R1**

**October 20, 2022**

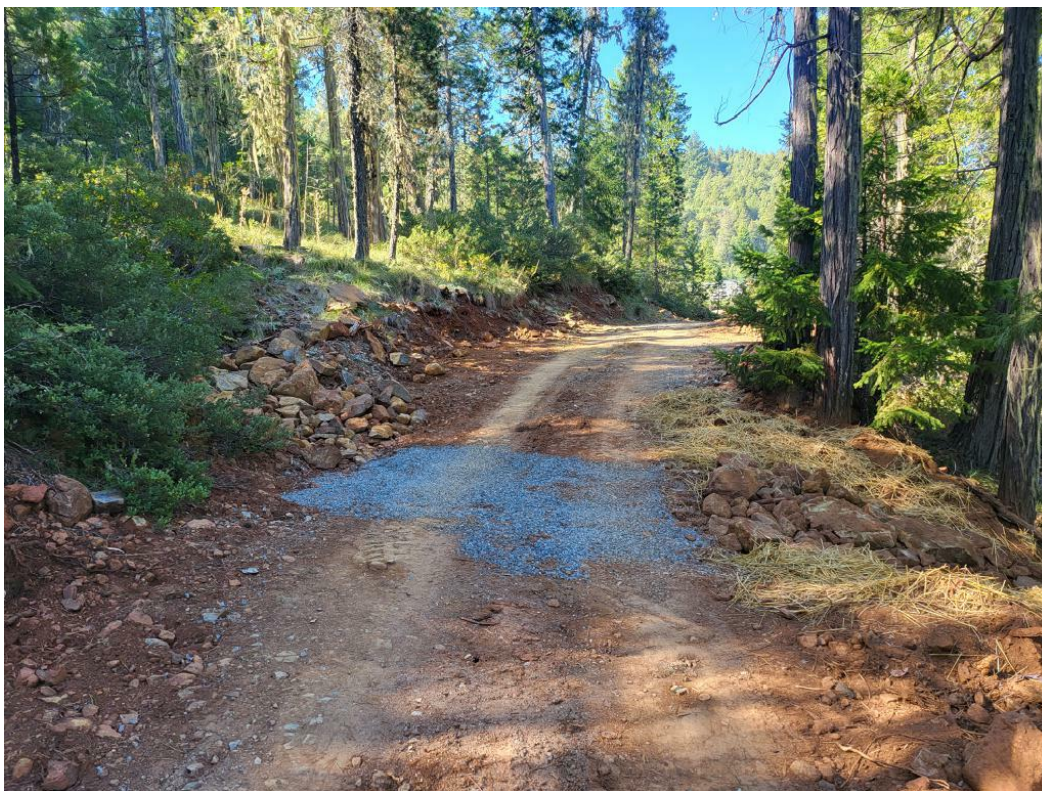
**Status at 10/5 Site Visit:** Armored ford has been properly installed.

*Figure 1: MP2 Installed Rocked Ford.*

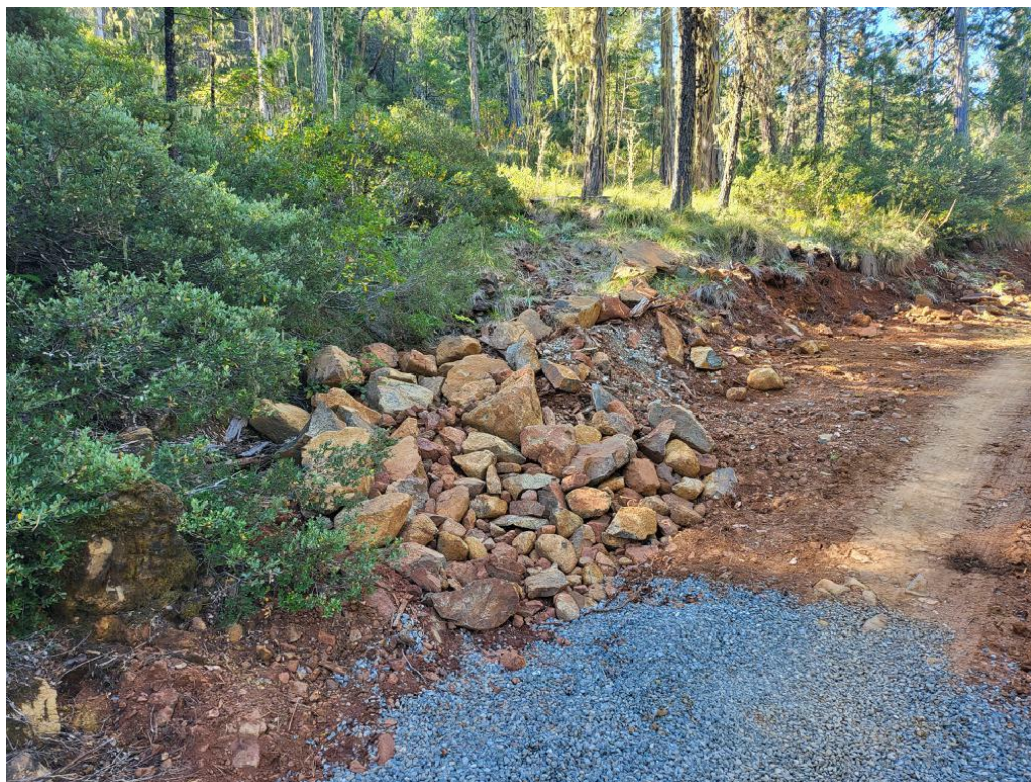
*Figure 2: Rock placed upstream of rocked ford crossing.*

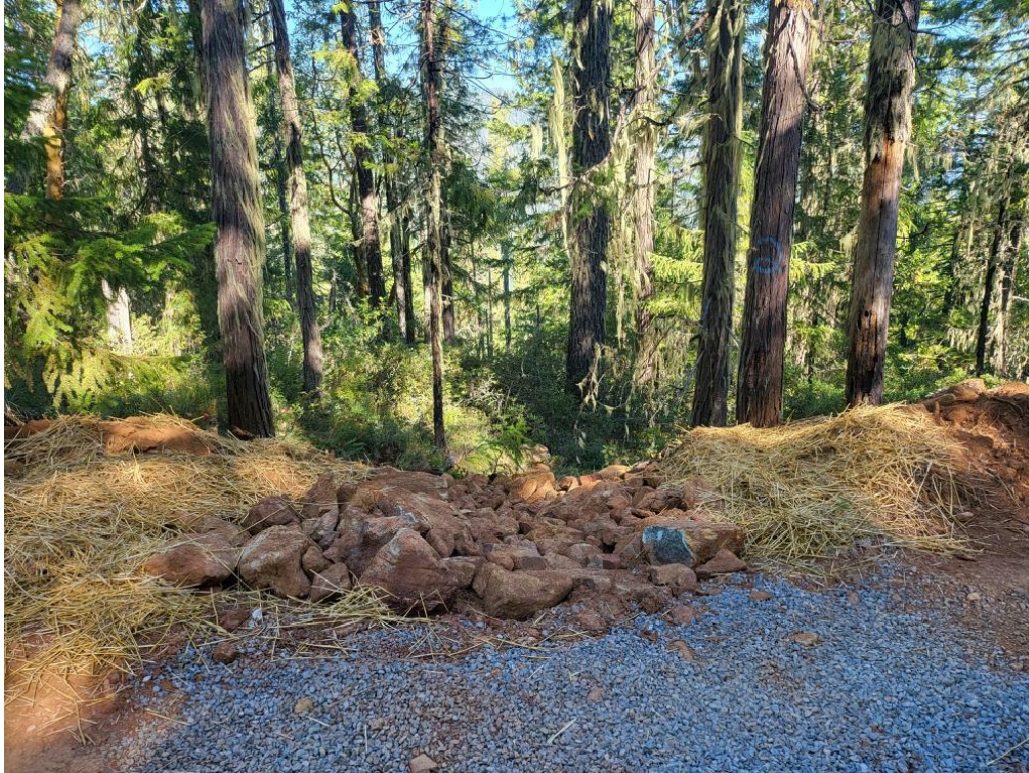
*Figure 3: Rock armor placed downstream of MP2.*

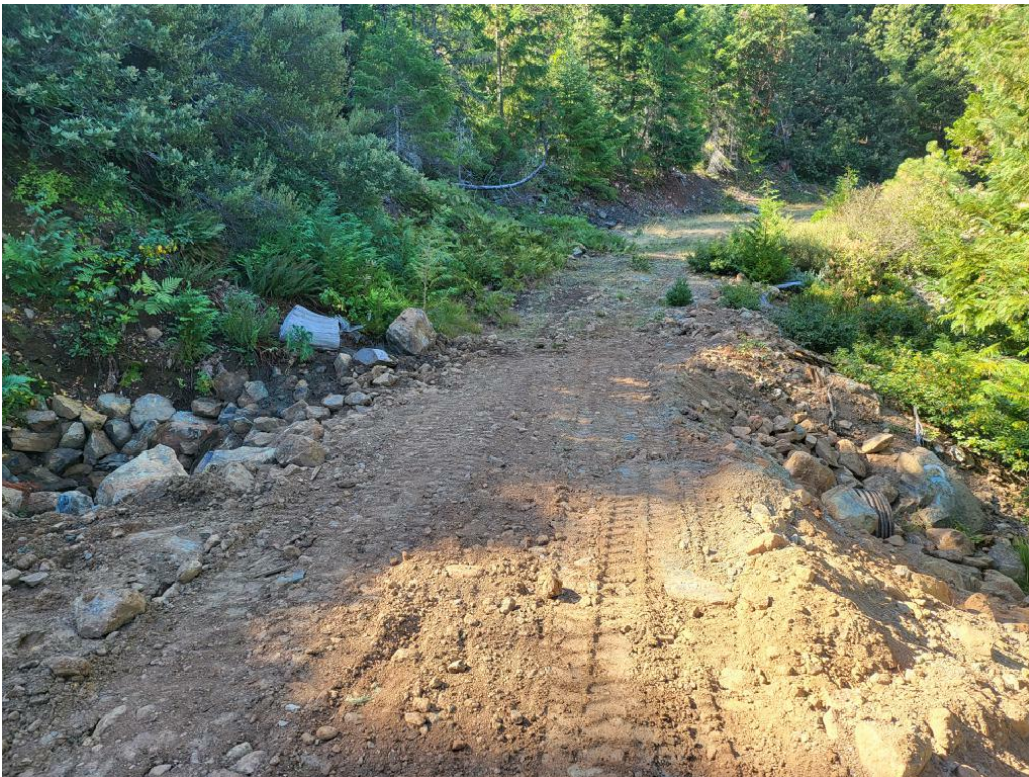
**Status at 10/5 Site Visit:** the 18" culvert has been properly replaced with a 24" culvert.

*Figure 4: MP3 replaced 24" culvert.*

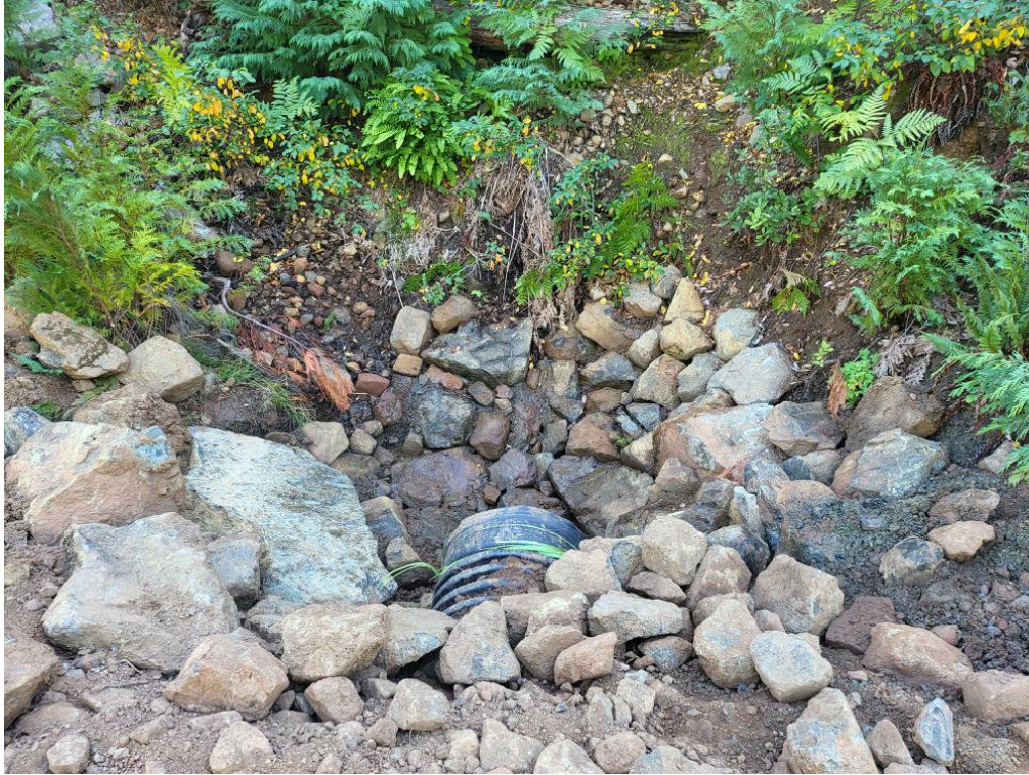
*Figure 5: MP3 24" culvert inlet.*

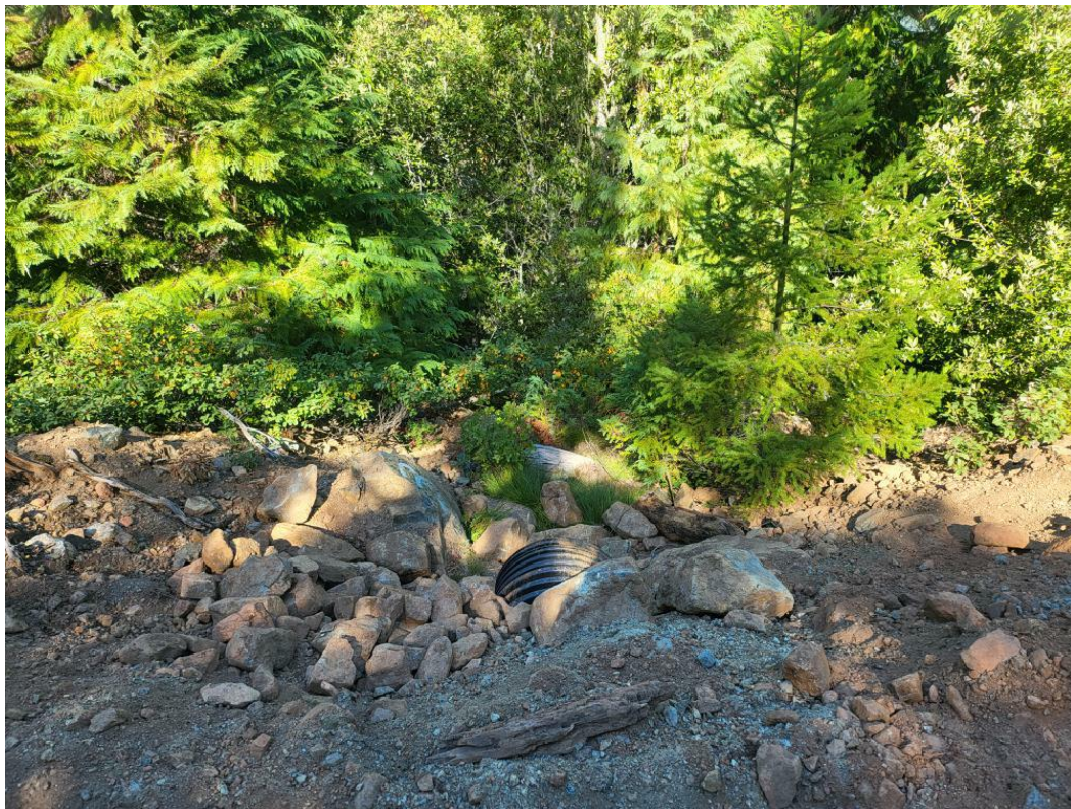
*Figure 6: MP3 24" culvert outlet.*

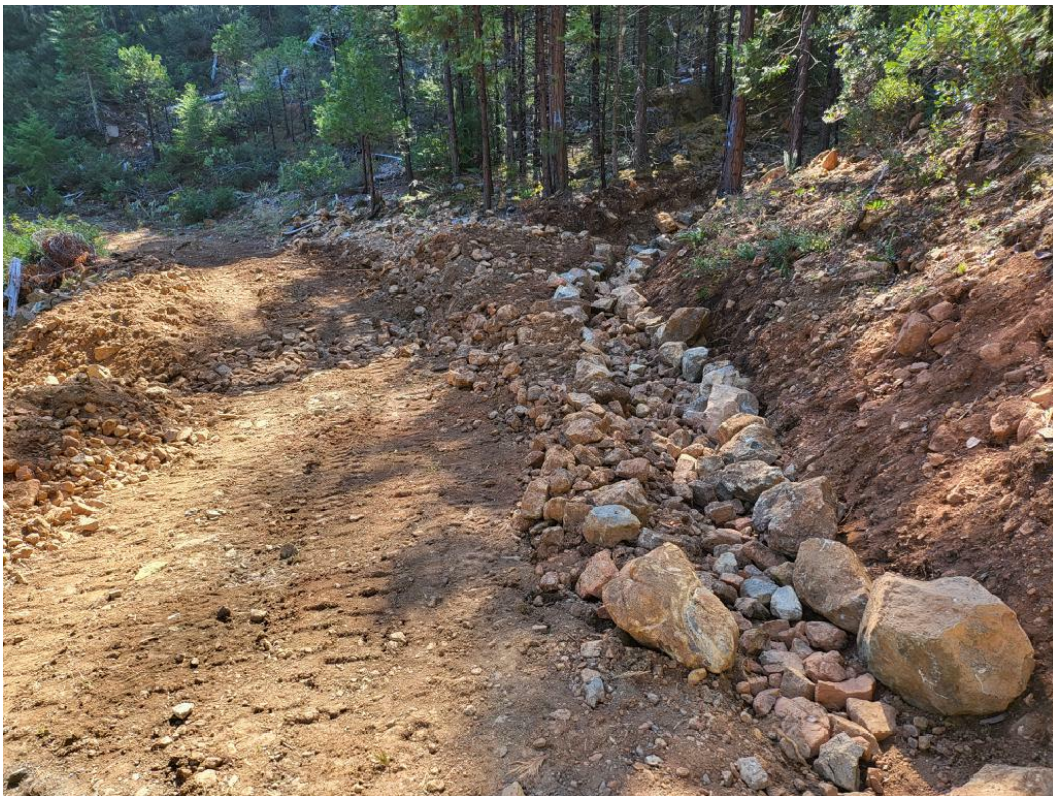
**Status at 10/5 Site Visit:** The 36" culvert has been properly installed and the 12" removed. The ditch has been rock armored and disconnected the roadway from the spring.

*Figure 8: MP4 rocked ditch disconnecting spring from roadway.*

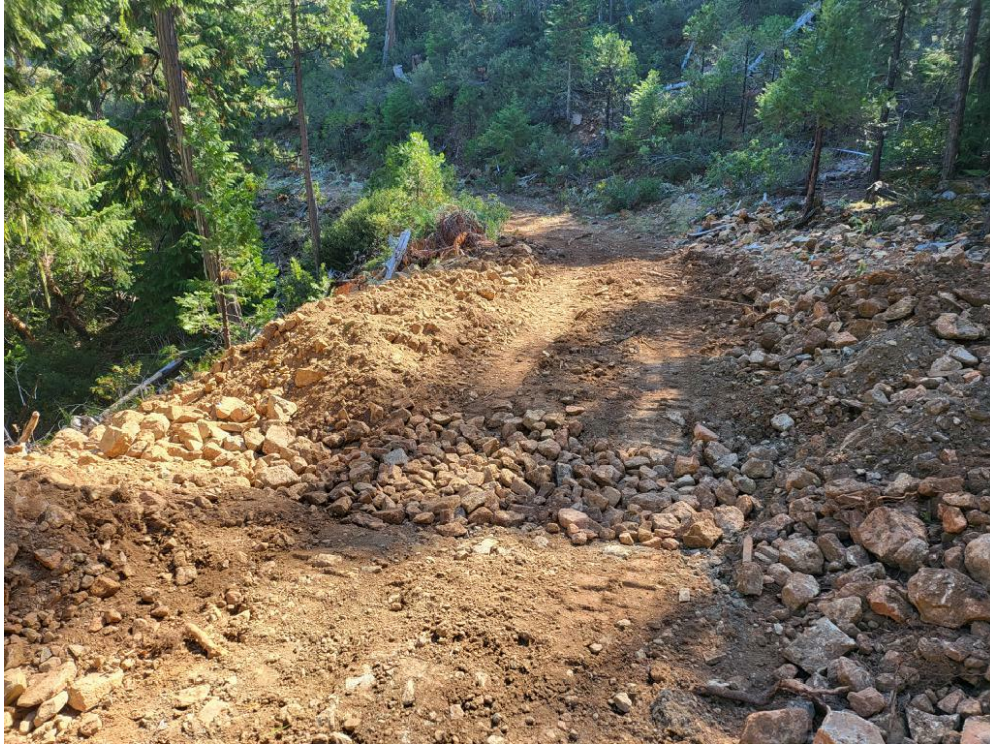
*Figure 9: MP4 disconnected roadway.*

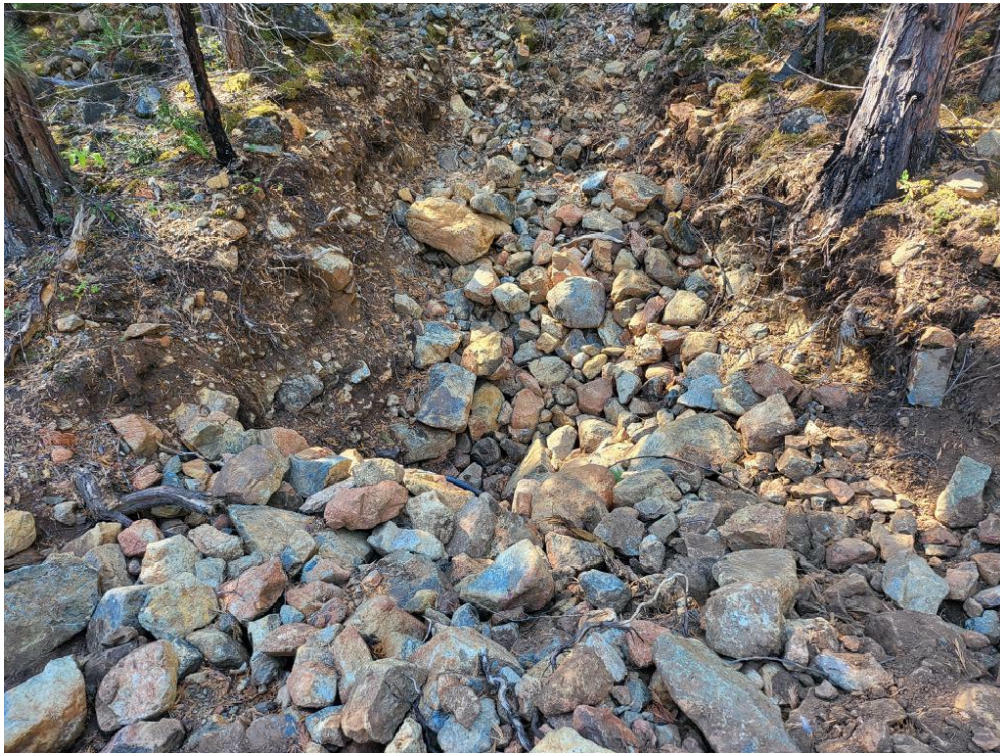
*Figure 10: Upstream of MP4.*

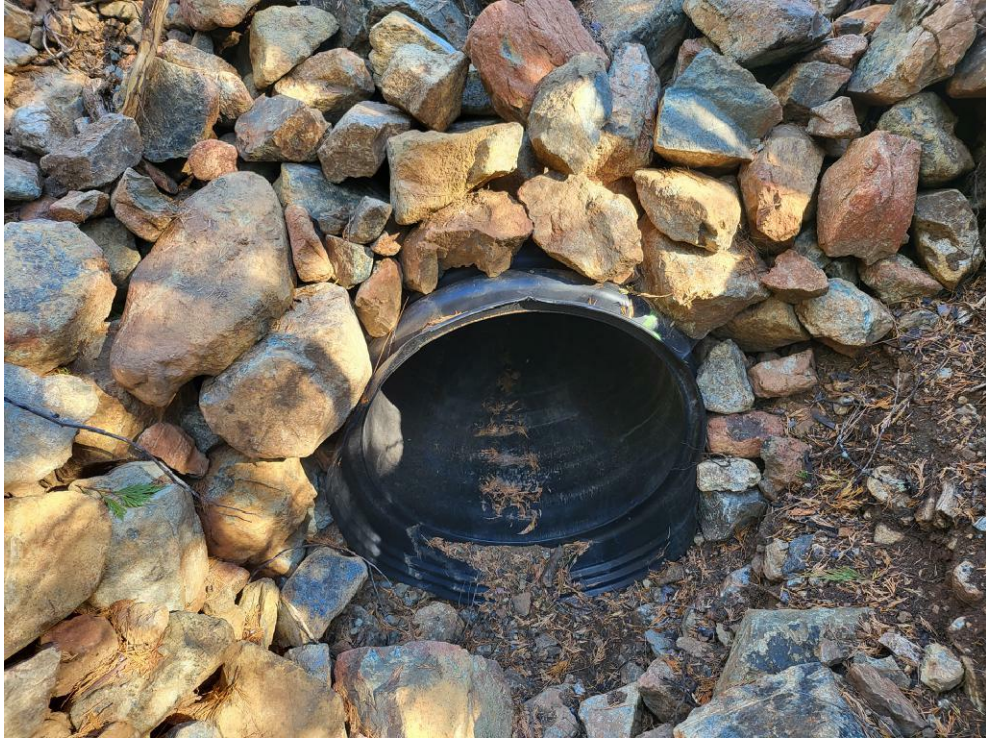
*Figure 11: Inlet of Mp4.*

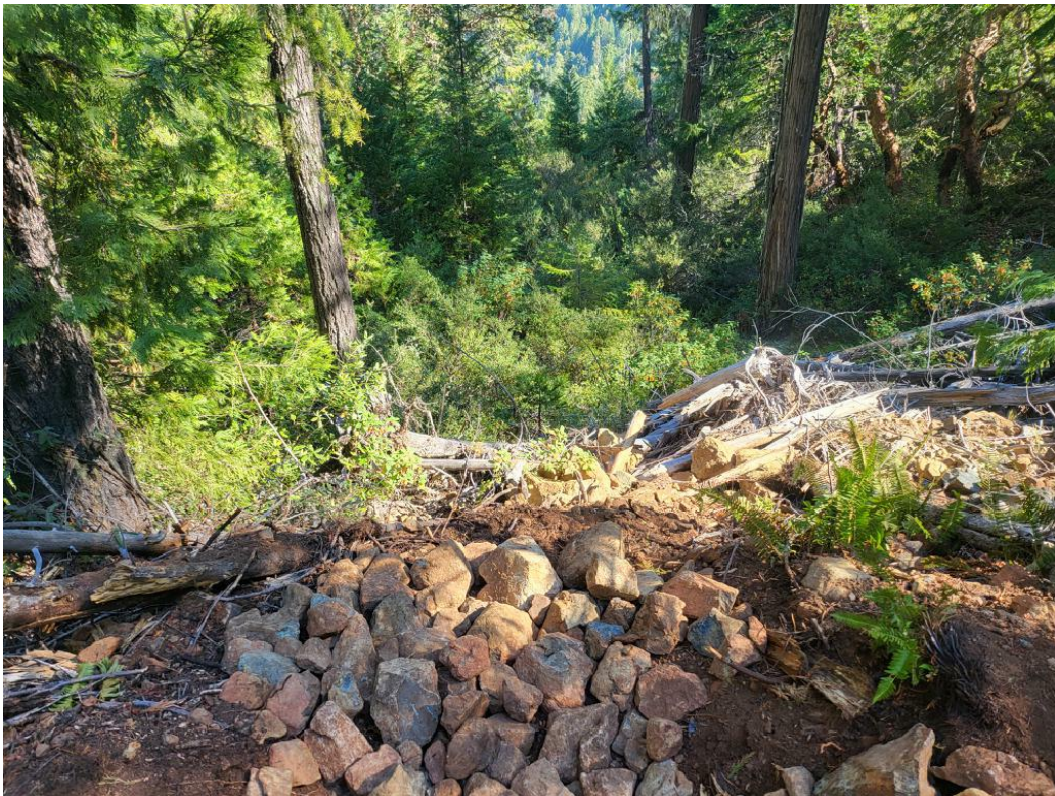
*Figure 12: Downstream of MP4.*

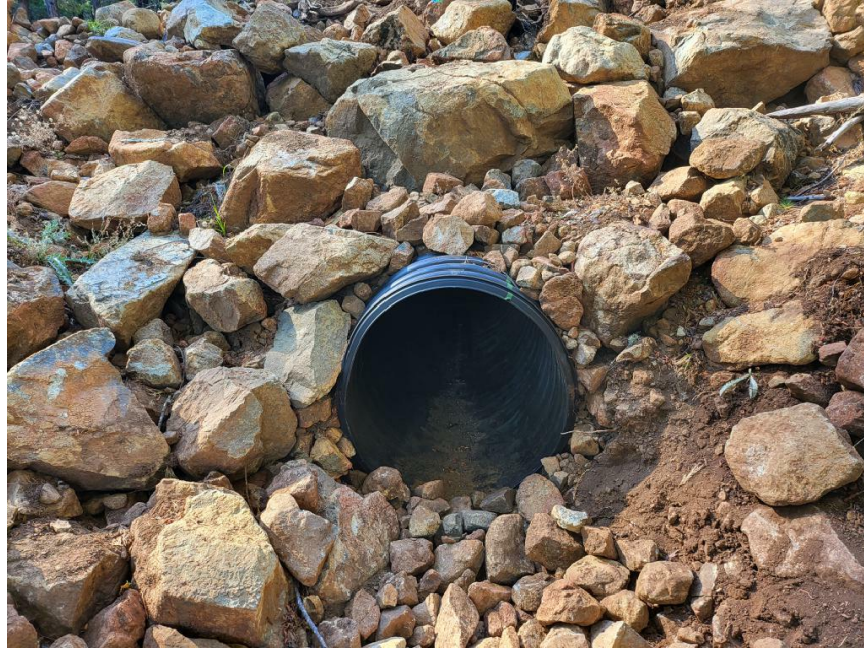
*Figure 13: MP4 outlet.*

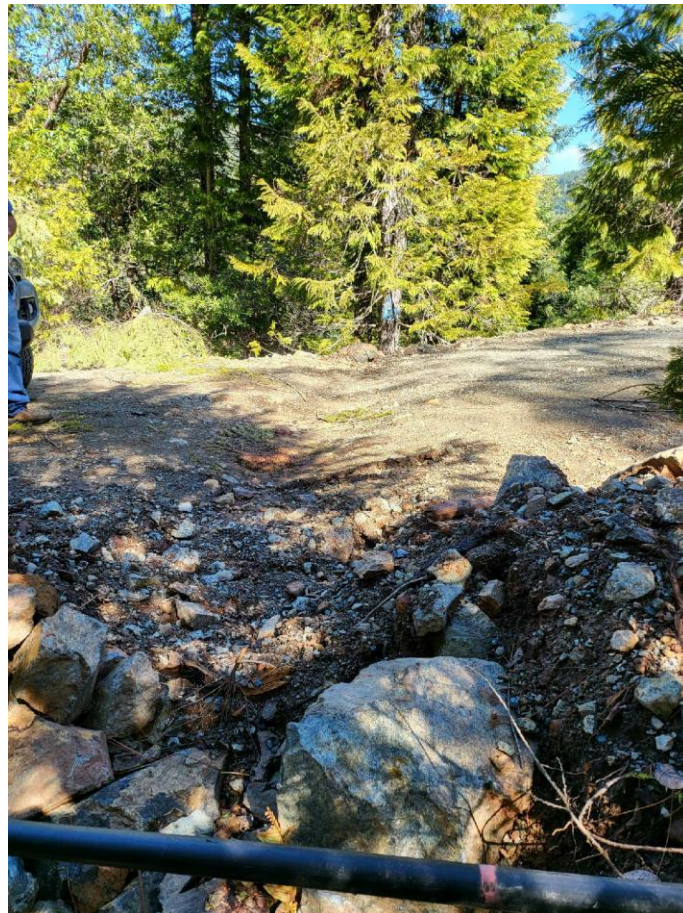
**Status at 10/5 Site Visit:** 24" culvert has been installed and disconnected from the adjacent channel.

*Figure 14: MP6 replaced 24" culvert.*

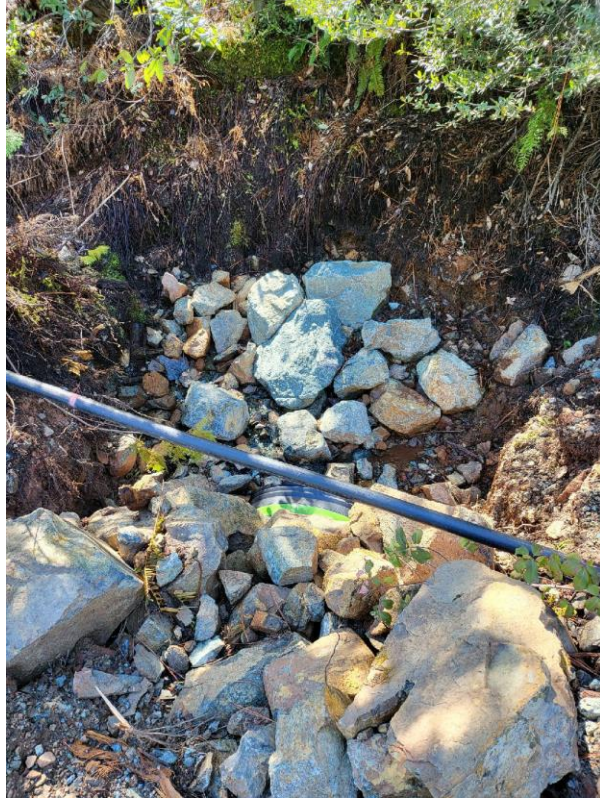
*Figure 15: MP6 Inlet.*

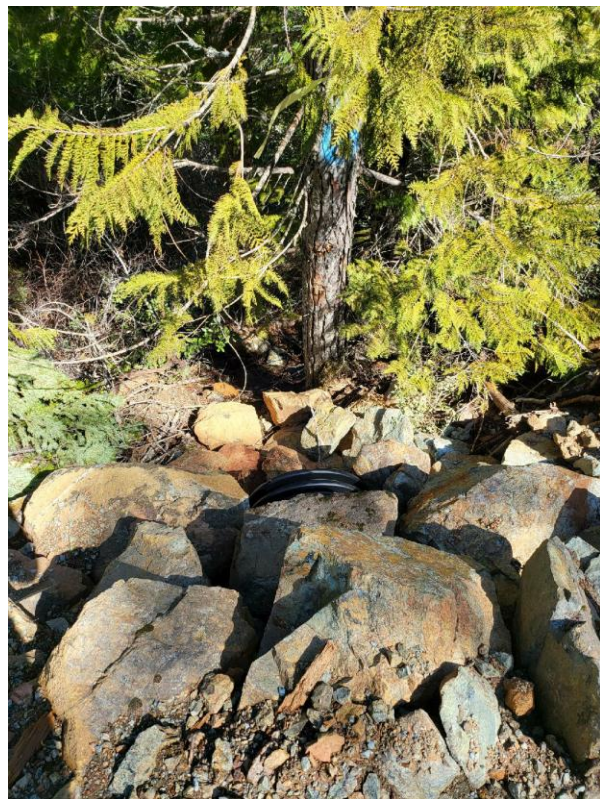
*Figure 16: MP6 outlet.*

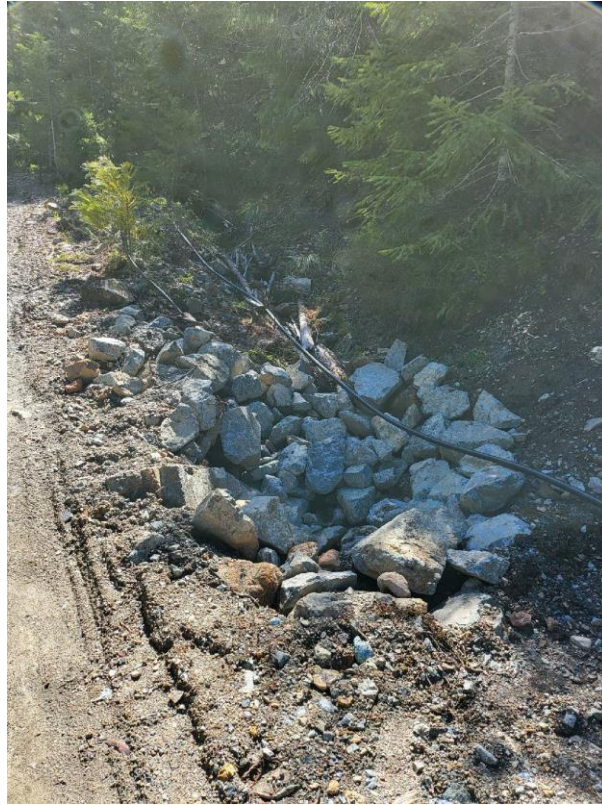
**Status at 10/5 Site Visit:** 18" culvert has been replaced with a 24" culvert.

*Figure 17: MP7 inlet.*

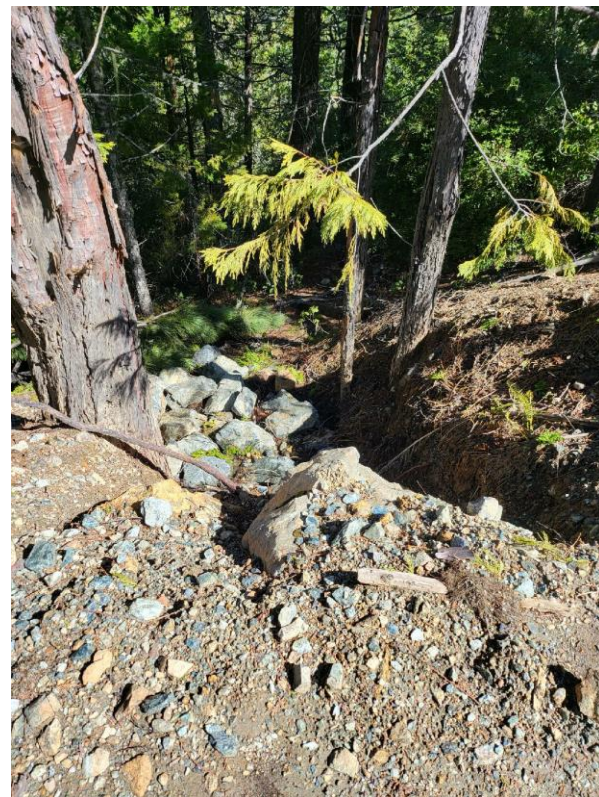
*Figure 18: MP7 downstream.*

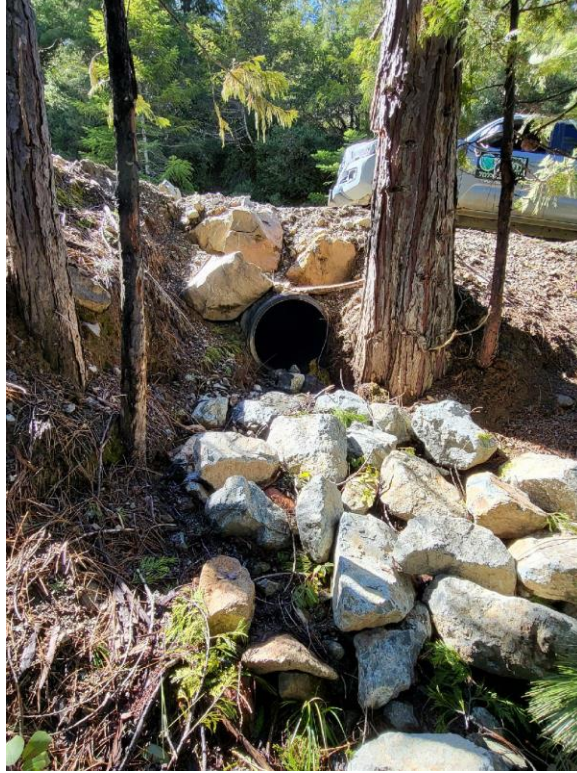
*Figure 19: MP7 outlet.*

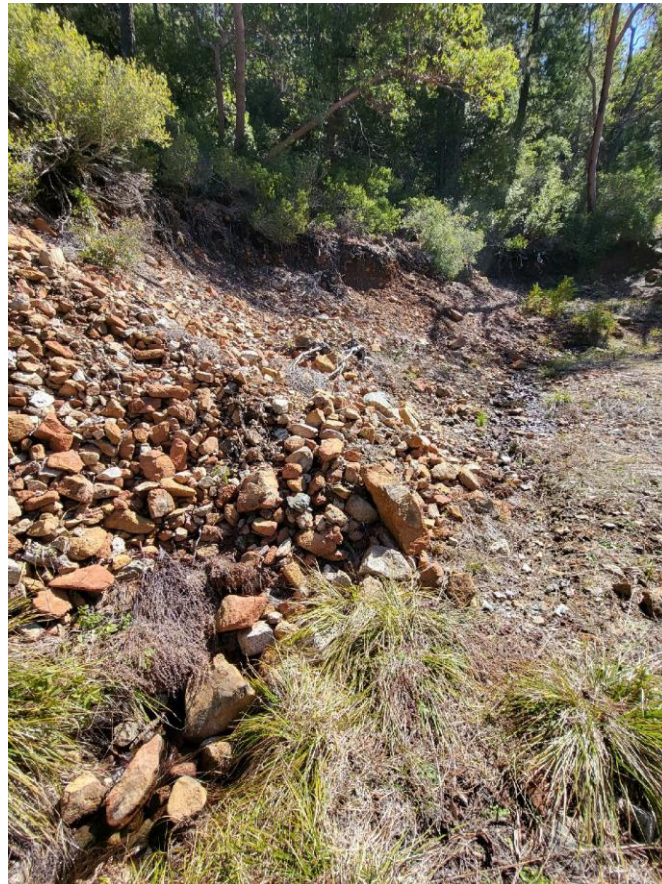
*Figure 22: MP8 perched unstable fill removed.*

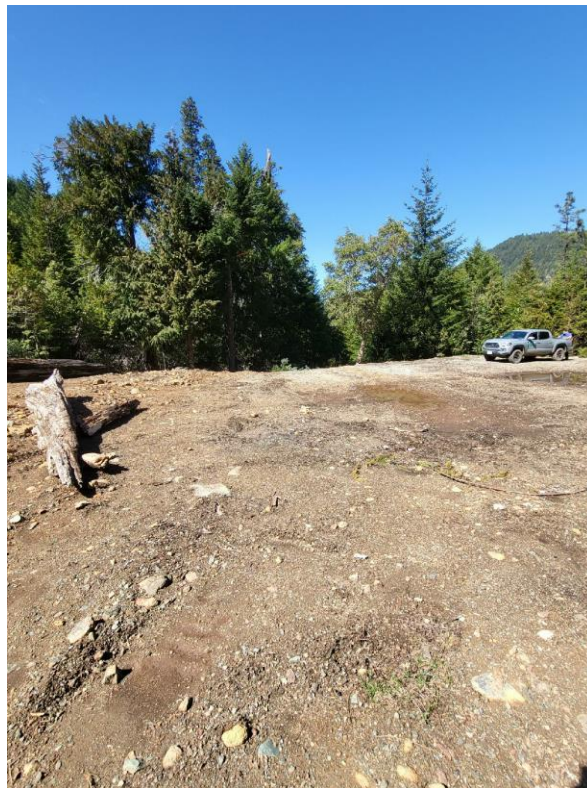
*Figure 24: MP8 all trash removed.*

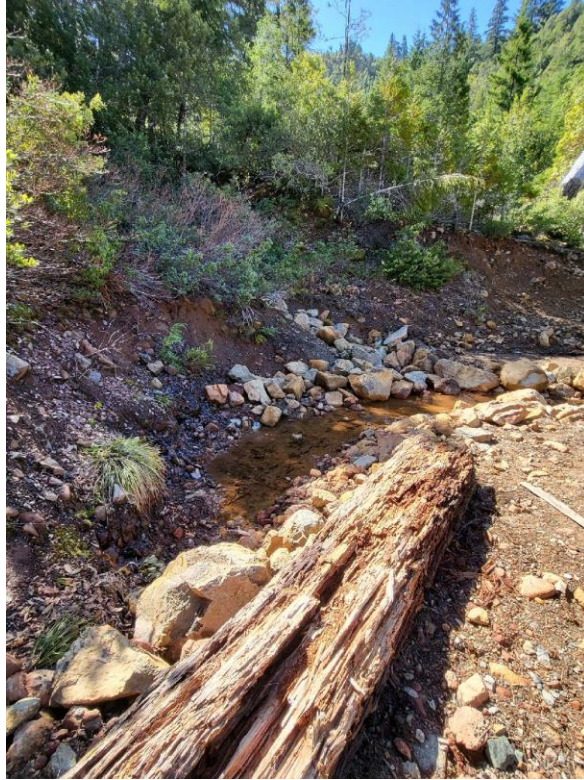
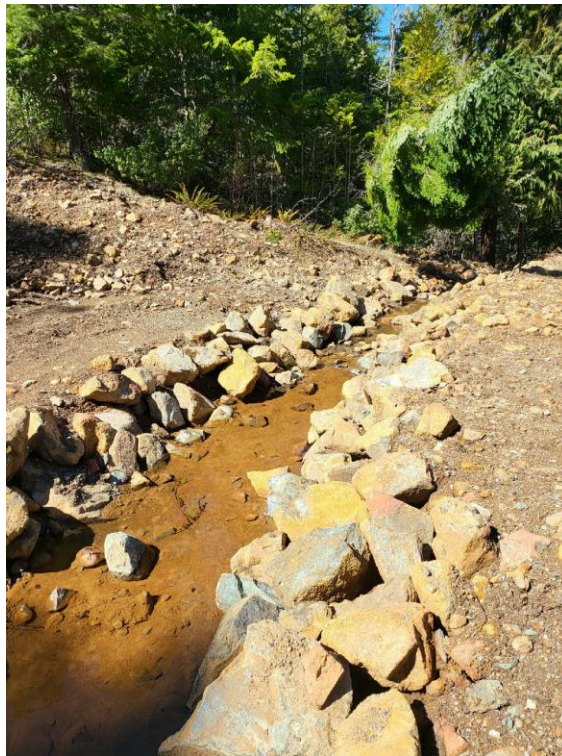
*Figure 25: MP8 stream channel excavation to connect spring flow to Class II channel.*

*Figure 26: MP8 stream channel excavation to connect spring flow to Class II channel.*

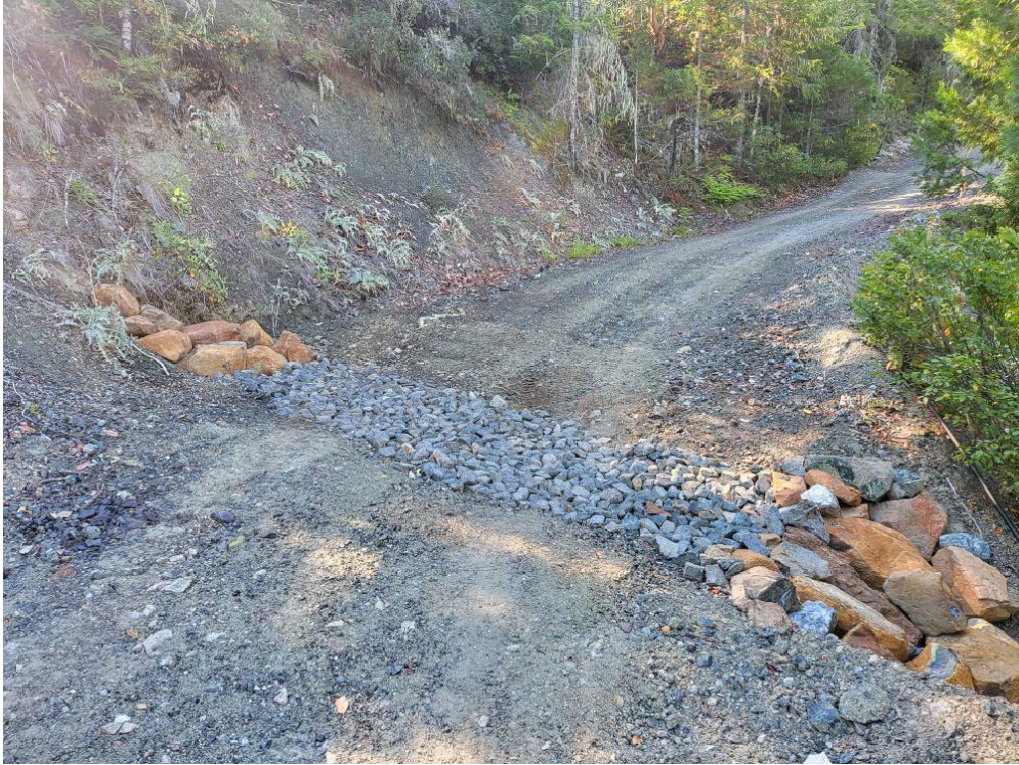
**Status at 10/5 Site Visit:** fill crossing excavated, and rock armor installed. Road approaches hydrologically disconnected.

*Figure 27: MP9 installed rock armor.*

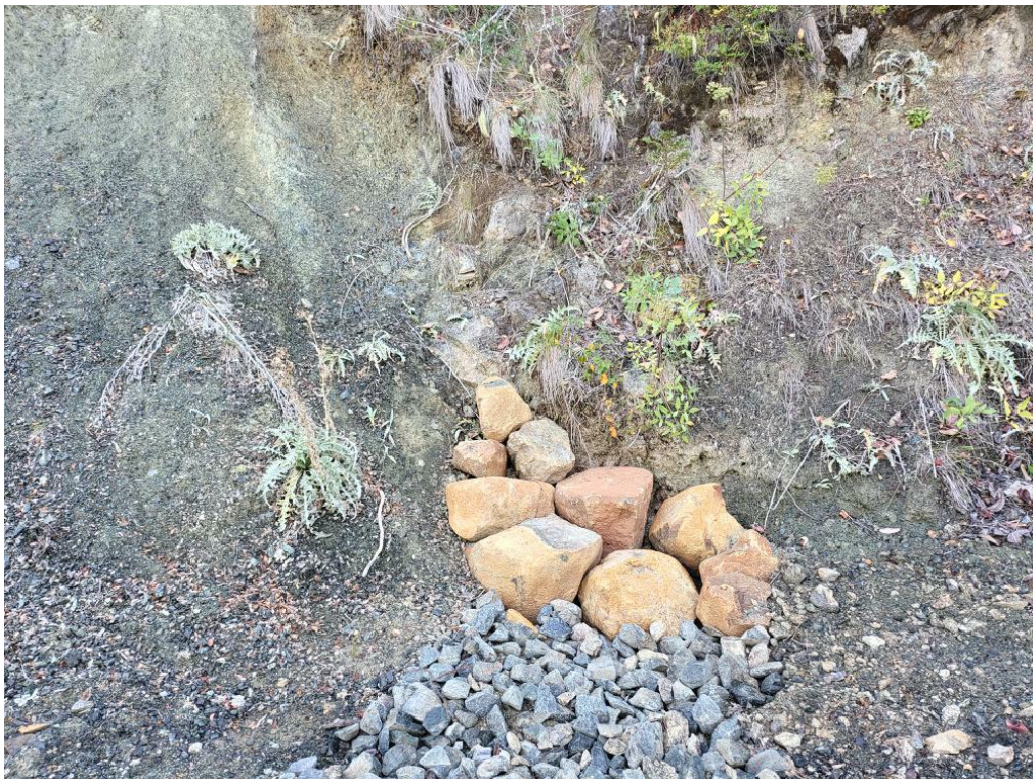
*Figure 28: MP9 upstream.*

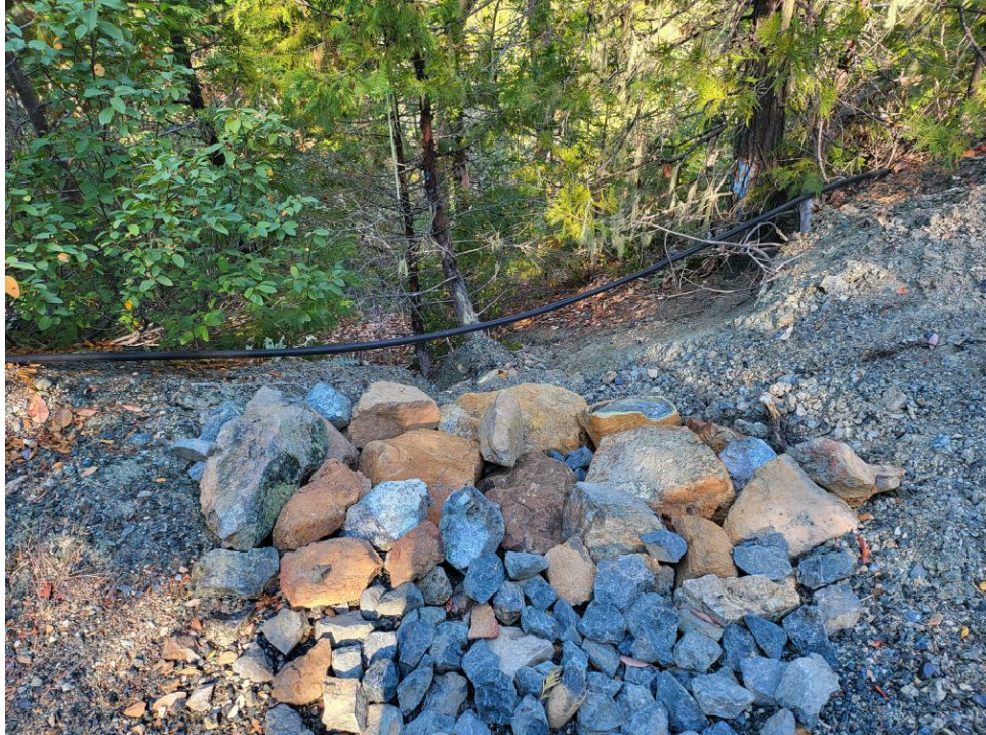
*Figure 29: MP9 downstream.*

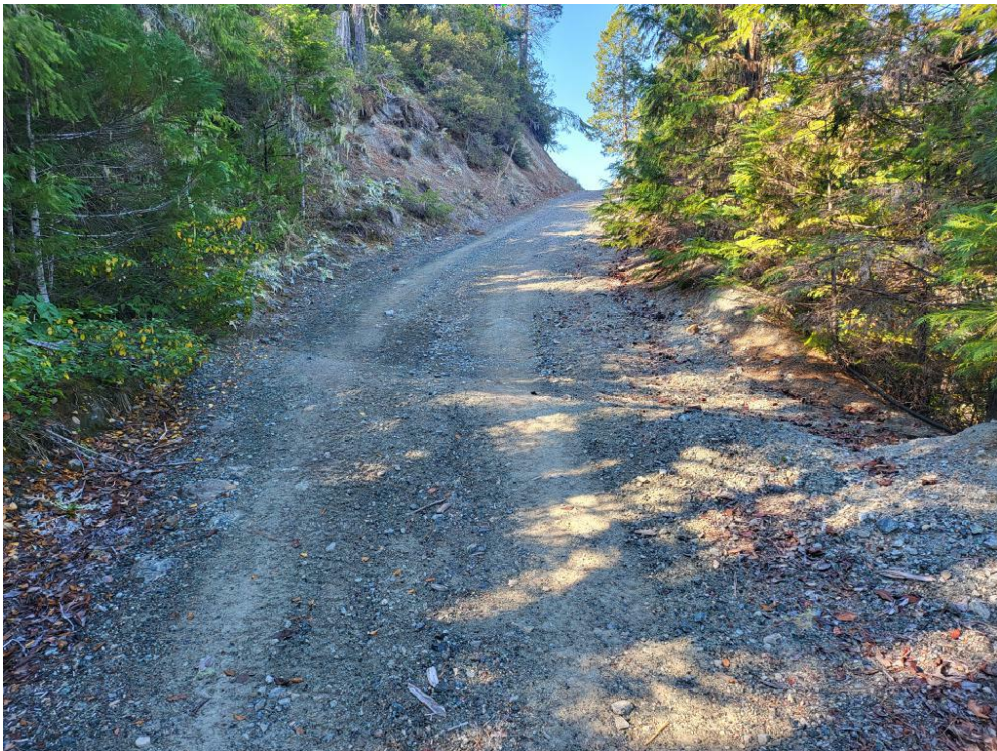
*Figure 30: Water bar up the road from MP9.*

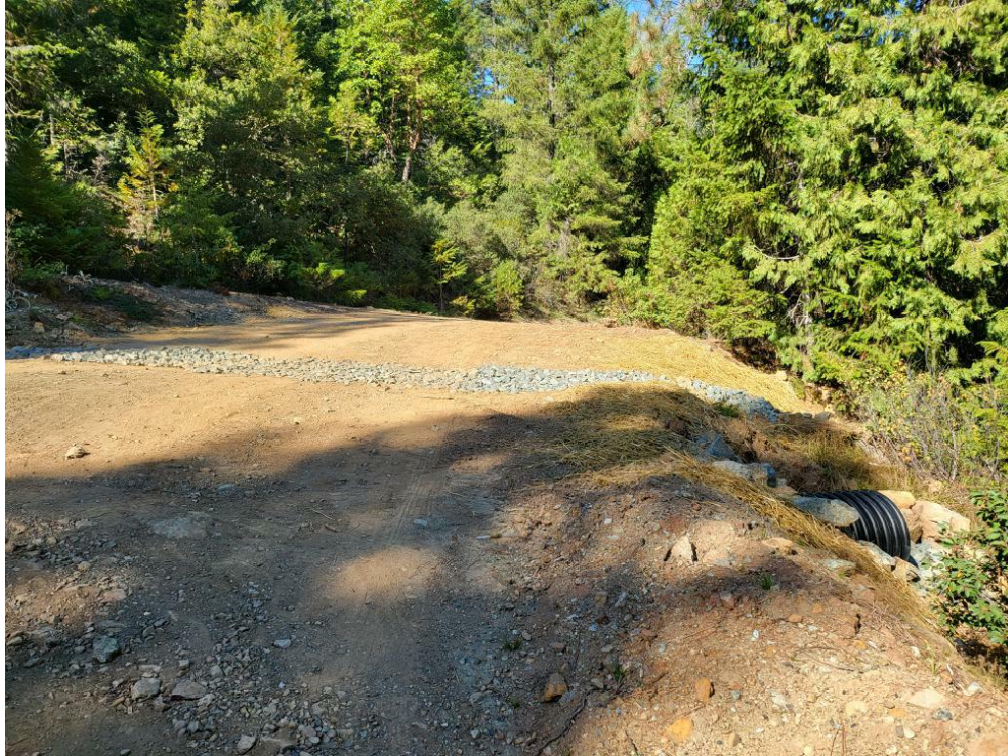
**Status at 10/5 Site Visit:** Culvert has been properly installed with the channel downstream excavated and reconstructed. The area has been revegetated and the boat removed.

*Figure 31: MP10 replaced culvert and rocked road surface.*

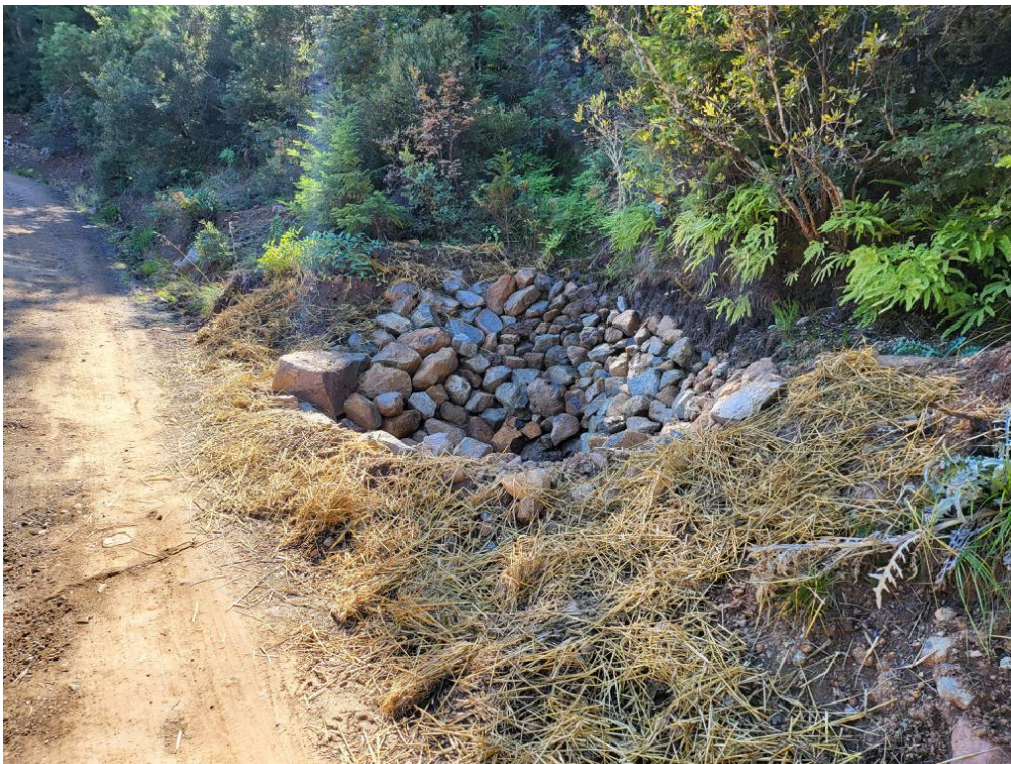
*Figure 32: MP10 inlet.*

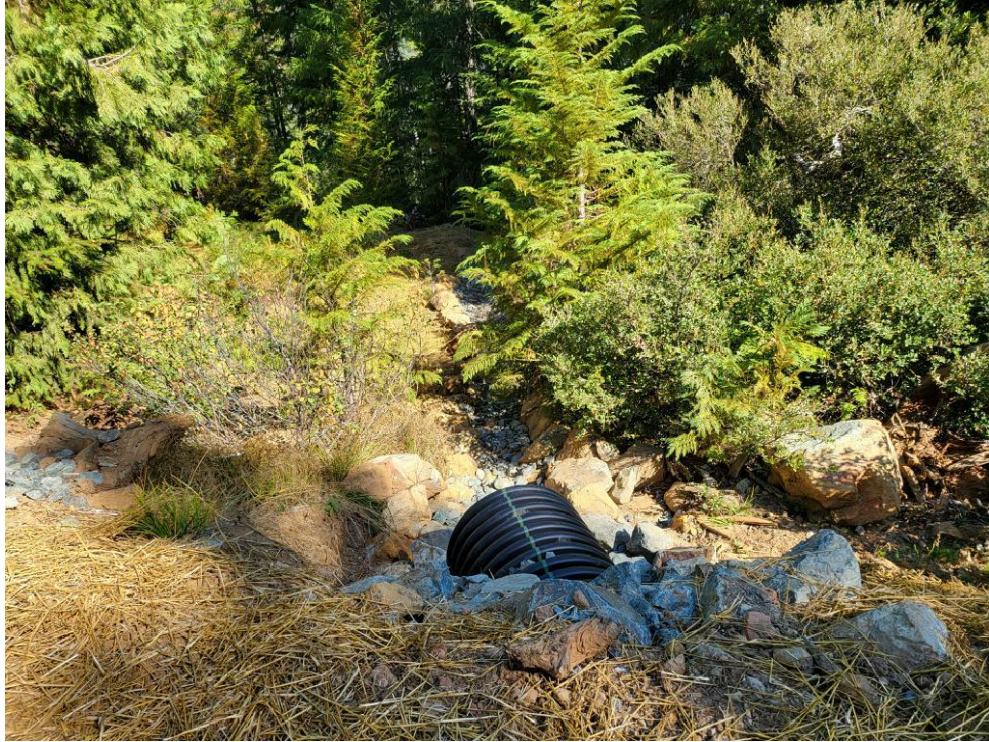
*Figure 33: MP10 outlet with reconstructed channel.*

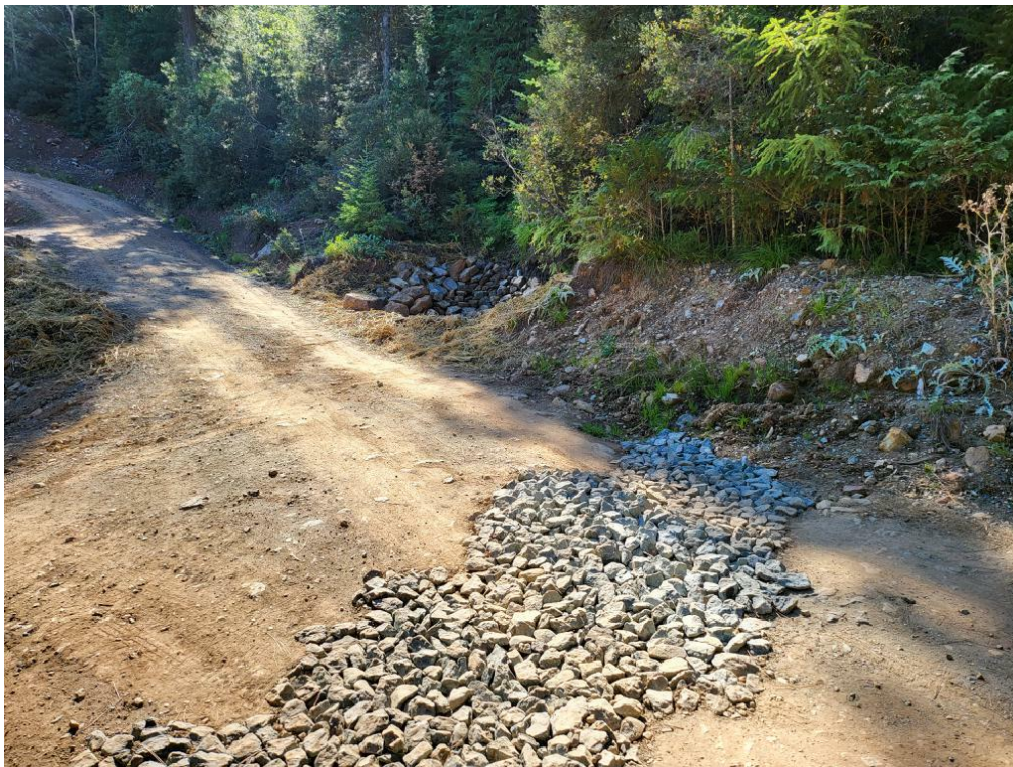
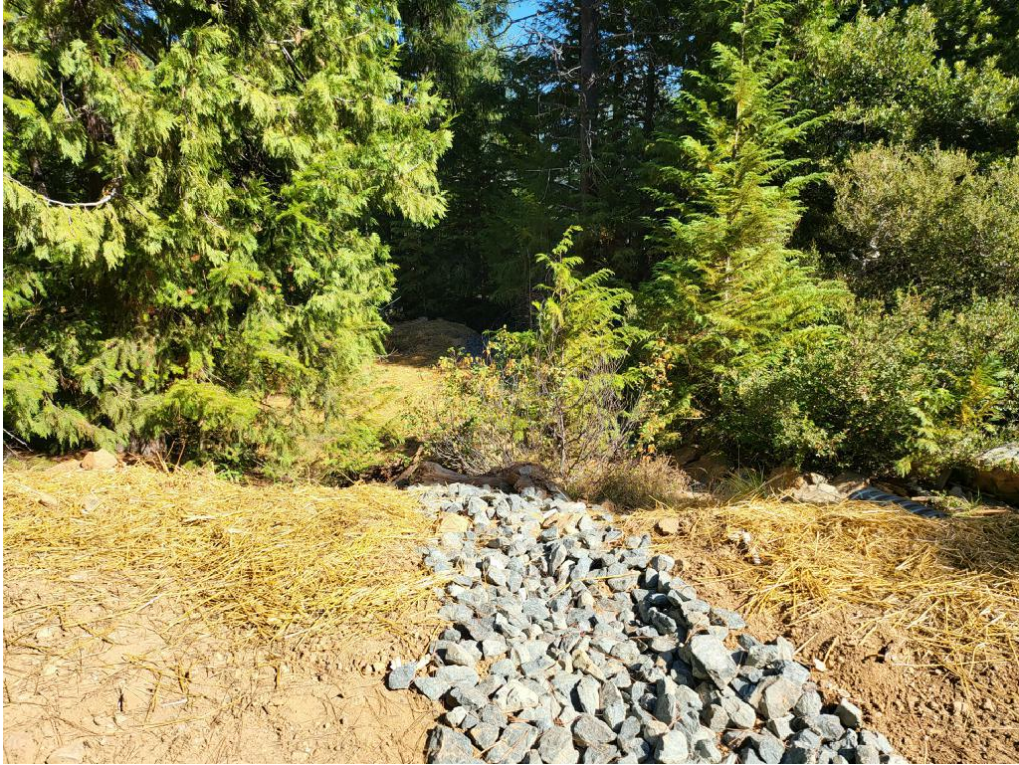
*Figure 34: MP10 disconnected road surface from watercourse.*

*Figure 35: MP10 disconnected road surface from watercourse.*

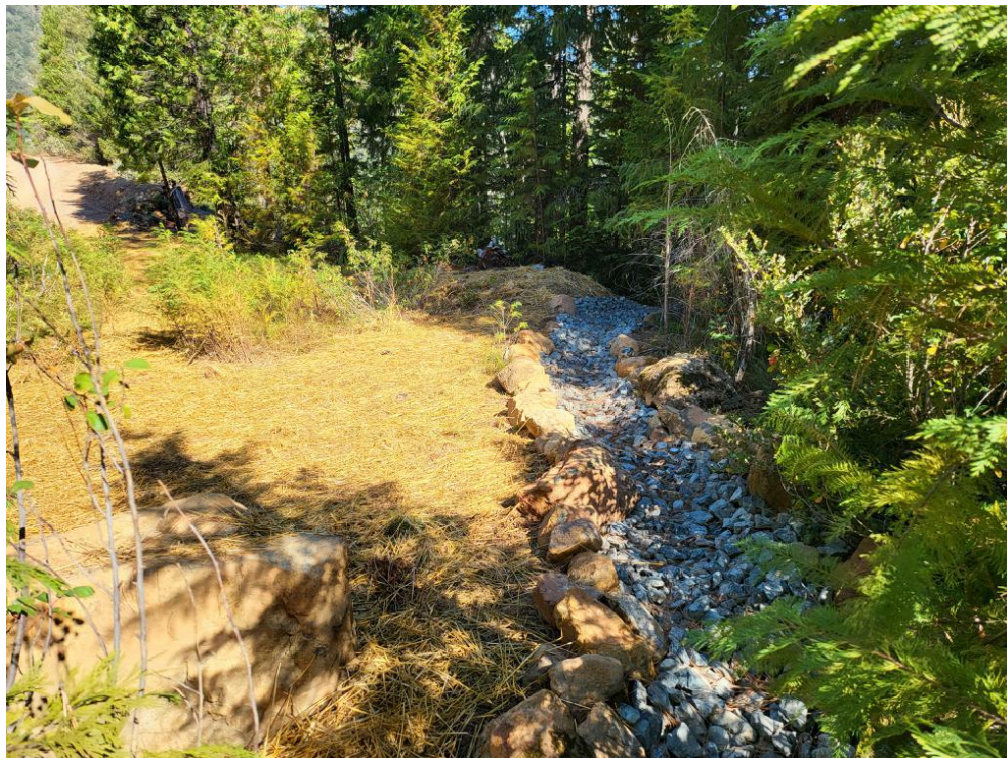
*Figure 36: MP10 reconstructed channel, revegetation, and removal of boat.*

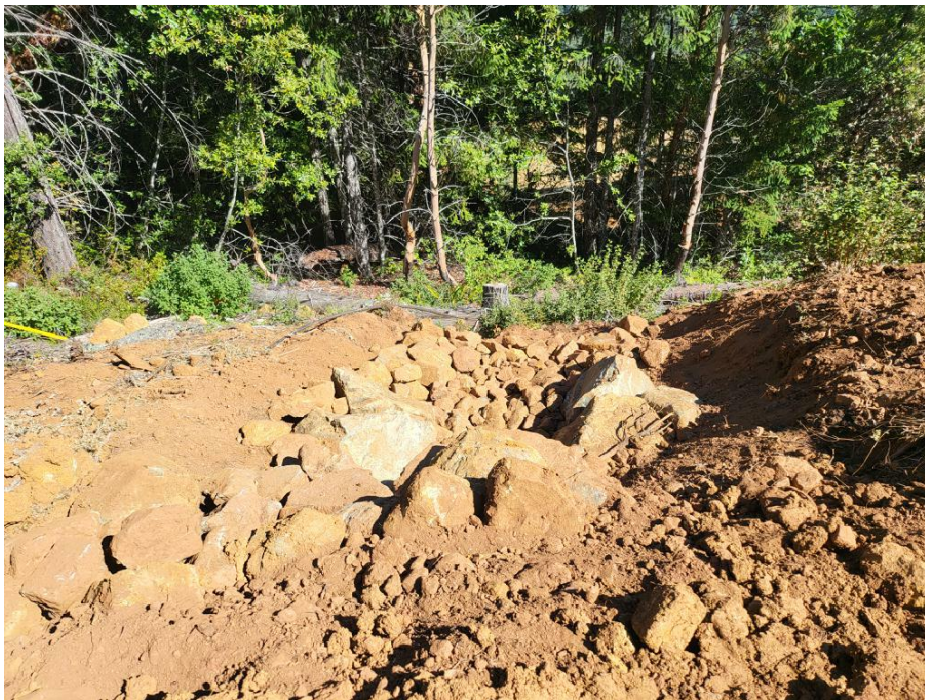
*Figure 38: MP12 downstream.*
