# Project Inspection Report

**APN: 316-071-004**

**Notification #1600-2017-0319-R1**

**October 20, 2022**

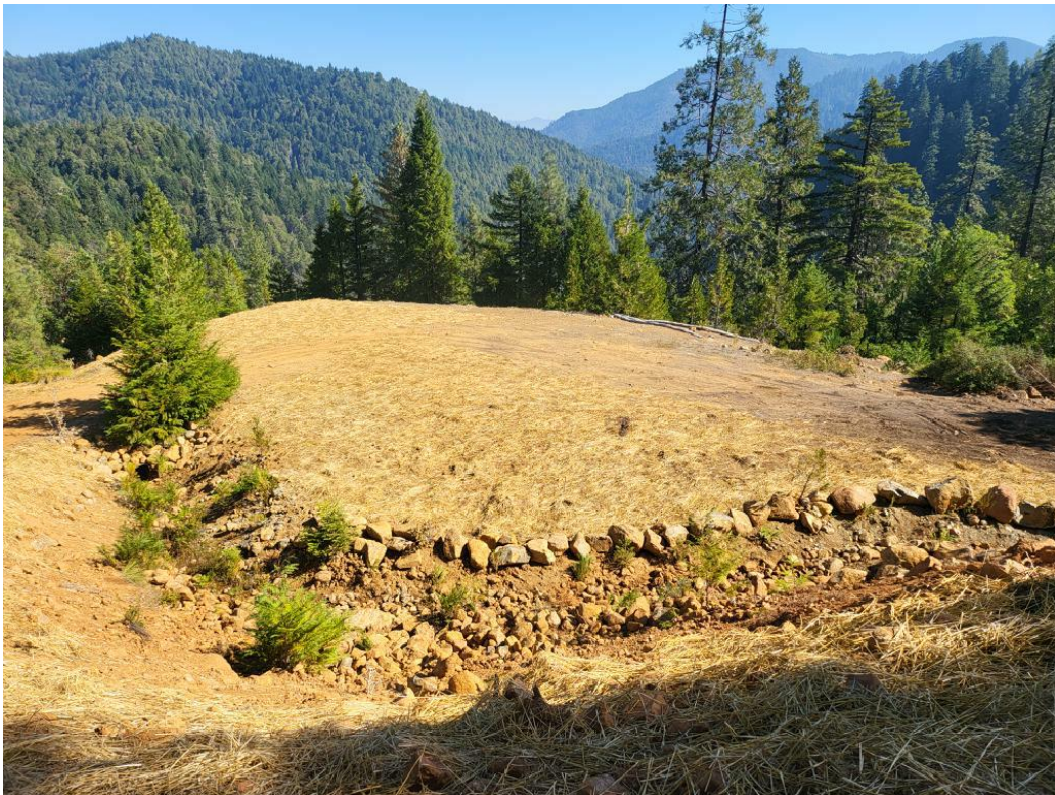
**Status at 10/5 Site Visit:** The western bank has been pulled back and the stream restored. The trash has been removed from the area and the culvert cleared. Revegetation efforts have been successful as of 10/5/2022.

*Figure 40: MP13 overview.*

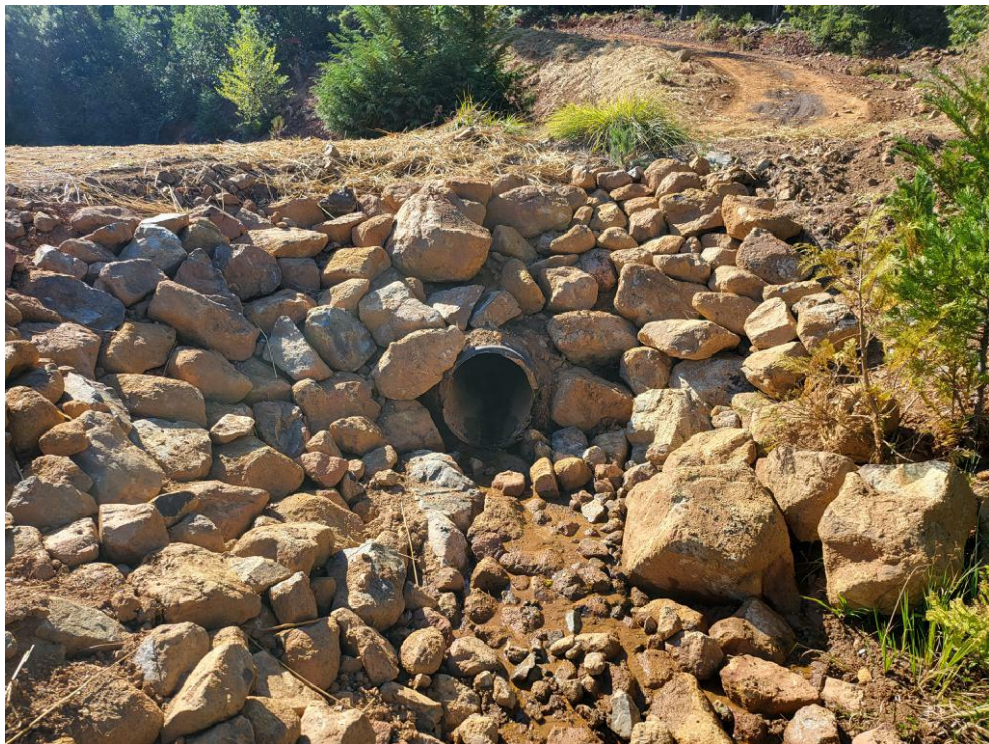
*Figure 42: MP13 culvert outlet.*

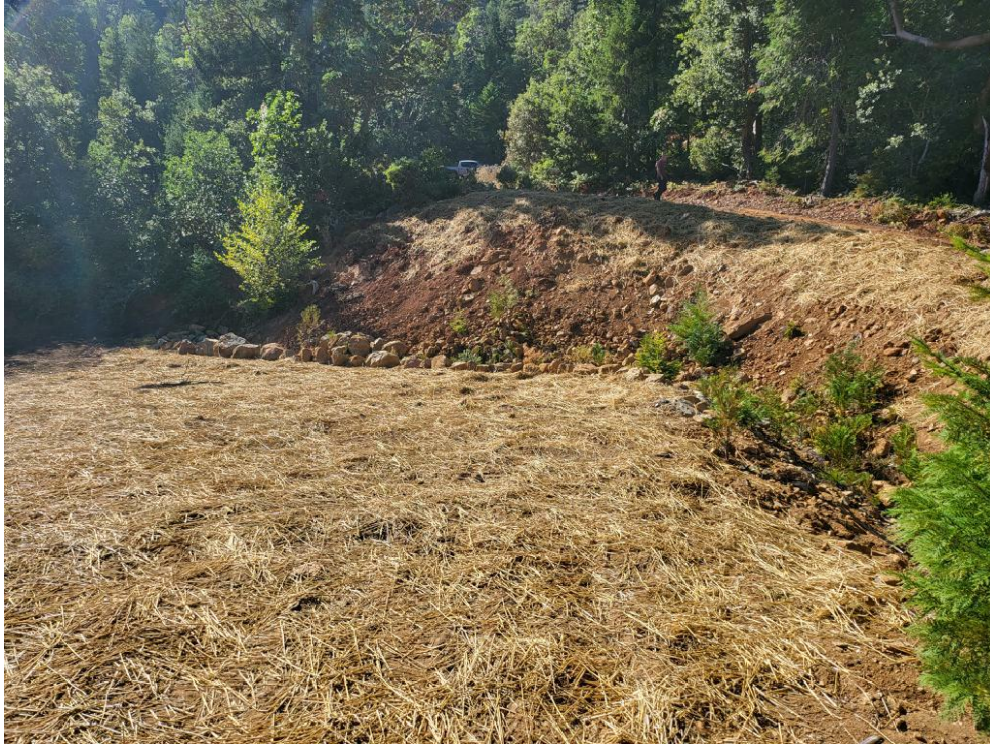
*Figure 43: MP13 slope pulled back, stream restored with revegetation efforts currently succeeding as of 10/5/2022.*

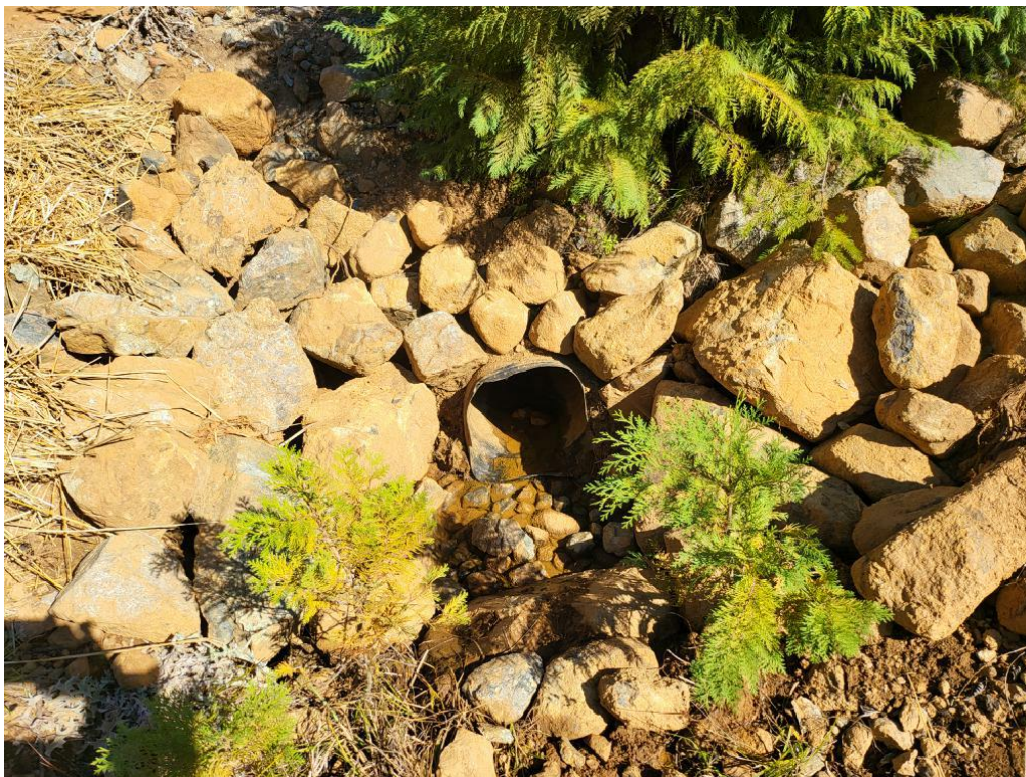
*Figure 44: MP13 cleared culvert inlet.*

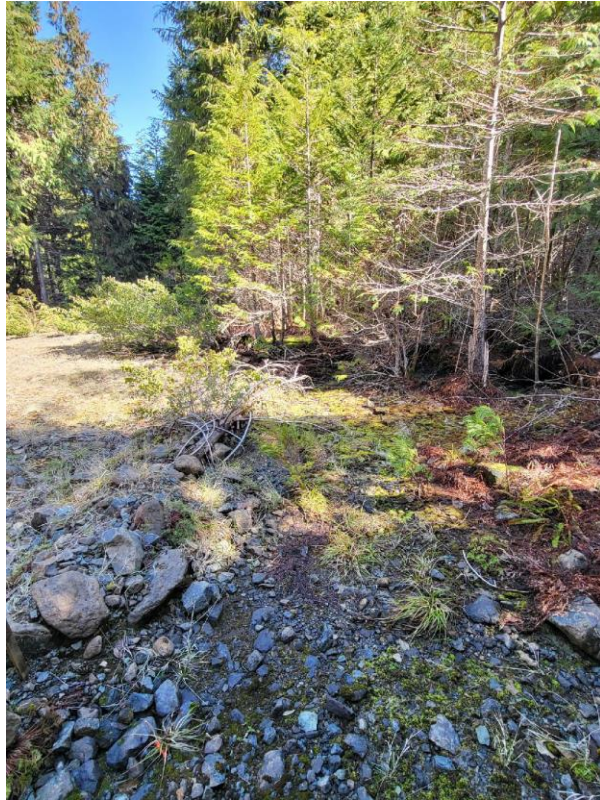
**Status at 10/5 Site Visit:** Crossing has been decommissioned and the area appears to be at natural stream bed elevation. Rock armor is lightly installed.

*Figure 45: MP14 naturalized channel with rock.*

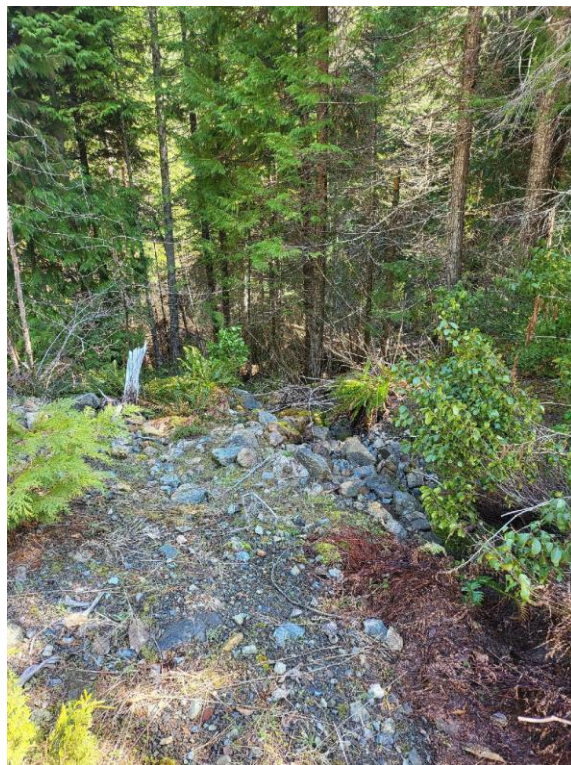
*Figure 46: MP14 rock armor.*

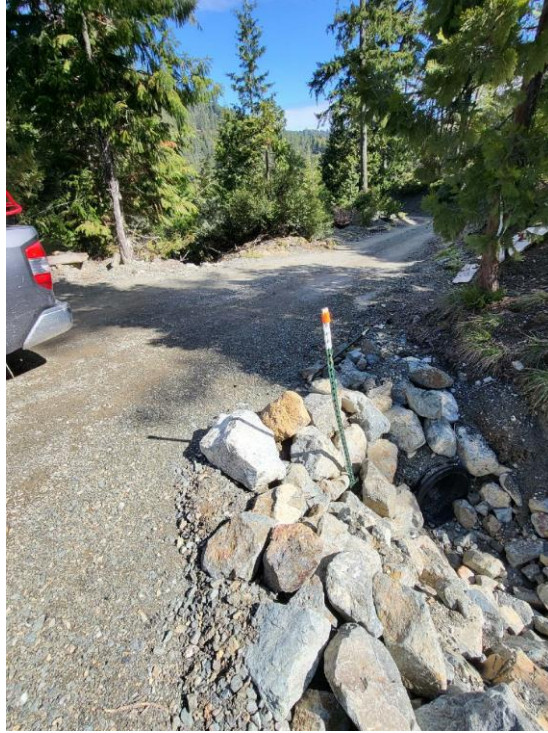
**Status at 10/5 Site Visit:** Channel has been reestablished along natural flow path with 24" culvert and rock armor installed.

*Figure 47: MP19 24" culvert.*

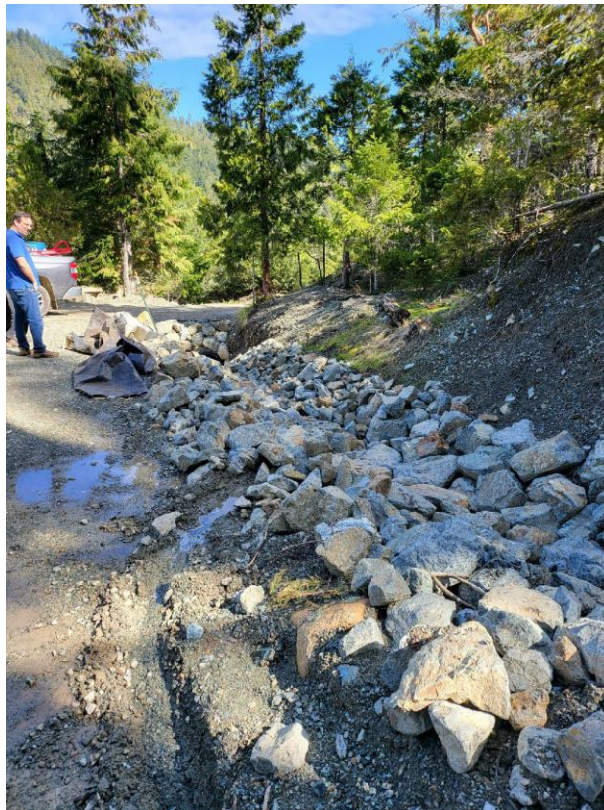
*Figure 48: MP19 reestablished channel with rock armor.*

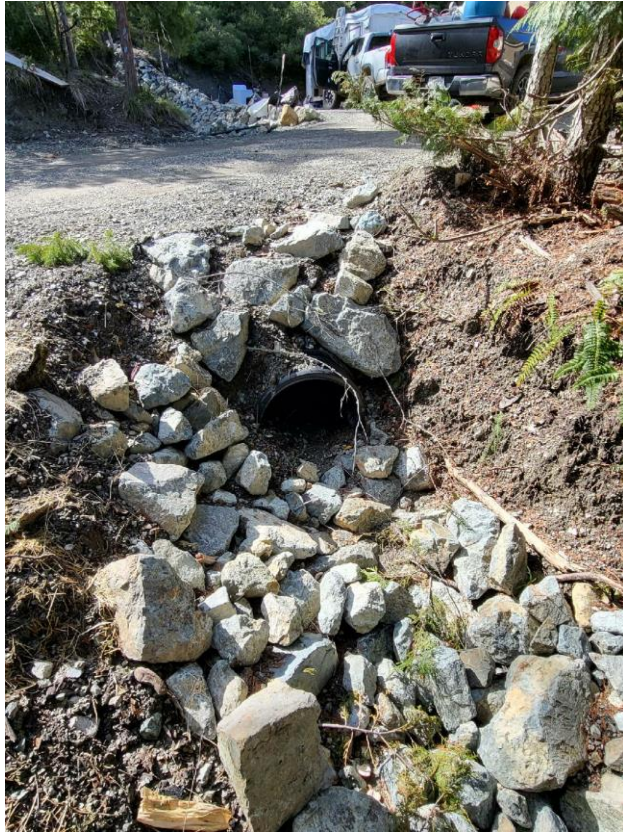
*Figure 49: MP19 outlet.*

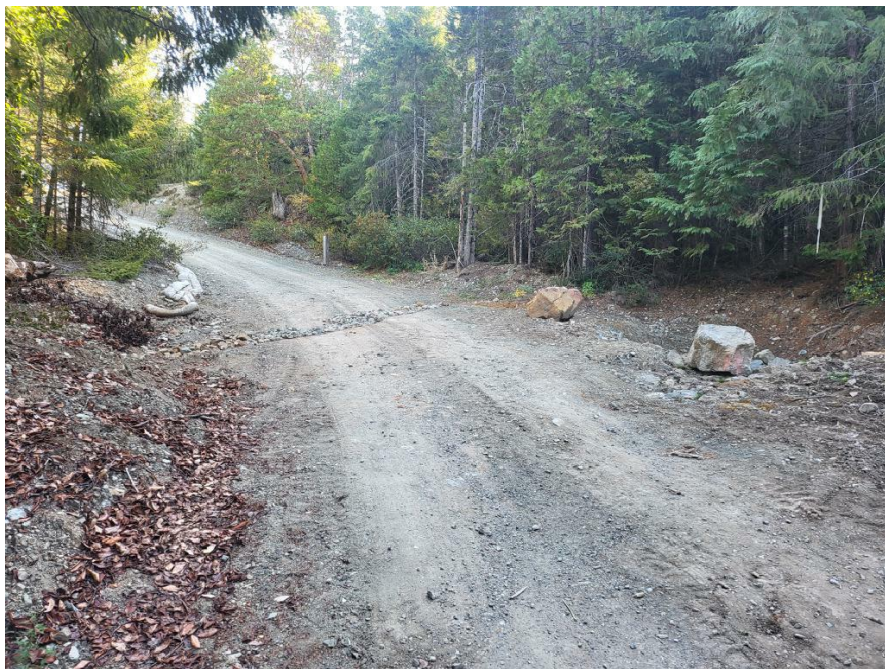
**Status at 3/17 Site Visit:** 24" culvert properly installed.

*Figure 50: MP20 culvert and water bar.*

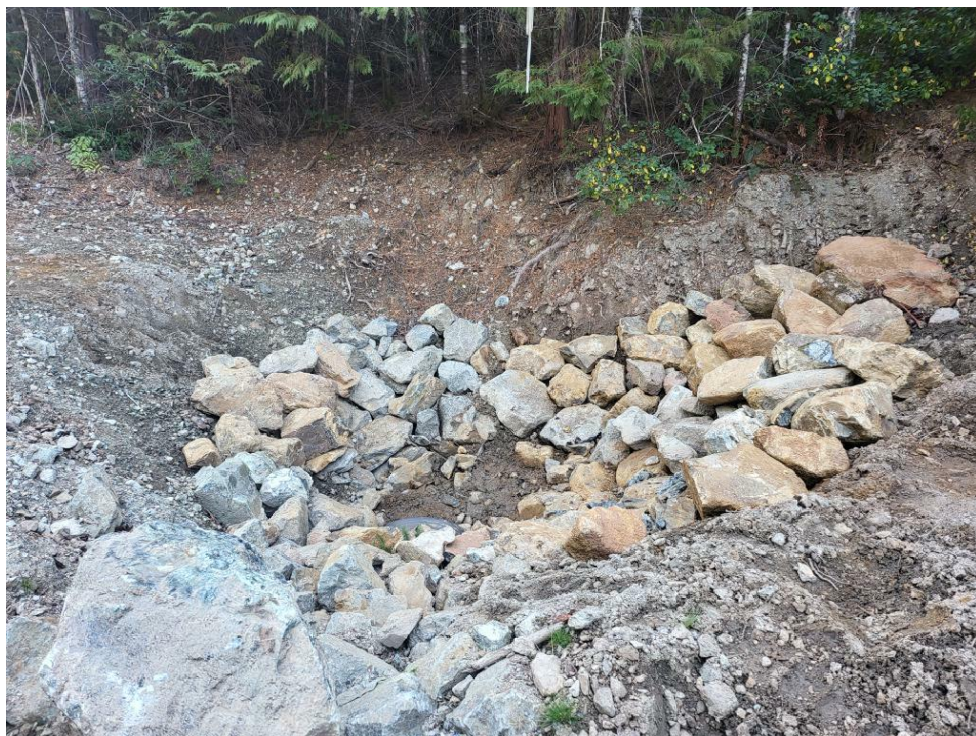
*Figure 51: MP20 culvert inlet.*

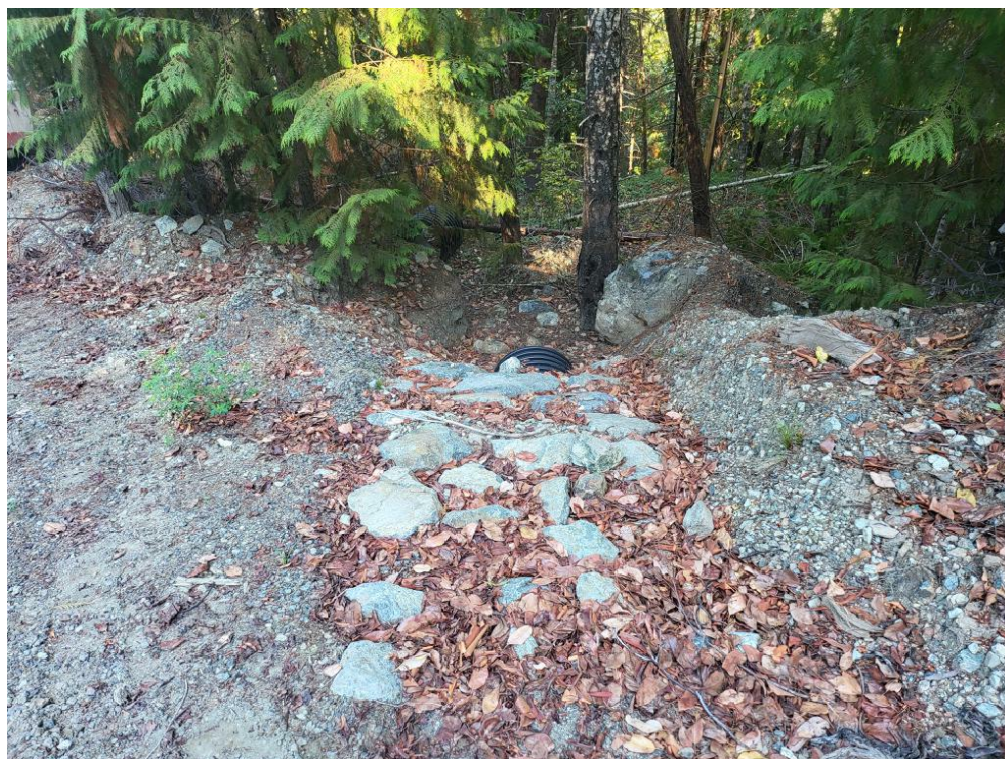
*Figure 52: MP20 culvert outlet.*

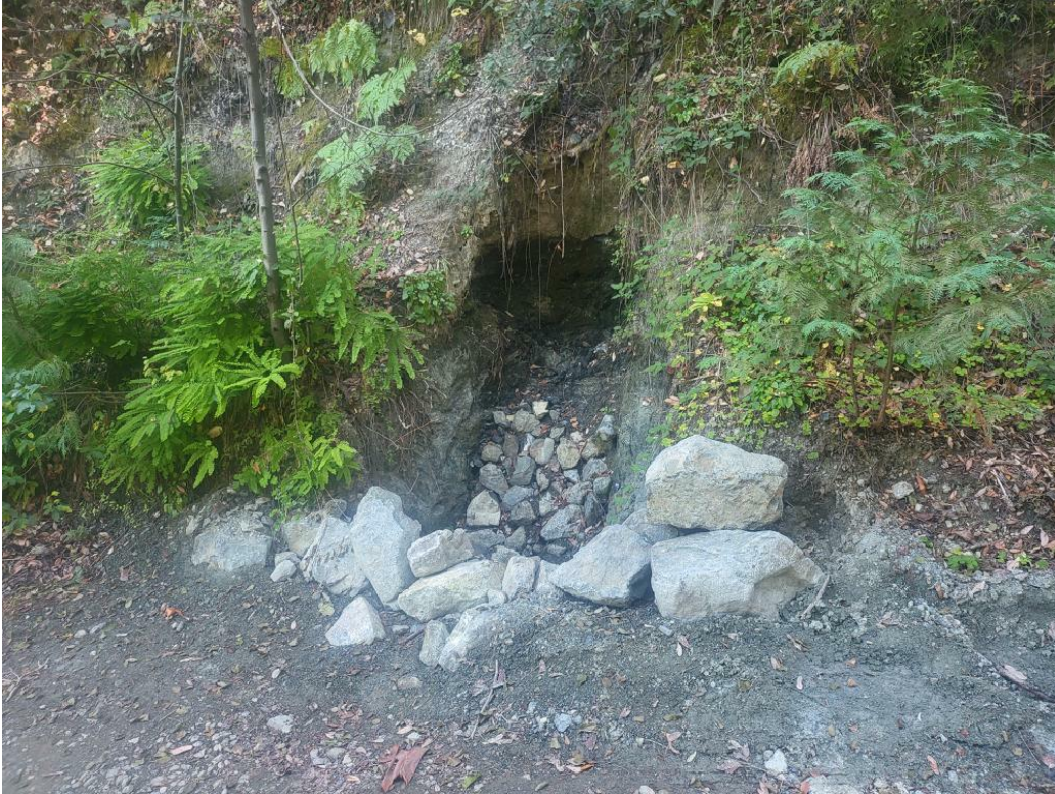
**Status at 3/17 Site Visit:** 24" culvert installed.

*Figure 53: MP21 culvert inlet.*

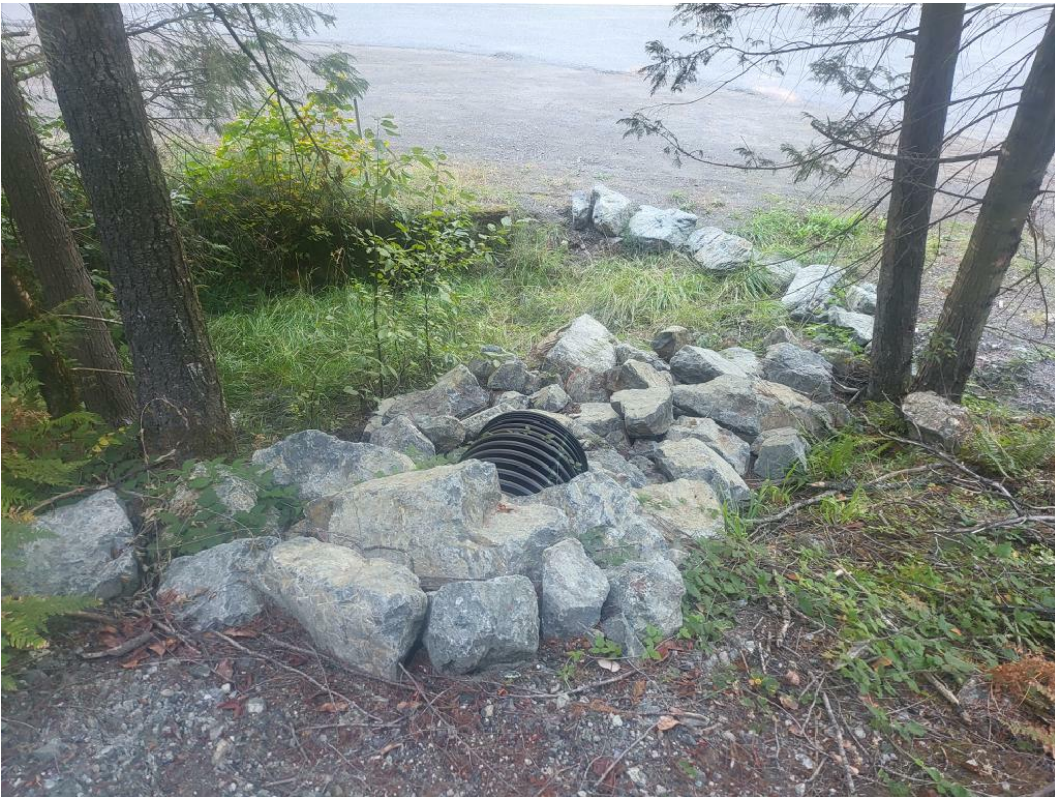
*Figure 54: MP21 culvert outlet.*
