DEPARTMENT OF FISH AND WILDLIFE
Northern Region, Eureka Field Office
619 2nd Street
Eureka, CA 95501

Field Note: Stream Setback Measurements and Coho Salmon Detections in Noisy Creek, Tributary to the Mad River, Humboldt County, California.

Prepared by: CDFW Environmental Scientists Katie Rian and Jonathan Hollis

Survey Date: January 30, 2025

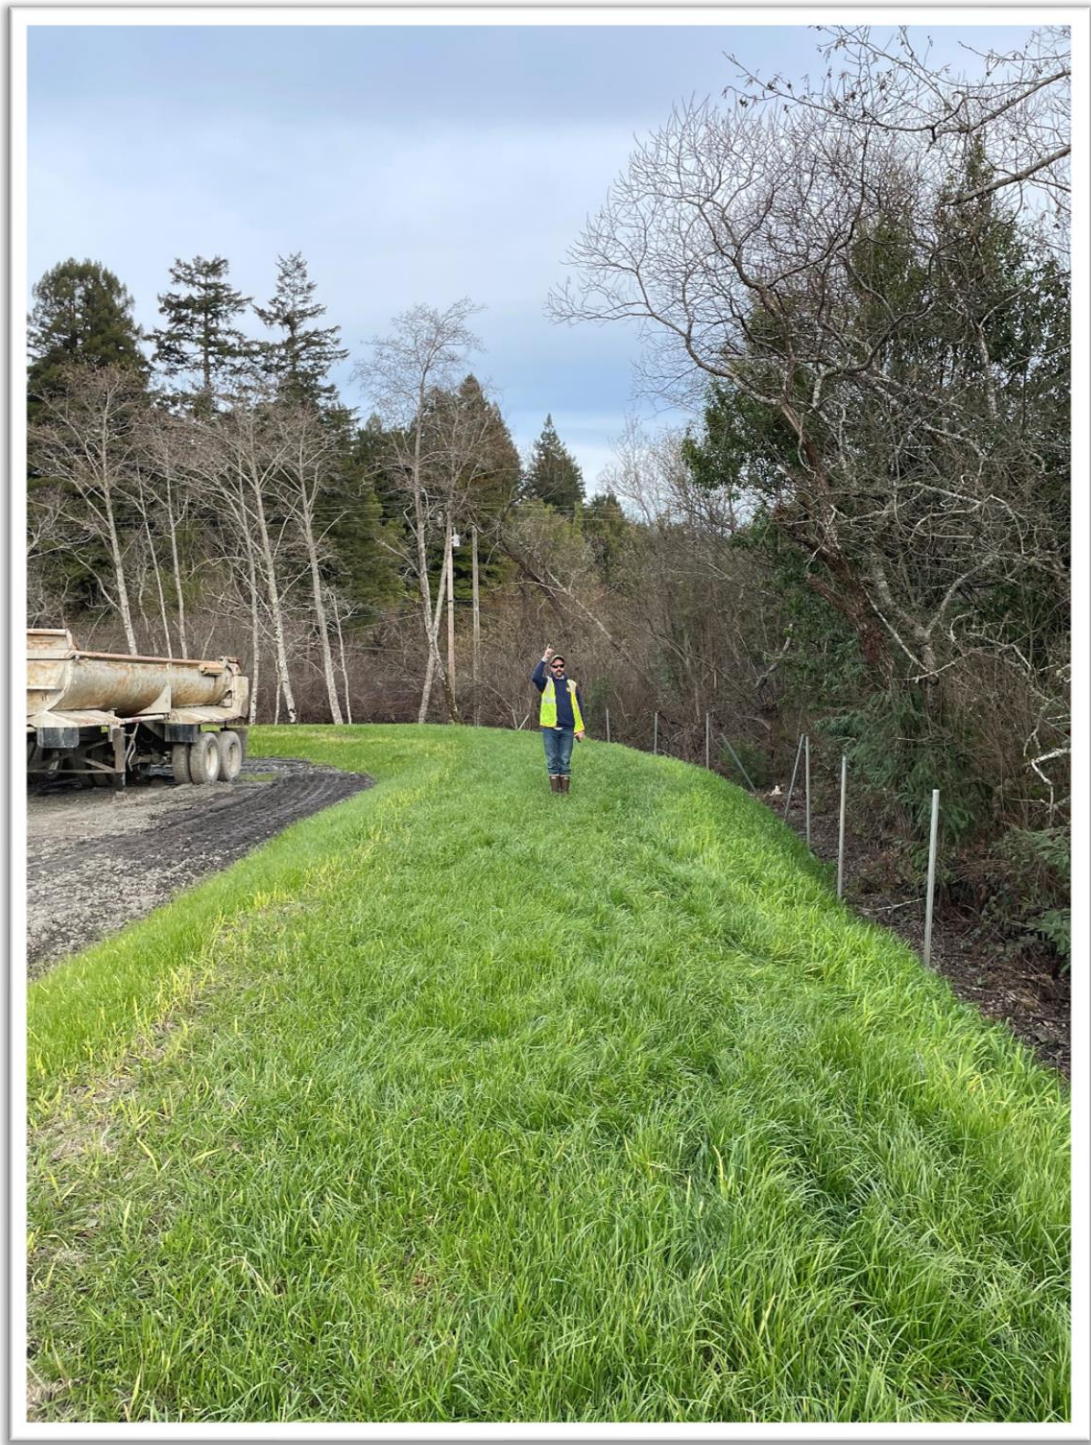
streambank using the internal receiver of an iPhone 12. Using a measuring tape, we measured the horizontal distance (to the nearest foot) from the bankfull channel edge to the streamside edge (toe) of the berm (Table 1). The setback was substantially wider at the first two locations (75 and 41 feet, respectively) just below the Glendale Drive crossing, after which distances constricted dramatically (fewer than ten feet at the narrowest point). Distances ranged from 8 to 75 feet, with a median value of 13.5 feet. Fifteen of the 18 measurements were less than 25 feet. At several points, the riparian dripline extended beyond the toe of the berm (Figure 4).

Figure 4. The dripline of the existing riparian canopy of Noisy Creek extends beyond the streamside edge of the berm, documented during the January 30, 2025, survey effort.

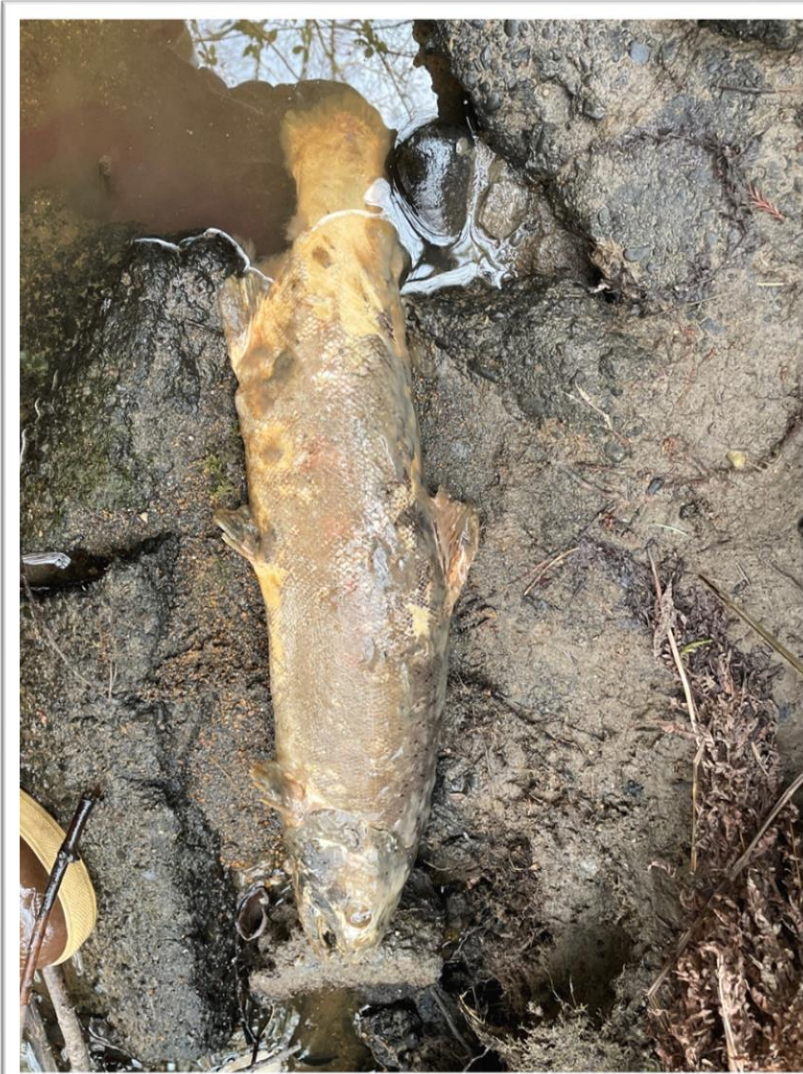
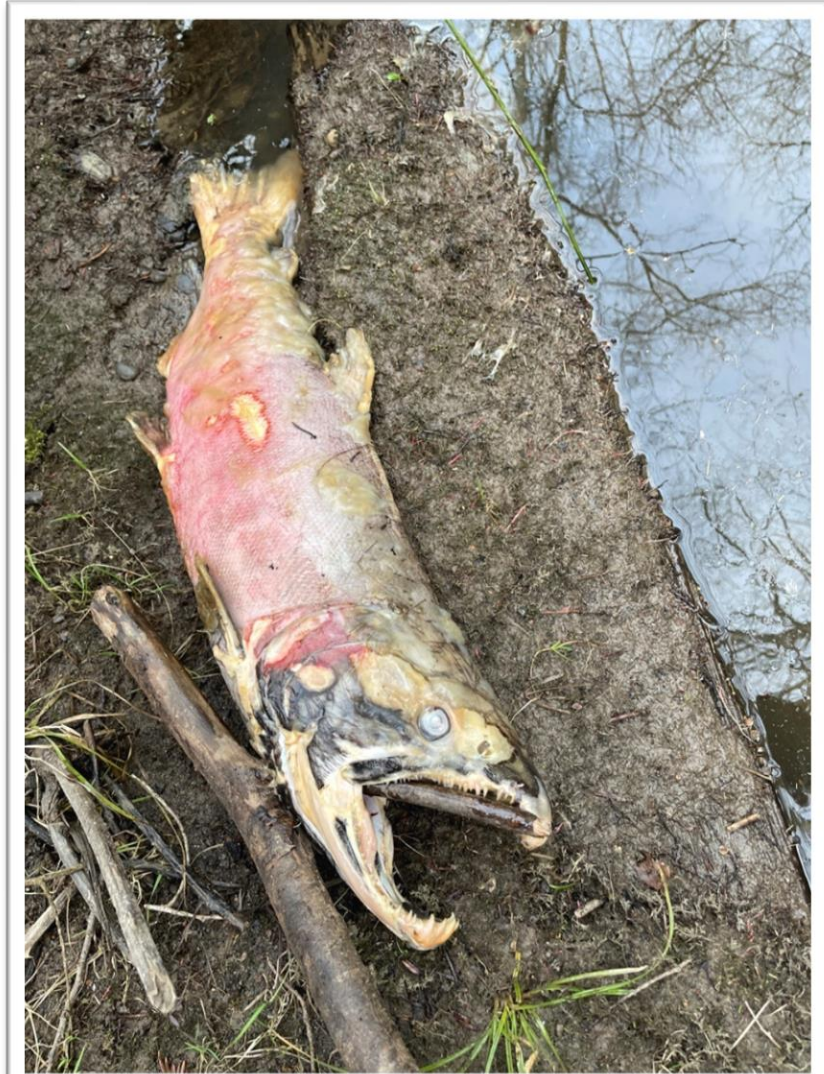
While conducting our survey, we observed the carcasses of two adult coho salmon (*Oncorhynchus kisutch*) within the reach, a male and female displaying signs of having recently spawned (Figure 5). We did not survey the reach for redds, however, on a prior visit to the construction yard on January 6, 2025, CDFW staff incidentally observed several spawning coho salmon across riffles approximately 200 to 300 feet downstream of the large CMP culvert.

Figure 5. Carcasses of adult female (left) and male (right) coho salmon (*Oncorhynchus kisutch*) observed in Noisy Creek during the January 30, 2025, survey effort.

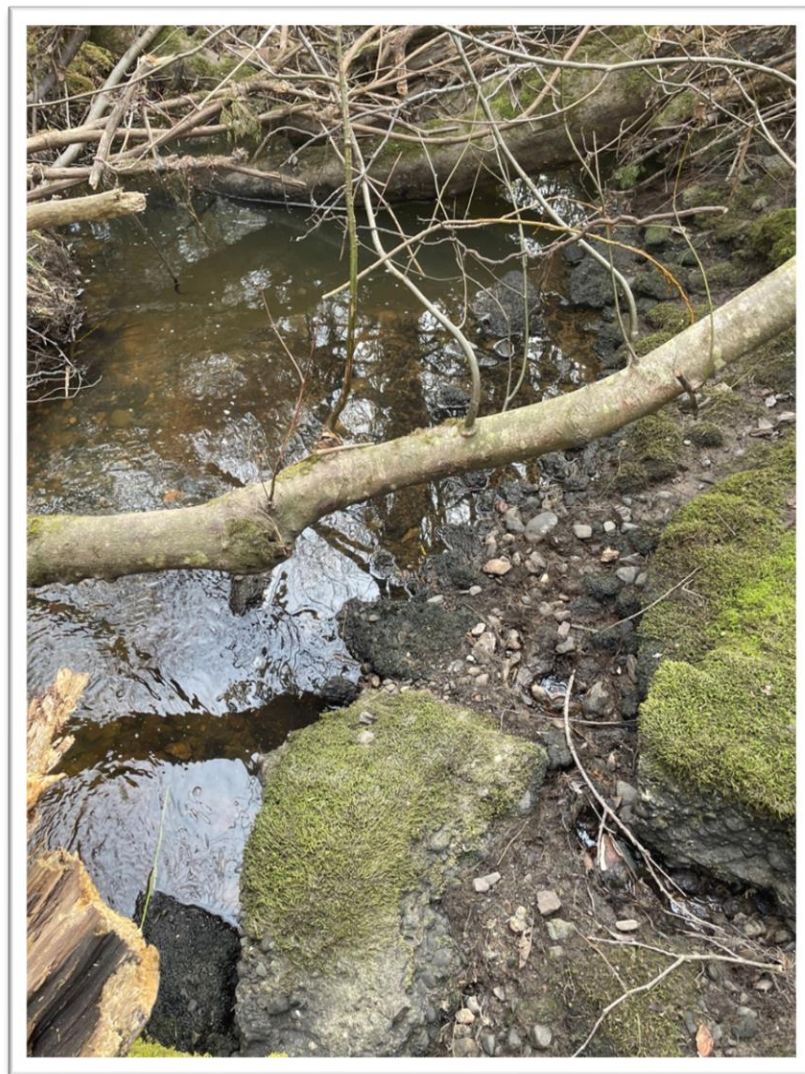
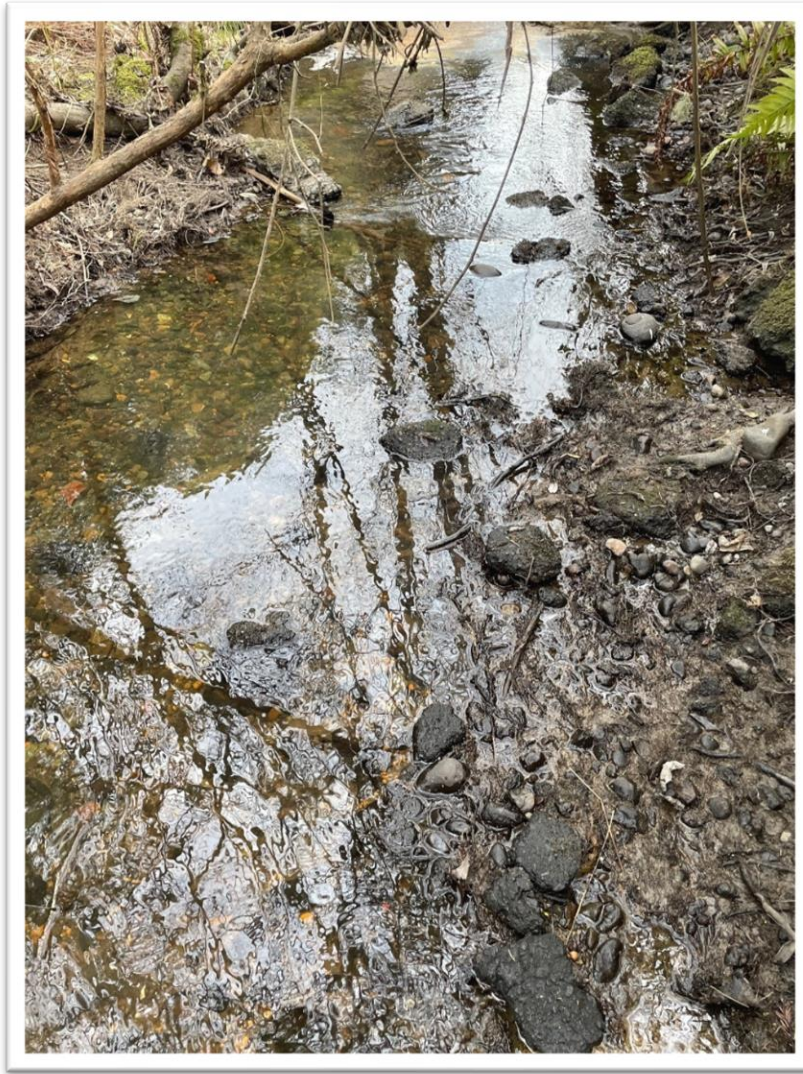
Figure 6. Concrete and asphalt debris in the channel and streambed of Noisy Creek, observed during the January 30, 2025, survey effort.

In addition to the salmon carcasses, we discovered waste concrete and asphalt debris abandoned in the streambed and channel (Figure 6). We recommend the composition and extent of this material be characterized and a plan for its removal and remediation of the streambed be developed and implemented following agency approvals.
