Road Evaluation Report

Humboldt Headless Chicken Ranch
Palo Verde Recreational Ranch

Reference: 018244.100

**Subject: Road Evaluation Report, Humboldt Headless Chicken Ranch Palo Verde
Recreational Ranch, Island Mountain Area, Humboldt County, California;
APN's 218-151-005 and 218-151-006**

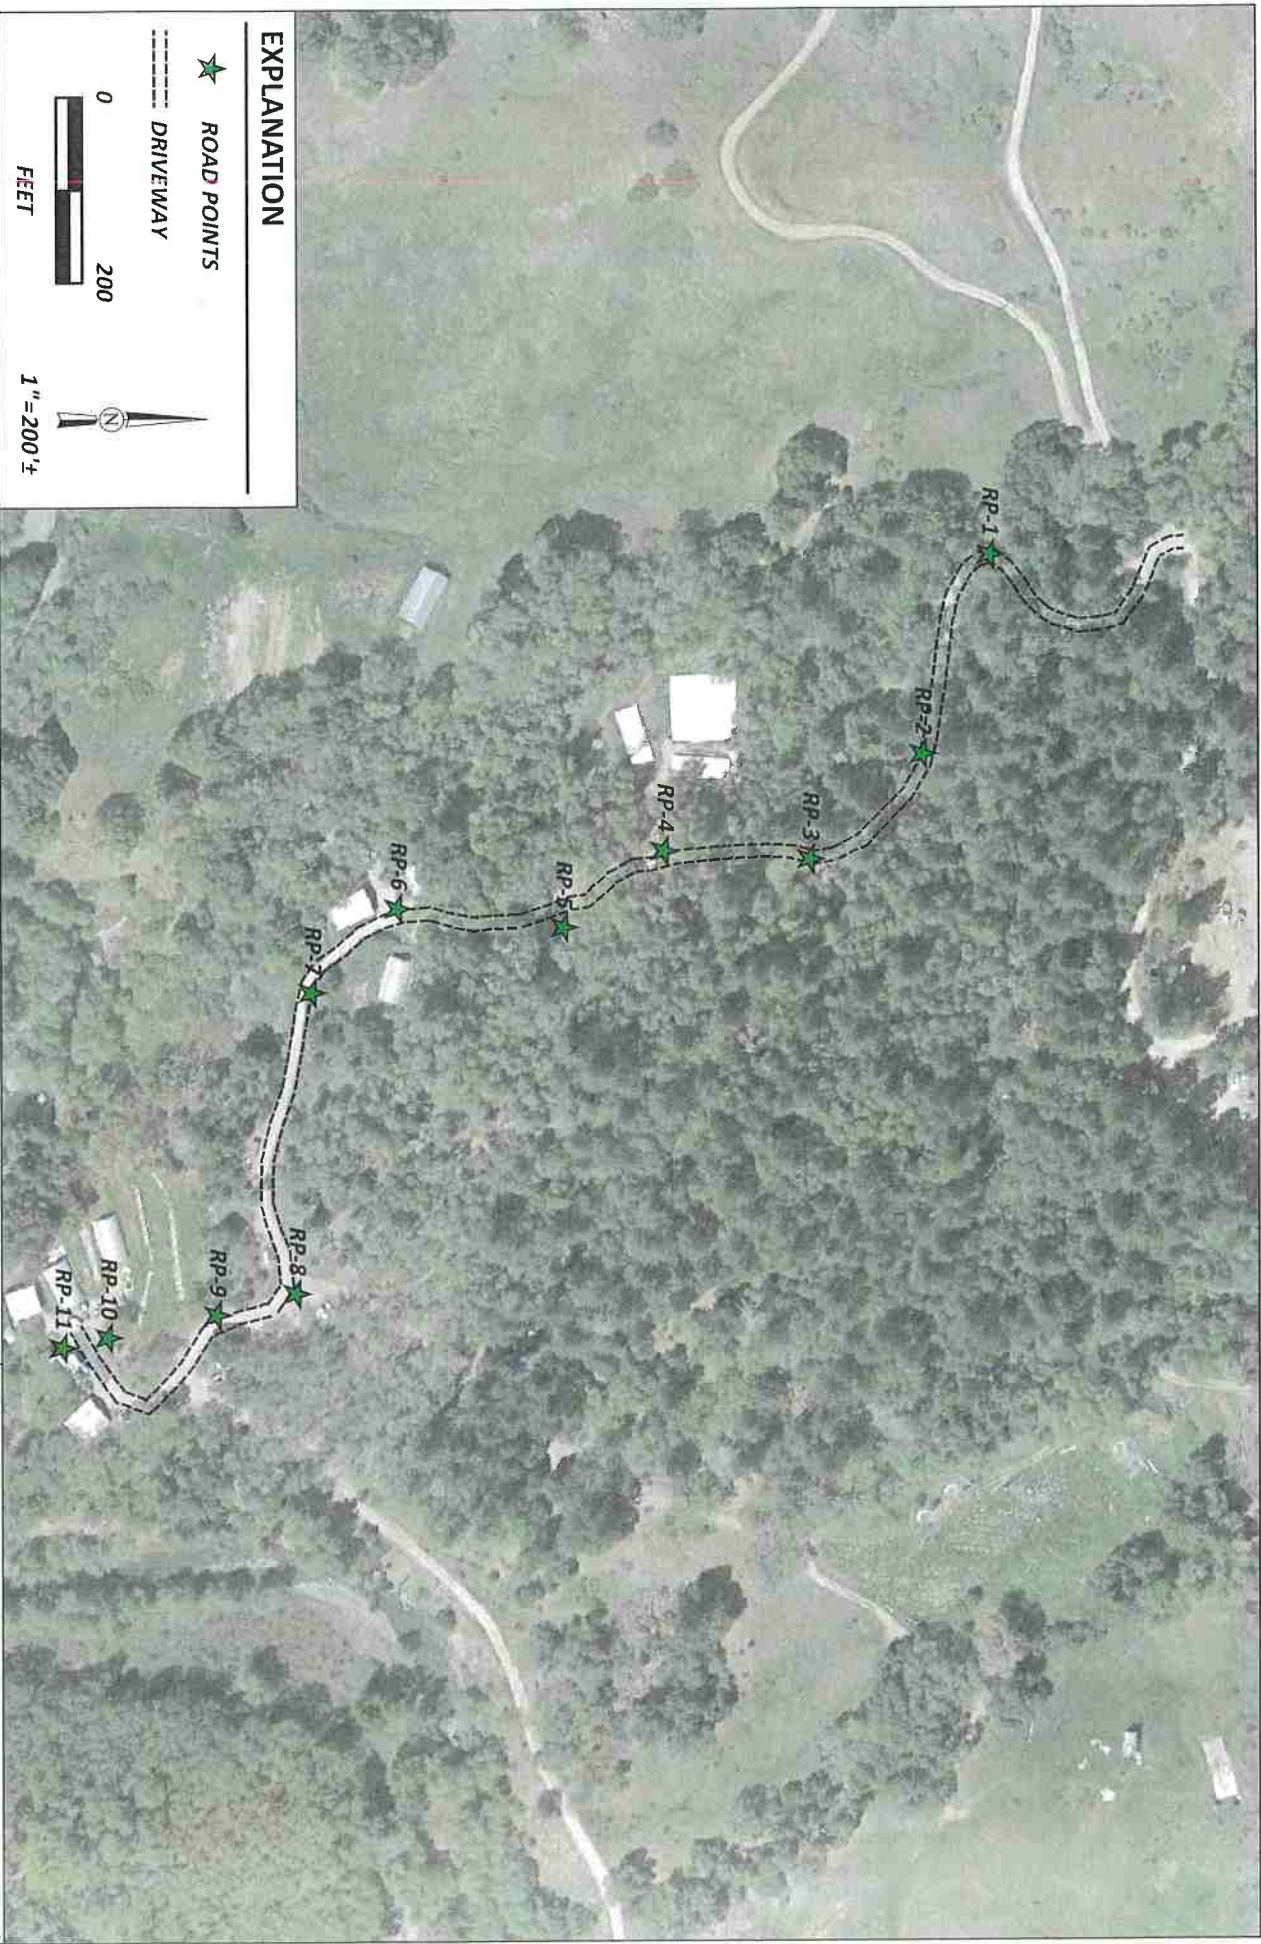
Figure 2

Specific road points discussed herein are shown on Figure 2. Road points are measured from the upper intersection with South Face Road. Locations indicated on the map provided are estimated, and actual locations of improvements may need to be verified in the field.

From the driveway entrance to RP-1, the driveway descends a winding, steep (23%) grade for 190 feet. There is a flatter section with a security gate. Below the gate, at RP-1 there is an existing drainage that encroaches on the west side of the driveway, fed by a culvert that discharges from South Face Road, upslope from this location. The drainage is known to incise and down cut during severe rain events. The drainage diverges away from the driveway as the driveway again descends a steep (23%) grade for 210 feet.

The driveway continues at 23% grade downhill then forms a gentle dip at RP-2. The dip coincides with a gentle swale in the landscape, and a relatively flat area is on the east side of the driveway. The driveway at this location remains wet for longer periods of time following a rain event; wet road and soft soil conditions have resulted in wheel ruts that causes water pond on the driveway surface. Ponding water aggravates the condition; if untreated, the road is likely to deteriorate with continued use.

This driveway segment is 310 feet long, steep (23% grade), and curved. There is an existing, relatively flat area on the outside road shoulder roughly halfway down on this slope.

A preexisting spur road on the west side of the driveway is located here. The spur surface is inclined, and the surface has not been well maintained.

On the east side of the driveway, an intersection with a spur road that provides access to 18, 4,800-gallon water tanks provides a potential pullout. At the time of our observations, there were several large, unused plastic water tanks staged adjacent to the driveway here.

There is a residence on the west side of the driveway at this site, and a spur road that has a Class II stream crossing with a culvert. The driveway was established with a gentle slope down to the west toward the stream crossing. The uphill boundary of the area draining to the stream crossing and culvert is defined by a break in slope on the driveway. Above the break in slope, water may flow from the outsloped road onto the vegetated slope.

The driveway continues downhill from the residence and stream crossing to a low point with a culvert. After the driveway crosses the culvert, it trends uphill for several meters, and then begins a steep (26%) descent. The western (downhill) side of the driveway is initially a vegetated, gentle slope that becomes steeper as one approaches the culvert. The culvert does not show signs of erosion at the discharge point, rather a small amount of sediment has been deposited at this location. On the west side of the driveway, between the culvert and the crest of the gentle rise, a 15-foot wide sidecast fill failure is encroaching to within a few feet of the driveway shoulder. The fill failure does not at this point create a hazard; however, if allowed to grow and develop, it may present a problem for the driveway.

The driveway continues downhill at a steep grade (up to 26%) for 145 feet. There is a spur road on the east side of the driveway. This intersection is a favorable location to develop a turnout. The drainage of this road segment is not well defined, and some modest gulying was observed here.

As the driveway continues to descend the steep (26%) slope, another spur road (Lower Road D) intersects the driveway from the east side. The landscape slopes down to the east. The driveway is 15 feet wide here.

The driveway becomes wider and less steep as it reaches the termination of the active road at the primary cultivation and processing area. There is an accessory building located on the east side of the driveway. The road surface is not well drained in this area and is flowing down the driveway. The driveway ends in a hammerhead turnout. The south arm of the turnaround continues downhill as a walking path but is currently unused by vehicular traffic. Runoff is currently flowing down the path forming gullies in the road surface.

- In order to improve drainage, install rolling dips across the road at favorable locations at intervals not exceeding 100 feet on steep slopes (greater than 15% grade).
- One specific rolling dip should be located such that the discharge point is downslope from the point where the driveway diverges away from the existing drainage such that water is prevented from entering the drainage.
- A rock energy dissipator should be constructed at the point of discharge, from which water should be allowed to flow across the vegetated slope.
- Between the security gate and the rolling dip (below the drainage), the driveway should be graded to prevent water from entering the drainage.
- Place and maintain rock on steep slopes above and below RP-1, and above the security gate.

- Break up the continuous flow between RP-1 and RP-2 by placing a rolling dip near the base of the slope approaching RP-2.
- Convey surface water to the vegetated slope southwest of the driveway.
- At RP-2, re-grade the road surface to facilitate drainage toward the outboard edge (west side of the driveway).
- Place angular rock on the steep 23% slope uphill from RP-2, and across the re-graded swale area at RP-2 for additional stability.
- Provide rock energy dissipator at the point of discharge at RP-2 (the lowest point of the swale).
- Create a turnout on the east side of the driveway at the existing (relatively flat) area adjacent to the swale, as it allows a line of sight uphill toward RP-1.

- Place rock on steep (23% grade) road surface.
- Develop the flat area at this location into a usable turnout (in accordance with Humboldt County Code Title III, Division 11 Chapter 2, section 3112-9, Figure 3112-8; see attached). Clear out existing vegetation, reshape the road edge to allow for vehicular access, and place rock to develop turnout.
- Rolling dips should convey water to the downhill (west) side of the road, be no more than about 100 feet apart, and be located above or below turnouts, not occupying the same part of the driveway.

- Create a pullout out of the spur road to allow traffic to pass.
- Re-grade the uphill portion of the spur road and place rock as needed to improve the surface.
- Uphill from the intersection with the spur road, install a rolling dip across the driveway, discharging to the west side of the driveway.
- Provide grading such that water is prevented from flowing off of the driveway onto the surface of the spur road.

- The rolling dip should be located uphill from the spur road far enough to allow for enough vegetated slope west of the driveway so as to act as an effective sediment filter.
- Outslope the driveway below the spur road.

- Remove unused water tanks and establish a serviceable turnout at this location to allow traffic to pass.
- Outslope the driveway immediately above and below the spur at this location.
- Place rock as needed on steep portions of the driveway.

- Place angular gravel on the driveway surface leading to the Class II crossing. Gravel should cover the surface of the road spur across the stream crossing and culvert. The gravel is intended to slow and filter runoff toward the Class II watercourse.
- Options to regrade the slope here to divert runoff away from the Class II watercourse are not feasible because they would require excessive earthwork.

- The section of driveway between the stream crossing at RP-6, above, and the 12-inch culvert should be outsloped to allow water to drain freely across the vegetated landscape.
- The driveway section between the culvert and the gentle rise should be insloped. An existing inboard ditch at this location is in poor condition; it should be cleaned out and regularly maintained to convey water to the culvert for relief.

- Due to vegetation growth and sedimentation, we were unable to see the culvert inlet during our inspection, although we observed that it was functioning. Thus, the culvert inlet will require cleaning out and regular maintenance as well. It is important to route water flow away from the sidecast fill failure.

- Re-grade the driveway above the pullout (spur road) so that it is insloped toward the inboard ditch. Outsloping the road here is not feasible as the outboard edge is coincident with the sidecast fill failure at this location. Again, it is important to guide water away from the sidecast fill failure.
- At the intersection, construct a water break (rolling dip) to drain water across the spur road. Construct a rock energy dissipator at the discharge point and allow water to flow across the vegetated landscape below the spur road.
- Place and maintain rock on steep grade, where it does not already exist.

- Re-grade the driveway so that it insloped (to the west side).
- Below the intersection with Lower Road D, construct a rolling dip across the driveway to convey water from the west side inboard ditch to the east side of the driveway.
- Discharge water to the vegetated landscape (south of Lower Road D intersection).
- Place and maintain rock on the steep driveway surface.

- Inslope the driveway.
- Construct an inboard ditch on the west side of the driveway.
- Develop a water break to convey runoff across the driveway to the outboard edge of the walking path at the downhill arm of the hammerhead turnaround. A rock energy dissipator should be constructed at the discharge point here. Water should then be allowed to flow across the vegetated landscape.
