# Timberland Conversion Evaluation Report

December 27, 2018

Legal Description of Ownership: PARCEL 62 TIMBERLINE RANCH EST RS BK 26 PG 135  
Address: Bear Creek Road  
Dinsmore, CA 32219

APN(s): 208-201-017  
Section 30; T2N; R5E; HB&M; Humboldt County  
Parcel Size: Approximately 40 acres  
Acres Converted: > 0.10 acres

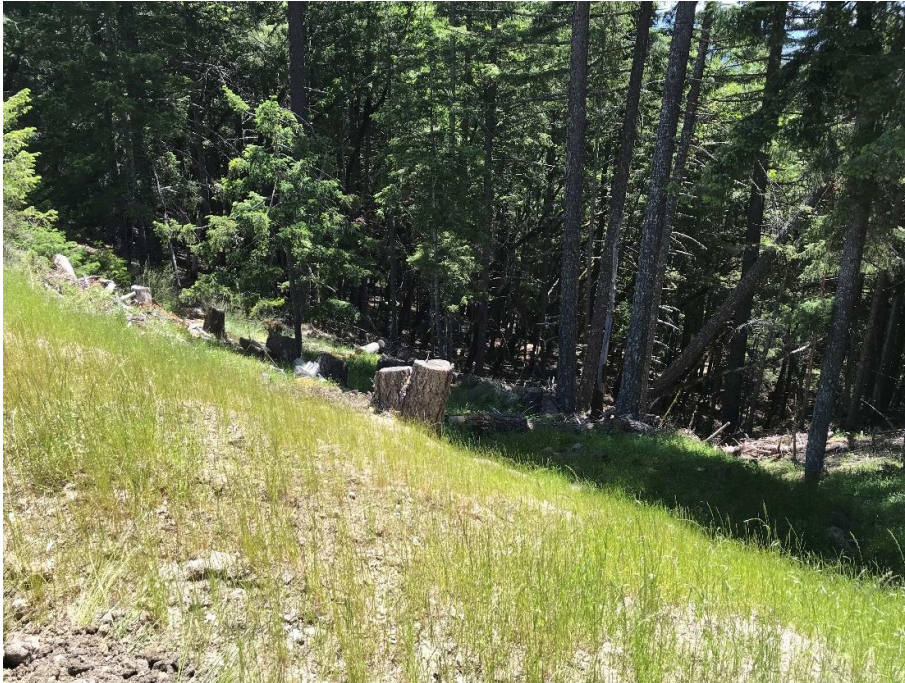
At Conversion Area #2, trees were felled below a graded fillslope along the southeastern edge of a graded flat. It appears these trees were removed to allow more light to the cultivation area. Additionally, because of notable erosion control issues on the fillslope near where trees were cut, trees were cut within a newly created Watercourse Protection Zone (WLPZ) of a Class III watercourse and may have been felled toward or across the watercourse/erosion gully (see Sections below for further explanation). Grading activity did not occur within the Class III WLPZ, and tractor operation were not likely associated with tree removal as the trees are still on the ground.

Photo 1. Looking down fillslope of graded flat above Conversion Area #2. Stumps from tree removal at base of fillslope.

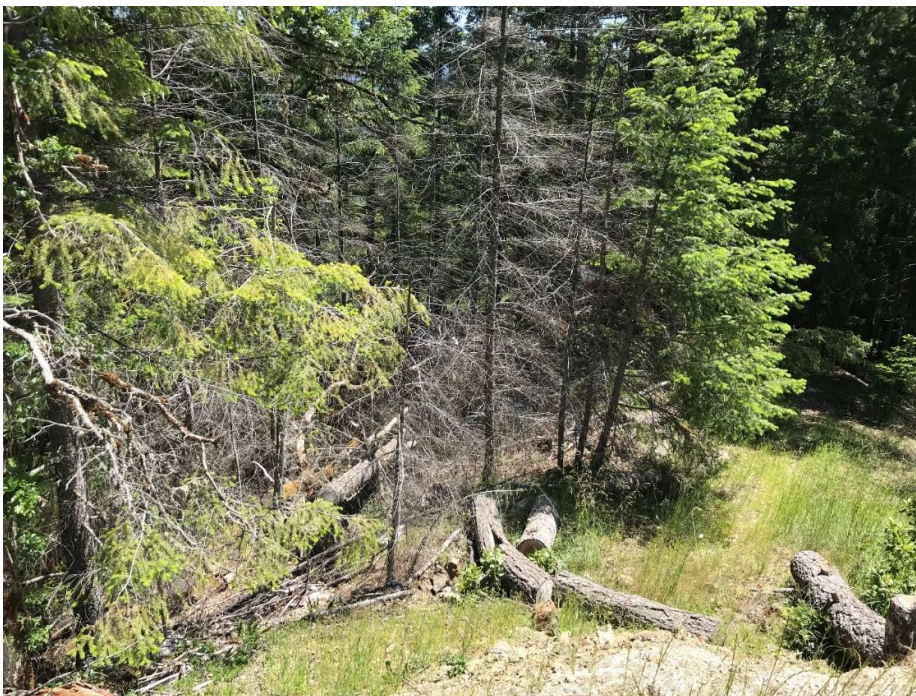
The conversion sites and the surrounding timber stand was walked and assessed for debris resulting from timberland conversion activities. There was one (1) site near Conversion Area #2 where Douglas-fir logs and debris, presumably resulting from nearby conversion activities, was accumulated (Observation Point 2(c)).

Photo 2. Observation Point 2(c), Hazard Reduction site from trees cut at Conversion Area #2.

Recommendations: Cut sawlogs at Observation Point 2(c) to a minimum of 2 feet in length as per 14 CCR 1104.1(a)(2)(D)(1).

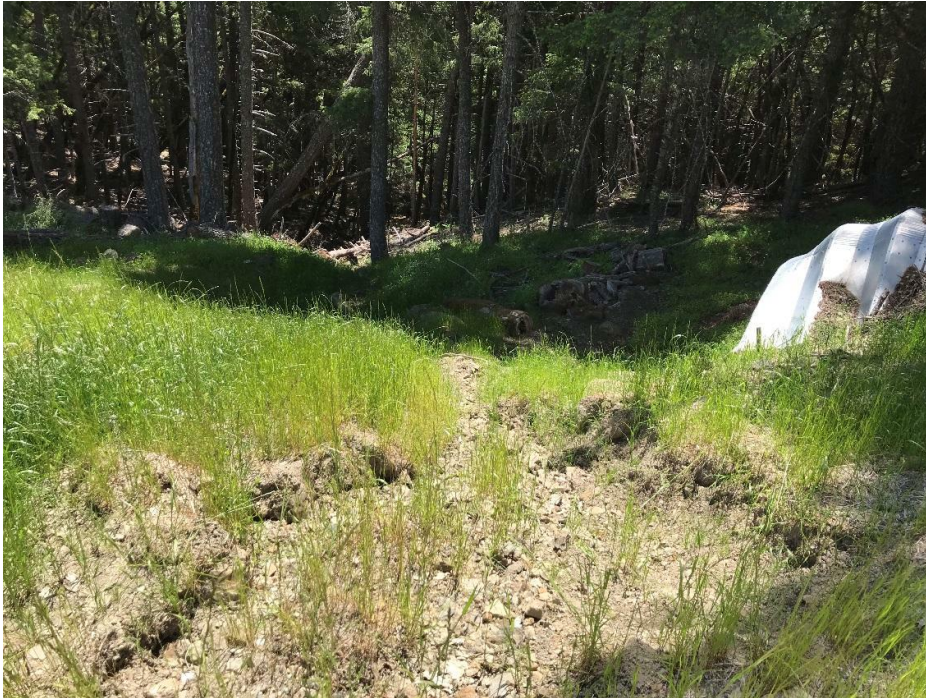
Conversion Area #2 exhibits advanced fillslope failure below the southeastern edge of the graded flat due to poor drainage management (Observation Point 2(a)) and requires immediate interim stabilization measures. The graded flat is concave at Observation Point 2(b) and funnels water toward the erosion point where it immediately incises down into the graded fillslope toward the head of a Class III watercourse (Observation Point 2(a)). The RPF (in agreement with the Disturbed Area Restoration Plan developed by Green Roads Consulting) recommends the following to address erosion control associated with Observation Points 2(a) and 2(b):

Photo 3. Observation Point 2(a), incised channel going down unstable fillslope toward Class III watercourse (in tree line) from concentration point on graded flat.

Interim measures to stabilize the water concentration point on the flat (Observation Point 2(b) by utilizing straw wattles or equivalent installed at the edge of the flat where it meets the fillslope and every 10 ft on the fillslope. Rock armor gully forming on fillslope for entire length of fillslope and erosion channel leading into the natural swale of the Class III watercourse just past existing treeline.

erosion gully at Observation Point 2(a), trees should be planted on any exposed fillslope within 30' of this gully.

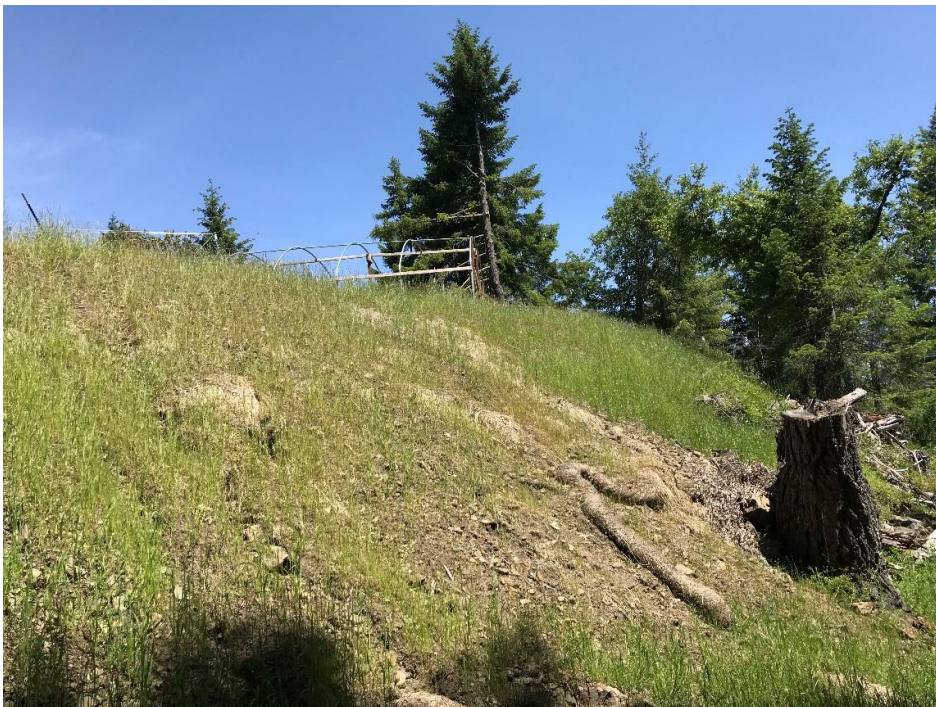
Approximately 10 trees were cut to get more light onto the flat and could have added to slope instability occurring below the fillslope. Poor drainage management from the graded flat above (Observation Point 2(b)) has caused a gully to erode down the fillslope (Observation Point 2(A)) which then leads to a Class III swale (described in the previous section above). The true natural surface head of this watercourse is downslope into the forest but due to the drainage issues from the graded flat above, the watercourse now begins just below the base of the fillslope of the graded flat. While CFPRs allow timber harvesting within Class III watercourse zones of traditional Timber Harvest Plans, Timberland Conversion Exemptions under 14CCR 1401.1 do not allow for any harvesting or tractor operations within watercourse protection zones.

Photo 4. Observation Point 2(a), view of fillslope where gully has formed from concentrated runoff graded flat. Also evidence of timber Conversion Area #2.

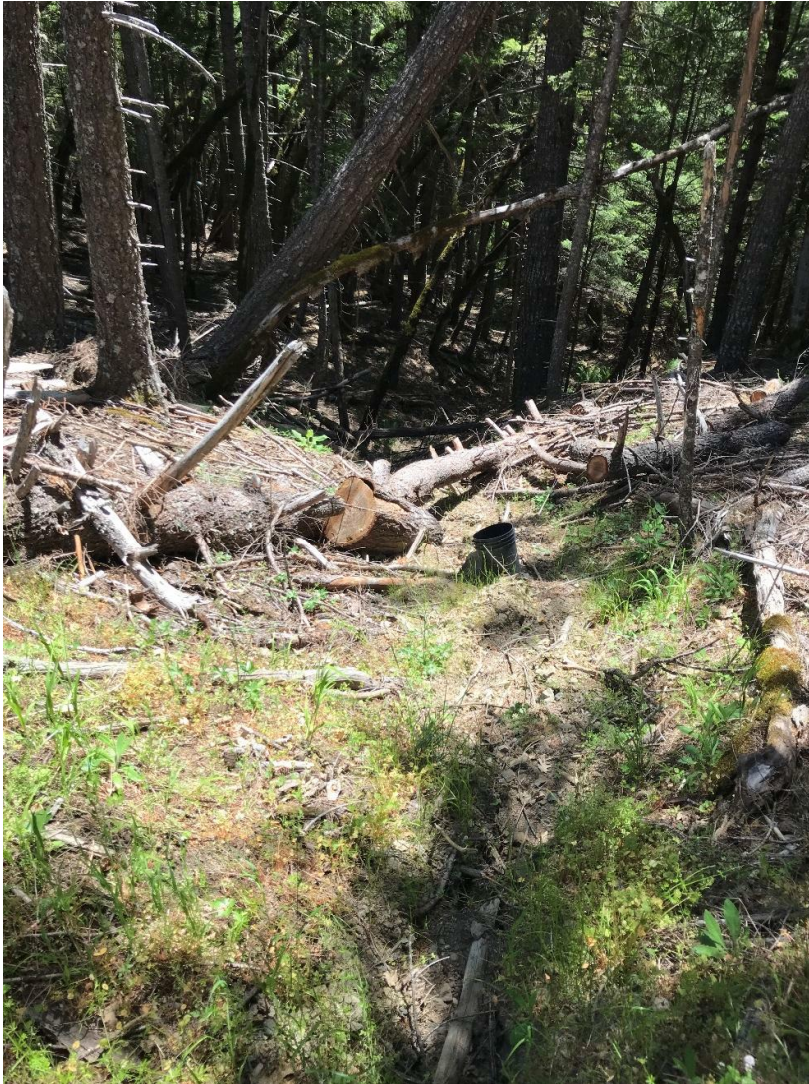
Photo 5. Bottom of Observation Point 2(a) where gully runs into Class III swale. Also Hazard Reduction from conversion activities present.

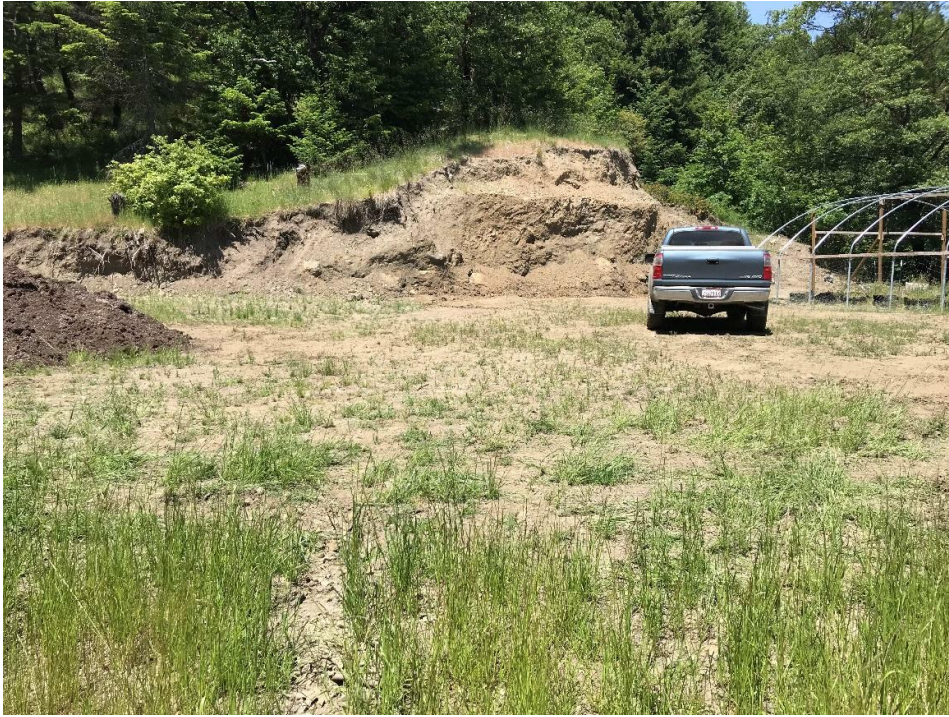
Photo 6. Observation Point 2(b), concaved area on graded flat where water concentrates before heading toward Observation Point 2(a) – fillslope and incises down to Class III watercourse.

Permanent measures involving reshaping/regrading (high-center and inslope) graded flat along Observation Point 2(b) to shed water toward an unconcentrated area away from Observation Point 2(a) and other fillslope areas.

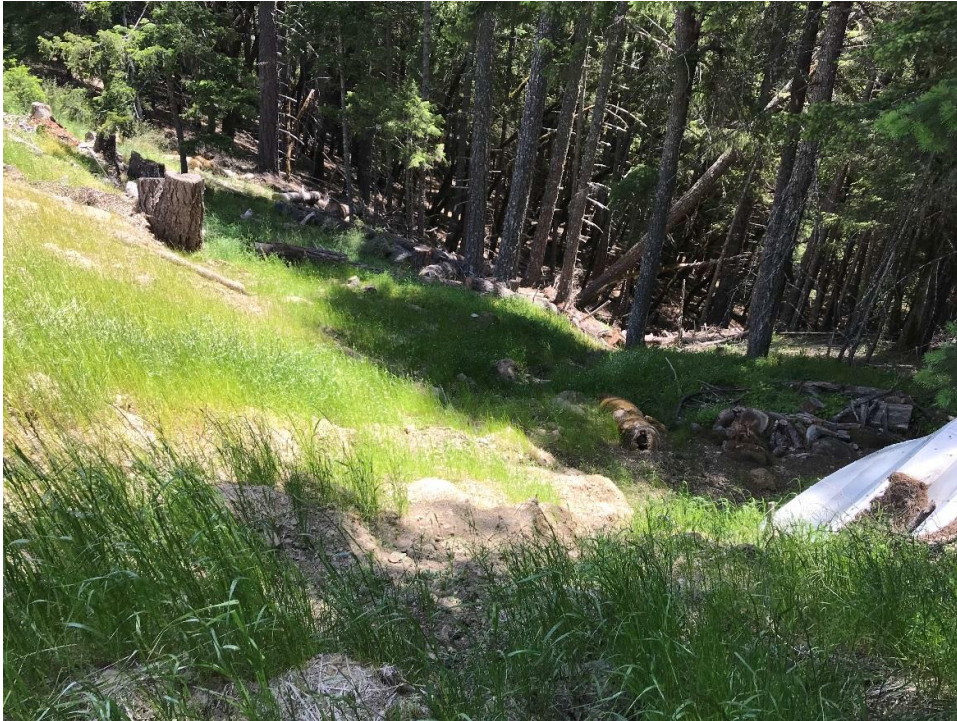
Photo 7. Another view looking down gullied fillslope at Observation Point 2(a), also note cut trees and hazard reduction debris.
