**Hydrologic Isolation of Existing Well from Surface Waters**

**Lindberg Geologic Consulting**

Project No: 0441.00

Subject: Hydrologic Isolation of Existing Well from Surface Waters  
1925 Elk Ridge Road, Briceland, APN: 220-272-003

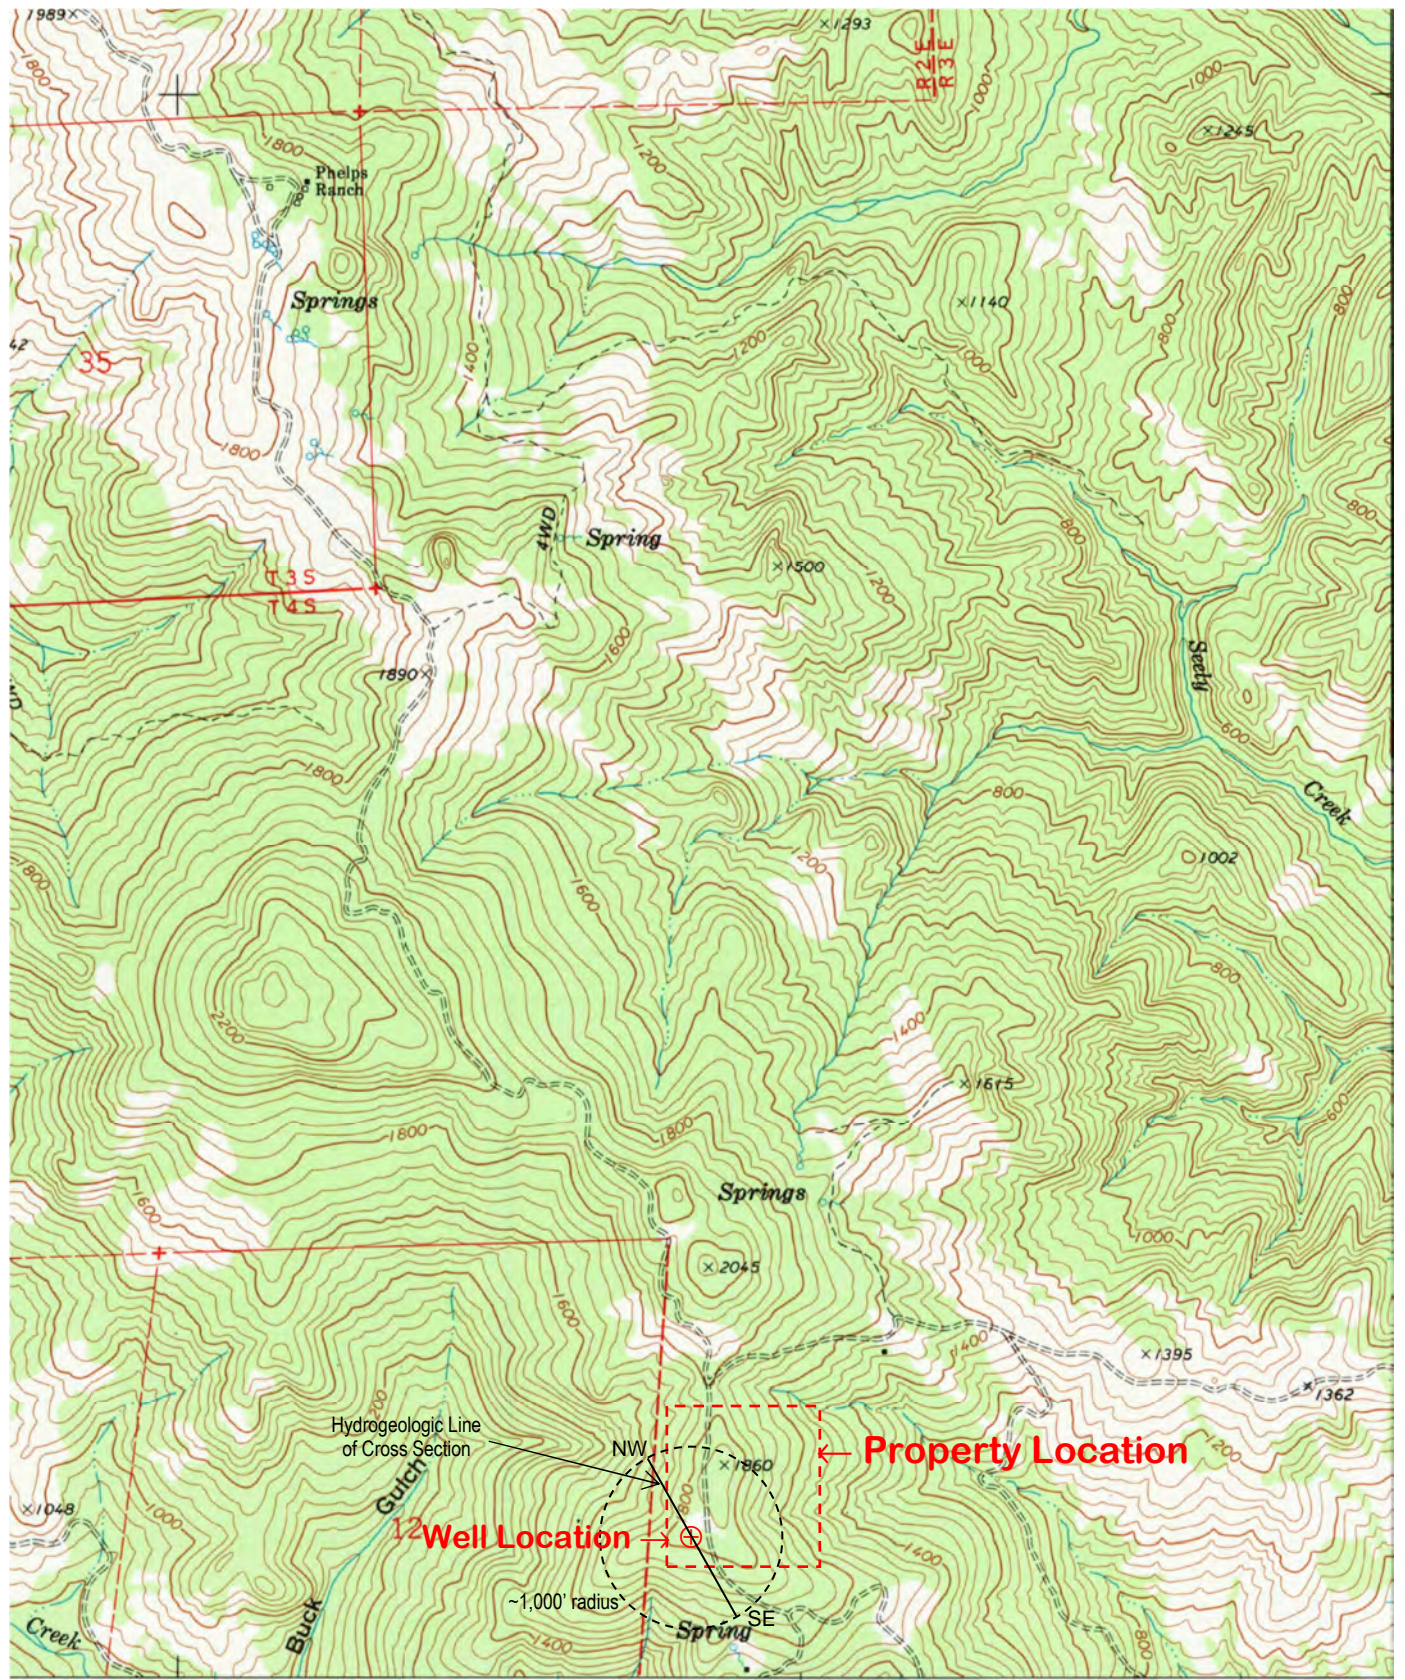
| Lindberg Geologic Consulting | Engineering-Geologic Hydrogeologic Well Isolation Report | Figure 1 |

Based on the Humboldt County WebGIS mapping, this well is approximately 710 feet from the nearest mapped surface waters, an ephemeral tributary of Buck Gulch (Figure 1). Based on interpolation from the 1969 USGS Ettersburg topographic quadrangle map (Figure 1), and the Humboldt County WebGIS, well elevation is approximately 1,820 feet above sea level. Fisch Well Drilling reports the depth of the well is 120 feet. At the nearest point to this well, the elevation of the Buck Gulch headwaters are approximately 1,590 feet. The elevation of the bottom of the subject well is approximately 1,700 feet which is 110 feet above the elevation of Buck Gulch at the nearest point on the WebGIS map.

One spring is mapped in the southwest quarter of Section 7 on the USGS Ettersburg, Calif (1969) topographic quadrangle map (Figure 1). From the well, this nearest mapped spring appears to be at least 1,250 feet southeast, at an elevation of approximately 1,520 feet, on parcel 220-272-004. We observed no other springs mapped in what we estimate to be Section 7. We will discuss other, more-distal springs later in this report.

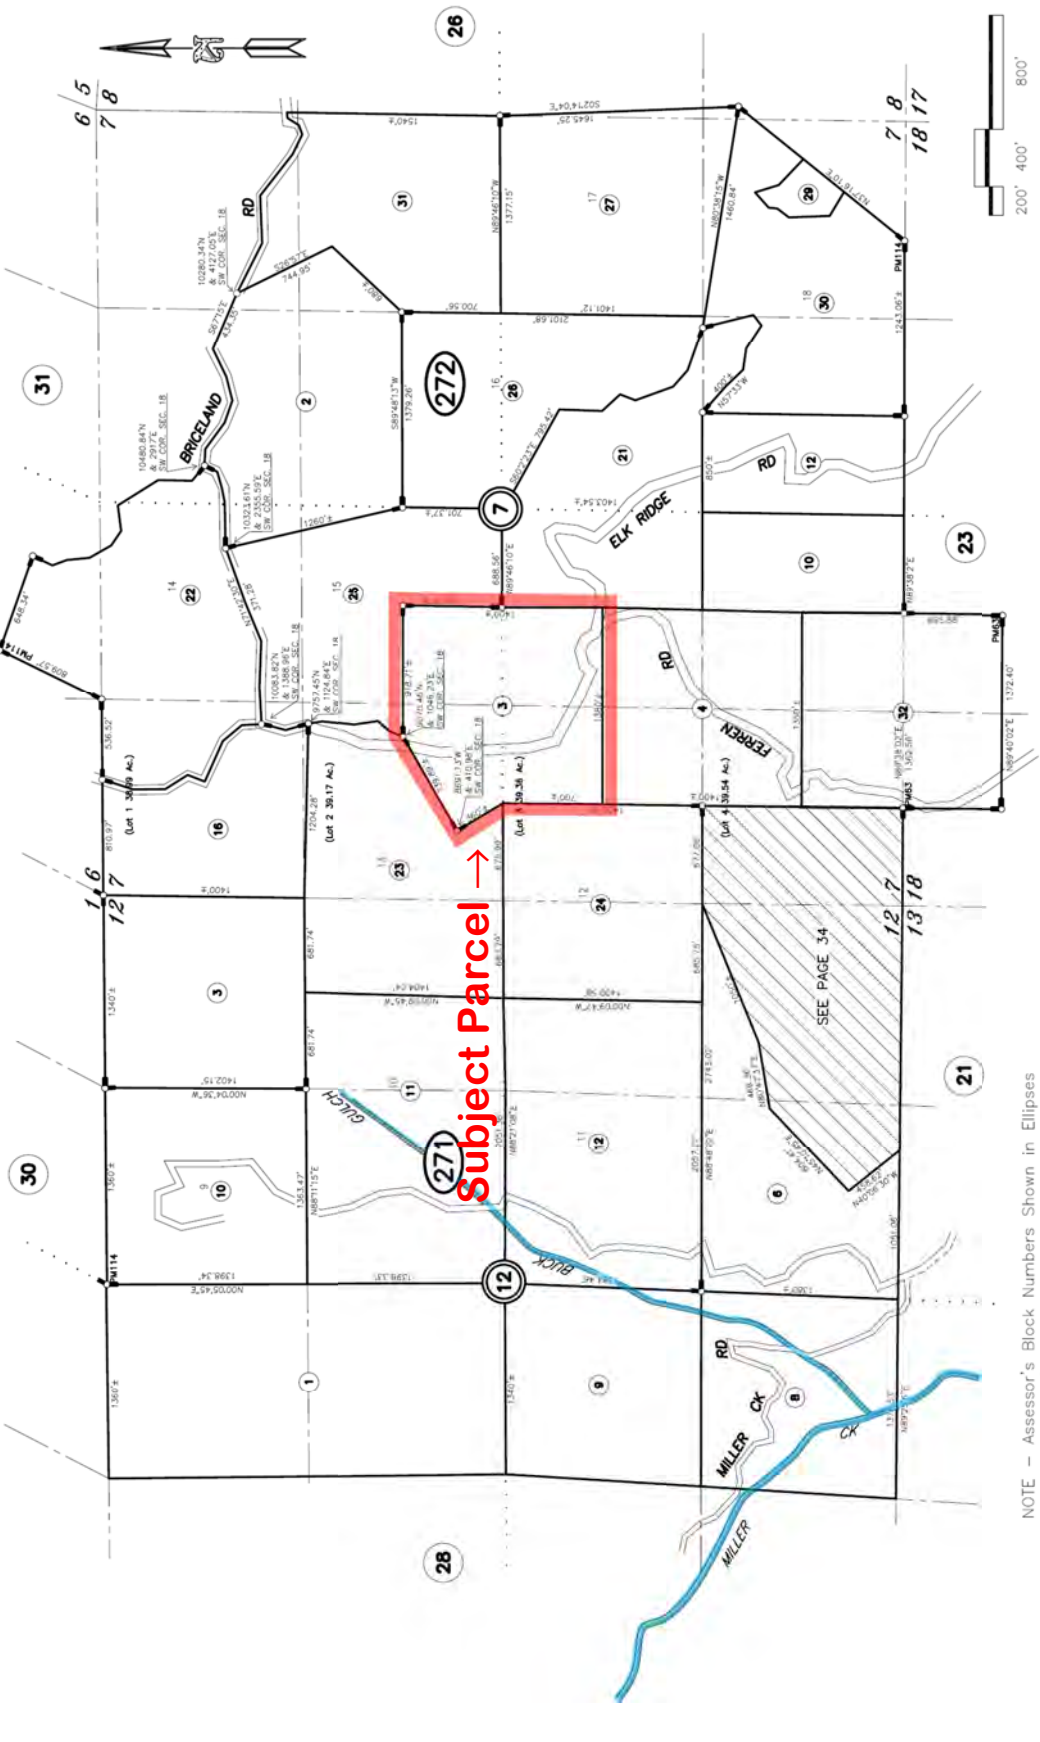
Figure 2  
August 26, 2022  
Project 0441.00  
Scale as Shown

The well location is shown approximately on the attached figures. According to the Humboldt County Assessor and the WebGIS, this parcel 220-272-003 (Figure 2) encompasses approximately 43 acres. Based on our on-site GPS measurements, the subject well is located approximately at latitude 40.12866° north, and longitude 123.90029° west ( $\pm 9'$ ), in Section 7, T4S, R3E, HB&M.

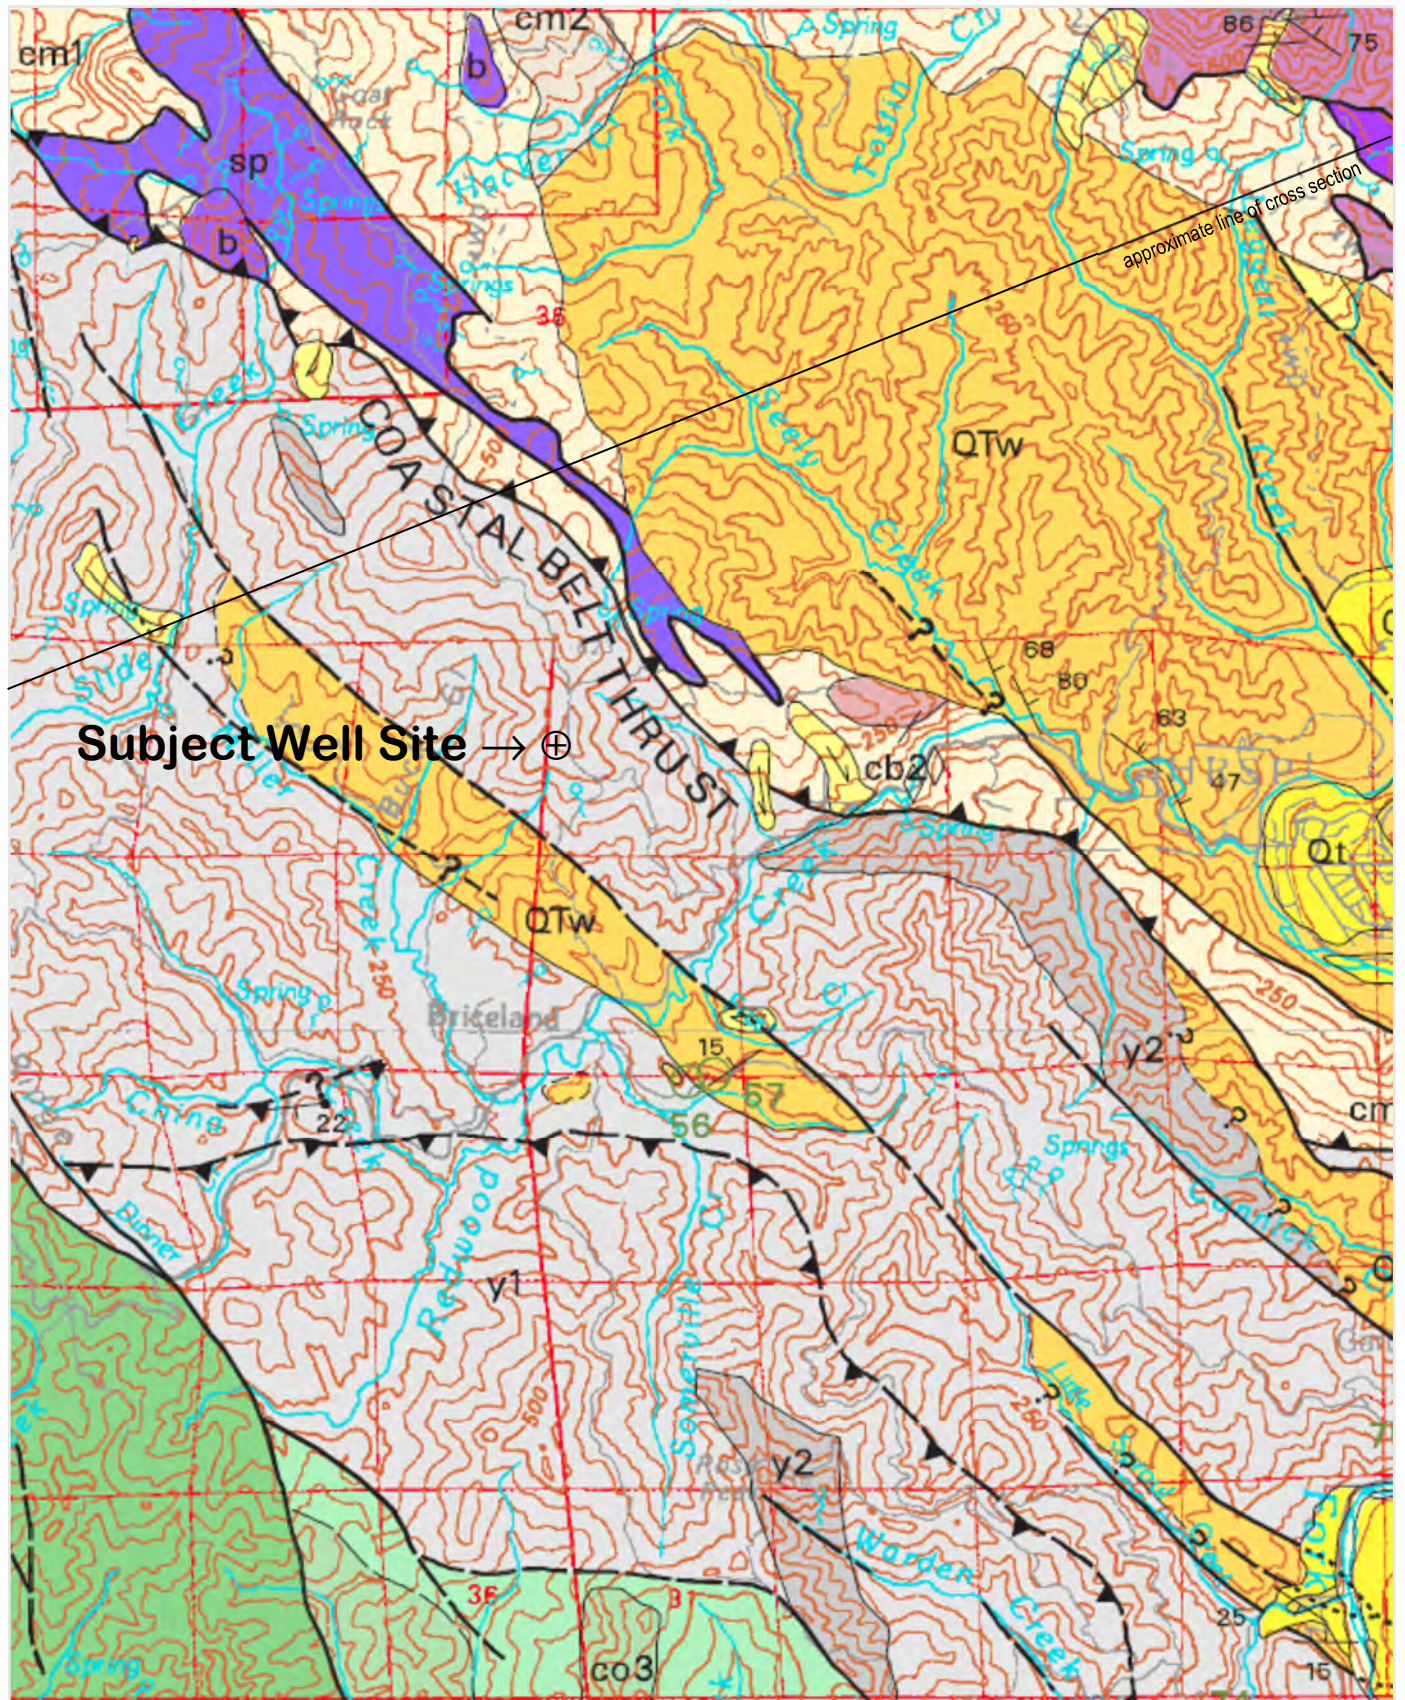
Figure 4  
August 26, 2022  
Project 0441.00  
1" ≈ 5,700'

On the geologic map (Figure 4), by McLaughlin et al. (2000), this area is underlain by the early Eocene to Paleocene, rocks of the Yager Terrane of the Coastal Belt of the Franciscan Complex. McLaughlin described the Yager as follows: "Argillite and arkosic sandstone rhythmically interbedded, thin to medium bedded; massive to thickly bedded arkosic sandstone with minor interbeds of argillite; and minor lenses of polymict boulder to pebble conglomerate. Southwest of Garberville, unit highly folded, but locally may be penetratively sheared or broken. Argillite and interbedded fine-grained sandstone is commonly calcareous and may have abundant plant debris in places. Sandstone characteristically contains prominent detrital muscovite. Based on fossil dinoflagellates and on spores and pollen from carbonate concretions in argillite, age of terrane is late to middle Eocene. Locally the lower beds of the terrane may be as old as Paleocene (McLaughlin and others, 1994). The Yager terrane is divided into 3 subunits based principally on topographic expression in aerial photographs and outcrop data: Sheared and highly folded mudstone-Includes minor rhythmically interbedded sandstone, locally with lenses of conglomerate. Exhibits irregular topography lacking a well-incised system of sidehill drainages".

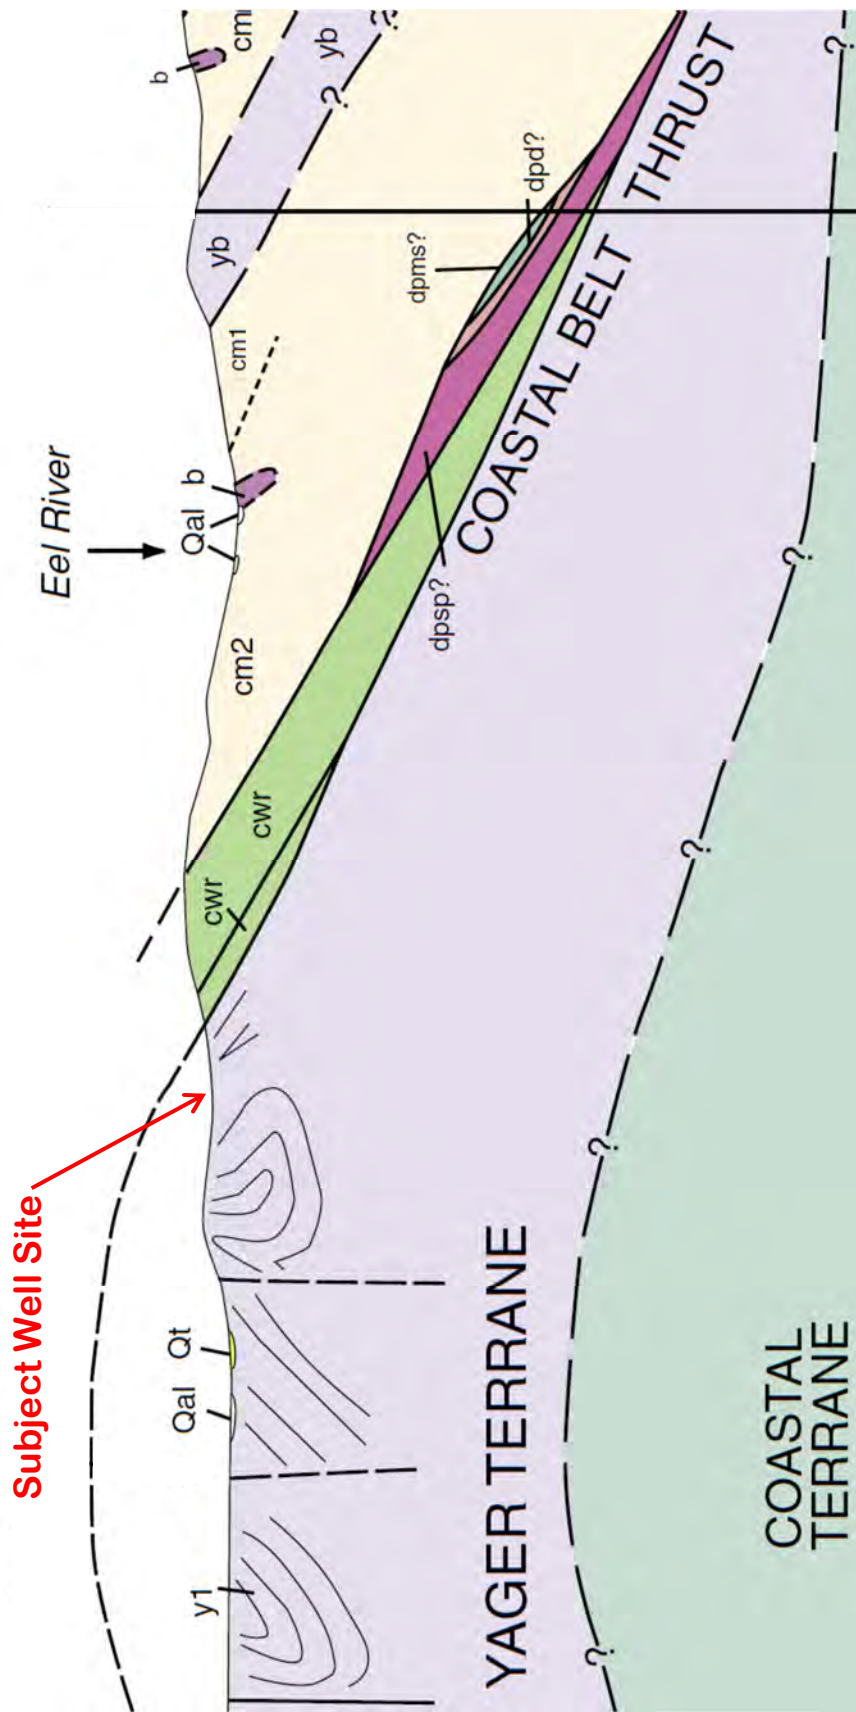
| Lindberg Geologic Consulting | Engineering-Geologic Hydrogeologic Well Isolation Report | Figure 5 |

A geologic cross section of the area after McLaughlin and Others (2000) shows the general structural and stratigraphic relationships between the local geologic units (Figure 5). The coastal belt units of the Franciscan Complex are shown dipping to the northeast and bounded by thrust fault planes. On-site, no dip of the rock units could be observed in the bedrock because it was mantled with soil and hillslope colluvium and obscured by vegetation. We interpret the faults to be hydrologic boundaries of minimal permeability (due to grinding and shearing along the fault planes) which effectively separate portions of the coastal belt Franciscan units from each other, and limit groundwater flow between these fault-bound units. A hydrogeologic cross section is included as Figure 6 and shows the well and topography with an interpretation of the phreatic surface.

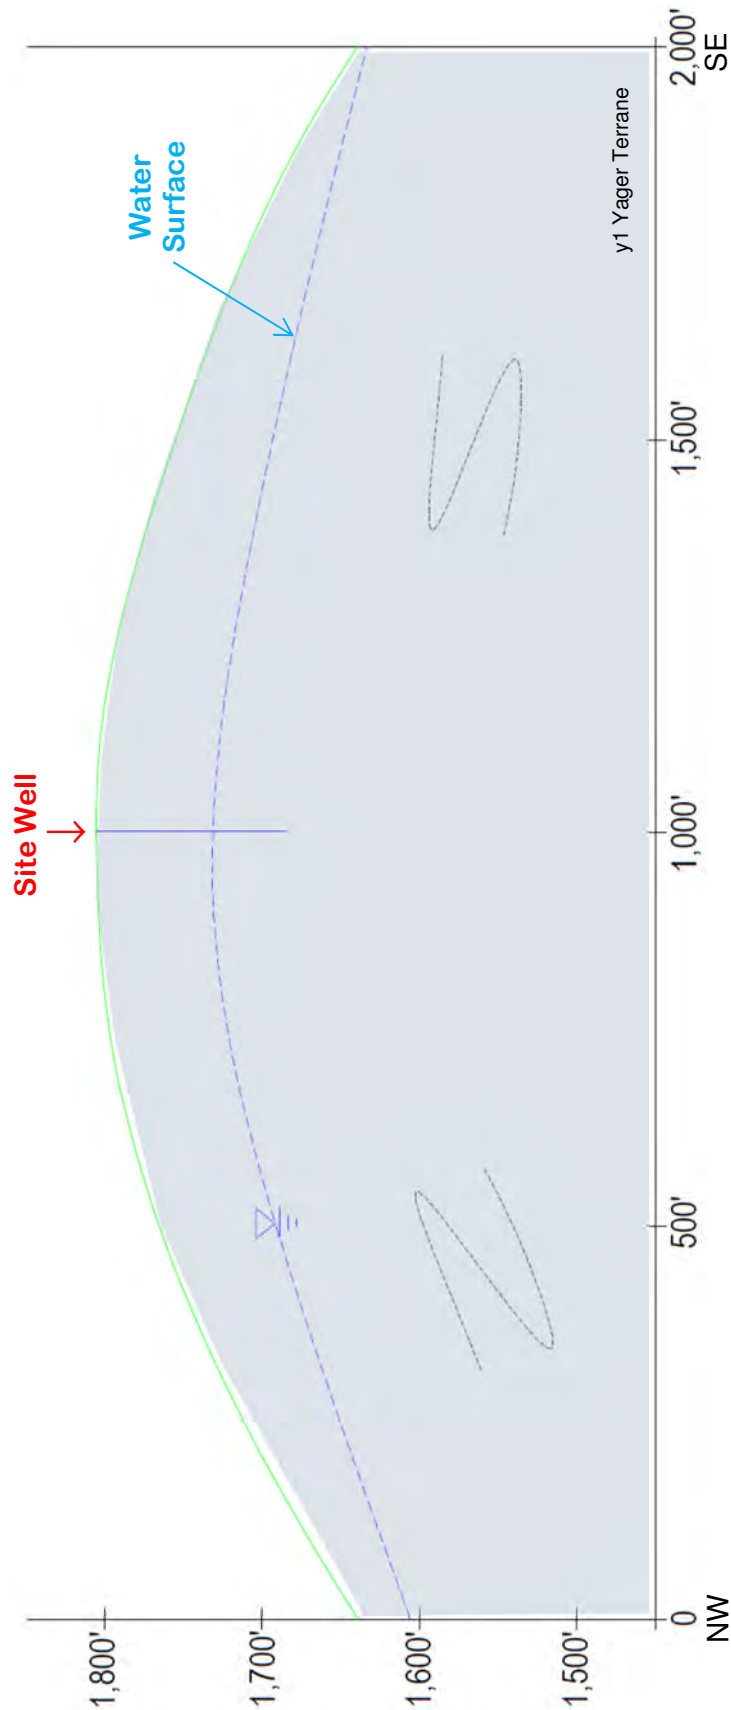
| Lindberg Geologic Consulting | Engineering-Geologic Hydrogeologic Well Isolation Report | Figure 6 |

In this vertically exaggerated (~2x) cross section, the view is looking up slope toward the northeast. Groundwater flow in the cross section is toward the viewer, or out of the page. Groundwater is presumed to flow from recharge areas in the high ground to the east and northeast, to the southwest toward Burr Creek. Bedrock subgrade is composed of abundantly fractured mélange (argillite and sandstone) of the Central Belt of the Franciscan Complex (cm1). These deposits are one of several components of the Central Belt Franciscan Complex. Groundwater is envisioned as flowing through zones of fractured sandstone in the mélange. Fractures are interpreted to be the primary preferential flow paths for groundwater in this area.

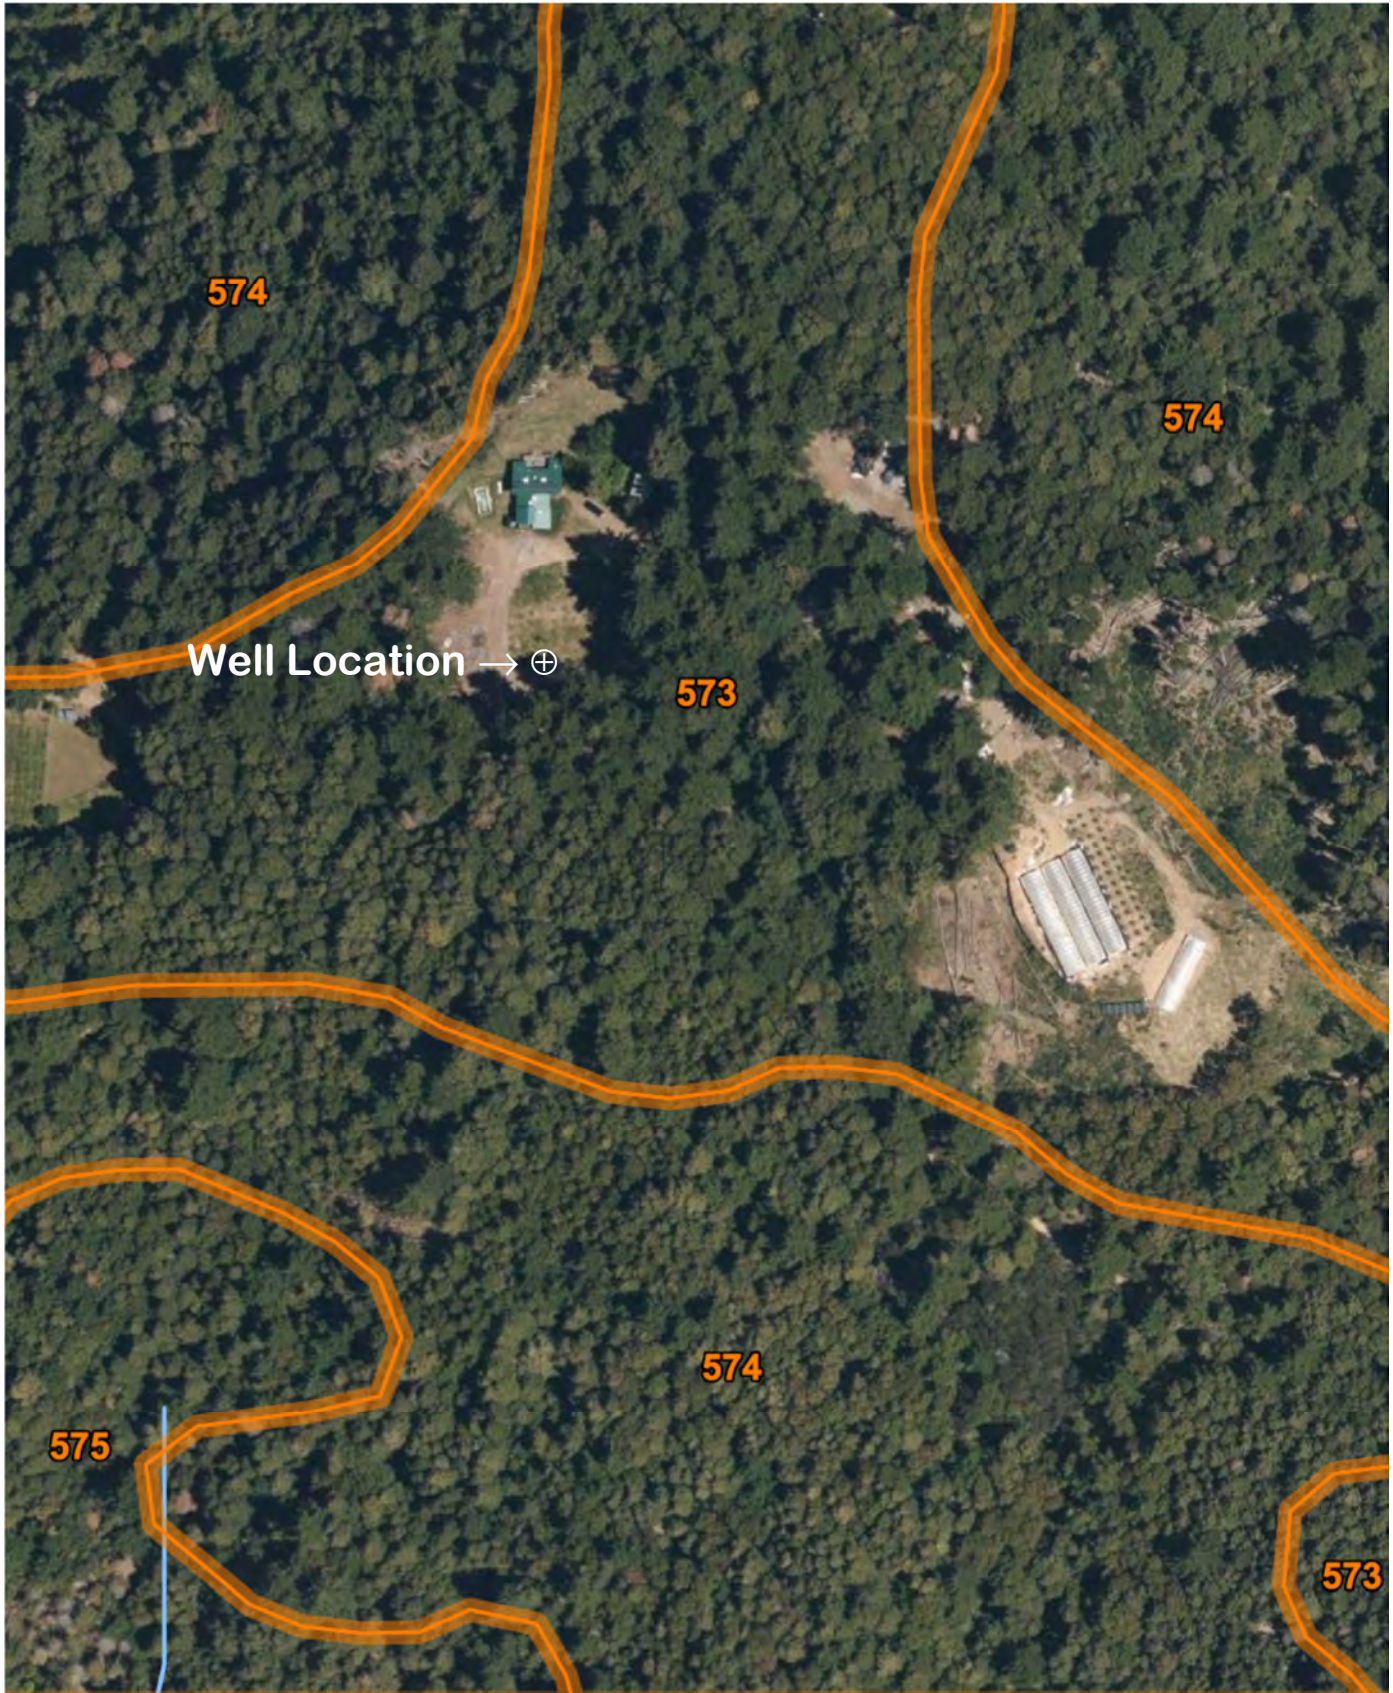
| Lindberg Geologic Consulting | Engineering-Geologic Hydrogeologic Well Isolation Report | Figure 7 |

The Natural Resources Conservation Service's, online Web Soil Survey, shows the subject well to be located within the Sproulish-Canoecreek-Redwohly soil complex (#573, Figure 7), which the NRCS describes as well-drained. The Web Soil Survey Unit description is attached to this report. According to the NRCS' Map Unit Description, the mean annual precipitation at this site is 60 to 100 inches per year. Capacity of the most limiting layer to transmit water (Ksat) is described as moderately high to high (0.20 to 2.00 in/hr). If we can assume that ten percent of the "lower-end" 60 inches of precipitation is absorbed by the soils and does not flow across the surface to local watercourses, then approximately 21.5 acre-feet, or over seven million gallons, of water per year may be expected to recharge the local aquifer below this 43-acre subject property alone.
