# Water Resource Protection Plan

APN 217-244-008

1B170491CHUM

**Timberland Resource Consultants**

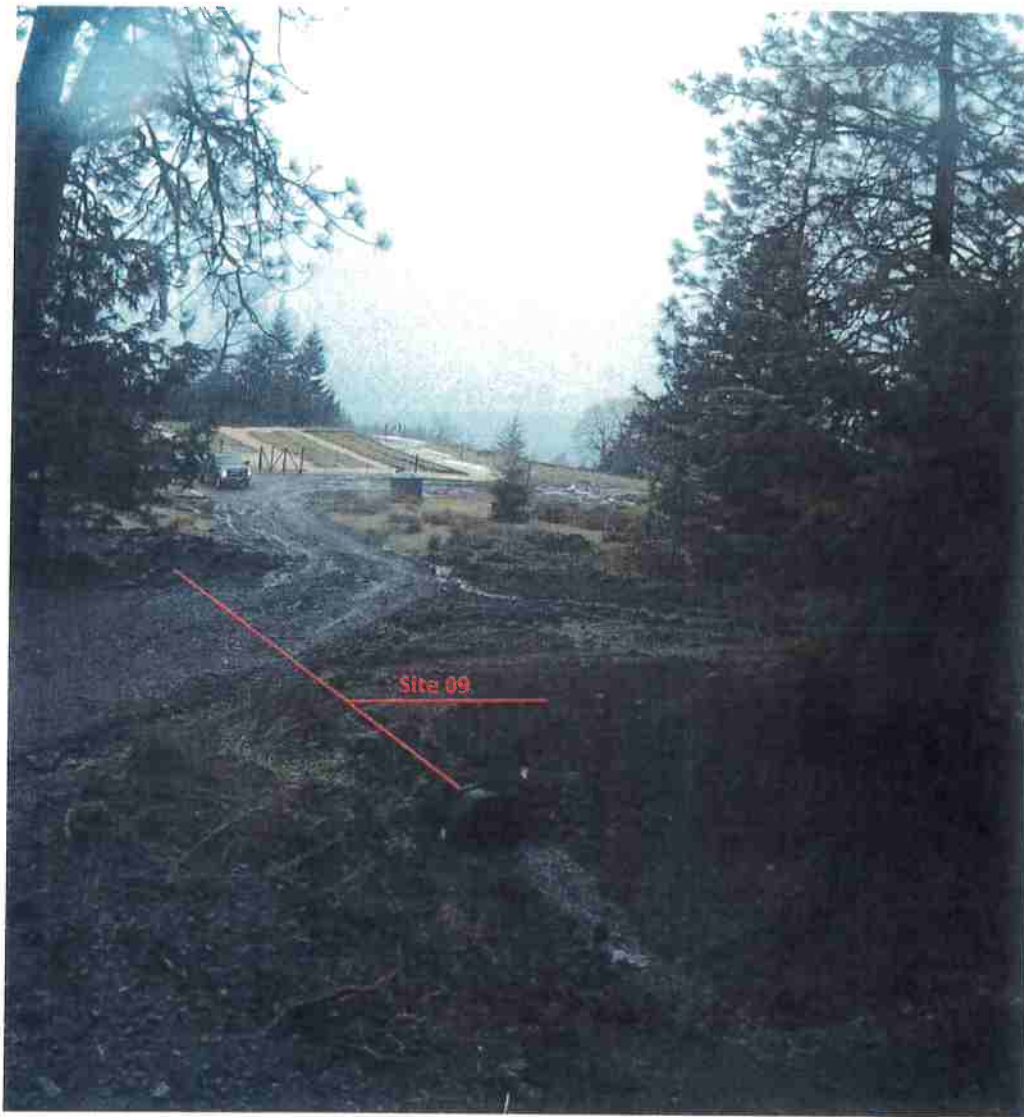
This photograph references Site 09 a 24" ditch relief culvert. Cultivation Area A is in the background.

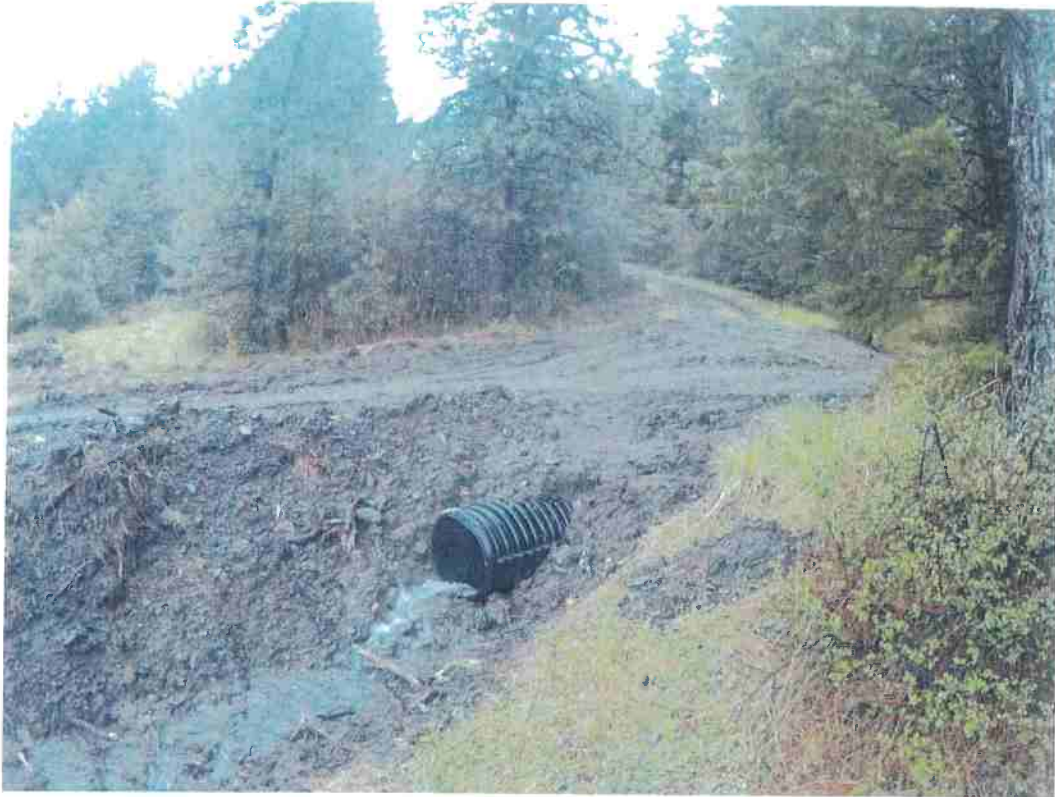
Site 09 – 24" ditch relief culvert. Functioning adequately.

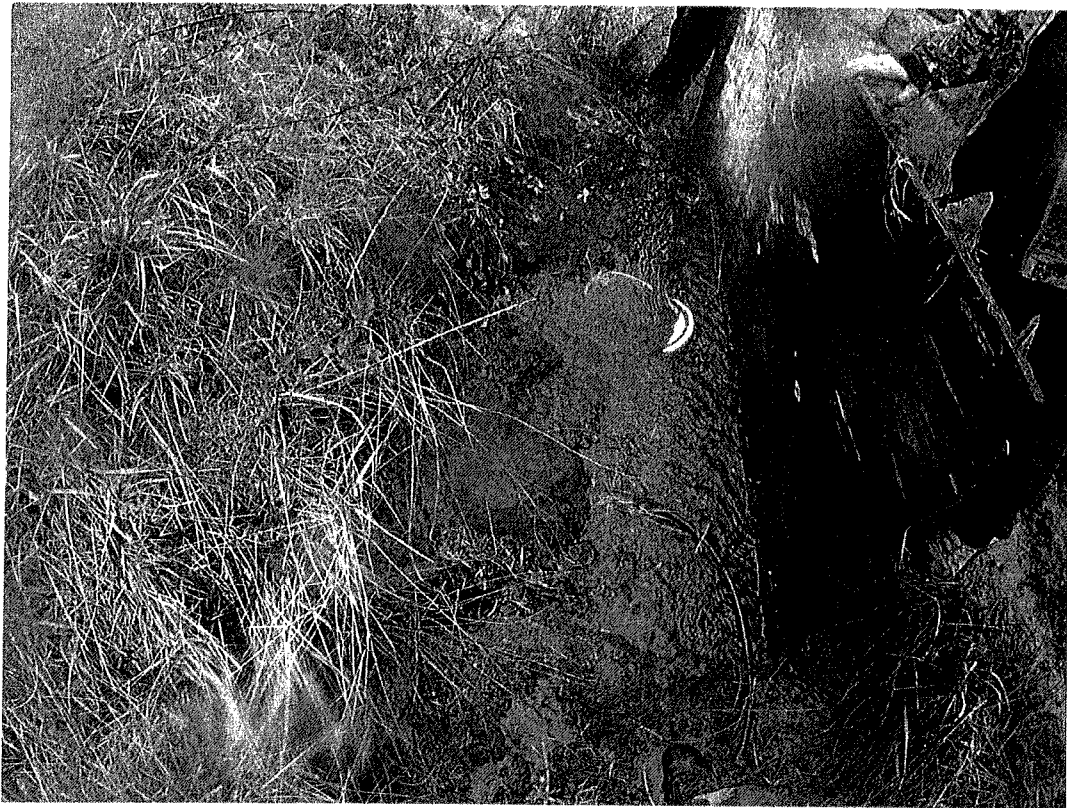
**Point of diversion. 5 gallon bucket burried with a 1" poly line gravity fed to holding tank.  
Utilized for domestic use.**

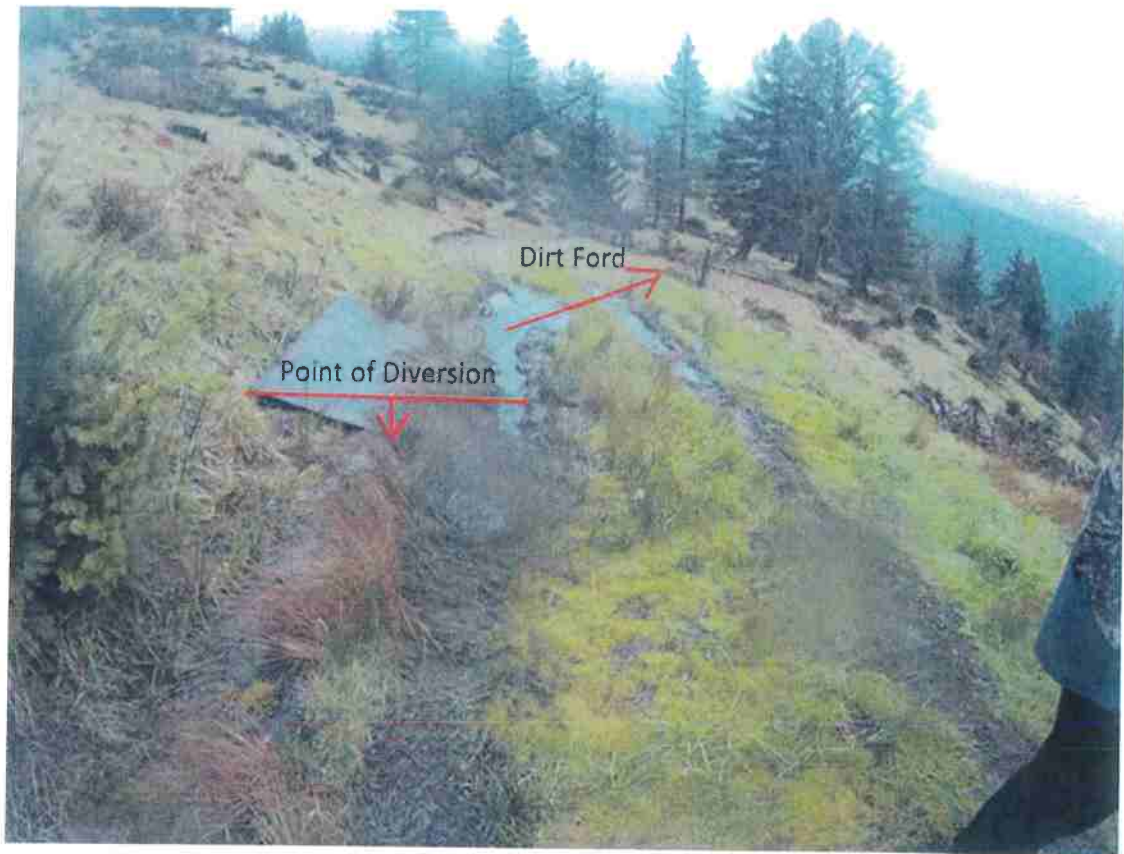
**Site 12 the point of diversion and Site 11 a dirt ford. Bank seep drains across legacy hunting road. It is being recommended to install a water bar at Site 11 to ensure the bank seep does not drain down the road surface.**

Unique Point	Lat-Long NAD 83	Road Type	Mitigation Planned	Monitor	1600	Standard Conditions	Treatment Priority	Date Completed
11	-123.597 40.3013	Seasonal	X	X		A.1.		
Current Condition: Location of a bank seep located on a legacy road. Spatial reference for monitoring.						Proposed Action : Bank seep pools on the road surface. It is being recommended to install a water bar at this location to ensure the bank seep does not drain down the road surface.		
Unique Point	Lat-Long NAD 83	Road Type	Mitigation Planned	Monitor	1600	Standard Conditions	Treatment Priority	Date Completed
12	-123.594 40.3015	Seasonal		X		A.1.		
Current Condition: Five gallon bucket buried in a bank seep, used as a point of diversion for domestic use.						Proposed Action: This point of diversion will require a Lake and Streambed Alteration Agreement.		
Unique Point	Lat-Long NAD 83	Road Type	Mitigation Planned	Monitor	1600	Standard Conditions	Treatment Priority	Date Completed
