Appendix H

Photos of Pre-project Site Conditions

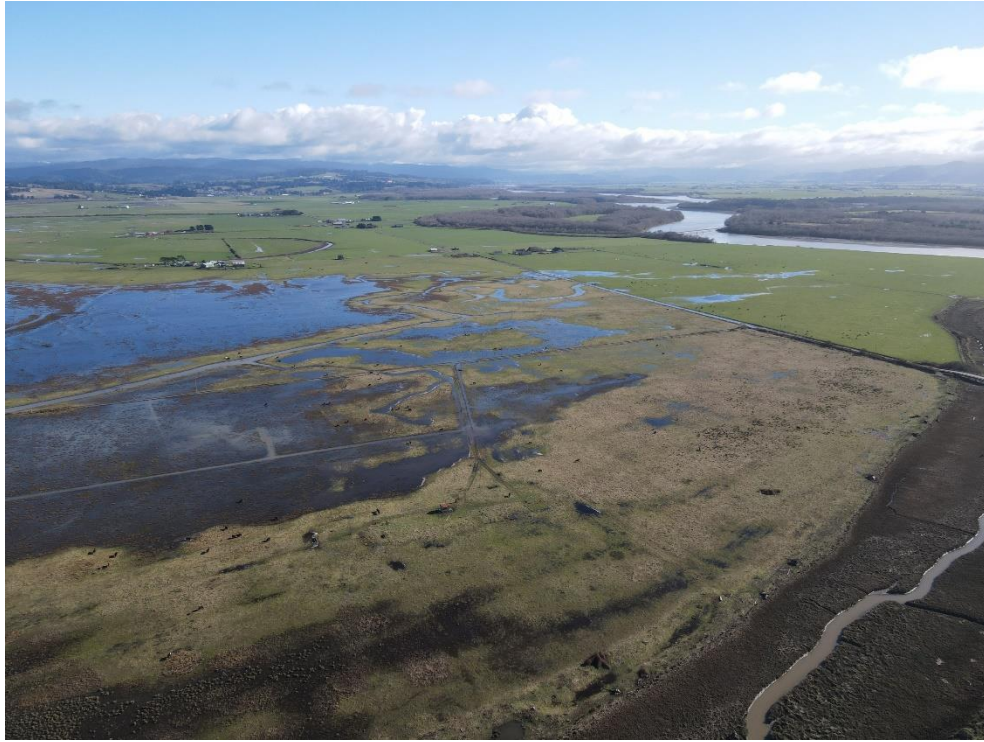
Photo 1—Drone footage from December 2021, looking southeast at Cannibal Island Road. Note flooding in road prism where the elevation has become lower relative to the edges of the pasture to the north and south of the road. Cannibal Island Road is proposed to be elevated in this area during Project implementation.

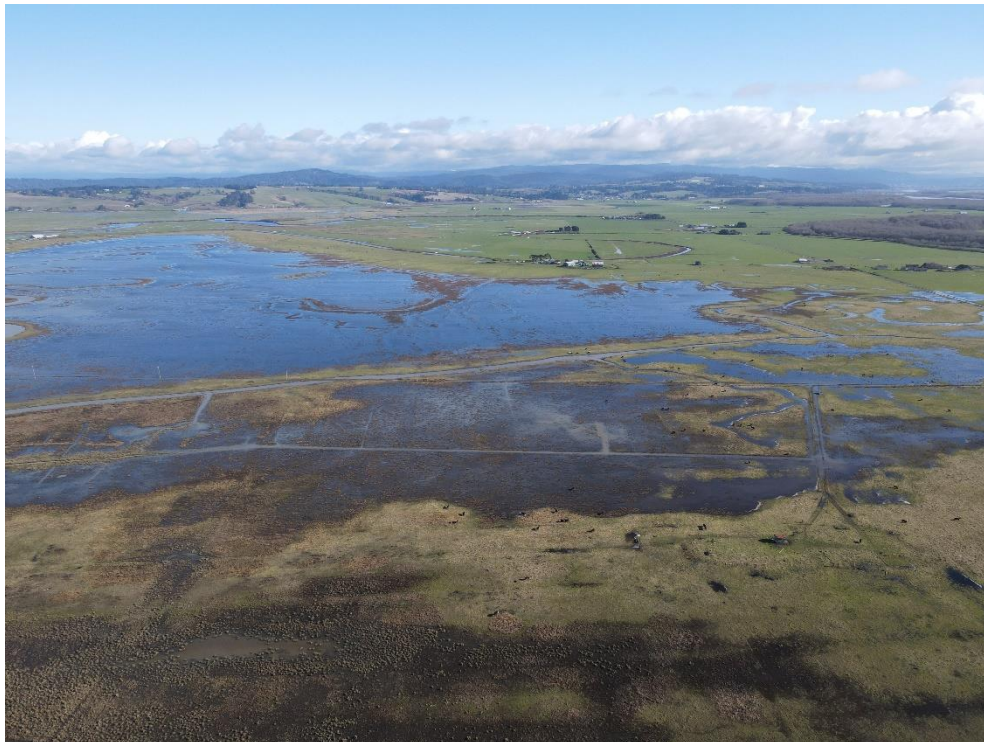
Photo 2—Drone footage from December 2021, looking east at muted tidal flooding that occurs within the interior of the existing levees, namely within the NRCS Wetland Reserve Easements (WRE). The small sliver of dry land in the furthest eastern extent of the Project Area is on private property that is proposed to be protected behind the new levee construction.

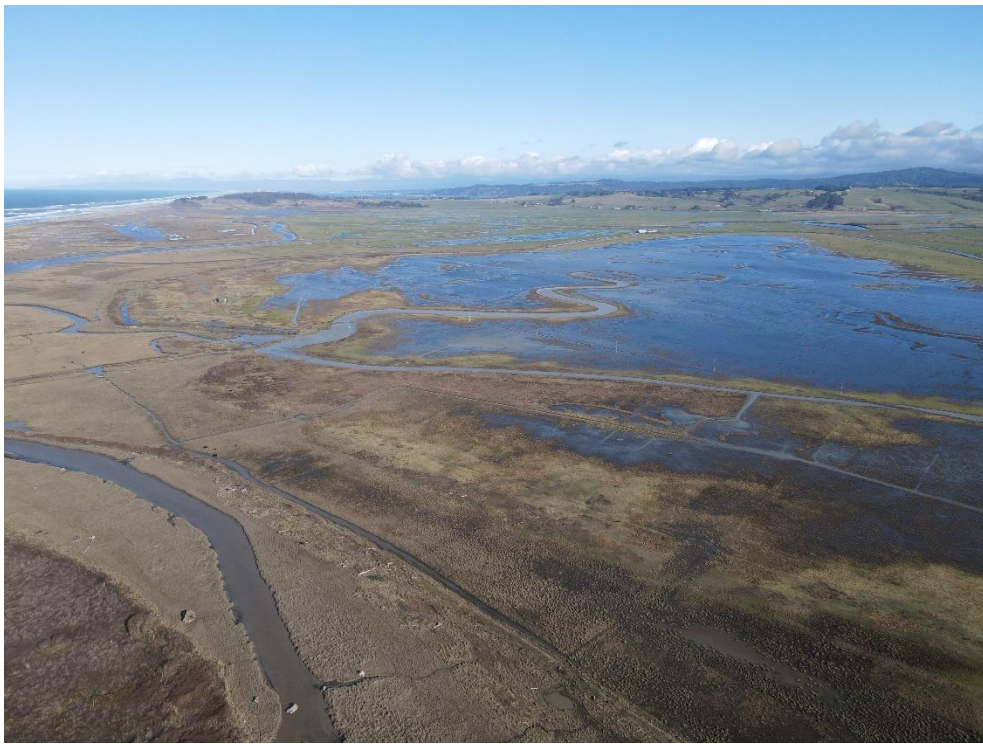
Photo 3—Drone footage from December 2021, looking northwest at the large interior slough channel (unnamed) that extends eastward into the Project Area, and another smaller slough channel that runs south. The existing levee system (and areas that have failed and breached), can be seen in the distant northern portion where there are small slivers of dry land.

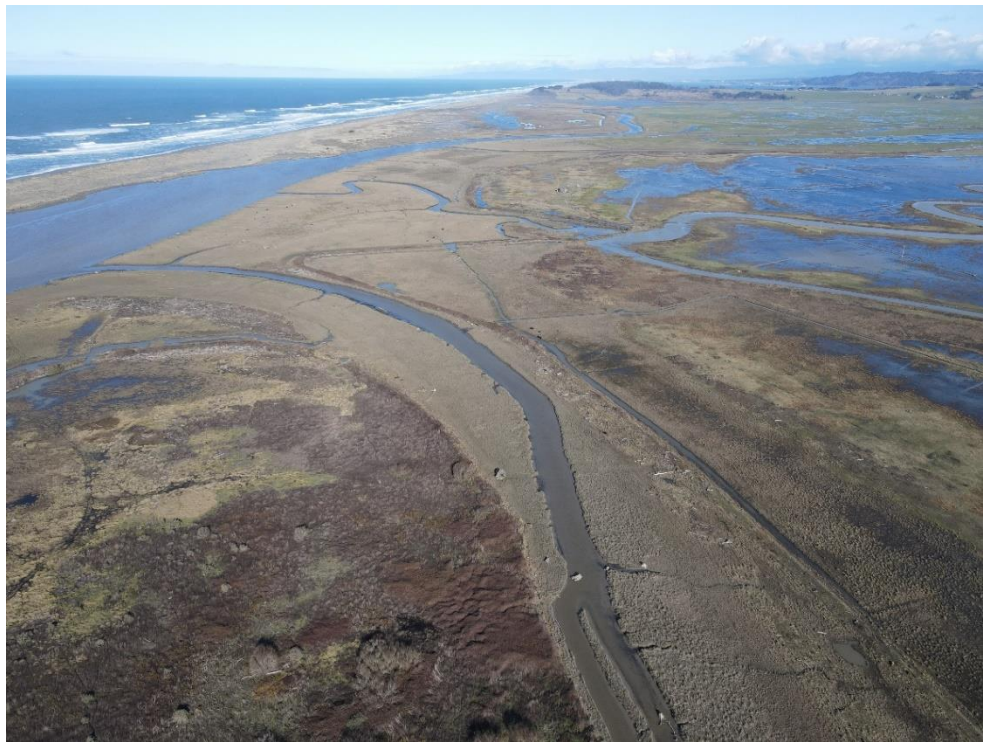
Photo 4—Drone footage from December 2021, looking northwest at the large interior slough channel (unnamed) and its confluence with North Bay (large water channel to the west). The confluence of Mosley Slough with North Bay is also captured (southernmost channel).

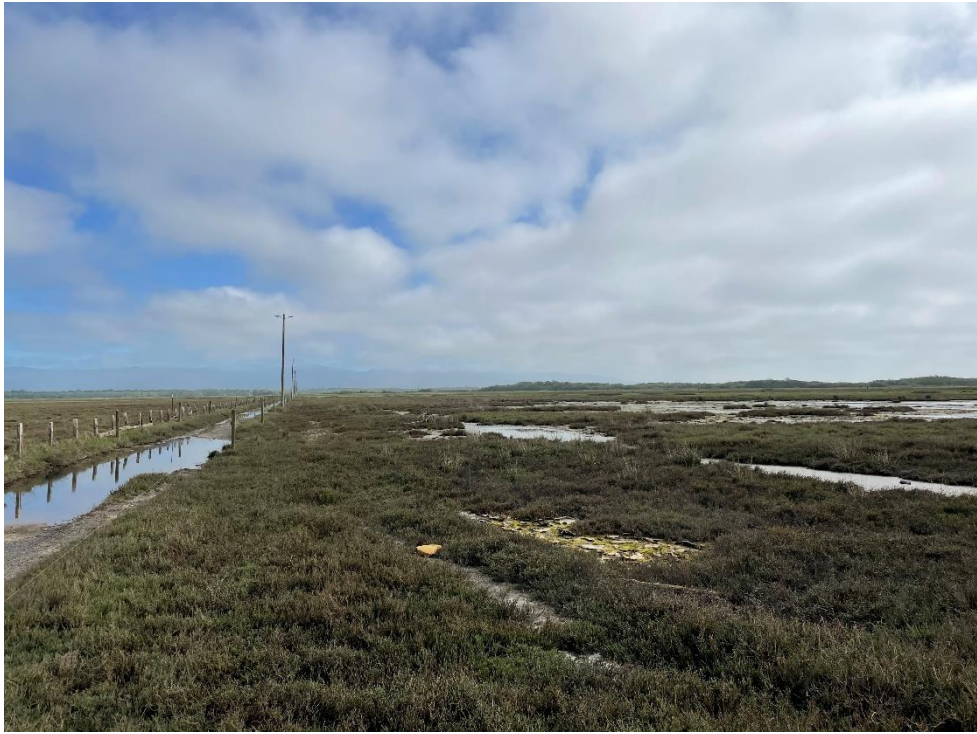
Photo 5—View of Senestraro Lane and flooded pasture with small slough channel crossing under the road within Project Area, facing north from Senestraro Lane. This area is coastal salt and brackish marsh dominated by pickleweed that intergrades with non-native agricultural pasture.

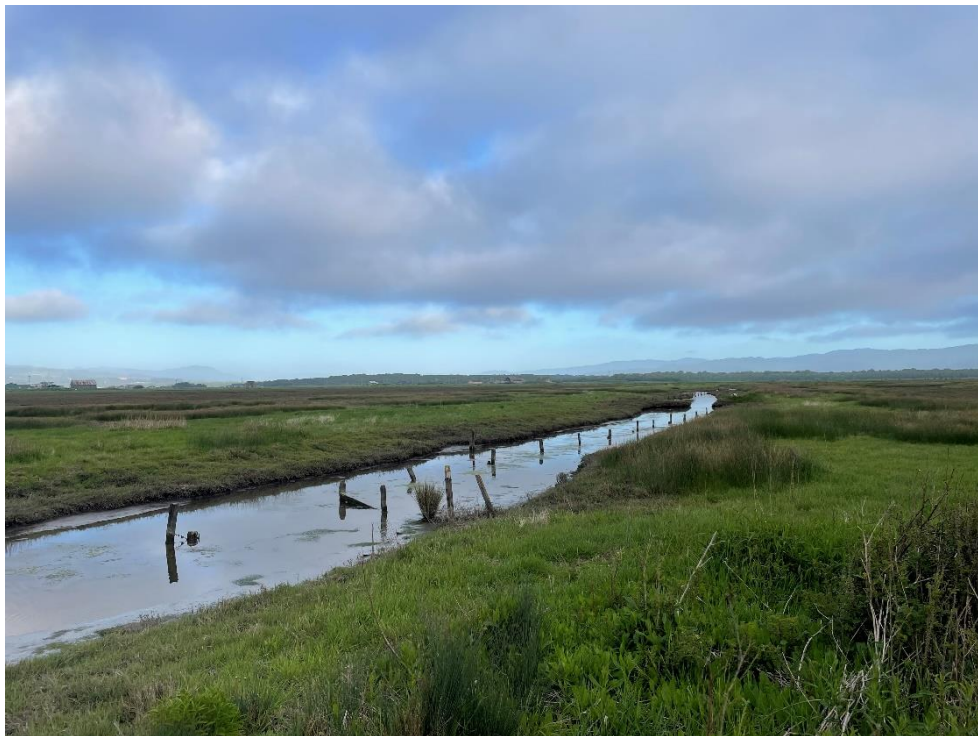
Photo 6—View of small slough that runs through muted coastal salt and brackish marsh within Project Area, facing east from Senestraro Lane.

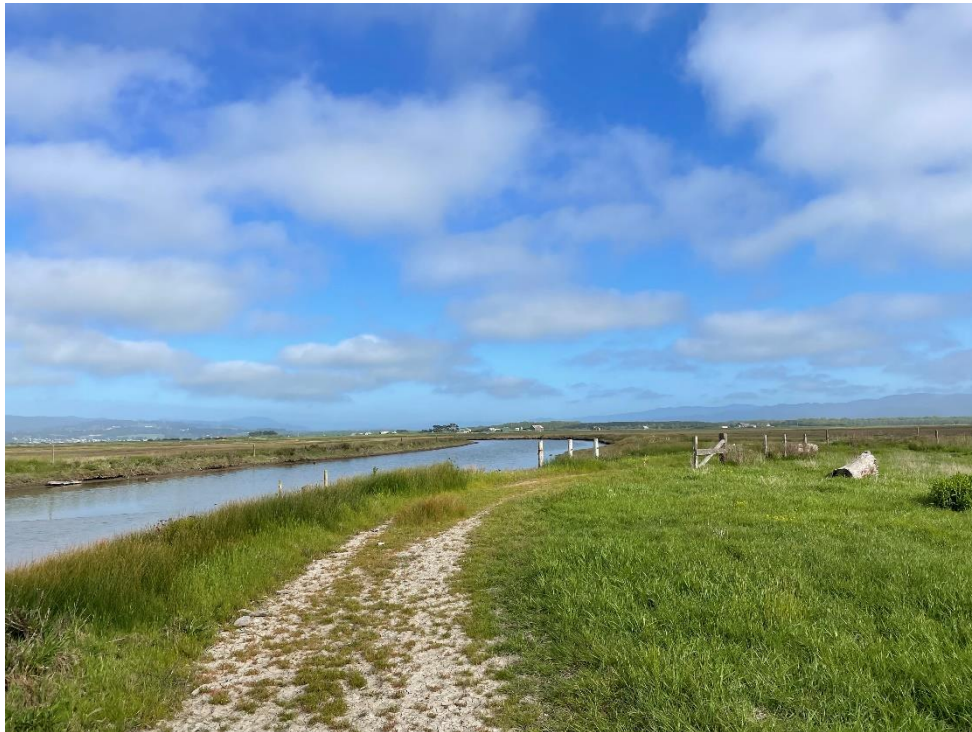
Photo 7—View of large interior slough (unnamed), facing east from Senestraro Lane

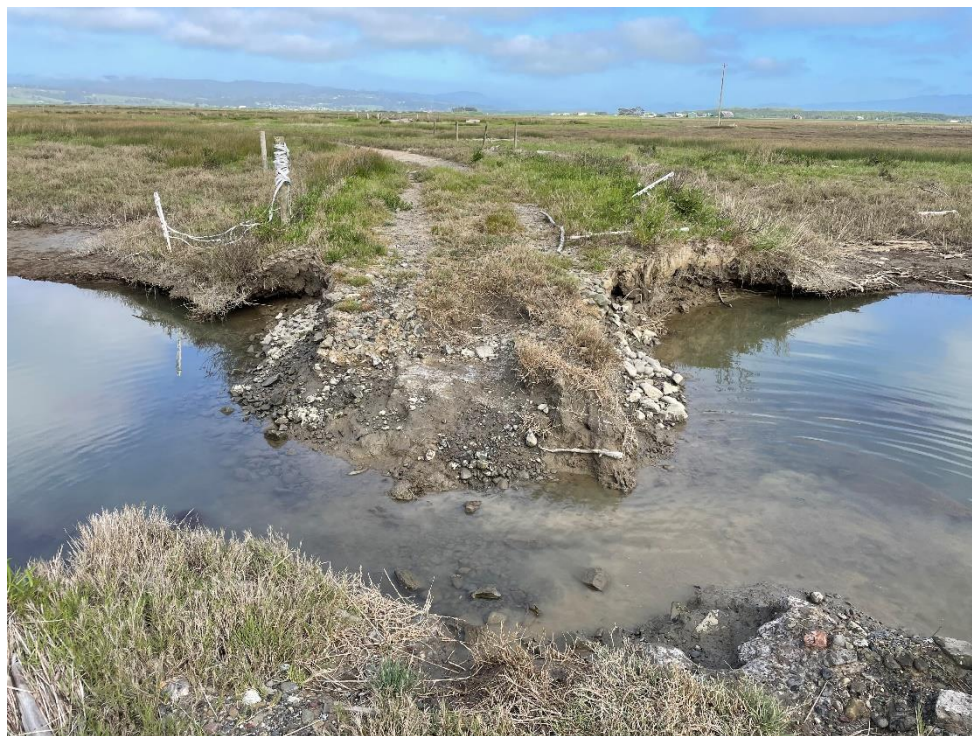
Photo 8—View of failed road crossing on Senestraro Lane (looking northeast) and the large interior slough (unnamed) that now passes over it.

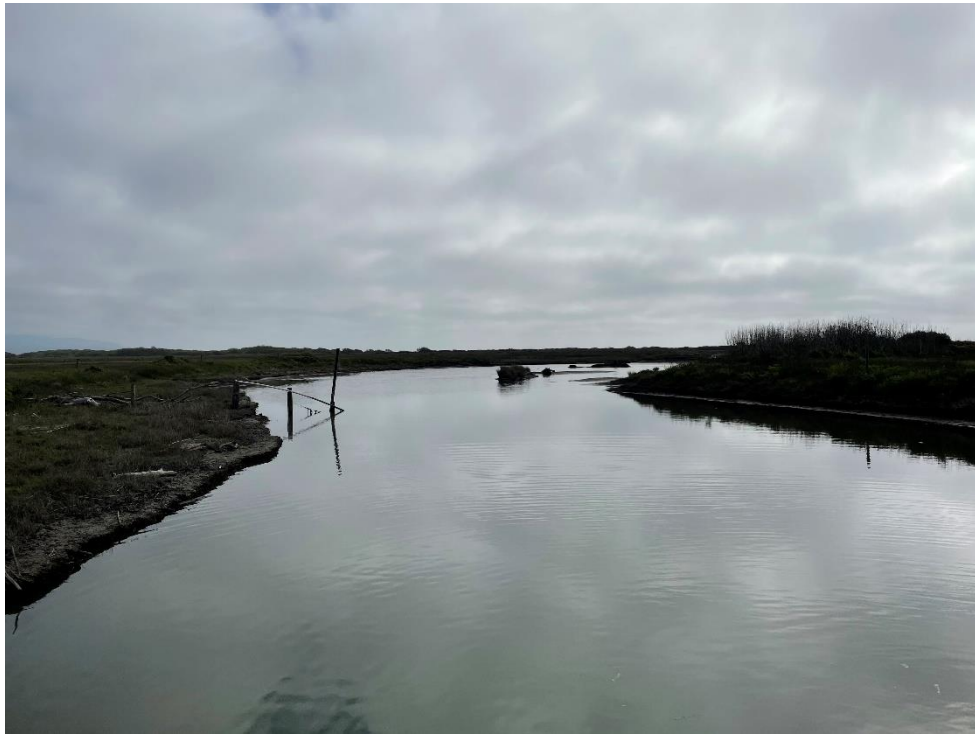
Photo 9—View of large interior slough (unnamed), facing southwest from failed road crossing along Senestraro Lane.

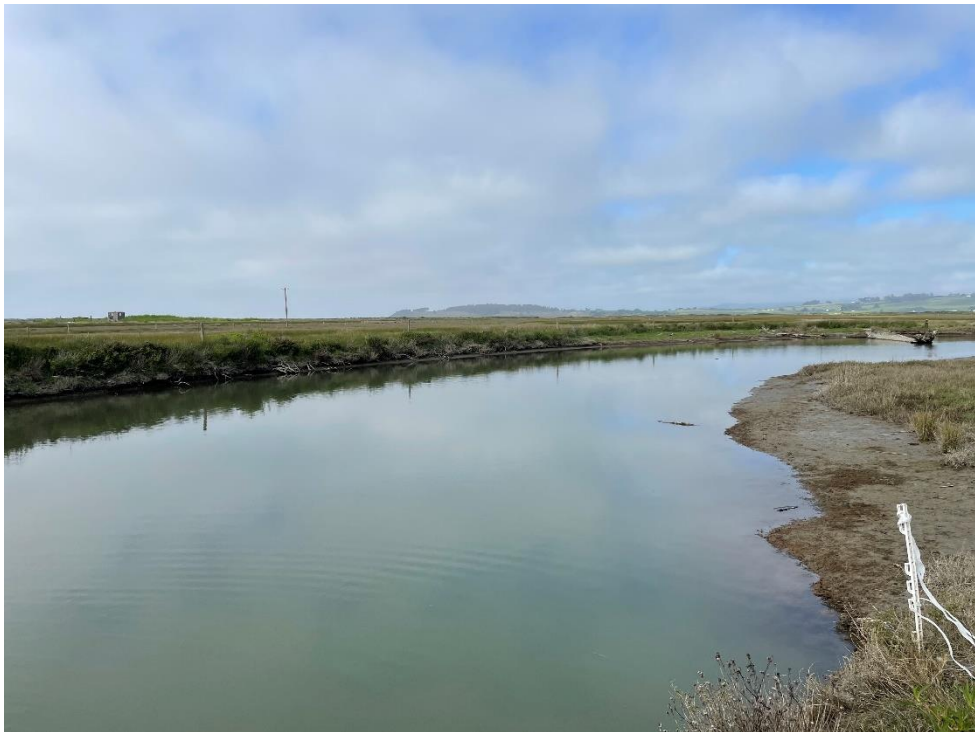
Photo 10—View of large interior slough (unnamed), facing northeast from failed road crossing along Senestraro Lane.

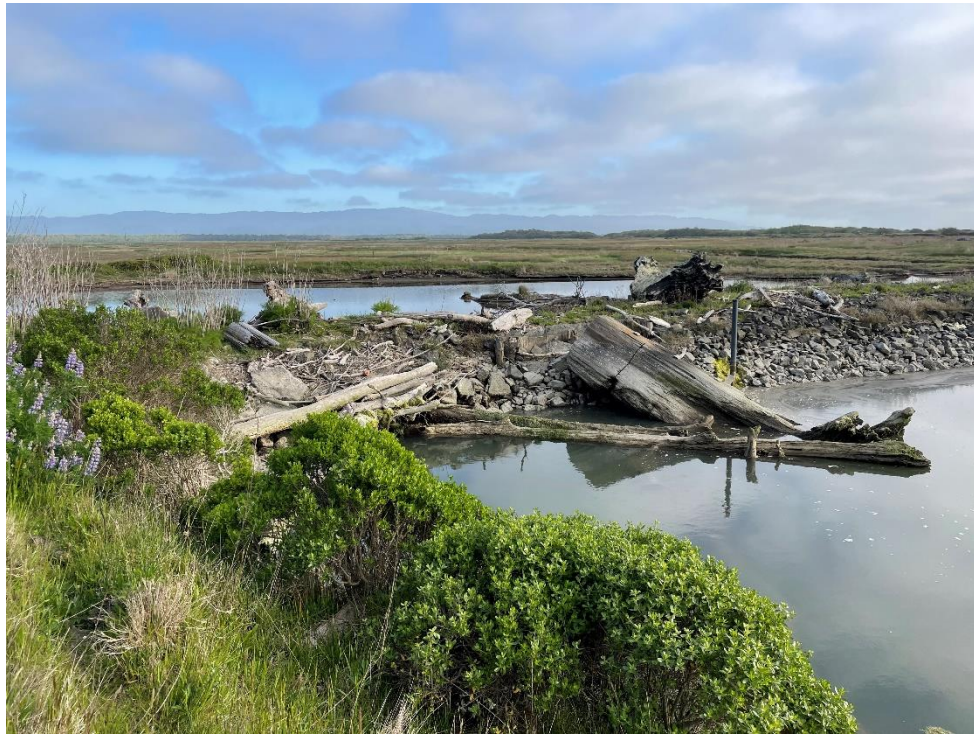
Photo 11—View of the large levee and failed tide gate (obscured by woody debris). Photo taken from levee facing south.

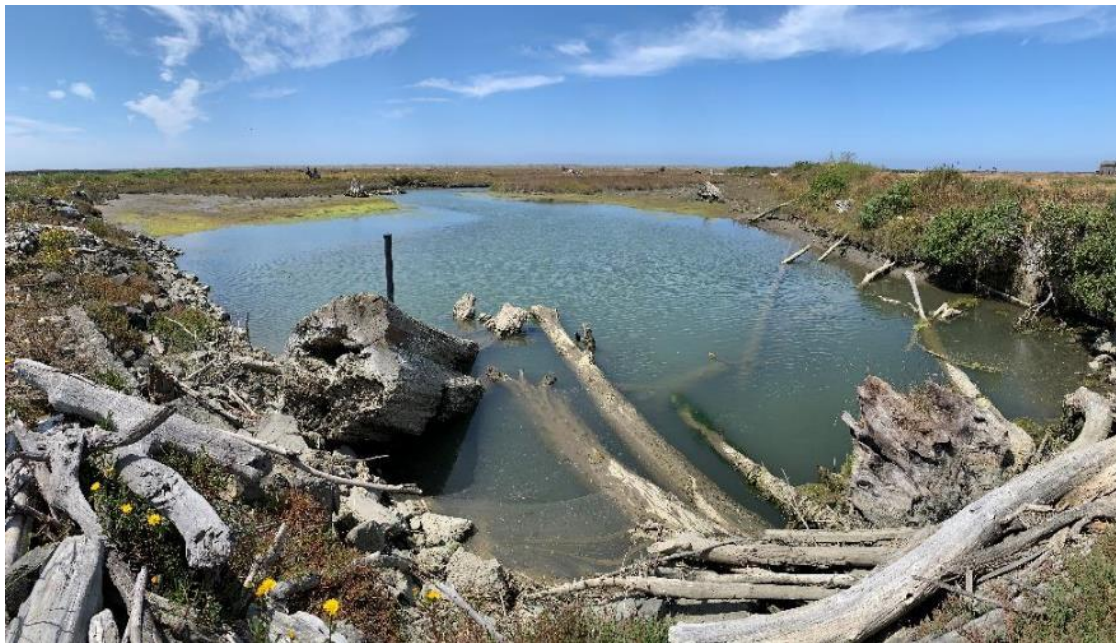
Photo 12—Failed tide gate (outboard), facing west.

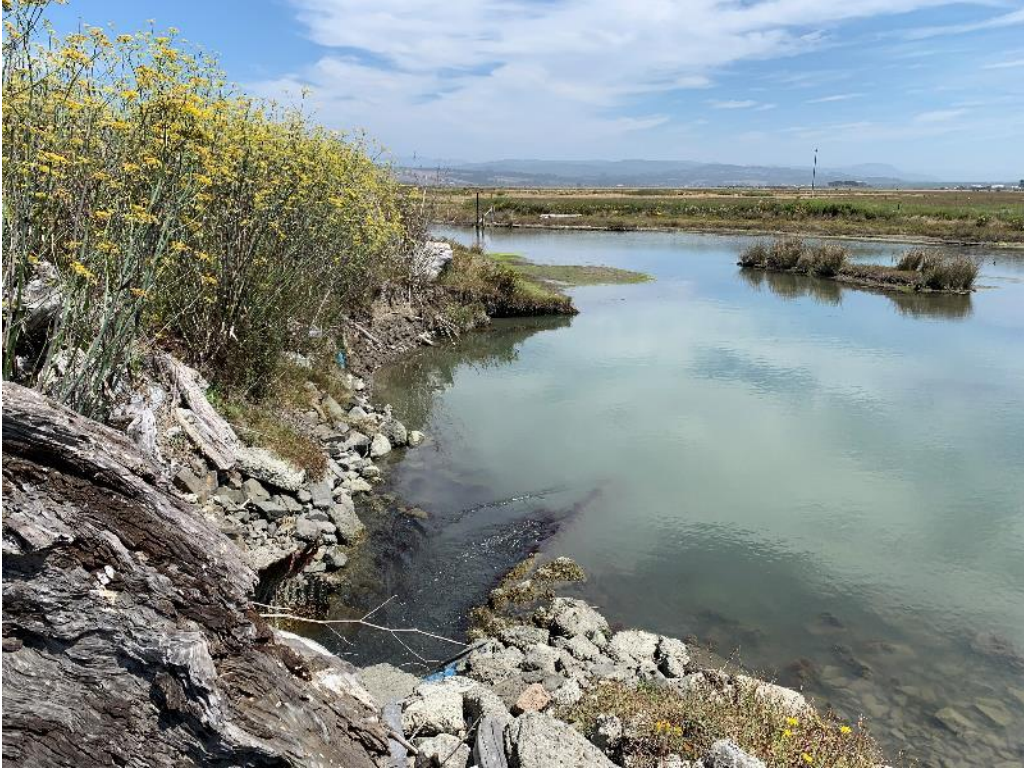
Photo 13—Failed culvert on inboard side of tide gate, facing southeast.

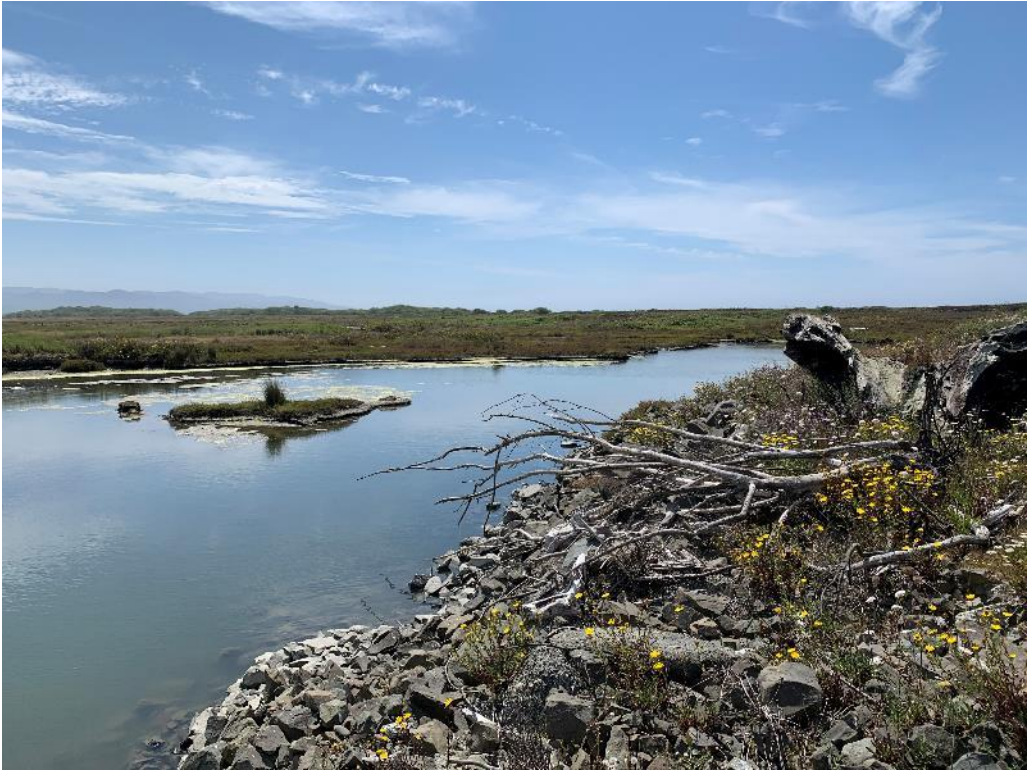
Photo 14—Rocked levees around the tide gate, facing southwest.

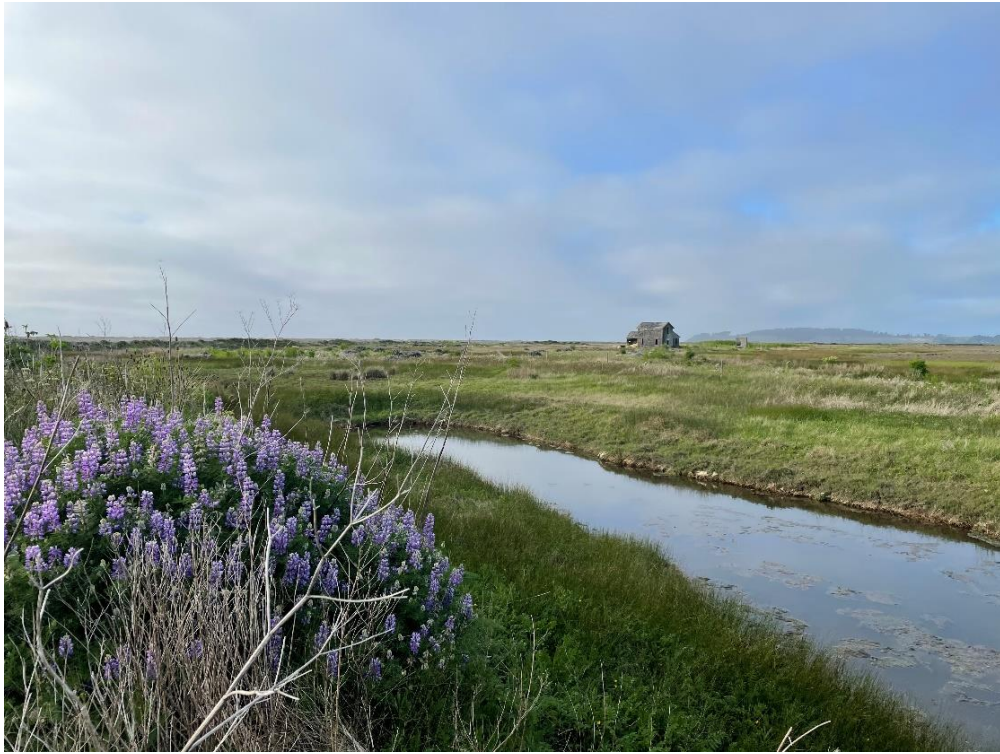
Photo 15—View of standing water to the east of large levee. Photo taken atop levee and facing north. The abandoned residential structure proposed for removal is in the background, and muted coastal brackish and salt marsh in the foreground.

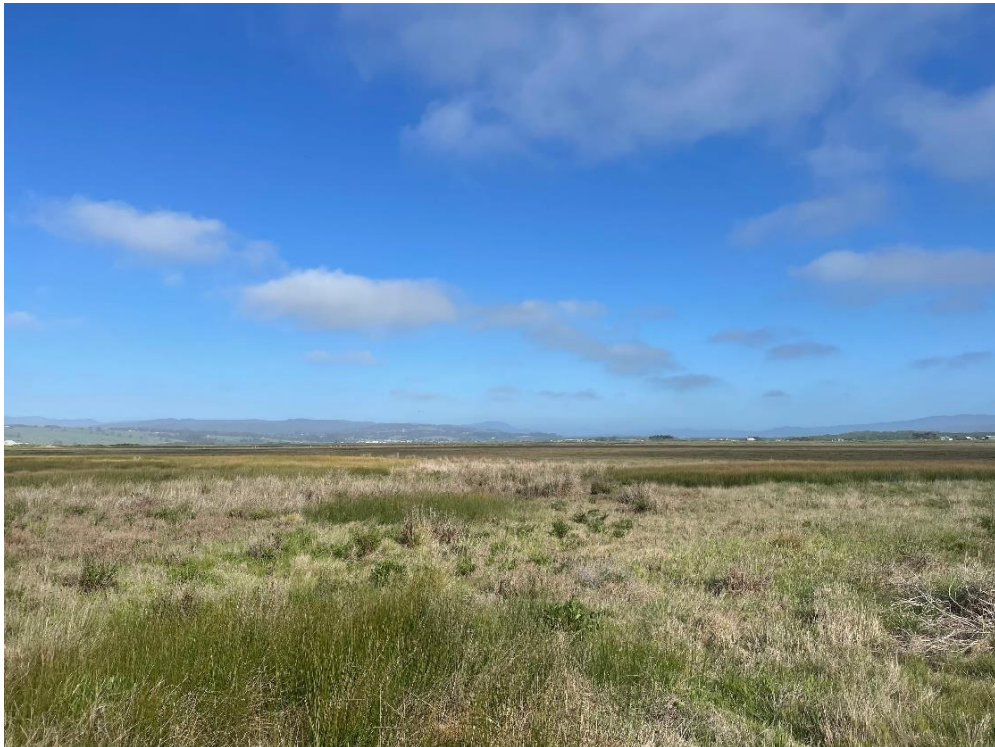
Photo 16—View of dense-flowered cordgrass marsh intergraded with non-native agricultural pasture and muted coastal salt and brackish marsh within Project Area, facing east.

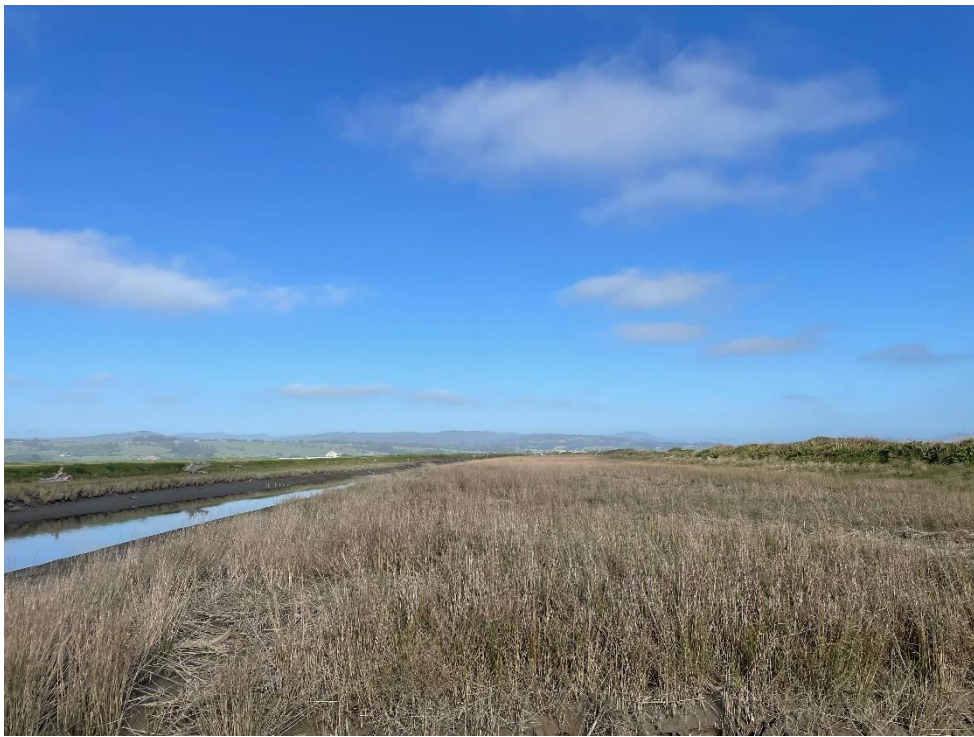
Photo 17—View of Sevenmile Slough and muted coastal salt and brackish marsh dominated by salt grass flats at northern limits of the Project Area, facing east.

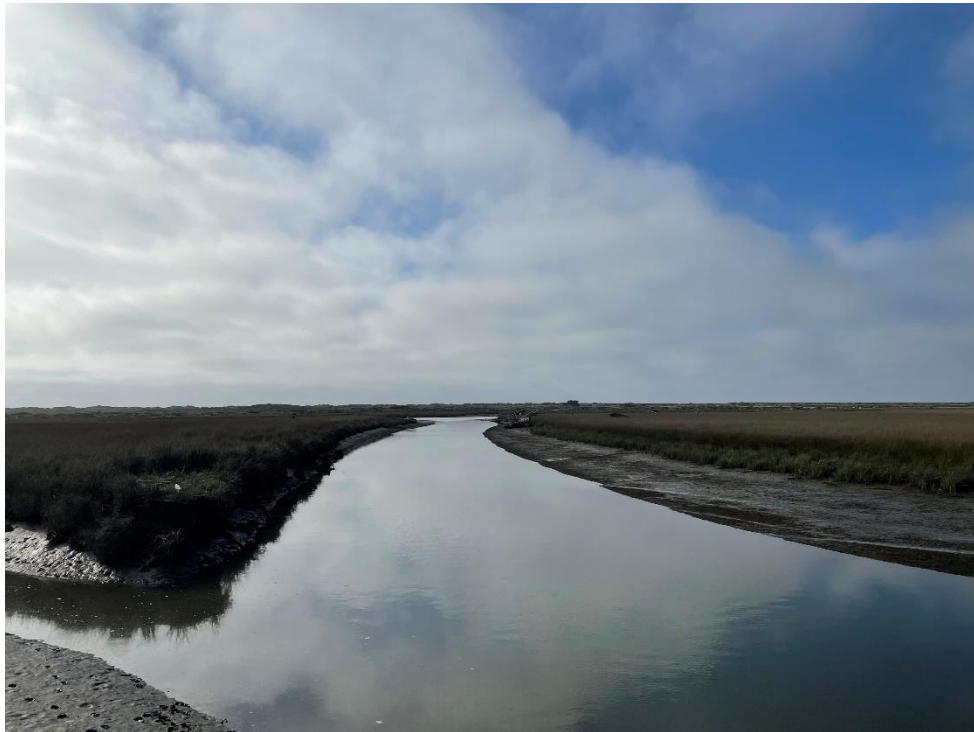
Photo 18—View of Sevenmile Slough with the confluence of the North Bay in the distance, facing northwest.

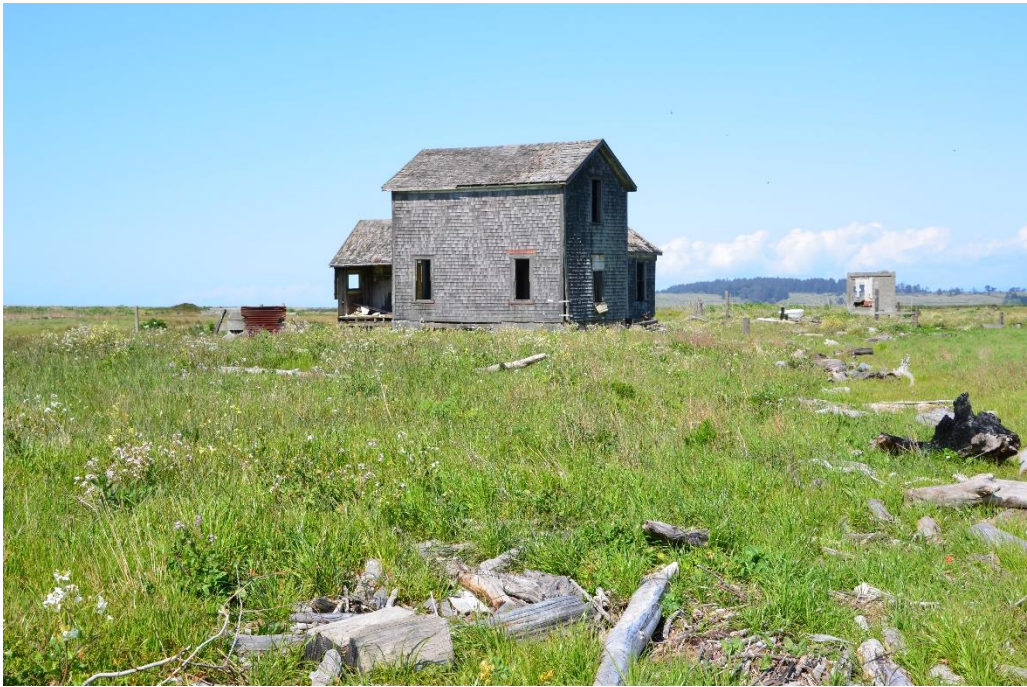
Photo 19—View of abandoned residential structure that is proposed to be demolished and removed from the non-native dominated ruderal habitat it was constructed in. This area will be reclaimed by full tidal influenced coastal salt and brackish marsh once the existing levees are graded to lower elevations.

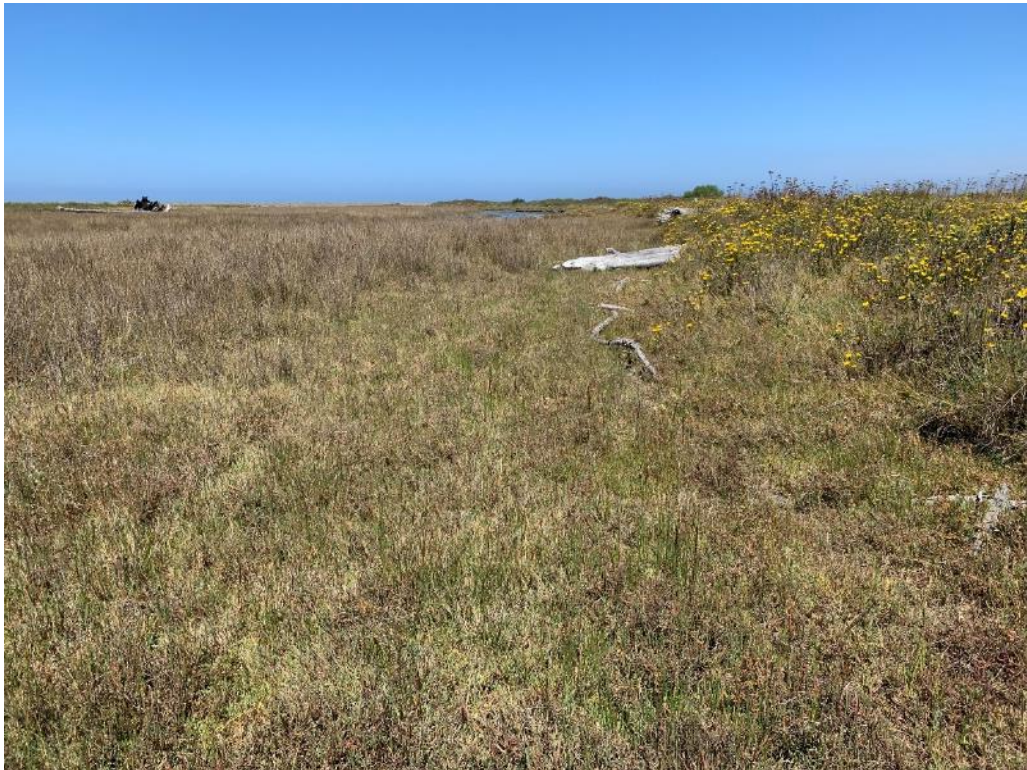
Photo 20—Dense-flowered cordgrass dominated low marsh outside of the levees. This species will be eradicated from the Project Area during implementation, and controlled post-implementation.
