To: Fantastic Gardens Humboldt, INC.
APN: 210-141-008
APPS#11966

RE: Pond Stability Report

This memo summarizes the assessment of an existing off-stream pond located on APN: 210-141-008. The pond was inspected and assessed for stability and risk of failure.

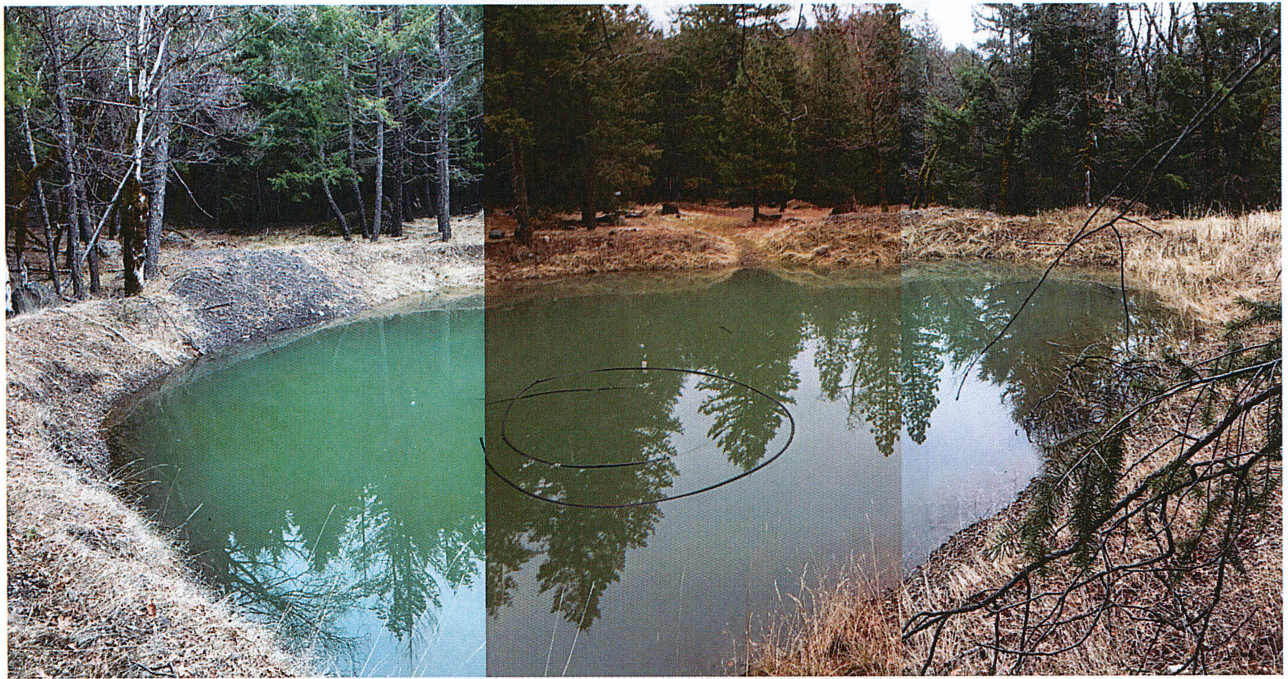
Figure 1: Entire pond. Facing East.

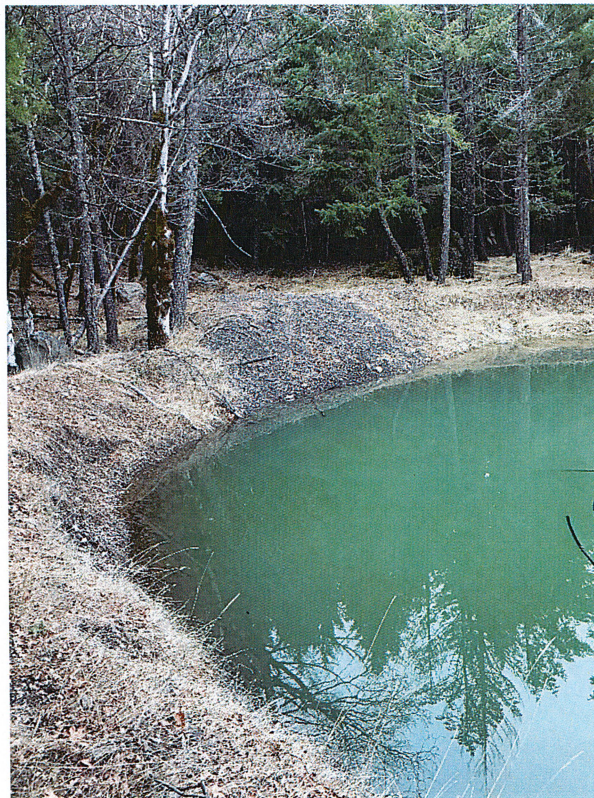
Figure 2: North embankment of pond.

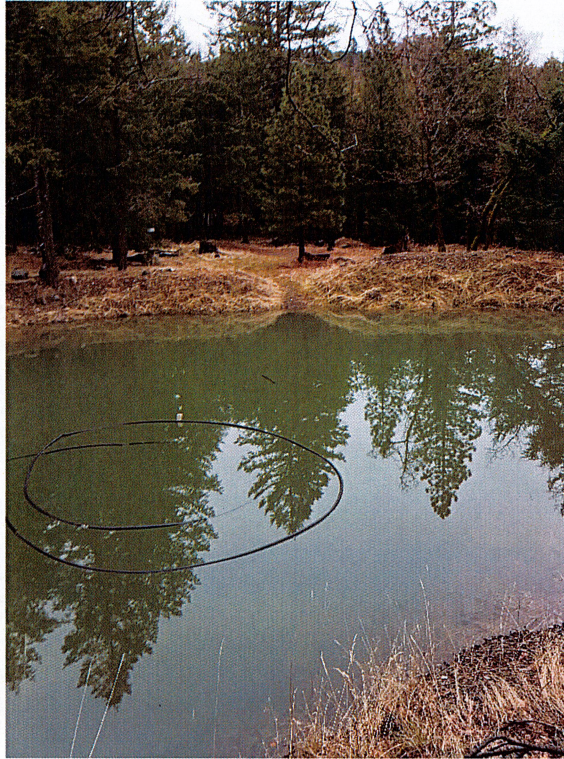
Figure 3: East embankment of pond. The existing spillway can be seen on the East side of the embankment.

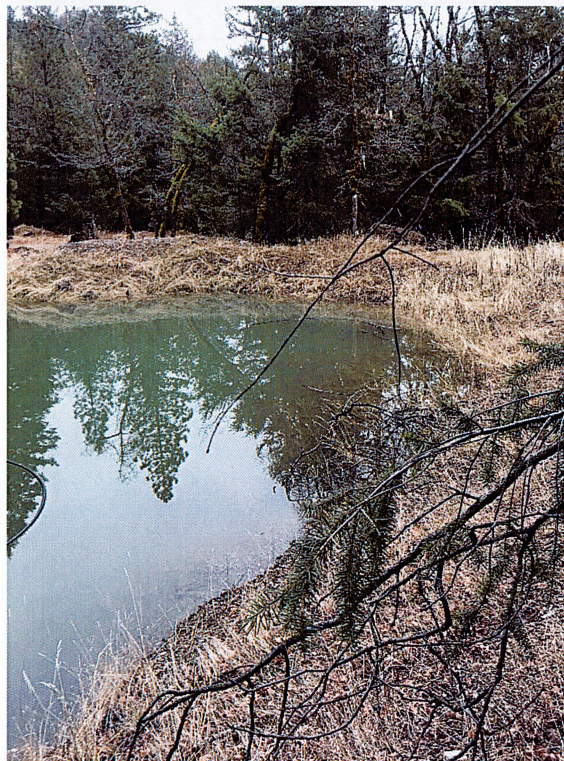
Figure 4: South embankment of pond.

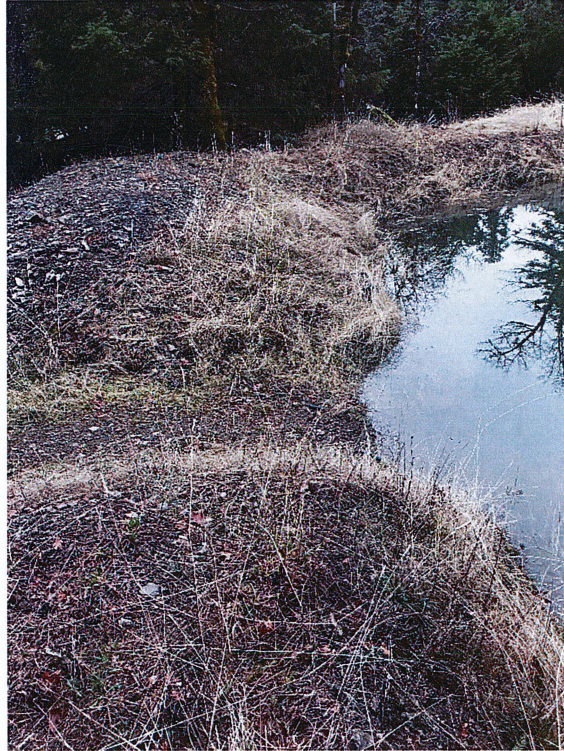
The embankment on the East side of the pond has been lowered, constructing a spillway. The current spillway is approximately 4 ft wide, consists of native soils and does not have any erosion protection or structure to convey overflow. There is approximately 4 ft elevation difference between the spillway crest and the top of the embankment, allowing for approximately 4 ft of free board. The location of the current spillway allows excess water to travel down a gravel road for approximately 300 ft, eventually intersecting the class II tributary to Dairy Creek.

Figure 5: Current spillway located on East embankment of pond.

Based on my inspection and assessment, I recommend the pond should be lined, have a spillway designed, and be permitted by the California Department of Fish and Wildlife and Humboldt County prior to further work.

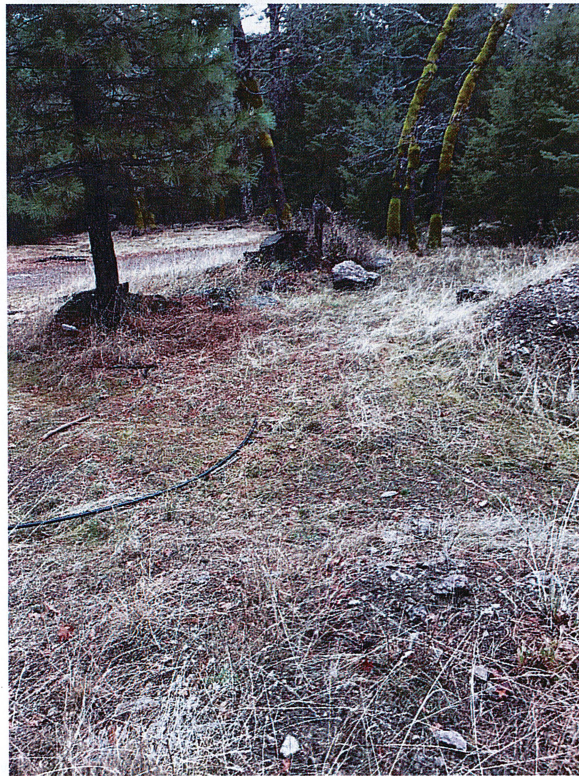
Figure 6: Current overflow flow path.

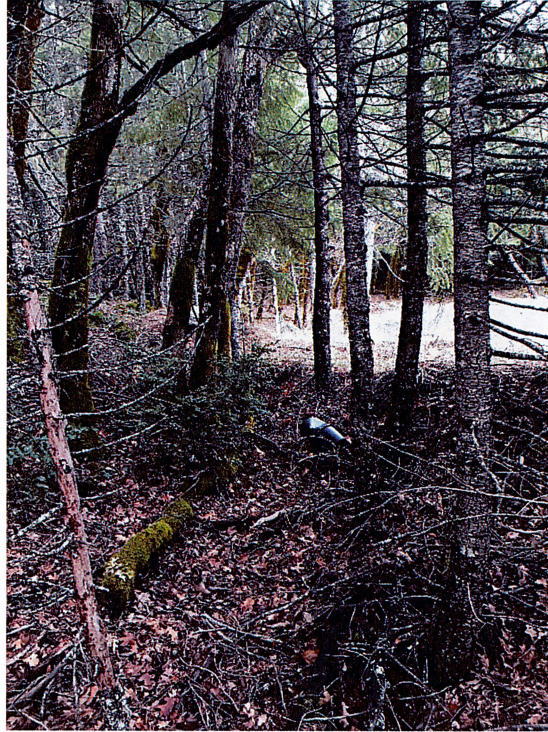
Figure 7: Location of proposed spillway. West embankment of pond. Facing East.

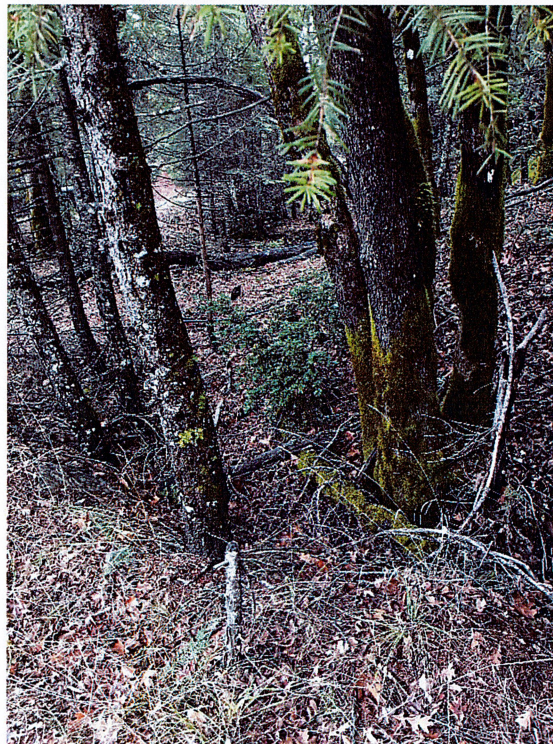
Figure 8: Downstream of proposed spillway. Class II tributary located approximately 75 ft downstream of proposed spillway.
