# Project: 6751

Date: 4/2/2024 9:10:54 AM

Street: 860 Nancy Ct.

Material: Corrugated Metal Pipe

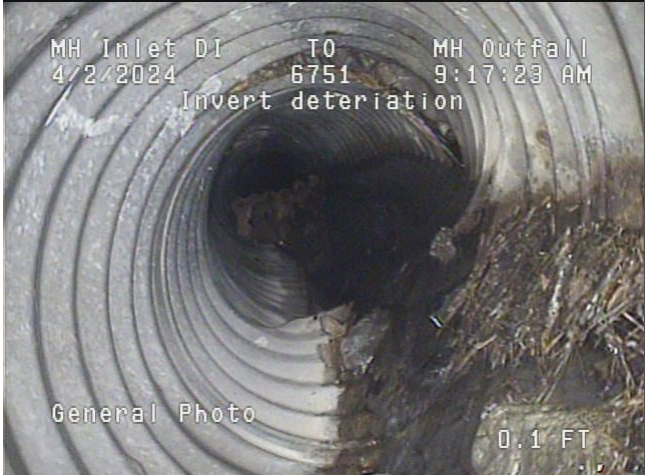
0.1	General Photo Severity: None Remarks: Invert deterioration	03:02

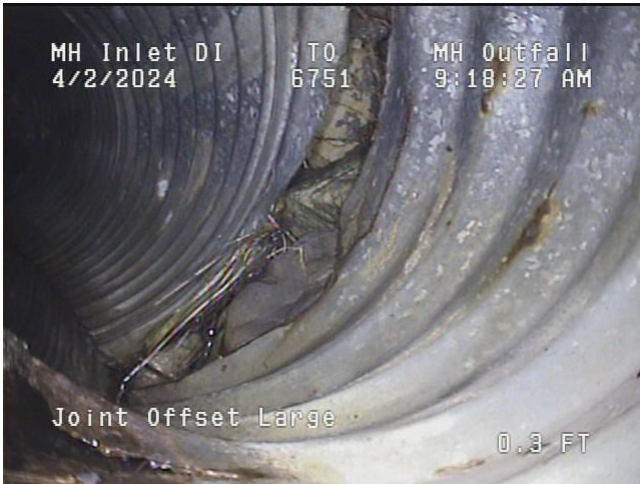
Distance	Fault Observation	Time	Picture
0.3	Joint Offset Large Severity: None Struct Weight: 2	04:06

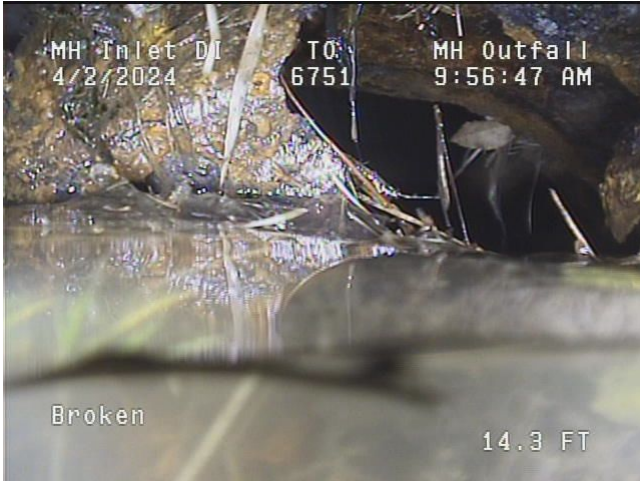
14.3	Broken Position: 4 To 8 Severity: None Struct Weight: 5	11:37

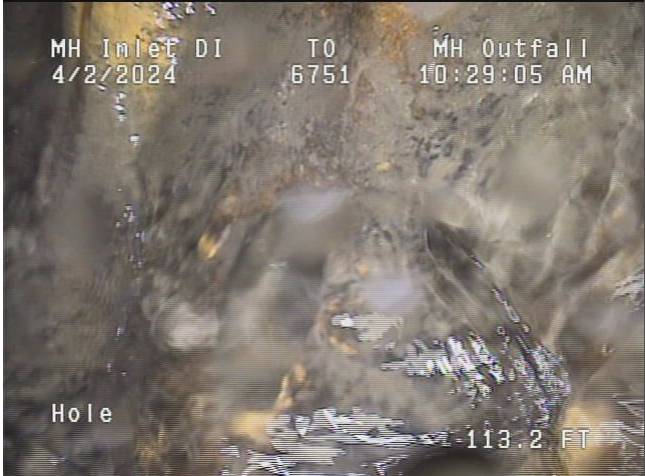
<p>MH Inlet DI TO MH Outfall 4/2/2024 6751 10:17:28 AM</p> <p>Water Level 0.0 FT</p>
113.2	<b>Hole</b> <b>Position: 6</b> <b>Severity: None</b> <b>Struct Weight: 3</b>	12:38

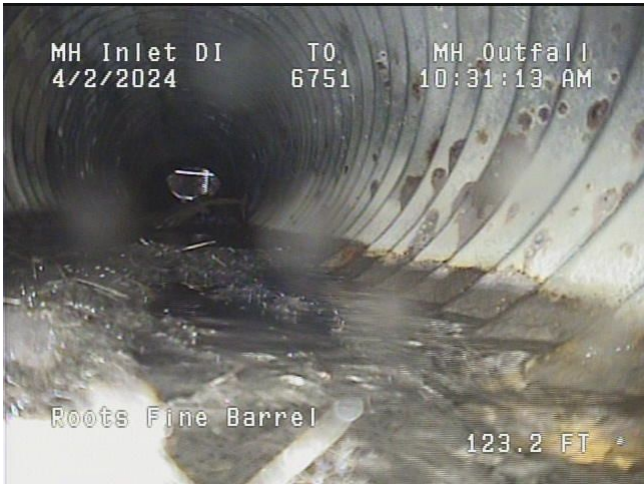
Distance	Fault Observation	Time	Picture
123.2	<b>Roots Fine Barrel</b> <b>Position: 5 To 7</b> <b>Severity: None</b> <b>Maint Weight: 2</b>	14:45

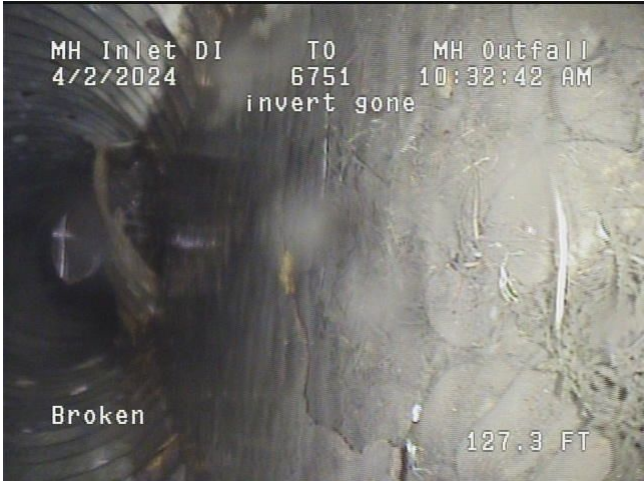
127.3	<b>Broken</b> <b>Position: 5 To 7</b> <b>Severity: None</b> <b>Remarks: invert gone</b> <b>Struct Weight: 4</b>	16:13
