PACIFIC WATERSHED ASSOCIATES INC.

Re: Characterization of existing structures within SMA, APN # 218-151-005

Photos of the two buildings constructed within the SMA APN: 218-151-005

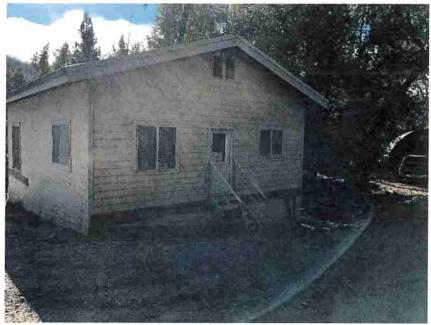
Photo of the northern building looking south. Note the rocked road, gutter system, and straw waddles that provide water quality protection.

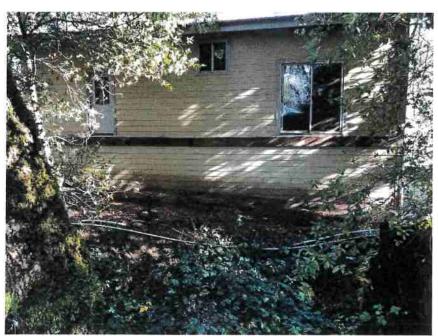
Photo of the northern building looking east from across the creek. Note the duff layers, Creekside vegetation, and lack of observed runoff from

Pacific Watershed Associates • PO Box 4433 • Arcata, CA 95518-4433 / 707-839-5130 / www.pacificwatershed.com Geologic and Geomorphic Studies • Wildland Hydrology • Erosion Control Planning • Septic Evaluation • Environmental Services the building site.

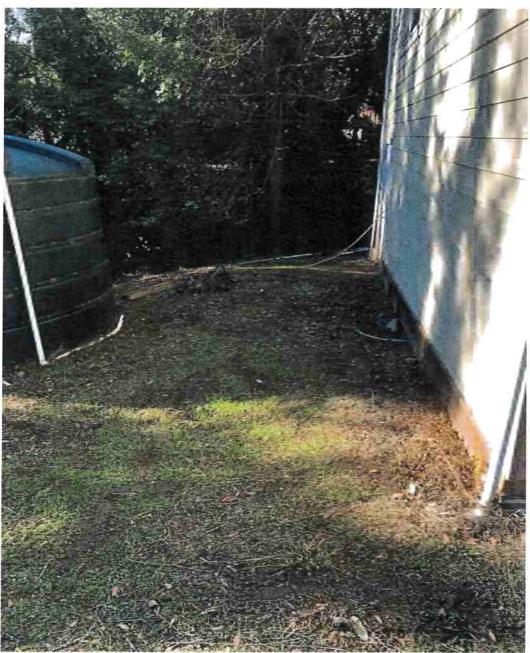
Photo of the southern margin of building #1. Note the rainwater capture system and the grassy undisturbed ground.

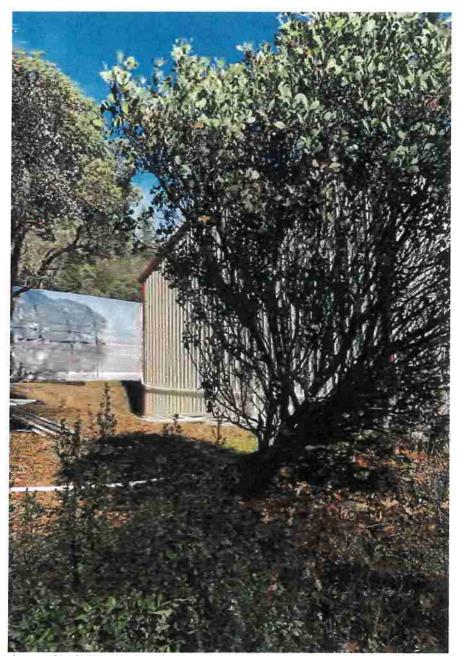
Photo of building #2 looking northeast. Note the thick vegetation and duff layers in the foreground.

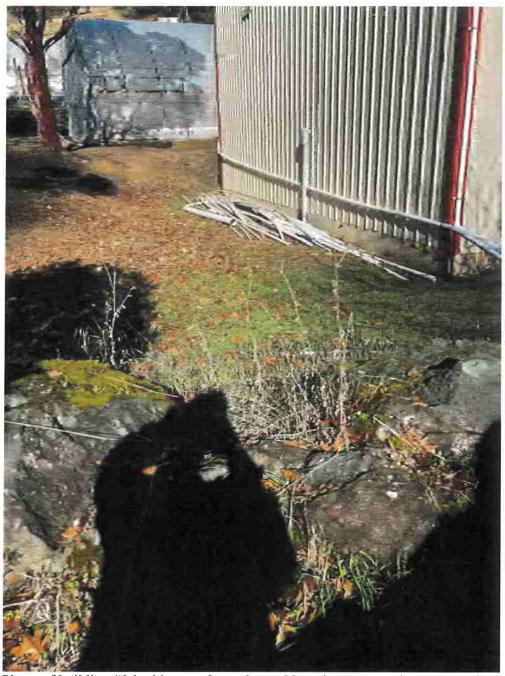
Photo of building #2 looking north-northeast. Note the grass, native rock, and duff on the margins of the building. Also note the rainwater capture infrastructure attached to the building.
