Engineering Geologic Report

12575 Buck Mountain Road
Dinsmore
County of Humboldt
California
APN: 210-131-021

> SEPTEMBER 2018 Project #1269

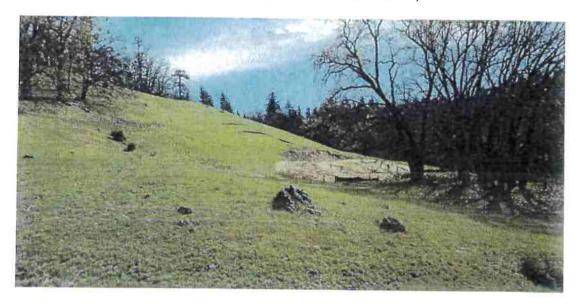
Site #1 - Landing to be removed (40.424239° N, -123.590931° W)

The location of the landing is along the northeastern portion of the project parcel. Presently, this site is occupied by a terraced landing that is presently unoccupied and occupies approximately ± 0.46 acres. For the development of the landing, approximately 700 cubic yards (CY) of materials had been excavated. The site was developed in the fall of 2017, without authorization.

Adjoining slopes based from the County of Humboldt GIS data are approximately 15 to 50%. Based from the topographic survey, the landing fill slopes range from 1:1 to 1.6:1 (h:v), where cut slopes range from 0.8:1 to 1:1. During the site visit, we observed multiple failure surfaces associated with the unauthorized grading. A shallow rotational-translational slide complex was observed above the upper most terrace cut bank, which is approximately 0.07 acres in size, where approximately 400 CY of materials have been mobilized. Groundwater was observed discharging from the cut bank where the toe of the slide is oriented. Adjacent to the slide mass to the east, a cut bank slump has developed where groundwater is discharging from the cut bank, where approximately 10 CY has been displaced.

It is proposed to remediate this site by returning the existing grading to the original configuration. All fill will meet the standards outlined in the *Recommendations* section. The proposed grading activities will disturb approximately ± 0.89 acres. Approximately

3,000 CY of earthwork quantities are expected. This site will also receive cut material from the adjoining pond site and are included in the previously mentioned quantities.

Any new bare earth will be covered with straw and seeded, where perimeter and erosion controls measures will be utilized as needed.

Inspection of the keyway subgrade and engineered fill by a qualified professional will be required. At the project termination, the client shall contact a qualified professional to conduct a final inspection of the grading activities and approve erosion and sediment control installation.

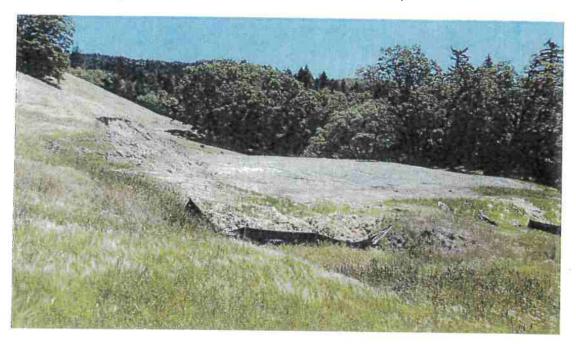
The location of the landing is along the northern portion of the project parcel, adjacent to the previously discussed landing. Presently, this site is occupied by a two-tiered landing that is presently unoccupied and occupies approximately ± 0.75 acres. For the development of the landing, approximately 2,200 cubic yards (CY) of materials had been excavated. The site was developed in the fall of 2017, without authorization. The landing is situated between the headwaters of two Class III watercourses, where grading activity has encroached into the Streamside Management Areas (SMA) of both of these watercourses.

Adjoining slopes based from the County of Humboldt GIS data are approximately 15 to 50%. Based from the topographic survey, the landing fill slopes range from 1:1 to 2:1, where cut slopes range from 0.5:1 to 1:1. During the site visit, we observed multiple failure surfaces associated with the unauthorized grading. Two slumps within the cut bank were observed with groundwater discharging from the cutbank that is discharging a top of a confining layer. A large rill was formed on the outboard slope due to overland flow and uncontrolled drainage. An unstable area was noted to the west of the landing area, where

the adjoining Class III watercourse on the western edge qualified as the boundary of the unstable area.

It is proposed to mitigate the landing by reconfiguring the existing landing by recontouring the outboard edges of the landing, stabilizing the cutslope and failure surfaces with rock slope protection (RSP), and expanding the upper landing deck to encompass the lower portion and sloping (2%) the landing surface towards a drainage structure ((P) 12" Drain Pipe) that will discharge to velocity dissipater with a vegetated bioswale. Approximately 600 CY of RSP will be used to armor the cut bank to increase the factor of safety and minimize future slope failure. A four (4) inch perforated toe underdrain with non-geotextile and drain rock shall be installed the length the RSP wall. Approximately 1,300 CY of materials will be graded and 0.69 acres will be disturbed.

There will be a total of 5,720 SF (245 LF) of temporary and 400 SF (21 LF) of permanent riparian disturbance associated with recontouring and stabilizing the landing.

Any new bare earth will be covered with straw and seeded, where perimeter and erosion controls measures will be utilized as needed.

Inspection of the keyway subgrade and engineered fill by a qualified professional will be required. At the project termination, the client shall contact a qualified professional to conduct a final inspection of the grading activities and approve erosion and sediment control installation.

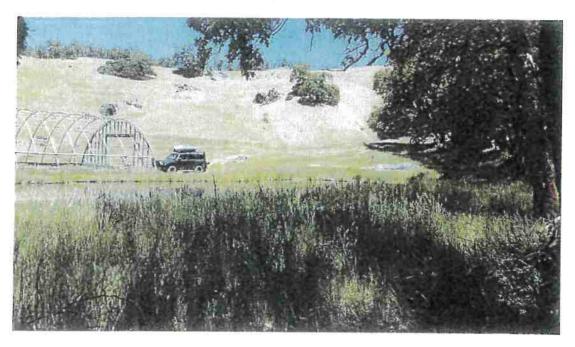
The location of Site #2 is within the west-southwestern portion of the project parcel. The existing clearing is comprised of a two-tiered landing, a small landing that contains a 35 foot by 75 foot greenhouse, and an approximate 155,000 gallon rainwater catchment impoundment. These features were completed without county authorization. For the development of these features, approximately 1,500 cubic yards (CY) of materials had been excavated. Approximately 1.12 acres have been disturbed relating to the development of these features. Site development based from historical imagery (Google Earth) began between 2005 and 2009, where the 2016 imagery set illustrates present-day conditions. A Class III watercourse bisects Site #2, where an access road and small two-tiered landing encroaches the SMA.

The topography within the site area range from 5 to 30% (County of Humboldt GIS).

In addition to existing site improvements, the client has agreed to re-grading the existing impoundment structure, due to uncertainty of compaction standards, embankment geometries and lack of keyway. A 280,000-gallon (0.86 acre-feet) impoundment structure is proposed to replace the existing structure and will be employed for agricultural and fire protection purposes. The footprint of the proposed structure will be approximately 150 feet by 50 feet with a depth of 10.5 feet.

All proposed inboard and outboard slopes will be 2:1, unless otherwise noted (refer to TVCE grading plan). All slopes will be mechanically compacted as outlined within the *Recommendations* section. The maximum fillslope will be approximately 7 feet and will have a keyway. Please review **Attachment 3** – *Technical Memorandum Slope Stability Analysis* for the justification of embankment design. There will be approximately 2,500

cubic yards of materials excavated, however 60 CY will be used as fill materials for the embankment and the remaining used as fill at *Site #1*. Approximately 0.34 acres will be disturbed during grading activities. A 24-mil reinforced polypropylene with non-woven fabric underlayment will be installed within the catchment structure in increase slope stability.

The proposed spillway will be a rock lined spillway with rock slope protection and will discharge into a vegetated bioswale adjacent to the proposed structure. The proposed trapezoidal geometry of the spillway will be 6 feet (L_{Top}) by 4 feet (L_{Bottom}) by 2 feet (Depth), comprised of 6 inch to 12 inch mixed angular rock with non-woven geotextile underlain. Beyond the bioswale, discharge will continue through an upgraded 18 inch culvert (replacing existing 12 inch culvert). An upland berm will be installed to eliminate the upland hydrologic connectivity, and will bifurcate sheet flow around the proposed structure.

Inspection of the keyway subgrade and engineered fill by a qualified professional will be required. At the project termination, the client shall contact a qualified professional to conduct a final inspection of the grading activities and approve erosion and sediment control installation.

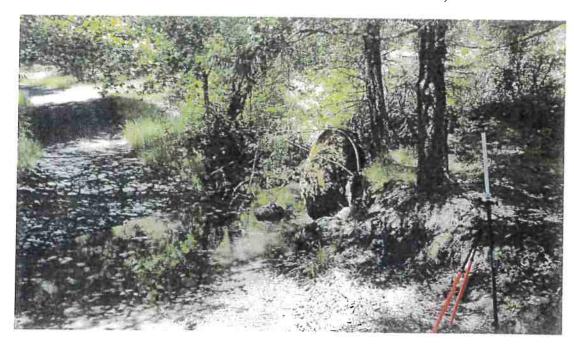
Site #3 - Existing low water crossing (40.421706° N, -123.592832° W)

The location of Site #3 is located on Dairy Creek, a Class II watercourse, along the project parcel seasonal access road to the cultivation area from the parcel residence. At this location, there is an existing rock ford low water crossing. The existing crossing does not meet the requirements outlined in Cafferata et al. (2017) for watercourse crossings for passage of 100-year flood flows.

Based on the hydraulics inferred from USGS Streamstats (2018) for this crossing, it is estimated the 100-year peak flood discharge would be 530 ft³/sec (CFS). We utilized the California Department of Forestry and Fire Protection (2017) spreadsheet for the Rock-armored crossing riprap design (See Attachment 4—Hydraulic Calculations) to determine crossing geometry and rock type needed. The rock chute width of the rock-armored crossing was approximated at 35 feet, based on existing stream geometries. Based on chute geometry and Q₁₀₀, the rip rap rock size (D₅₀) that will be used will ranges from 2.75 feet to 4.1 feet in diameter. Approximately 150 CY of rip rap will be utilized as fill for the structure. Approximately 0.03 acres (38 LF) will be disturbed associated with the installation of the upgraded rock armored crossing. New permanent riparian disturbances of 800 SF (23 LF) are expected for the crossing upgrade. Minor grading will be necessary to key the RSP and placement of the rock chute within the streambed and roadway (~55 CY earthwork quantities).

In addition, rock slope protection will be utilized to armor the river-left bank (looking upstream) to protect the access road and to prevent channel diversion once the armored crossing is installed. Approximately 150 CY of rip rap will be utilized as fill for the structure. The rip rap rock size (D₅₀) that will be used will range from 1 foot to 1.5 feet in diameter. Approximately 300 SF (48 LF) will be disturbed associated with the installation

of the upgraded rock armored crossing. Minor grading will be necessary to key the RSP into the stream bank.

Any new bare earth will be covered with straw and seeded, where perimeter and erosion controls measures will be utilized as needed. The access road shall be rocked 100 feet in either direction of the centerline of Dairy Creek with 2 inch minus base rock.

Inspection of the keyway subgrade and engineered fill by a qualified professional will be required. At the project termination, the client shall contact a qualified professional to conduct a final inspection of the grading activities and approve erosion and sediment control installation.

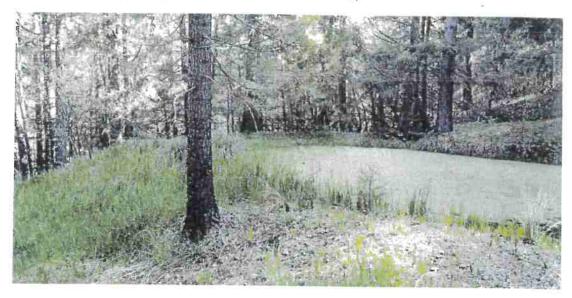
The location of Site #4 is located between Site #3 and the onsite residence. For the development of this structure, approximately 300 cubic yards (CY) of materials had been excavated. Approximately 0.19 acres have been disturbed relating to the development of this structure. Site development based from historical imagery (Google Earth) occurred prior to 1993. A Class III watercourse (discharge from Site #5) is adjacent to the northern portion of the pond area.

The topography within the site area range from 30 to greater than 50% (County of Humboldt GIS). Based from the topographic survey, the pond inboard geometry is sloped at approximately 1.5:1, where outboard slopes range from 1.5:1 to near flat. The depth of the pond is no greater than 4 feet deep. The approximate storage capacity of the structure is 25,000 gallons (0.08 acre-feet). Cutbank seepage from an adjoining road cut along the access road is channeled into an inboard ditch and directed toward the structure. During the site visit, we observed the southwestern portion of the pond had minimal freeboard and

was allowing discharge over the fill slope. The existing spillway was found to be inadequately armored, where discharge from the pond during the wet season appeared to be causing headcut erosion.

Inspection of the grading by a qualified professional will be required. At the project termination, the client shall contact a qualified professional to conduct a final inspection of the grading activities and approve erosion and sediment control installation.

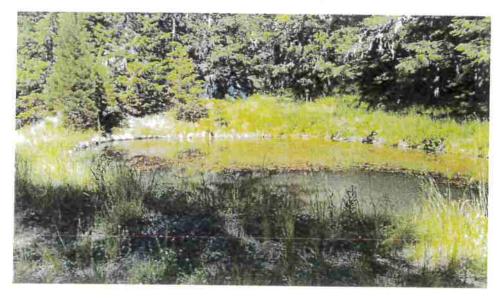
The location of Site #5 is located adjacent to the onsite residence. For the development of the structure, approximately 766 cubic yards (CY) of materials had been excavated. Approximately 0.37 acres have been disturbed relating to the development of this structure.

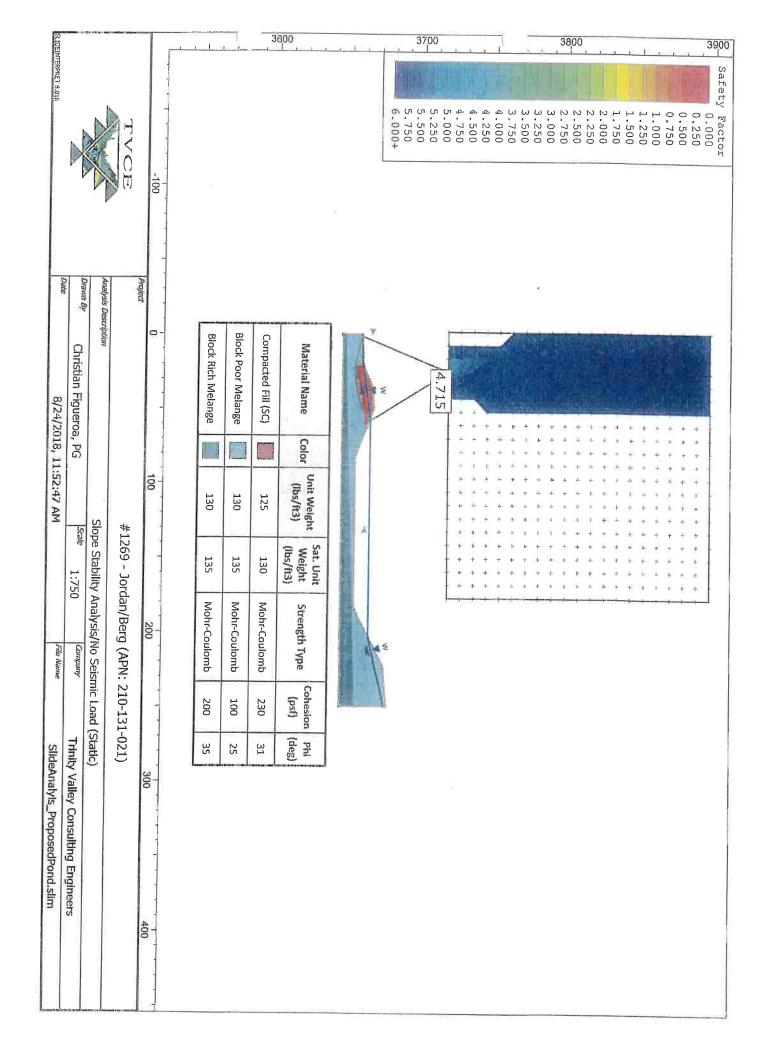
Figure 1: Proposed Embankment Slope Analysis (Static Conditions)

Generally, the minimum factor of safety (F-value) necessary to consider a slope to be stable is 1.5 for static conditions and 1.15 for dynamic (pseudo-static) conditions. Our results of modeled proposed embankment slope should be considered stable for static conditions (F = 4.715, Figure 1). The analysis under dynamic conditions with the seismic coefficient 0.15 applied (CGS), measured a factor of safety of F = 2.323 (Figure 2), and with the seismic coefficient 0.271 applied (NCHRP -0.5*PGA), measured a factor of safety of F = 1.636 (Figure 3).
