ATTACHMENT 1b  
Sprowl Creek Full Resubmittal

# ETA Humboldt, LLC

**Photographs Correlating to Site Management Plan Map**

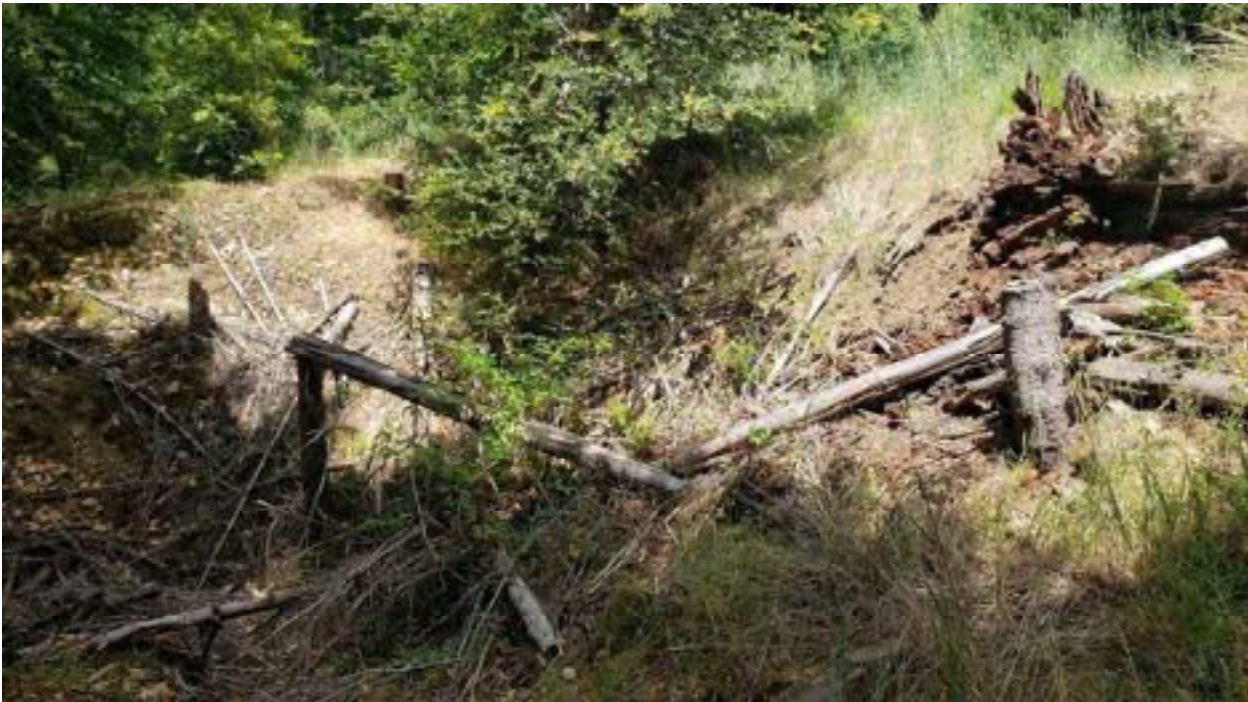
Site 19. Looking at the outlet.

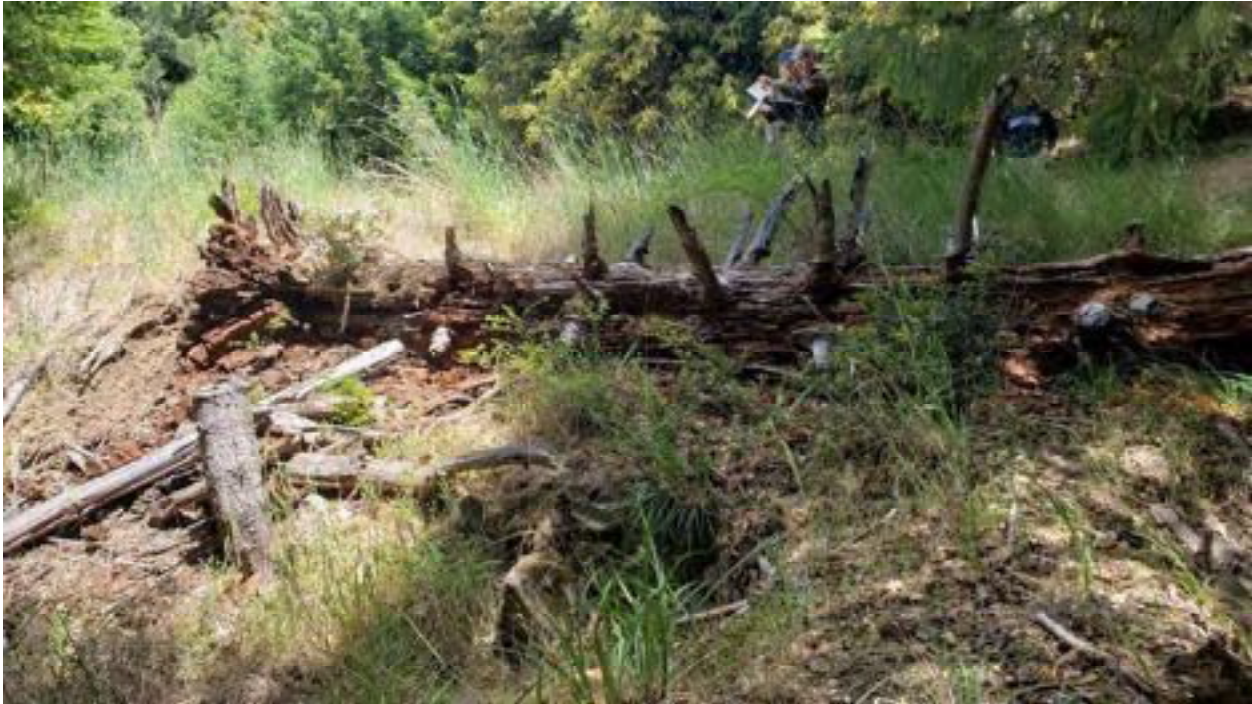
Site 19. Photo of the southeastern embankment of G5/G6/G, immediately down stream of the outlet of the watercourse crossing at Site 19. Note vegetation and rotted tree in the upper right. Indicative that this location has been in this condition for many years and was not recently created.

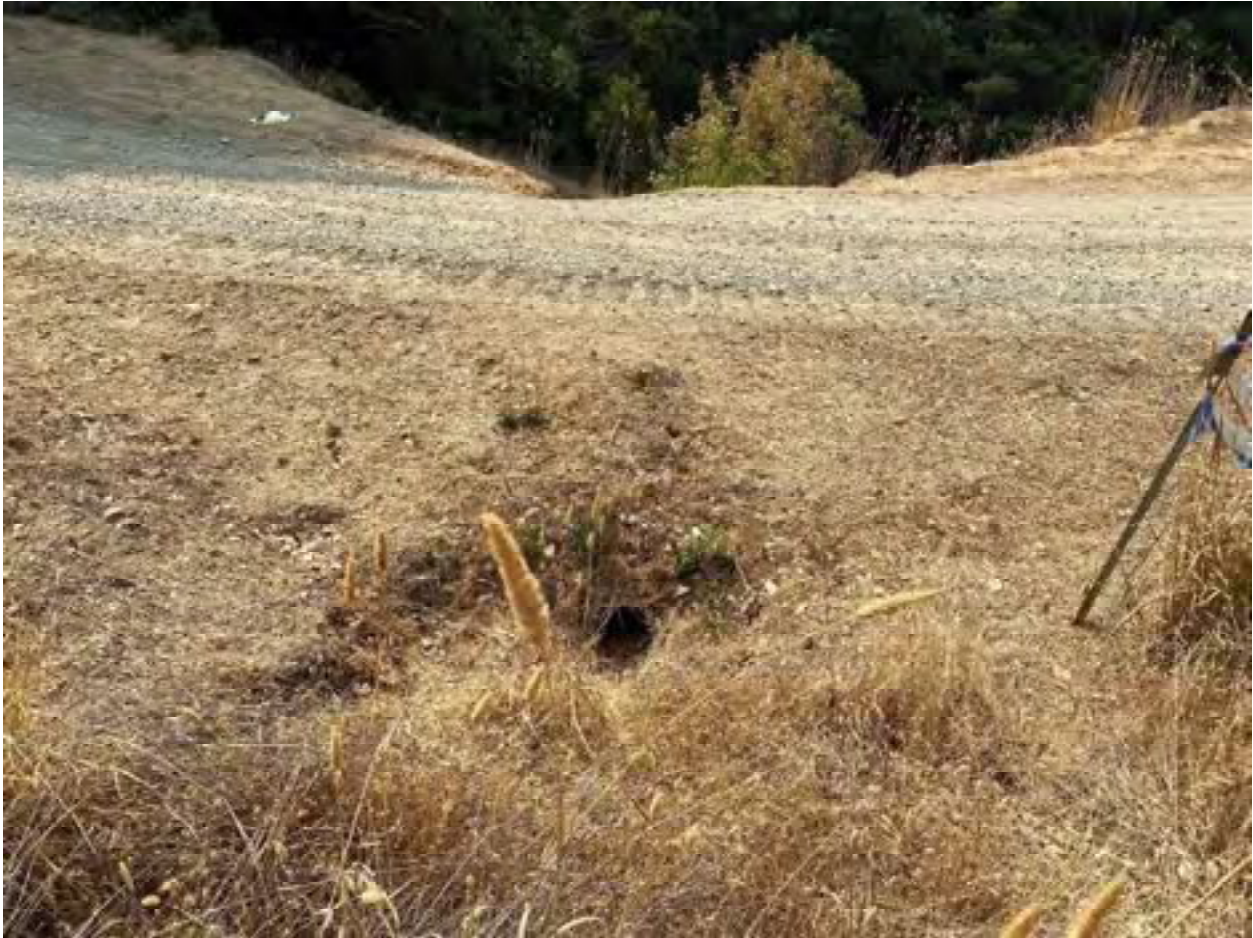
| Unique Point | Lat-Long<br>NAD 83 | Road Type | Mitigation<br>Planned | Monitor | 1600 | Treatment Priority | Date<br>Completed |
|---|---|---|---|---|---|--|---|
| <p>Current Condition: Class III watercourse crossing consisting of a 8" diameter corrugated metal pipe that is too short, shotgunned, not-to-grade, eroding the road fillslope at the outlet, and undersized for the 100-year storm event.</p> | | | | | | <p>Prescribed Action: Upgrade the existing culvert with an 18" diameter culvert per the specifications in the attached BMP's. See Permanent Culvert Crossing, Permanent Culvert Crossing Design: Critical Dip and Hydrologic Disconnect Placement, Critical Dip, Culvert Orientation, Inlet and Outlet Armoring, General Operations BMPs, and General Erosion Control specifications.</p> | |

**Photo 6:** Stream Crossing 03. Looking downstream towards the inlet of the 8-inch diameter culvert at stream crossing 03. Photo date 9-1-2021.

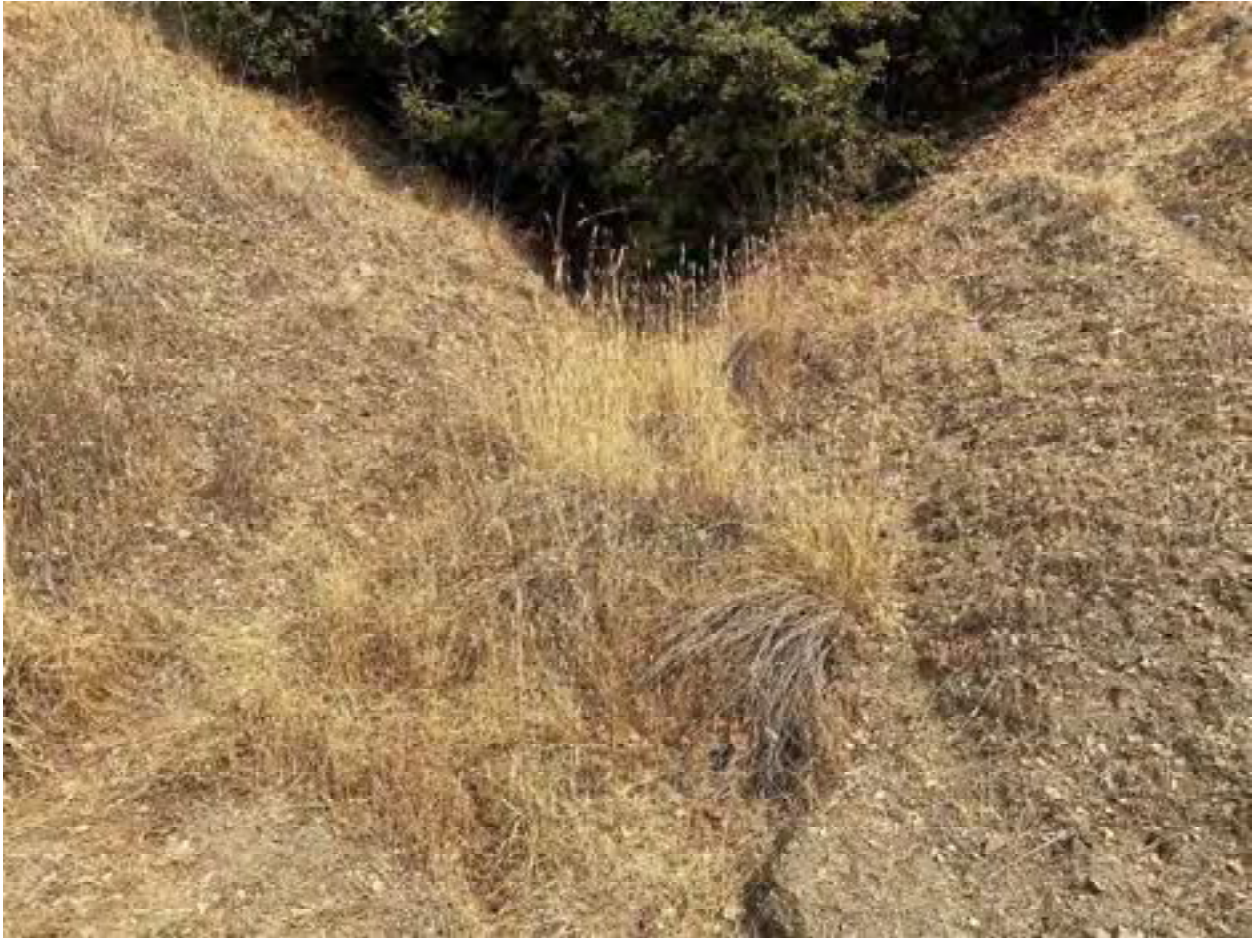
**Photo 7:** Stream Crossing 03. Looking upstream from the inlet of the 8-inch diameter culvert at stream crossing 03. Photo date 9-1-2021.

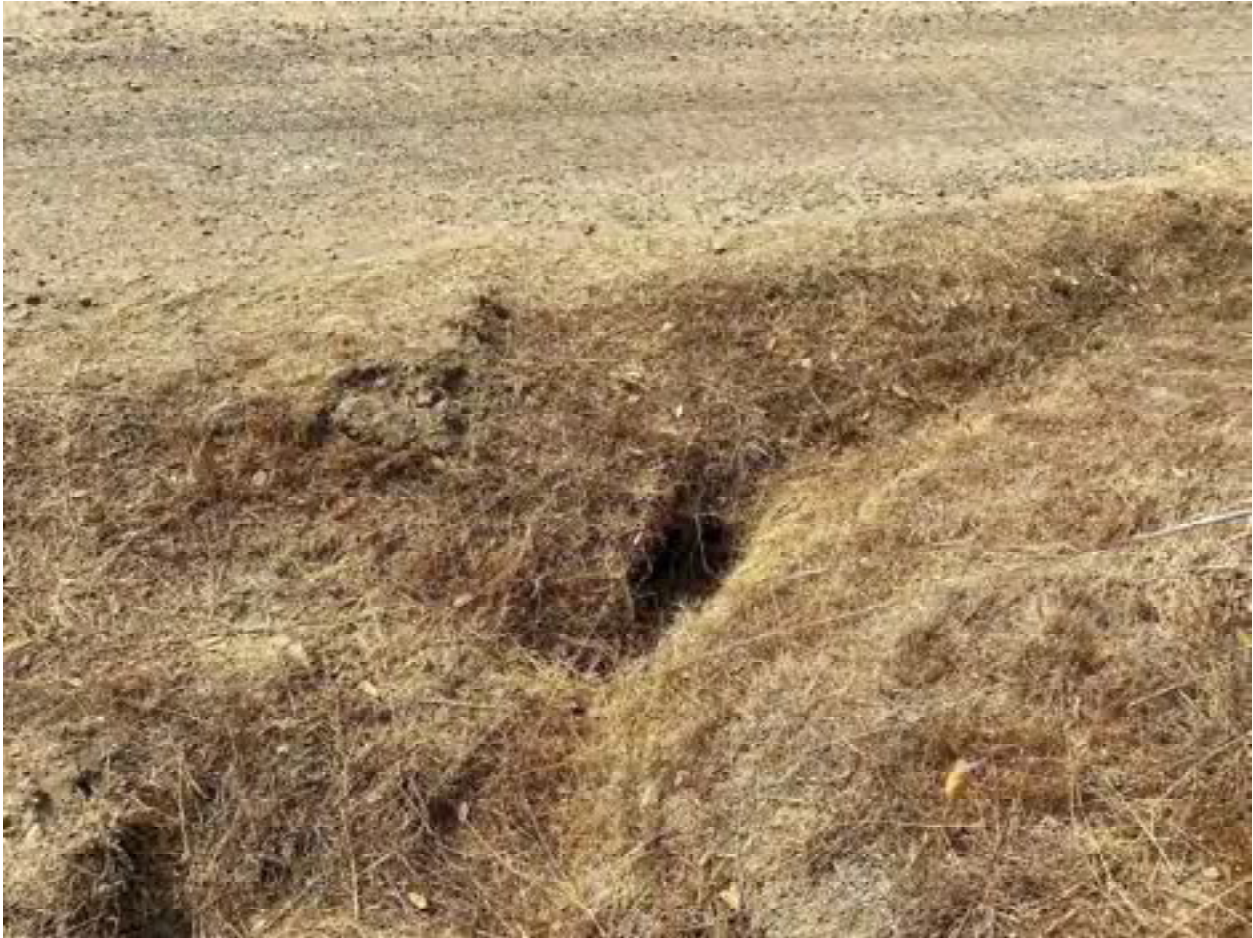
| Unique Point | Lat-Long<br>NAD 83 | Road Type | Mitigation<br>Planned | Monitor | 1600 | Treatment Priority | Date<br>Completed |
|---|---|---|---|---|---|--|---|
| <p>Current Condition: Class III watercourse crossing consisting of a 8" diameter steel pipe that is too short, shotgunned, not-to-grade, eroding the road fillslope at the outlet, and undersized for the 100-year storm event.</p> | | | | | | <p>Prescribed Action: Upgrade the existing culvert with an 18" diameter culvert per the specifications in the attached BMP's. See Permanent Culvert Crossing, Permanent Culvert Crossing Design: Critical Dip and Hydrologic Disconnect Placement, Critical Dip, Culvert Orientation, Inlet and Outlet Armoring, General Operations BMPs, and General Erosion Control specifications.</p> | |

**Photo 11:** Stream Crossing 04. Looking downstream towards the inlet of the 8-inch diameter culvert at stream crossing 04. Photo date 9-1-2021.

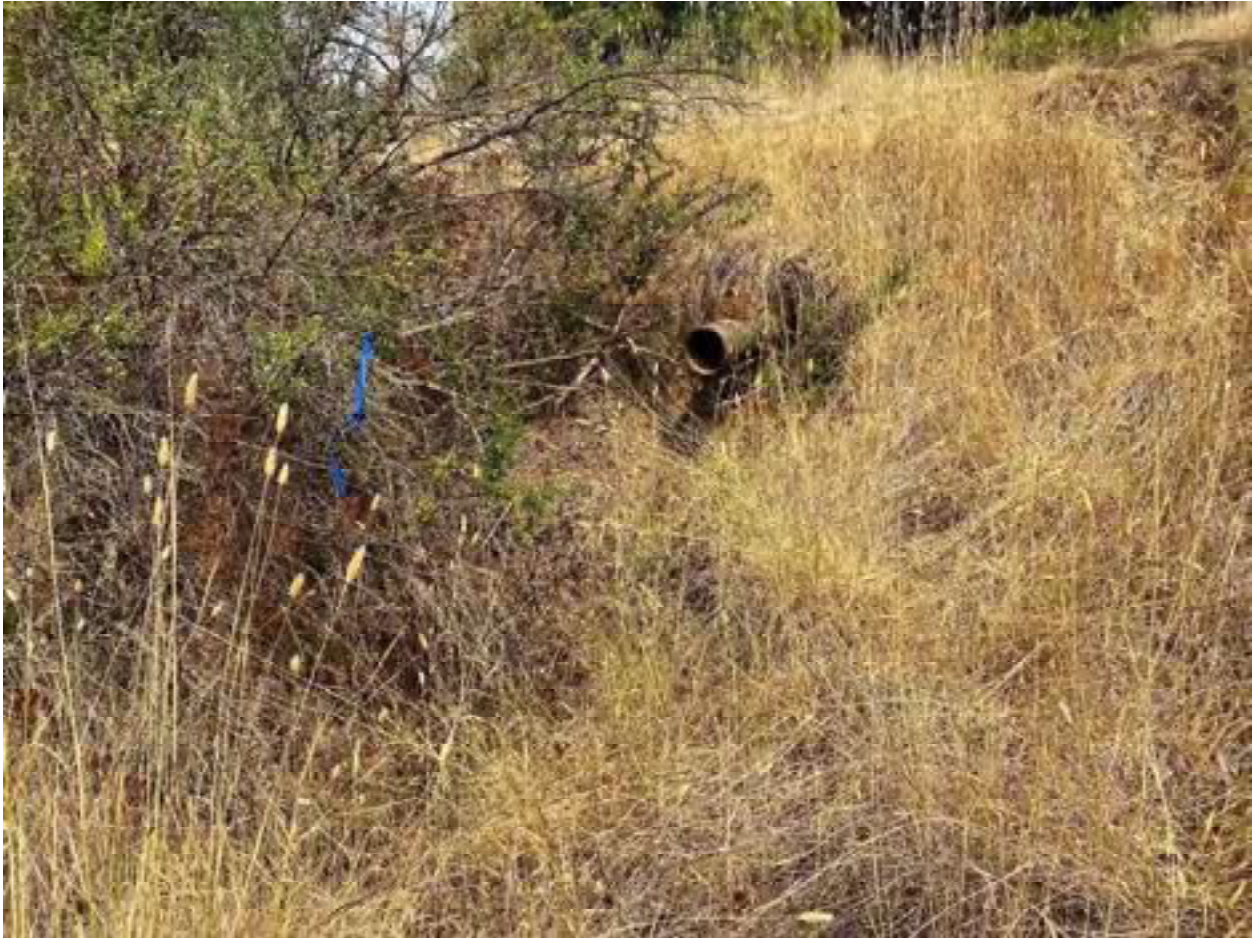
**Photo 14:** Stream Crossing 04. Looking upstream towards the outlet of the 8-inch diameter culvert at stream crossing 04. Photo date 9-1-2021.

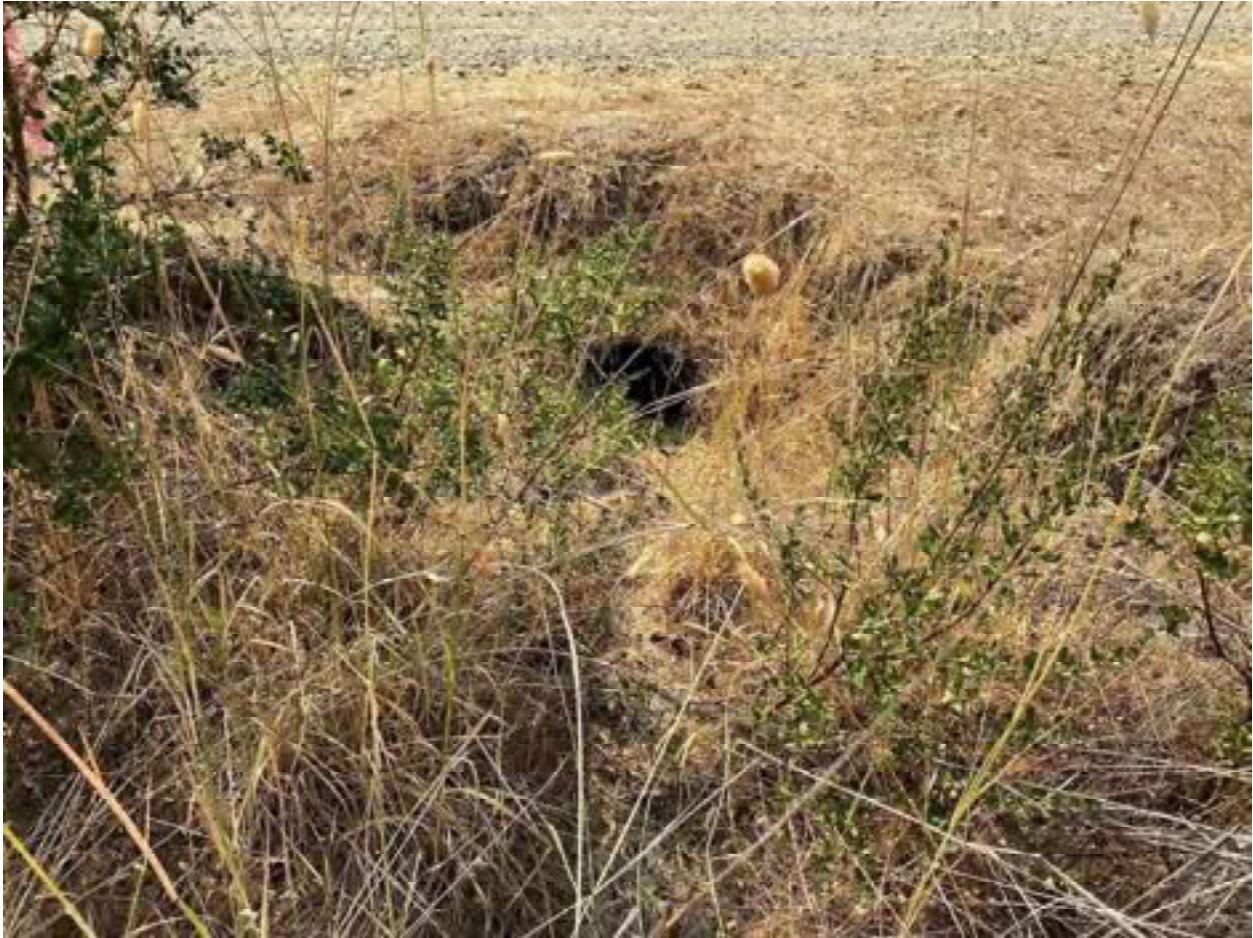
**Photo 16:** Stream Crossing 05. Looking downstream towards the inlet of the 12-inch diameter culvert at stream crossing 05. Photo date 9-1-2021.

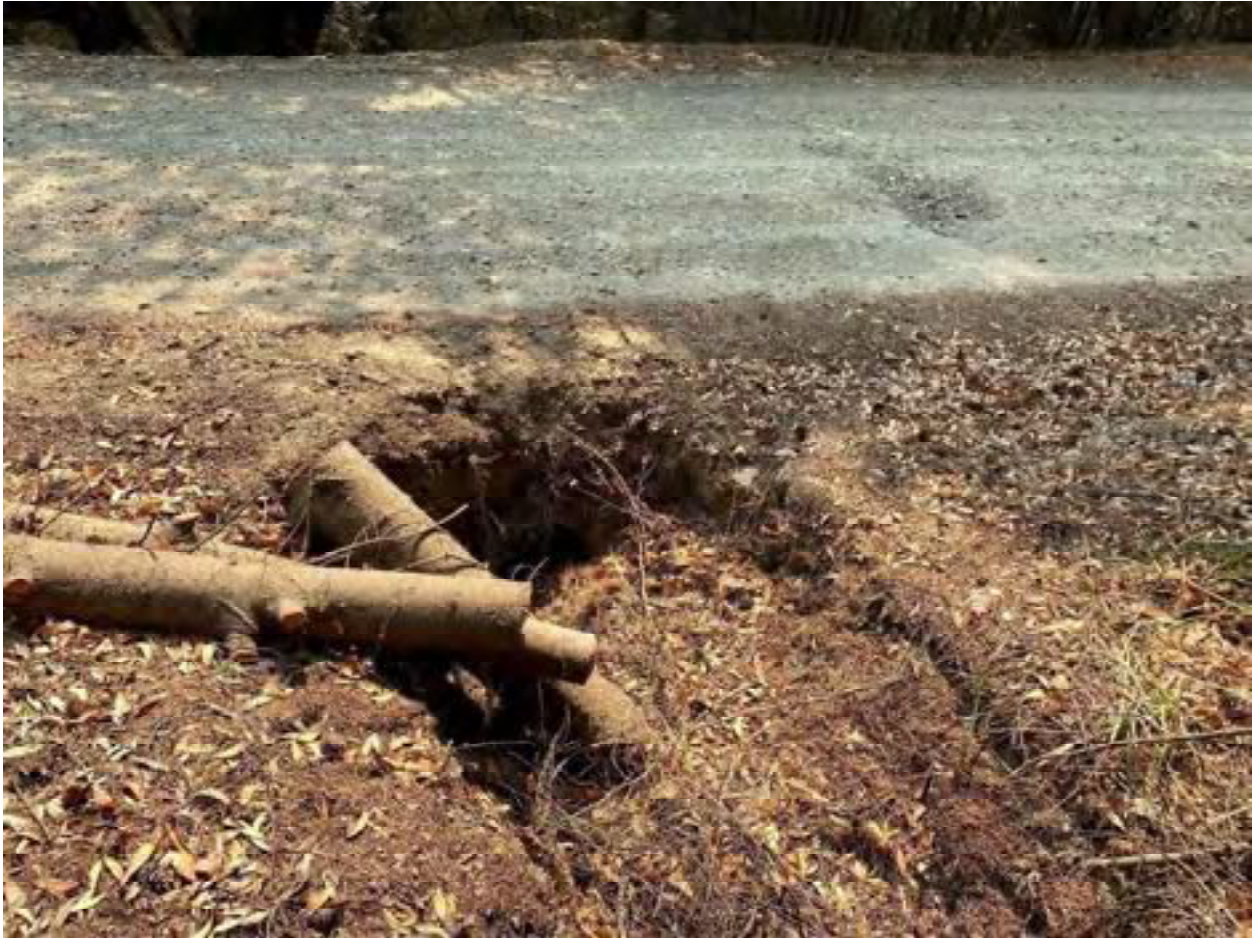
**Photo 21:** Stream Crossing 06. Looking downstream towards the inlet of the 12-inch diameter culvert at stream crossing 06. Photo date 9-1-2021.

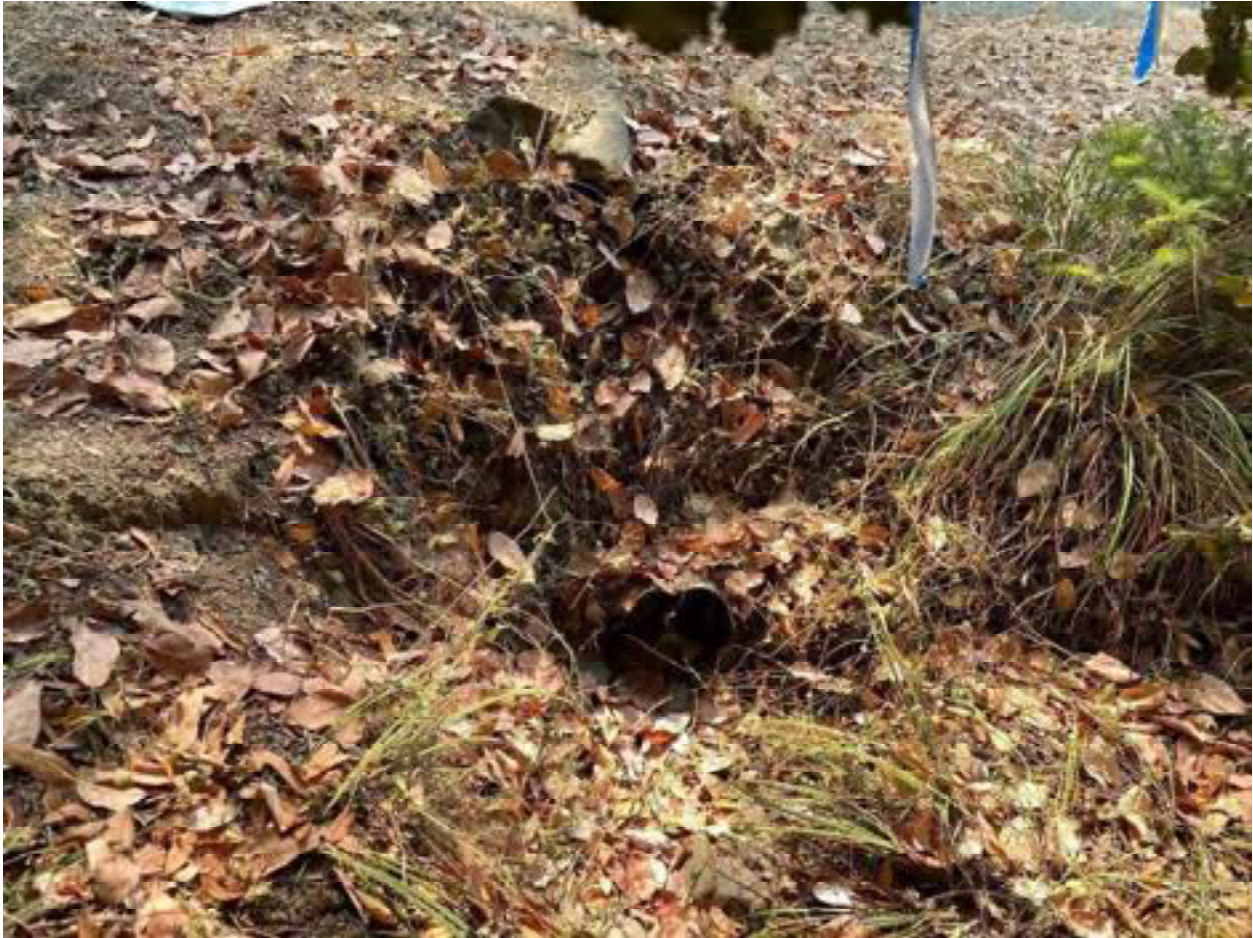
**Photo 25:** Stream Crossing 07. Looking downstream towards the inlet of the 12-inch diameter culvert at stream crossing 07. Photo date 9-1-2021.

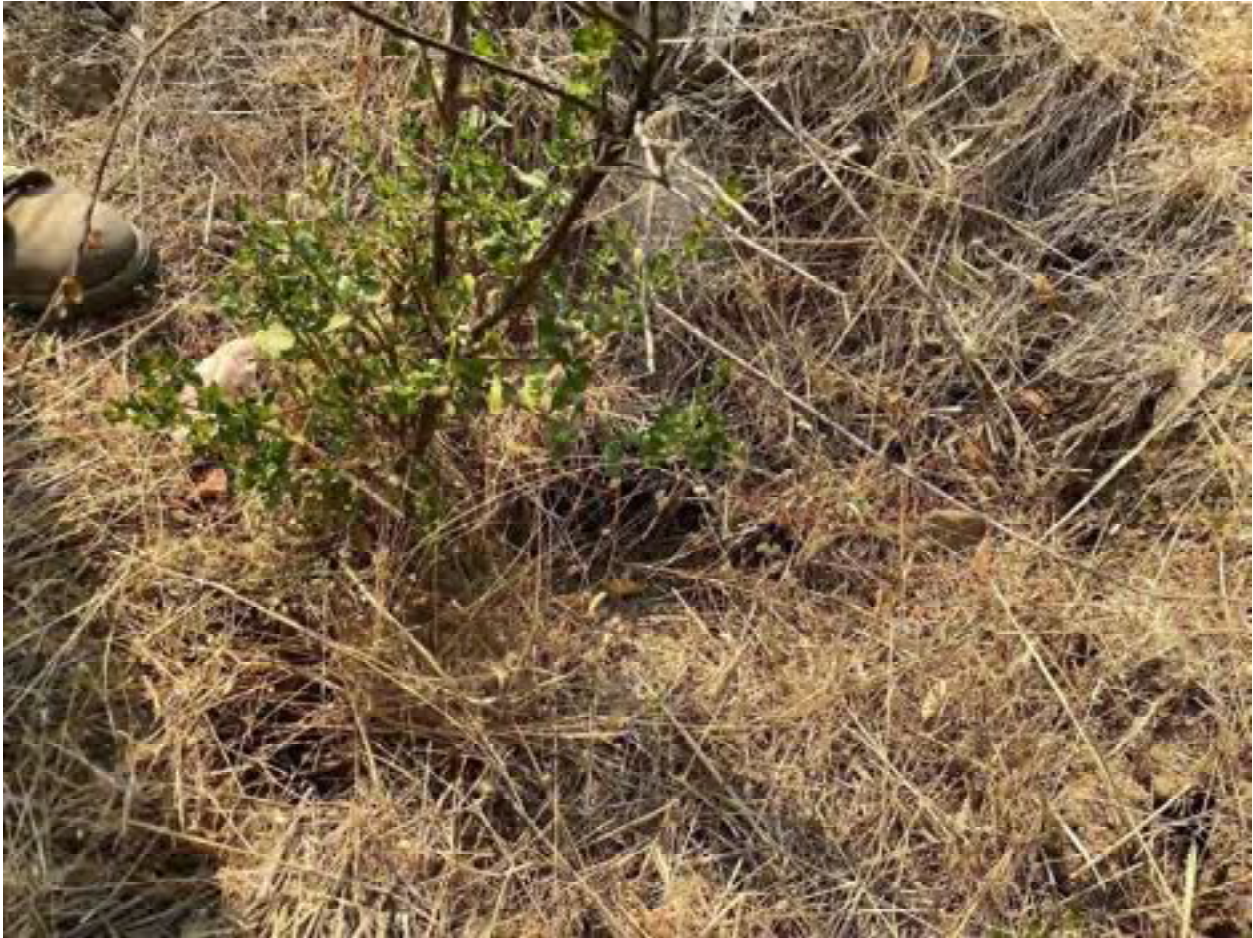
**Photo 30:** Stream Crossing 08. Looking downstream towards the inlet of the 8-inch diameter culvert at stream crossing 08. Photo date 9-1-2021.

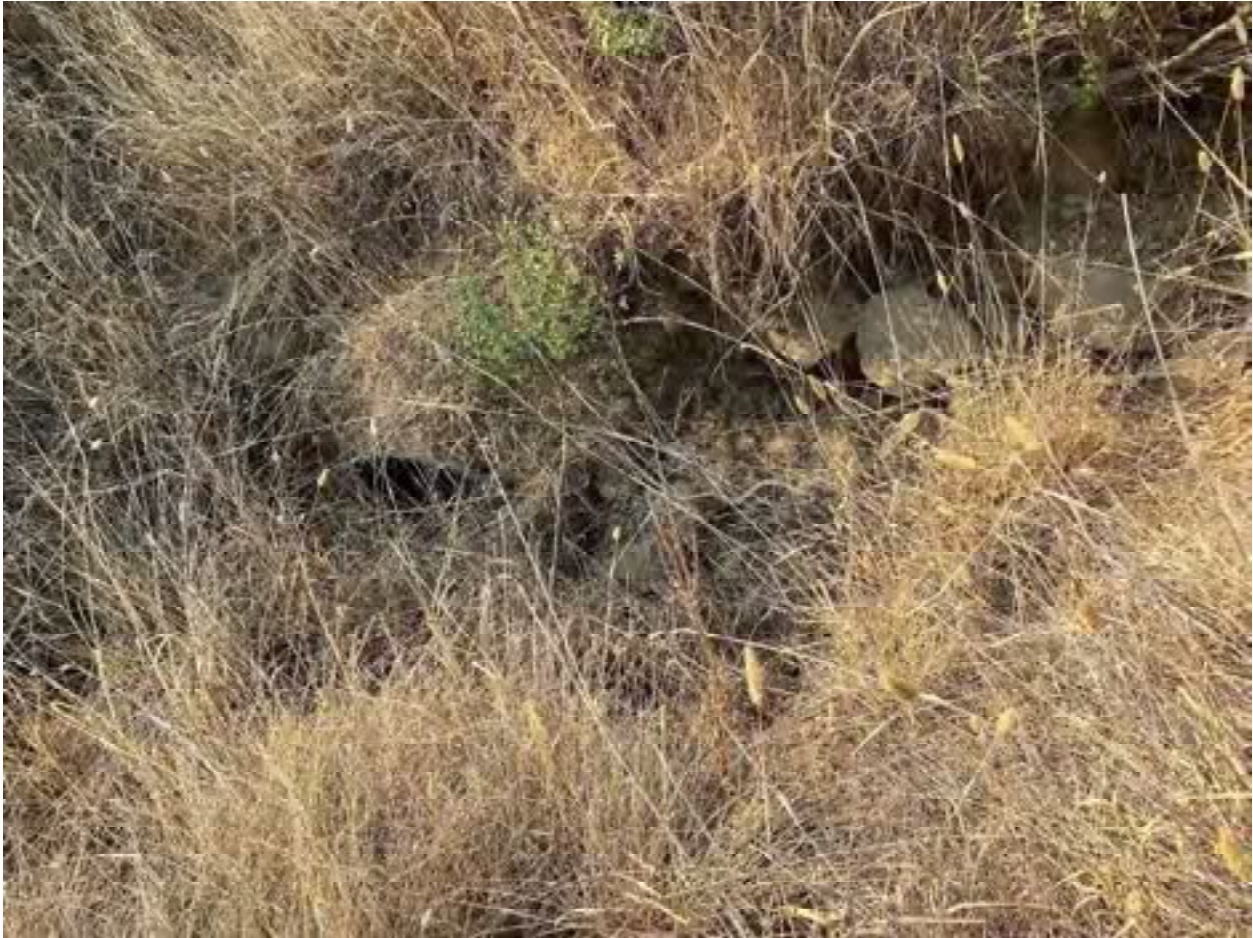
**Photo 35:** Stream Crossing 11. Looking downstream towards the inlet of the 24-inch diameter culvert at stream crossing 11. Photo date 9-1-2021.

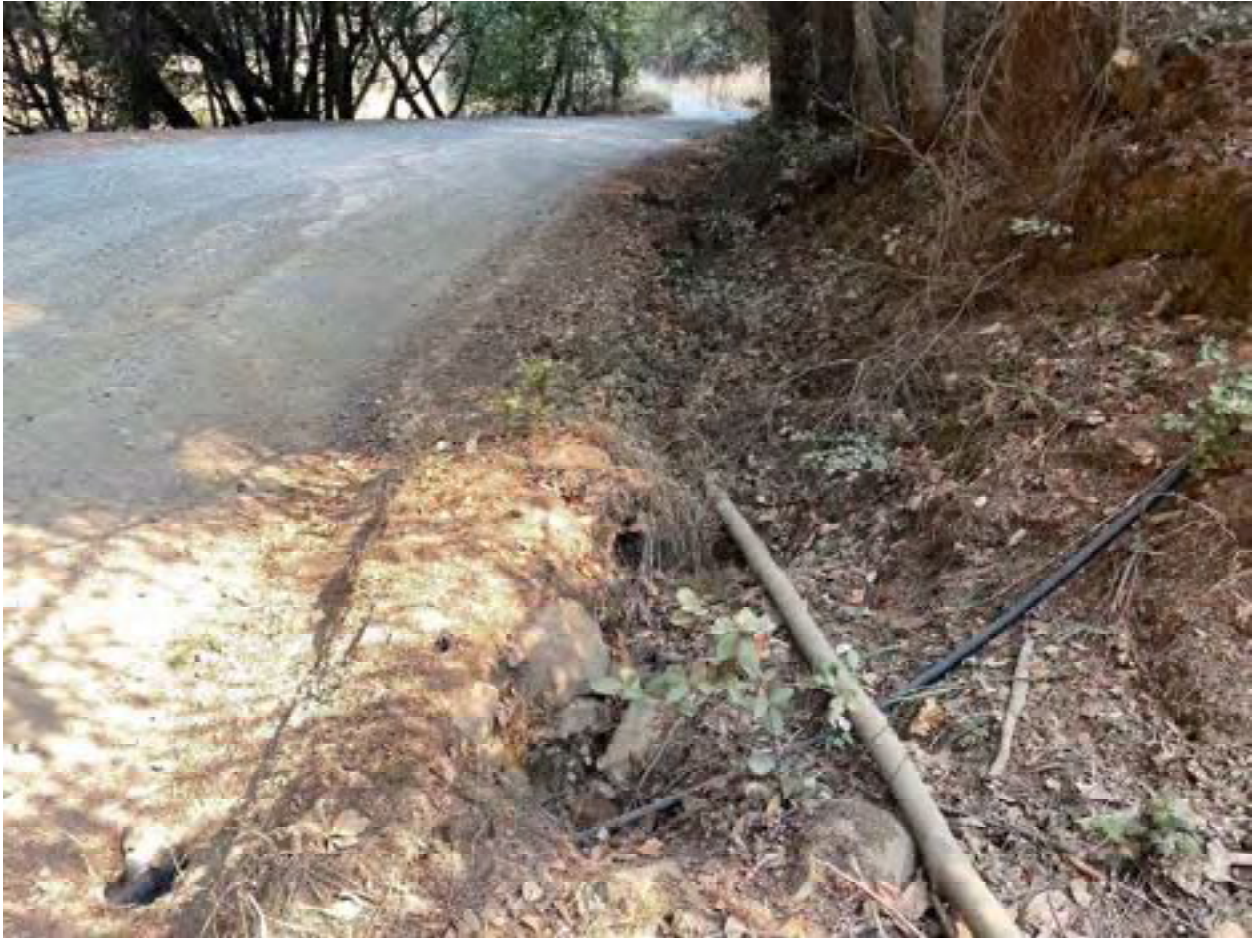
**Photo 44:** Stream Crossing 13. Looking upslope from the inlet of the DRC along the inside ditch that is currently diverting the flow away from the native stream channel at stream crossing 13. Photo date 9-1-2021.

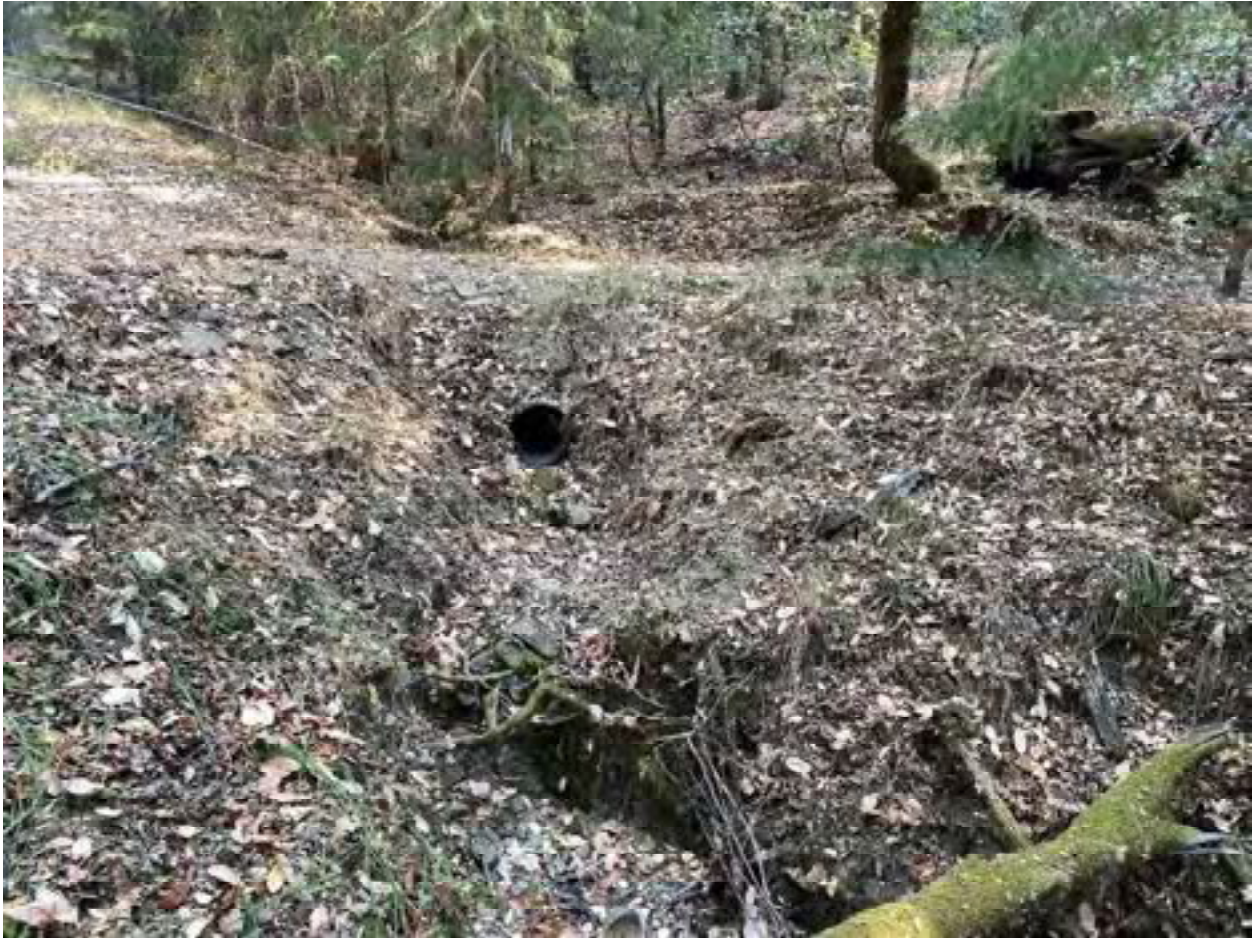
**Photo 50:** Stream Crossing 17. Looking upstream towards the outlet of the 18-inch diameter culvert at stream crossing 17 that is proposed for removal. Photo date 9-1-2021.

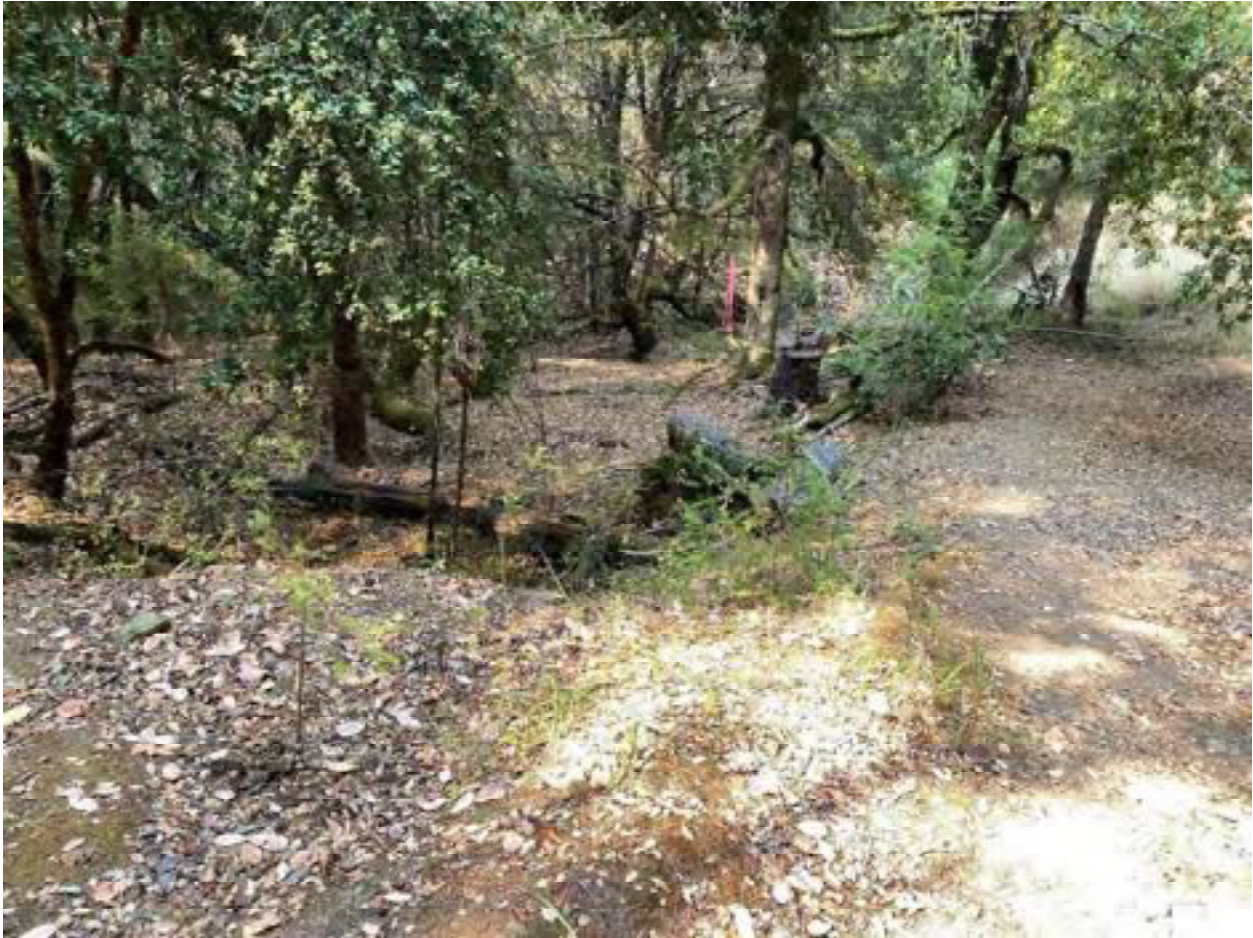
**Photo 57:** Stream Crossing 19. Looking downstream from the road. The pink flag indicates where the native stream channel is and where the stream will be realigned to once stream crossing 19 is decommissioned. Photo date 9-1-2021.

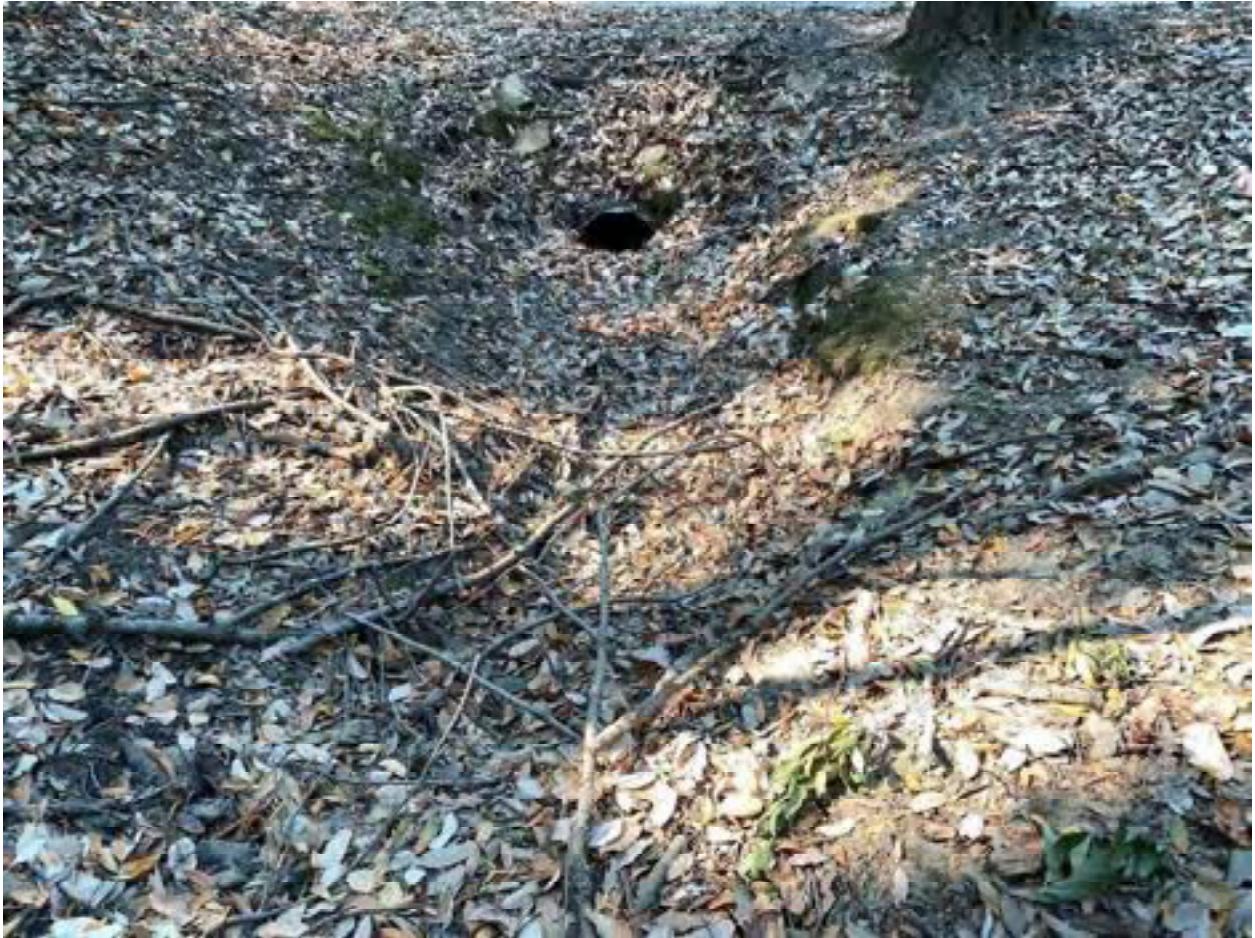
**Photo 58:** Stream Crossing 23. Looking downstream towards the inlet of the double barreled 18-inch and clogged 12-inch diameter culvert at stream crossing 23. Photo date 9-1-2021.

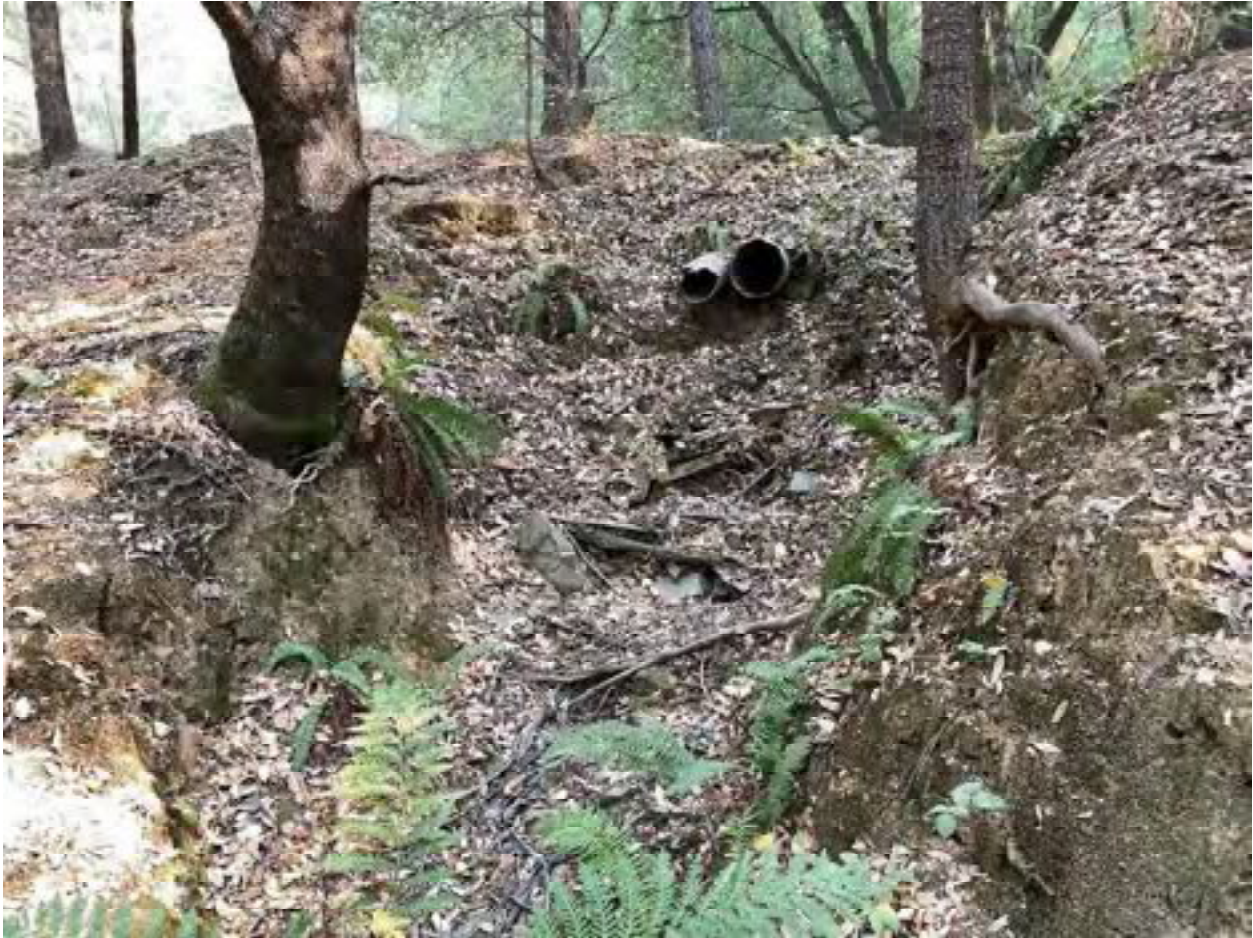
**Photo 61:** Stream Crossing 23. Looking upstream towards the outlet of the double barreled 18-inch and clogged 12-inch diameter culvert at stream crossing 23. Photo date 9-1-2021.
