12569
Report of Unauthorized Timberland Conversion Inspection and Recommendations

16533 Cobb Rd, Dinsmore, CA

Humboldt County APN 208-341-021

Date of inspection: 12/28/2017; by Merritt Lindgren RPF #2522 and Natural Resources Management field technician Aaron Katz. No one else was present.

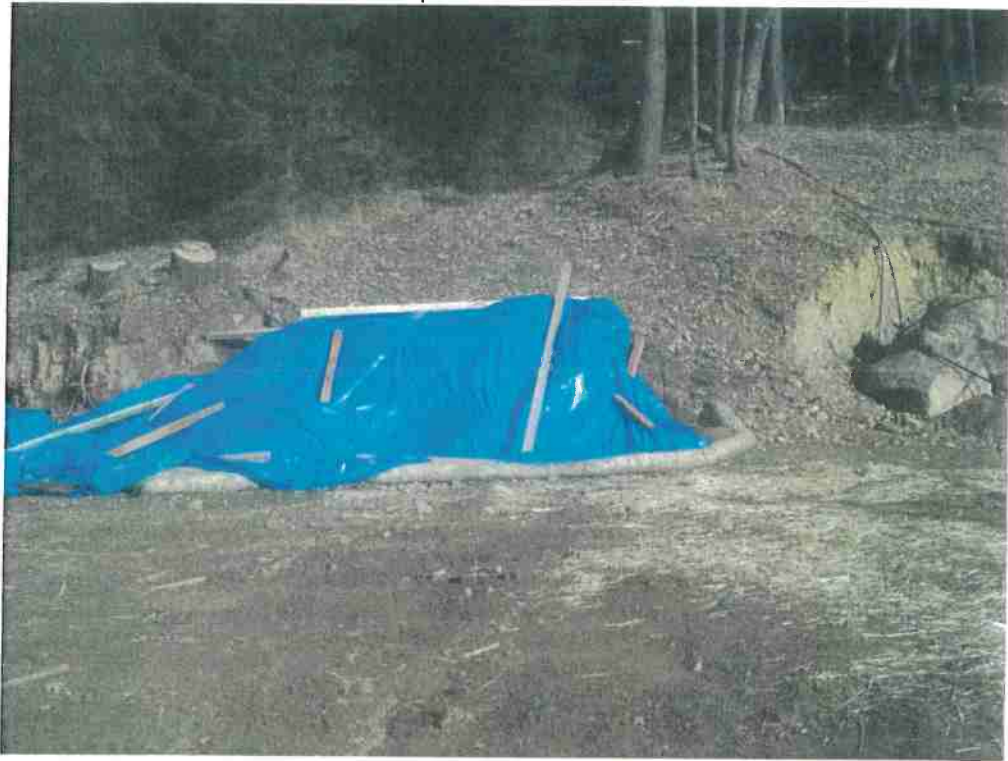
grow soil were tarped and straw wattled (see figure 1.). Cut bank failures have occurred on the banks of each terrace and the lower fill slope is also starting to fail. It does not appear that these failures are currently contributing sediment to any watercourse. Although portions of the upper cut bank have gentler slopes and has started to revegetate, there is a 40 foot wide bank failure on its northwestern side (see figure 2.). The landowner has started to stabilize this failure by placing large rocks along its base (see figures 2 & 3.). The cut bank of the lower terrace is nearly vertical and is starting to fail (see figure 4.). The fill slope on the downhill side of the lower terrace has been recently constructed and includes a car and large pieces of wood (see figure 6). It is also starting to fail (see figure 5).

Figure 1.
Tarped soil and mulch

8. Remove the car and larger pieces of wood from the fill slope on the downhill side of the lower terrace and leave it at a 1:1 slope (45°).
9. Mulch and seed all of the exposed soils on the cut and fill slopes.

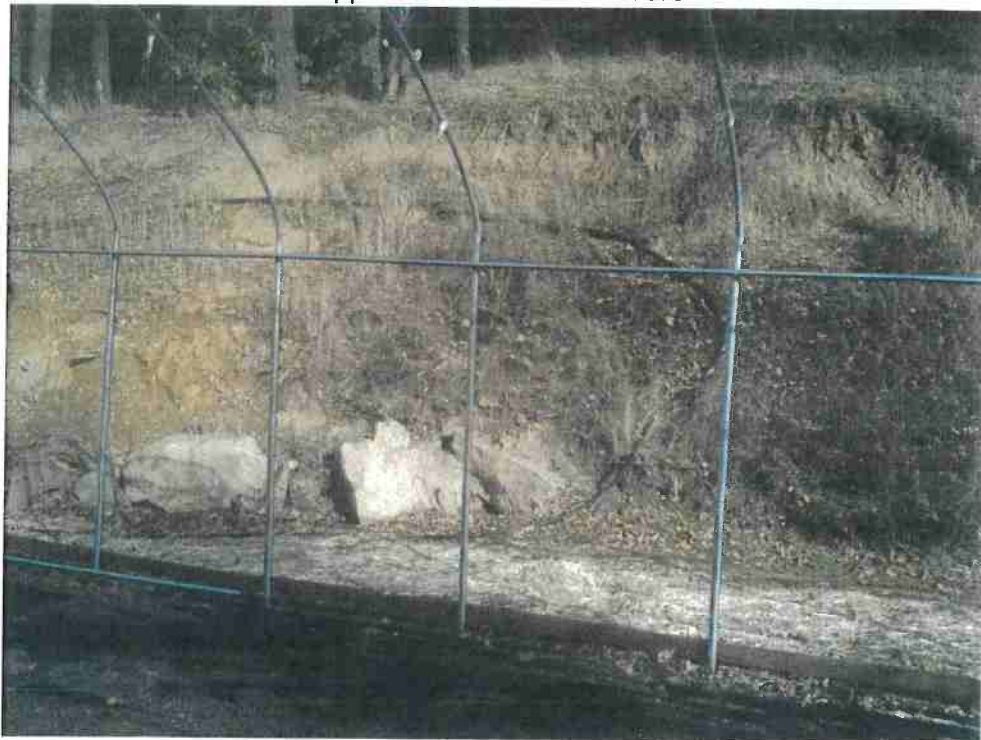
Figure 2
Upper terrace Cut Bank Failure

6. Stabilize the cutbank failure on the northwest side of the upper terrace by adding more rock along its base.
7. Reslope the lower terrace cutbank to a 1:1 slope (45°) or improve the angle of the slope and line the bottom of it with large rocks.

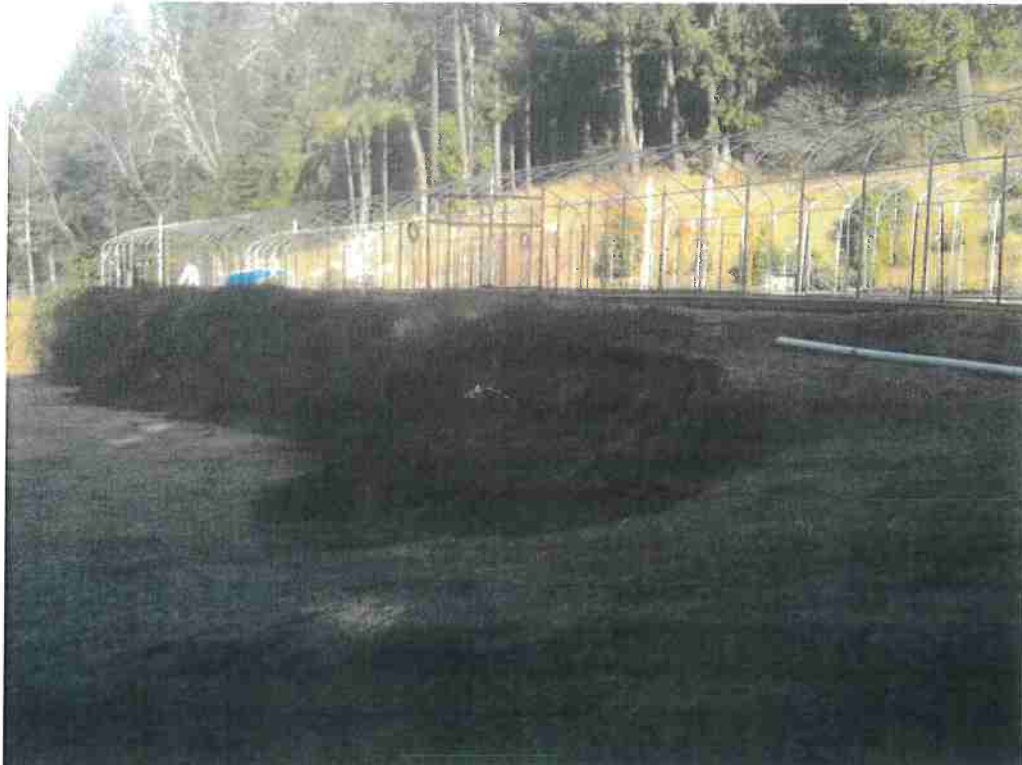
Figure 4
Lower Terrace Cut Bank Failure

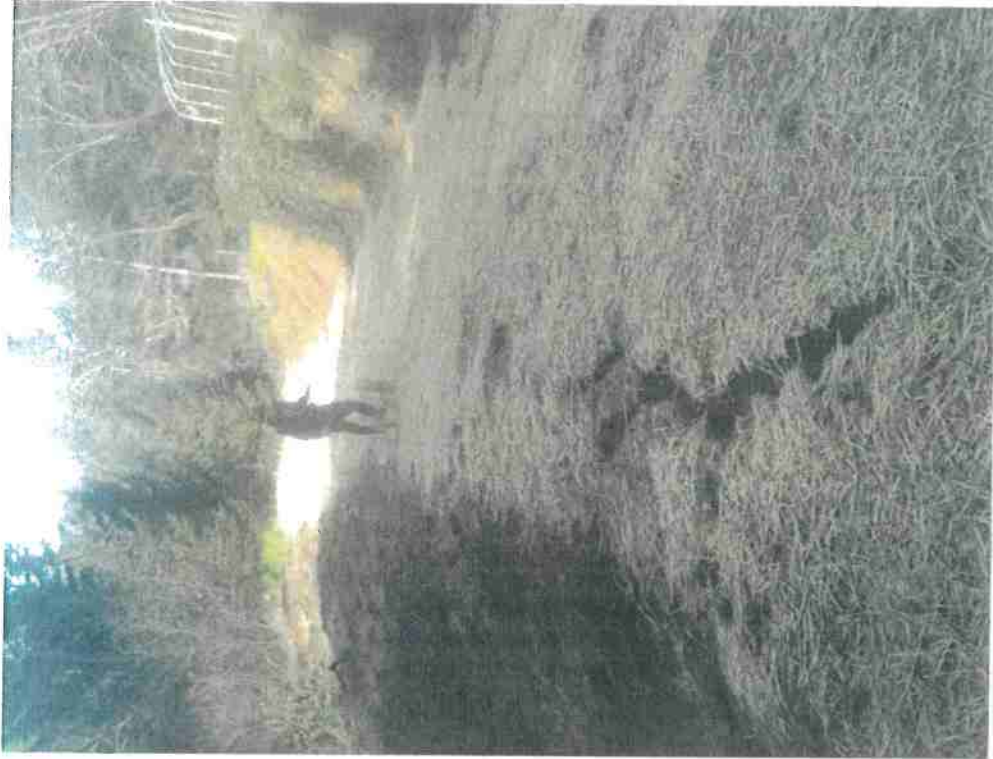
Figure 5
Lower Terrace Fill Failure
