Brunelle & Clark Consulting, LLC

December 26, 2018

1800320

Re: Limited Asbestos Survey & Representative Paint Sampling for ADA Renovations, Humboldt County Coroner's Office, 720 Wood Street, Eureka, CA.

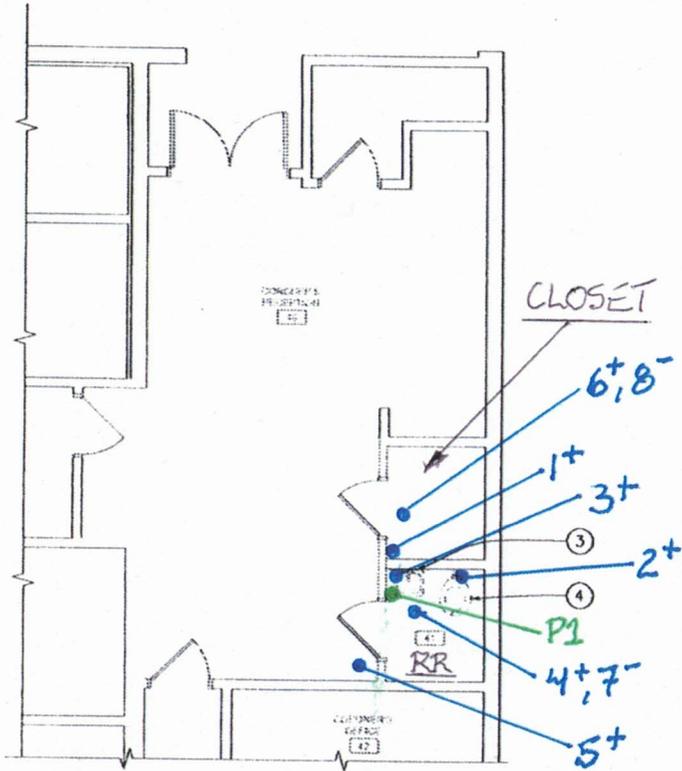
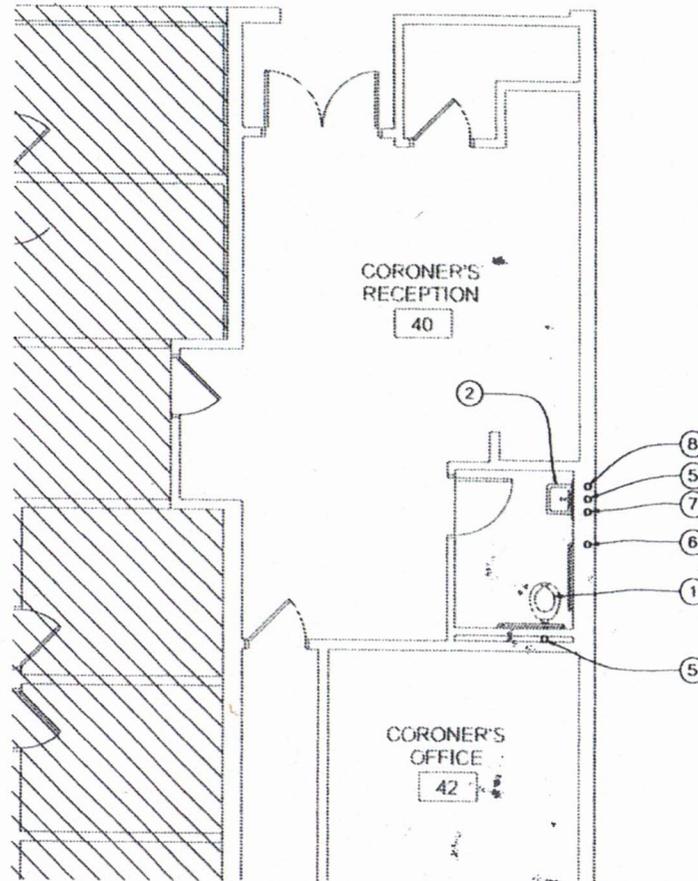
One (1) representative paint chip sample was collected from the drywall in the restroom. The sample location is shown on attached Figure 3. The sample was submitted to an accredited laboratory for the analysis of lead content. The result is summarized in the attached Table 3.

The sample was found to contain 340 ppm lead and is categorized as LCSC.

INTERIOR SAMPLE LOCATIONS

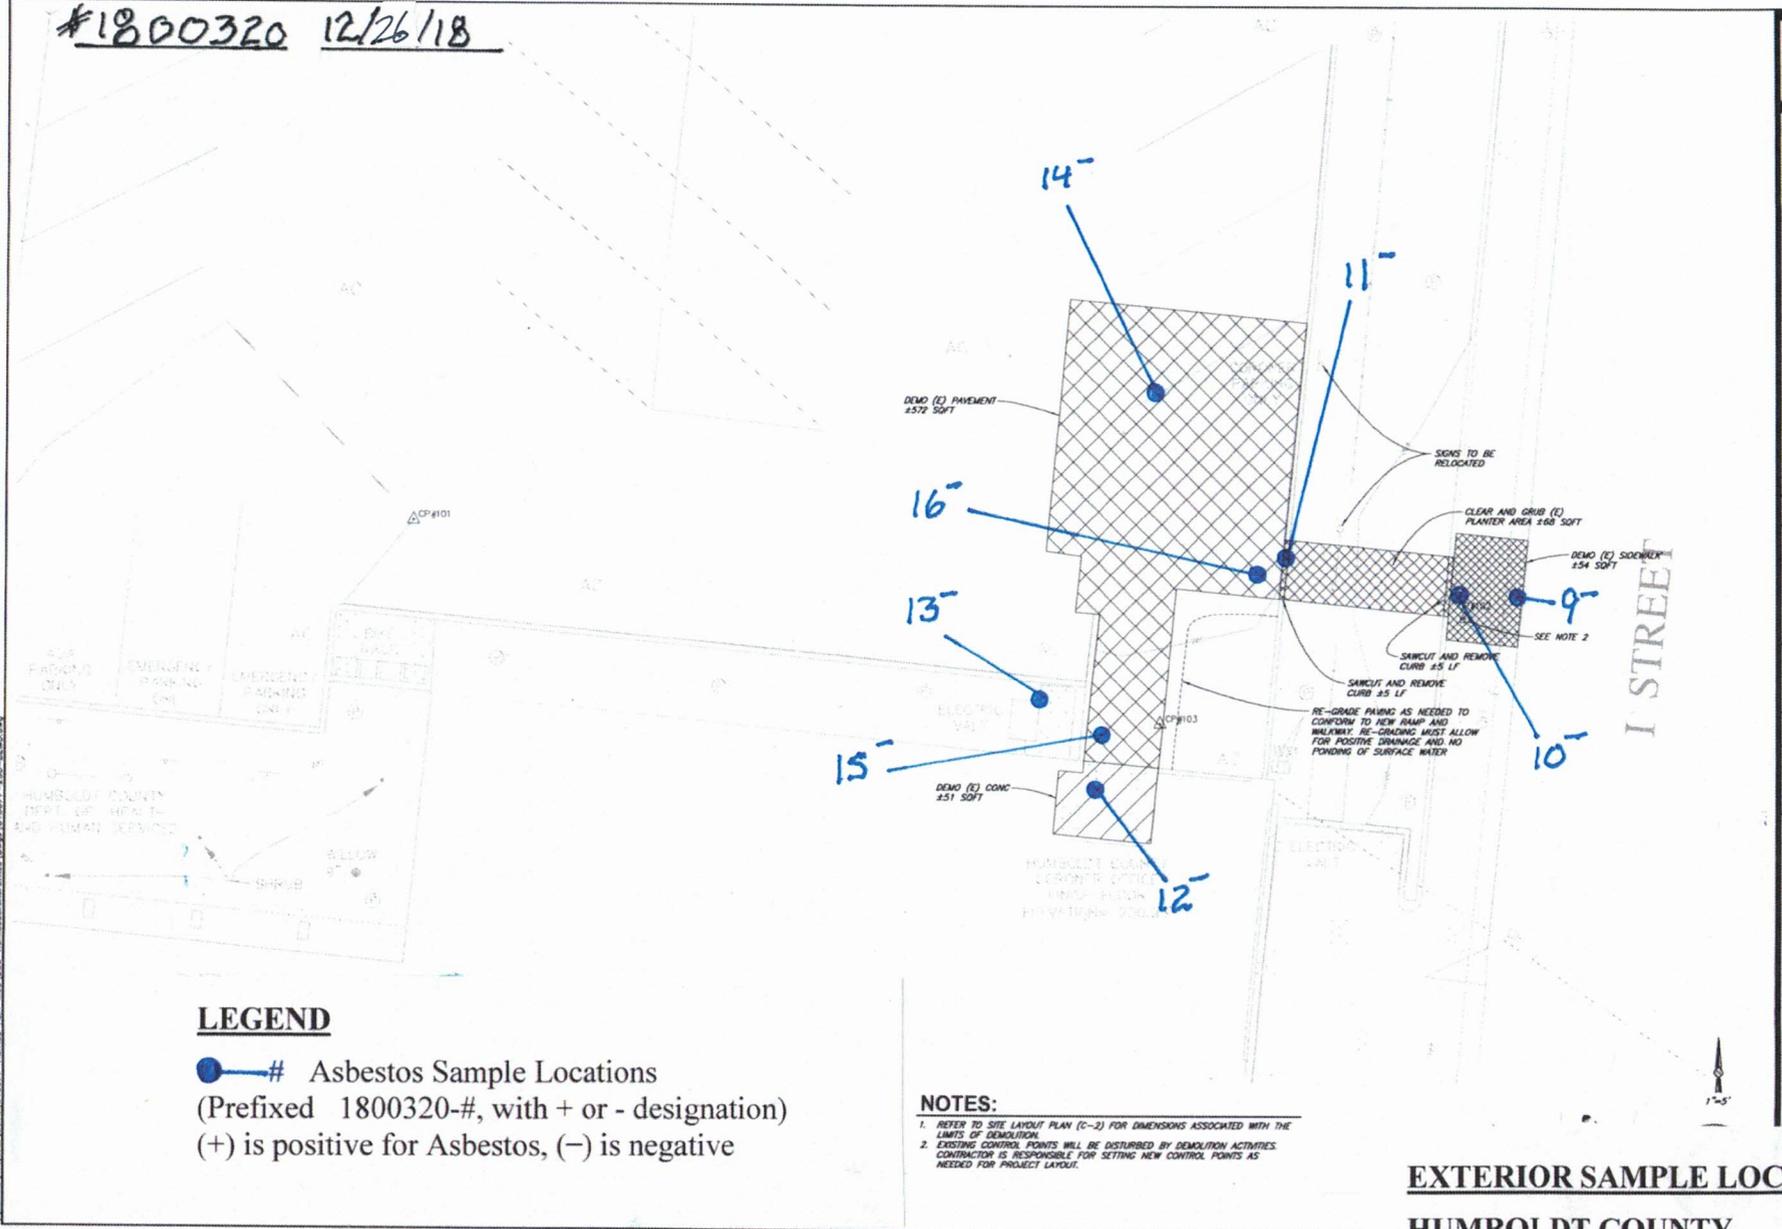
FIG. 4

EXTERIOR SAMPLE LOCATIONS

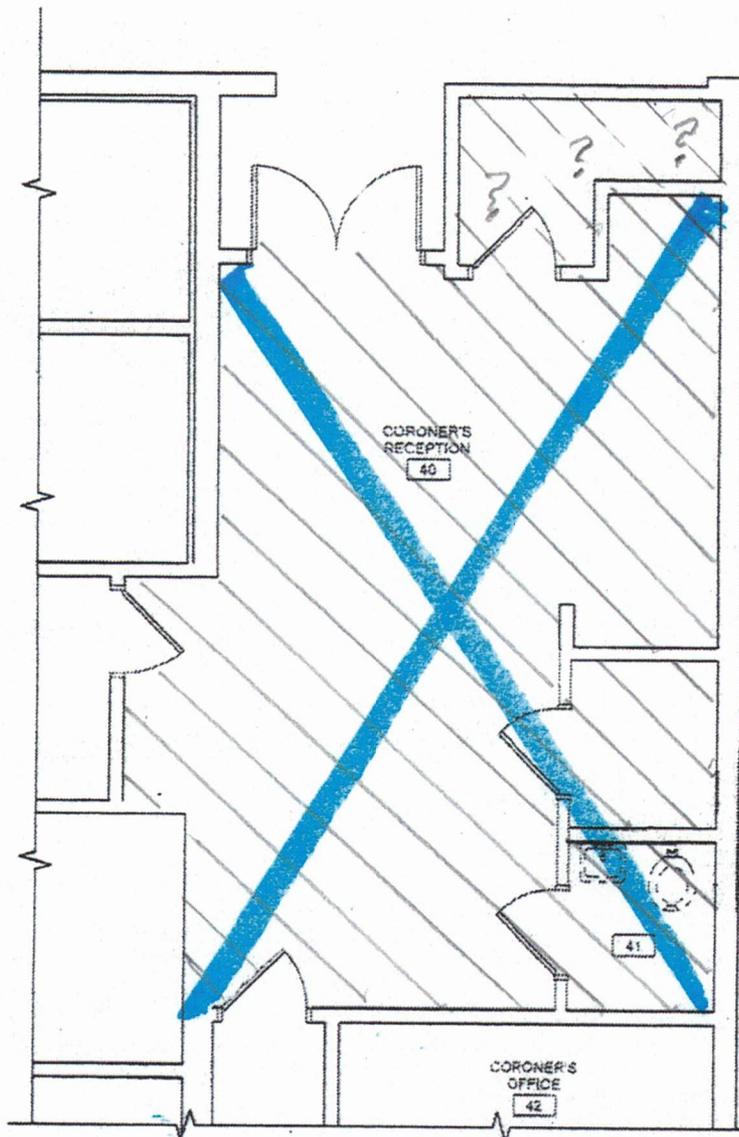
FIG. 5

The locations of the ACCM are shown on attached Figure 5. See attached Table 2 for quantities, agency categorizations, abatement and disposal requirements.

ACCM joint compound/gypsum board drywall
-

ACCM flooring mastic, black & brown and brown only, on concrete substrate and as contaminant on sheet flooring

PACM: Possible ACM TSI on piping behind walls & ceilings, must "soft" demo to locate if present.

ACCM Joint Compound/Drywall: The drywall joint compound found in the project areas contains asbestos. Two samples of joint compound were re-submitted for accurate determination of actual asbestos content by 400 Point Count analysis and were found to contain <1% asbestos. Therefore, the drywall is defined as ACCM. While the ACCM designation excludes this material from regulation under NESHAP, Cal/OSHA requires Class II methods for abatement/disturbance of the ACCM drywall materials by a licensed asbestos abatement contractor. *It is recommended herein to augment the standard Class II abatement with negative air containment of the abatement area.*

ACCM Flooring Mastic: The dark flooring mastic found on the concrete slab floor under sheet flooring and as a contaminant on the sheet flooring contains asbestos. The sheet flooring material itself is otherwise non-detect for asbestos. A mastic sample was re-submitted for accurate determination of actual asbestos content by 400 Point Count analysis and was found to contain <1% asbestos. Therefore, the flooring mastic is defined as ACCM. While the ACCM designation excludes this material from regulation under NESHAP, Cal/OSHA requires Class II methods for abatement/disturbance of the ACCM drywall materials by a licensed asbestos abatement contractor. *It is recommended herein to augment the standard Class II abatement with negative air containment of the abatement area.*

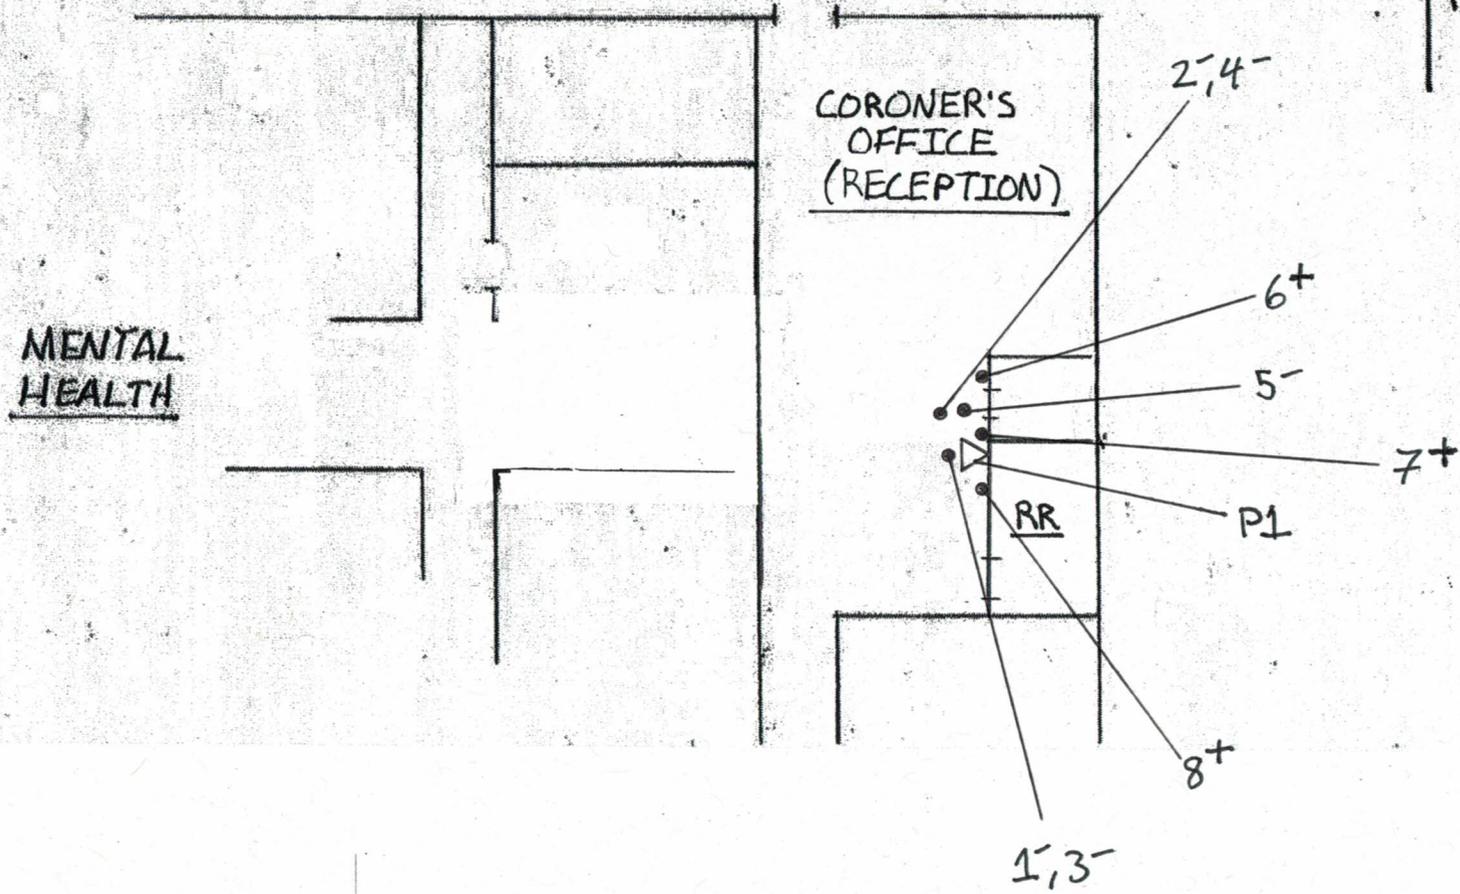
FIG. 1

The drywall joint compound material was found to contain <1% asbestos by the 400 Point Count analysis above and is categorized as ACCM, as listed below:

ACCM Joint Compound/Drywall: The drywall joint compound found above the ceiling tile in the reception area contains asbestos. One sample of joint compound was re-submitted for accurate determinations of actual asbestos content by 400 Point Count analyses, and was found to contain <1% asbestos. Therefore, the drywall is defined as ACCM. While the ACCM designation excludes this material from regulation under NESHAP, Cal/OSHA requires Class II methods for abatement/disturbance of the ACCM drywall materials by a licensed asbestos abatement contractor. *It is recommended herein to augment the standard Class II abatement with negative air containment of the abatement area.*
