SZS ENGINEERING ACCESS

RIO DELL LIBRARY

ADA ACCESS COMPLIANCE ASSESSMENT

715 WILDWOOD AVENUE, RIO DELL CA
(COUNTY LEASED FACILITY)

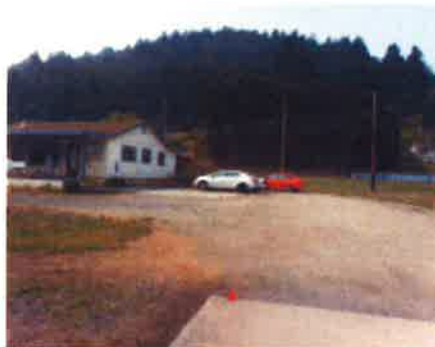
The photo at right illustrates the existing conditions for pedestrians who reach the library. The paved sidewalk ends in a dirt parking lot where the only paved parking stall is the stall identified as van accessible. The stall was constructed directly adjacent to the pedestrian ramp with no accessible route in front of the vehicle space to allow a pedestrian to safely travel from the sidewalk to the ramp past the existing parking stall identified as accessible.

According to state and federal regulations and statutes, people with disabilities cannot be forced to travel behind vehicles that they are not traveling in, as it is an extreme safety risk. The existing design of the paved accessible stall and ramp require alterations to provide an accessible route in front of the vehicle space that connects to the pedestrian ramp.

The ramp was identified with barriers to access and will need to be replaced, including the bottom landing which is located within the accessible stall access aisle, which was identified with a non-compliant slope. Maneuvering space at the intermediate landing was not compliant and guardrails were provided with no handrails. Also, the guardrail footings created an abrupt change in level at each post support.
