DRAFT REVIEW FOR REVIEW ONLY- Updated

Subject: 12-201, Town Of Samoa, Contributing Outbuilding Study

The following are my assessments and recommendations for each of the 11 Contributing Outbuildings.

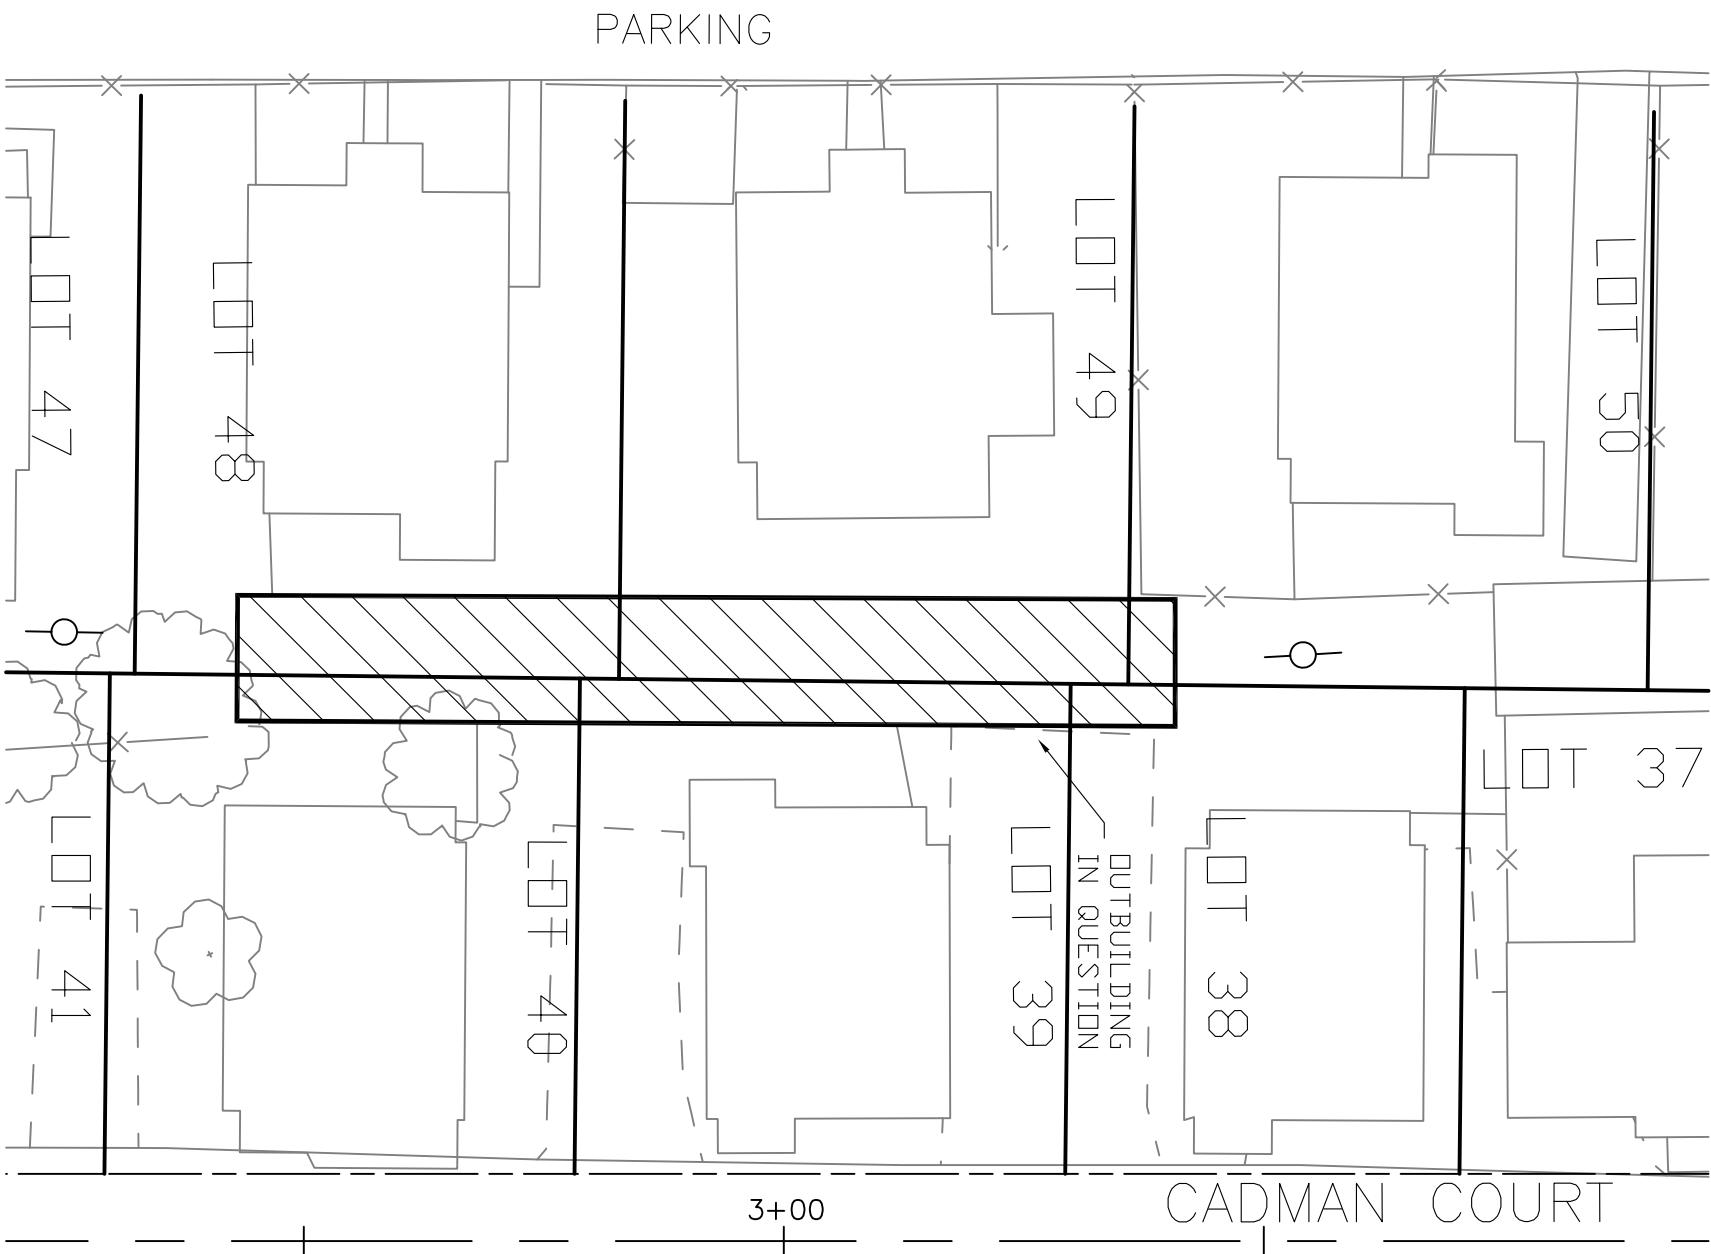
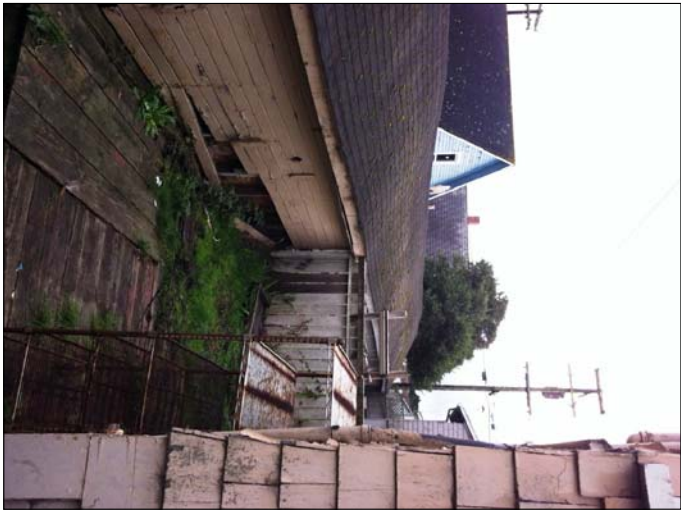
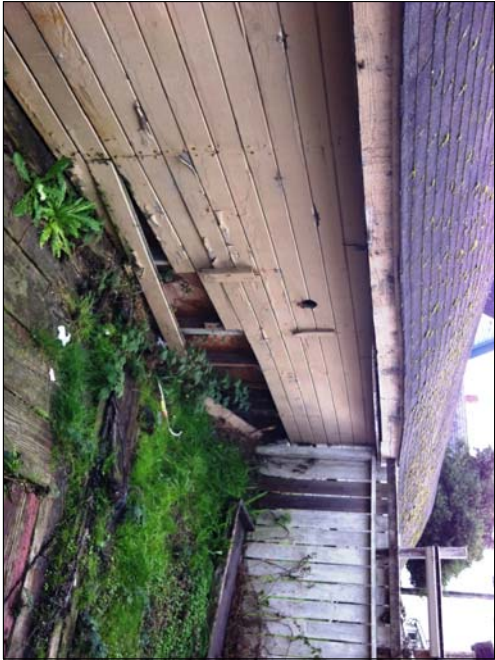
CONTRIBUTING BUILDINGS
ASSESSMENT
LOTS 38,39,40,48,49,50
SAMDA, CALIFORNIA

This building is of wood frame construction, it has a wooden post and pier block foundation, horizontal tongue & groove wood siding, and shingle roof. The building is located on six different lots and is approximately 98 feet long by 13 feet wide. Its condition shows advanced deterioration; the roof has moss growing on it, and appears to be failing due to the broken trusses located inside, evidenced by the sags which can be seen on the outside. The roofing system has significant areas of structural failure, and leaks. The building sides have significant structural failure and some of the siding has fallen off. The paint is peeling. The building is not structurally sound in it's current state and by my estimation is beyond it's useful life. I would consider it a hazard. The remaining wood pieces are dilapidated, so that they could not be re-used in the event the building were to be torn down with the intention of reconstruction. My recommendation would be to demolish and remove it due to the impossibility of moving it because of its size. As well, it appears to be near the end of its usable life span due to deterioration.

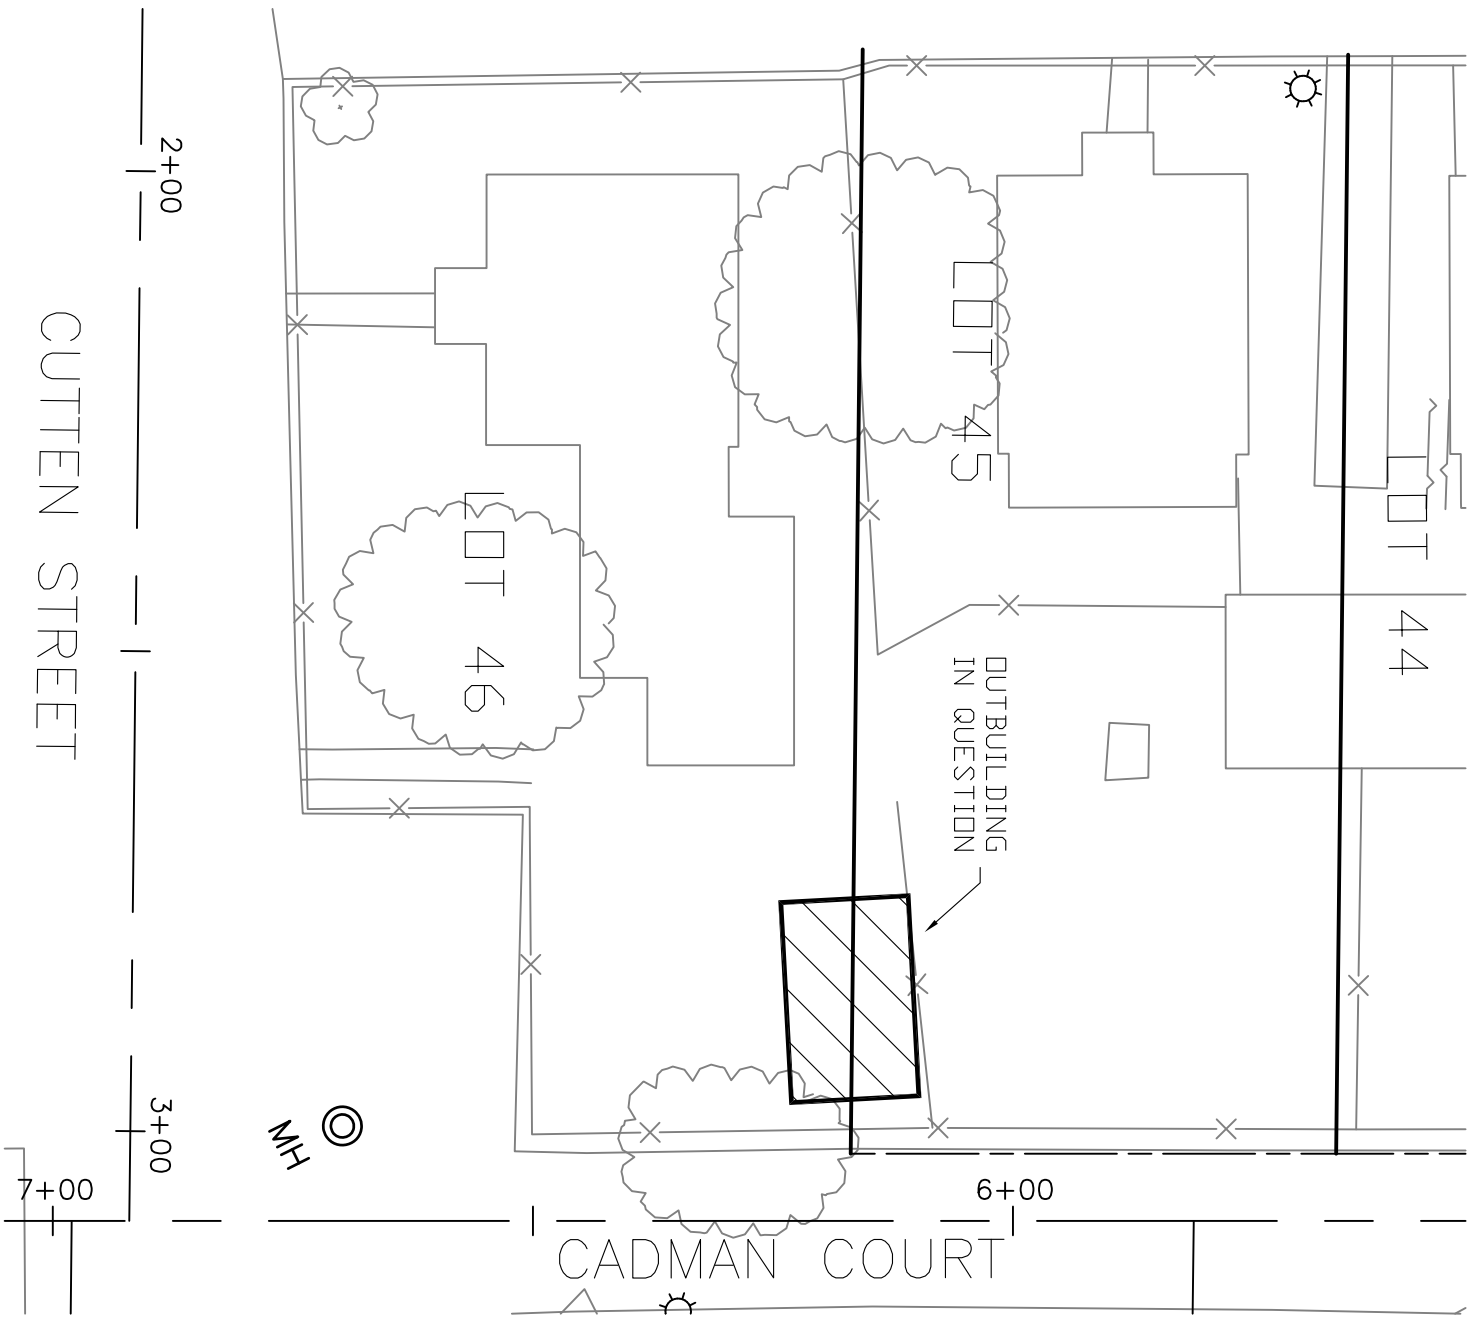
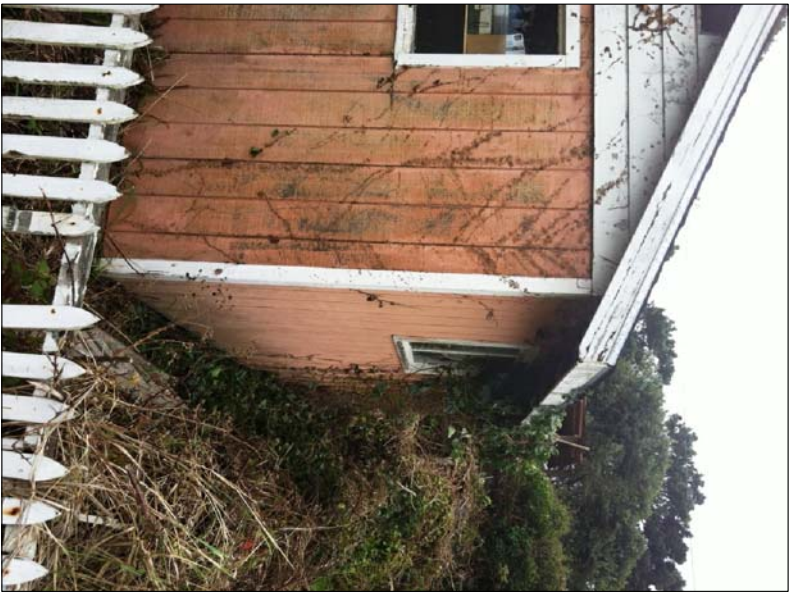
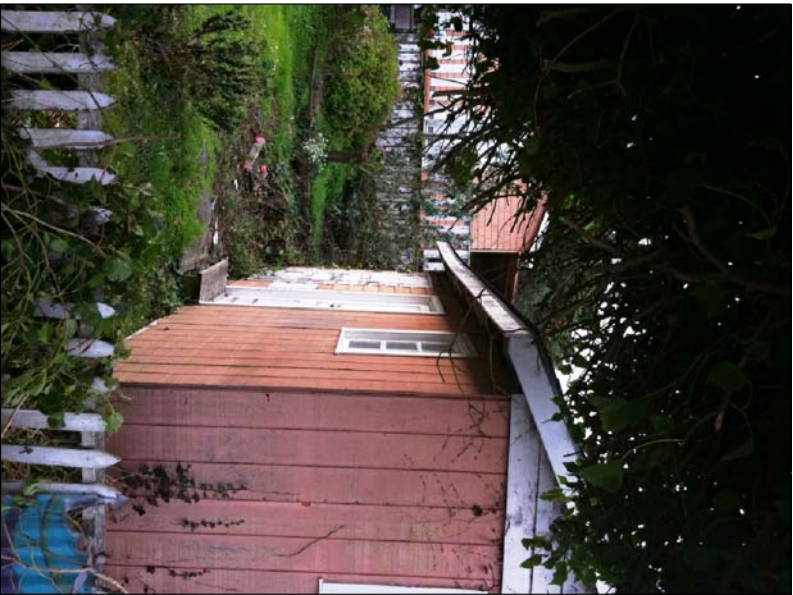
CALIFORNIA ENGINEERING COMPANY, INC.	CONTRIBUTING BUILDINGS ASSESSMENT
1110 CIVIC CENTER BLVD., STE. 404 YUBA CITY, CALIFORNIA 95993 JOB NO. 12-201 DATE: 01/28/13	LOTS 45 & 46 SAMDA, CALIFORNIA
SHEET 2 OF 9	ADDRESS: 2 CUTTEN ST
STRUCTURAL INTEGRITY ASSESSMENT

This building is of wood frame construction, it has a wooden post and pier block foundation, plywood siding, and shingle roof. This building is located on two different lots, and measures approximately 21x13. The structure is in poor condition; the shingles are newer and siding intact, however there is significant dry rot throughout the structure. This building does not appear to be of the same chronological era as many of the other structures located within the town, and it's my assertion that this structure may be of limited or no historical significance. Its my assessment that this building could not be moved, however, even though it's in fair shape, as the floor diaphragm would not be able to hold the building together and upon picking it up, I feel that the building floor will not structurally support the acting downward and lateral forces as would be caused by moving the structure. Due to the wood type and age, it's my assessment that tearing the

building down and placing it in another location is not a viable option. Even though the building appears to be in fair condition, moving or relocating it otherwise would destroy it, so it's my recommendation is that this outbuilding be removed entirely from the site.

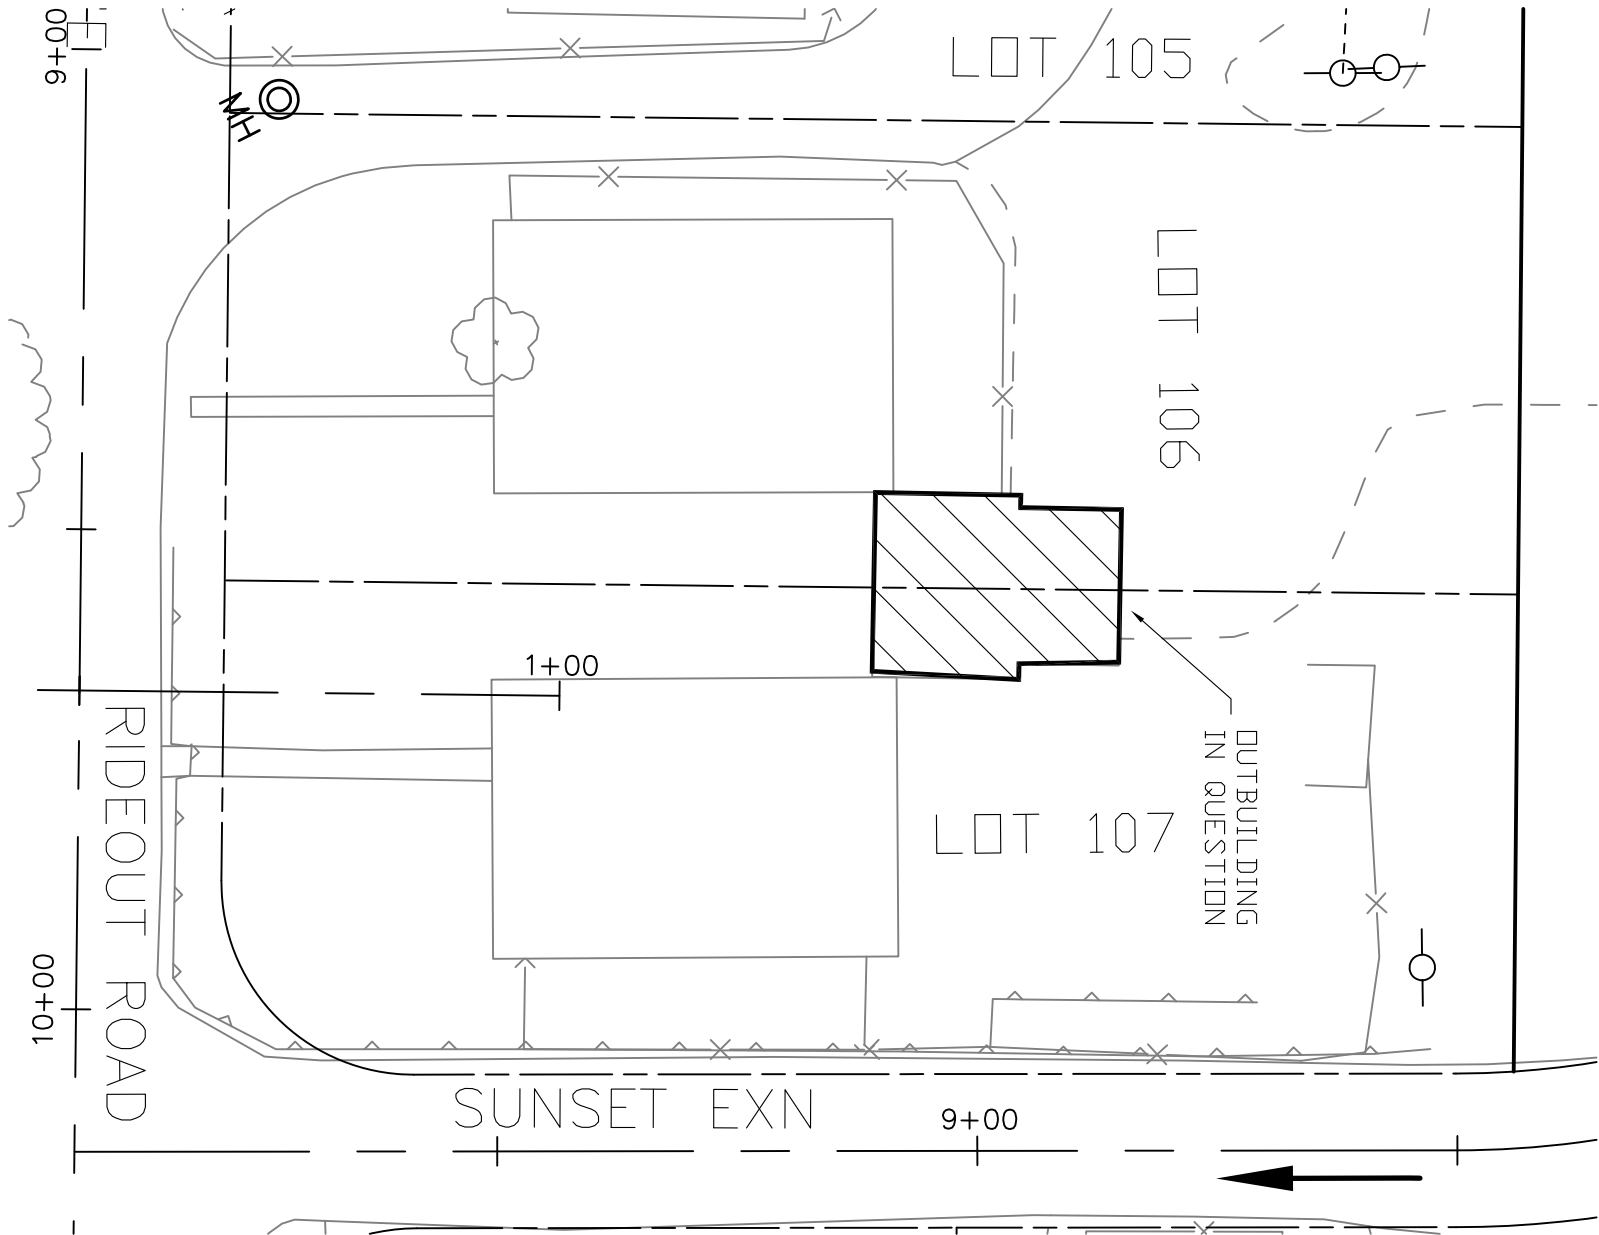
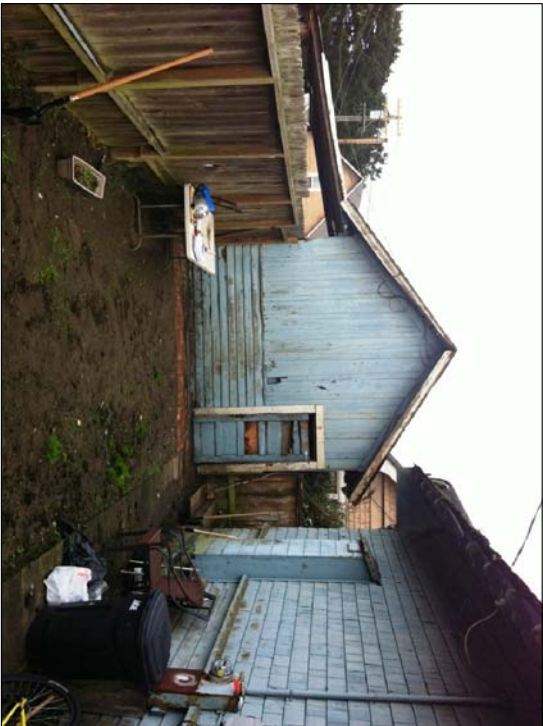
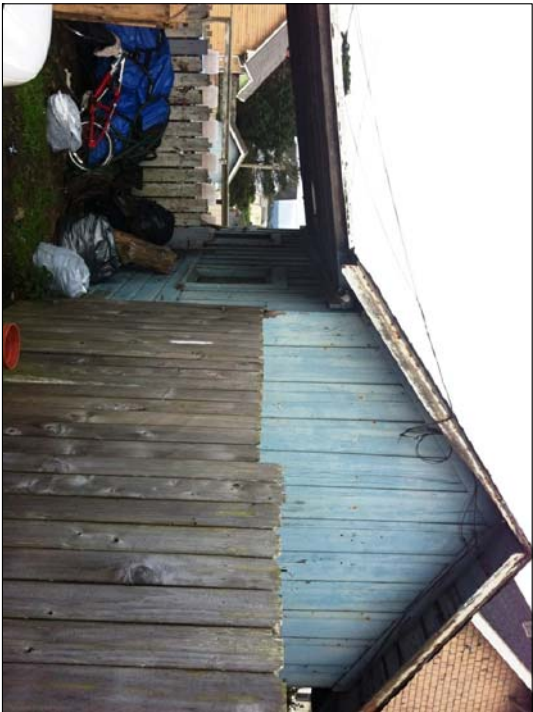
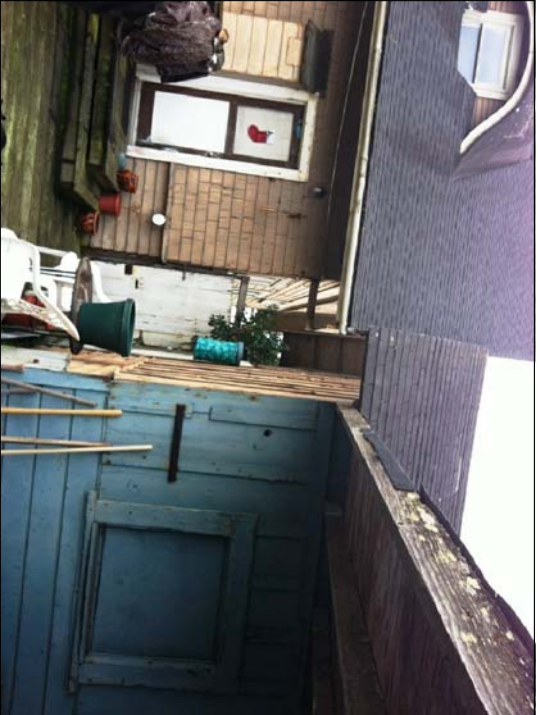
CALIFORNIA ENGINEERING COMPANY, INC.	STRUCTURAL INTEGRITY ASSESSMENT
1110 CIVIC CENTER BLVD., STE. 404 YUBA CITY, CALIFORNIA 95993 JOB NO. 12-201 DATE: 01/28/13	ADDRESS: 110 & 112 RIDECOUT RD
CONTRIBUTING BUILDINGS ASSESSMENT LOTS 106 & 107 SAMOA, CALIFORNIA

This building is of wood frame construction, it has a wooden post and pier block foundation, a combination of vertical board and batten; and horizontal tongue & groove wood siding, and shingle roof. It is located on two lots and is 19x15 with an attached 16x11 attached overhang. The overall condition of the structure is poor. The interior roof trusses show signs of failing and the exterior of the walls are in disrepair. The building is beyond its useful life and would completely fall apart upon attempting to move it. The building materials are extremely poor shape and it would not be a candidate to tear down and reconstruct at another location, because the existing materials would not be useable. I recommend removing this building and the attached awing/overhang.

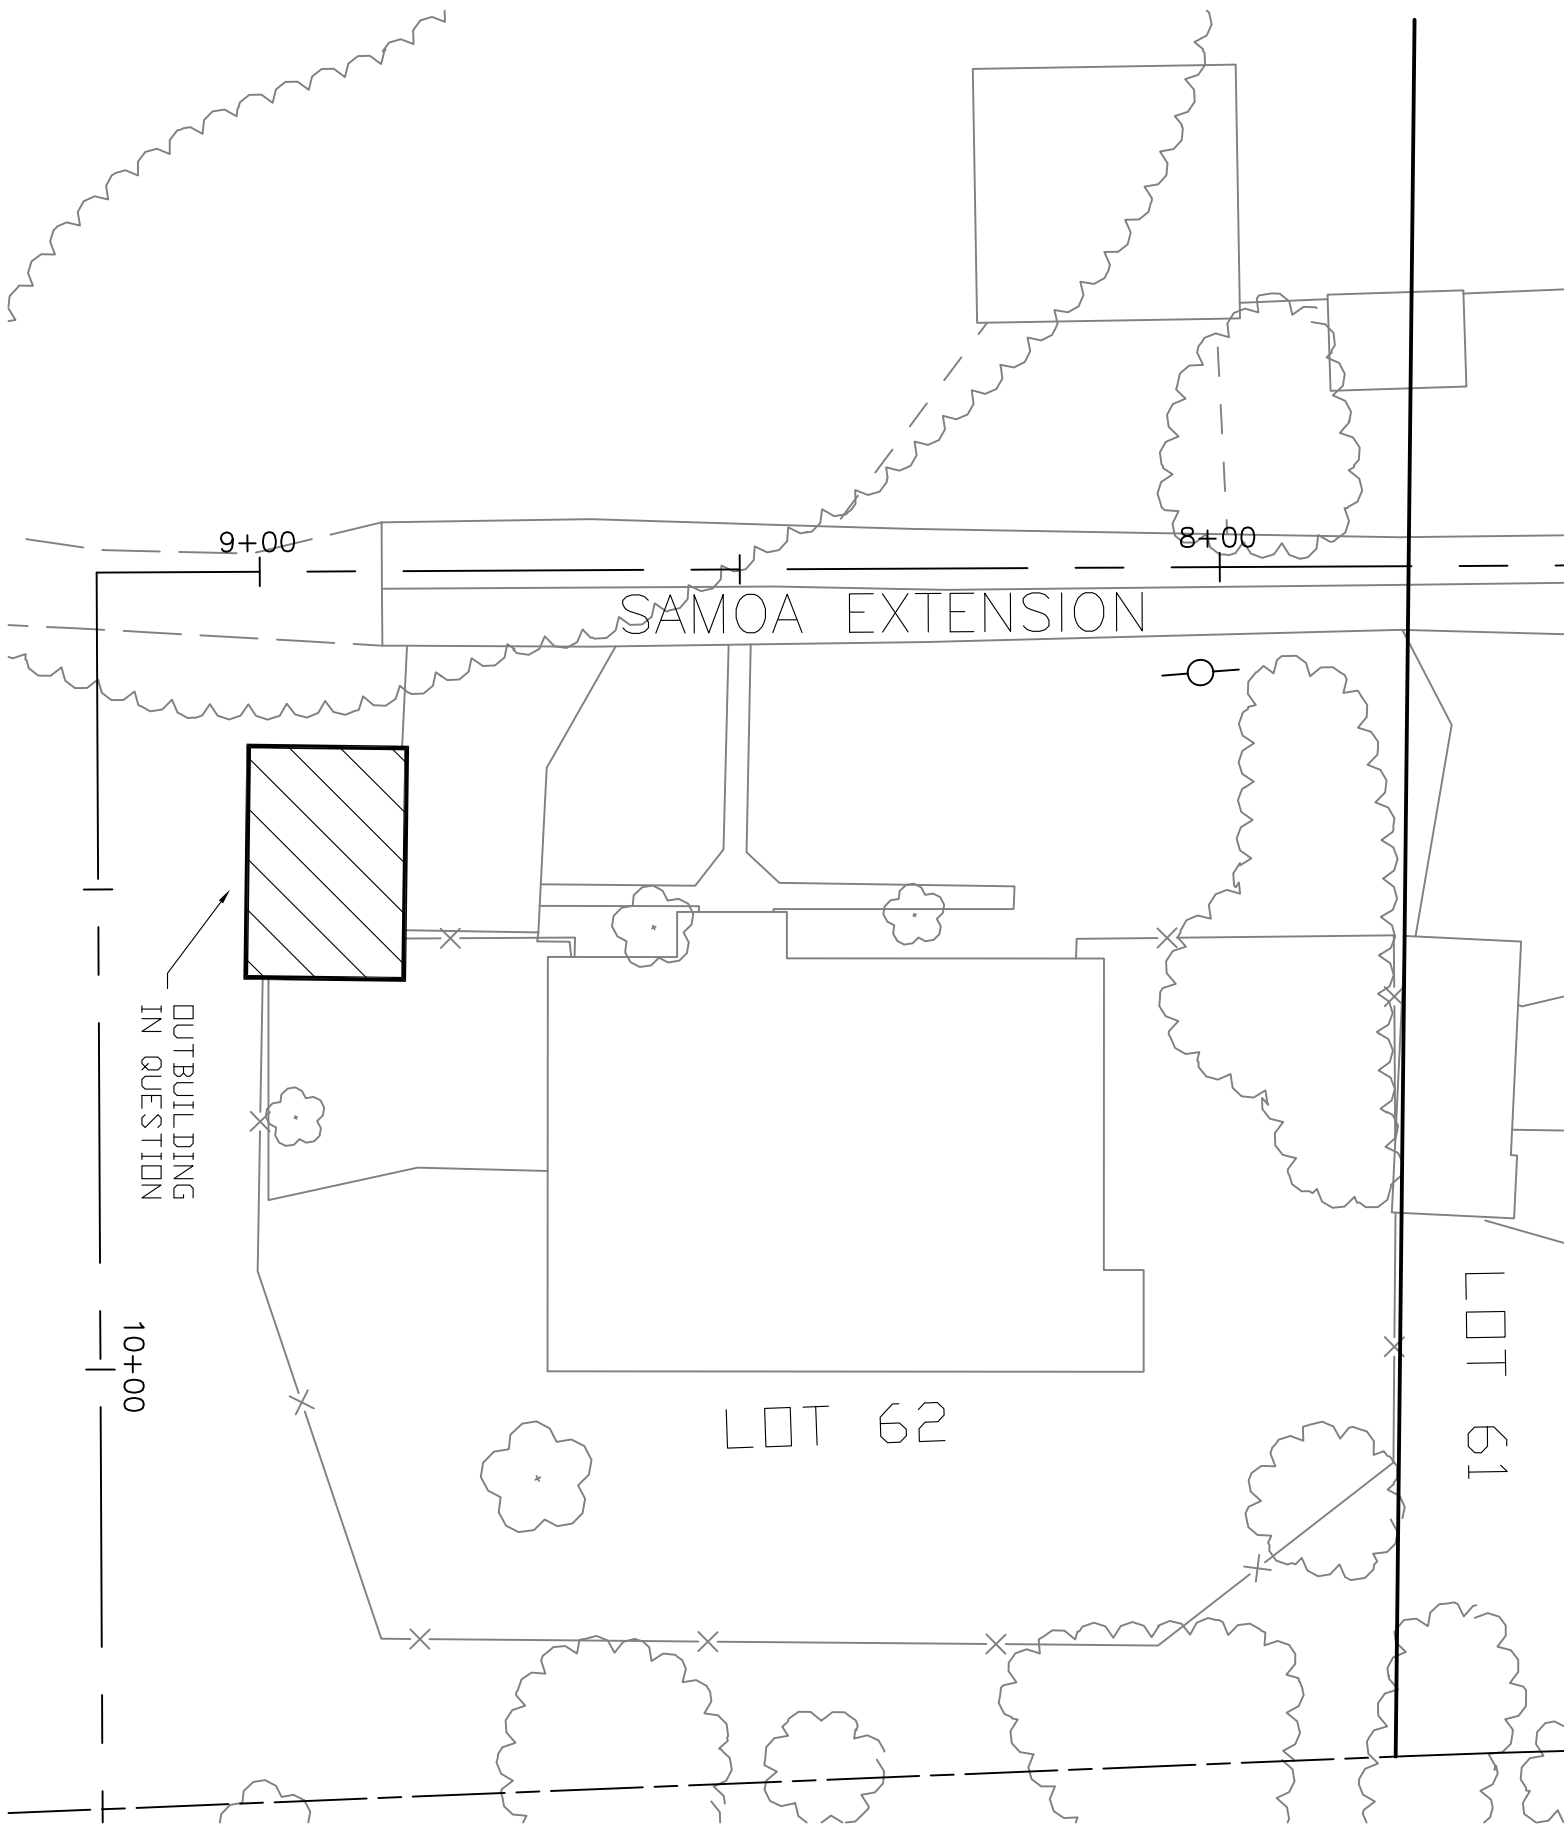
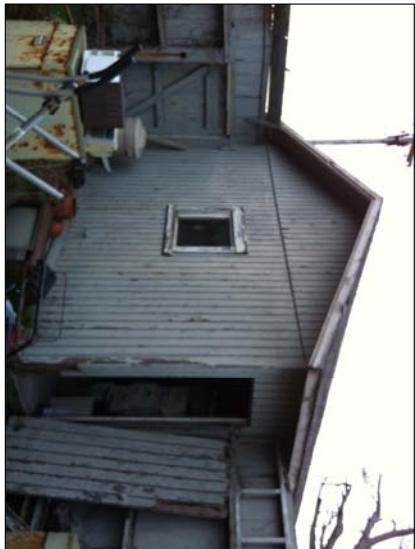
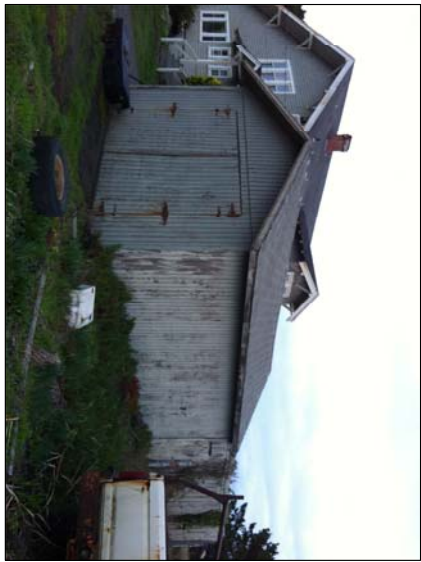
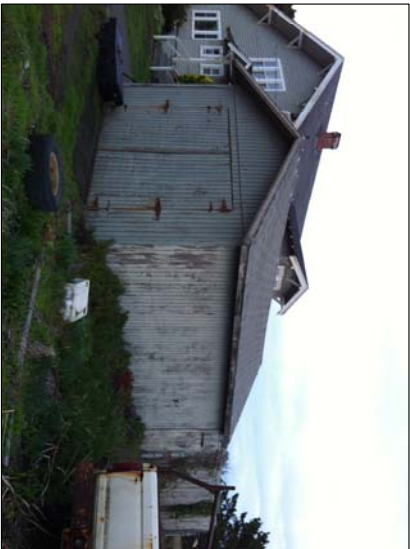
SHEET 4 OF 9

This building is of wood frame construction, it has a wooden post and pier block foundation, wood plank tongue and groove siding, and shingle roof. Located on one lot, the building is approximately 16.5x24 in dimension. It has two large gate-hinge doors so as to allow a vehicle inside. The condition of the roofing is fair/poor. Paint has peeled badly in places. One door has come off. The building otherwise seems structurally sound. This building could not be relocated as it lacks any structural integrity to withstand a move. The existing materials could not be removed and reconstructed elsewhere as they are no longer of structural. This building could be repaired/preserved if addressed in a timely fashion (right away) and new door hinges and roof shingles added. My recommendation would be to preserve the outbuilding due to its moderate amount of remaining lifespan, which could be extended and location on a solitary lot.

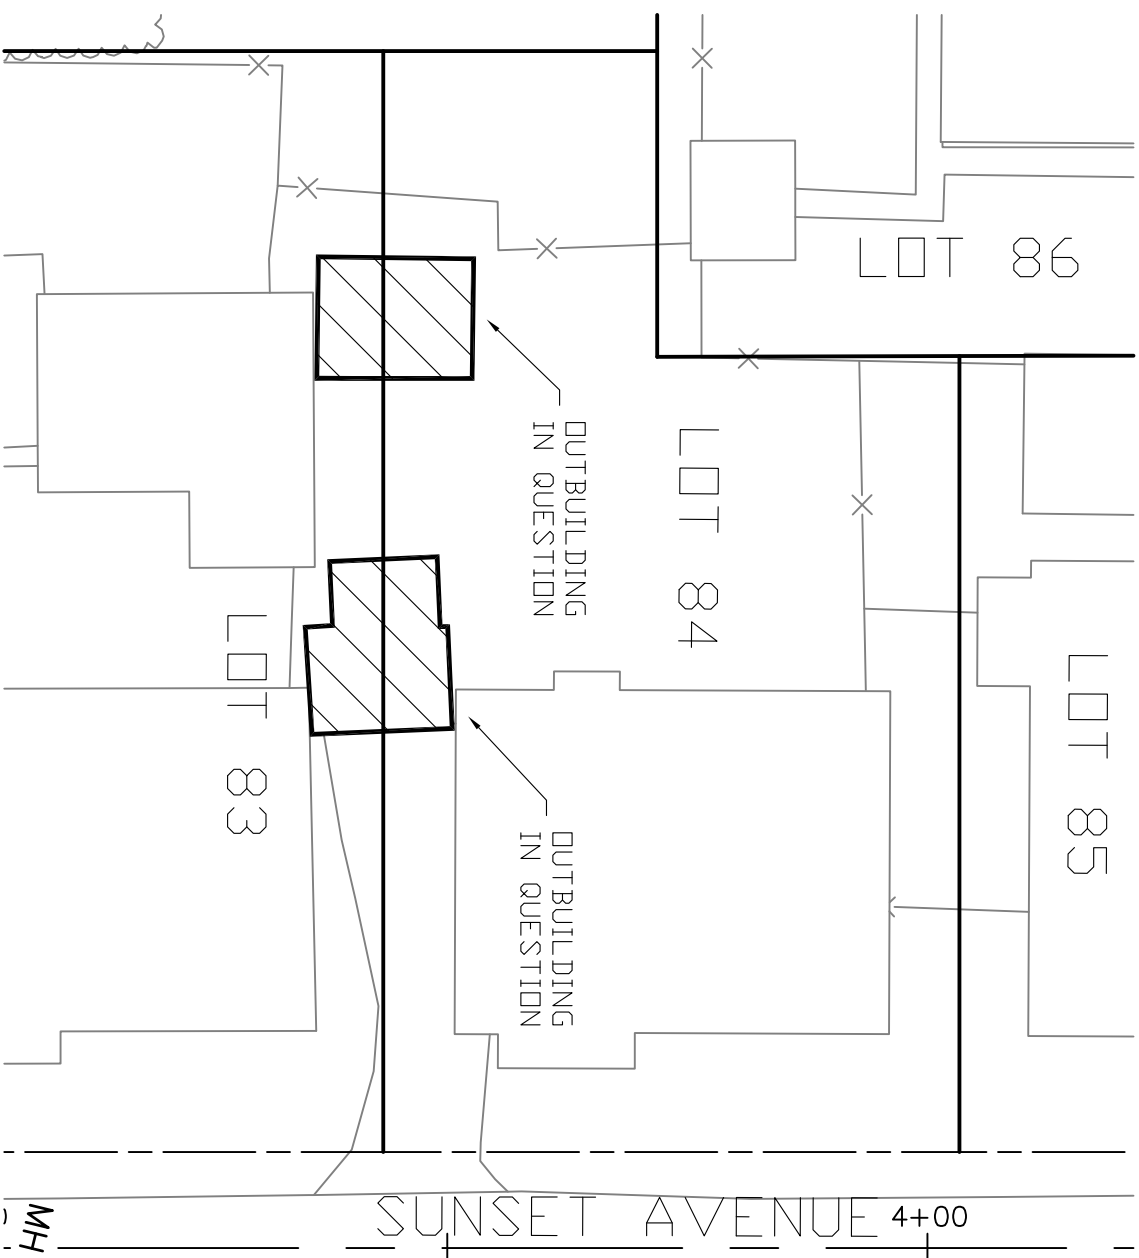
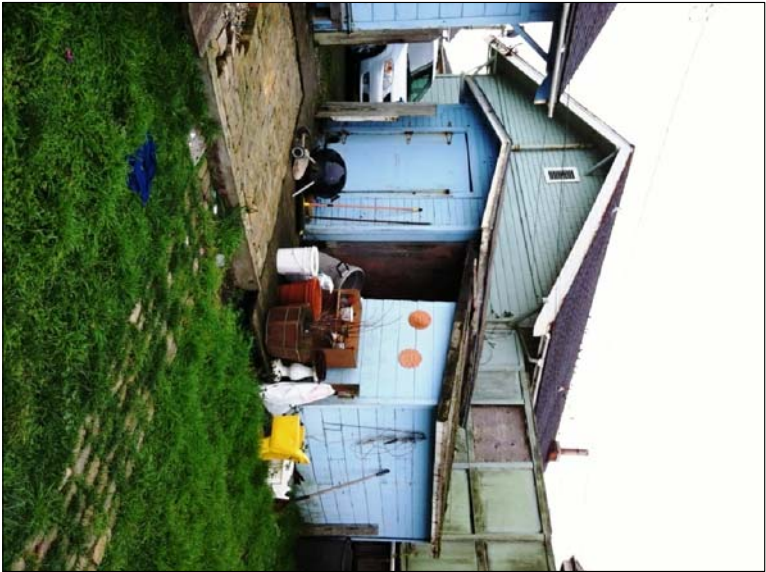
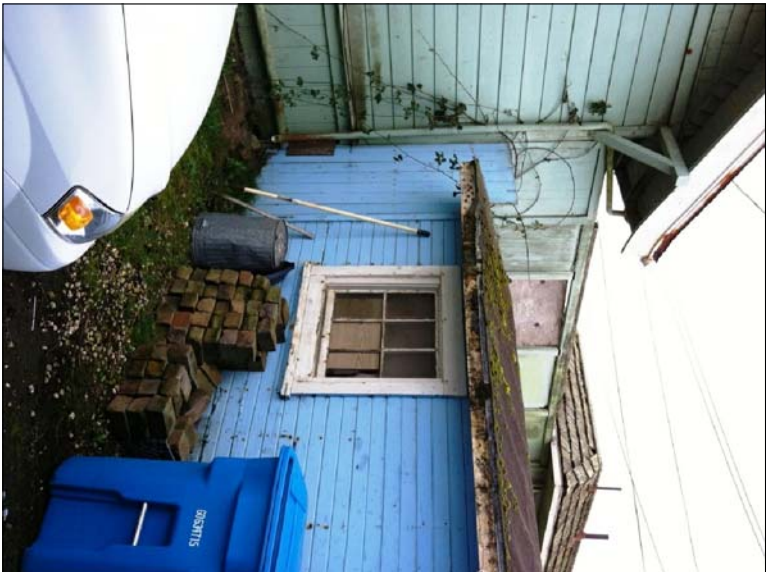
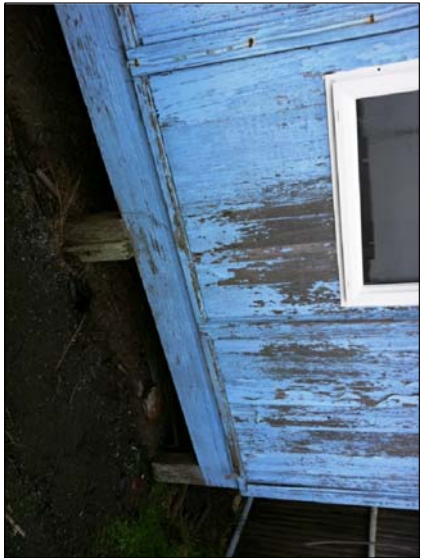
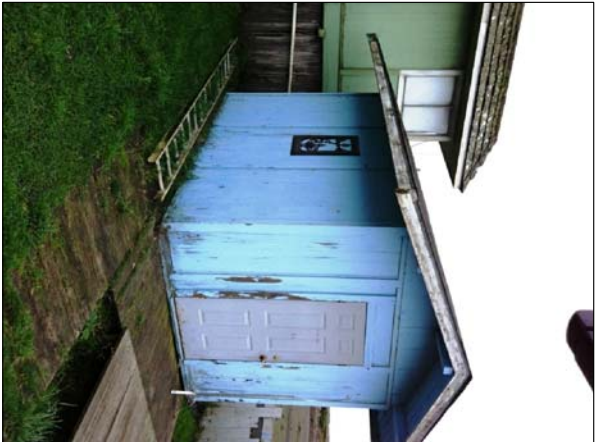
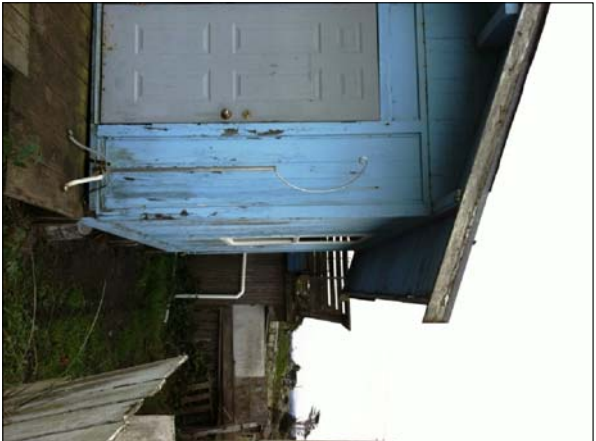
STRUCTURAL INTEGRITY ASSESSMENT
ADDRESS: 127 SUNSET AVENUE
CONTRIBUTING BUILDINGS
ASSESSMENT
LOTS 83 & 84
SAMDA, CALIFORNIA

The first building (nearest Sunset Ave) is of wood frame construction, it has a wooden post and pier block foundation, horizontal tongue & groove wood siding, and tarpaper roof. It measures 18x15 with an open breezeway. The roof is in poor condition with considerable moss. Some window panes are missing and some siding cracked. The building is a hodgepodge of construction with a small open breezeway separating two rooms. The entire structure is in poor condition. Moving this structure is not an option, as the condition is so poor that it will not withstand and significant outside forces imposed on it by moving. Additionally the breezeway is a weak point in the structure. Even moving it in two pieces is not an option for this structure. Similarly, tearing it down and then rebuilding it somewhere else is not an option as the wood framing is well past its useful life. My recommendation is to demolish this building.

The second, rear, building is of wood frame construction, it has a wooden post and pier block foundation, plywood siding, and tarpaper roof. The building is 16x12.5 and in fair condition. There is considerable paint missing, but otherwise relatively sound. I recommend preserving or moving this outbuilding due to its small size and relative remaining lifespan.

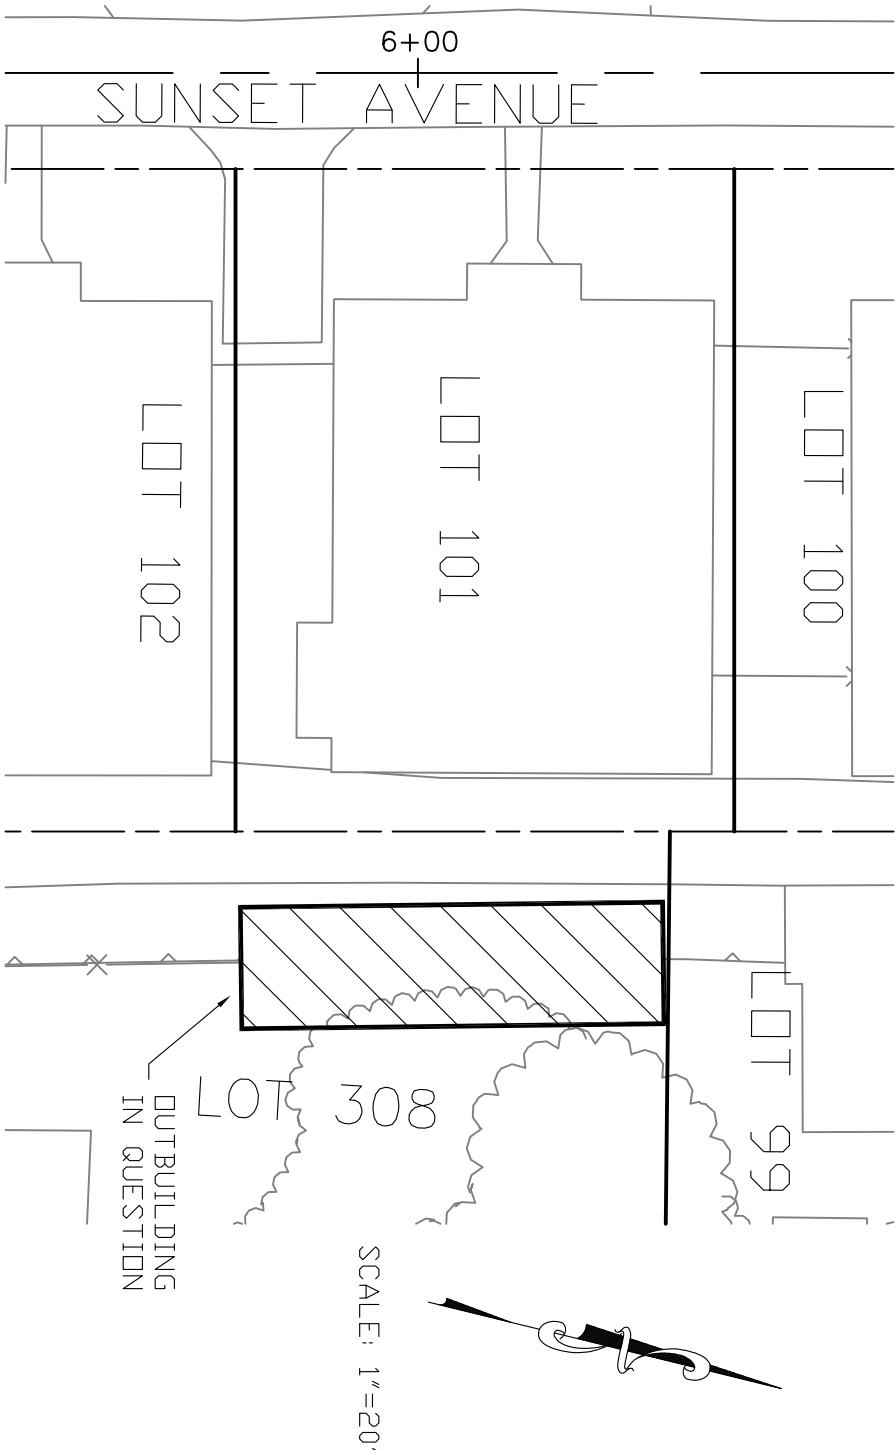
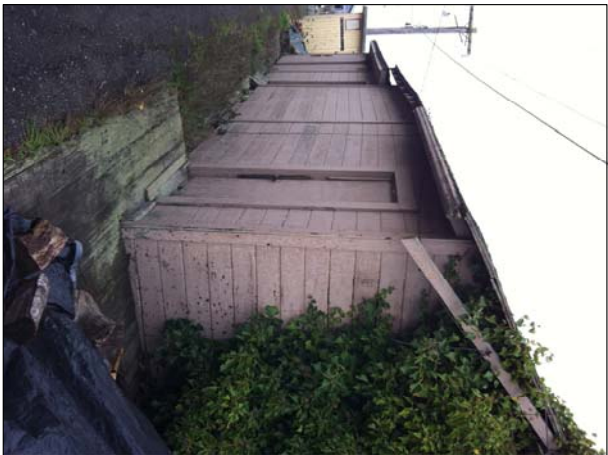
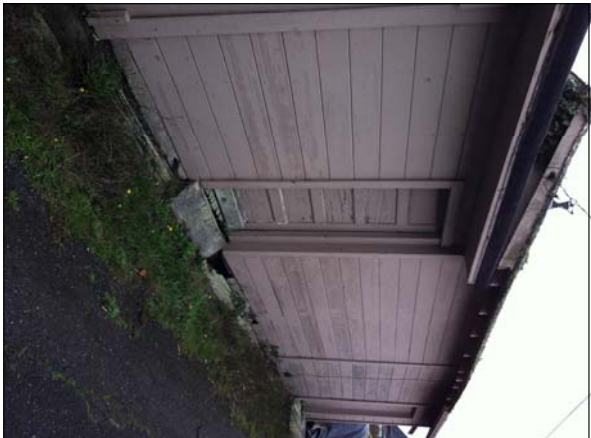
CALIFORNIA ENGINEERING COMPANY, INC. 1110 CIVIC CENTER BLVD., STE. 404 YUBA CITY, CALIFORNIA 95993 JOB NO. 12-201 DATE: 01/28/13	STRUCTURAL INTEGRITY ASSESSMENT ADDRESS: 122 SUNSET AVENUE	CONTRIBUTING BUILDINGS ASSESSMENT LOT 308 SAMDA, CALIFORNIA
--	---	--

This building is of wood frame construction, it has a wooden foundation on one half of the structure and is supported by a combination cantilever wood bracing system along the back side for the other half of the building. The walls consist of horizontal tongue & groove wood siding, and shake and tarpaper roof. The building is completely located off of lot 92. The outbuilding is long and narrow, measuring 44x13. It has two separate roof structures, the shake part is in poor condition with lots of moss and broken fascia. The building is in poor condition with and the foundation systems outlined above have all but failed. The building, as it sits is a hazard and unsafe for occupancy and usage. My recommendation is to remove this building due to its unsafe condition and failing foundation systems.

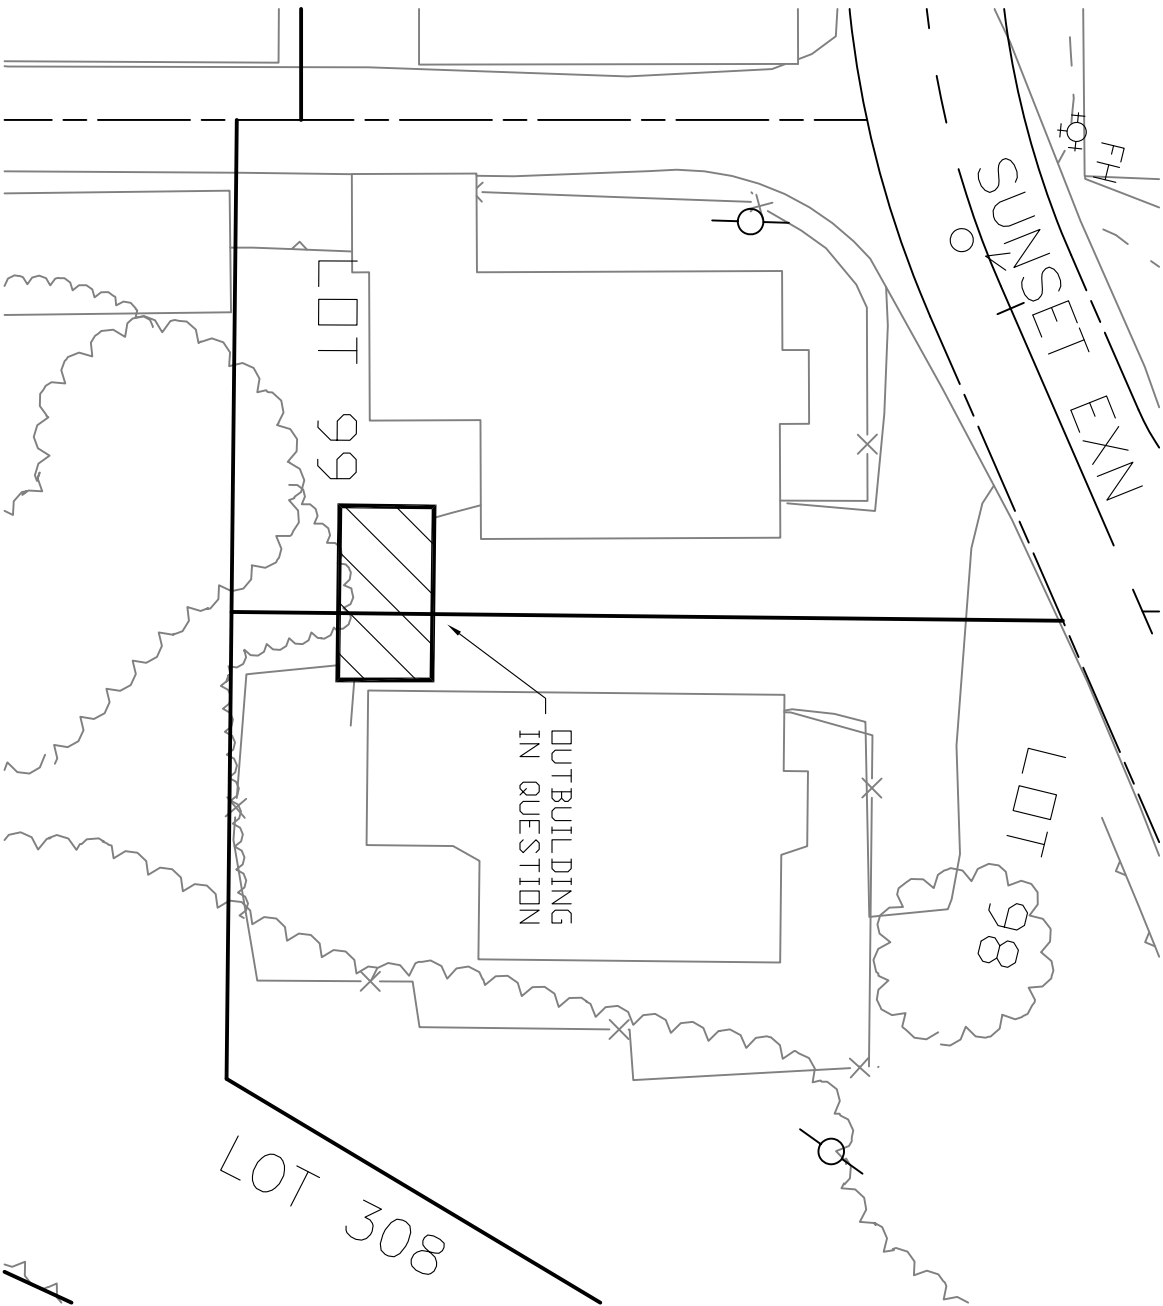
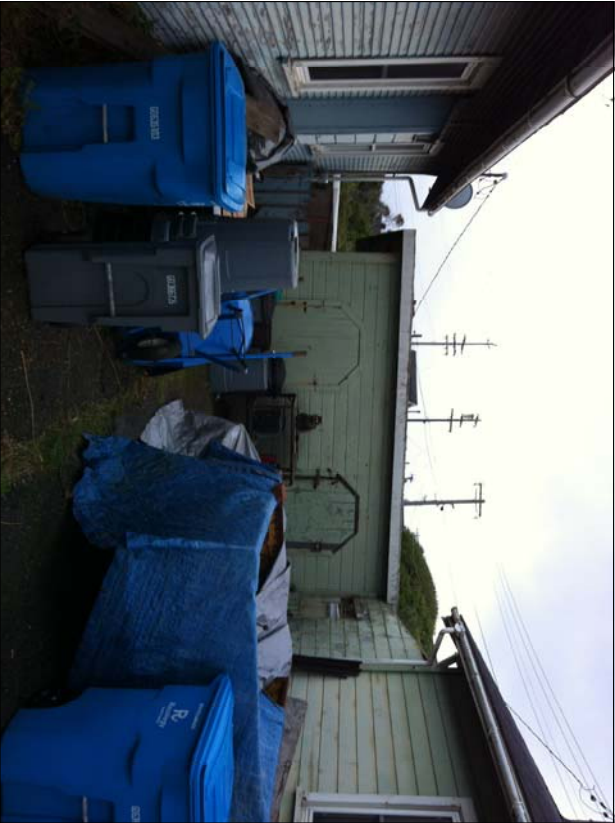
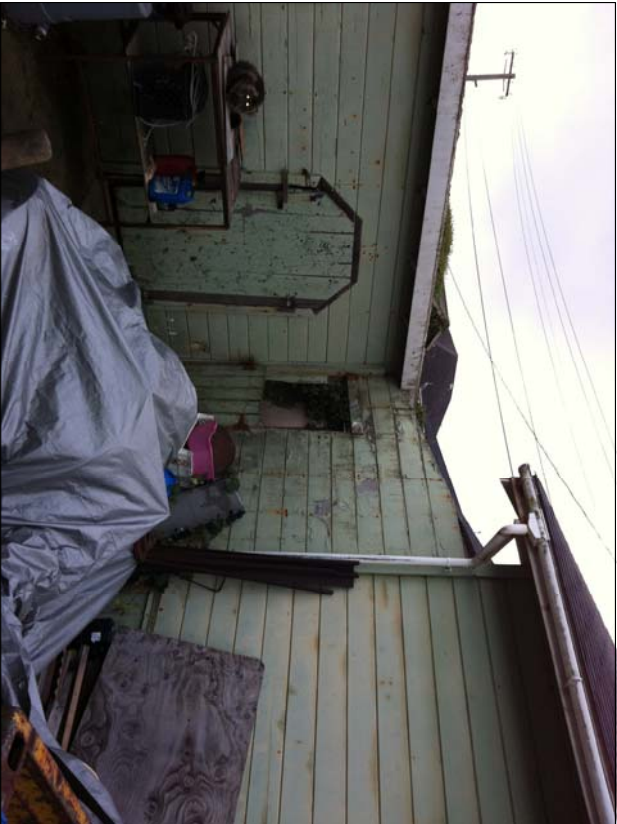
SHEET 7 OF 9

This building is of wood frame construction, it has a wooden post and pier block foundation, horizontal tongue & groove wood siding, and tarpaper roof. It is small, measuring 18x11 and located on two lots. The building appears to have been built at some point and time by the residents whom lived in the home and lacks any normal or reliable building systems, that would suffice to hold it together to be moved. The roof is completely ruined, and growing significant moss, in some areas 2-3 inches thick. The sides are not square and the building is not plumb. Tearing this structure down and rebuilding it is not considered realistic as it would be rebuilt with the same issues as explained herein. I recommend removing the building from the site in its' entirety.
