DRAFT REVIEW FOR REVIEW ONLY- Updated

Subject: 12-201, Town Of Samoa, Contributing Outbuilding Study

The following are my assessments and recommendations for each of the 11 Contributing Outbuildings.

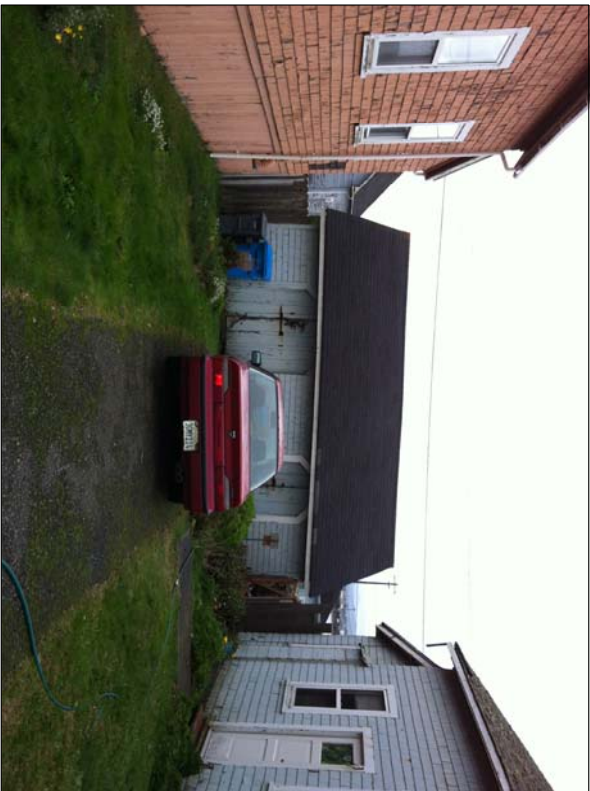
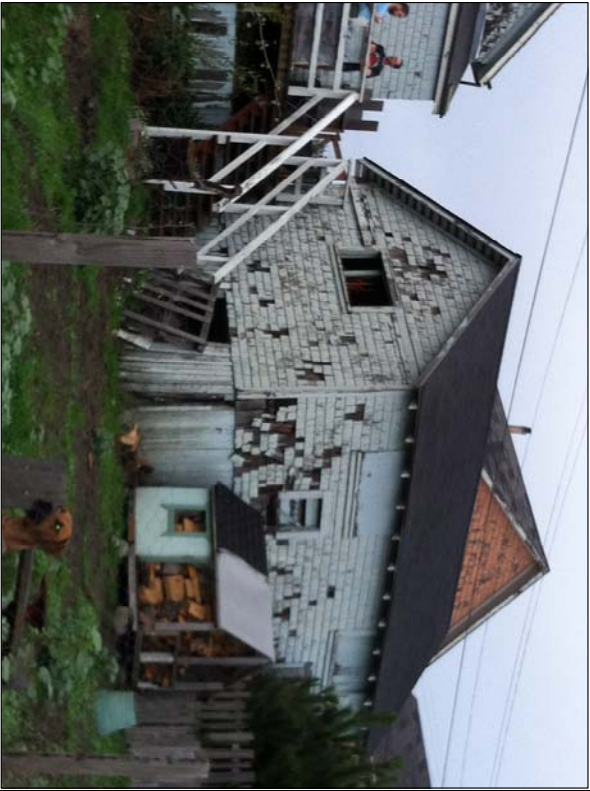
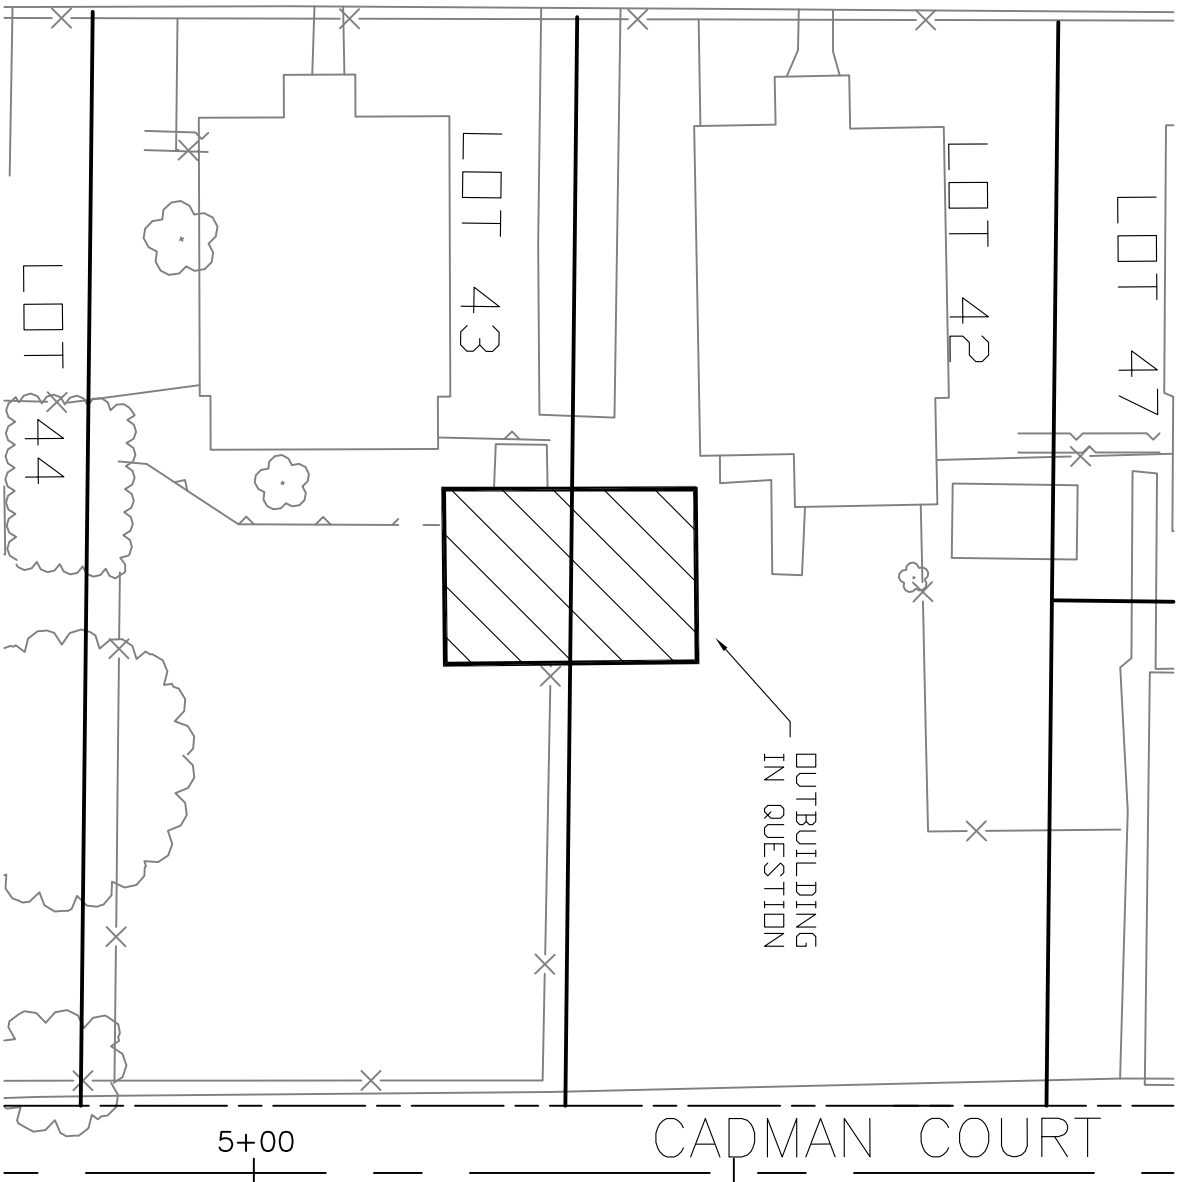
SHEET 8 OF 9

This building is of wood frame construction, it has a wooden post and pier block foundation, which varies from the front to the back of the building due to topography. It has shake siding, and shingled roof. It measures 26x18 and is located on two separate lots. The roof is in good condition. The windows are missing or have been boarded. The shake siding is in poor condition, many shakes are missing or loose and paint has peeled. The foundation is elevated due to the slope of the terrain, and based on my inspection is no longer structurally sound. My recommendation is to demolish this outbuilding due to its declining condition.

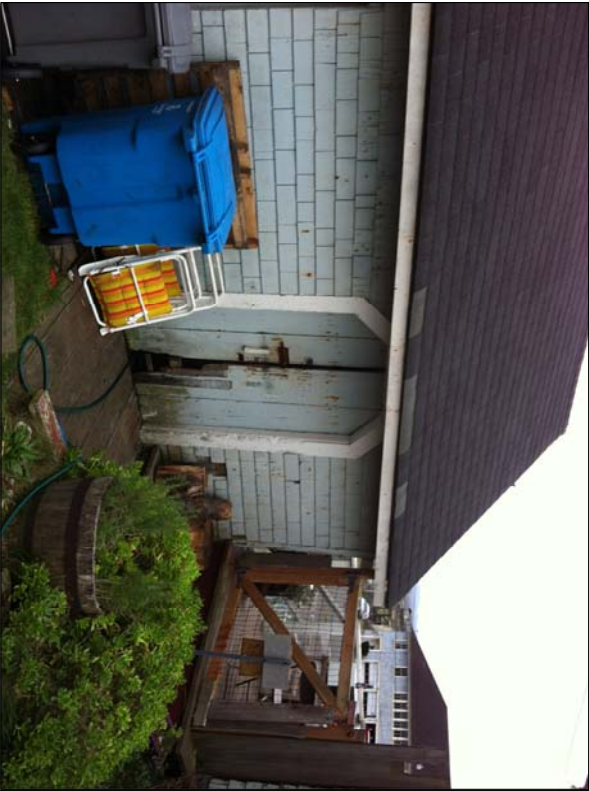
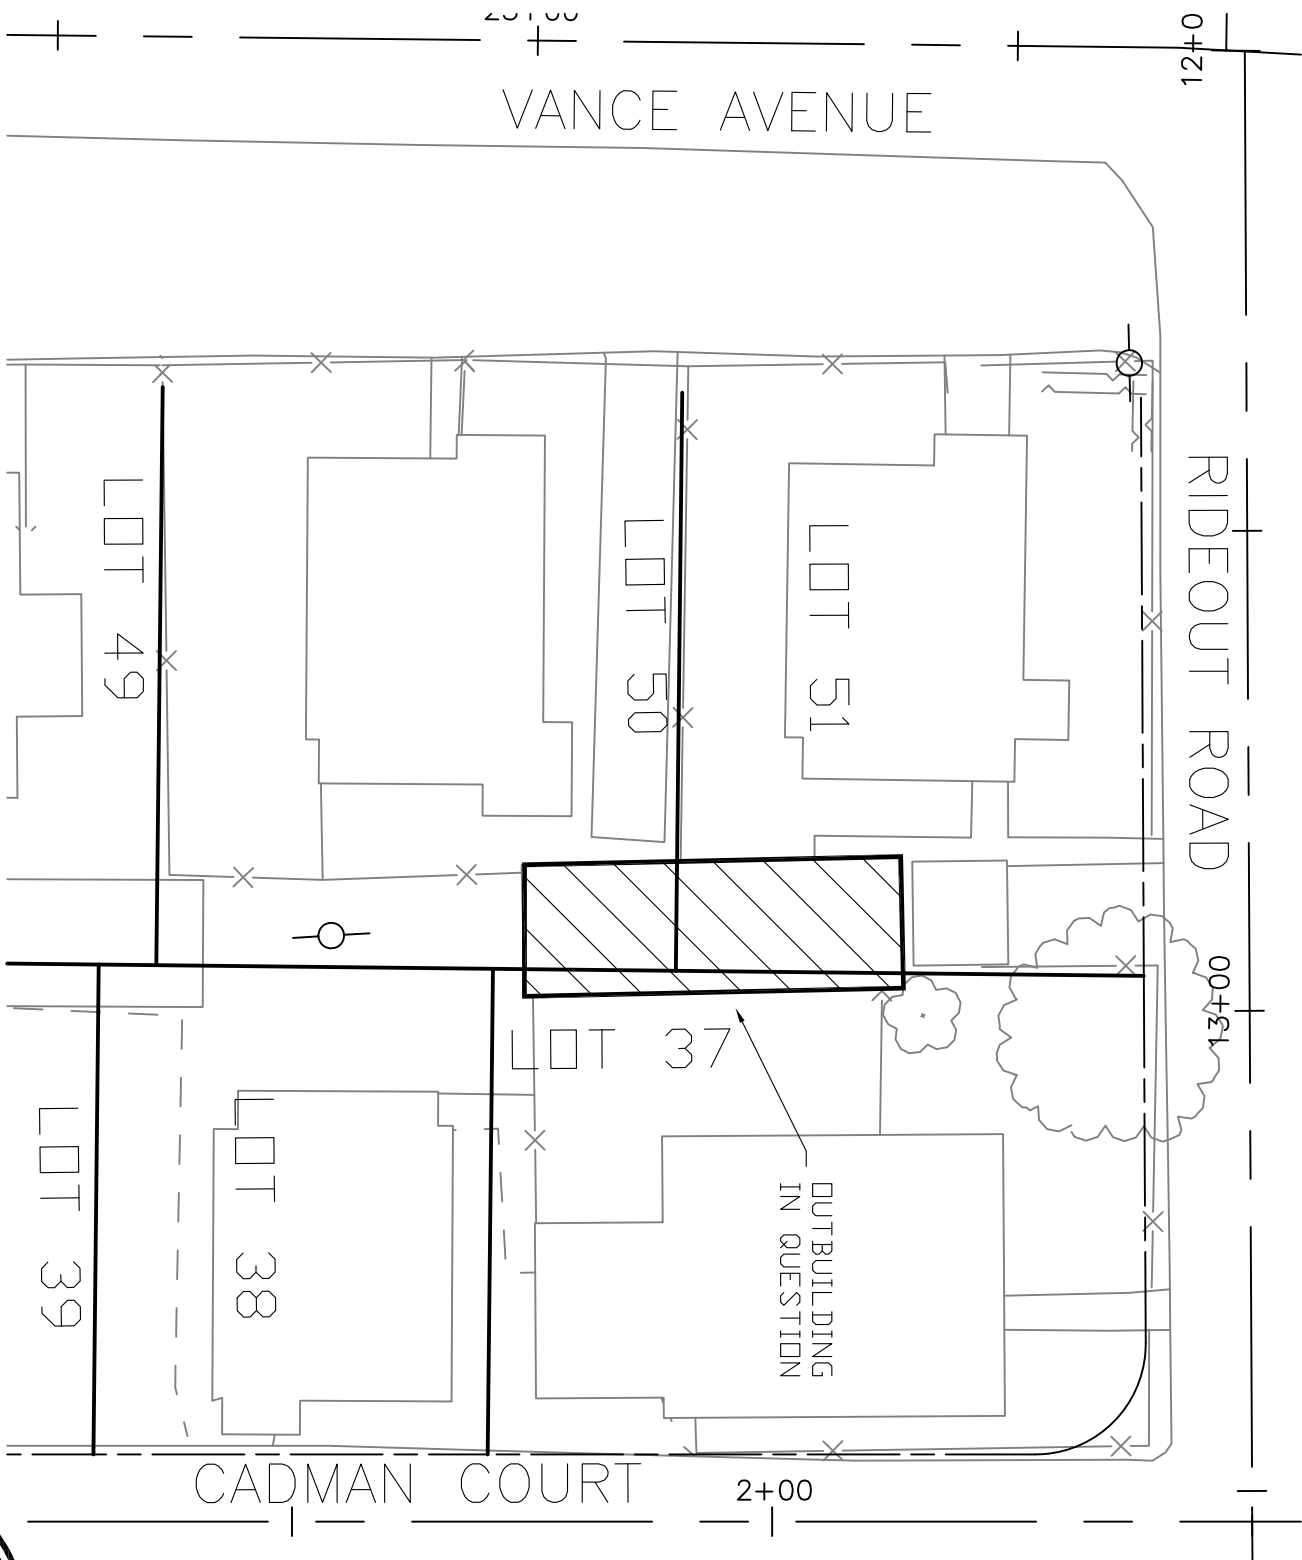
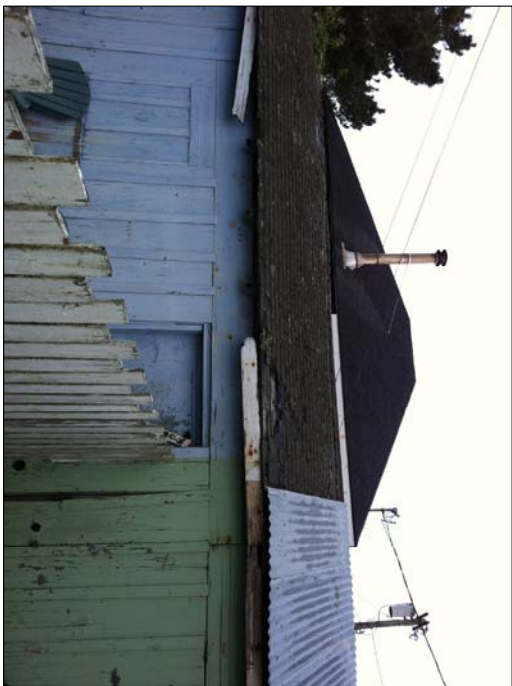
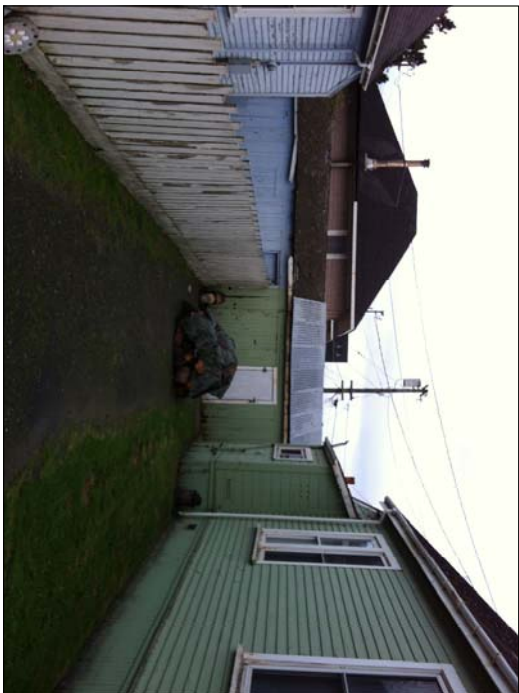
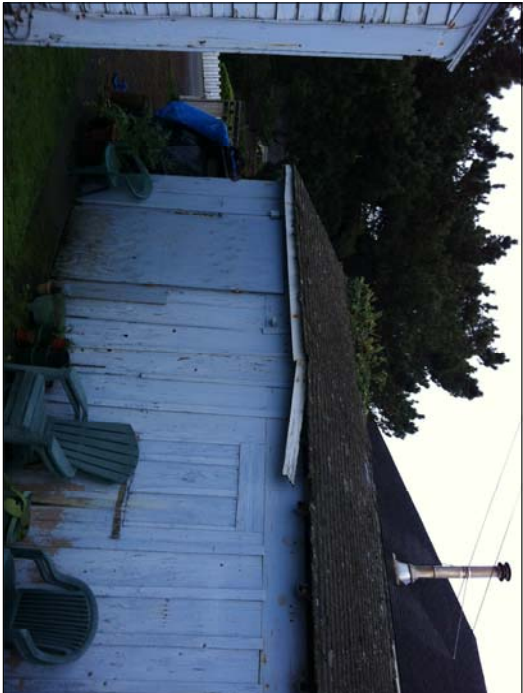
SHEET 9 OF 9

This building is of wood frame construction, it has a wooden post and pier block foundation, vertical board and batten siding, and partial shake and partial corrugated metal roof. It is located on two lots and measures approximately 39.5x14. The roof is in poor condition with rotted shakes and broken fascia. The paint is in poor condition. The

walls of this structure a no longer plumb and beginning to fall in on themselves. The roof trusses inside the building are failing, and the foundation is also in very poor condition. The building materials are literally rotting away and could not be reused. I recommend demolishing this outbuilding due to its deteriorated condition. Its size is also a detriment towards relocating it.
