NOVEMBER 2018

Water Resource Protection Plan & Site Management Plan for Humboldt County APN ARSTINE

222-071-017

Stillwater Sciences 850 G Street, Suite K Arcata, CA 95521

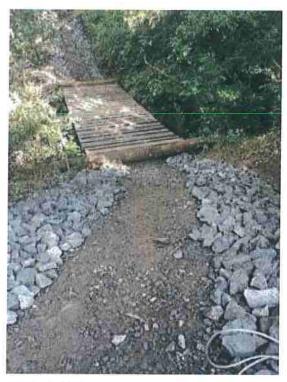
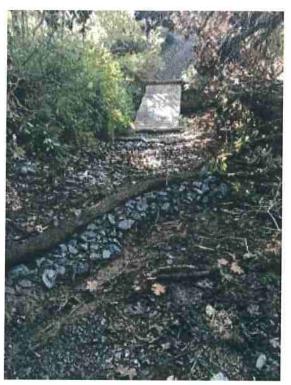
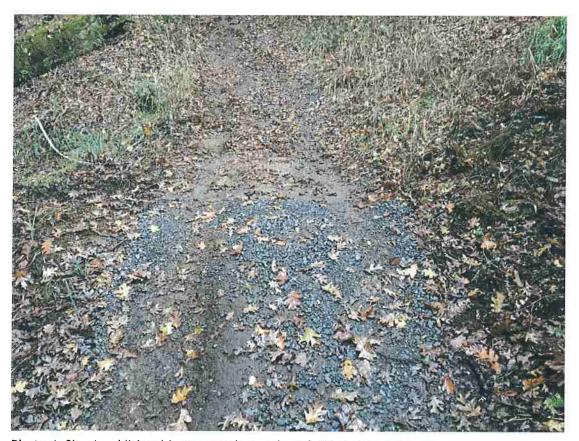
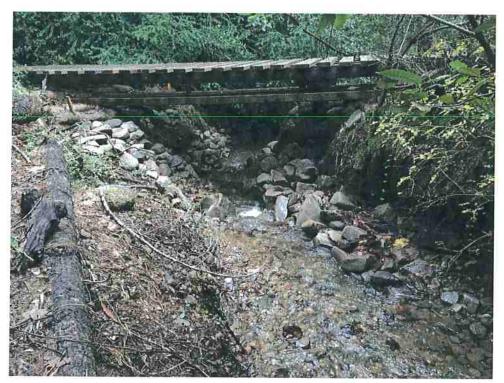
Photo 1. Site 1, western approach

Photo 2. Site 1, eastern approach.

Photo 4. Site 1, additional large waterbar upslope from eastern approach.

Photo 5. Site 1, channel armoring.

Recommendation: Where the trail crosses Jones Creek, pull back the top edge of the vertical stream banks on both sides to decrease the likelihood of sediment from sloughing and toppling into the creek. Armor the newly excavated bank segments with small rip-rap (i.e. cobbles and boulders). Approximately 3" thickness of road rock should be added to the trail on each approach. The trail segment west of the stream crossing is relatively short (~20 ft) and drains a small area. Continue to maintain BMP's (i.e. straw waddles) on this segment during the rainy season. On the trail east of the stream crossing construct 2-3 water-bars, in addition to the straw waddles, to drain trail-related runoff in the steep segment extending for ~50 ft upslope from Jones Creek. These new water bars must be excavated to a sufficient depth to drain the inboard ditch and the inboard ditch must be plugged to eliminate the concentrated runoff from entering the creek at Site 1. Beyond this relatively steep trail segment, leading up to the cultivation site, continue maintaining the existing BMP's. Prior to each rainy season, the straw wattles must be checked to insure that OHV traffic has not damaged their functionality, and replaced if appropriate.

As-Built Description: Due to difficult equipment access, weather issues, and goal of reducing construction disturbance, work at this site was conducted by hand. As such, as-built photos reflect the following changes to the initial recommendations: Used +/- 1' diameter cobble for channel bank armoring, excavation of 6" toe trench, no excavation at top of bank, ~1' thickness, 3' height, 10' length rock armoring both sides of creek, total of 2 CY armoring.

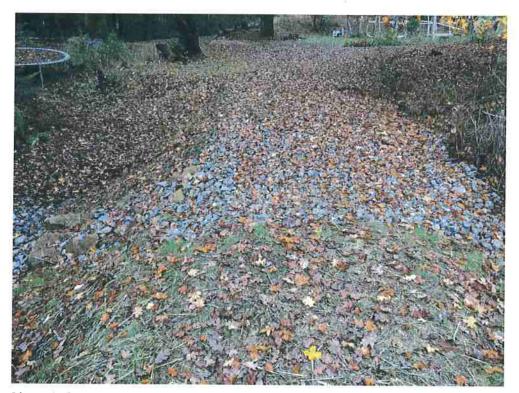
Photo 6. Site 2, new pond spillway.

**Recommendation:** Excavate and pull back the vertical edges of the ditch to 2:1 (Horizontal: Vertical) slope. Armor the outlet ditch with small riprap rock such that pond has minimum of 1.5' of freeboard. Extend the armoring to dissipate outlet flow where it meets the native soil beyond

As-Built Description: Prior to construction, engineer conducted additional site reconnaissance and discovered that existing pond outflow should be relocated due to erosion and gullying downslope from outflow. As such, outflow was relocated to a more suitable/stable location on the south side of the pond and constructed per recommendations above. Existing outflow was filled with soil, compacted, seeded, and mulched.

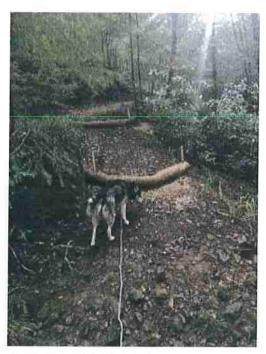
Photo 7. Site 3, new straw wattles.

**Recommendation:** Continue to maintain existing BMP's, install straw wattle or water bar on eastern approach to prevent runoff concentration.

As-Built Description: Constructed per recommendations.

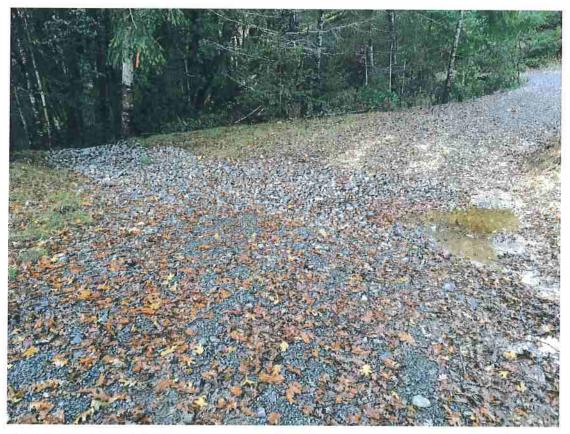
Photo 8. Site 4, new rolling dip.

**Recommendation:** Fill existing cross road drain and construct a new rolling dip to the west. The new dip should be deep enough to drain ponding water and broad enough (~15-20 ft) to diffusely drain flow onto native soils and vegetation and avoid diversion onto the expanded shoulder/pad. Gravel road segment with 6" thickness of road rock.

As-Built Description: Constructed per recommendations.

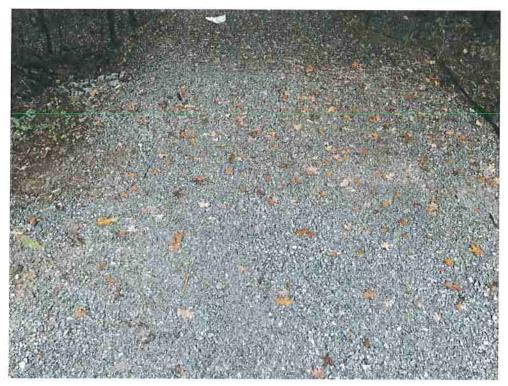
Photo 9. Site 6, new rolling dip.

**Recommendation:** Construct a rolling dip that is broad enough (~15-20 ft) to diffusely drain flow onto native soils and vegetation. Gravel road surface across dip with 6" thickness of road rock.

As-Built Description: Constructed per recommendations.

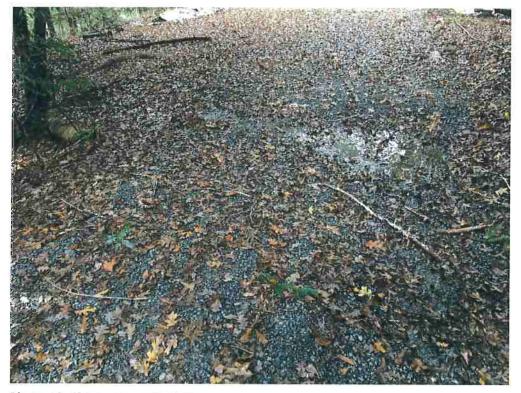
Photo 10. Site 7, new rolling dip.

**Recommendation:** Construct a rolling dip that is broad enough (~15-20 ft) to diffusely drain flow onto native soils and vegetation. Gravel road surface across dip with 6" thickness of road rock.

As-Built Description: Constructed per recommendations.

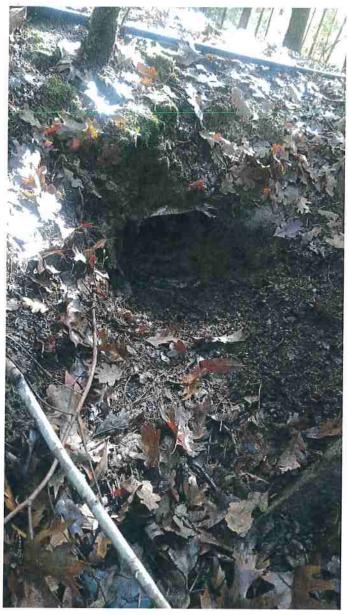
Photo 11. Site 8, newly cleaned culvert inlet.

**Recommendation:** Hydrologic analyses for this site determined that the existing 12" diameter culvert has sufficient capacity to carry 100-year flows. Therefore, the only recommendation is to clean the culvert inlet with hand tools.

As-Built Description: Constructed per recommendations.

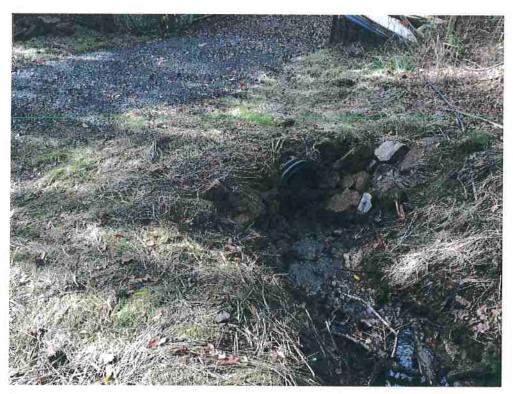
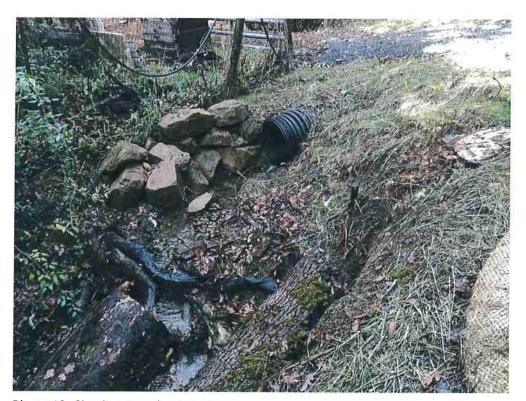
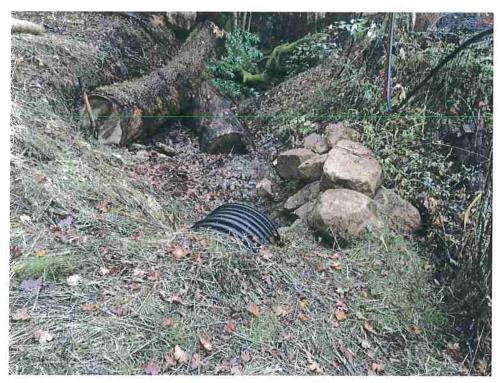
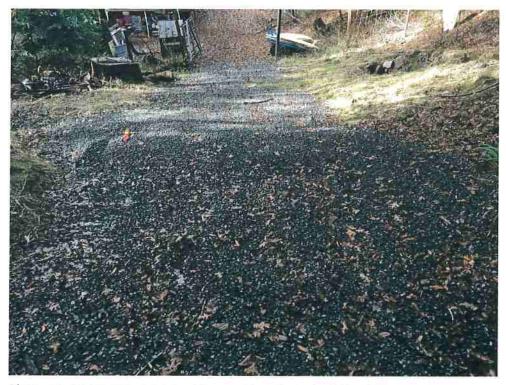
Photo 12. Site 9, new culvert inlet.

Photo 13. Site 9, new culvert outlet.

Photo 14. Site 9, new culvert downstream channel.

Photo 15. Site 9, new culvert upslope rolling dip and road surface.

**Recommendation:** Upgrade the crossing with a new 24" diameter culvert along the same alignment. Appropriately armor the inlet/outlet and gravel roadway. In addition to standard culvert replacement activities, one new rolling dip should be installed on the road up-gradient from the culvert to prevent road runoff from concentrating at the culvert site, and road rock should be placed on  $\sim 100$ ' of the upslope road segment. In addition, water supply lines that are currently running in the road and through the culvert should buried in their own separate trenches of at least 1' depth so that they are not located on the roadway or in the culvert. Damaged and/or leaking water lines can cause additional erosion and sedimentation.

As-Built Description: Generally constructed per recommendations; less rock armoring used than originally recommended due to use of large logs to stabilize downstream channel.

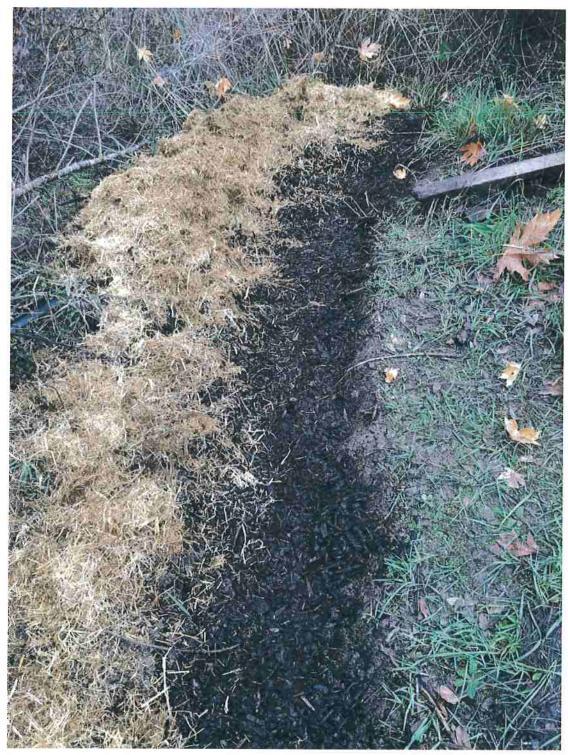
Photo 16. Site 10, bioswale.

**Recommendation:** Move all cultivation sites to be a minimum of 50' from the seasonal tributary and 100' from Jones Creek. Construct a bio-swale along the down slope extent (southeastern and southern) of the cultivation area to retain any sediment and/or nutrients derived from the cultivation area surface. Bio-swale dimensions will be approximately 50' length x 2' bottom width x 1' depth with 2:1 side slopes.

As-Built Description: Due to difficult equipment access, weather issues, and goal of reducing construction disturbance, work at this site was conducted by hand. As such, asbuilt photos reflect the following changes to the initial recommendations: Bio-swale dimensions of approximately 30' length x 1' width x 1' depth.

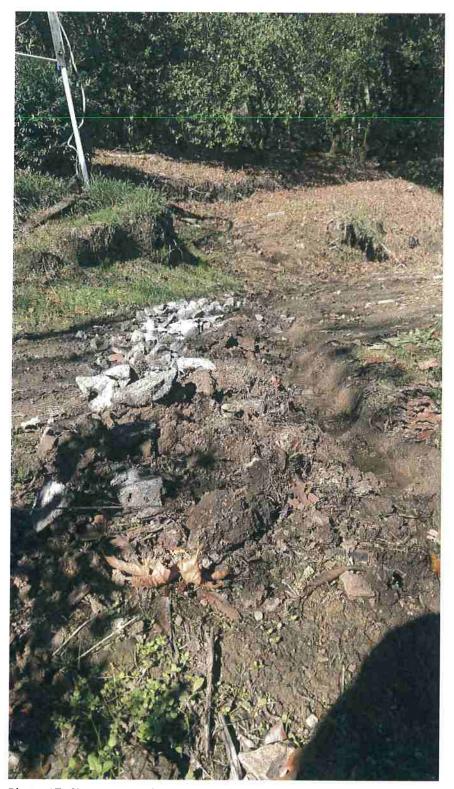
Photo 17. Site 11, waterbar.

**Recommendation:** Pull back the over-steepened cutbank along this road segment and use the newly excavated material to re-grade an outsloped road surface profile (~4% side slope) extending west from the residence toward the swale in the road where water currently ponds. Gravel the newly graded road surface with 6" thick road rock.

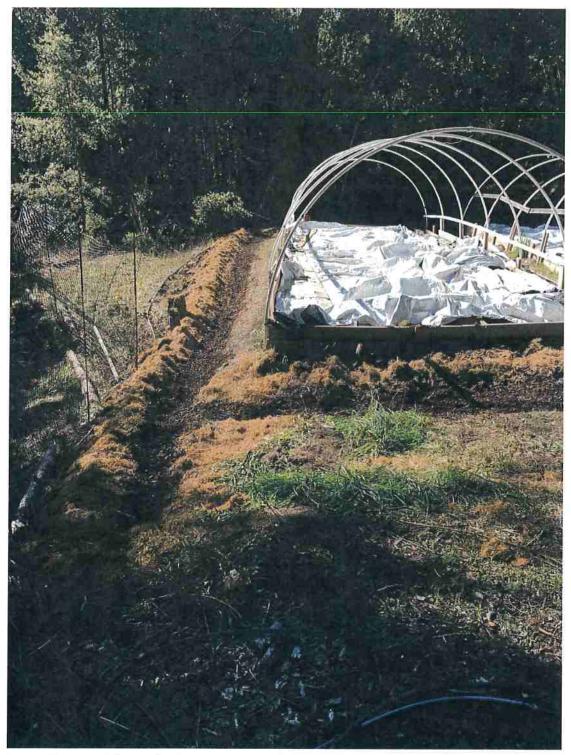
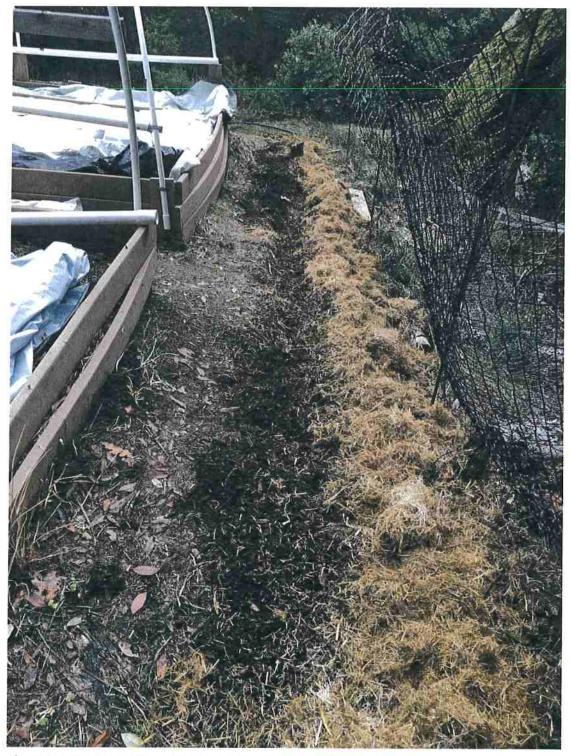
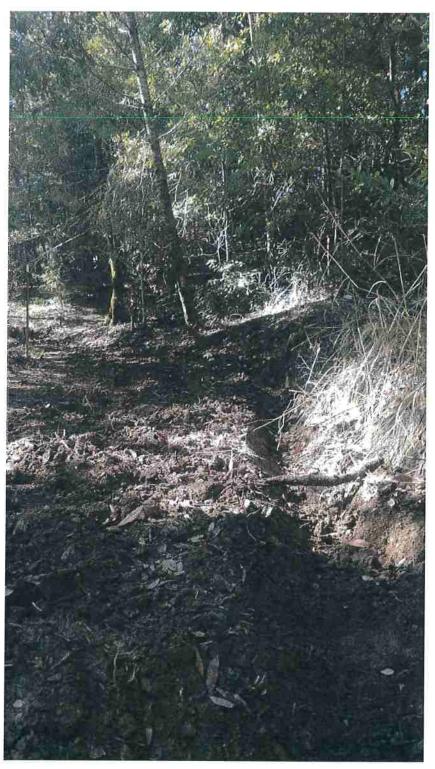
Photo 18. Site 13, bioswale along southern and eastern extent of cultivation site.

Photo 20. Site 13, bioswale along western extent of cultivation site.

**Photo 21.** Site 13, drainage ditch on northern side of cultivation area to direct surface runoff around site.

**Recommendation:** Construct a bio-swale along the down slope sides (southeastern, southern, and southwestern) of the cultivation site to retain any sediment and/or nutrients derived from the cultivation area surface. Bio-swale dimensions will be approximately 100' length x 2' bottom width x 1' depth with 2:1 side slopes. Construct a small drainage ditch (2' bottom width x 1' depth with 2:1 side slopes) along the northern side of the site to direct seasonal runoff westward past the site preventing it from entering the cultivation area. Place approximately 5 cubic yards of small rock armoring in the newly constructed drainage ditch.

As-Built Description: Due to difficult equipment access, weather issues, and goal of reducing construction disturbance, work at this site was conducted by hand. As such, asbuilt photos reflect the following changes to the initial recommendations: Bio-swale dimensions of approximately 100' length x 1' width x 1' depth. Drainage ditch along north side of site was also constructed by hand with approximately dimensions of 1' width by 1' depth. Due to minimal disturbance of handwork activities, no rock armoring needed to stabilize ditch.

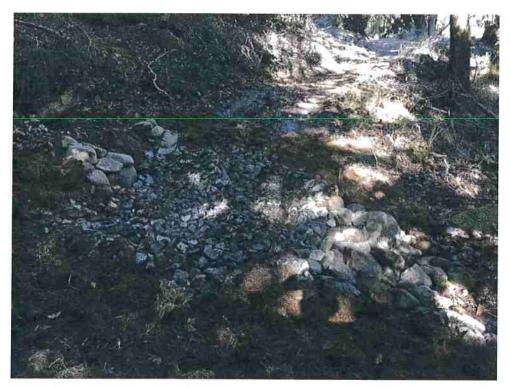
Photo 22. Site 14, small armored ford.

Recommendation: Construct an armored ford.

As-Built Description: Generally constructed per recommendations; less rock armoring used than originally recommended due to fact that project was constructed by hand which minimized disturbance of existing vegetation and topsoil.

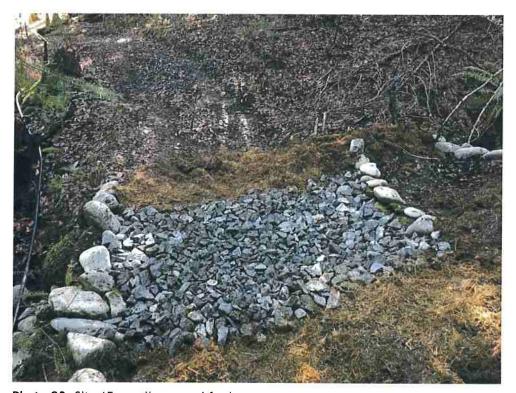
Photo 23. Site 15, small armored ford.

Recommendation: Construct an armored ford.

As-Built Description: Generally constructed per recommendations; less rock armoring used than originally recommended due to fact that project was constructed by hand which minimized disturbance of existing vegetation and topsoil.

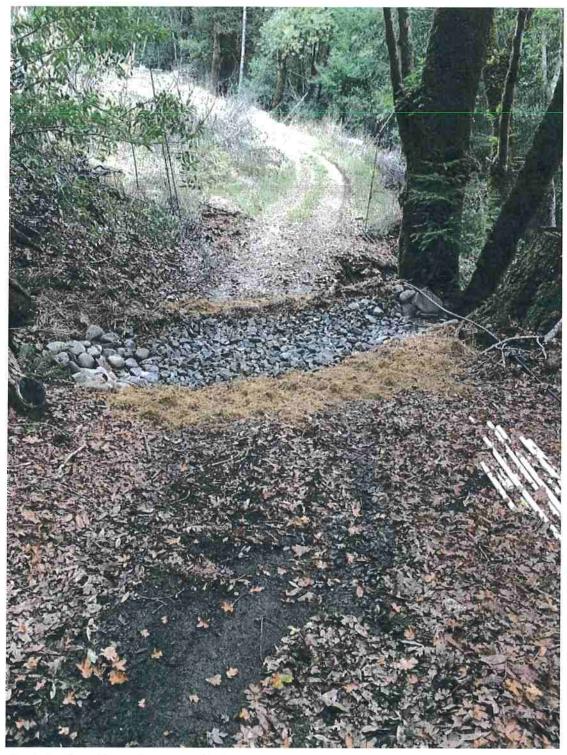
Photo 24. Site 17, small armored ford.

**Recommendation:** Construct an armored ford crossing.

As-Built Description: Generally constructed per recommendations; less rock armoring used than originally recommended due to fact that water was routed back to its original course which is armored by existing large woody debris.

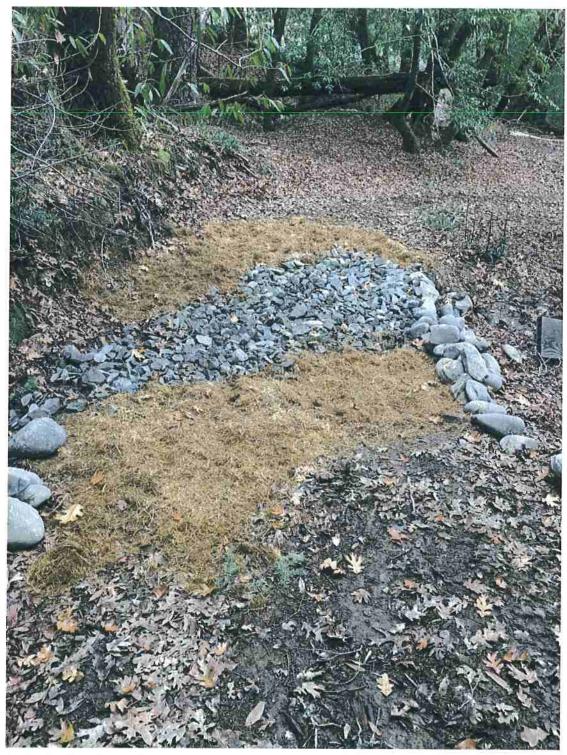
A seasonal class III watercourse crosses a former access road at an un-engineered crossing. The inlet flows through standing trees and is choked with sediment and debris. The outboard road surface is minimally gullied and water flow is directed toward a log pile which causes diversion back onto the road. The diverted flow then travels down the road to Site 17. The landowners intend to use this as a low-use/OHV trail.

Photo 25. Site 18, small armored ford.

**Recommendation:** Construct an armored ford crossing. Additionally, remove the log pile and construct a channel (3' bottom width x 1.5' depth with 2:1 side slopes) extending from the newly constructed armored ford past the log deck and connecting with the natural channel downslope. Armor the newly constructed channel with 3 grade control structures with a total of 6 cubic yards of small rock armoring.

As-Built Description: Armored ford generally constructed per recommendations; less rock armoring used than originally recommended due to fact that project was constructed by hand which minimized disturbance. However, prior to constructing the new downstream channel, engineer conducted additional site reconnaissance and determined that there is a small active landslide downslope from this crossing and that it is best to let runoff dissipate in the log pile and then sheet flow in multiple directions.

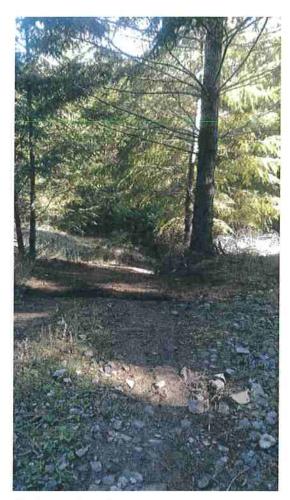
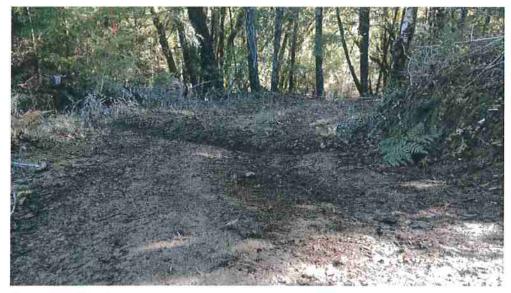
Photo 26. Site 19, upper waterbar.

Photo 27. Site 19, lower waterbar.

**Recommendation:** Construct two water bars at 50-foot intervals between this site and Site 18. The uphill water bar will drain to the existing inboard ditch. The downhill water bar will drain to the outboard edge of the road onto native soil and vegetation.

As-Built Description: Constructed per recommendations.

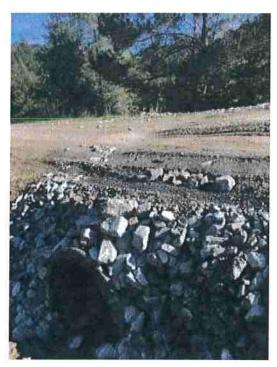
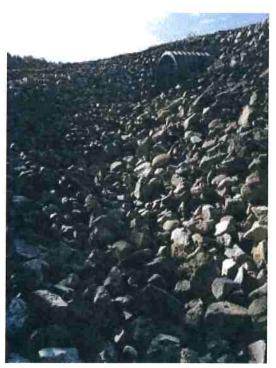
An existing undersized culvert (12" diameter) carries water draining a small vegetated swale and the inboard ditches from both directions under West Moody Lane/Oak Rock Road before entering a downslope gully. Both the inlet and outlet are damaged and rusting. Water exits the culvert through a rusted hole before reaching the outlet. Further failure of this culvert could threaten the road surface and lead to significant additional erosion.

Photo 28. Site 22 culvert inlet.

Photo 29. Site 22 culvert outlet.

**Recommendation:** Upgrade the crossing with a new 24" diameter culvert on the same alignment. Appropriately armor the inlet and outlet.

As-Built Description: Constructed per recommendations.

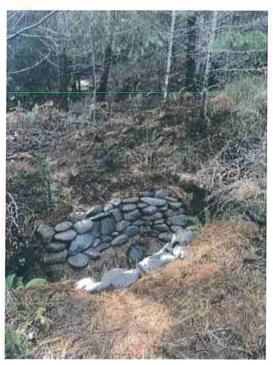
Photo 30. Site 24 small crossing decommissioning.

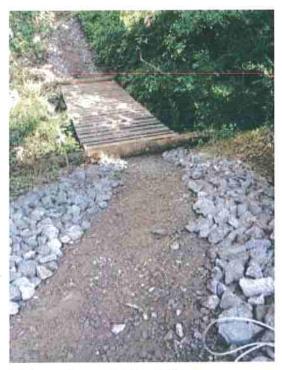
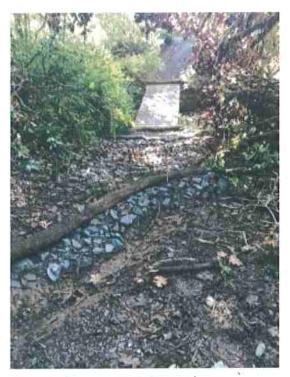
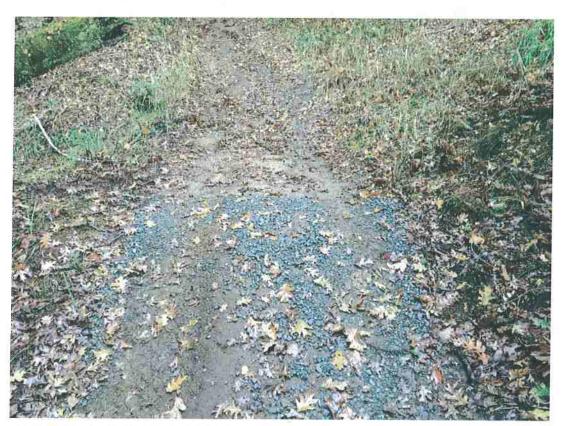
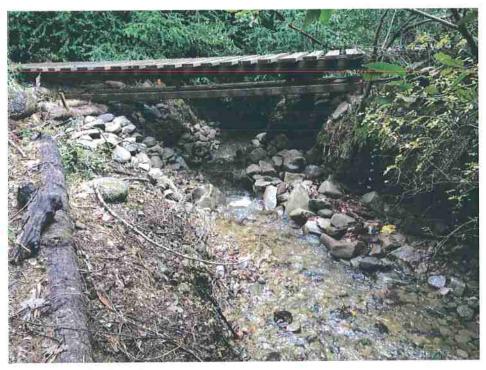
Photo 1. Site 1, western approach

Photo 2. Site 1, eastern approach.

Photo 4. Site 1, additional large waterbar upslope from eastern approach.

Photo 5. Site 1, channel armoring.

Recommendation: Where the trail crosses Jones Creek, pull back the top edge of the vertical stream banks on both sides to decrease the likelihood of sediment from sloughing and toppling into the creek. Armor the newly excavated bank segments with small rip-rap (i.e. cobbles and boulders). Approximately 3" thickness of road rock should be added to the trail on each approach. The trail segment west of the stream crossing is relatively short (~20 ft) and drains a small area. Continue to maintain BMP's (i.e. straw waddles) on this segment during the rainy season. On the trail east of the stream crossing construct 2-3 water-bars, in addition to the straw waddles, to drain trail-related runoff in the steep segment extending for ~50 ft upslope from Jones Creek. These new water bars must be excavated to a sufficient depth to drain the inboard ditch and the inboard ditch must be plugged to eliminate the concentrated runoff from entering the creek at Site 1. Beyond this relatively steep trail segment, leading up to the cultivation site, continue maintaining the existing BMP's. Prior to each rainy season, the straw wattles must be checked to insure that OHV traffic has not damaged their functionality, and replaced if appropriate.

As-Built Description: Due to difficult equipment access, weather issues, and goal of reducing construction disturbance, work at this site was conducted by hand. As such, asbuilt photos reflect the following changes to the initial recommendations: Used +/- 1' diameter cobble for channel bank armoring, excavation of 6" toe trench, no excavation at top of bank, ~1' thickness, 3' height, 10' length rock armoring both sides of creek, total of 2 CY armoring.

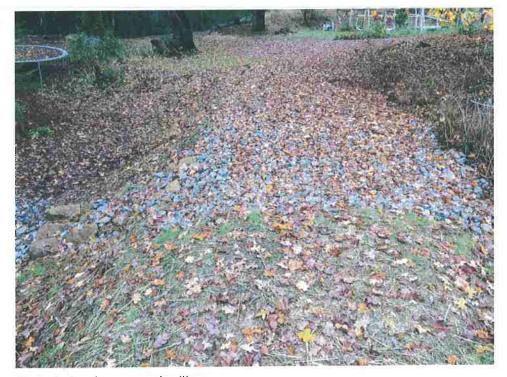
Photo 6. Site 2, new pond spillway.

**Recommendation:** Excavate and pull back the vertical edges of the ditch to 2:1 (Horizontal: Vertical) slope. Armor the outlet ditch with small riprap rock such that pond has minimum of 1.5'

As-Built Description: Prior to construction, engineer conducted additional site reconnaissance and discovered that existing pond outflow should be relocated due to erosion and gullying downslope from outflow. As such, outflow was relocated to a more suitable/stable location on the south side of the pond and constructed per recommendations above. Existing outflow was filled with soil, compacted, seeded, and mulched.

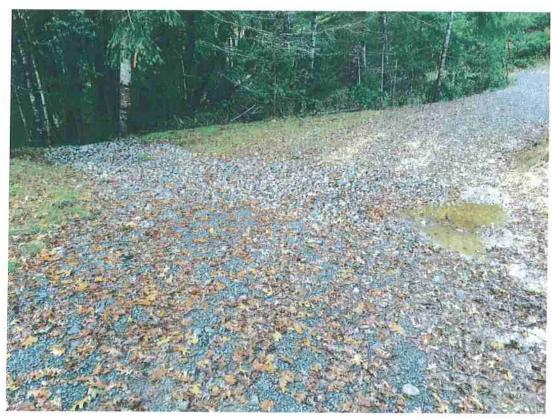
Photo 8. Site 4, new rolling dip.

**Recommendation:** Fill existing cross road drain and construct a new rolling dip to the west. The new dip should be deep enough to drain ponding water and broad enough (~15-20 ft) to diffusely drain flow onto native soils and vegetation and avoid diversion onto the expanded shoulder/pad. Gravel road segment with 6" thickness of road rock.

As-Built Description: Constructed per recommendations.

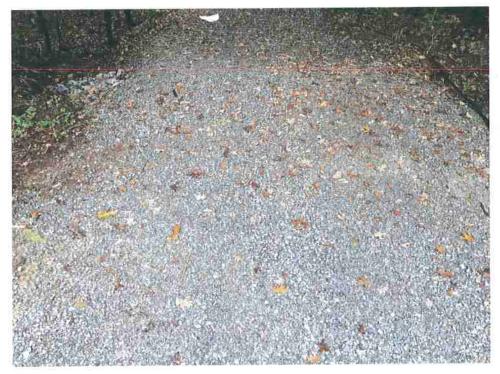
Photo 9. Site 6, new rolling dip.

**Recommendation:** Construct a rolling dip that is broad enough (~15-20 ft) to diffusely drain flow onto native soils and vegetation. Gravel road surface across dip with 6" thickness of road rock.

As-Built Description: Constructed per recommendations.

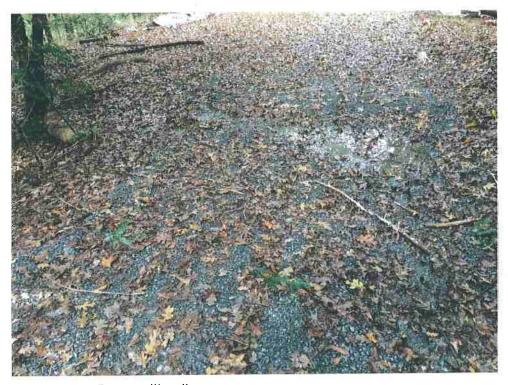
Photo 10. Site 7, new rolling dip.

**Recommendation:** Construct a rolling dip that is broad enough (~15-20 ft) to diffusely drain flow onto native soils and vegetation. Gravel road surface across dip with 6" thickness of road rock.

As-Built Description: Constructed per recommendations.

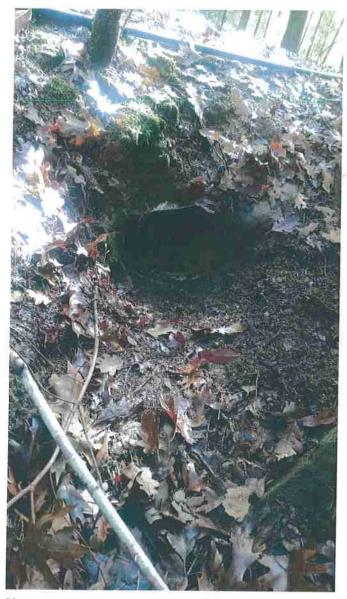
Photo 11. Site 8, newly cleaned culvert inlet.

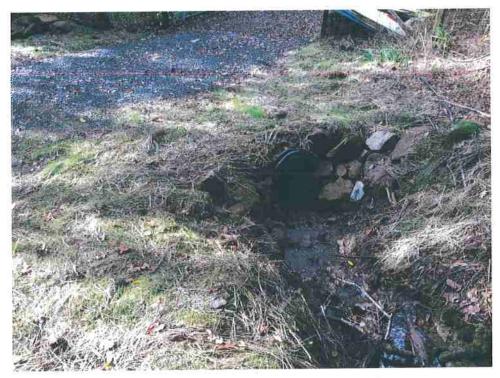
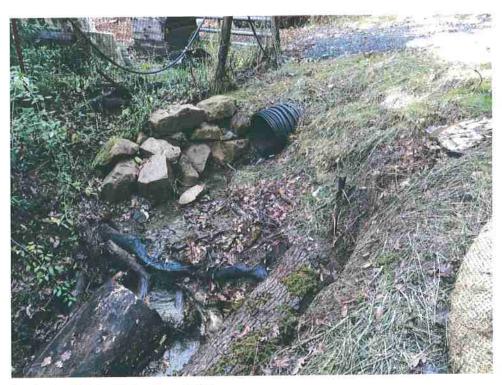
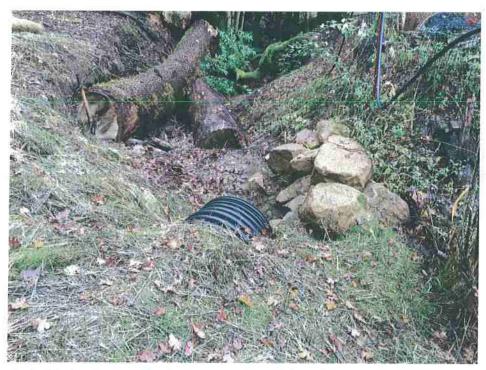
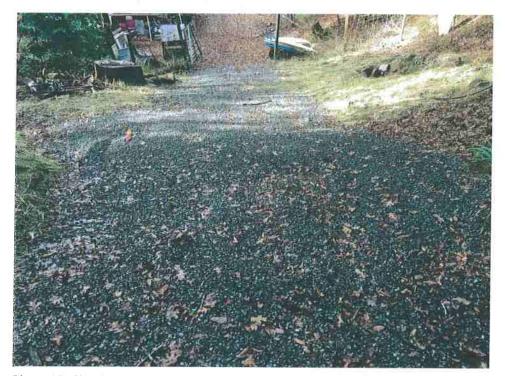
Photo 12. Site 9, new culvert inlet.

Photo 13. Site 9, new culvert outlet.

Photo 14. Site 9, new culvert downstream channel.

Photo 15. Site 9, new culvert upslope rolling dip and road surface.

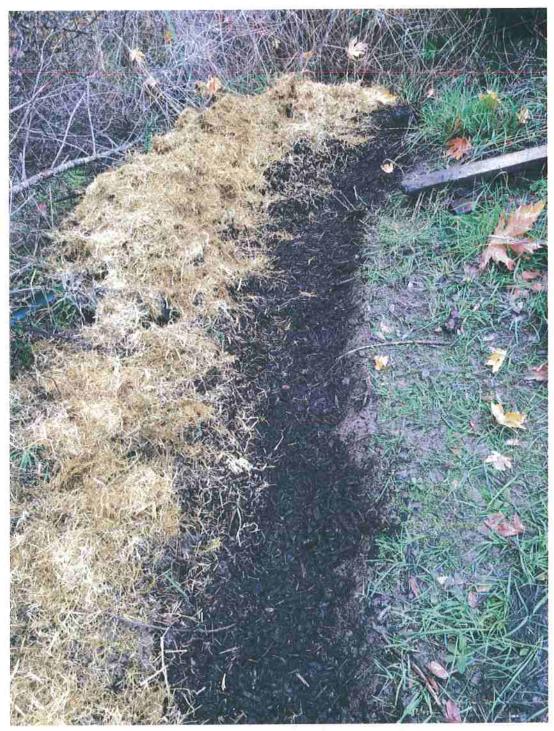
Photo 16. Site 10, bioswale.

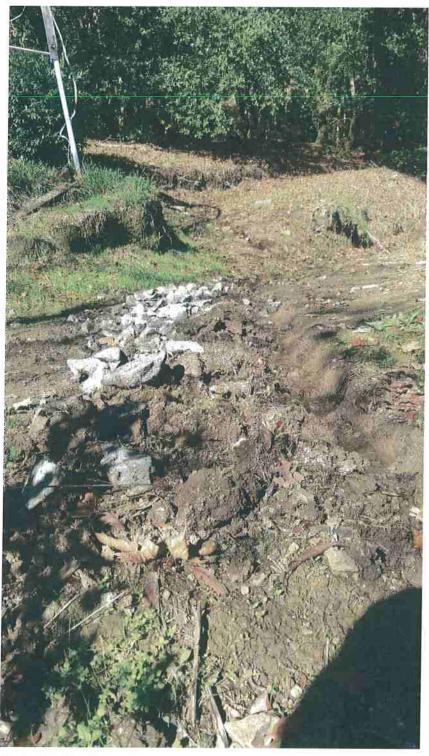
Photo 17. Site 11, waterbar.

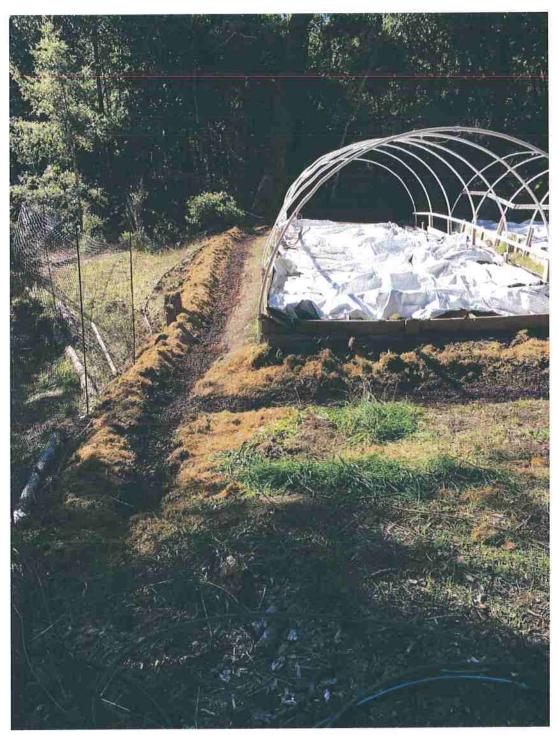
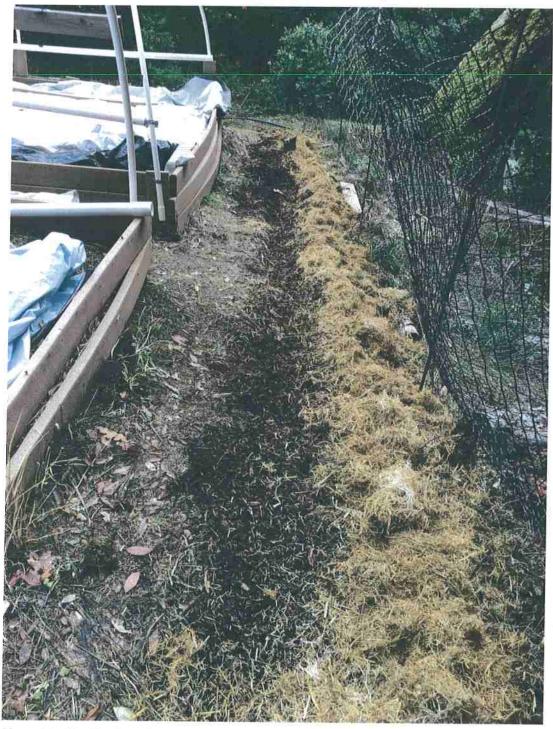
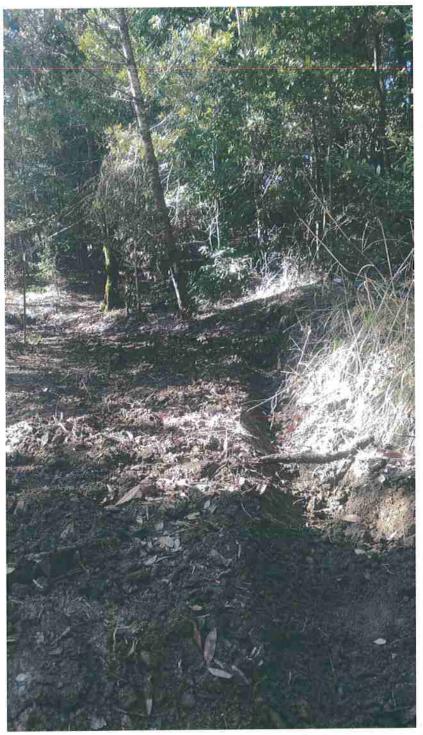
Photo 18. Site 13, bioswale along southern and eastern extent of cultivation site.

Photo 20. Site 13, bioswale along western extent of cultivation site.

**Photo 21.** Site 13, drainage ditch on northern side of cultivation area to direct surface runoff around site.

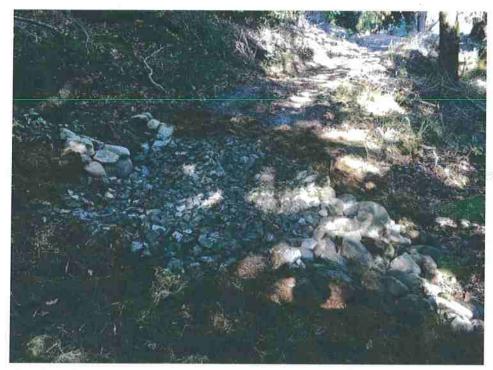
Photo 22. Site 14, small armored ford.

Recommendation: Construct an armored ford.

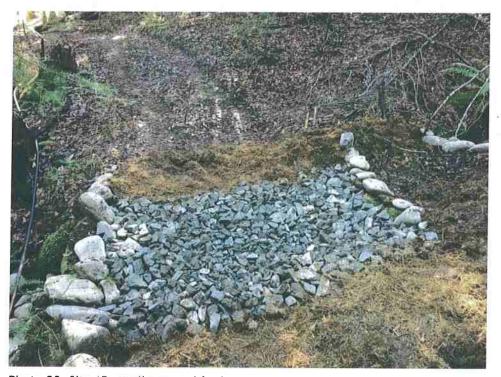
Photo 23. Site 15, small armored ford.

Recommendation: Construct an armored ford.

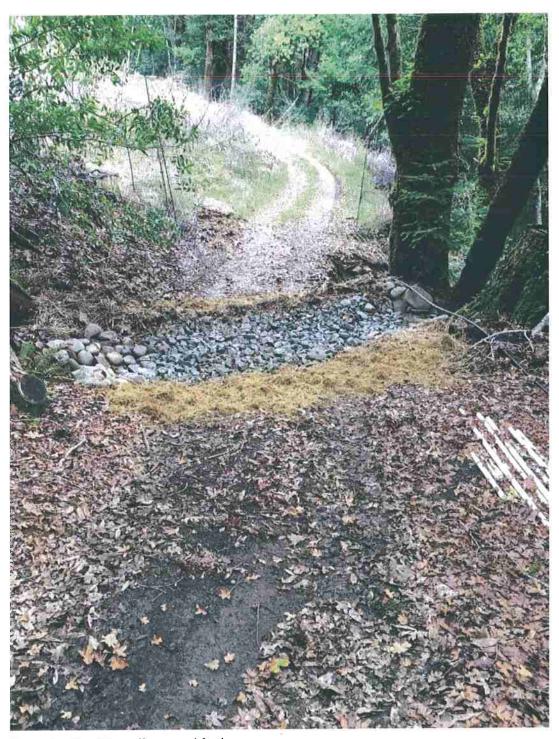
Photo 24. Site 17, small armored ford.

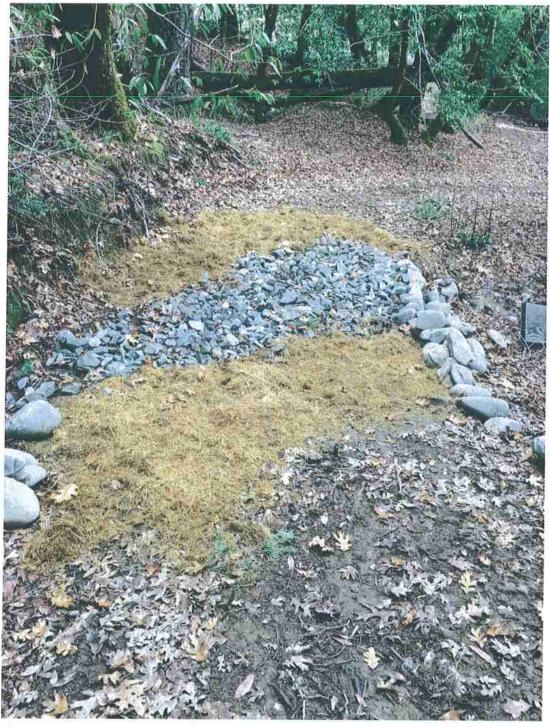
Photo 25. Site 18, small armored ford.

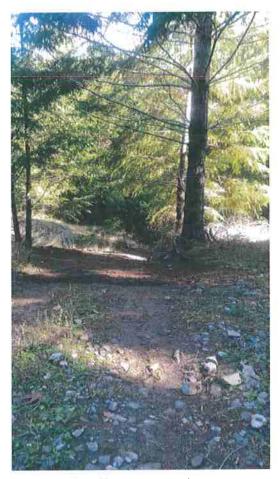
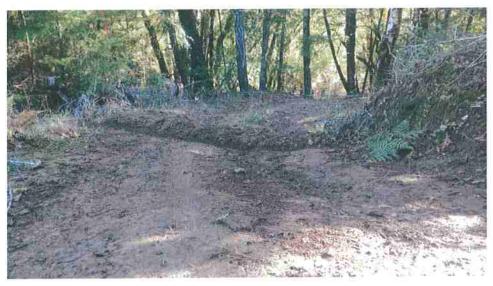
Photo 26. Site 19, upper waterbar.

Photo 27. Site 19, lower waterbar.

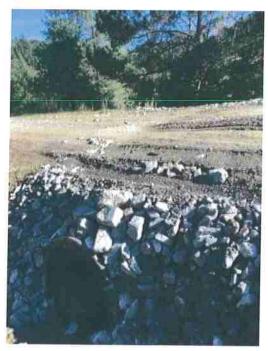
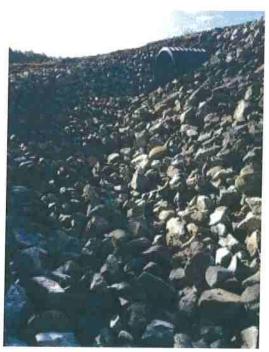
Photo 28. Site 22 culvert inlet.

Photo 29. Site 22 culvert outlet.

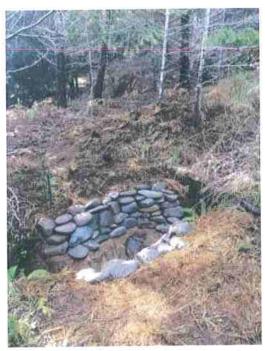
Photo 30. Site 24 small crossing decommissioning.
