# Road Evaluation and Hydrologic Assessment

11/02/2018

Indra Valley Strategic  
Marketing Group, LLC

**MOTHER EARTH  
ENGINEERING**

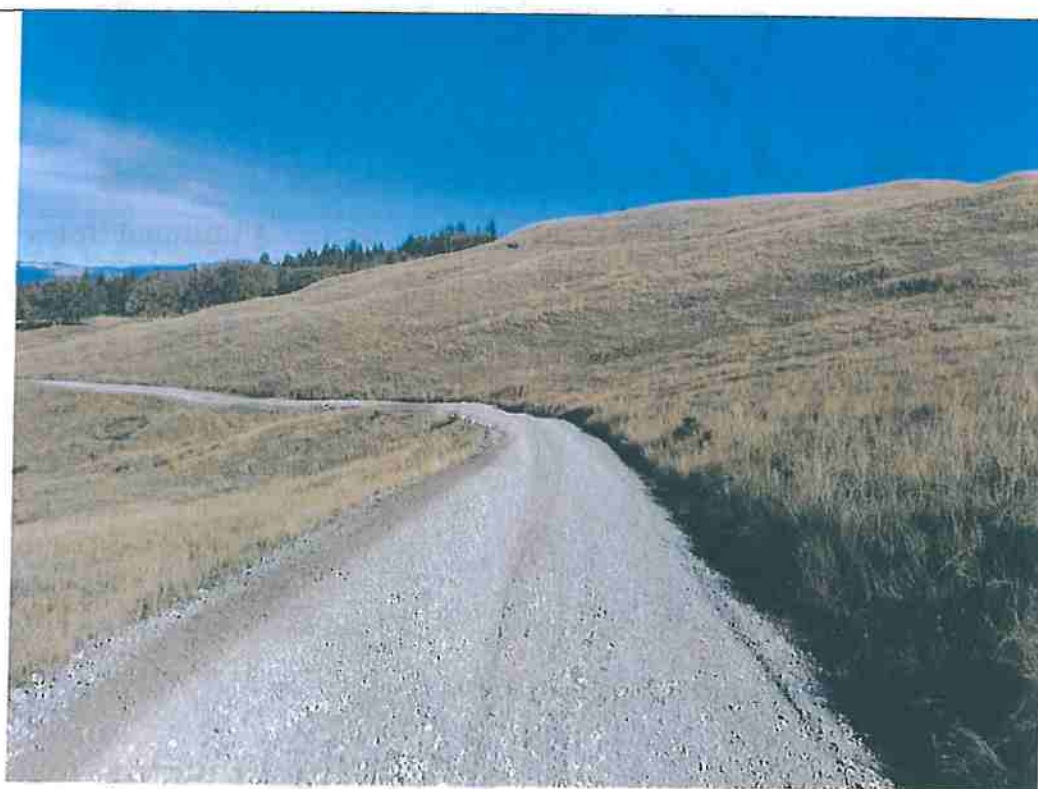
Feature ID	Latitude	Longitude	Road Mileage	Additional Notes
MP10	40.7135	-123.9093	0.03	Photo of the recently spread roadbase.

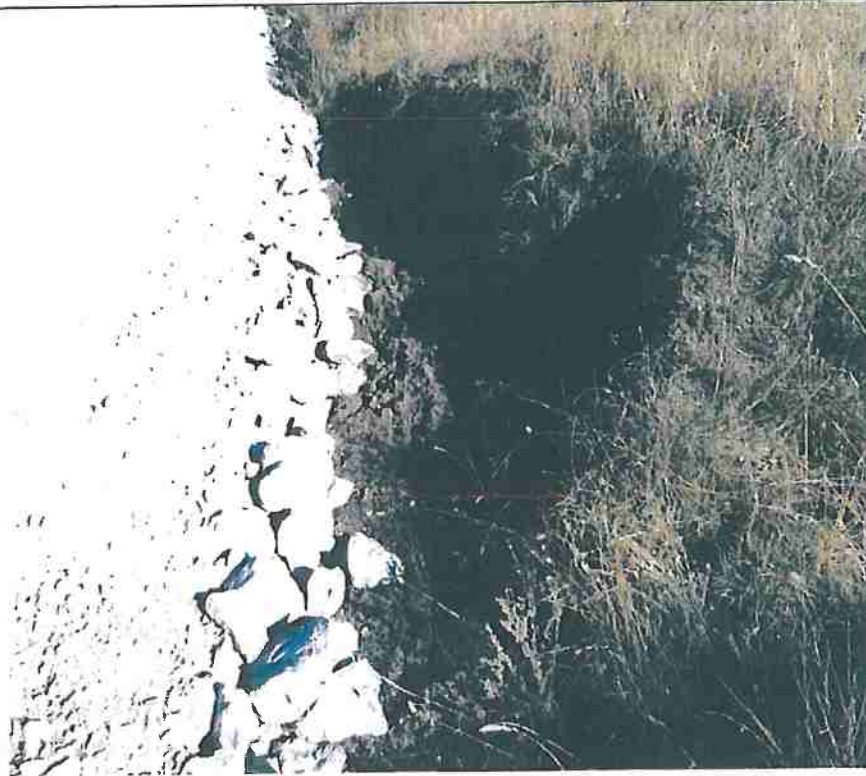
Feature ID	Latitude	Longitude	Road Mileage	Additional Notes
MP11	40.7136	-123.9089	0.05	Remove loose fill and install additional riprap.

- At MP11 use hand tools to remove loose fill that is in pile in the inboard ditch. Use 4" to 8" diameter riprap to reinforce cut bank to prevent erosion.
- Remove loose fill at MP12 with hand tools. Cover exposed earth area with gravel or riprap.
- Use hand tools to clear the outlet of ditch relief culvert at MP19.
- Use hand tools to clear the inlet and outlet of ditch relief culvert at MP28.

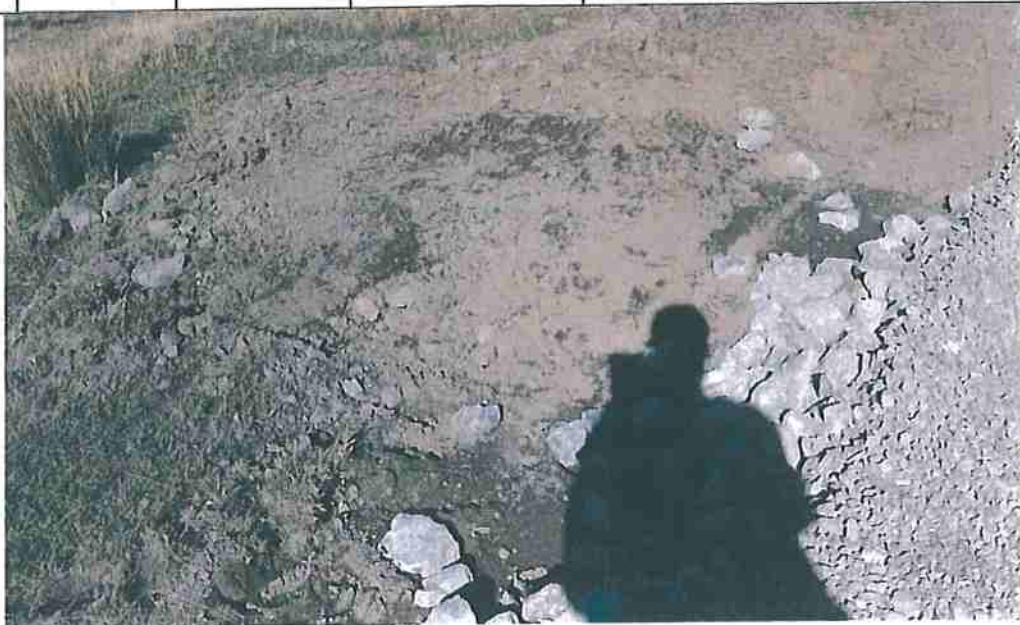
Feature ID	Latitude	Longitude	Road Mileage	Additional Notes
MP12	40.7137	-123.9088	0.06	Remove loose fill. Armor exposed earthen area with gravel or riprap.

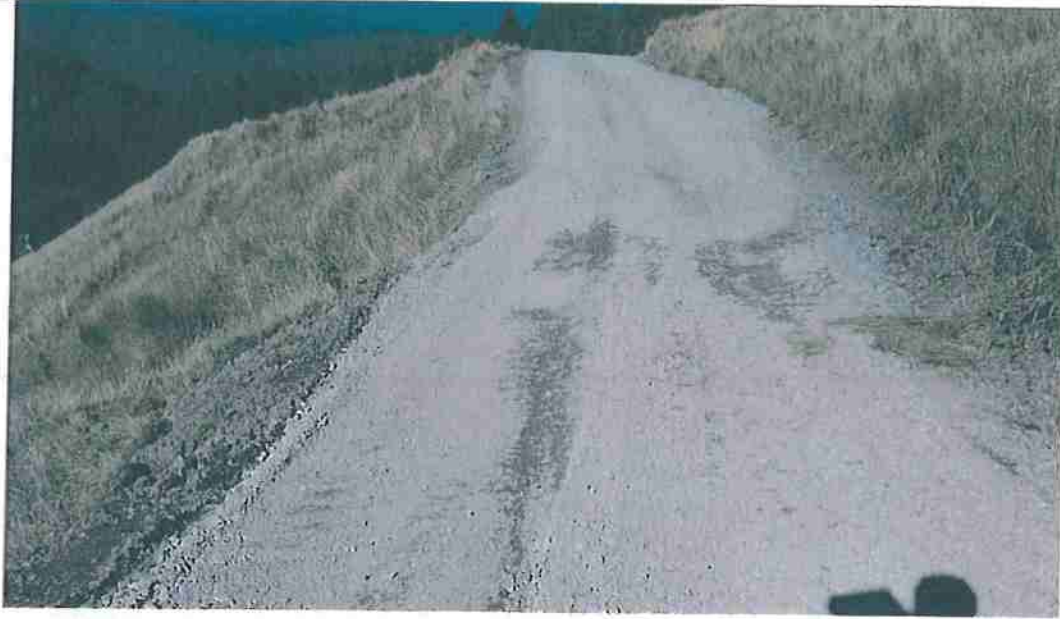
Feature ID	Latitude	Longitude	Road Mileage	Additional Notes
MP13	40.7141	-123.9086	0.08	Reshape rolling dip and armor outlet.

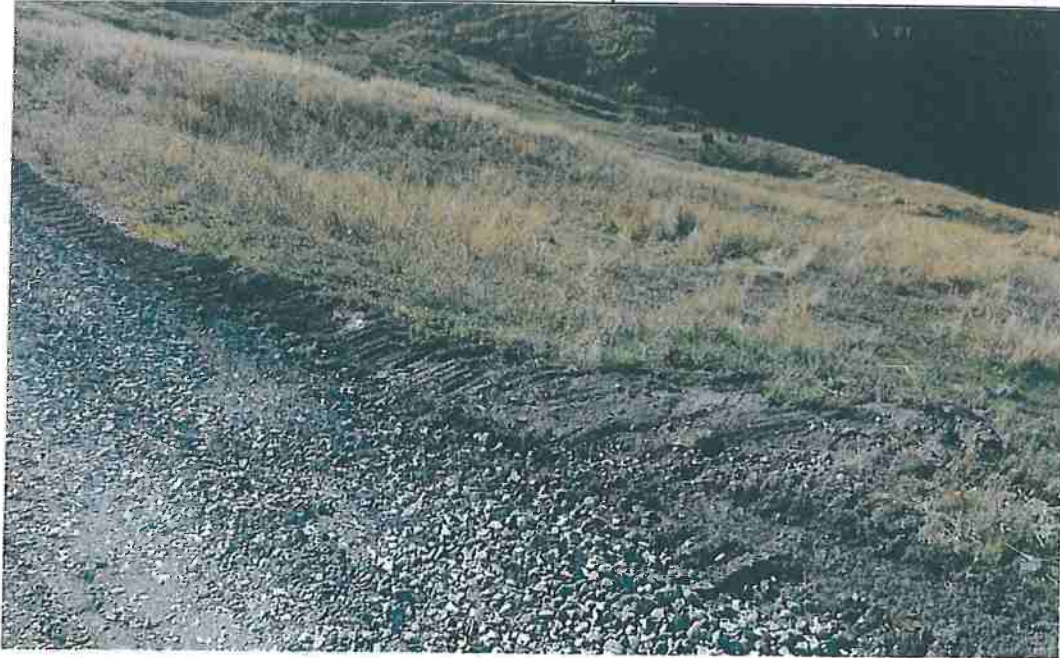
Feature ID	Latitude	Longitude	Road Mileage	Additional Notes
MP14	40.7146	-123.9086	0.12	Reshape rolling dip and armor outlet.

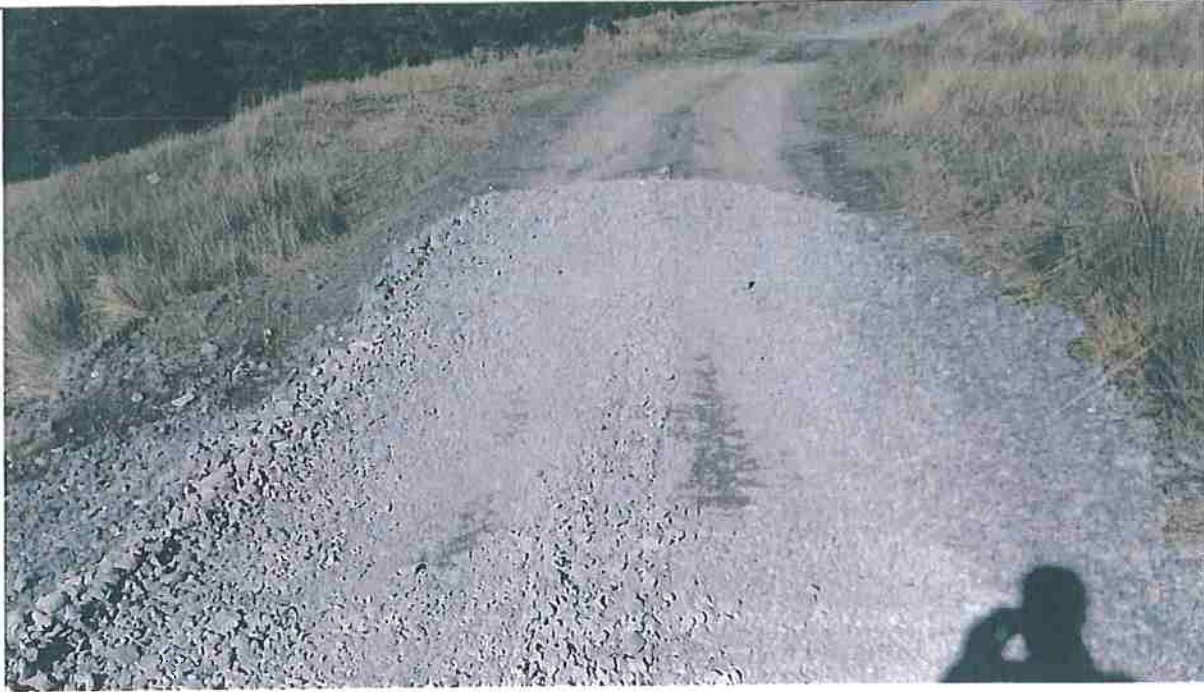
Feature ID	Latitude	Longitude	Road Mileage	Additional Notes
MP15	40.7152	-123.9084	0.17	Reshape rolling dip and armor outlet.

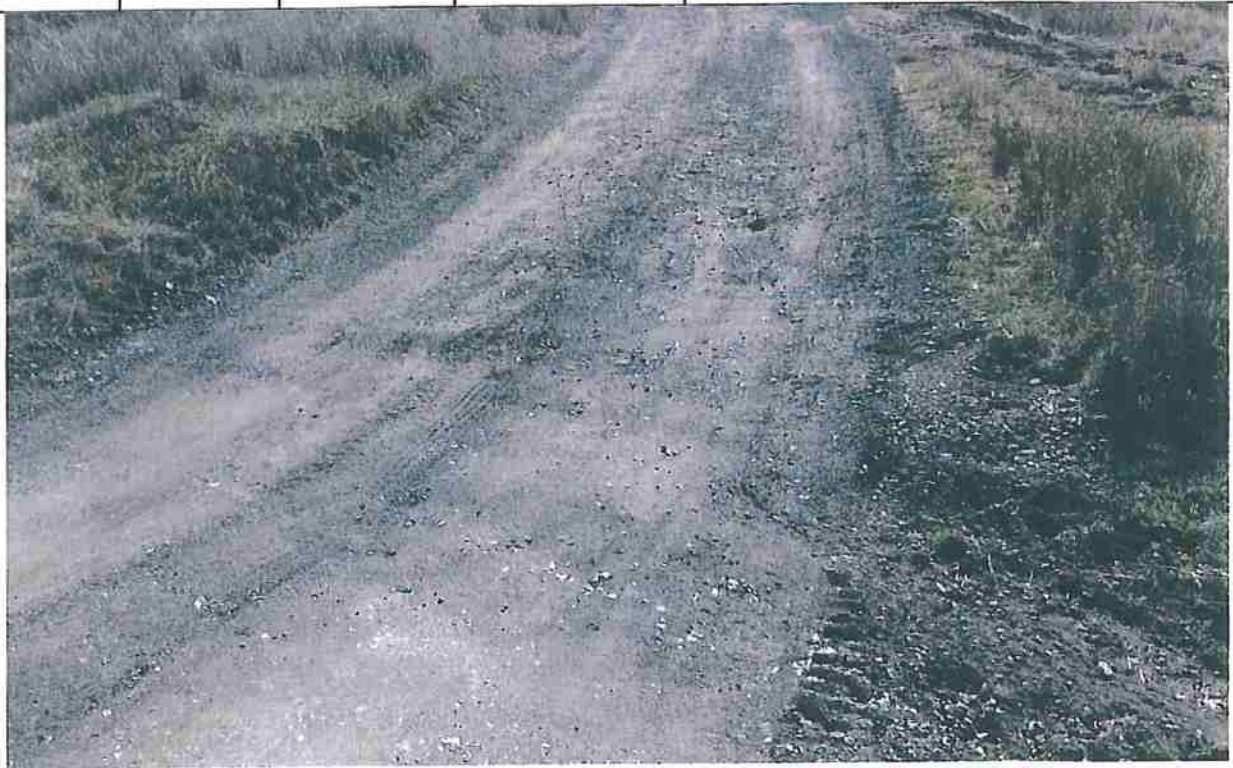
Feature ID	Latitude	Longitude	Road Mileage	Additional Notes
MP16	40.7154	-123.9084	0.18	Reshape rolling dip and armor outlet.

- Use machinery to install a rolling dip at MP16, the site of a poorly defined dip. Install riprap at outlet.
- Use machinery to install riprap rock ford at site of seep spring at MP29. Regrade road into an outsloping surface.
- Ditch and road surface stormwater flow must be disconnected from directly flowing into the Class III watercourse at MP38. Use machinery to install waterbars or rolling dips on both sides of the watercourse crossing within 30 to 100 feet of the crossing.
- Ditch and road stormwater flow must be disconnected from directly flowing into the Class III watercourse at MP41. Use machinery to install waterbars or rolling dips on both sides of the watercourse crossing within 30 to 100 feet of the crossing.
- Install defined drainage at intersection of roads (MP32 and MP42) complete with energy dissipation and sediment capture at outlet.

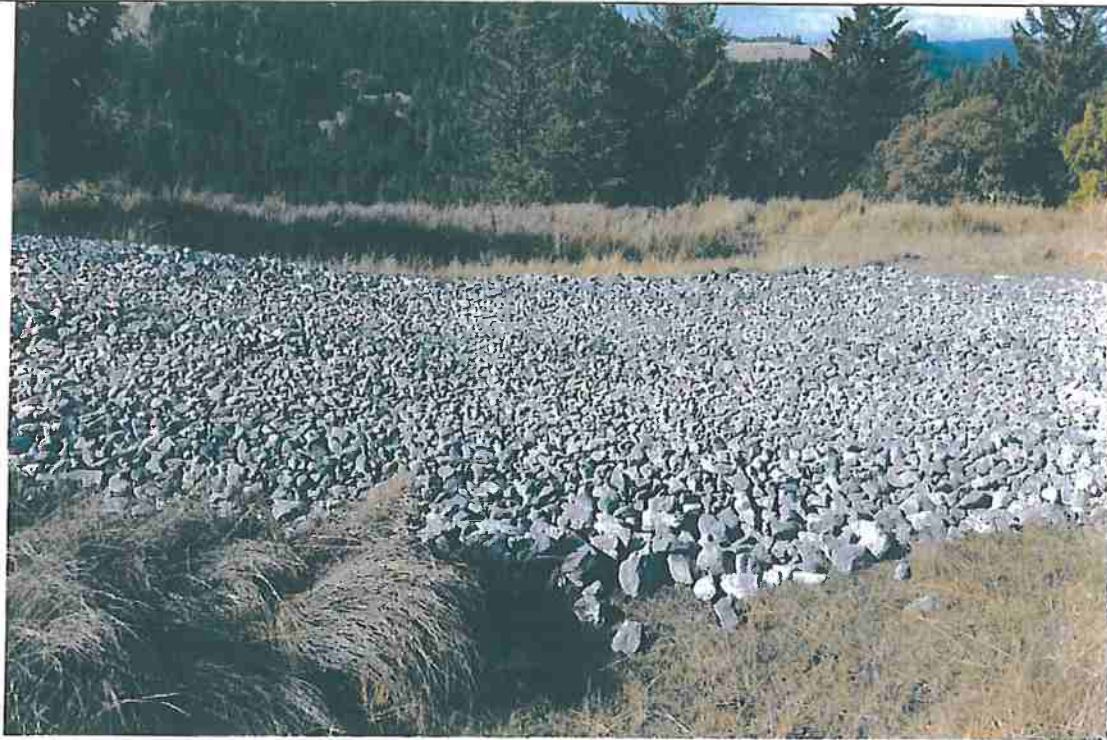
Feature ID	Latitude	Longitude	Road Mileage	Additional Notes
MP17	40.7155	-123.9083	0.18	Class III headwaters/armored crossing. Maintain and monitor.

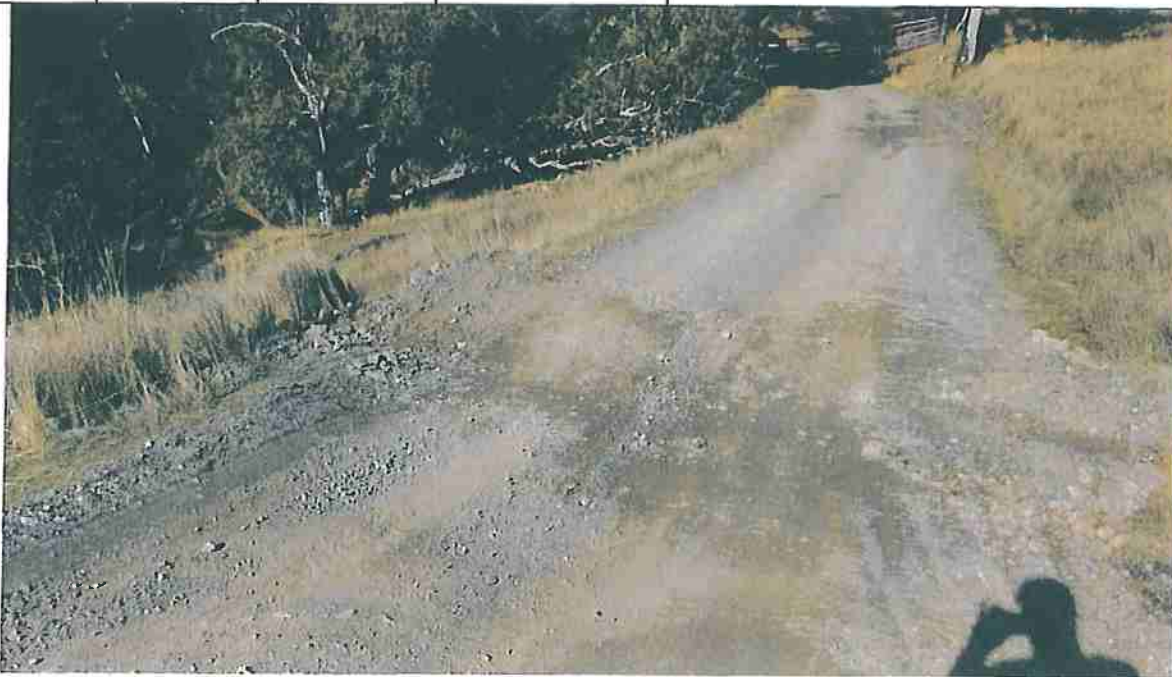
Feature ID	Latitude	Longitude	Road Mileage	Additional Notes
MP18	40.7158	-123.9080	0.21	Reshape rolling dip and armor outlet.

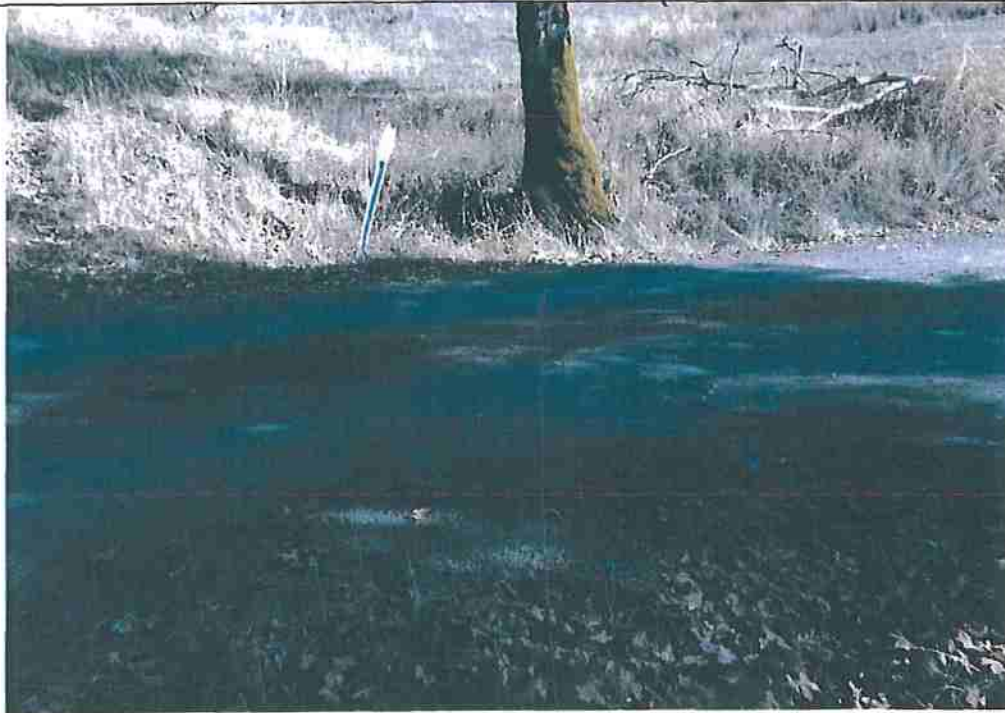
Feature ID	Latitude	Longitude	Road Mileage	Additional Notes
MP19	40.7161	-123.9080	0.23	This is the site of a 12" diameter metal ditch relief culvert. Clear debris from outlet of ditch relief culvert.

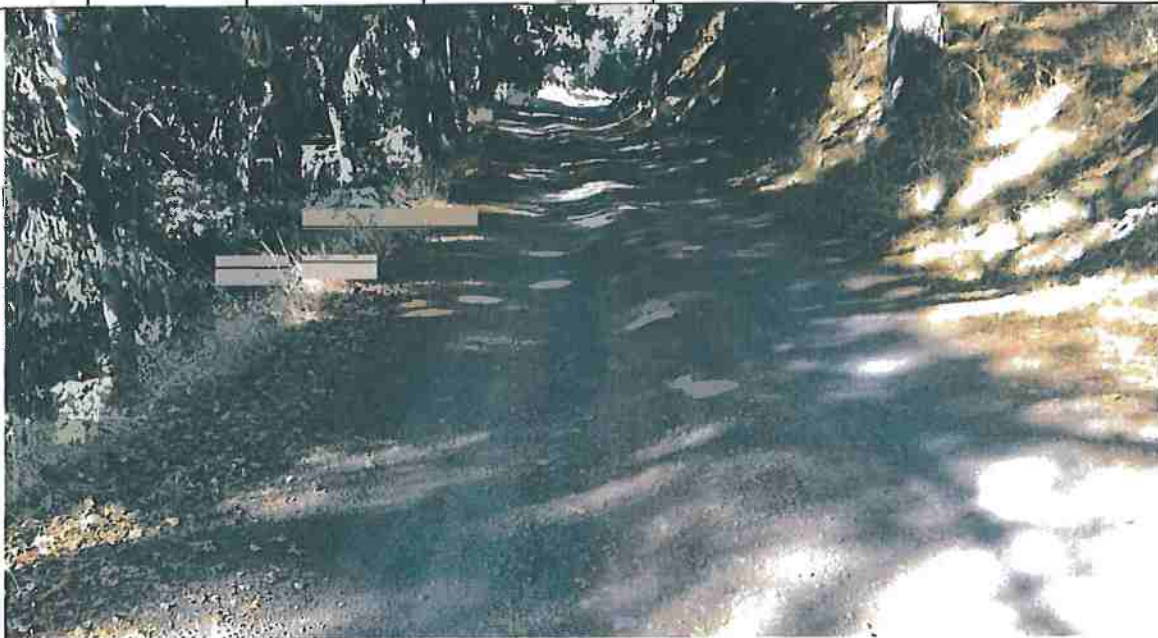
Feature ID	Latitude	Longitude	Road Mileage	Additional Notes
MP20	40.7164	-123.9082	0.25	Maintain and monitor, regrade to outsloping surface wherever possible.

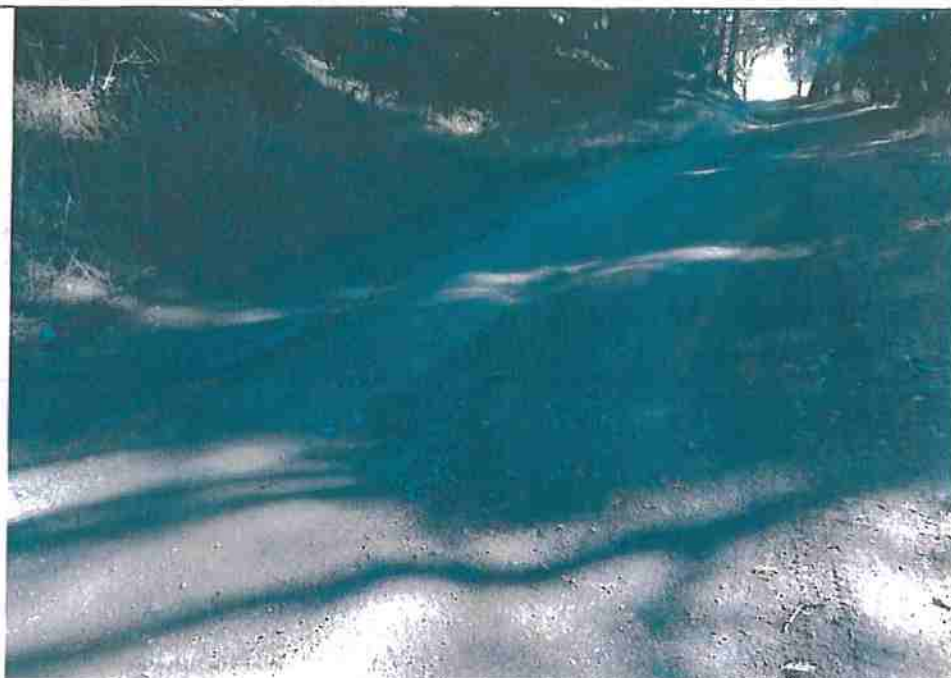
Feature ID	Latitude	Longitude	Road Mileage	Additional Notes
MP21	40.7169	-123.9084	0.29	Reshape rolling dip and armor outlet.

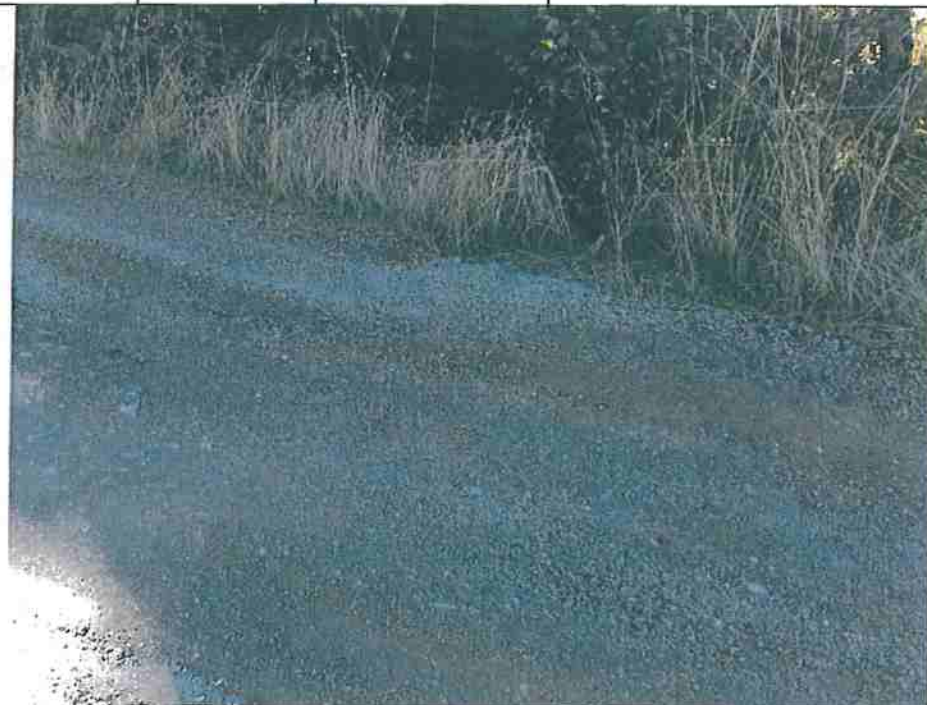
Feature ID	Latitude	Longitude	Road Mileage	Additional Notes
MP22	40.7174	-123.9086	0.32	Reshape rolling dip and armor outlet.

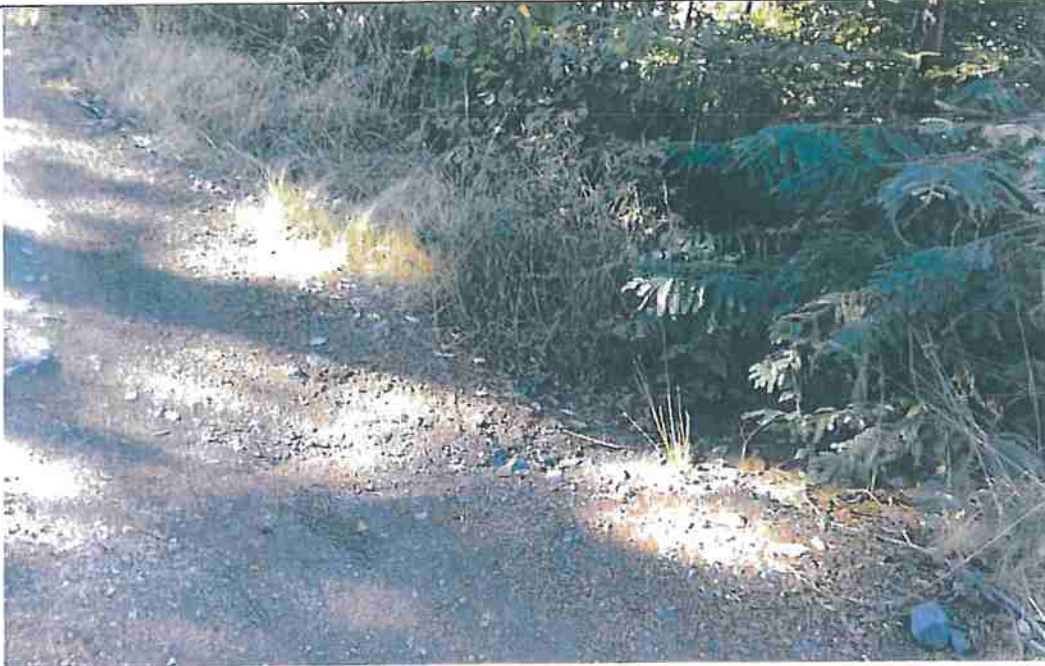
Feature ID	Latitude	Longitude	Road Mileage	Additional Notes
MP23	40.7181	-123.9084	0.38	Reshape rolling dip and armor outlet. Regrade road surface to remove ruts and create outsloping surface.

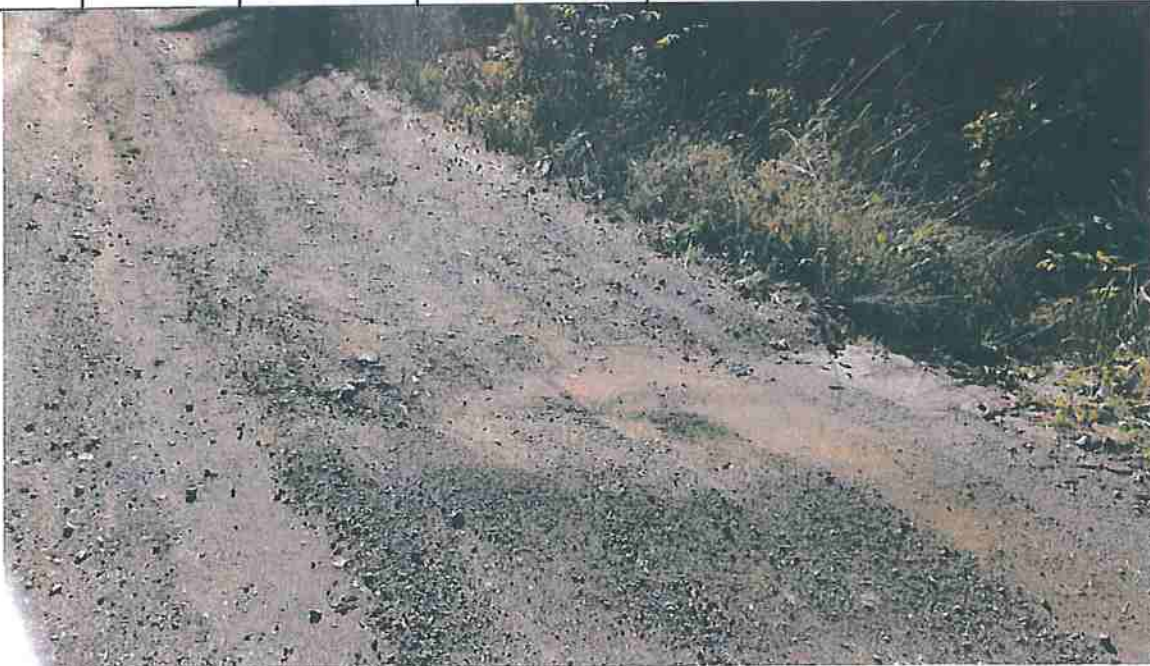
MP24	40.7189	-123.9079	0.44	Poorly defined rolling dip, exposed earth at outlet. Continuous tire ruts.	Reshape rolling dip and rock armor outlet. Outslope road as feasible.
MP25	40.7193	-123.9077	0.47	Undefined rolling dip.	Reshape rolling dip and rock armor outlet. Outslope road as feasible.
MP26	40.7198	-123.9071	0.52	Undefined rolling dip.	Reshape rolling dip and rock armor outlet. Outslope road as feasible.

Feature ID	Latitude	Longitude	Road Mileage	Additional Notes
MP24	40.7189	-123.9079	0.44	Reshape rolling dip and armor outlet. Regrade road surface to remove ruts and create outsloping surface.

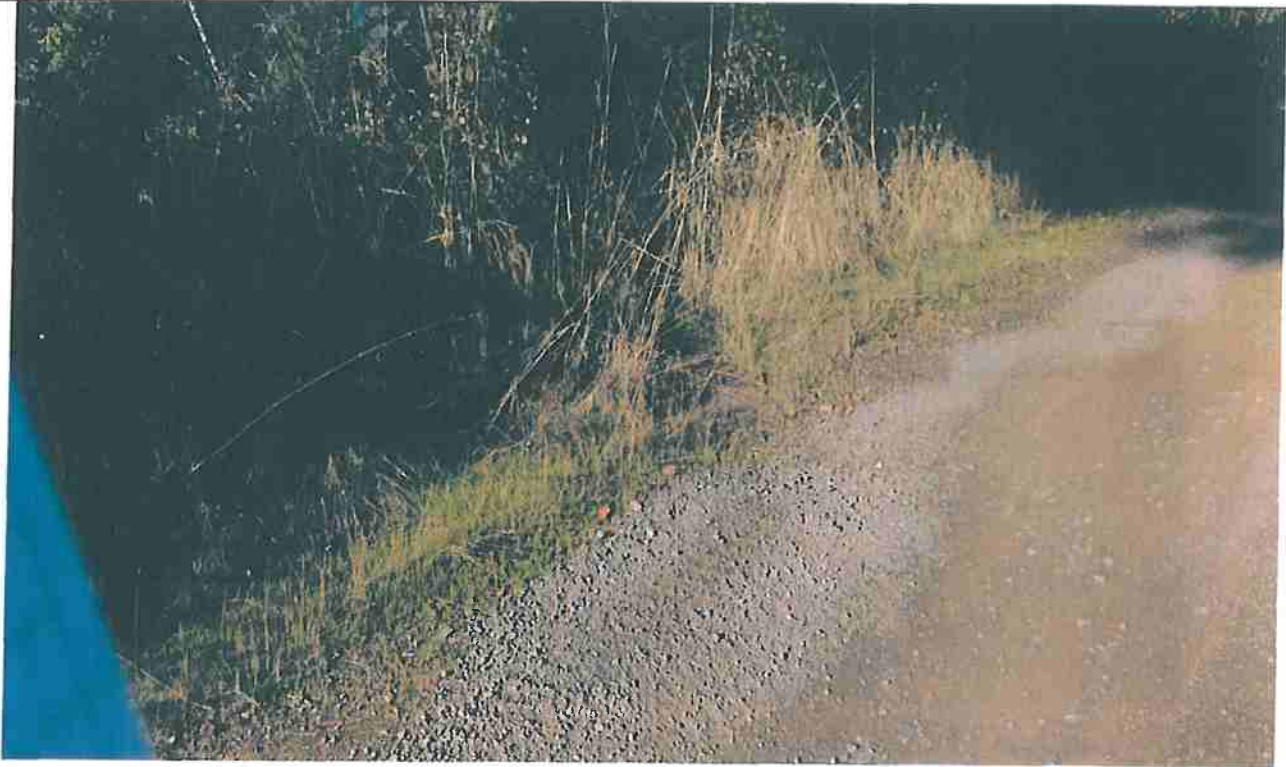
Feature ID	Latitude	Longitude	Road Mileage	Additional Notes
MP25	40.7193	-123.9077	0.47	Reshape rolling dip and armor outlet.

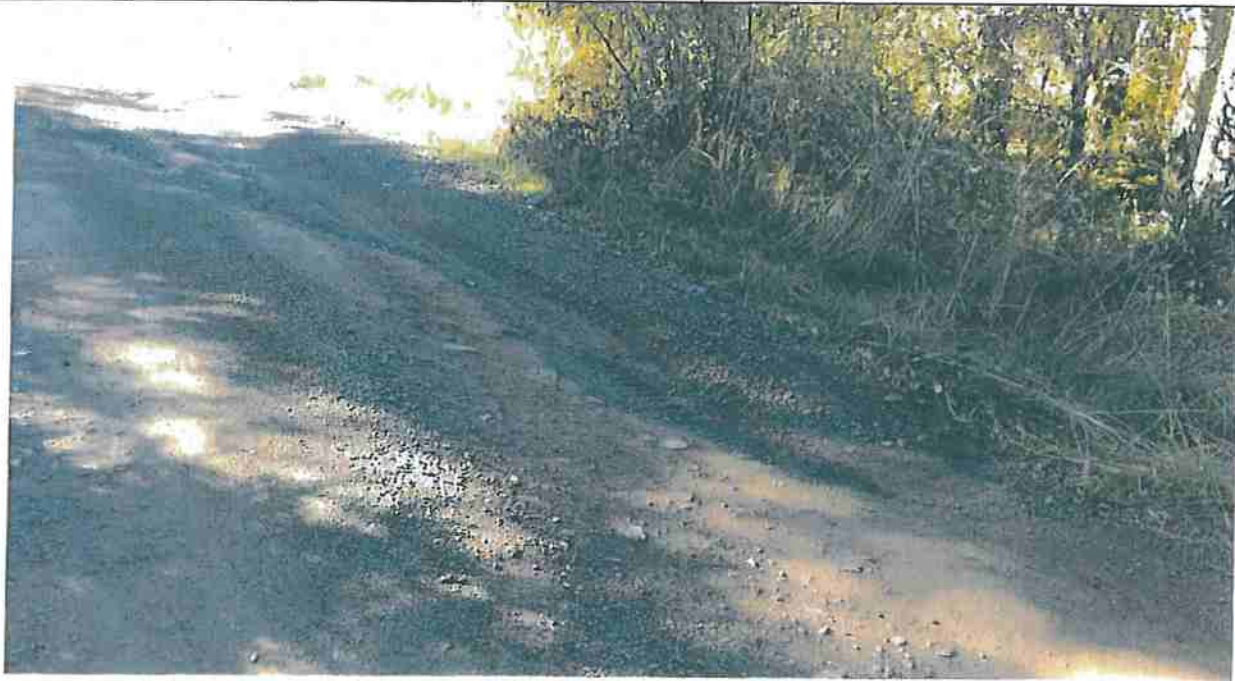
Feature ID	Latitude	Longitude	Road Mileage	Additional Notes
MP26	40.7198	-123.9071	0.52	Reshape rolling dip and armor outlet.

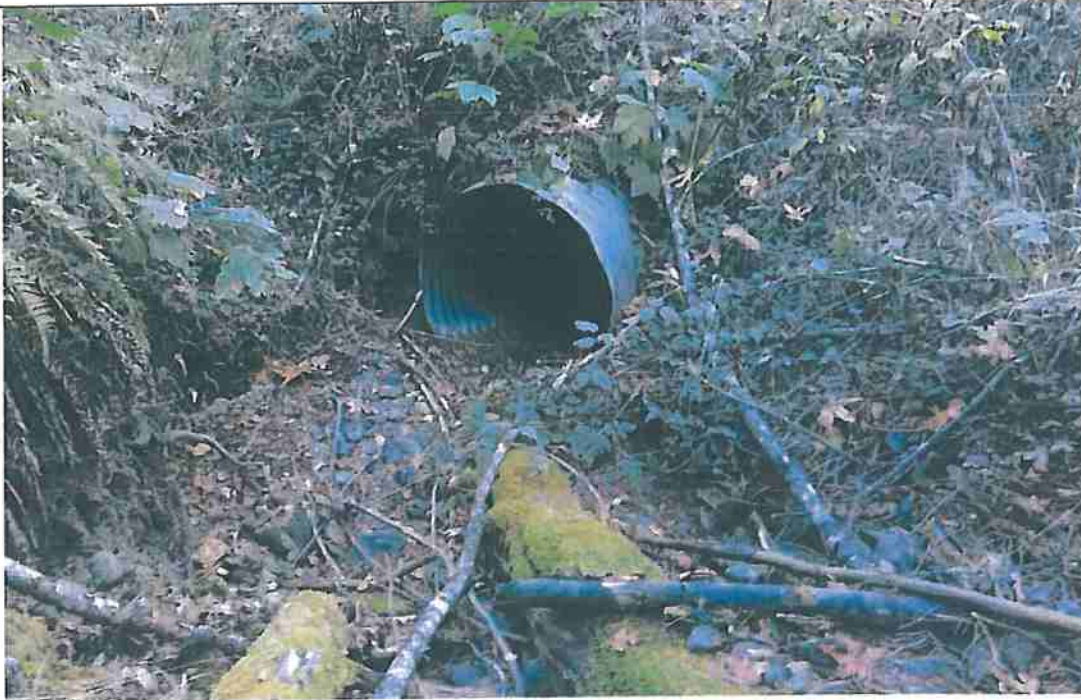
Feature ID	Latitude	Longitude	Road Mileage	Description	Prescription
MP27	40.7199	-123.9060	0.59	Class III watercourse crossing with corrugated metal 36" diameter culvert. Hydrologic connection roadside ditch at inlet in both directions	Hydrologically disconnect roadway from watercourse with waterbars or rolling dips.
MP28	40.7199	-123.9043	0.69	12" corrugated metal ditch relief culvert. Poorly defined inboard ditch. Debris build up at inlet and outlet.	Clean out inlet and outlet immediately. Long term objective: reshape ditch.
MP29	40.7198	-123.9039	0.71	Inboard seep flowing on roadway. Two 4" PVC perforated pipe installed to drain roadway. Potholes throughout roadway.	Install a rock armor crossing for seep to pass directly across roadway. Regrade road surface to outsloping surface.
MP30	40.7207	-123.9032	0.78	Undefined rolling dip.	Reshape rolling dip and rock armor outlet. Outslope road as feasible.

Feature ID	Latitude	Longitude	Road Mileage	Additional Notes
MP27	40.7199	-123.9060	0.59	Site of a 36" diameter stream crossing culvert. Hydrologically disconnect roadway from watercourse with waterbars or rolling dips.

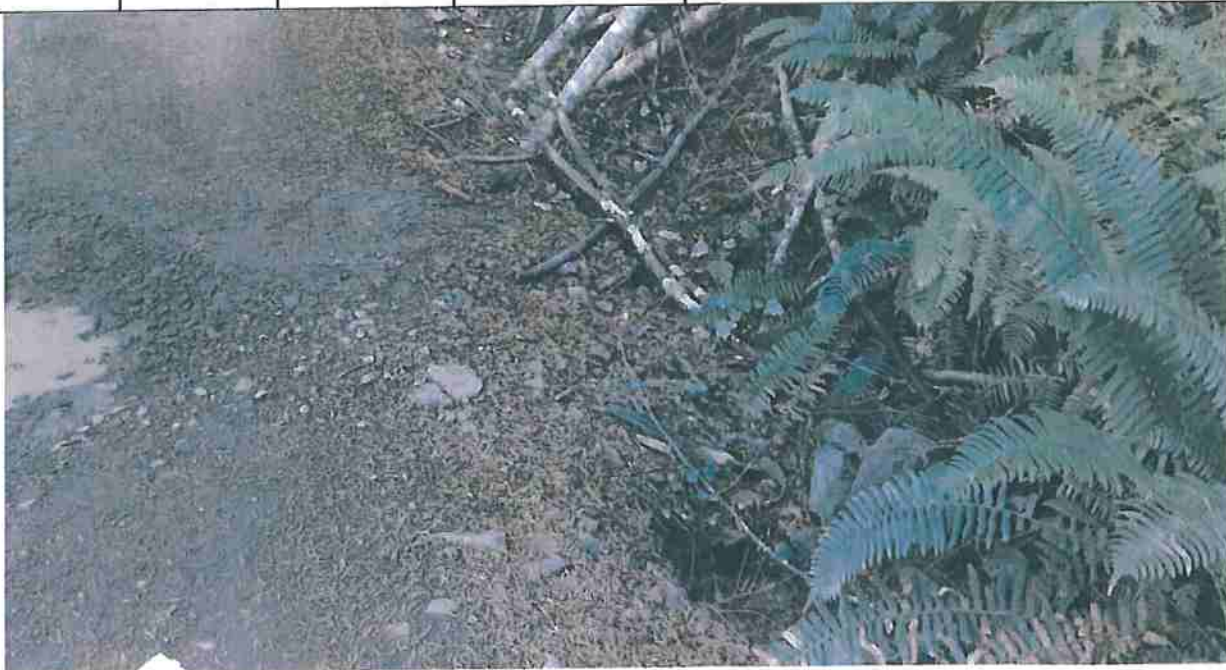
Feature ID	Latitude	Longitude	Road Mileage	Additional Notes
MP28	40.7199	-123.9043	0.69	Clean out inlet and outlet immediately. Long term objective: reshape ditch.

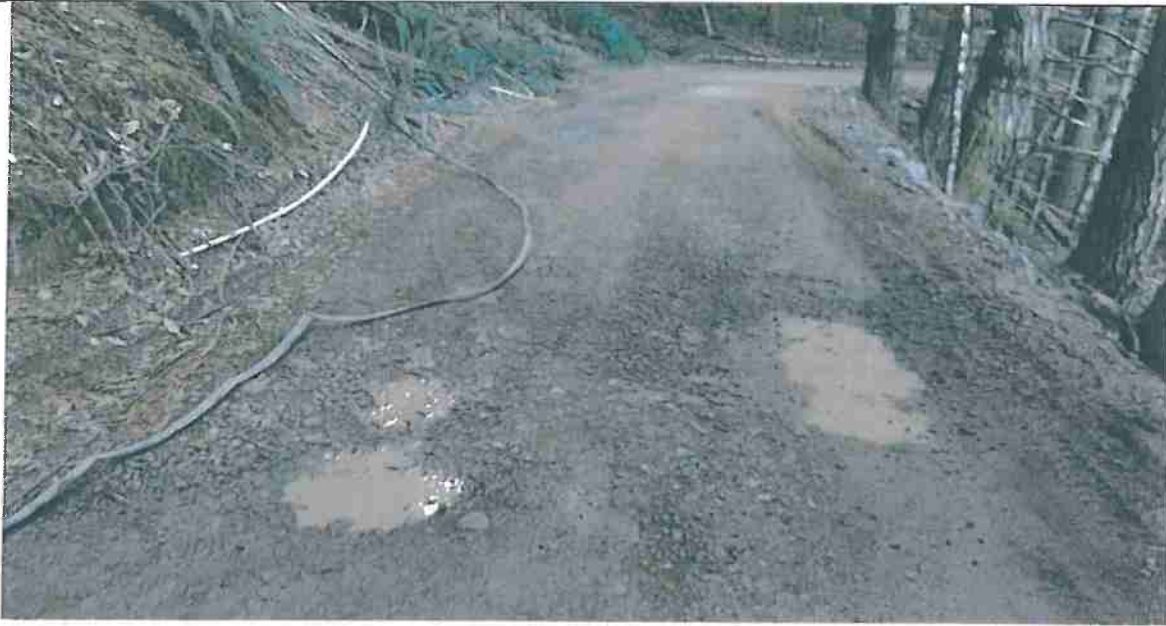
Feature ID	Latitude	Longitude	Road Mileage	Additional Notes
MP29	40.7198	-123.9039	0.71	Install a rock armor crossing for seep to pass directly across roadway. Regrade road surface into an outsloping surface.

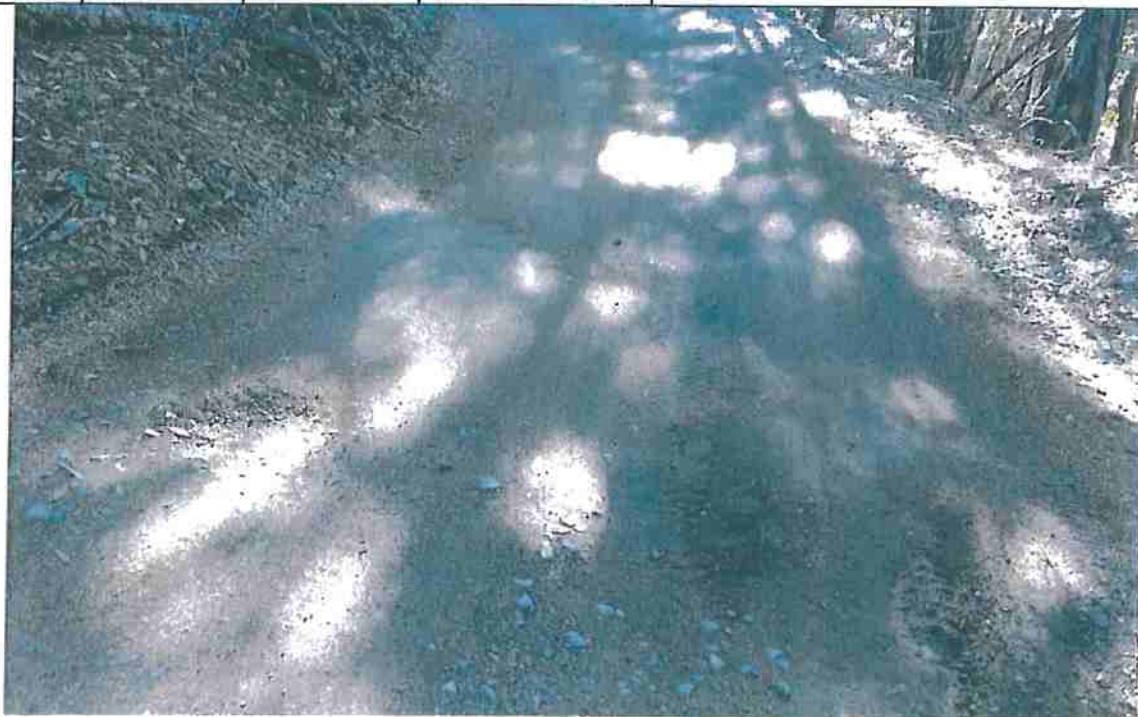
Feature ID	Latitude	Longitude	Road Mileage	Additional Notes
MP30	40.7207	-123.9032	0.78	Reshape rolling dip and armor outlet. Regrade surface to out slope.

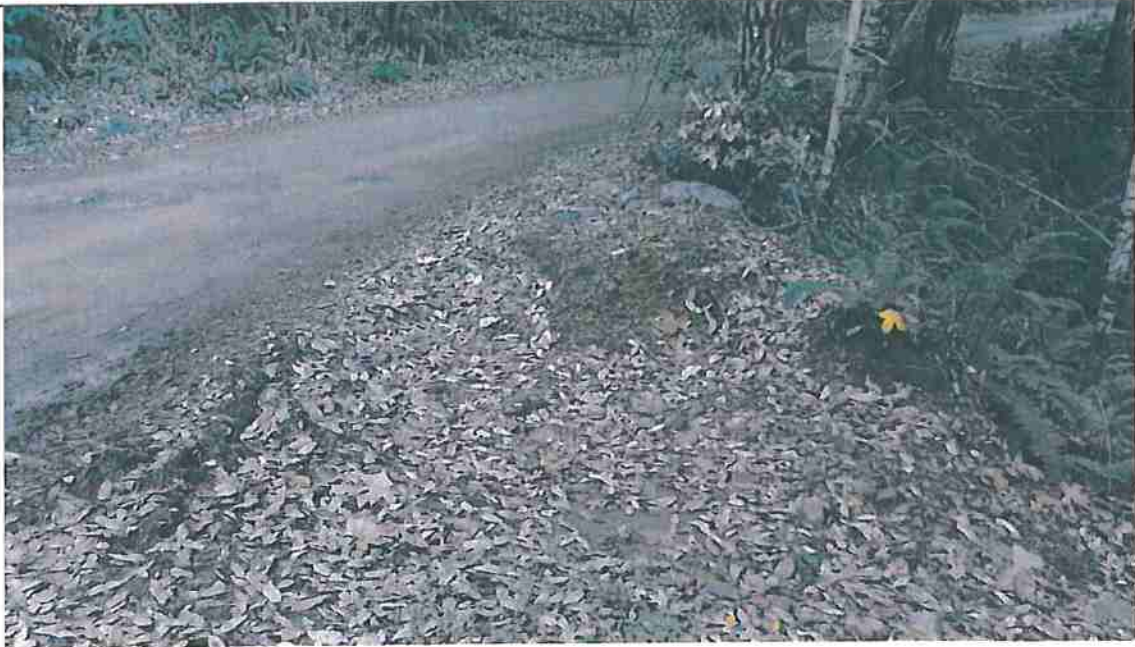
MP31	40.7209	-123.9016	0.87	Low point of road with no defined outlet.	Install rolling dip and rock armor outlet.
MP32	40.7214	-123.9011	0.92	Drainage for landing and surface water from spur road. No defined drainage.	Install rolling dip and rock armor outlet, install energy dissipation and sediment capture.
MP33	40.7217	-123.8989	1.04	Undefined rolling dip.	Install rolling dip and rock armor outlet.
MP34	40.7218	-123.8973	1.13	Poorly defined rolling dip.	Reshape rolling dip and rock armor outlet.
MP35	40.7215	-123.8969	1.16	Poorly defined rolling dip.	Reshape rolling dip and rock armor outlet.

Feature ID	Latitude	Longitude	Road Mileage	Additional Notes
MP31	40.7209	-123.9016	0.87	Reshape rolling dip and armor outlet.

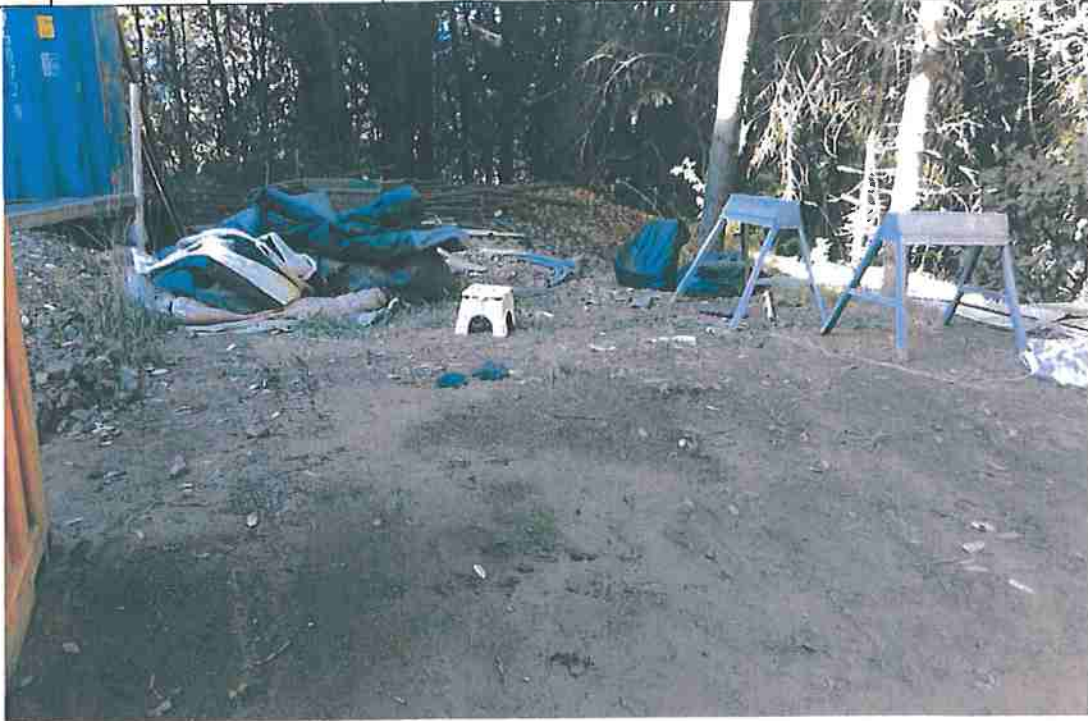
Feature ID	Latitude	Longitude	Road Mileage	Additional Notes
MP32	40.7214	-123.9011	0.92	No defined drainage at intersection of roadways. Develop drainage with energy dissipation and sediment capture.

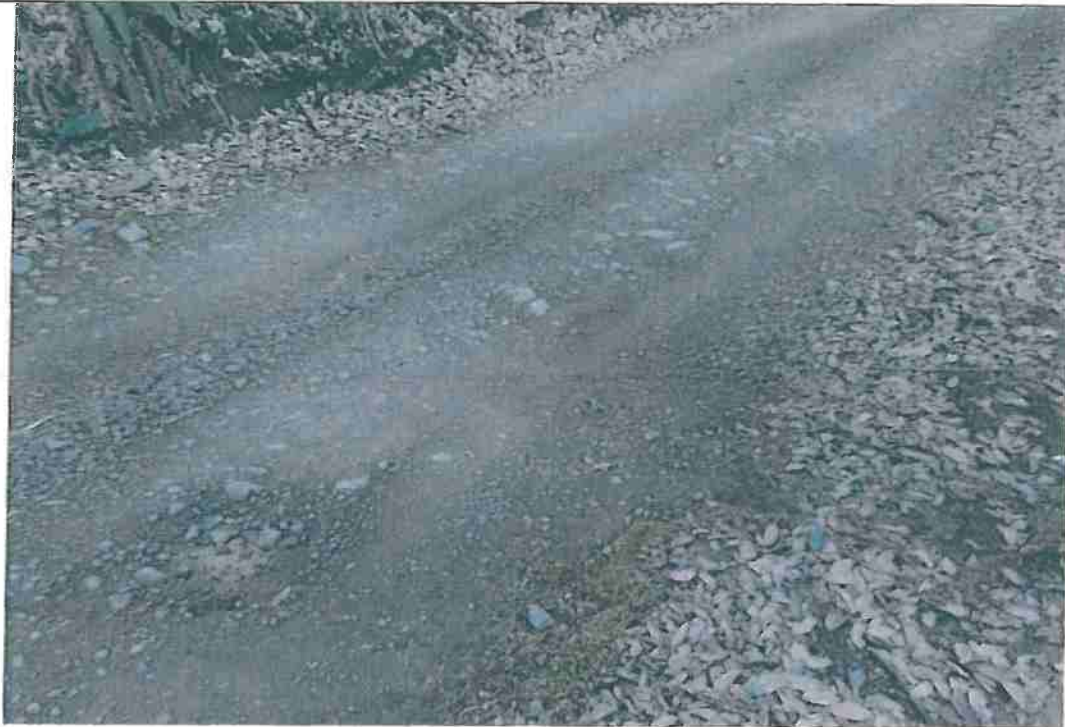
Feature ID	Latitude	Longitude	Road Mileage	Additional Notes
MP33	40.7217	-123.8989	1.04	Reshape rolling dip and armor outlet.

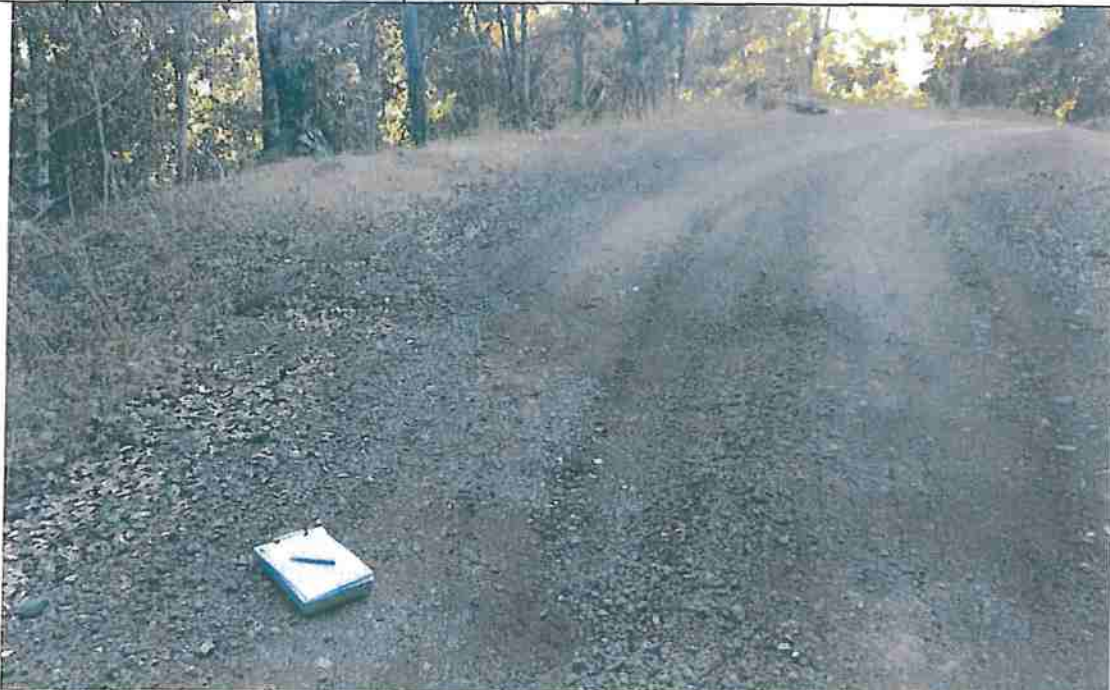
Feature ID	Latitude	Longitude	Road Mileage	Additional Notes
MP34	40.7218	-123.8973	1.13	Reshape rolling dip and armor outlet.

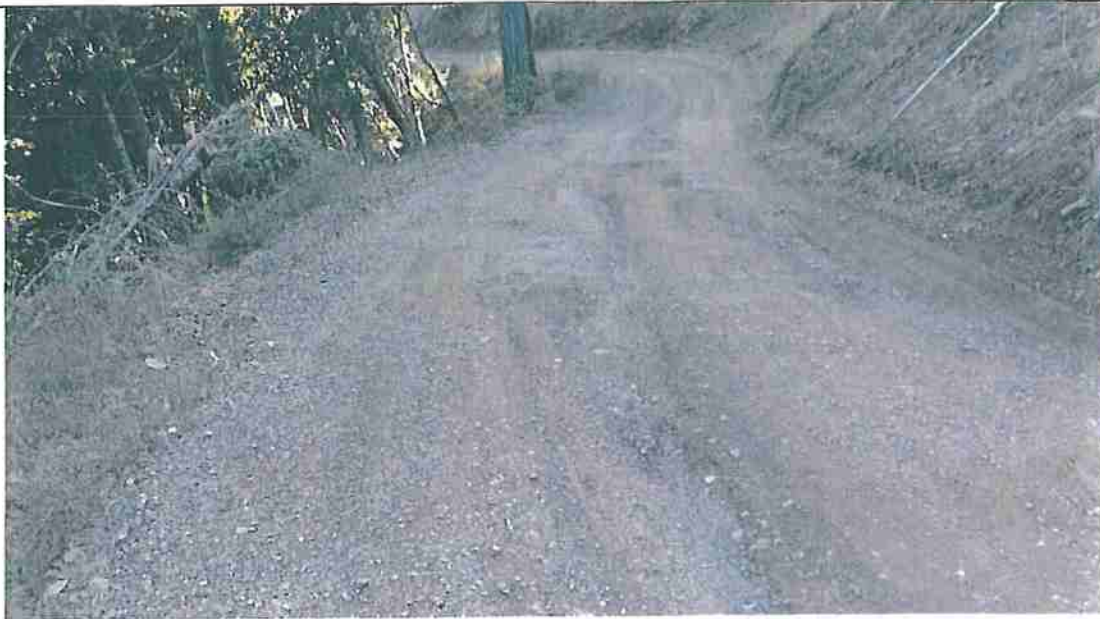
Feature ID	Latitude	Longitude	Road Mileage	Additional Notes
MP35	40.7215	-123.8969	1.16	Reshape rolling dip and armor outlet.

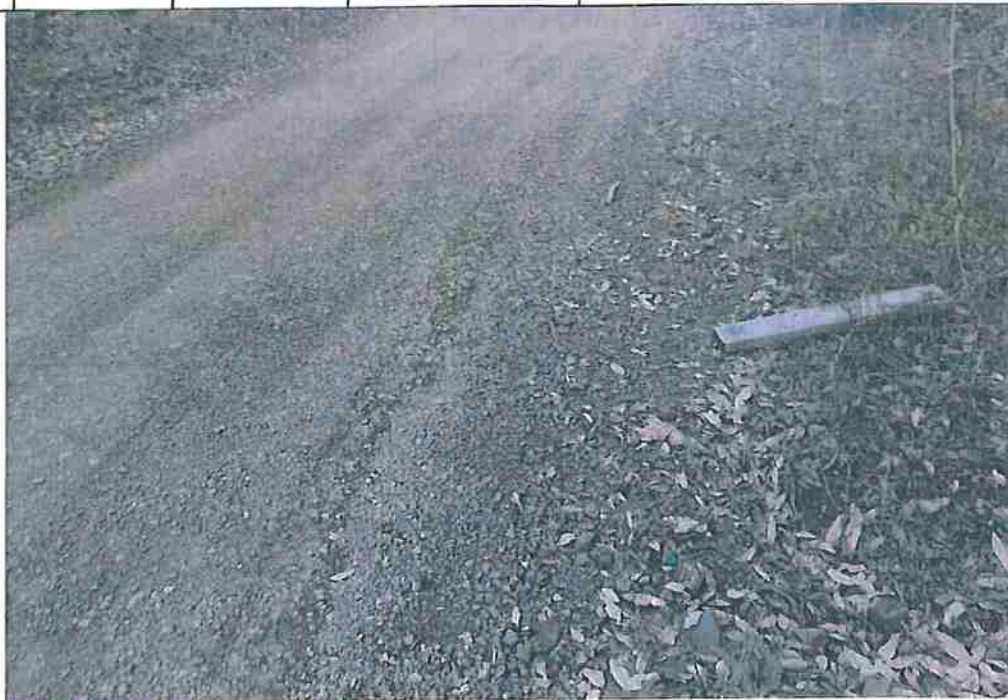
Feature ID	Latitude	Longitude	Road Mileage	Description	Prescription
MP36	40.7212	-123.8970	1.19	Poorly defined rolling dip. Primary road drainage is in tire rut.	Reshape rolling dip and rock armor outlet. Outslope road as feasible.
MP37	40.7208	-123.8967	1.21	Meandering rut runs across road drains into old cast off.	Long term objective: regrade road and install a rolling dip. Armor outlet.
MP38	40.7205	-123.8966	1.24	Class III stream crossing through a 36" diameter corrugated metal culvert. Hydrologic connection on both sides at inlet and outlet.	Hydrologically disconnect roadway from watercourse with waterbars or rolling dips.
MP39	40.7209	-123.8962	1.28	Poorly defined rolling dip.	Long term objective: reshape rolling dip and armor outlet.
MP40	40.7212	-123.8961	1.30	Poorly defined rolling dip.	Long term objective: reshape rolling dip and armor outlet.
MP41	40.7207	-123.8947	1.41	Class III stream crossing through a 36" diameter corrugated metal culvert. Hydrologic connection on both sides at inlet and outlet.	Hydrologically disconnect roadway from watercourse with waterbars or rolling dips.

Feature ID	Latitude	Longitude	Road Mileage	Additional Notes
MP36	40.7212	-123.8970	1.19	Reshape rolling dip and armor outlet.
