# Road Evaluation and Hydrologic Assessment

11/02/2018

Indra Valley Strategic  
Marketing Group, LLC

**MOTHER EARTH  
ENGINEERING**

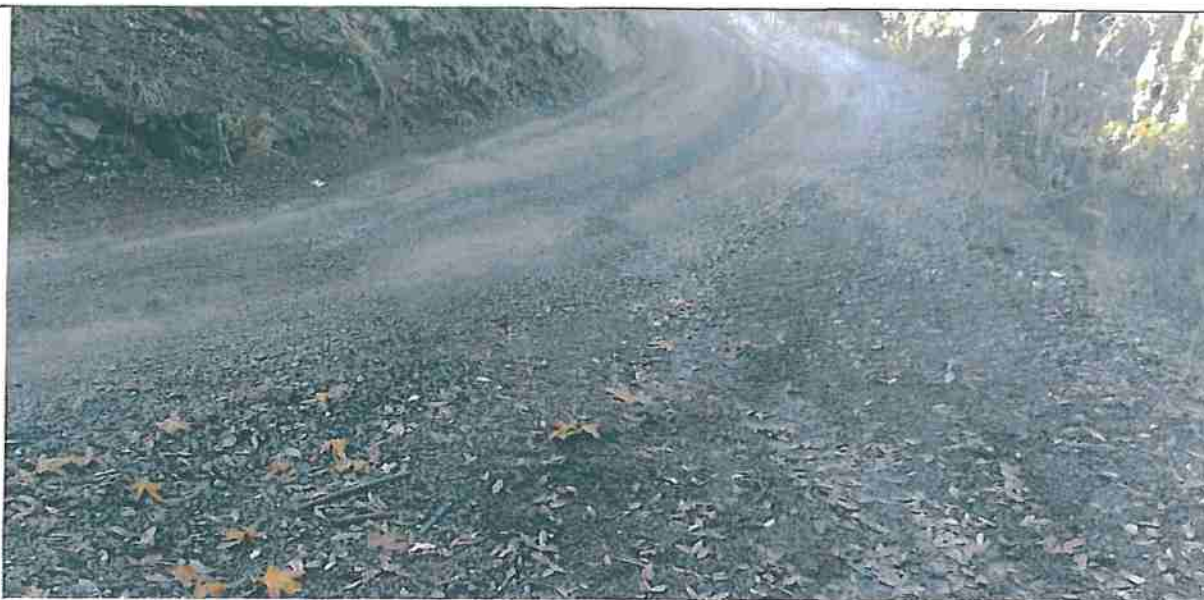
Feature ID	Latitude	Longitude	Road Mileage	Additional Notes
MP37	40.7208	-123.8967	1.21	Reshape rolling dip and armor outlet.

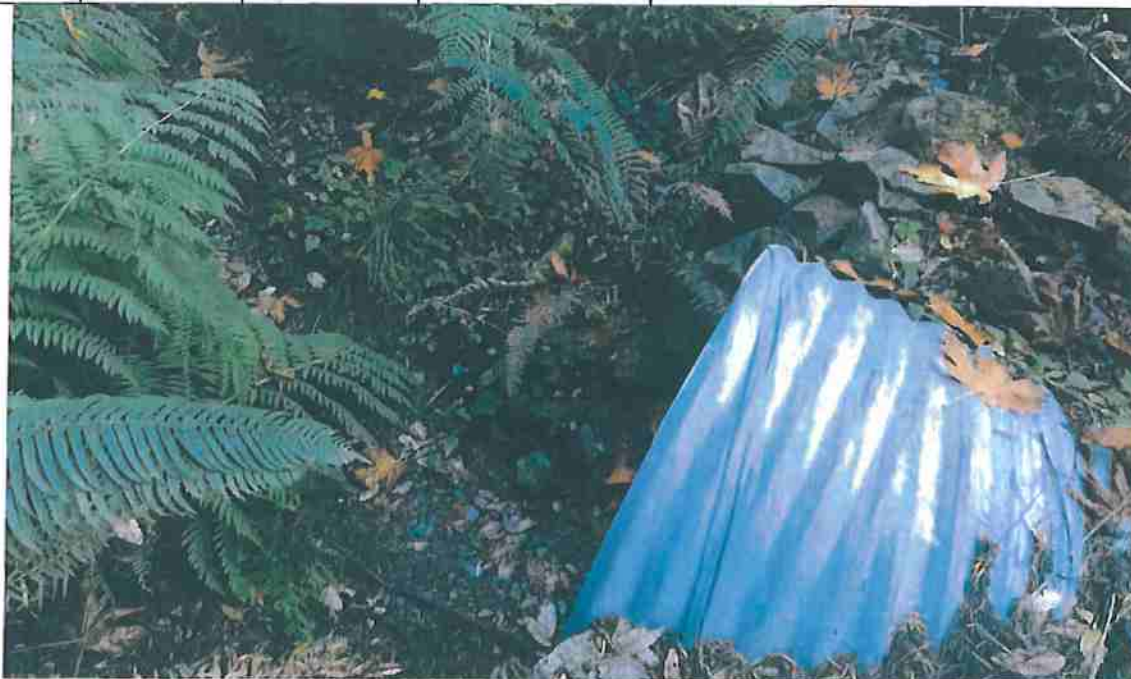
Feature ID	Latitude	Longitude	Road Mileage	Additional Notes
MP38	40.7205	-123.8966	1.24	Site of a 36" diameter stream crossing culvert. Hydrologically disconnect roadway from watercourse with waterbars or rolling dips.

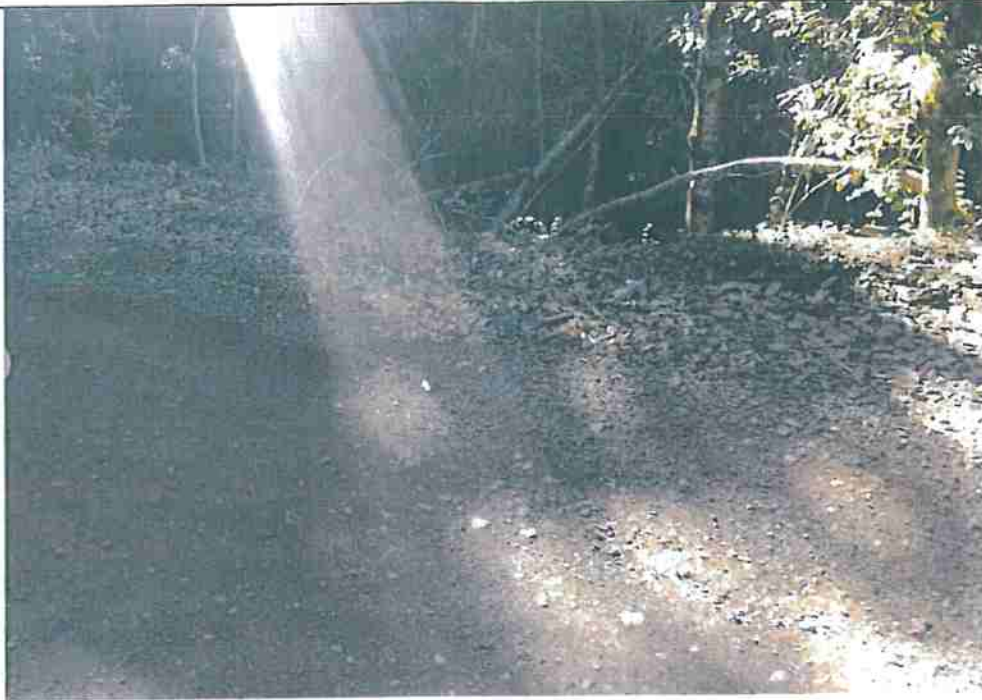
Feature ID	Latitude	Longitude	Road Mileage	Additional Notes
MP39	40.7209	-123.8962	1.28	Install rolling dip and armor outlet.

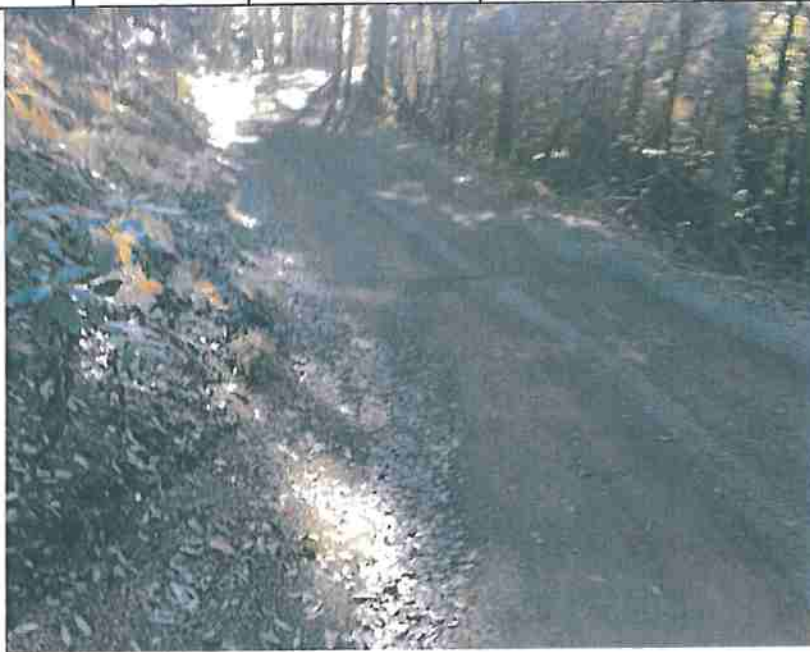
Feature ID	Latitude	Longitude	Road Mileage	Additional Notes
MP40	40.7212	-123.8961	1.30	Install rolling dip and armor outlet.

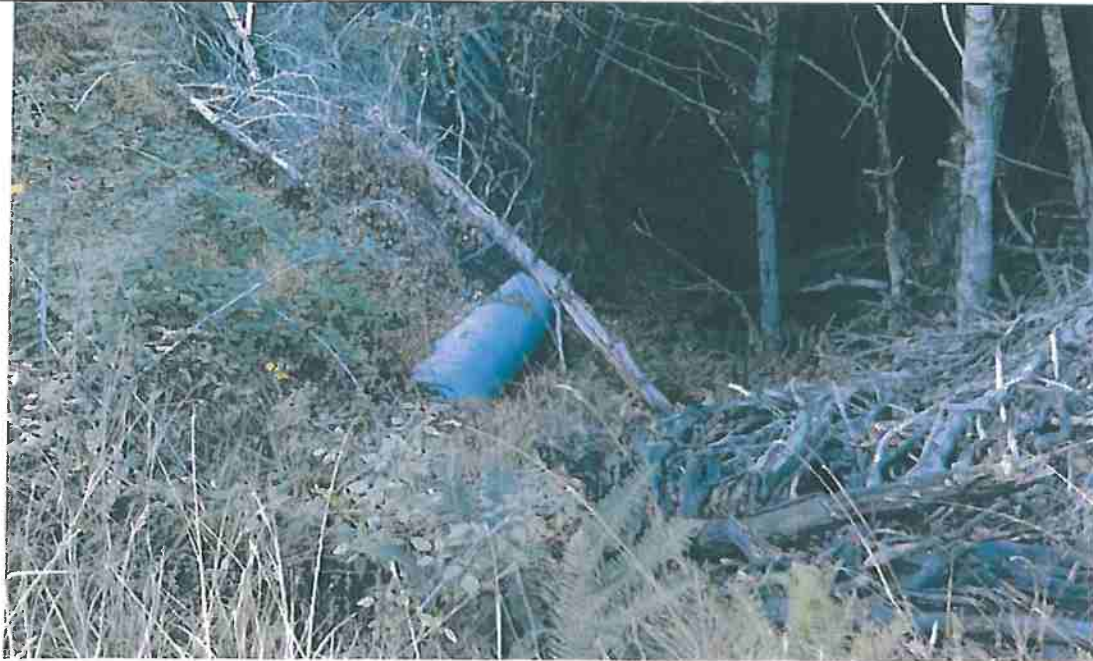
Feature ID	Latitude	Longitude	Road Mileage	Additional Notes
MP41	40.7207	-123.8947	1.41	Site of a 36" diameter stream crossing culvert. Hydrologically disconnect roadway from watercourse with waterbars or rolling dips.

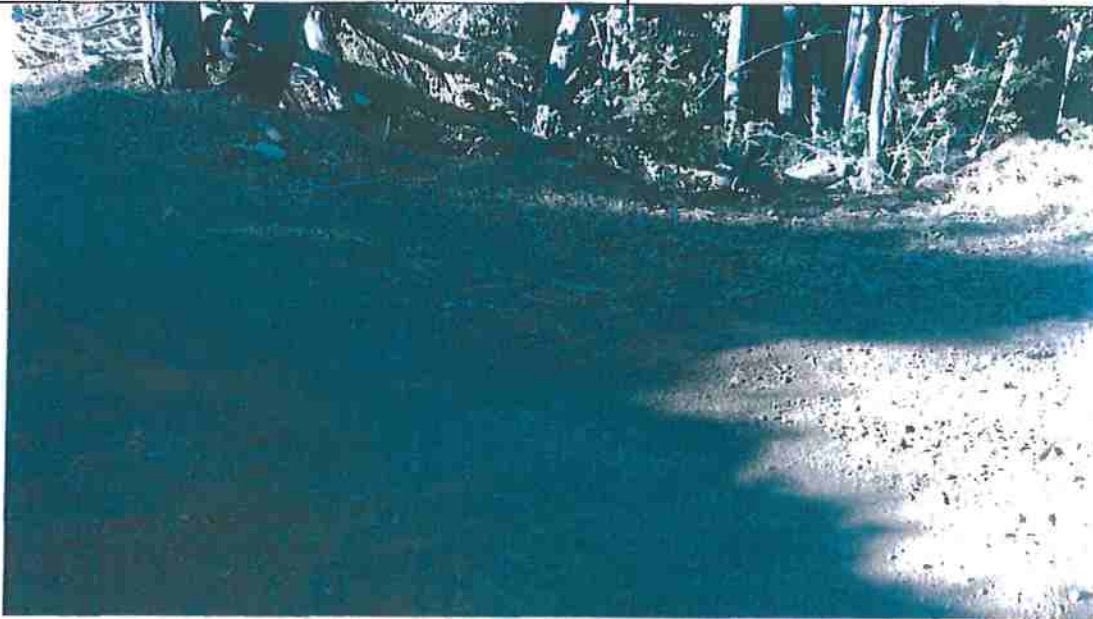
MP42	40.7212	-123.8938	1.47	Rutted drainage from cultivation area, poorly defined.	Develop defined drainage with energy dissipation and sediment capture.
MP43	40.7210	-123.8927	1.53	Poorly defined rolling dip.	Long term objective: reshape rolling dip and armor outlet.
MP44	40.7207	-123.8923	1.57	Poorly defined rolling dip.	Long term objective: reshape rolling dip and armor outlet.

Feature ID	Latitude	Longitude	Road Mileage	Additional Notes
MP42	40.7212	-123.8938	1.47	Develop defined drainage with energy dissipation and sediment capture.

- Use machinery to install a rolling dip at MP16, the site of a poorly defined dip. Install riprap at outlet.
- Use machinery to install riprap rock ford at site of seep spring at MP29. Regrade road into an outsloping surface.
- Ditch and road surface stormwater flow must be disconnected from directly flowing into the Class III watercourse at MP38. Use machinery to install waterbars or rolling dips on both sides of the watercourse crossing within 30 to 100 feet of the crossing.
- Ditch and road stormwater flow must be disconnected from directly flowing into the Class III watercourse at MP41. Use machinery to install waterbars or rolling dips on both sides of the watercourse crossing within 30 to 100 feet of the crossing.
- Install defined drainage at intersection of roads (MP32 and MP42) complete with energy dissipation and sediment capture at outlet.

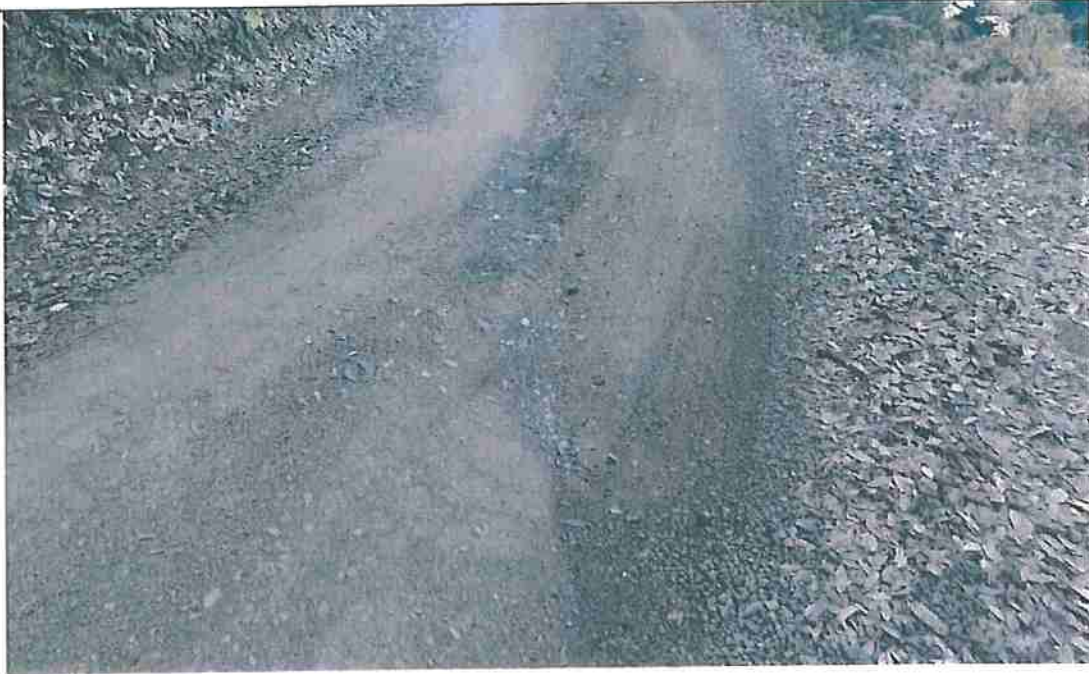
Feature ID	Latitude	Longitude	Road Mileage	Additional Notes
MP43	40.7210	-123.8927	1.53	Reshape rolling dip and armor outlet.

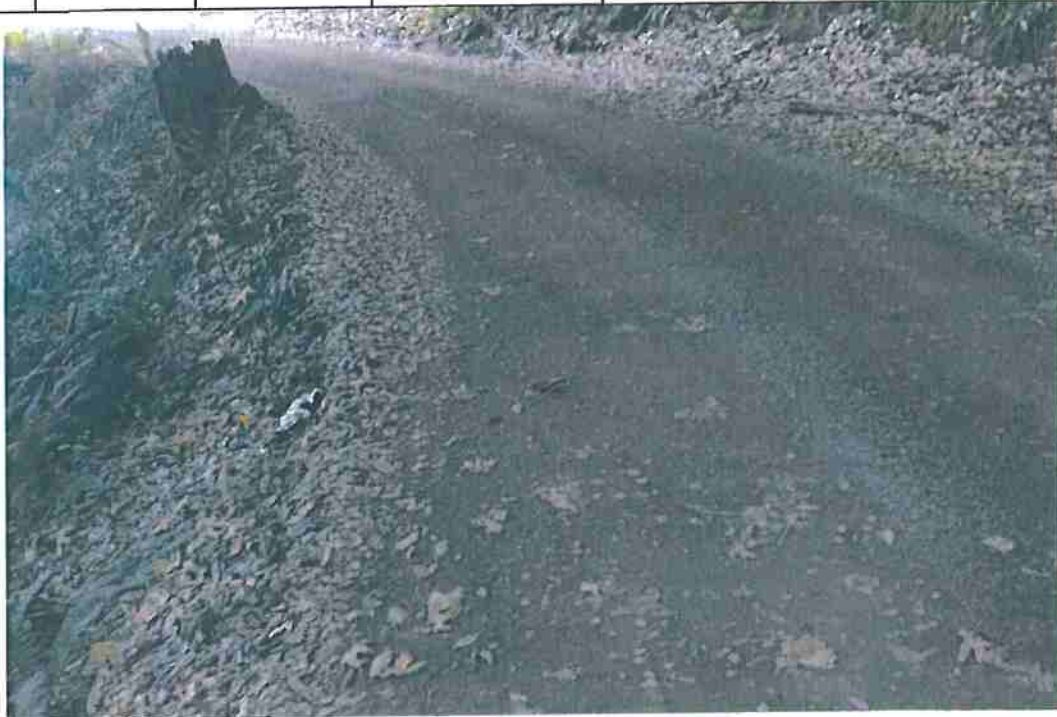
Feature ID	Latitude	Longitude	Road Mileage	Additional Notes
MP44	40.7207	-123.8923	1.57	Install rolling dip and armor outlet.

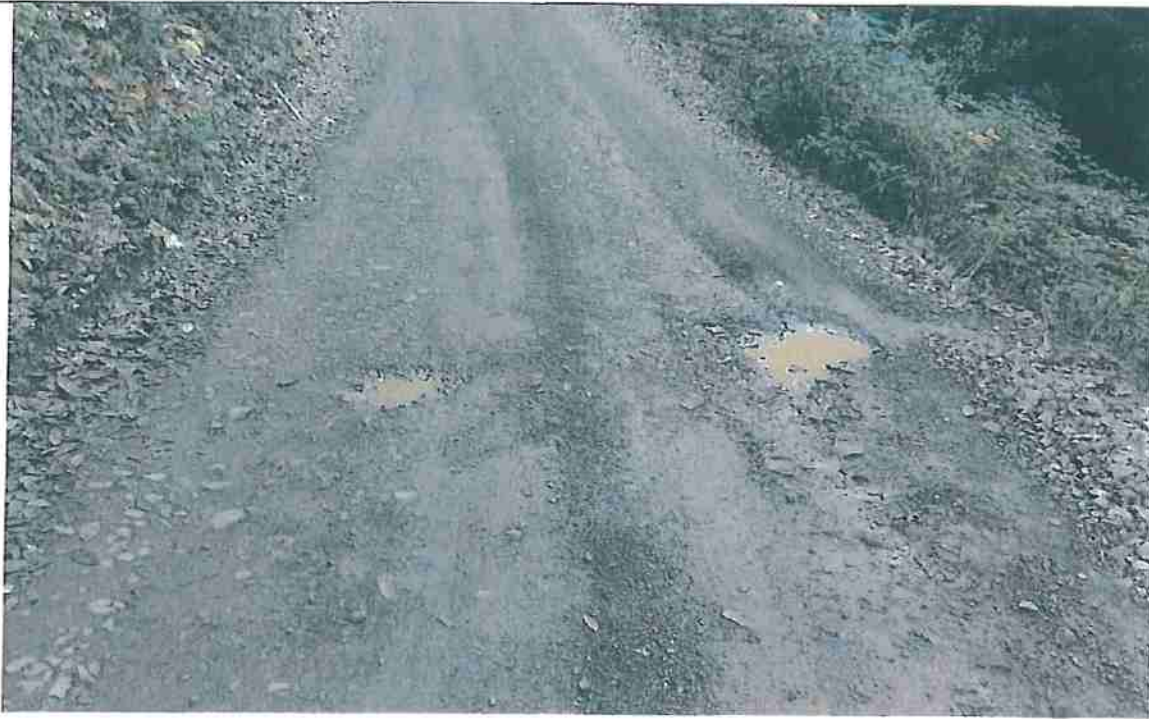
Feature ID	Latitude	Longitude	Road Mileage	Description	Prescription
MP45	40.7209	-123.8915	1.62	Pot holes, low point with no defined outlet.	Long term objective: install rolling dip and armor outlet. Grade or fill potholes.
MP46	40.7192	-123.8886	1.82	End of road evaluation - road makes a hairpin turn and proceeds to adjacent parcels.	Maintain and Monitor.

Feature ID	Latitude	Longitude	Road Mileage	Additional Notes
MP45	40.7209	-123.8915	1.62	Long term objective: reshape rolling dip and armor outlet. Regrade road to outsloping surface.
