**Water Resource Protection Plan
For
WDID #1B16437CHUM**

9-9-2016

WRPP Map - WDID 1B16437CHUM

Section 13, T7N-R4E, H.B.M. - APN 522-073-002 - 9/9/16

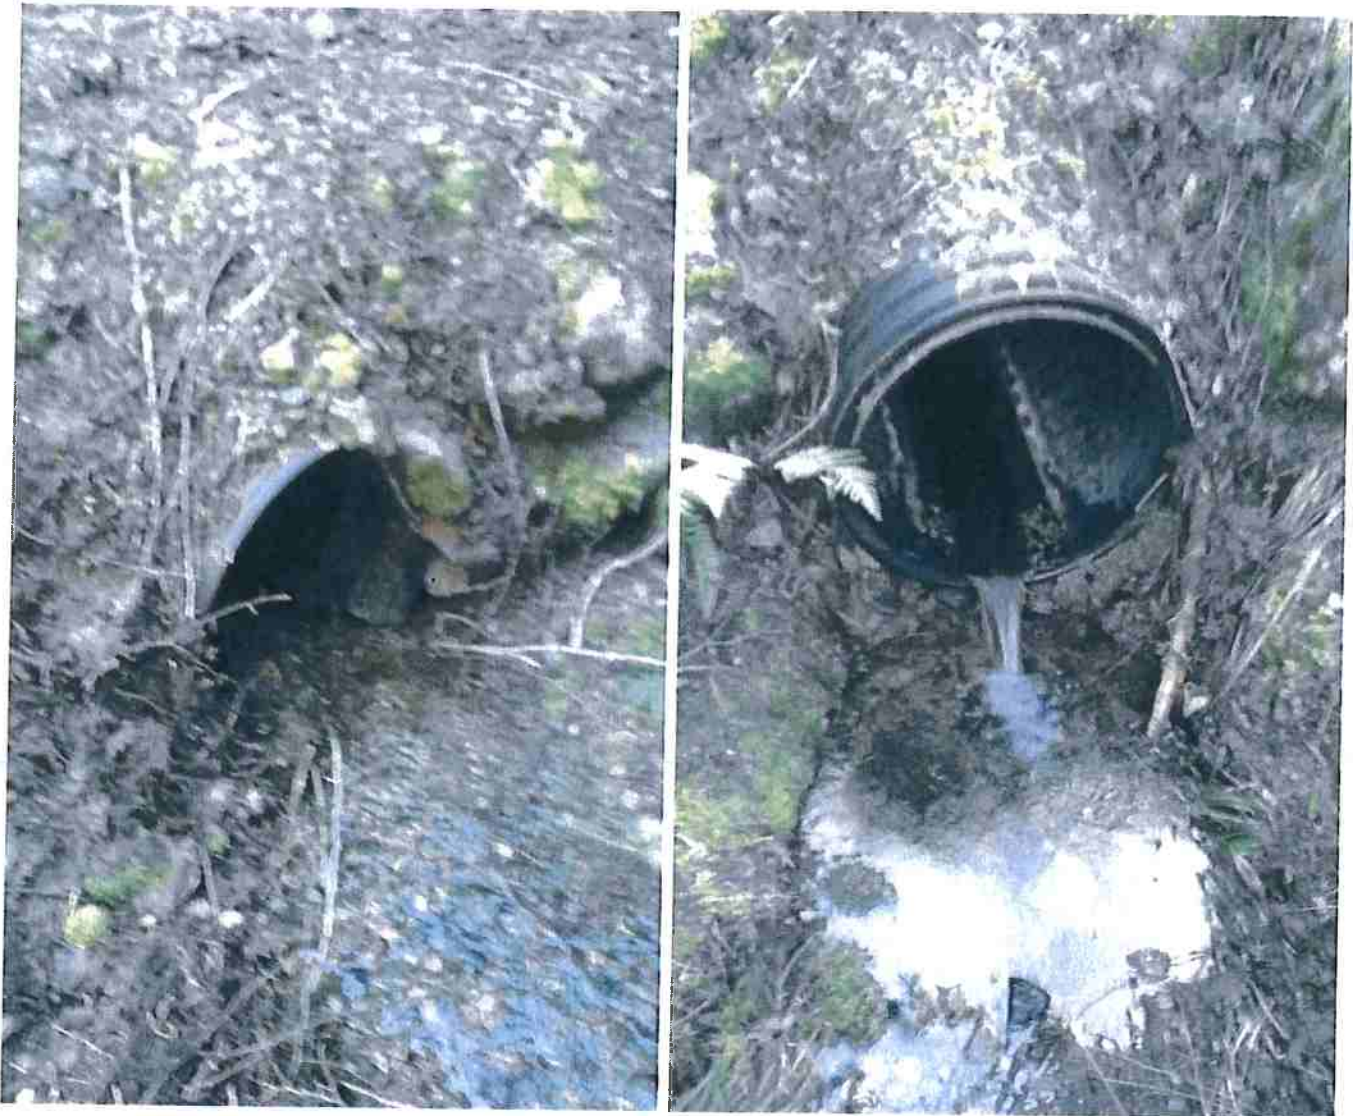
Map Point 1: This is a 24 inch diameter, permanent, plastic culvert crossing of a spring fed Class II watercourse. It appears to have been in place for several years, but the exact year of installation is unknown. The inlet and the outlet were armored at the time it was installed and it is set at the grade of the watercourse. It appeared to be maintained, functioning well, and was free of obstructions on the assessment date, 2/23/16. It has a low diversion potential and was not a source of erosion. Its diameter appears to be adequate for the flows that it receives and there was no sign of it being overtopped during the heavy rainfall of December 2015 and January 2016. It is located on a spring fed Class II watercourse that apparently goes underground downstream of this crossing because it was not evident on the lower road downslope of this crossing. A determination on paper, as to whether this crossing is adequately sized for the possible 100 year peak streamflow was made difficult because the watercourse's drainage area is not easily definable on the USGS Quad. Map. Using a range of different acreages for the drainage area above the crossing, a best estimate for the 100 year peak streamflow is between 10 and 20 cubic feet per second (cfs). A streamflow of 10 cfs requires a 24 inch diameter culvert. A streamflow of 20 cfs requires a 30 inch diameter culvert. This indicates that the existing culvert

currently in place may be sized adequately or could be slightly undersized for the peak streamflow at this location. There is no physical evidence of erosion, overtopping, or eminent failure at this crossing site. The crossing should continue to be maintained and monitored in the future. If in the future this culvert appears close to being overtopped or in need of being replaced for any reason such as age, deterioration, holes, etc., it should be upsized to a 30" diameter culvert.

Pictures 1 and 2: These are pictures of the inlet and outlet of the 24 inch culvert crossing of a Class II watercourse at Map Point 1. Photo date 2/23/2016

Unique Map Point(s)	Map Point Description	Associated Standard Condition	Temporary BMP	Permanent BMP	Priority for Action	Time Schedule for completion of Permanent BMP	Completion Date
Map Point 1 and 3	Existing 24 inch culverts class II watercourse crossings (slightly undersized)	A(2)	N/A	Monitor and maintain especially during heavy rain. If they appear close to being overtopped or in need of being replaced for any reason such as age, deterioration, holes, etc., they should be upsized in diameter (30" dia.).	2	11/15/16	
Map Point 2	Existing 24 inch culvert class II watercourse crossing (moderate diversion potential, slightly undersized)	A(2)	N/A	Install a Critical Dip (priority 3). Monitor and maintain especially during heavy rain (priority 2). If this culvert appears close to being overtopped or in need of being replaced for any reason such as age, deterioration, holes, etc., it should be upsized in diameter (30" dia.).	2 3	11/15/16 11/15/17

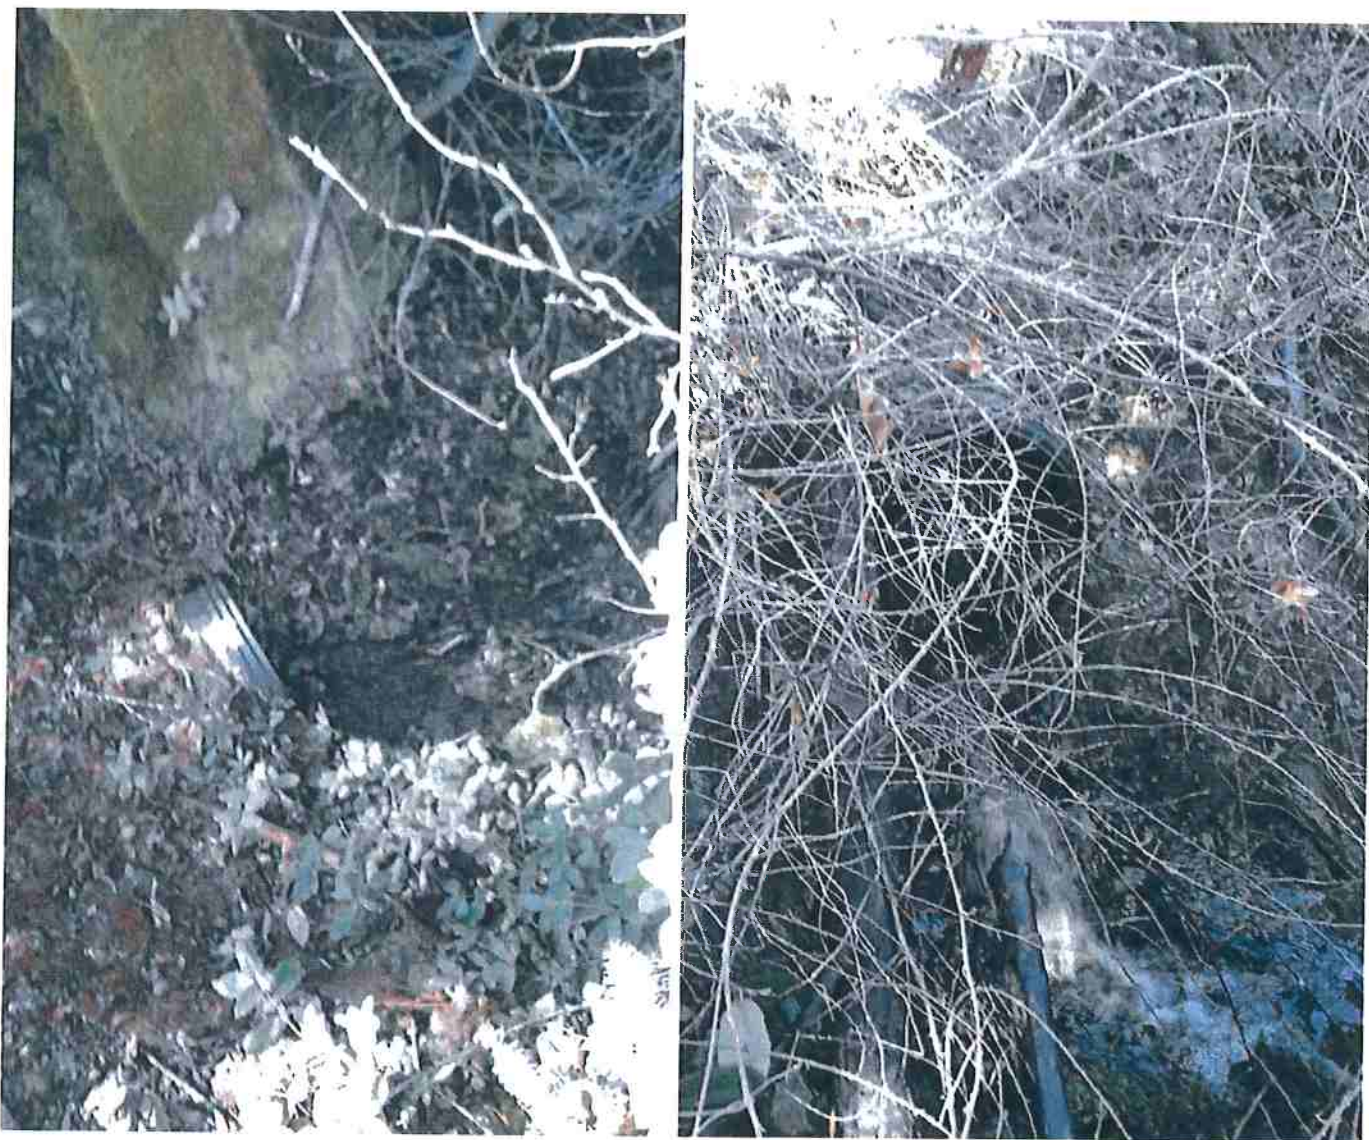
Map Point 2: This is a 24 inch diameter, permanent, plastic culvert crossing of a Class II watercourse. It appears to have been in place for several years, but the exact year of installation is unknown. It appeared to be maintained, functioning well, and was free of obstructions on the assessment date, 2/23/16. Its diameter appears to be adequate for the flows that it receives and there was no sign of it being overtopped during the heavy rainfall of December 2015 and January 2016. Its source is approximately 200 feet above the crossing. A determination on paper, as to whether this crossing is adequately sized for the possible 100 year peak streamflow was made difficult because the watercourse's drainage area is not easily definable on the 80 foot contour interval, USGS Quad. Map. Its mapped location is not within a swale, but rather on a minor ridge feature. Using a range of different acreages for the drainage area above the crossing, a best estimate for the 100 year peak streamflow is between 13 and 14 cubic feet per second (cfs). Streamflow of these magnitudes require a culvert diameter of slightly larger than the 24 inch diameter culvert that is currently in place. This indicates that the existing culvert currently in place may be sized adequately or could be slightly undersized for the 100 year peak streamflow at this location. There is no physical evidence of erosion, overtopping, or eminent failure at this crossing site. There is a moderate diversion potential at this site due to the road configuration at the crossing site and the lack of a critical dip. The crossing should continue to be maintained and monitored in the future, and a critical dip should be installed across the road surface below the crossing site. If in the future this culvert appears close to being overtopped or in need of being replaced for any reason such as age, deterioration, holes, etc., it should be upsized to a 30" diameter culvert.

Pictures 3 and 4: These are pictures of the inlet and outlet of the 24 inch culvert crossing of a Class II watercourse at Map Point 2. Photo date 2/23/2016

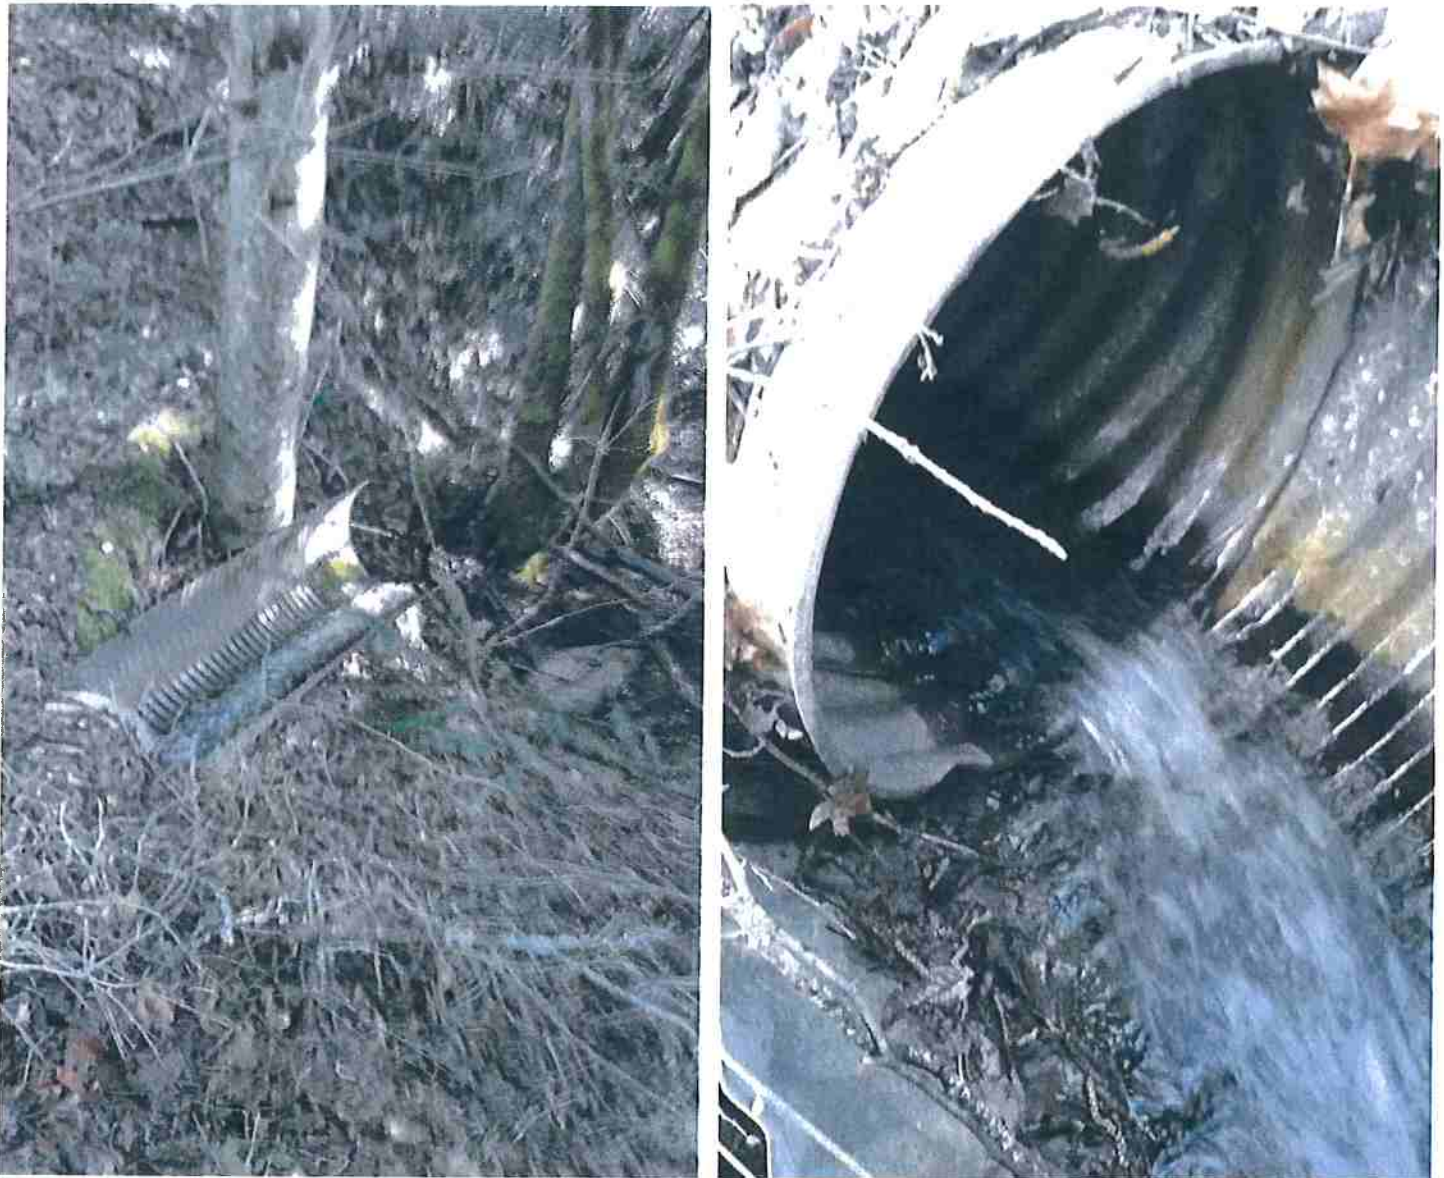
Map Point 3: This is a 24 inch diameter, permanent, metal culvert crossing of a Class II watercourse. The exact year of installation is unknown, but it appears to have been in place longer than the plastic culverts at Map Points 1 and 2. It appeared to be maintained, functioning well, and was free of obstructions on the assessment date, 2/23/16. Its diameter appears to be adequate for the flows that it receives and there was no sign of it being overtopped during the heavy rainfall of December 2015 and January 2016. A shallow basin of approximately 10 feet wide is located at the inlet. It is located in a low spot in the road and its diversion potential is low. It is not set at the natural grade of the watercourse at the outlet. There is a 6 to 10 foot long downspout attached to the outlet to compensate. The metal culvert walls and the metal downspout are solid and free of excessive rust deterioration. It is located approximately 100 feet downstream from the crossing at Map Point 2. Because it is on the same watercourse as Map Point 2 and only 100 feet below, a determination on paper, as to whether this crossing is adequately sized for the possible 100 year peak streamflow was met with the same difficulties as Map Point 2 above. A best estimate for the 100 year peak streamflow is between 13 and 14.5 cubic feet per second (cfs). Streamflow of these magnitudes require a culvert diameter of slightly larger than the 24 inch diameter culvert that is currently in place. This indicates that the existing culvert currently in place may be sized adequately or could be slightly undersized for the 100 year peak streamflow at this location. There is no physical evidence of erosion, overtopping, or eminent failure at this crossing site. The rust scour line is only in the very bottom of the culvert floor. This crossing should continue to be maintained and monitored in the future. If in the future this culvert appears close to being overtopped or in need of being replaced for any reason such as age, rust, holes, etc., it should be upsized to a 30" diameter culvert.

Pictures 5 and 6: These are pictures of the outlet and the downspout of the 24 inch culvert crossing of a Class II watercourse at Map Point 3. Photo date 2/23/2016

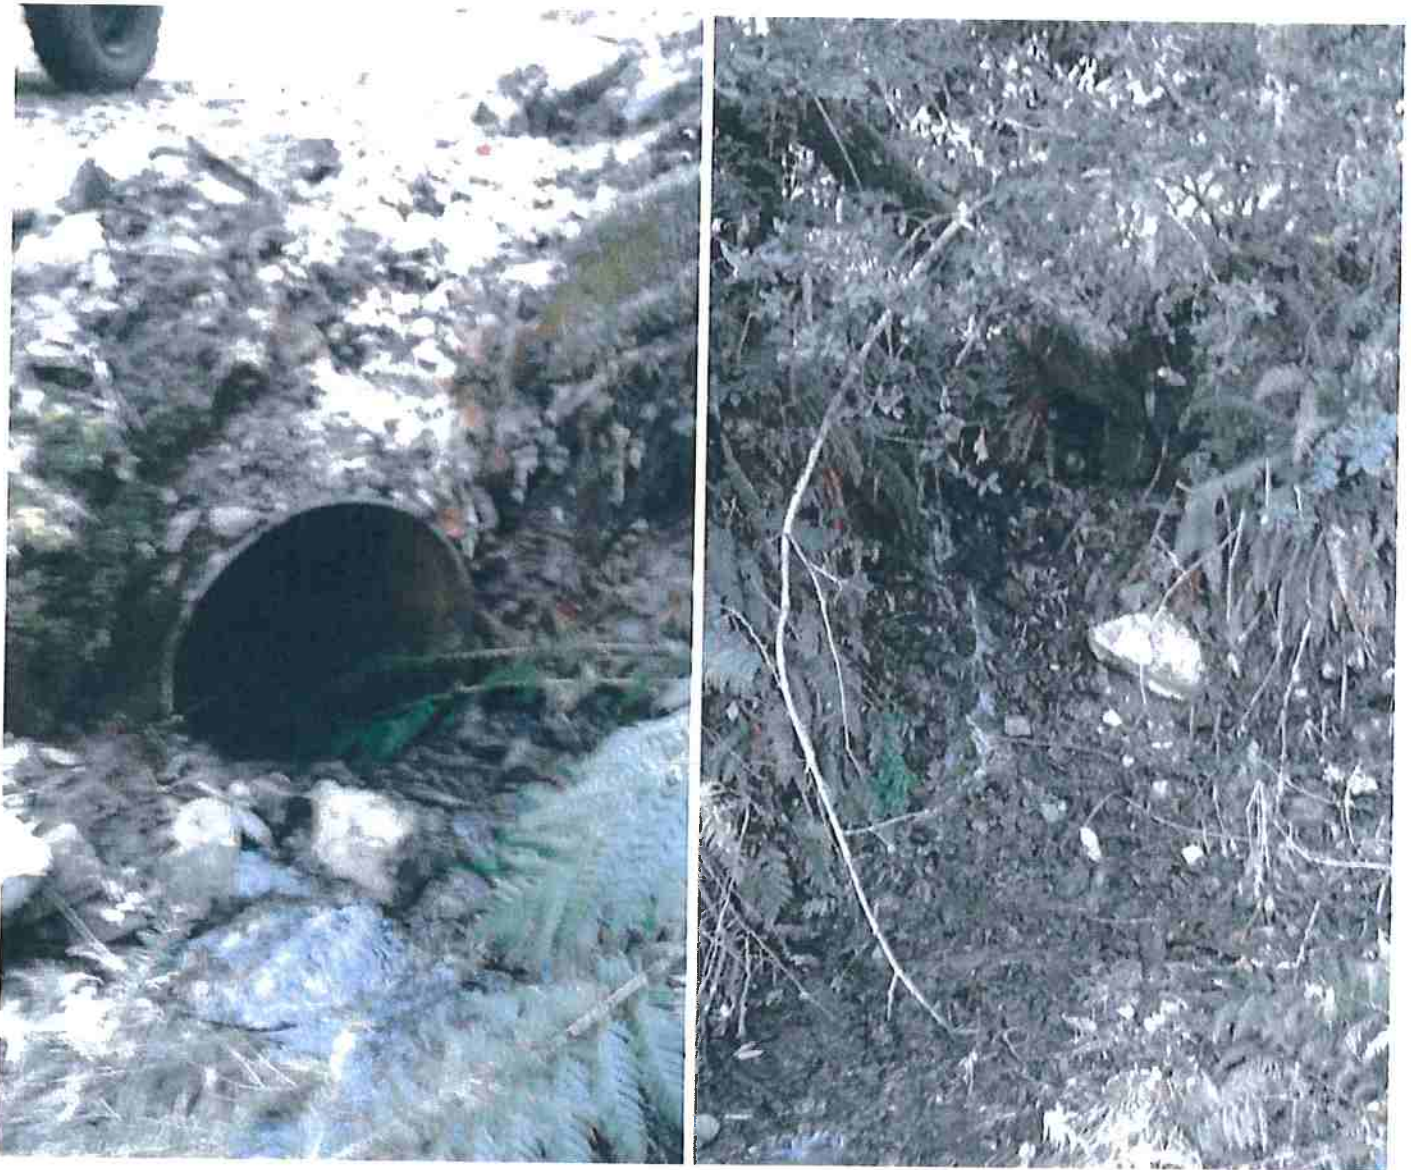
Map Point 4: This is a 24 inch diameter, permanent, metal culvert crossing of a Class II watercourse. The exact year of installation is unknown, but it appears to have been in place for several years and is likely the same age as the metal culvert crossing at Map Point 3. It appeared to be maintained, functioning well, and was free of obstructions on the assessment date, 2/23/16. Its diameter appears to be adequate for the flows that it receives and there was no sign of it being overtopped during the heavy rainfall of December 2015 and January 2016. Its inlet is set to grade but the outlet is slightly above the grade of the watercourse. The outlet is elongated, slightly "shotgunned", and drains onto large rocks and wood in the channel. The culvert is not currently causing erosion. It is located less than 100 feet southeast of another crossing shown as Map Point 5. These separate watercourses come together approximately 50 feet below the road. Moderate diversion potential exists for both Map Points 4 and 5. A critical dip should be placed across the road surface southeast of Map Point 4. This will reduce the risk of diversion of the watercourse at Map Point 4 and Map Point 5 as well.

Its mapped location is not a swale, but rather on the same minor ridge feature as the watercourse associated with Map Points 2 and 3. Its source is believed to be spring fed, and similar in elevation to the previously mentioned watercourse. Lacking a defined drainage area on the 80 foot contour interval, USGS Quad. Map, made calculating the 100 year peak streamflow difficult. A best estimate for the 100 year peak streamflow for this crossing is approximately 5 to 10 cfs. Streamflow of these magnitudes require a culvert diameter of between 18 and 24 inches. This indicates that the existing culvert currently in place may be sized adequately. There is no physical evidence of erosion, overtopping, or eminent failure at this crossing site. The rust scour line is only in the very bottom of the culvert floor. This crossing should continue to be maintained and monitored in the future. Also, a critical dip should be placed across the road surface southeast of Map Point 4 to reduce the risk of diversion of this watercourse or the nearby watercourse at Map Point 5 should they become obstructed.

Pictures 7 and 8: These are pictures of the inlet area of the 24 inch diameter culvert crossing at Map Point 4. The picture on the left is the inlet. The picture on the right is taken looking upstream from the inlet. Photo date 2/23/2016

Map Point 4	Existing 24 inch culvert class II watercourse crossing (moderate diversion potential)	A(2)	N/A	Install a Critical Dip (priority 3). Monitor and maintain especially during heavy rain (priority 2). If this culvert appears close to being overtopped or in need of being replaced for any reason such as age, deterioration, holes, etc., it should be replaced with at least a 24" dia. culvert.	2 3	11/15/16 11/15/17	
Map Point 5	Existing 24 inch culvert class II watercourse crossing (moderate diversion potential, undersized)	A(2)	N/A	Install a Critical Dip (priority 3). Monitor and maintain especially during heavy rain (priority 2). If this culvert appears close to being overtopped or in need of being replaced for any reason such as age, deterioration, holes, etc., it should be upsized in diameter (48" dia.). If banks adjacent to the channel above the inlet become unstable, hire a certified geologist to provide recommended mitigation.	2 3	11/15/16 11/15/17

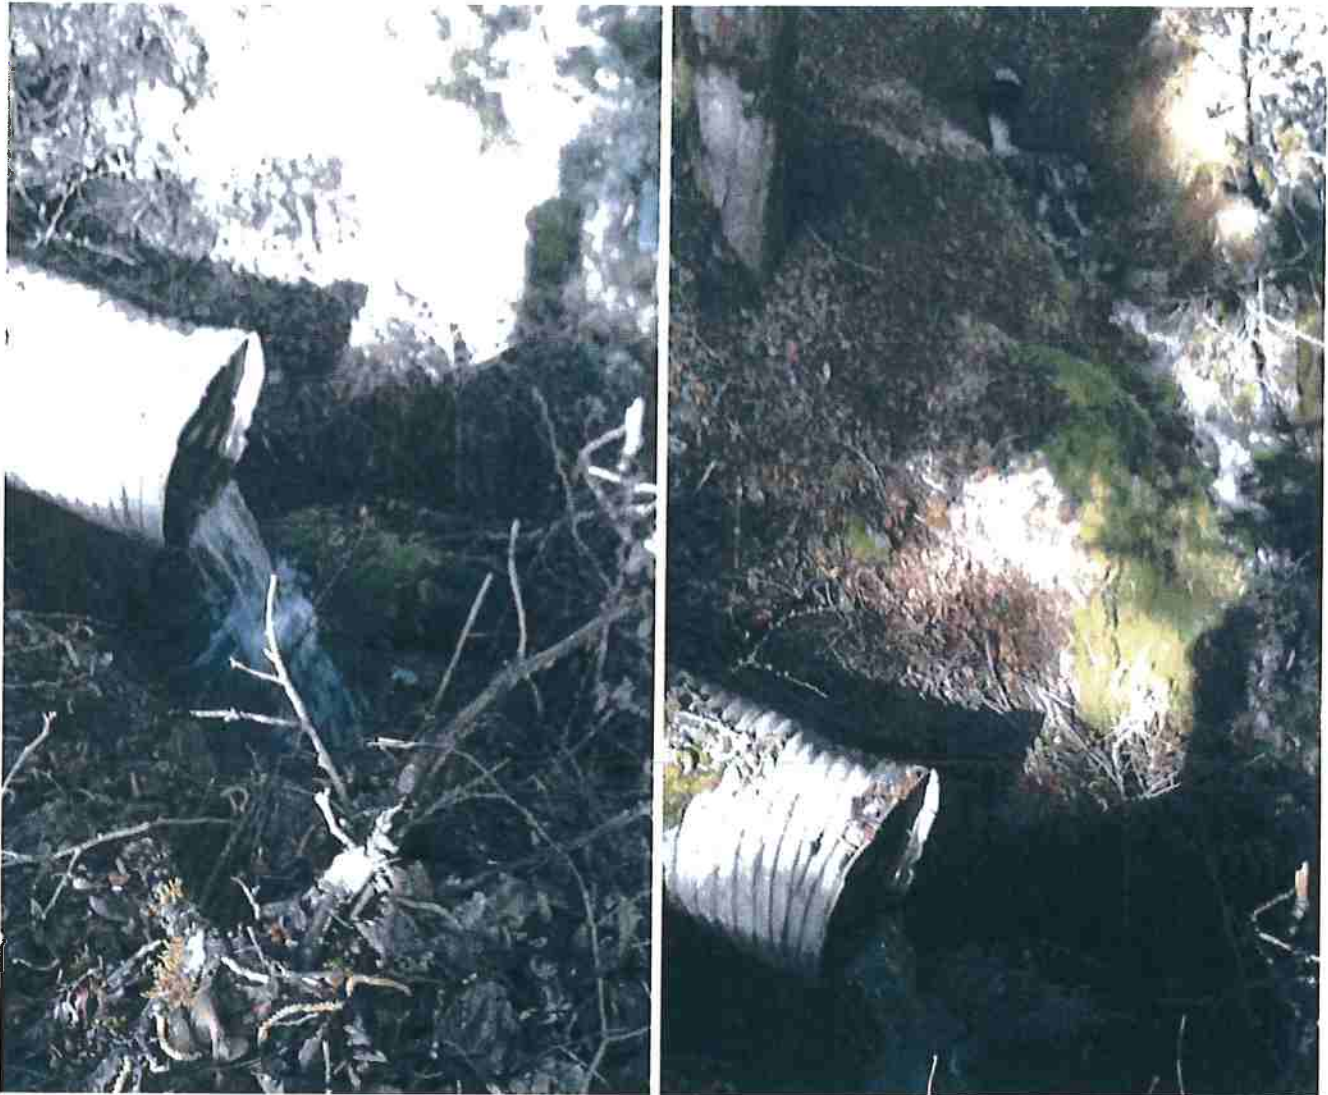
Pictures 9 and 10: These are pictures of the outlet of the 24 inch diameter culvert crossing at Map Point 4. The picture on the left shows the outlet. The picture on the right shows the same outlet as well as the outlet of the crossing at Map Point 5 in the distance. Photo date 2/23/2016

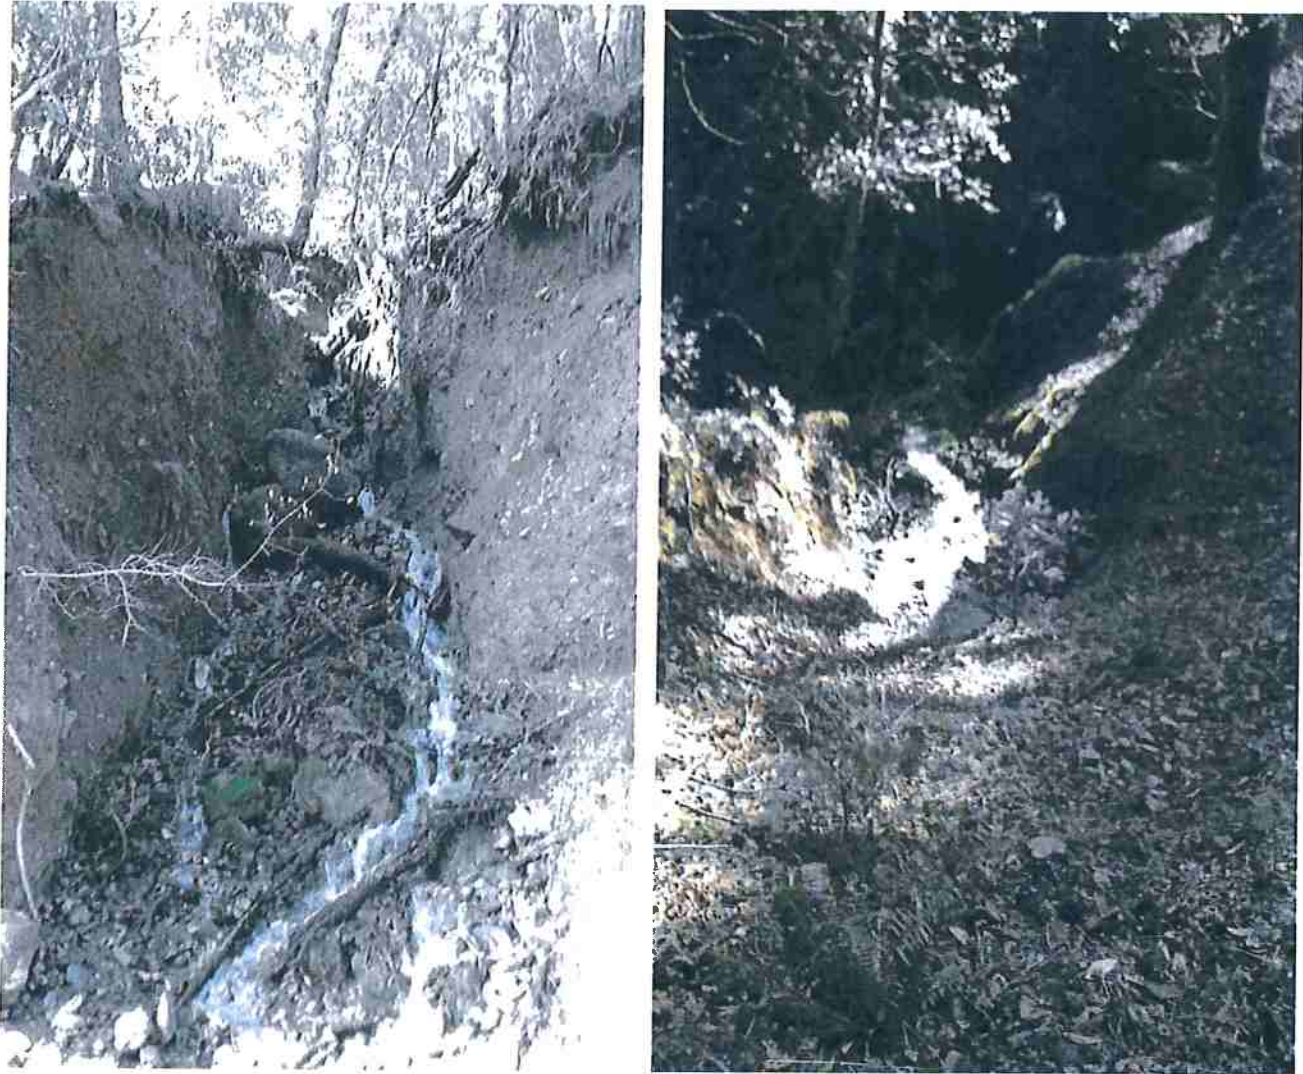
Map Point 5: This is a 24 inch diameter, permanent, metal culvert crossing of a Class II watercourse. The exact year of installation is unknown, but it appears to have been in place for several years and is likely the same age as the metal culvert crossing at Map Point 4. It appeared to be maintained, functioning, and was free of obstructions on the assessment date, 2/23/16. Its diameter appears to be adequate for the flows that it receives and there was no sign of it being overtopped during the heavy rainfall of December 2015 and January 2016. Its inlet is set to grade and is slightly dented. The outlet is slightly above the grade of the watercourse but not eroding. It is located less than 100 feet northwest of the crossing shown at Map Point 4. These separate watercourses come together approximately 50 feet below the road. Moderate diversion potential exists at this crossing and Map Point 4 as well. A critical dip should be placed across the road surface southeast of Map Point 4. This will serve to reduce the risk of diversion potential at both crossings, Map Point 5 and Map Point 4, as well.

This crossing has a characteristic that separates it from the crossings described previously. The channel above the inlet is flanked by 15 feet tall vertical, unvegetated banks. The height of these banks reduces upstream from the crossing. Approximately 100 feet upstream, the height of these banks is greatly reduced. The watercourse for 50 feet above the inlet braids within a 5 foot wide, rocky bottom substrate in between the tall, unvegetated banks. An old skidtrail parallels the north side of the watercourse up on top of the high bank. It is vegetated, has small trees growing on it, and does not appear to have contributed to this condition. The cause of this condition above the inlet is unknown. Investigation a short distance upstream did not reveal any obvious causes. A search of historic aerial photography shows that the area was heavily logged in the early to mid 1980's. No unstable areas could be identified at this location or upstream through aerial photography review. The stability of these tall banks is unclear, but they appeared stable on the date of the assessment, 2/23/16. The landowner stated that they have remained unchanged during his time on the property, but that only includes three winter

seasons. Although sediment deliveries may have occurred in the past at this site, it did not appear to be a controllable sediment site currently. On the date the site was observed, high flows were not occurring but had occurred recently. This site should be monitored by the landowner at the required intervals stated in the Monitoring Plan Section of the Water Resource Protection Plan. In the future, if the banks adjacent to the stream channel appear unstable, this area should be inspected by a certified geologist. Any mitigation work at this site to improve slope stability or to reduce the threat of sediment input from the watercourse banks, should only be conducted following a recommendation by a certified geologist.

Pictures 11 and 12: These are pictures taken at the 24 inch diameter culvert crossing at Map Point 5. The picture on the left is looking upstream from the inlet. The picture on the right is looking downstream from the outlet. Photo date 2/23/2016

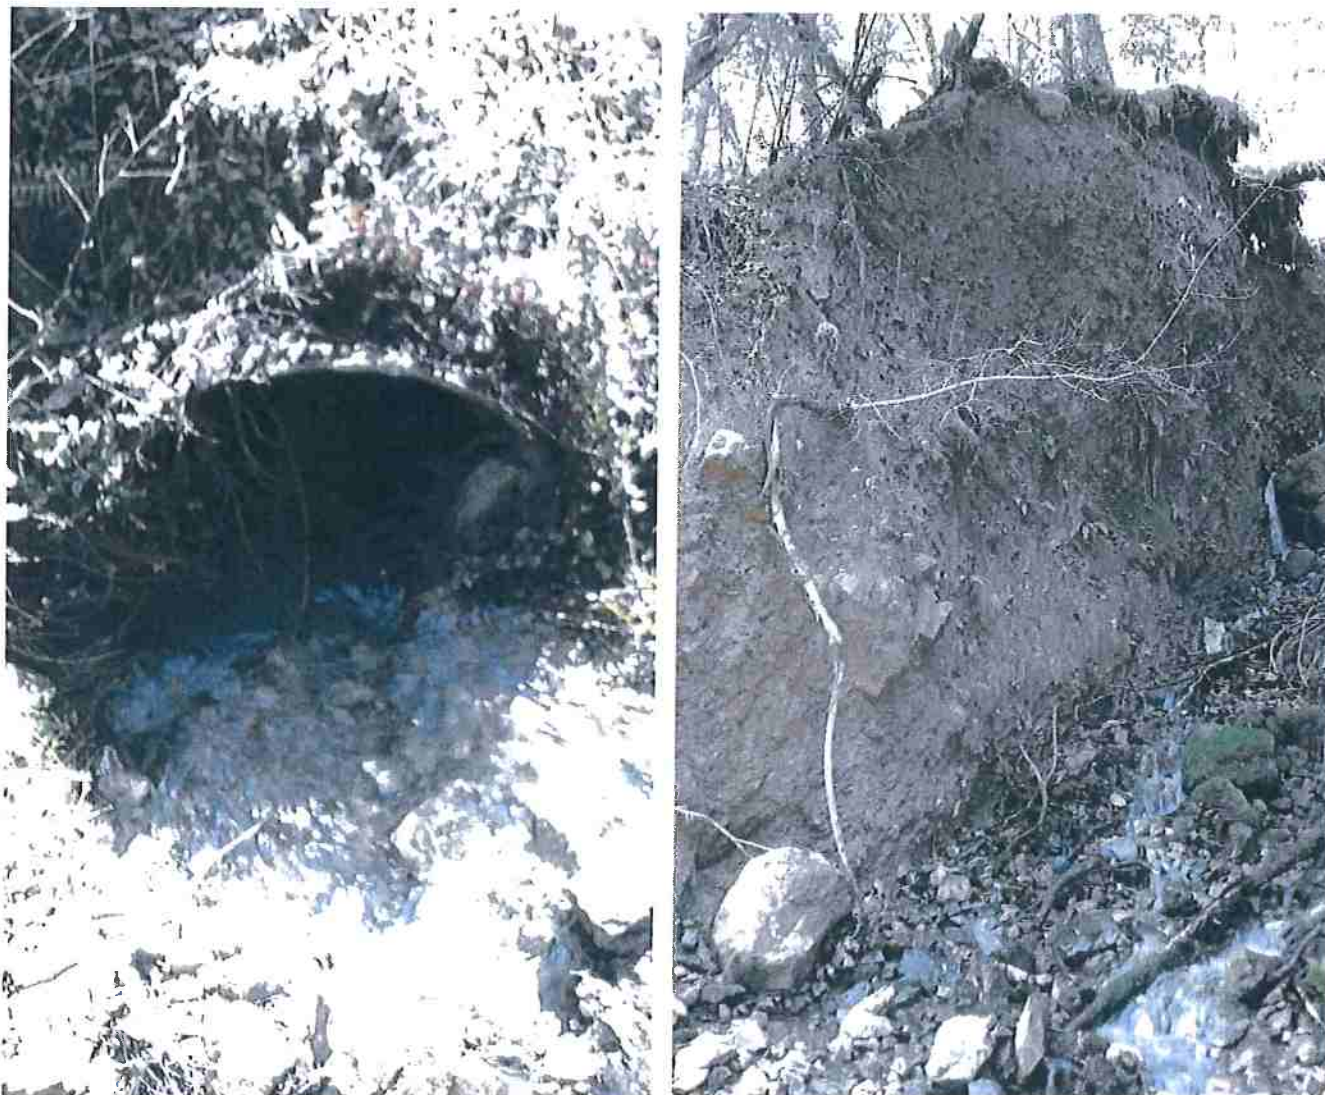
The lower half of this watercourse is located within a mapped swale. Upon mapping this watercourse upstream from the crossing location, its track was mapped crossing definable drainage basins on the 80 foot contour interval, USGS Quad. This made the acreage of the drainage basin, as well as the 100 year peak streamflow, difficult to determine. A best estimate for the 100 year peak streamflow for this crossing is approximately 63 cfs. Streamflow of this magnitude requires a culvert diameter of 42 to 48 inches in diameter. This indicates that the existing culvert currently in place is likely undersized. There is no physical evidence of erosion, overtopping, or eminent failure at this crossing due to being undersized. The rust scour line is only in the very bottom of the culvert. This crossing should continue to be maintained and monitored in the future. If in the future this culvert appears close to being overtopped or in need of being replaced for any reason such as age, rust, holes, etc., it should be upsized to a 48" diameter culvert. Also, a critical dip should be placed across the road surface southeast of Map Point 4 to reduce the risk of diversion of this watercourse or the nearby watercourse at Map Point 5 should they become obstructed.

Pictures 13 and 14: These are pictures taken at the 24 inch diameter culvert crossing at Map Point 5. The picture on the left shows the inlet. The picture on the right is taken looking upstream from the crossing inlet and shows the 15 foot tall bank that is adjacent to the watercourse channel. Photo date 2/23/2016

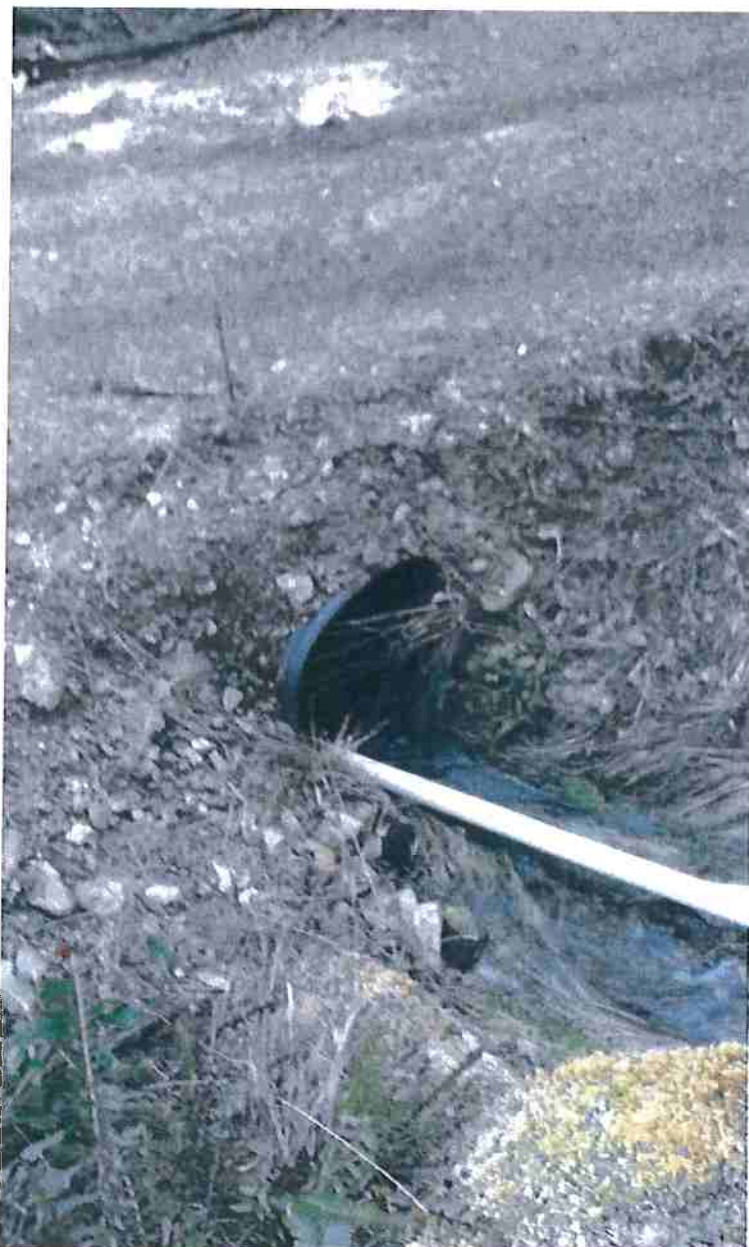
Map Point 6: This is a 24 inch diameter, permanent, plastic culvert crossing of a Class II watercourse. The exact year of installation is unknown, but it appears to have been in place for several years. It appeared to be maintained, functioning, and was free of obstructions on the assessment date, 2/23/16. Its diameter appears to be adequate for the flows that it receives and there was no sign of it being overtopped during the heavy rainfall of December 2015 and January 2016. Its inlet and outlet are set to the natural grade of the watercourse, and it is located in a natural dip so its diversion potential is low. It is located on the same watercourse as the watercourse crossing at Map Point 5. Because it is on the same watercourse as Map Point 5, a determination on paper, as to whether this crossing is adequately sized for the possible 100 year peak streamflow was met with the same difficulties as Map Point 5 above. A best estimate for the 100 year peak streamflow for this crossing is approximately 36 cfs. Streamflow of this magnitude requires a culvert diameter of 36 to 42 inches in diameter. This indicates that the existing culvert currently in place may be undersized. There is no physical evidence of erosion, overtopping, or eminent failure at this crossing due to being undersized. This crossing should continue to be maintained and monitored in the future. If in the future this culvert appears close to being overtopped or in need of being replaced for any reason such as age, holes, etc., it should be upsized to a 36" diameter culvert.

Pictures 15: This is a picture taken at the 24 inch diameter culvert crossing at Map Point 6. The picture shows the inlet. The waterline in the picture is from the POD described above which is located a short distance upstream. Photo date 2/23/2016

Unique Map Point(s)	Map Point Description	Associated Standard Condition	Temporary BMP	Permanent BMP	Priority for Action	Time Schedule for completion of Permanent BMP	Completion Date
Map Point 6	Existing 24 inch culvert class II watercourse crossing (slightly undersized)	A(2)	N/A	Monitor and maintain especially during heavy rain. If it appears close to being overtopped or in need of being replaced for any reason such as age, deterioration, holes, etc., it should be upsized in diameter (36" dia.).	2	11/15/16	
Pond Overflow Channel	Pond Overflow Channel	A(3)	N/A	During periods of pond overflows, monitoring should take place at this site to determine whether or not there is sediment transport occurring and to determine an effective mitigation measure if necessary.	2	11/15/16	
Gas Can Storage (No Unique Map Point)	Gas Can Storage	A(9)	N/A	Store portable gas cans in enclosed structures protected from precipitation.	4	Shortest time possible, no later than 5 years.

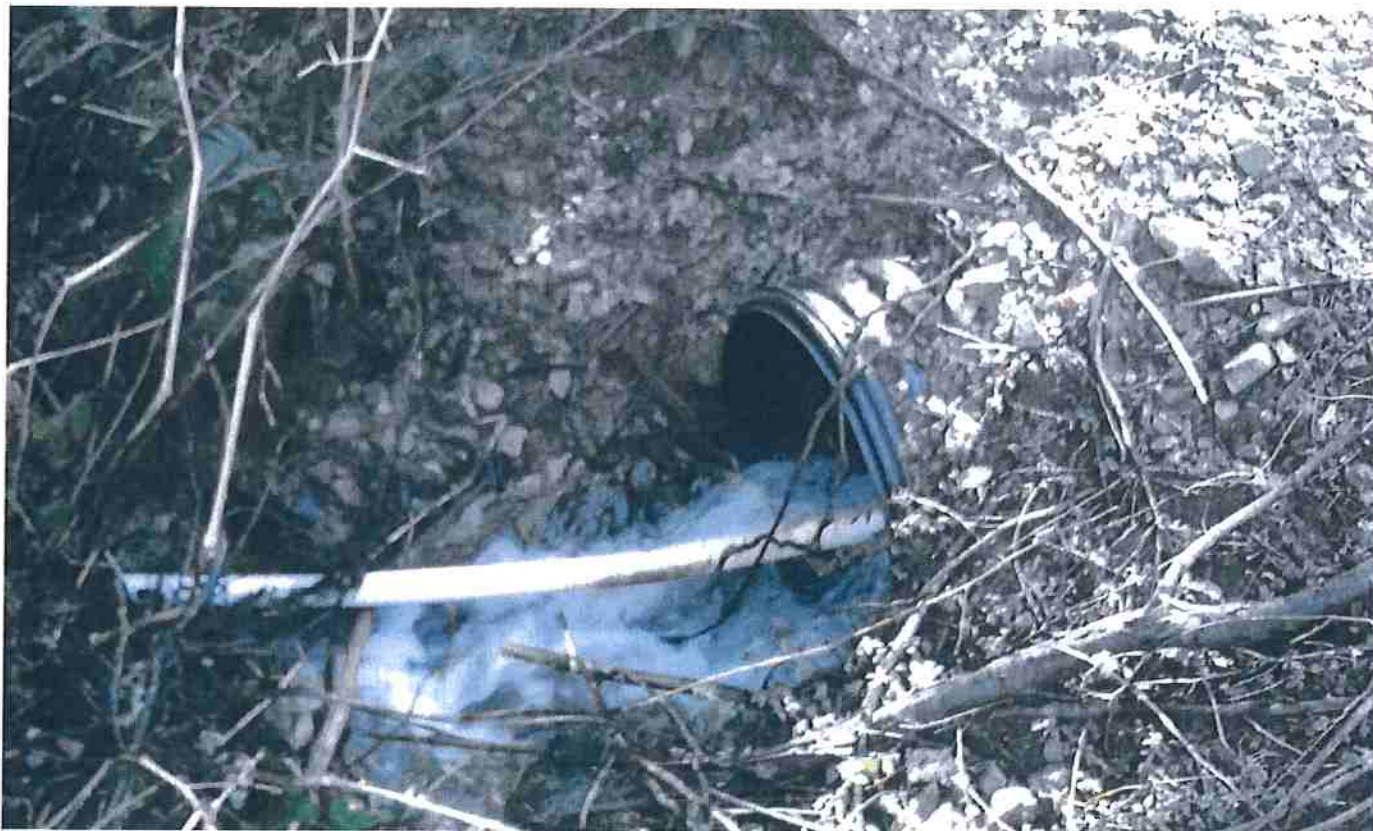
Pictures 16: This is a picture taken at the 24 inch diameter culvert crossing at Map Point 6. The picture shows the outlet. The waterline in the picture is from the POD described above which is located a short distance upstream. Photo date 2/23/2016

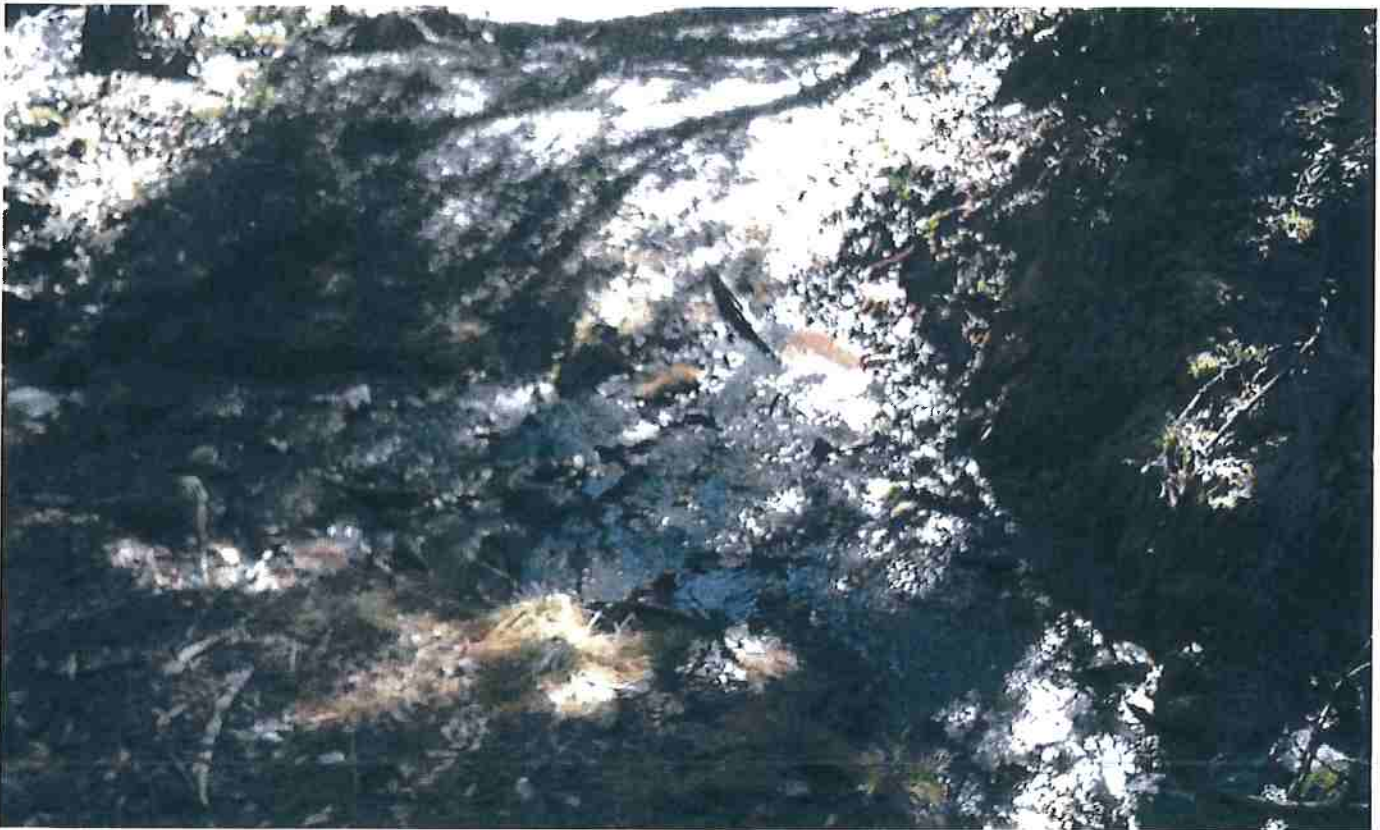
Map Point 8: This is a watercourse crossing on a road that the landowner does not use. The crossing structure was pulled several years ago and the site is not eroding. The site does not require mitigation, maintenance, or monitoring.

Picture 17: This is a picture taken at Map Point 8. It is a pulled crossing on a road that is not used by the landowner. No mitigation or monitoring is required at this site. Photo date 2/23/2016

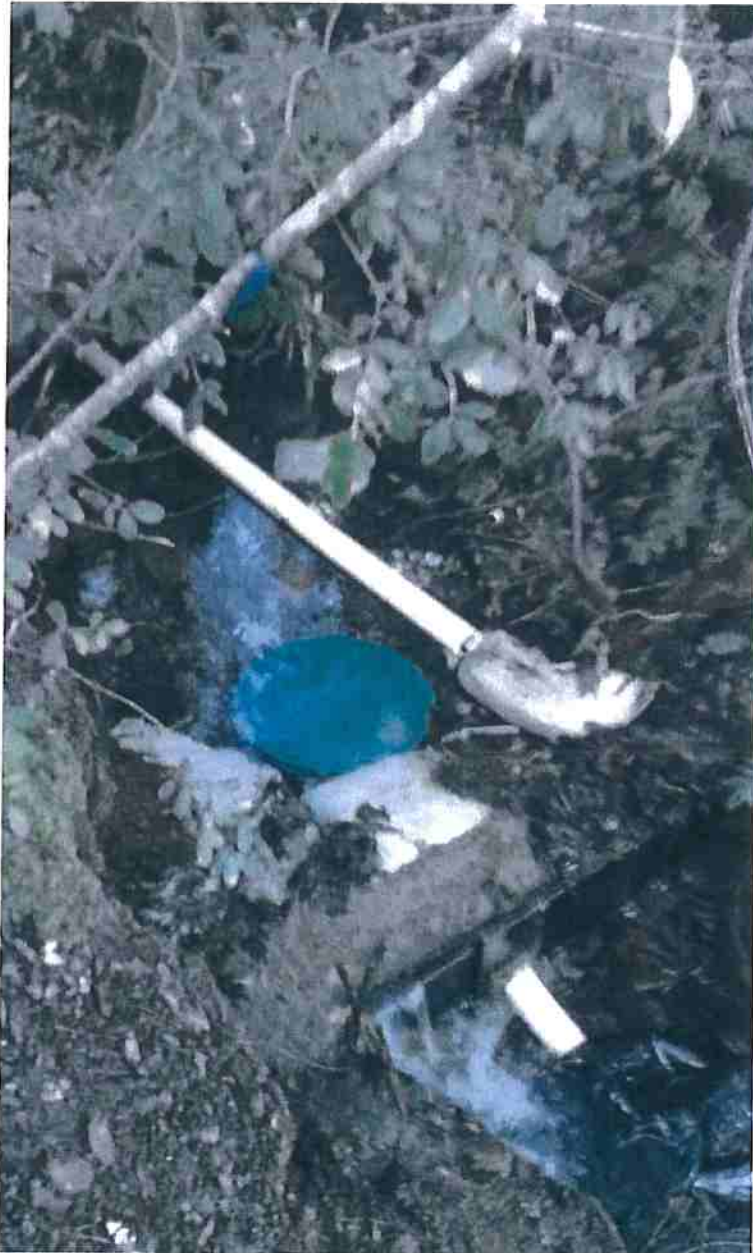
Picture 18: This is a picture taken at the surface point of diversion, just above Map Point 6. Photo date 2/23/2016

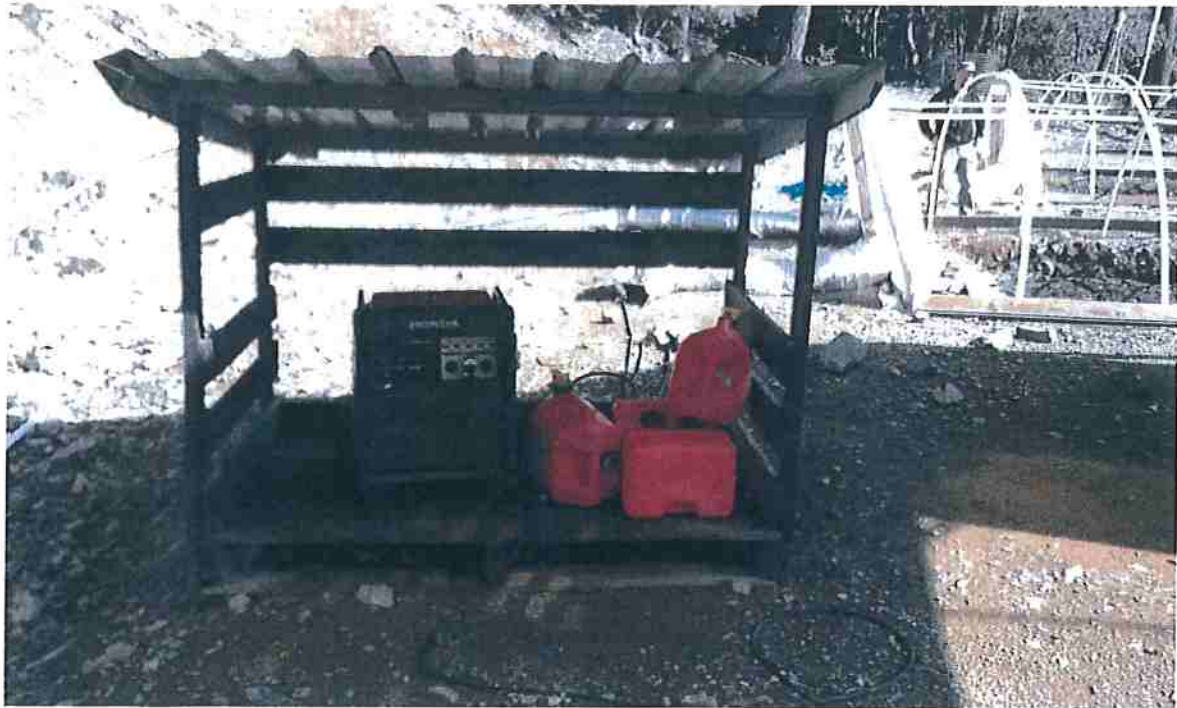
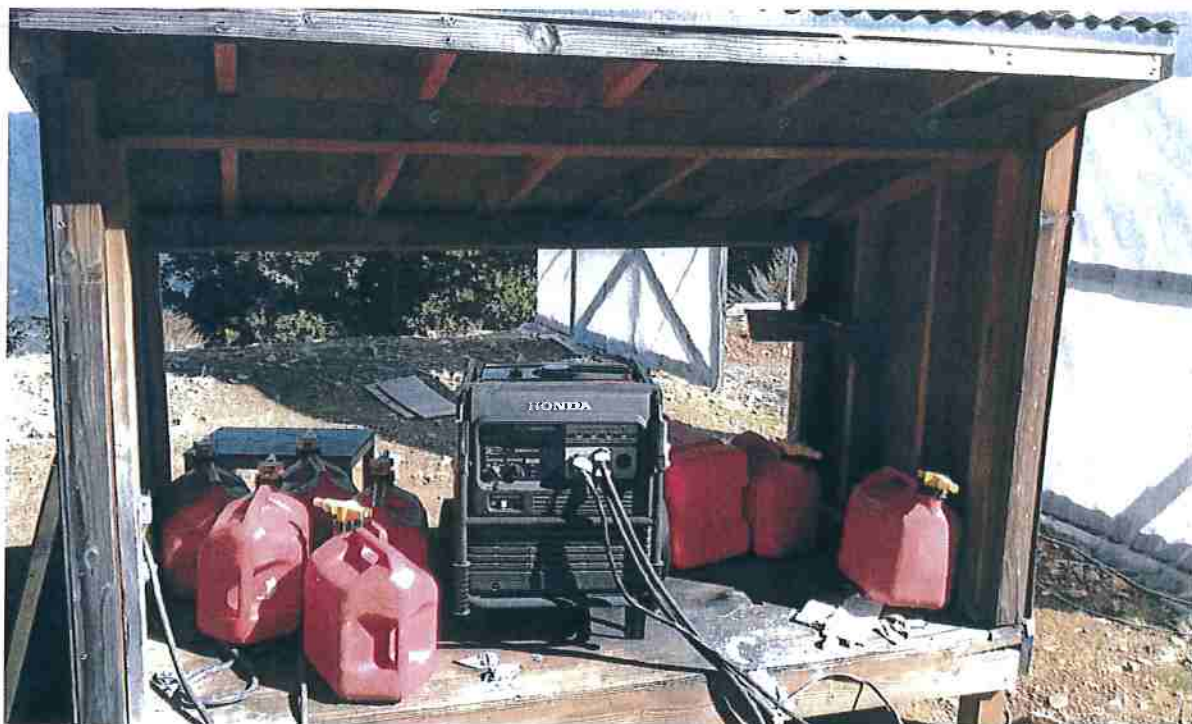
Pictures 19 and 20: These are pictures of the two small generator / fuel can storage areas. These should be enclosed with wood, metal, or plastic sheeting to provide protection from side wind protection if they are to be used to store gas cans through the rainy season. As an alternative gas cans can be stored indoors, in the garage or many covered sheds on the property. Photo date 2/23/2016
