LSAA Restoration Plan for APN 211-362-015

Subject: Notice of Violation of Fish and Game Code Sections 1602, 5650, and 5652 in
Conjunction with Cannabis Cultivation

CDFW LSA Notification
Sharp Ridge
APN: 211-362-015 (HUM)

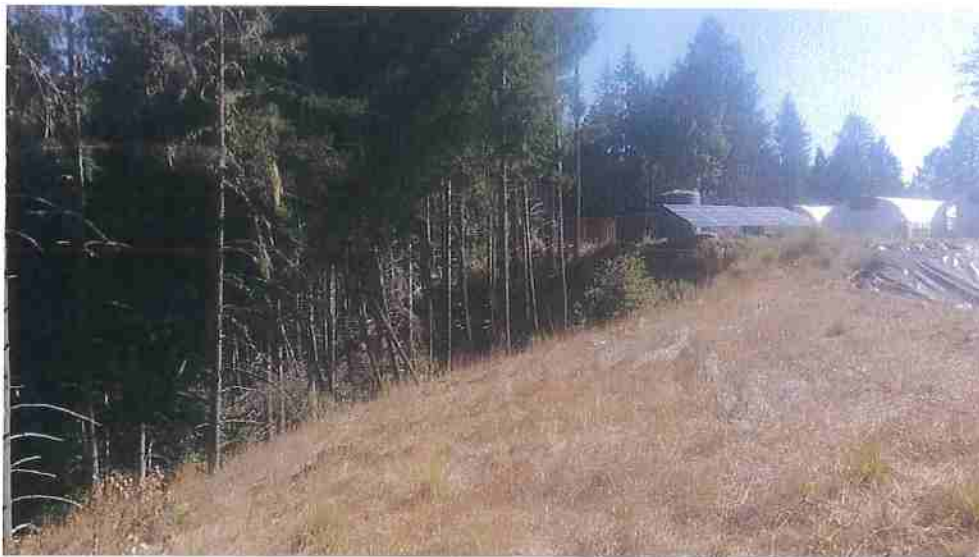
Figure 12. Photograph showing the impoundments berm on the northern side of the rainwater impoundment structure. Sloughing is occurring during ground saturating events due to not being compacted properly. The sloughed material has migrated down slope toward Drainage 1. The

sloughing will continue and the material will continue to migrate down slope unless addressed. To address the sloughing before the rainy season. The interim plan is to keep the water off the berm and fill bank below the berm by placing sheets of plastic on the slope. The sheets of plastic are to be held down with sand bags which are to be keyed into the fill bank. The plastic sheets are to span from the rain water impoundment structures liner to below the sloughed areas. A straw bale row is to be constructed below the plastic sheets to dissipate the rainwater and to collect potential sloughed materials.

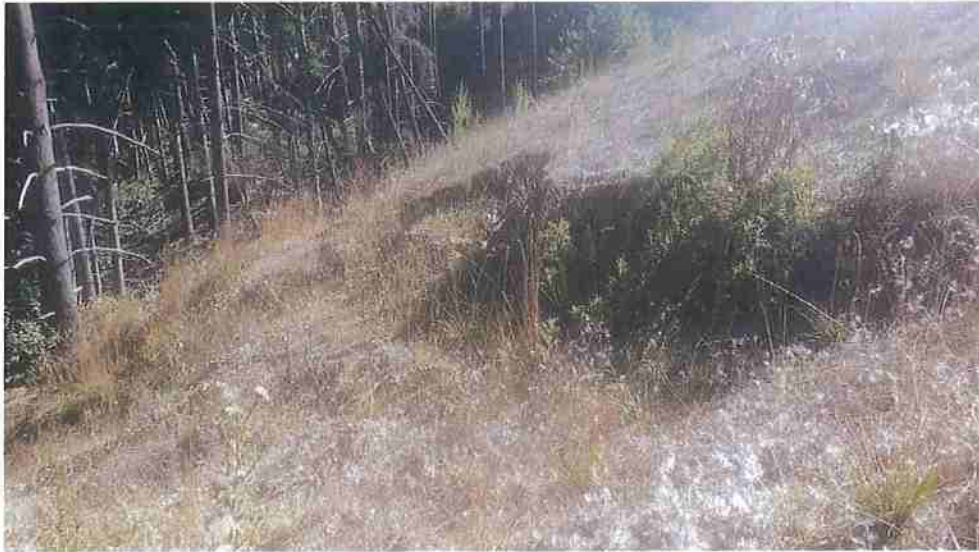
Figure 13. Photograph showing the area north west of the impoundment where sloughing is occurring during saturated events. The sloughed material has migrated down slope onto a road that is hydraulically connected to a watercourse. Approximately 5 yards of material sloughed off the fill bank onto the road and is being transported towards the stream during rain events. Approximately 5 yards of rock slope protection will be place to stabilize the bank in this location.

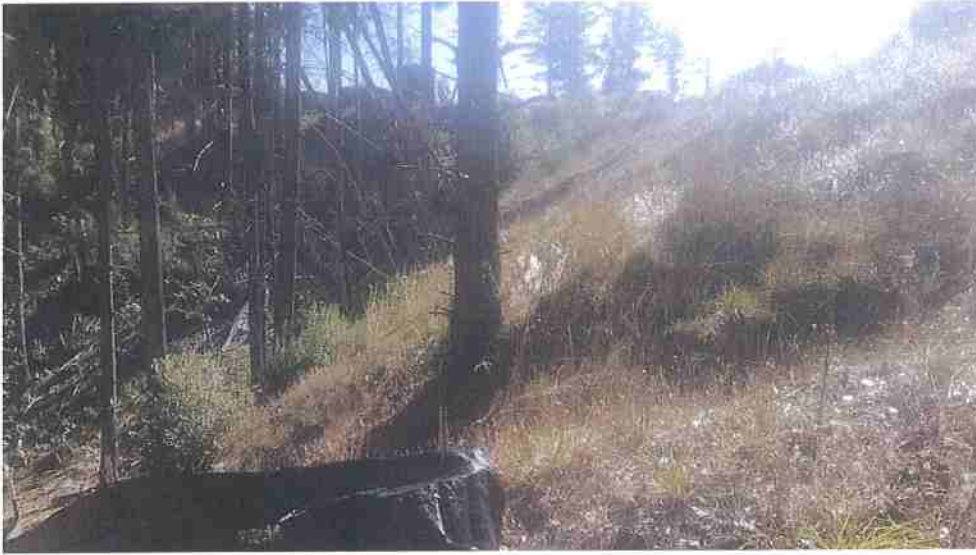
Figure 14. Photograph showing the slope below the impoundment structures north side. Sloughing is occurring during ground saturating rain events. The sloughed material has migrated down slope toward a watercourse. The sloughing will continue and the material will continue to migrate down slope unless addressed which starts approximately 75 feet below is a swale. Approximately 75 yards of material from the fill-slope has slumped and is migrating down slope into the swale. The interim plan will be to place sheets of plastic used to cover the fill slope. The sheets of plastic are to be held down by sand bags. The permanent plan will be to stabilize the fill-slope by removing the organic matter from within the limits of fill, recompact in place and placing approximately 75 yards of rock slope protection (RSP) on the fill sloped. The RSP will be keyed three feet into original ground.

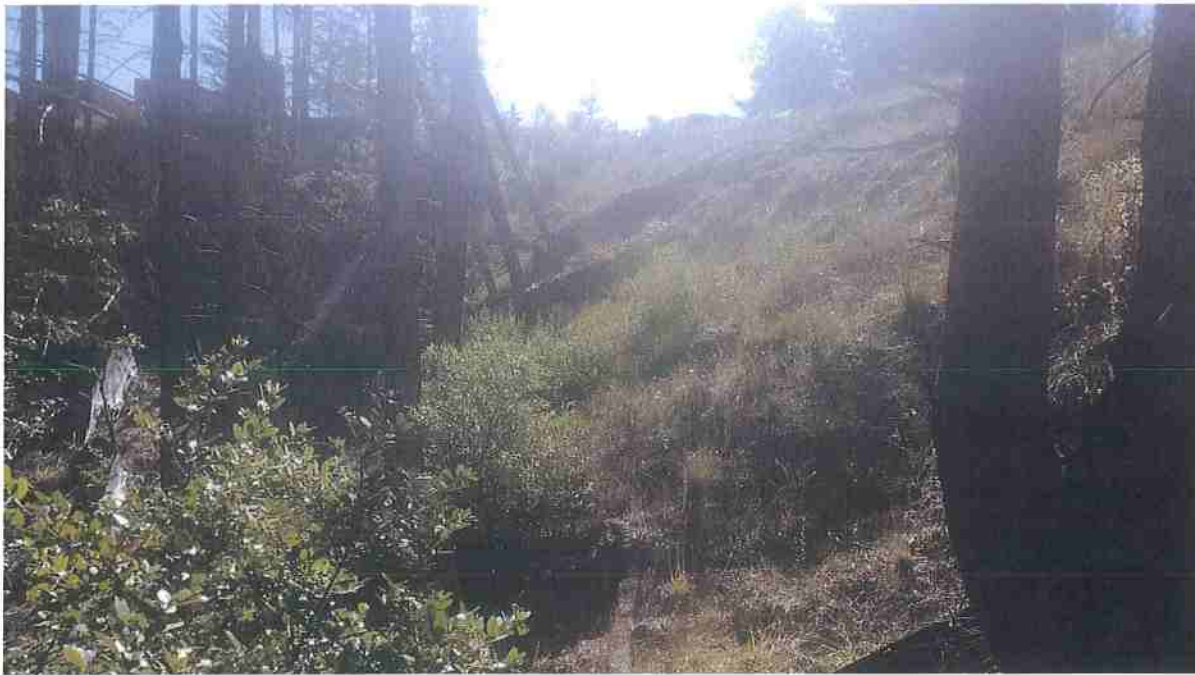
Figure 15. Photograph showing the sloughing that is occurring on slope below the rainwater impoundment north side. The sloughing will continue and the material will continue to migrate down slope unless addressed. The organic material within the limits of the fill shall be removed, the fill-slope shall be compacted in place and approximately 75 yards of rock slope protection (RSP) on the fill bank shall be placed. Much of the sediment transport is due to runoff from an increase in impermeable area at Site 2. I propose constructing a drainage ditch to prevent the increased runoff from Site 2 from flowing toward the north to Drainage 1. The drainage ditch will drain to the rain water impoundment structure which will drain to a bio-swale. The bio-swale will also be constructed to drain to the rainwater impoundment structure toward the hill side to the south. The bioswale shall be constructed so that the impoundments effluent water is dispersed to the hillslope where slopes are approximately 35%. The bioswale shall be a 6 feet wide, approximately 100 feet long and will be sloped at 5%. The bioswale shall be set 2 feet below the ground level and the bottom lined with 6 inches of rock.

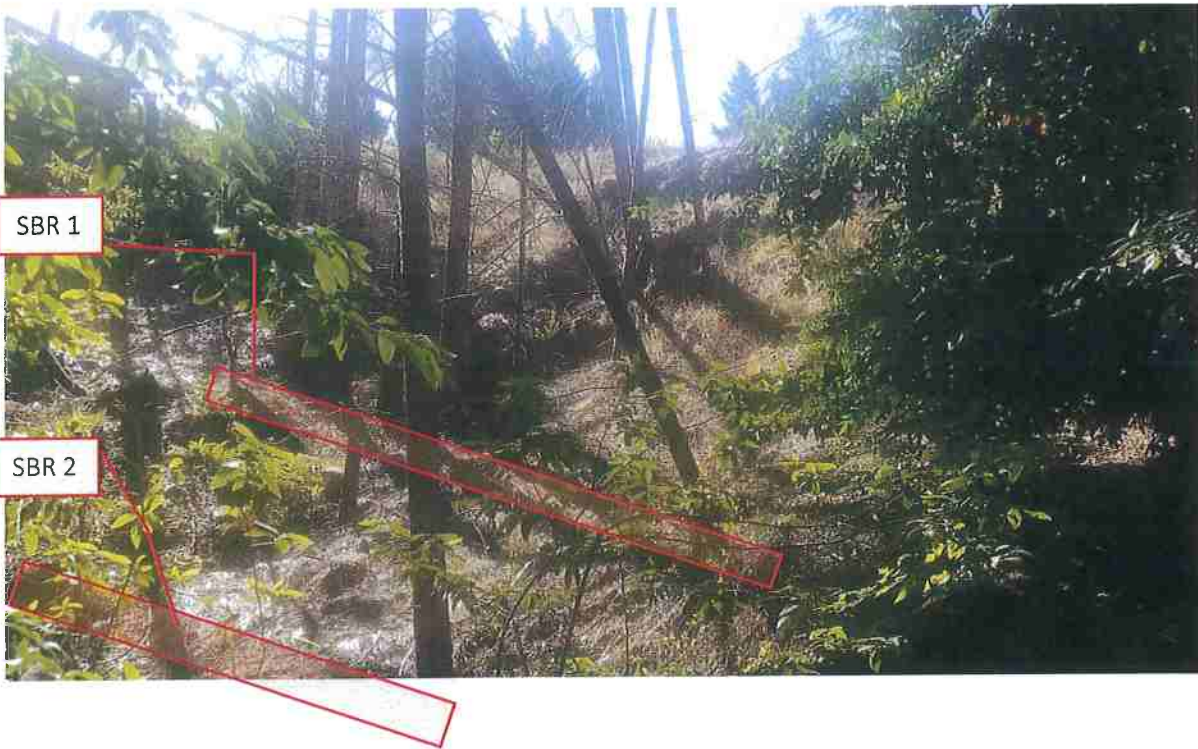
Figure 17. Photograph showing the slope below the impoundment where sloughing is occurring. The sloughed material has migrated down slope toward a watercourse. The sloughing will continue and the material will continue to migrate down slope unless addressed. To address the sloughing before the rainy season, I propose constructing straw bale rows (SBR) to capture potential sloughing materials. The red rectangles in the photograph show the suggested locations of the placement of straw bale rows.

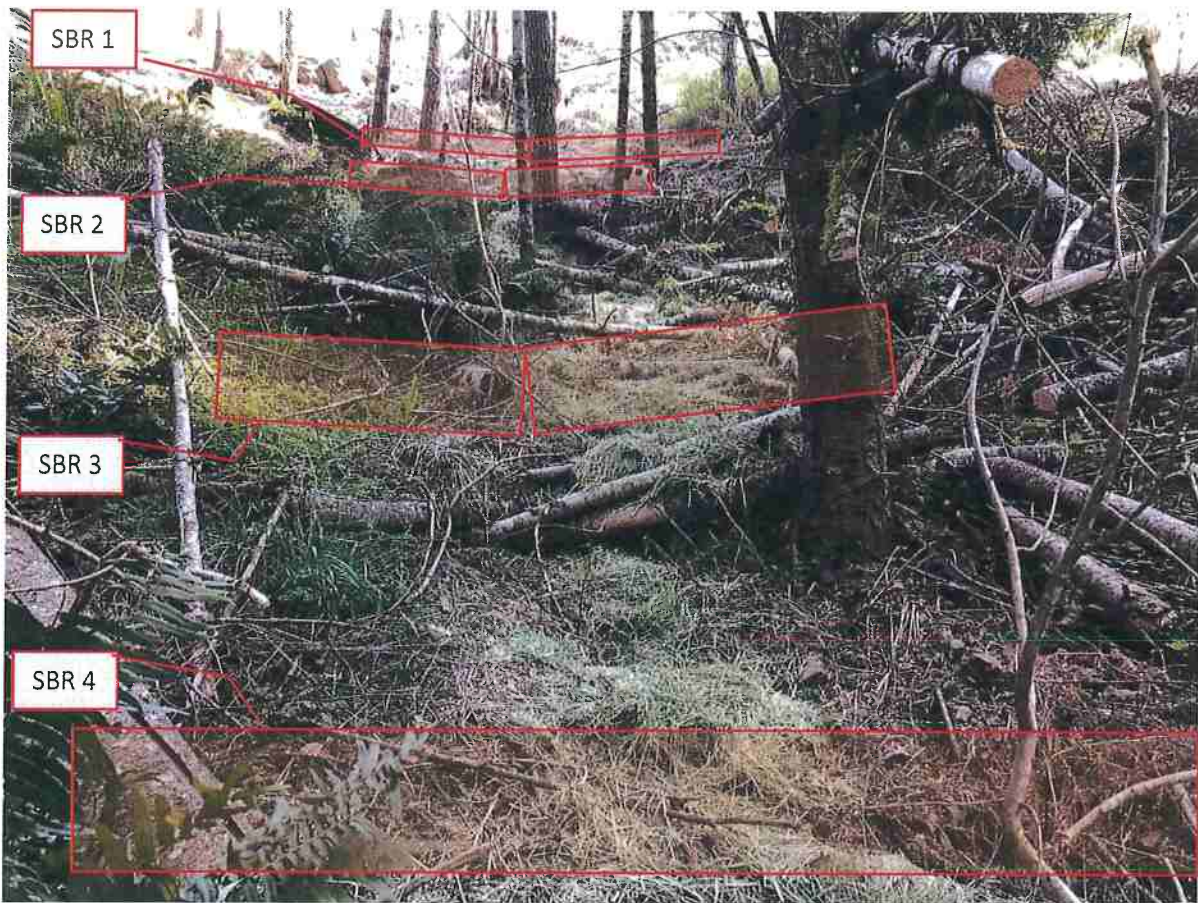
Figure 18. Photograph showing the slope below the impoundment where material is migrating downslope into the drainage below. Clear Ag-Services put into place temporary stabilization efforts implementing Stanslee Certified straw to cover exposed soils along with cut logs placed within the flow path. The red rectangles show the proposed placement of four straw bale rows within the flow path that shall be place as preventative measures for potential sediment transport.

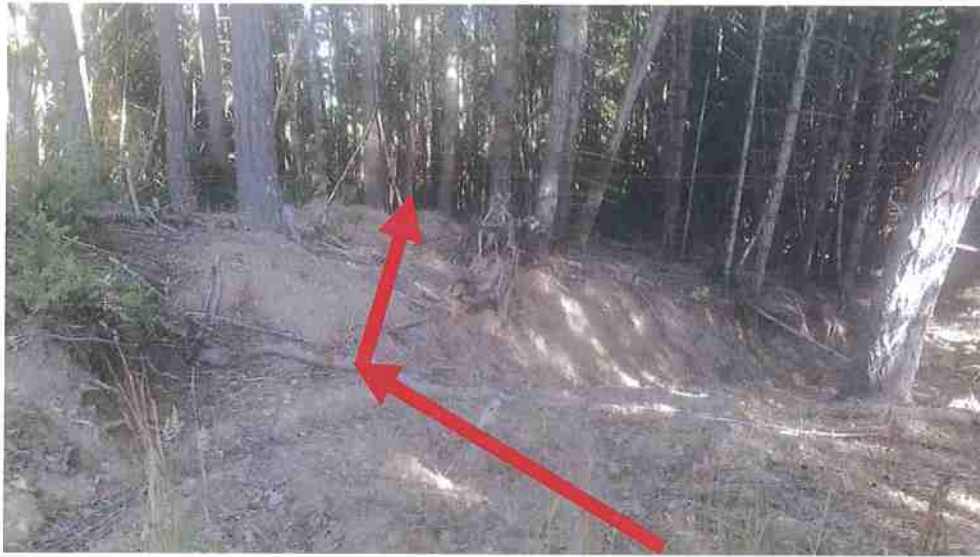
Figure 19. The road leading to below the rainwater impoundment (Violations 1, 2 & 3) is transporting sloughed material into the stream channel. The road shall be disconnected from the stream channel by constructing a oversized water bar in the location shown.

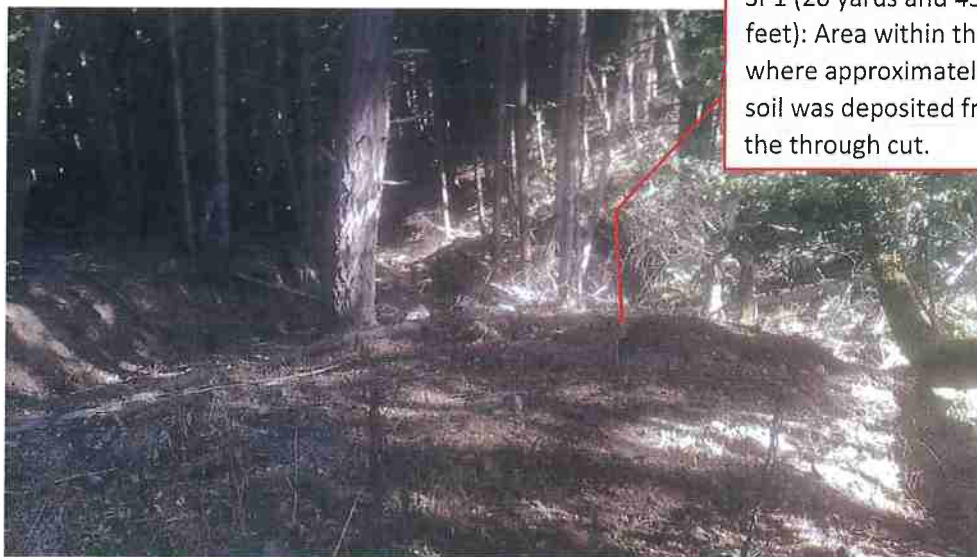
SP1 (20 yards and 450 square feet): Area within the drainage where approximately 20 yards of soil was deposited from creating the through cut.

the debris and place it on the access roads cut bank to create the original contour. No trees will be removed during the process of relocating soil pile SP1.

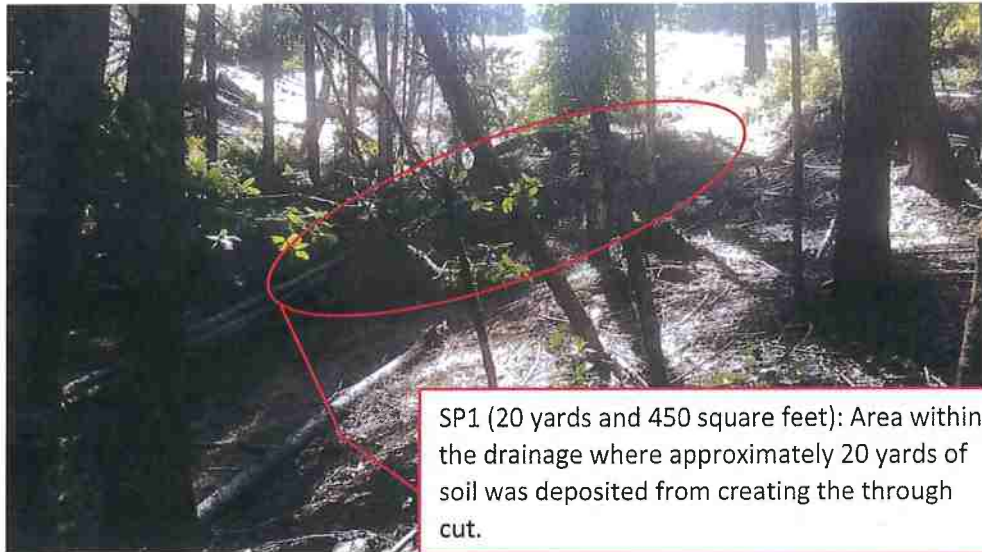
Figure 21. Photograph showing the access road leading towards the drainage that materials are being transported along. The access road was created as a through cut generating approximately 35 yards of material that was pushed into the drainage along with 8 fir trees and other organic material. The access road was created to access an old logging road that has four buildings located along its path (see Site Map, Buildings 1-4).

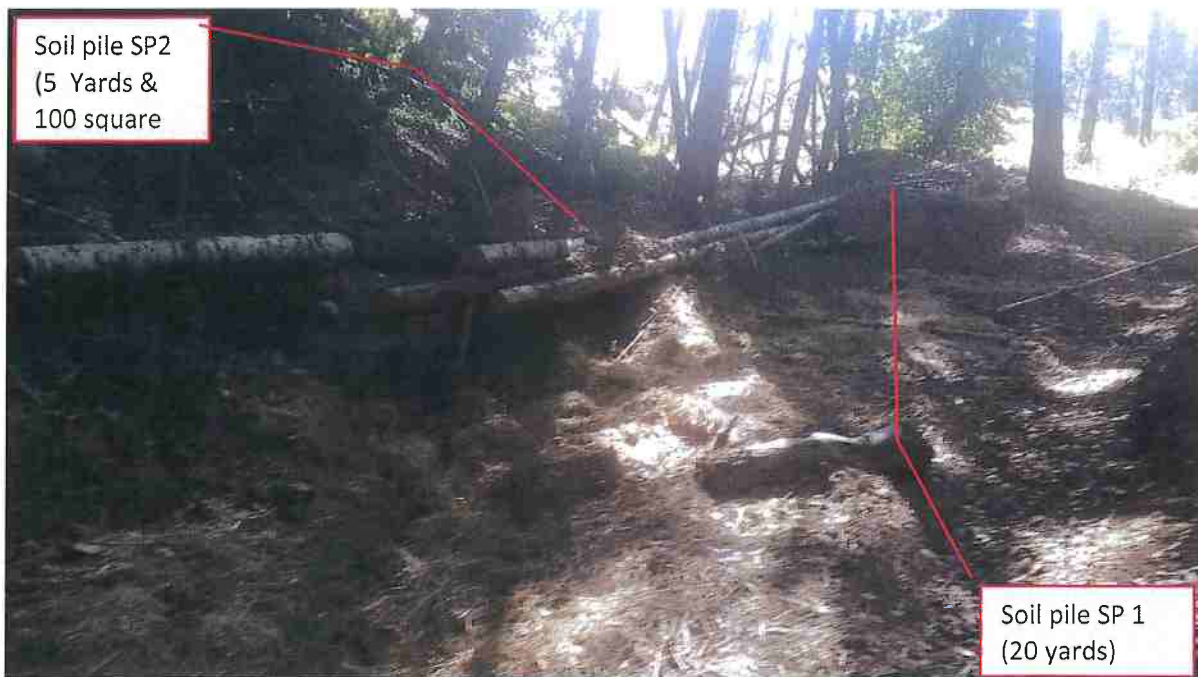
Figure 22. Photograph showing the access road where it enters Drainage 1. Organic debris and soil piles SP1 and SP2 are shown. The soils piles will be excavated and places on the road to rebuild the hills original contour. Soil pile SP2

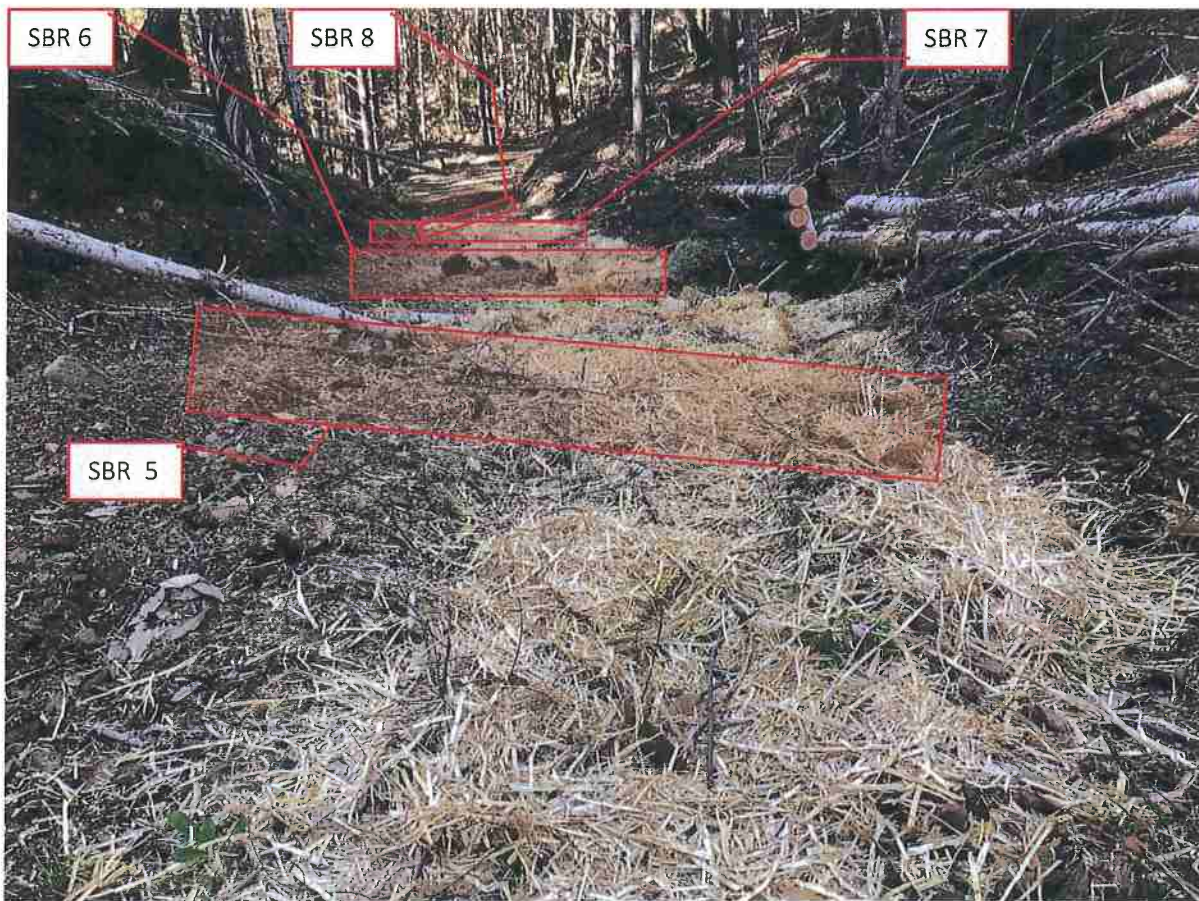
Figure 23. Photograph showing the access road below the impoundment structure where it enters the flow path of the drainage. The access road runs for approximately 80 feet in the drainage and flow path before exiting the drainage toward the east. The red rectangles show the placement locations of four proposed straw bale rows (SBR 5-8).

Soil Pile 3 (5 yards & 100 SF): Location of pushed fill during the construction of access the road. The permanent remediation will be to remove the road and reconstruct the stream bed. The fill is to be excavated and placed in the though cut and access road in the drainage so that they are reshaped to their natural contour.

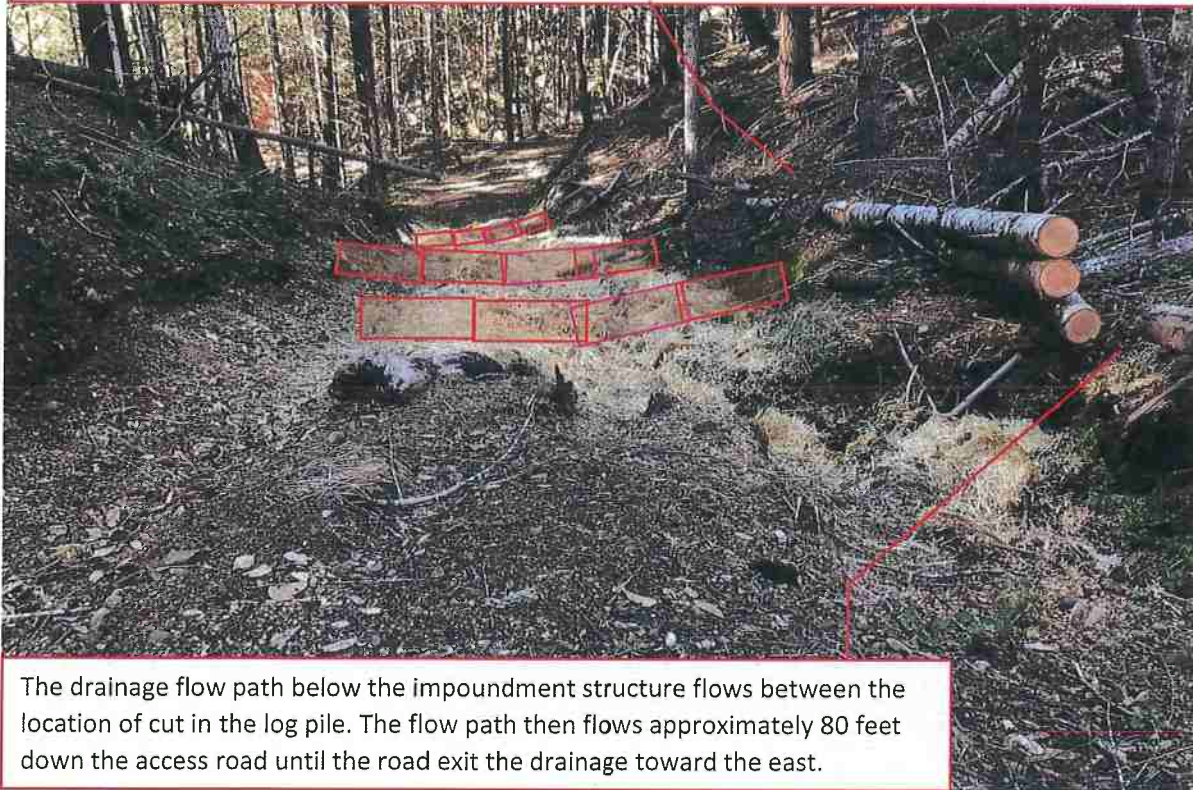
The drainage flow path below the impoundment structure flows between the location of cut in the log pile. The flow path then flows approximately 80 feet down the access road until the road exit the drainage toward the east.

Figure 24. Photograph showing the access road below the impoundment structure where it enters the flow path of the drainage. The access road runs for approximately 80 feet in the drainage and flow path before exiting the drainage toward the east. The red rectangles show the placement locations of three proposed straw bale rows. The permanent remediation of the drainage will require pulling the transported material

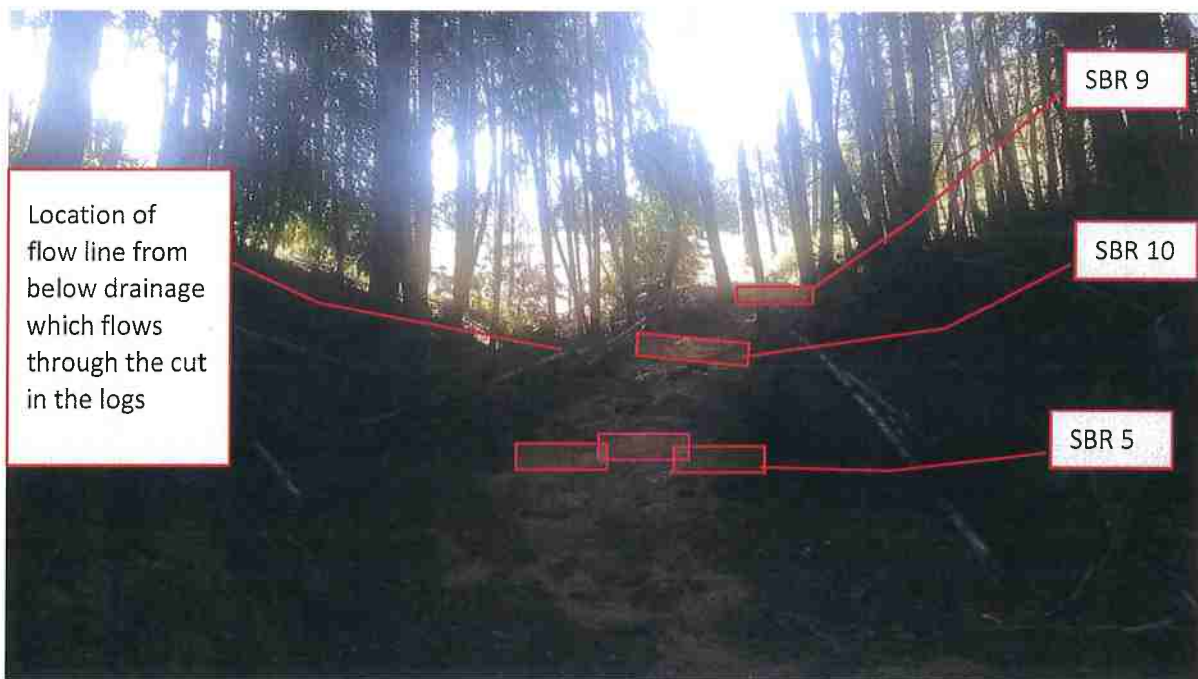
Figure 25. Photograph taken looking up at the impoundment structure from the access road below showing the through cut and material pushed into the drainage. The red rectangles show the proposed location of three rows of straw bales.

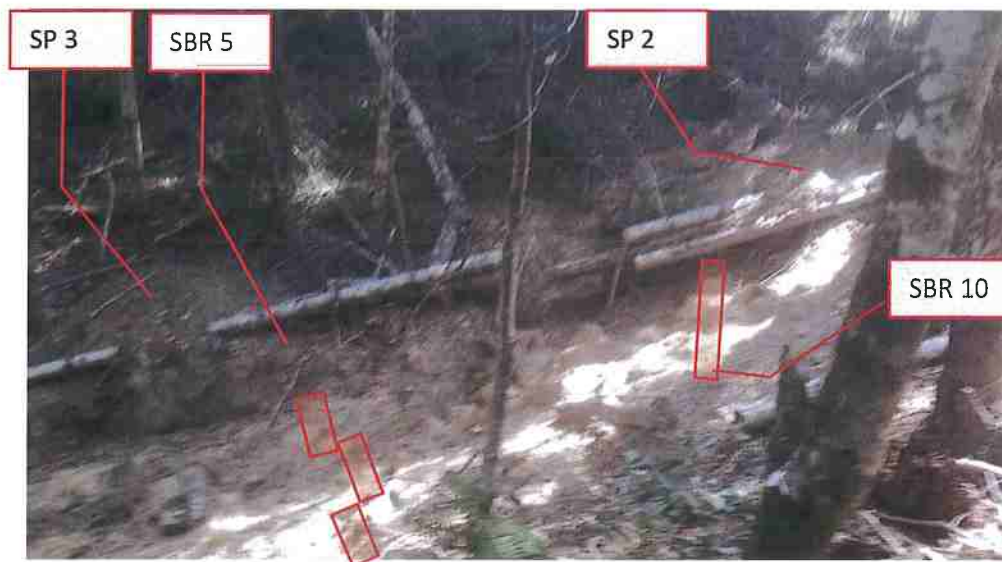
Figure 26. Photograph showing where the access road enters Drainage 1 and the proposed placement location of two straw bale rows. The proposed locations of straw bale rows SBR 10 and SBR 5

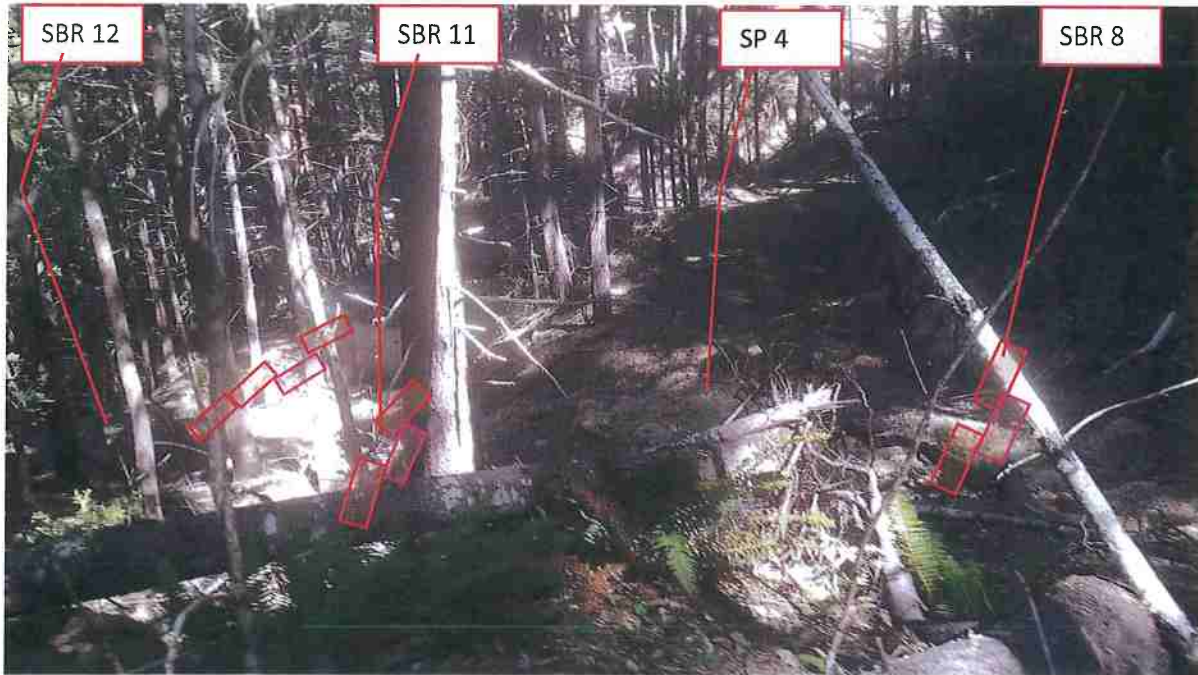
Figure 27. Photograph showing where the access road exits the drainage below the impoundment structure toward the east leaving drainage 1 and heading toward drainage 2. The drainage flow path flows to the west side of a structure that is situated on an old logging road (see Site Map, Building 2). The red rectangles above show the proposed placement locations of proposed straw bale rows SBR 8, 11 & 12 along with soil pile SP 4. The proposed straw bale rows will be used to collect potential transported sediment and act as velocity dissipation. Soil pile SP 4 consists of approximately 5 yards of soil that spans 60 square feet that was placed as the access roads fill in order to make the turn out of the stream channel.

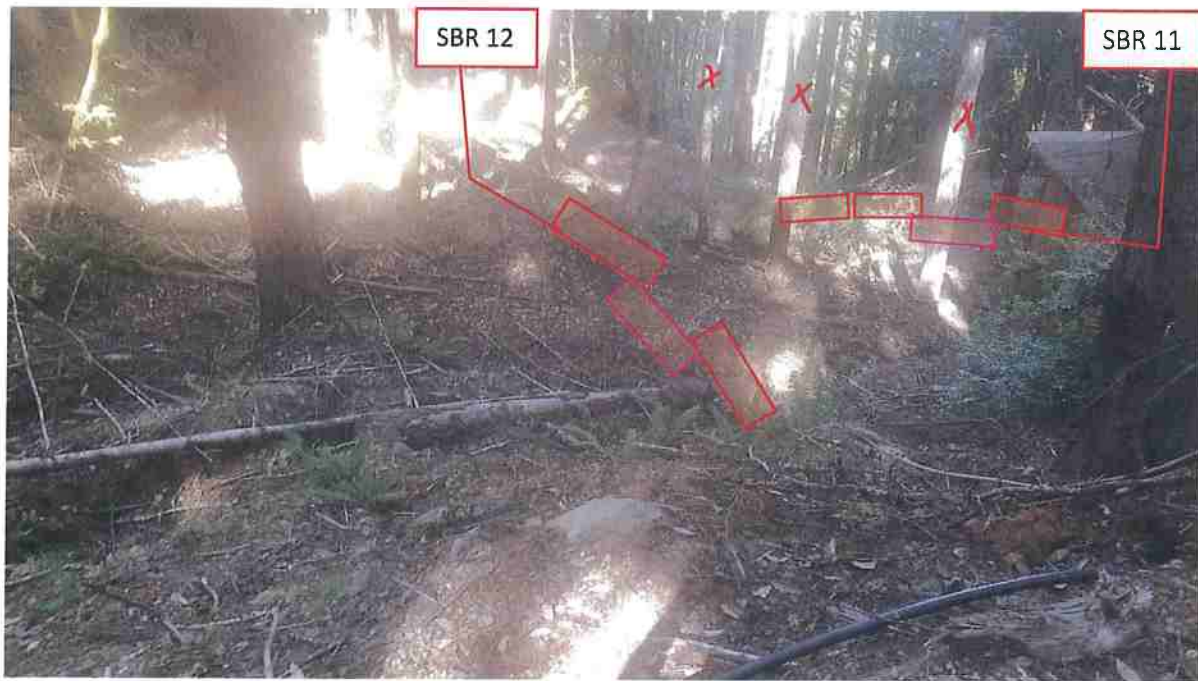
Figure 28. Photograph showing the drainage flow path between the access road and the old logging road that Building 2 is situated on. Two rows of straw bales are proposed as being placed with locations shown by the red rectangles as part of the interim plan. The proposed straw bale rows will collect potential transported sediment. Approximately five yards of material from sloughing that occurred at the top of the access road has been transported down gradient by runoff from a hydraulically connected road network. The permanent remediation plan for the area will be to reconstruct the stream channel for approximately from 20 feet upgradient (south) of where the access road accessed the stream channel to the approximately 30 feet below the logging road and area below Buildings 1-4 (see Site Map). The stream starts approximately 20 feet above the access road and flows north before intersecting with the access road to flow another 60 feet before the access road exits the drainage. The stream then travels another 40 feet before flowing a crossed an old logging road to drop 25 feet to the channel below. There are no signs of erosion on the downhill side of the fill bank. Approximately 5 yards of soil has been transported by the stream onto the old logging road and around Building 2. Building 2 will be deconstructed and the channel will be reconstructed by removing three Douglas fir trees. Approximately 15 yards of fill will be pulled back onto the access road to create the hillslopes original contour in the area the photo was taken.

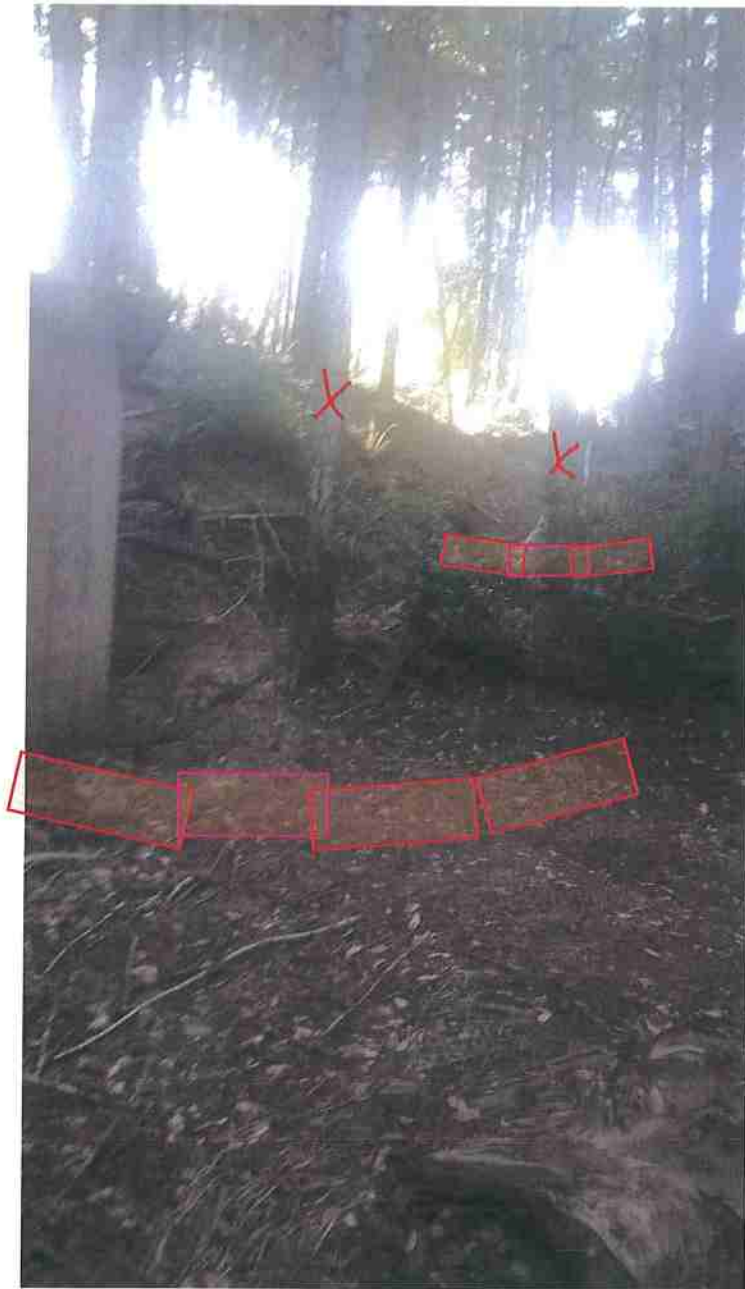
Figure 29. Photograph taken looking toward the south up the drainage flowline from the old logging road. Building 2 can be seen at the west side of the flowline where transported soil from the stream crossing has collected against the structure. The proposed location of two temporary rows of straw bales is shown by the red rectangles. The permanent remediation for the logging road removal will be to reconstruct the stream channel by pulling 20 yards of soil from the within the road surface so that the channel is set to original grade and contour. Approximately 8 yards of soil will be removed from the area above the cut bank.

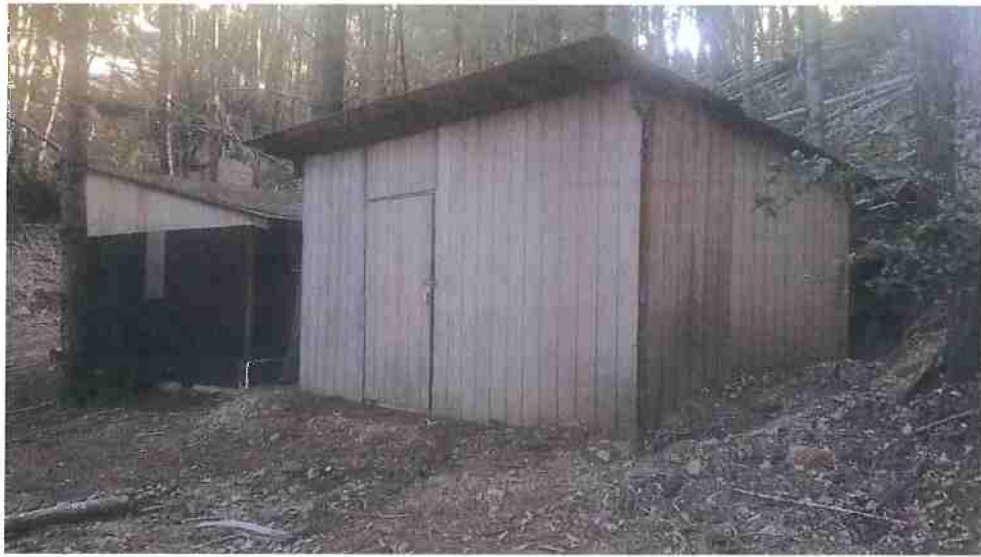
Figure 30. Photograph taken looking north-east showing Building 2 and Building 3. Soil has been transported onto the base of Building 2 from the access road over the years.

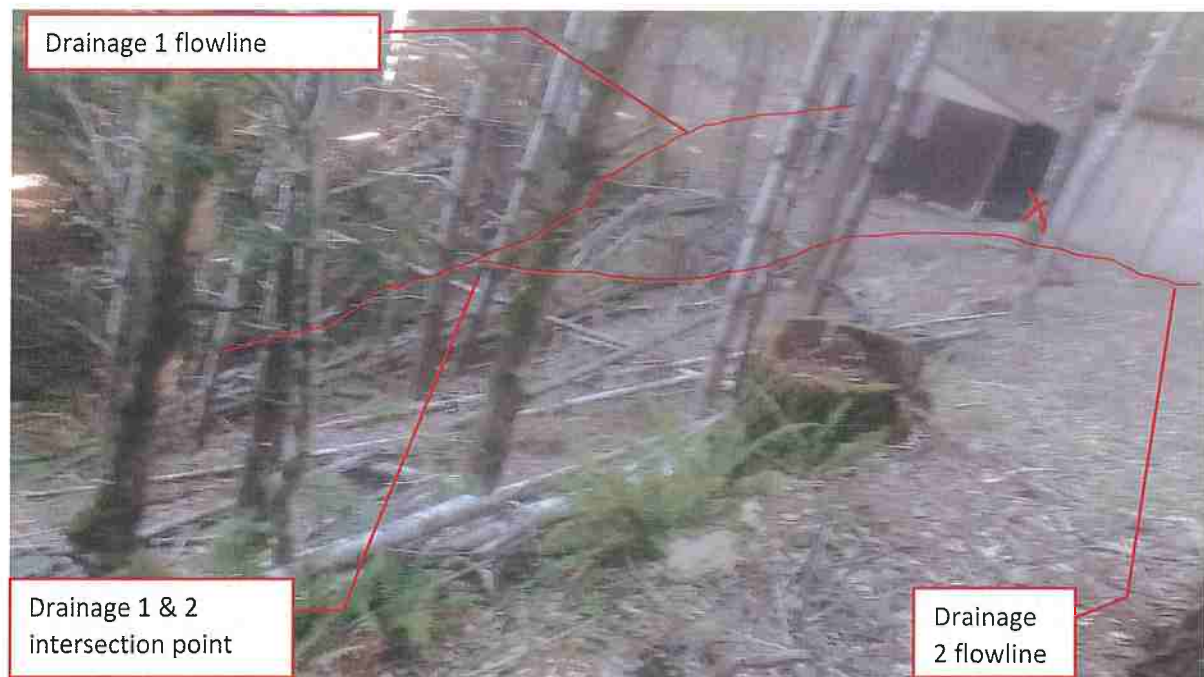
Figure 31. Photograph showing the drainage below the old logging road that the access road accesses. Building 2 and Building 3 can be seen in the upper right-hand corner and will be removed. A second drainage flow path is situated beyond the buildings shown. The two drainages intersect approximately 10 feet below the road prism toe of the old logging road. The permanent remediation plan proposes reconstructing the two channels in the area of the logging

road. Channel 1 will disturb approximately 60 linear feet of channel in drainage 1 and 130 linear feet in channel two. The area disturbed for reconstructing the channel will be approximately 1,200 square feet in Drainage 1 and 20,000 square feet in Drainage 2. Reconstruction of Drainage 1 will necessitate the excavation of approximately 20 yards of material from Drainage 1 and 60 yards out of Drainage 2.

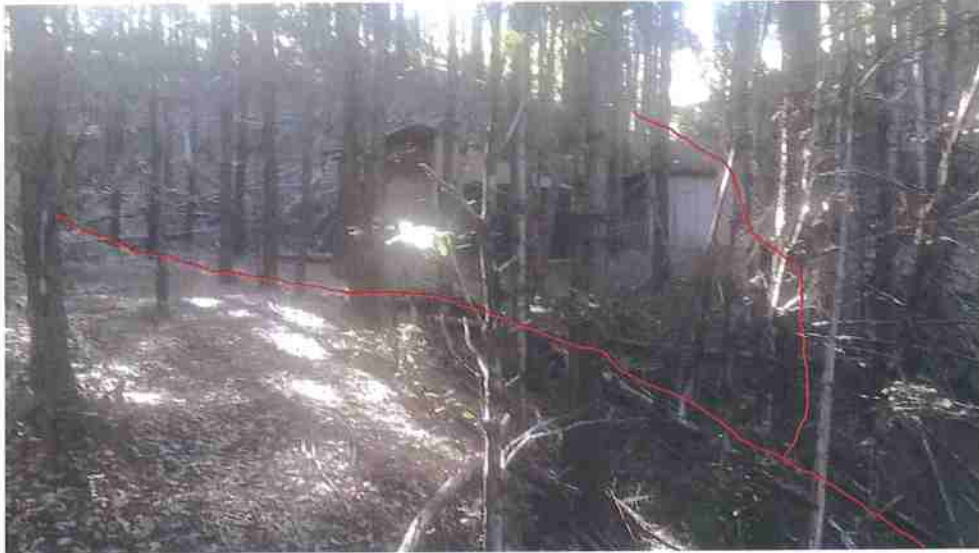
Figure 32. Photograph looking south showing the old logging road, access road, Building 2, Building 3 and the two drainages that intersect approximately 40 feet below the logging road (redline denotes the flow paths). Building 2 and Building 3 are not being used as cannabis.

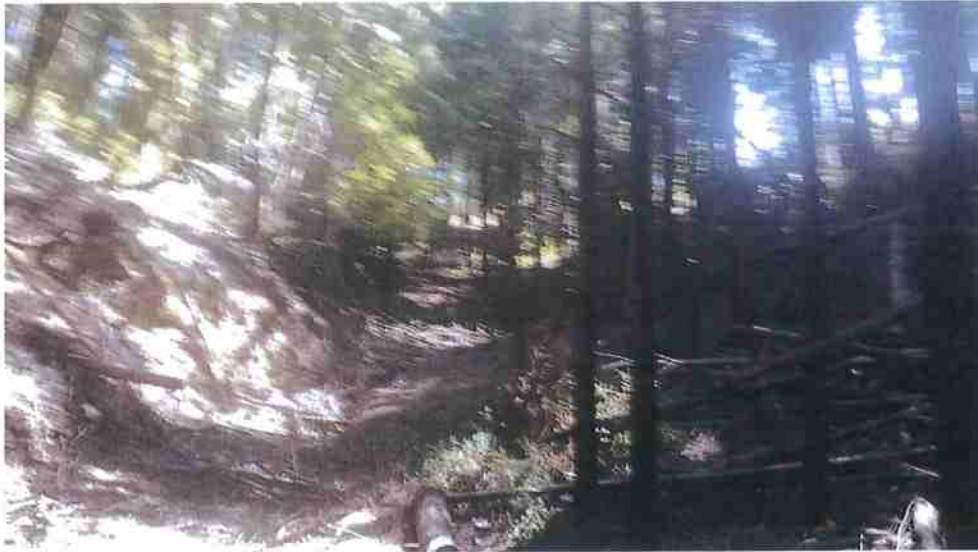
Figure 33. Photograph looking east from the logging road at Drainage 2. The road runs for approximately 100 feet up the drainage before turning to the south. An interim plan was implemented in the spring of 2019 which consisted of placing logs and brush in the flow path. The interim plan implemented in the spring is sufficient for preventing erosion until the permanent plan is implemented. The permanent plan consist of reconstructing the stream channel by excavating the access road to the original contour and placing the material on the access road out of the drainage. The construction of the road in the stream course disturbed an approximately area of 1200 square feet. Approximately 30 yards of soil was pushed into the stream channel from construction of the access road.

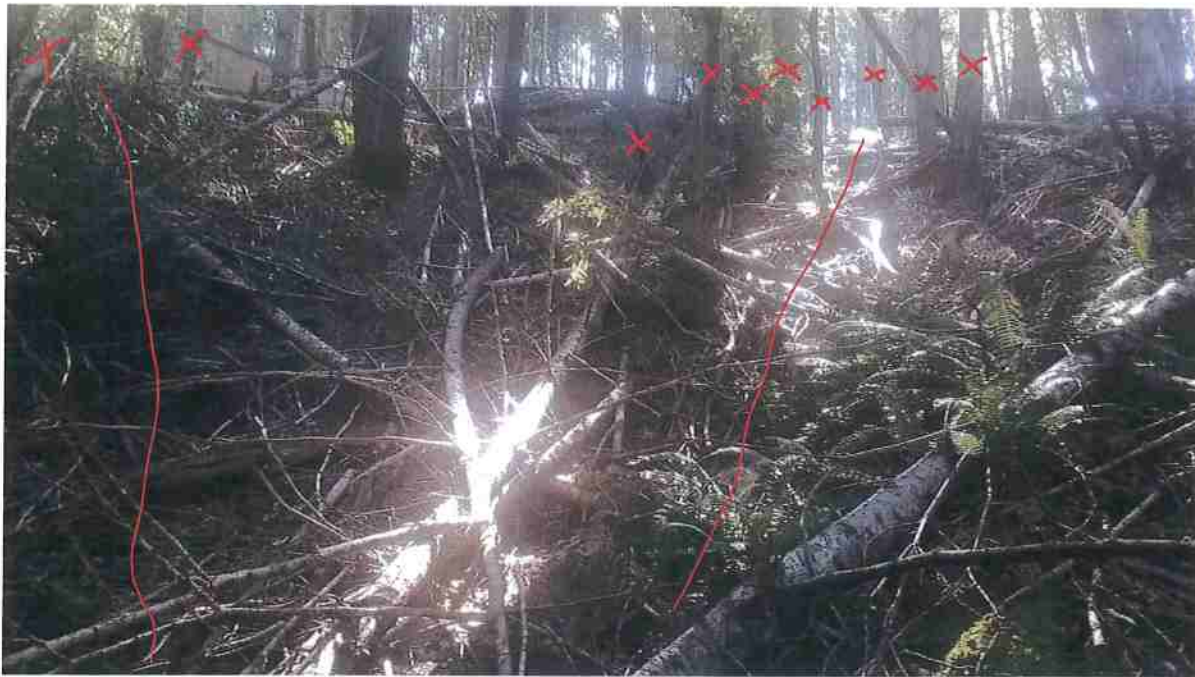
Figure 35. Photograph looking north showing the flowlines located at Drainage 1 and Drainage 2. The red X's mark 10 oak trees that will need to be removed to rebuild the two drainage channels to their original contours. All organic materials will be stockpiled out of the construction area and then will be placed back on after reconstruction of the channel is complete.

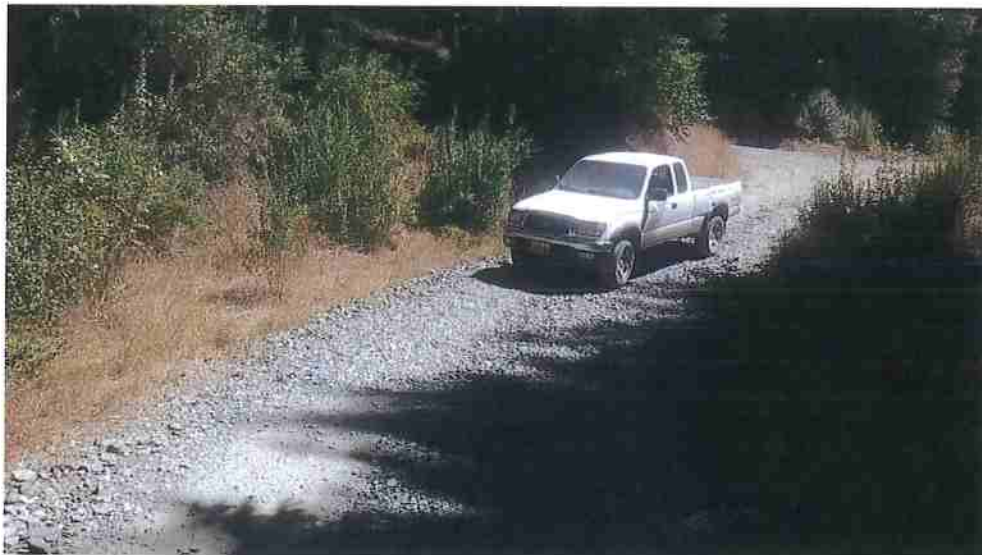
Stream Crossing SC2

Figure 40. Photograph of stream crossing CS2 (40.2564, -123.7777) which is approximately 200 feet south west of the impoundment on the main access road leading to Site 3. At this location there is no channel above the road and a channel starts approximately 30 feet below the road prism toe of fill. There are no signs of erosion at this location. The road is within the SMA area and a rockford currently exists that lacks rock on the downhill fill slope. The road is to be rockford for approximately 50'

in both directions from the crossing with 6 inches of road base. Refer to Chapter 4 Section 4 and Chapter 5 Section I.2 of Weaver et al. (2015) Handbook for Forest, Ranch and Rural Roads: A guide for planning, designing, constructing, reconstructing, upgrading, maintaining, and closing wildland roads for recommendations and best management practices associated with forest road bridge design.

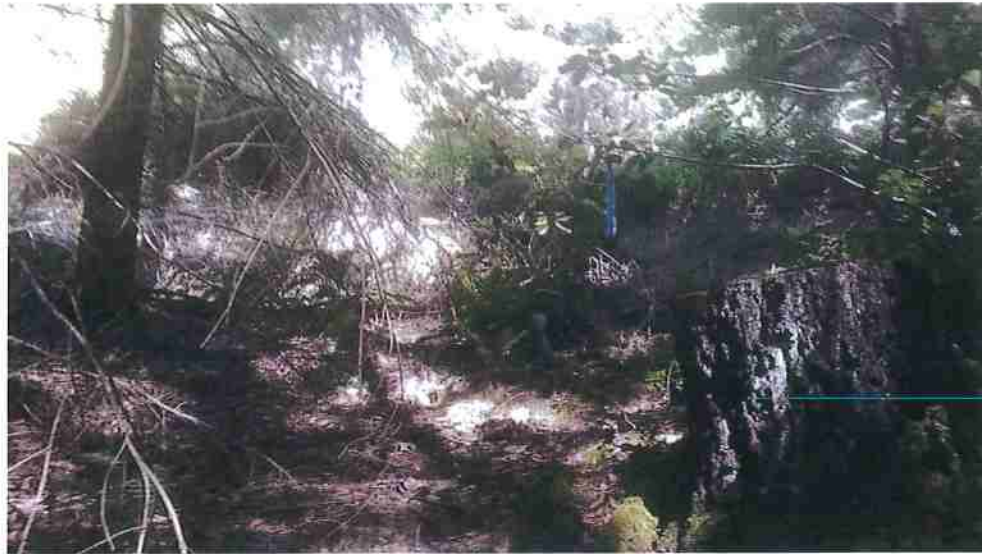
Figure 43. Photograph from the stream channel below the rolling dip (CS2). No channel is present below the road prism and the stream starts 30 feet below the toe of the roads prism.

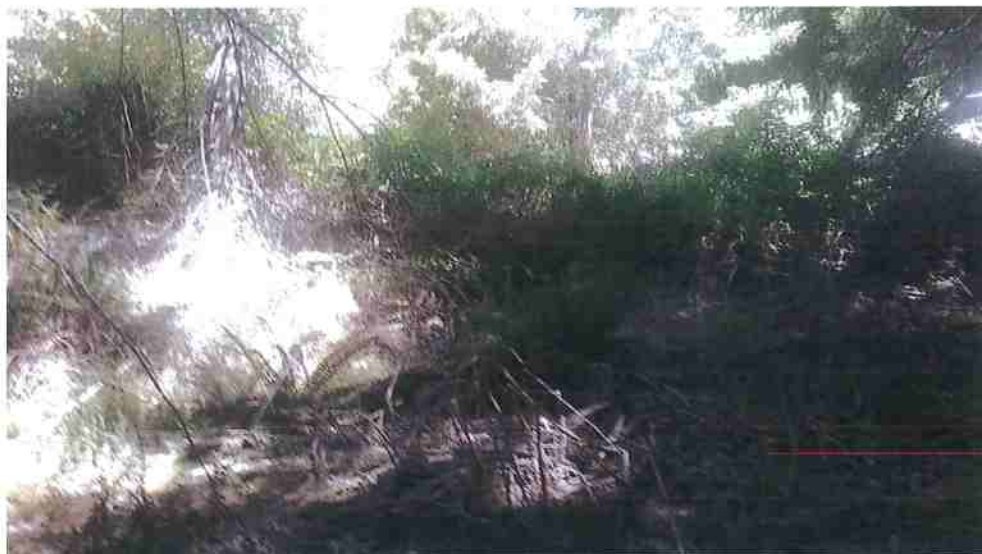
Figure 44. Photograph showing the road prism. The fill bank shall be rocked with 6-12 inch rock slope protection (RSP) placed on a non-woven geo-fabric. 10 raspberry plants and 1 Sword Fern will be removed during the placement of the RSP
